**2019 Annual Land-Use Covenant
Inspection Report
for DOE Areas at the Laboratory
for Energy-Related Health
Research/Old Campus Landfill
Superfund Site
University of California, Davis**

January 2020

**U.S. DEPARTMENT OF
ENERGY**

Legacy
Management

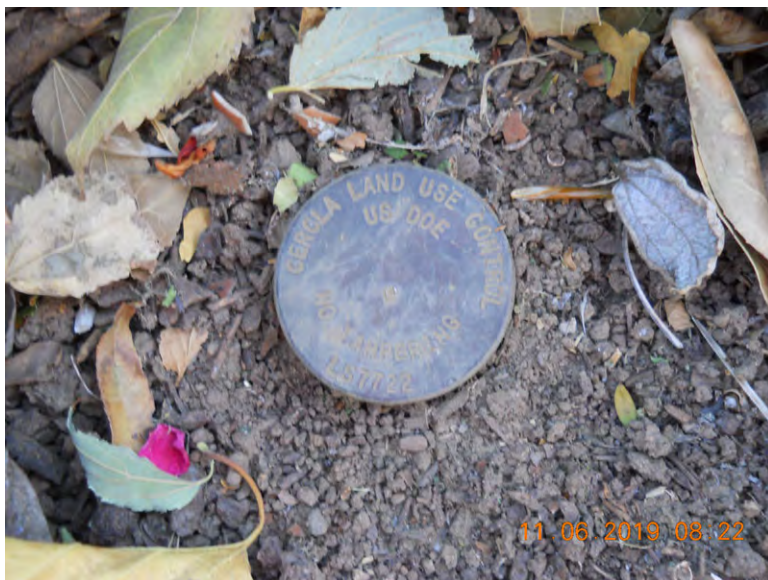
Monument No.	Close-up Photo ¹	Setting Photo ²	Damaged or missing? (Y/N) If Y, explain	Comments
1	3792	3793	N	
2	3794	3795	N	
3	3796	3797	N	Needs new cone cone disposed TRM 11-8-19
4	3798	3799	N	
5	3818	3819	N	
6	3807	3808	N	
7	3820	3821	N	
8	3824	3825	N	
9	3822	3823	N	
10	3841 3842	3842 3843	N	
11	3843	3844	N	
12	3845	3846	N	
13	3847	3848	N	
14	3849	3850	N	
15	3851	3852	N

Survey Monument 3: Southwest corner of Dry Wells A–E Area
(Photo No. 3796).

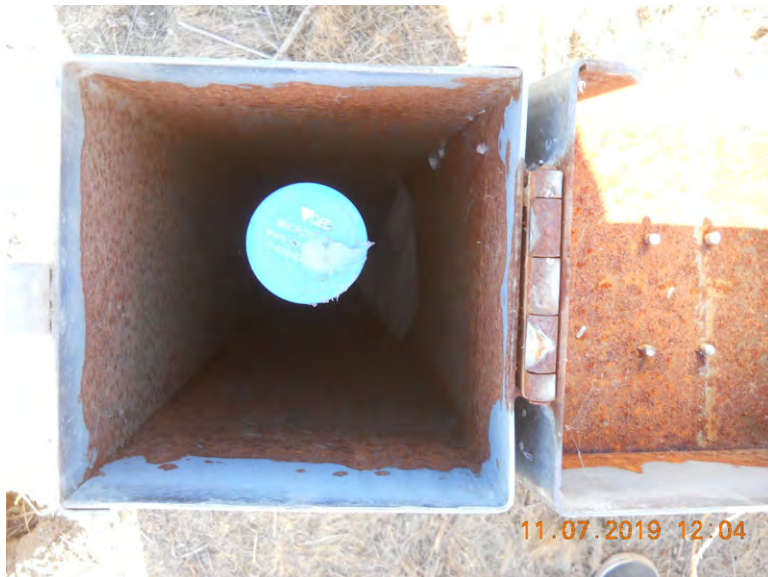
UCD1-063 Interior (Photo No. 3959).

*UCD1-063 Interior plaque missing;
no photo.*

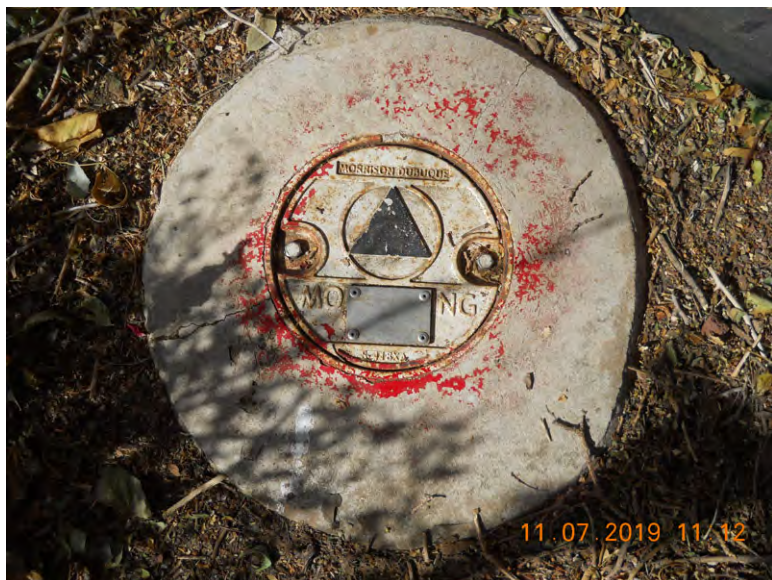
RD/RA Work Plan (DOE 2010). The pump in well UCD1-073 pumped at the low end of the target flow range but was deemed acceptable. Pump port plugs were noted to be missing in well UCD1-071 (Appendix A).

UCD1-071 Wellhead (Photo No. 3947).

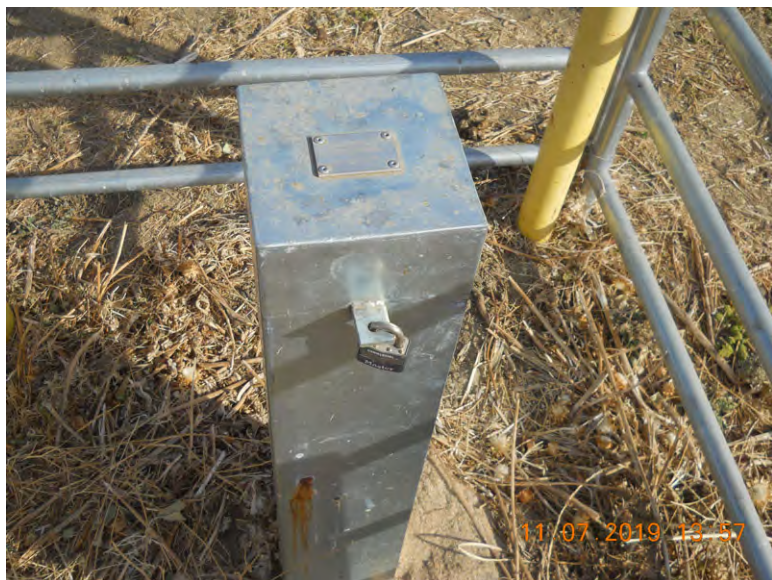
UCD1-073 Wellhead (Photo No. 3964).

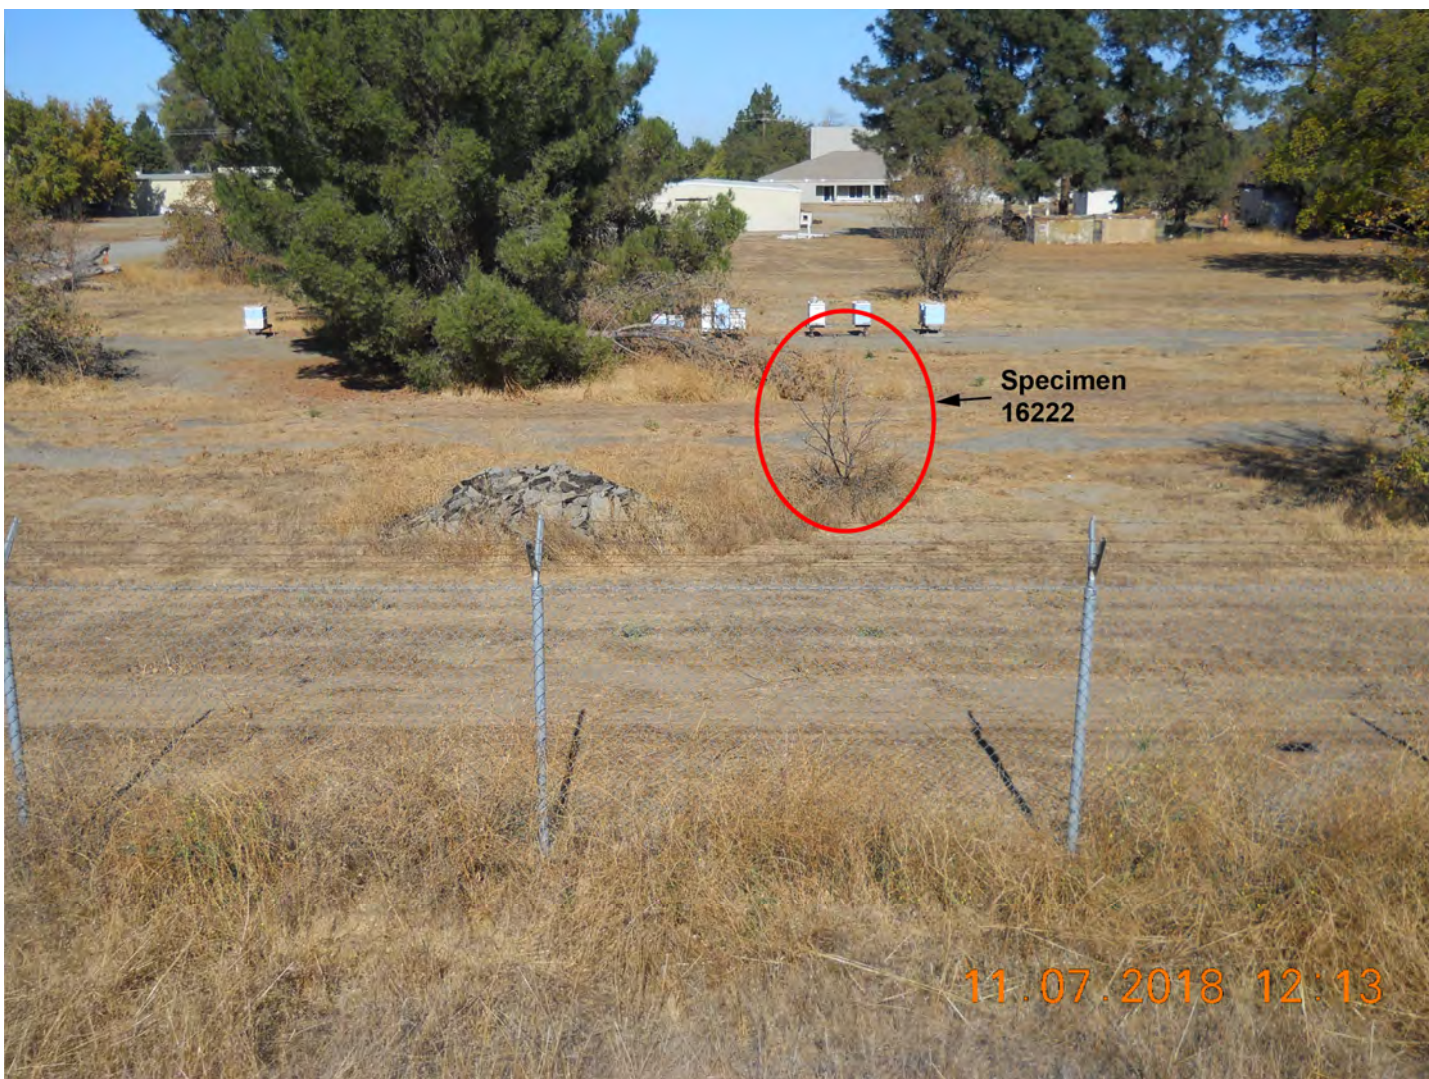
All trees and shrubs identified in the survey were located during the inspection except a small elderberry shrub (Survey ID 16222) that was found dead and fallen in the EDPs Area (Appendixes E2 and E3). On the basis of historical file photographs, this specimen was an elderberry shrub about 6 feet tall (identified herein as Specimen 16222). The elderberry appeared healthy in 2017 but was dying or dead in 2018 (Appendix E3). The remains of Specimen 16222 were located and photographed, and the survey map and table were updated to indicate this tree as being dead and fallen as of November 2019. Specimen 16222 branches (no leaves were observed) were placed in a plastic bag and will be sampled according to SMP requirements. Per the SMP, DOE will develop a separate report documenting the sampling results and disposition of the plant material and provide this report to the Environmental Health and Safety (EH&S) Unit at UC Davis. The tree and shrub survey table (Appendix E1) and figure (Appendix E2) from the SMP have been updated to reflect the removal of Specimen 16222.

2018 inspection; view north; Eastern Dog Pens Area from
North Levee; Specimen 16222 right of center; dying or dead (Photo No. 3691).

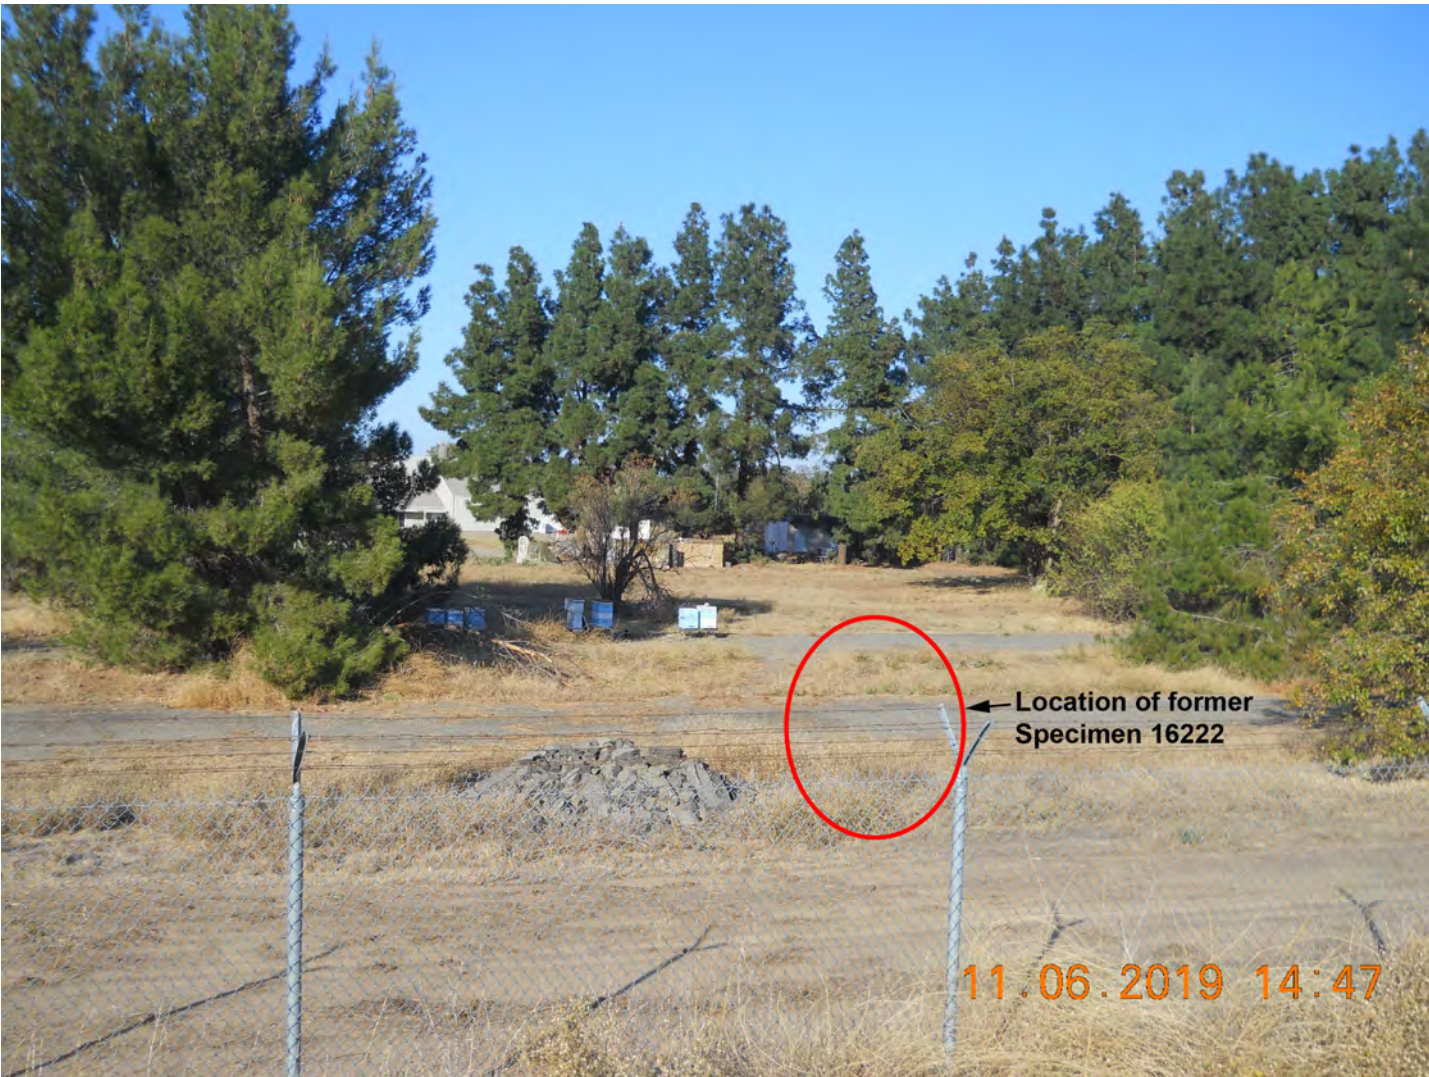
2019 inspection; view north; Eastern Dog Pens Area from North Levee; Specimen 16222 not visible (Photo No. 3910).

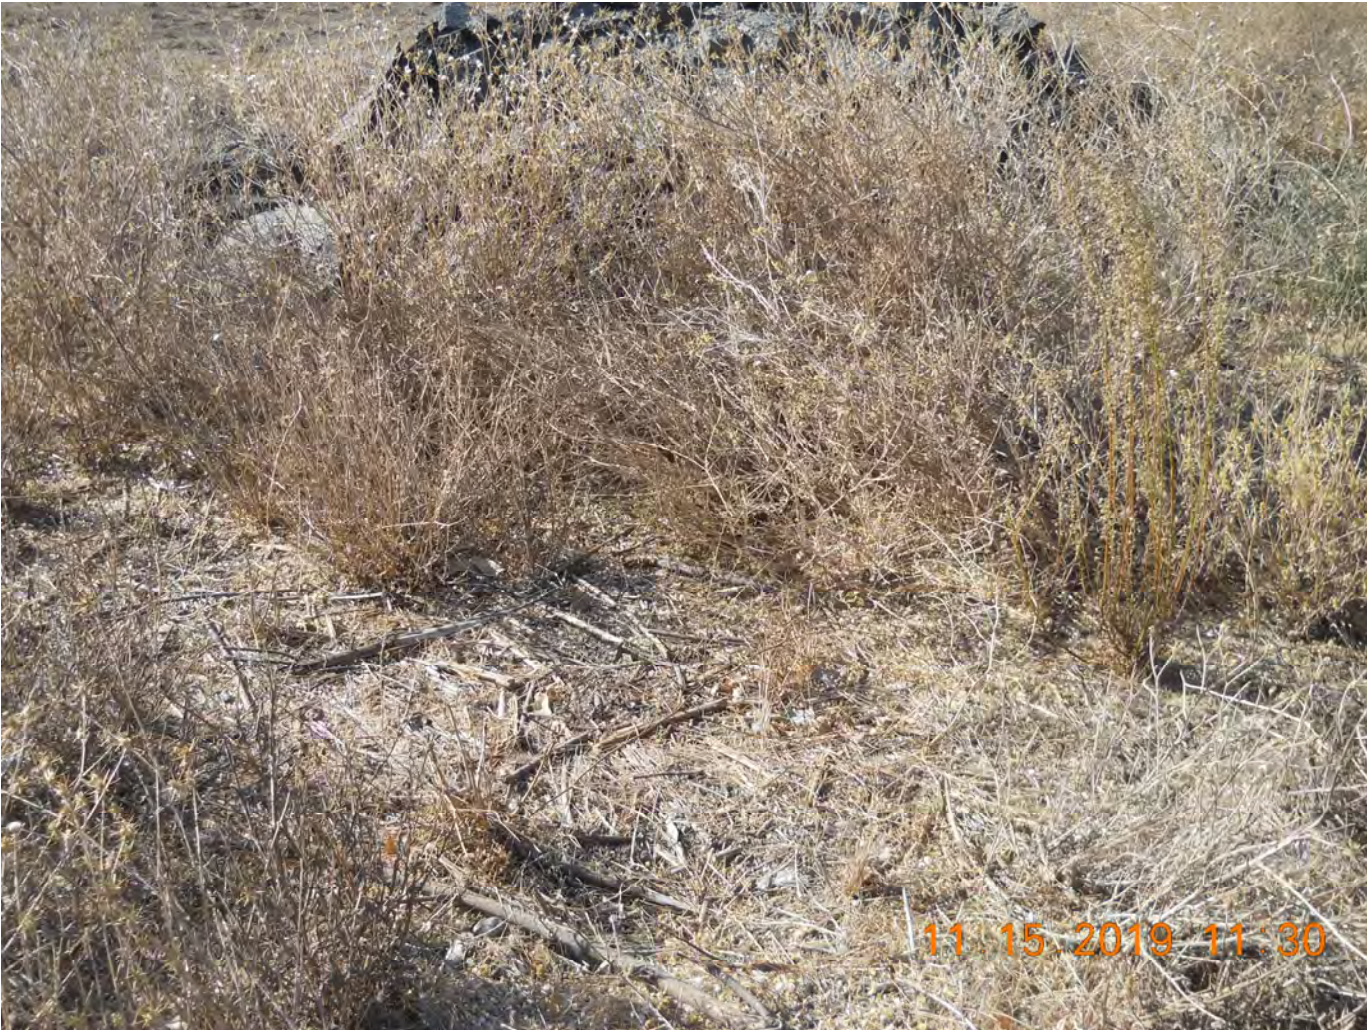
View west; Specimen 16222 remains at bottom of photo; asphalt pile at top of photo (Photo No. 4018).
