PRELIMINARY REPORT ON THE GEOLOGIC EFFECTS
OF THE FAULTLESS EVENT

F. A. McKeown, D. D. Dickey and W. L. Ellis

ABSTRACT

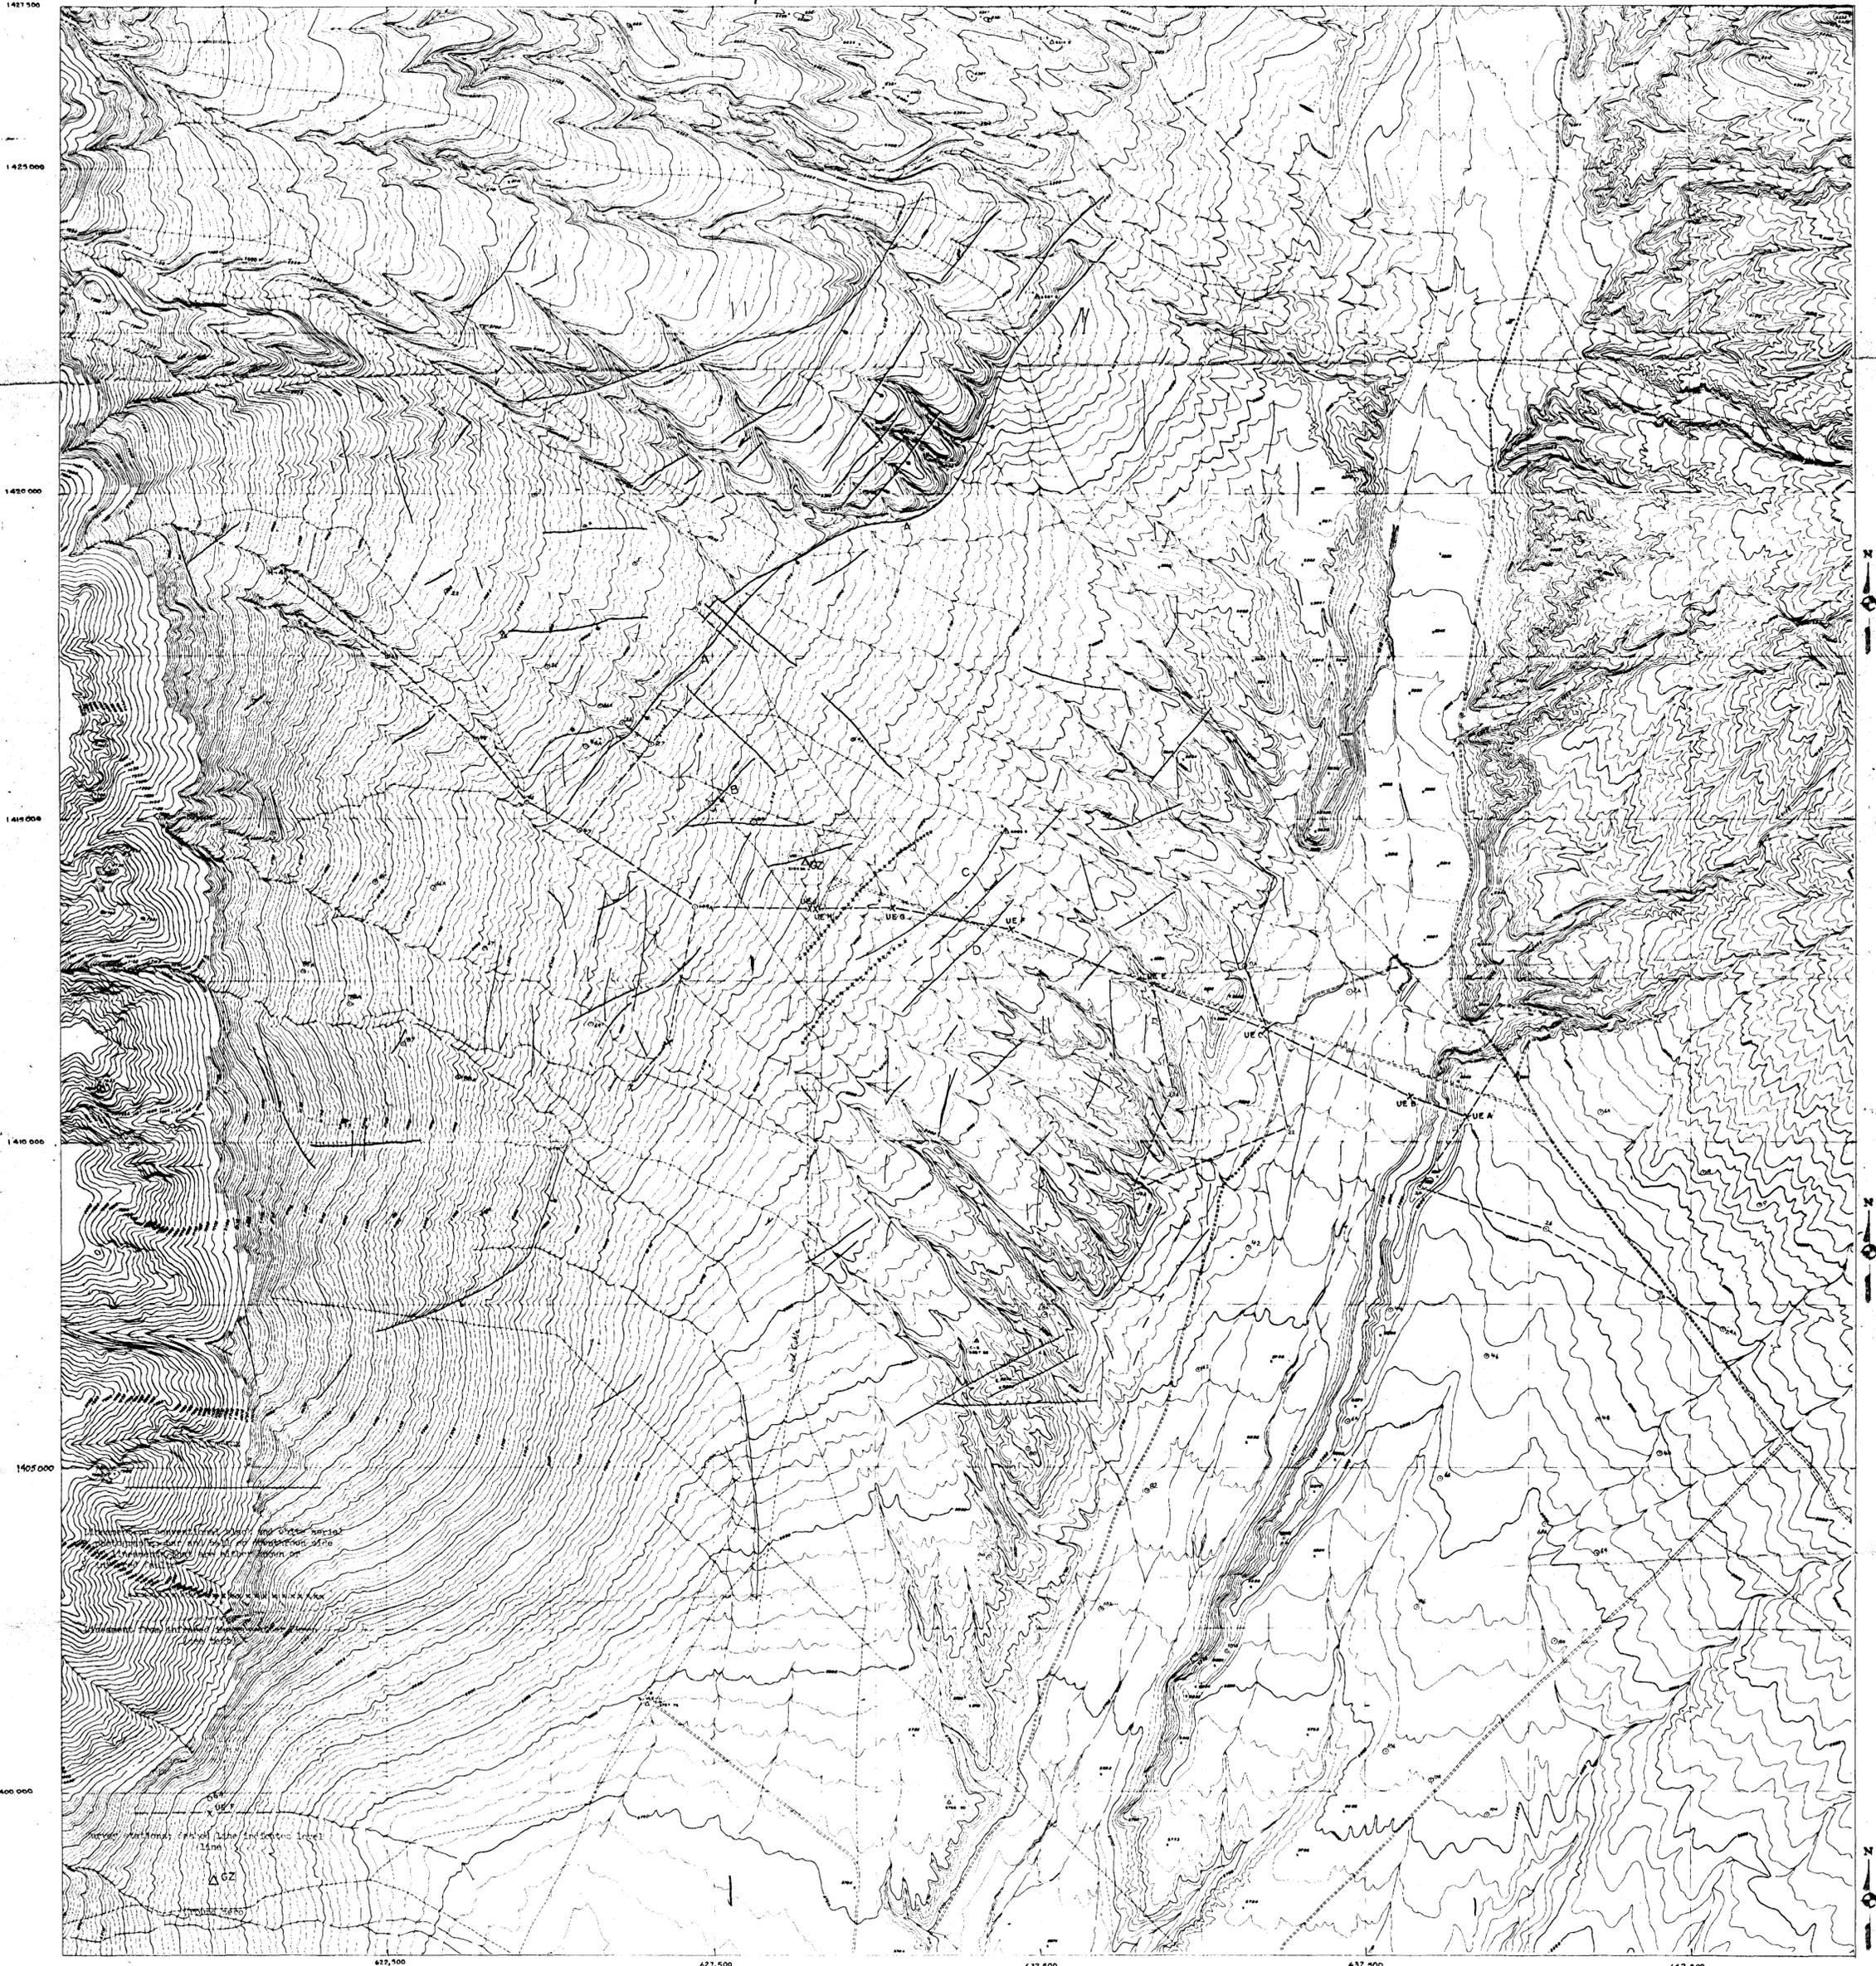
The thick alluvial fill of Hot Creek Valley displays little evidence of the structural framework of the valley. Only a few of the lineaments could be demonstrated or inferred from scarps in the alluvium to have been faults before the Faultless event; these are shown with bar and ball on figure 2a. The infrared imagery lineaments, in particular, were of dubious origin and location. No evidence of their origin could be found by trenching (Ekren, 1967, p. 4). Further, because of the distorted scale characteristics inherent in photographic prints of the infrared imagery, the location of the lineaments on figure 2a may be in error by as much as several hundred feet.

Inspection of the lineaments shown in figure 2a indicates that in order of length and abundance a first (strongest) set of lineaments trends about N. 25° E. to N. 45° E.; a second set trends from about N. 70° E. to due east; and a third, very weak set trends nearly due north. The first set is in part subparallel to the trend of the local mountain ranges (fig. 1). As this set also contains more lineaments that are known or inferred faults than other sets, it presumably represents the principal structural grain of Hot Creek Valley. Furthermore, scarps in the alluvium along some faults in this set are evidence of recent movement and indicative of the principal direction of the current tectonic stress field.

Figure 2a.-Topographic map showing preevent lineaments in vicinity of Faultless ground zero.

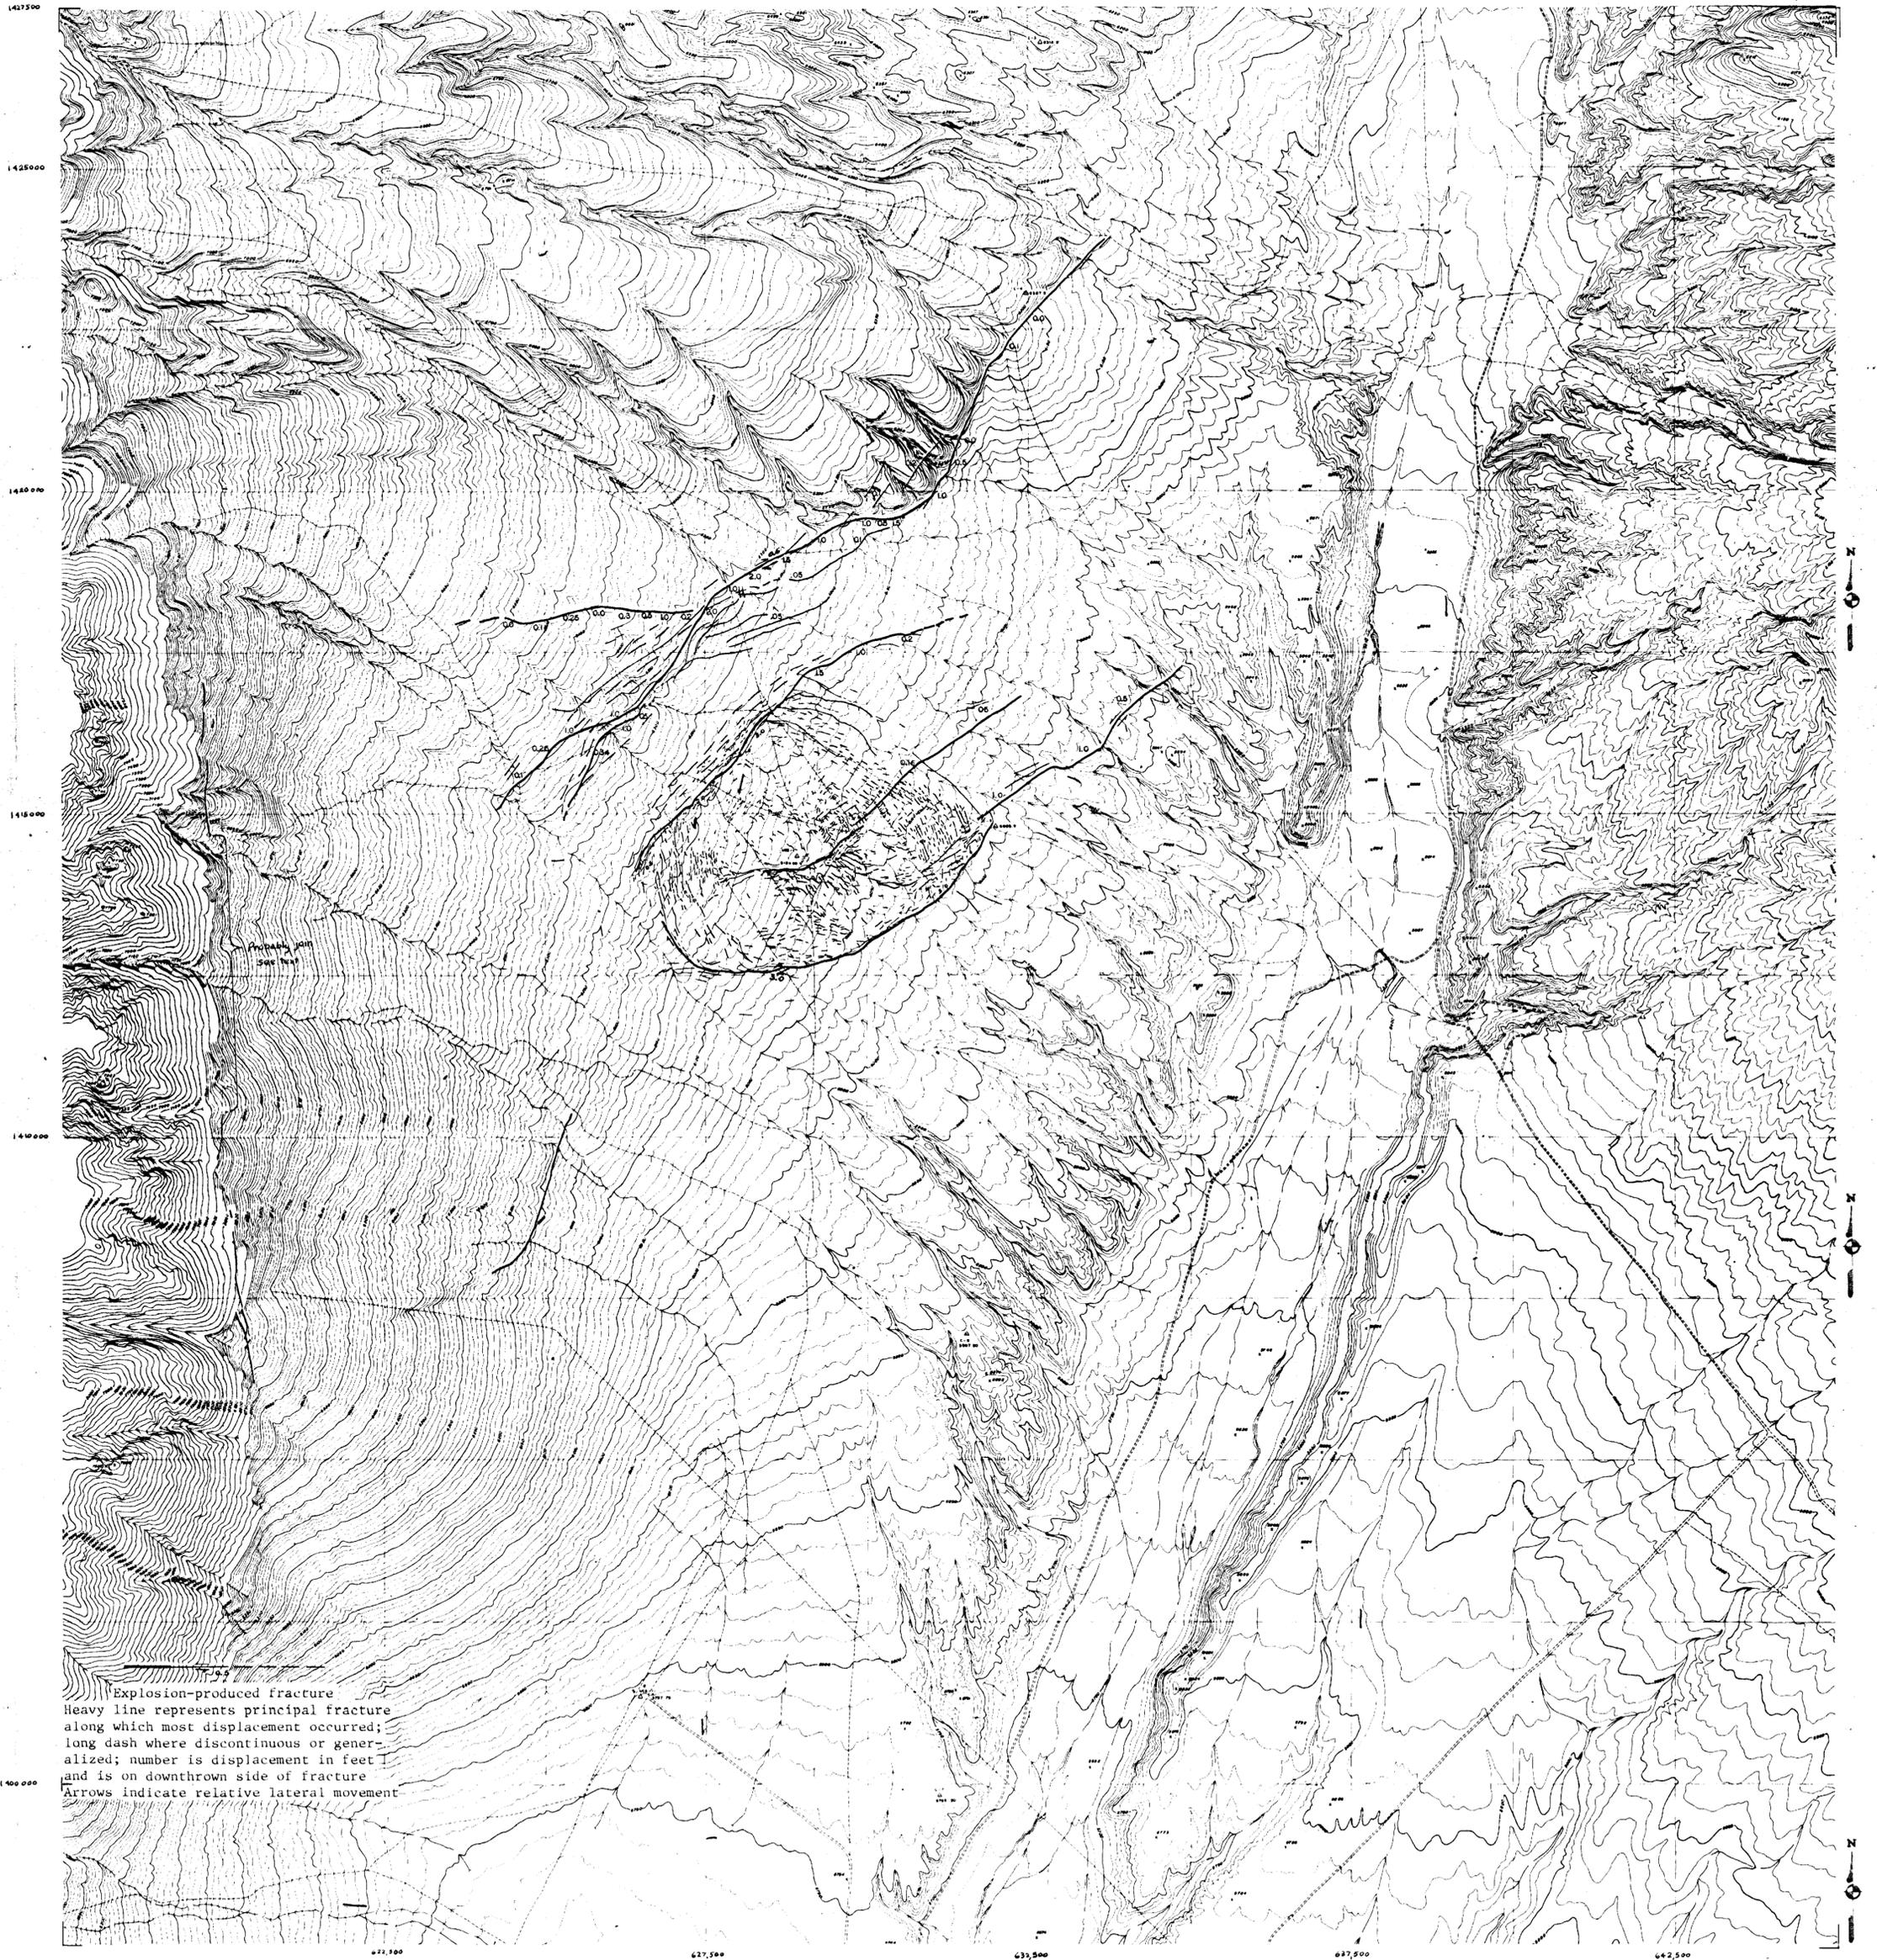
Three of the principal fractures produced by the explosion occurred on lineaments A, B, and C (figs. 2a and 2b), which had been mapped prior to the explosion. Nearly all other fractures may be related spatially in various degrees of coincidence to lineaments.

located on lineaments (figs. 2a and 2b). One of these fractures strikes westerly from a point 4,000 feet N. 35° W. of ground zero; maximum displacement on this fracture is 1 foot down on the south side. The other fracture has nearly the same strike as lineament A and starts from a point about 3,500 feet N. 45° W. of ground zero. Unlike the displacement on the lineament A fracture, this fracture is vertically down on the northwest about 1 foot.

Figure 2b.—Fractures produced by Faultless event in vicinity of ground zero
