3.0 Canonsburg, Pennsylvania, Disposal Site

3.1 Compliance Summary

The Canonsburg, Pennsylvania, Uranium Mill Tailings Radiation Control Act (UMTRCA) Title I Disposal Site was inspected on November 2, 2021. No changes were observed on the disposal cell or in the associated drainage features. Evidence of site trespassing was noted beneath the west fence at an erosional area under the fence. Metal slats preventing entry had been removed, allowing a trespasser to crawl under the fence. Inspectors replaced the slats. No cause for a follow-up inspection was identified.

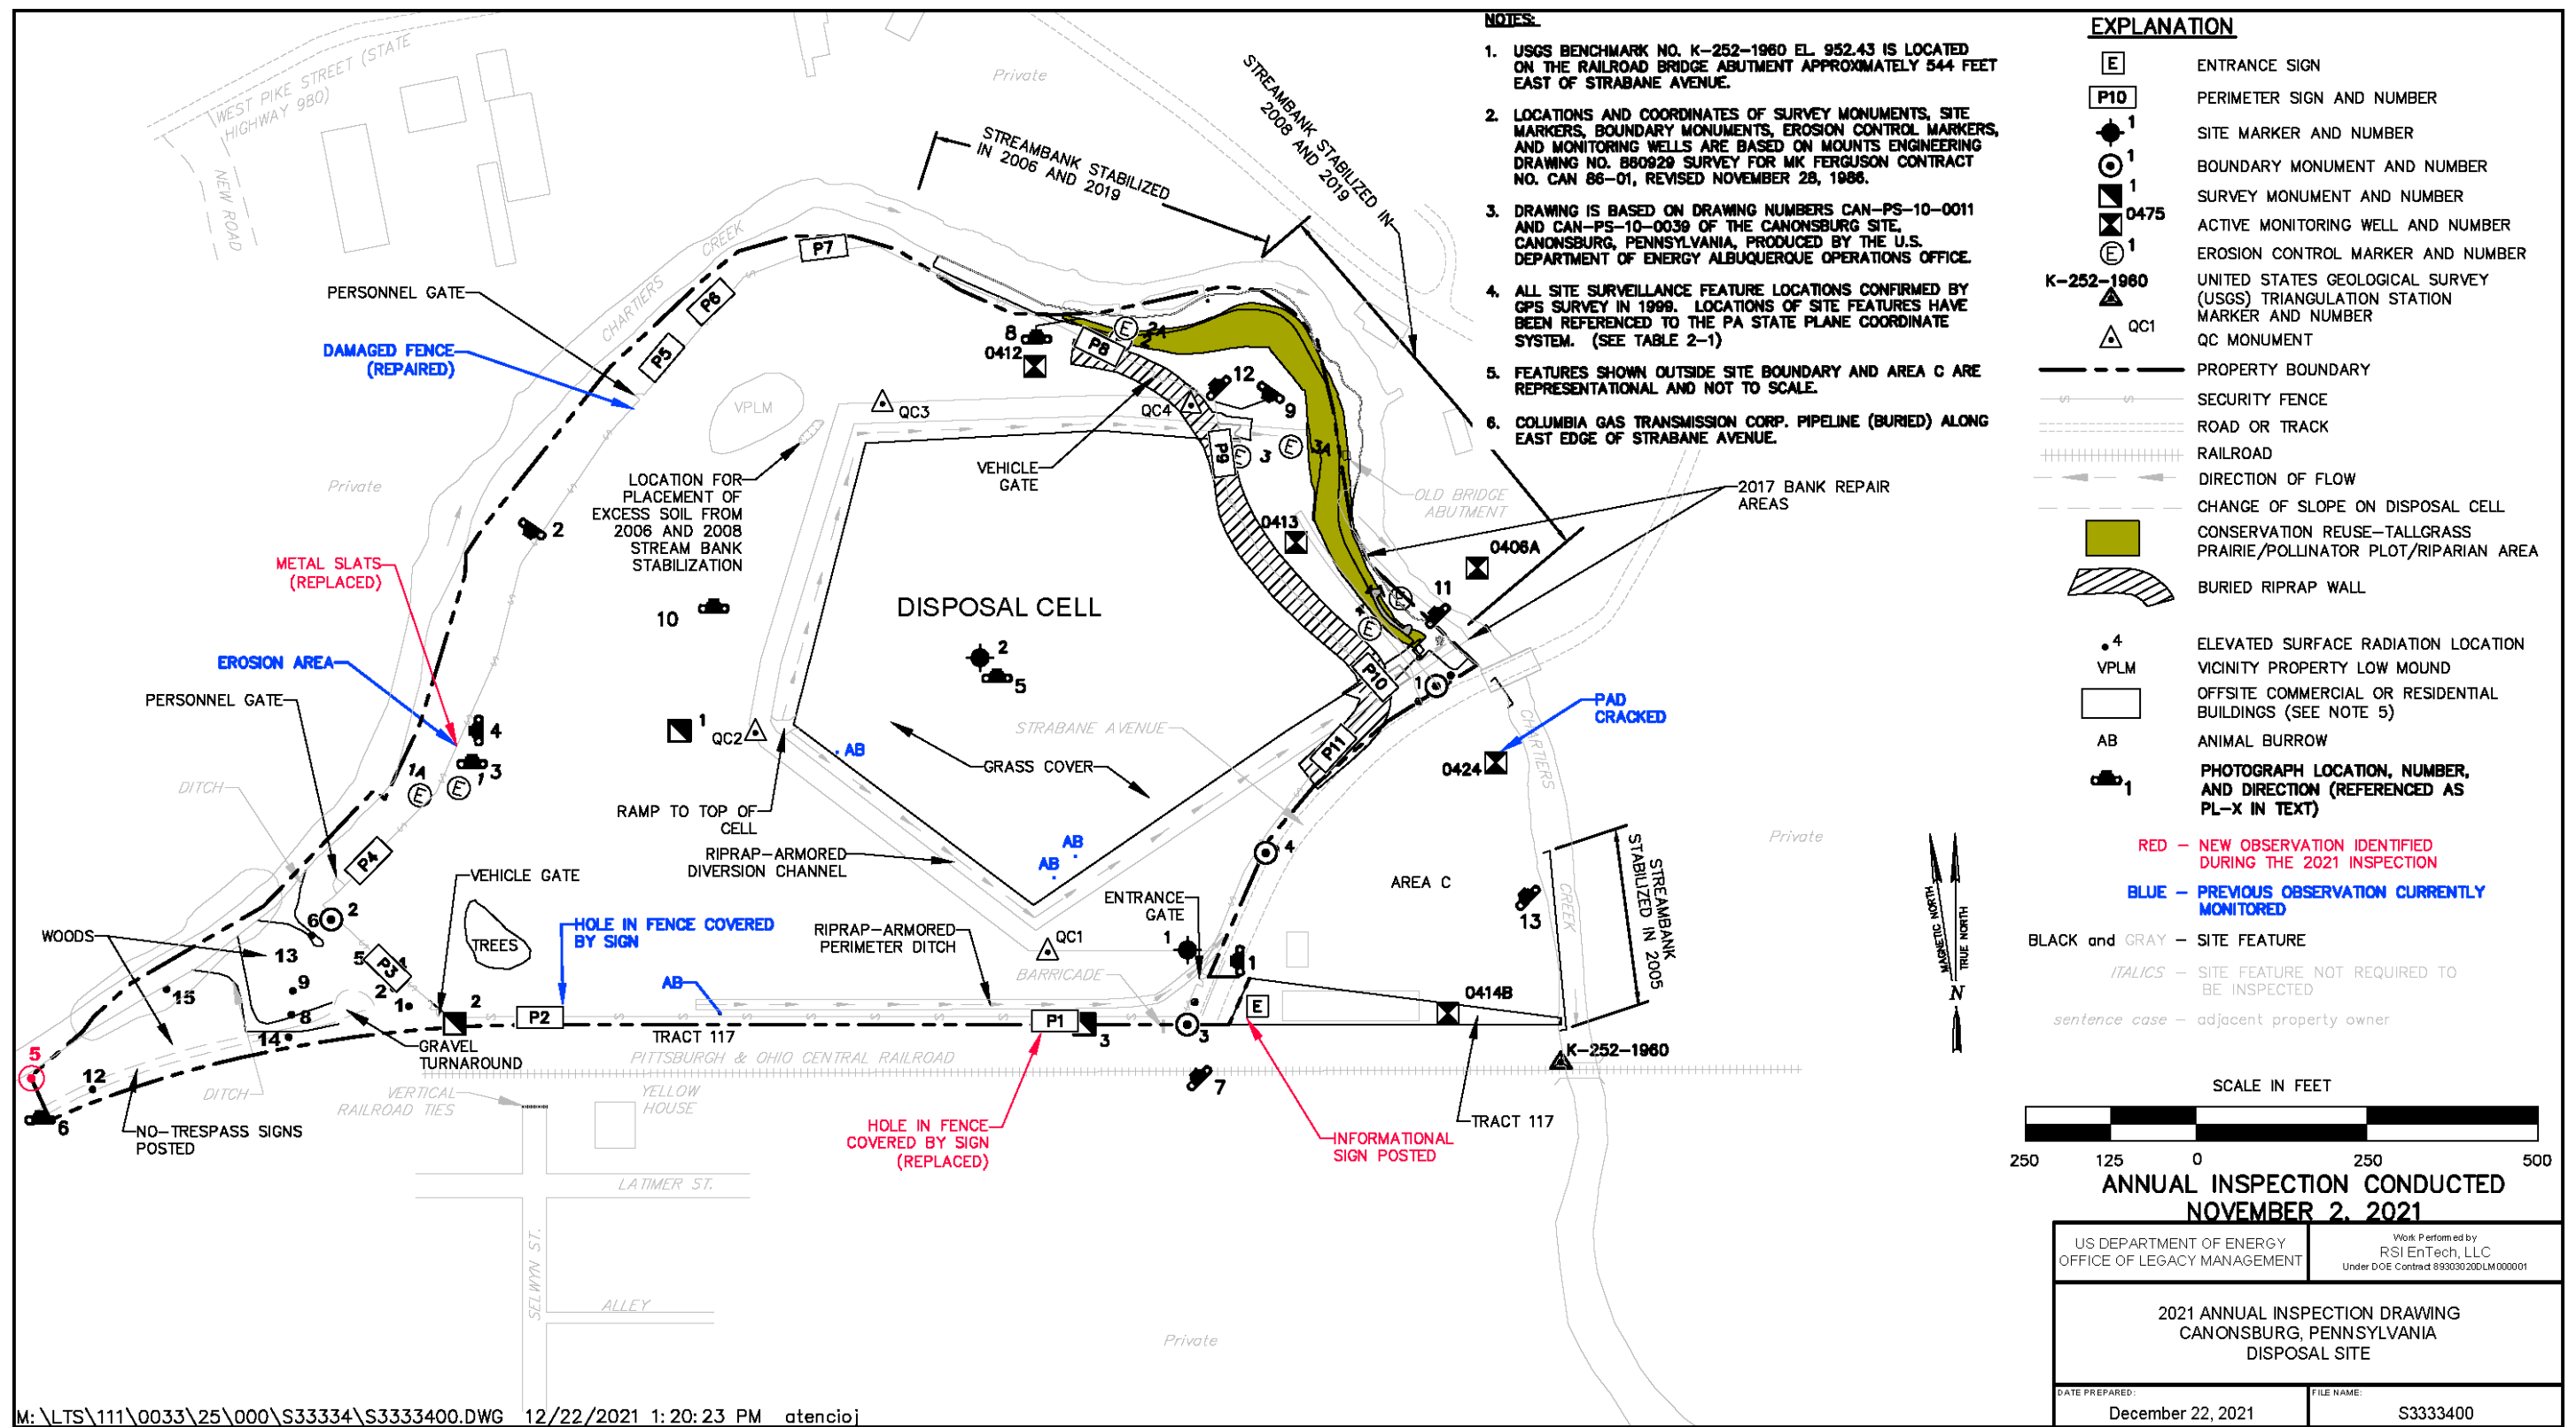
Figure 3-1. 2021 Annual Inspection Drawing for the Canonsburg, Pennsylvania, Disposal Site

Figure 3-1 shows the locations of site features, including site surveillance features and inspection areas, in black and gray font. Site features that are present but not required to be inspected are shown in italic font. Observations from previous inspections that are currently monitored are shown in blue text, and new observations identified during the 2021 annual inspection are shown in red. Inspection results and recommended maintenance activities associated with site surveillance features are included in the following subsections. Photographs to support specific observations are identified in the text and in Figure 3-1 by photograph location (PL) numbers. The photographs and photograph log are presented in Section 3.10.

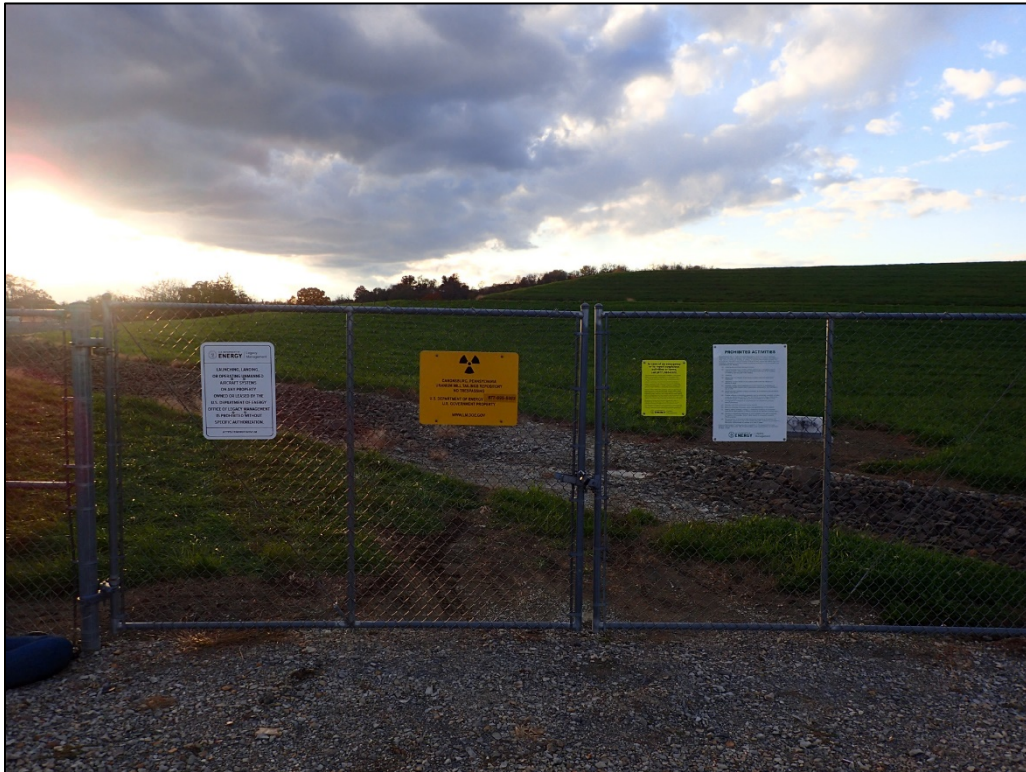
Main access to the site is from Strabane Avenue. There are three vehicle gates: the main entrance gate at the southeast corner of the site along Strabane Avenue, a vehicle access gate at the southwest corner of the site, and a vehicle access gate north of the disposal cell between perimeter signs P8 and P9. There are also two personnel access gates. All gates were locked and functional. The entrance sign is posted on the main entrance gate. Three additional information signs were also posted on the main entrance gate during the inspection (PL-1). No maintenance needs were identified.

PL-1. Signage on Entrance Gate

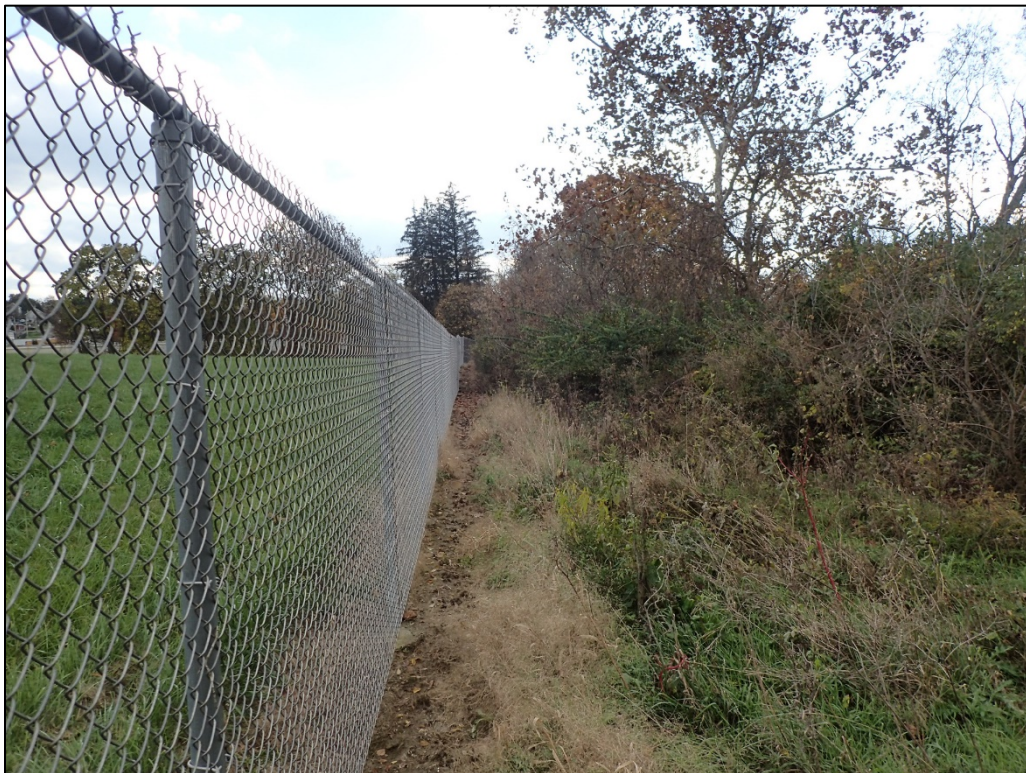
PL-2. West Fence Line

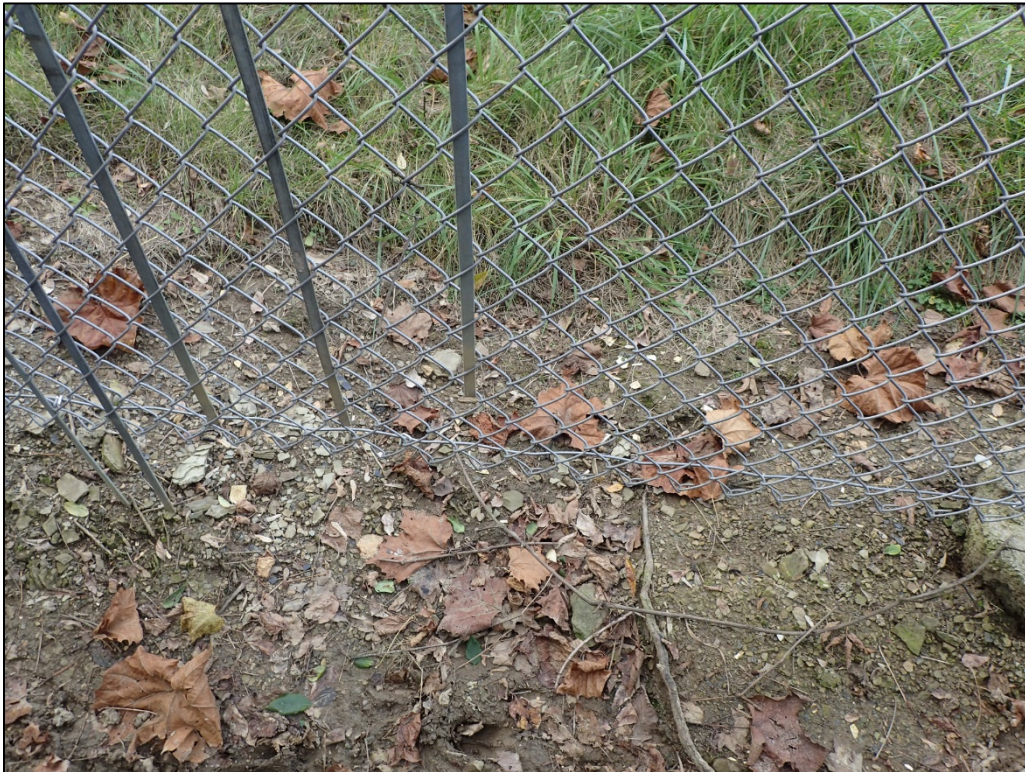
A chainlink security fence encloses most of the site. A vegetation-free buffer zone is maintained around the entire security fence (PL-2). An eroded area remains under the west security fence. The area appears to be stable; the erosion area has not expanded in several years. For added security, slats were installed in 2016 in the area beneath the fence to help close the gap. Inspectors noted that several of the slats had been removed, allowing enough space for someone to crawl under the fence (PL-3). Inspectors replaced the slats (PL-4) during the inspection.

PL-3. Erosion Area Under West Fence

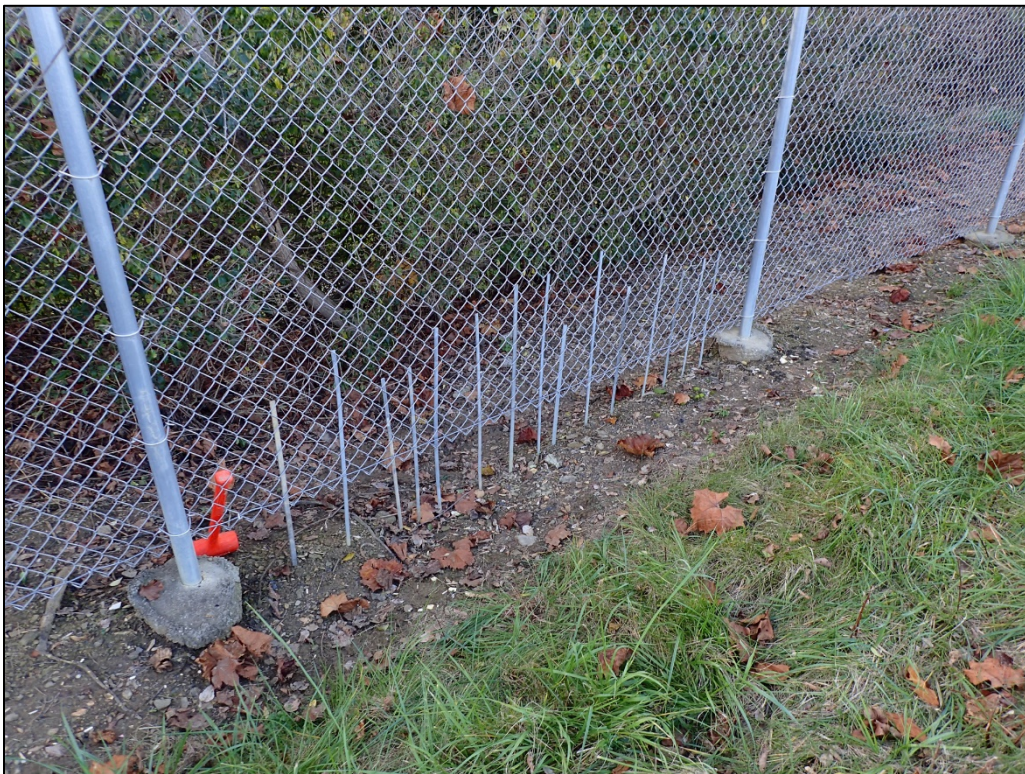
PL-4. New Slats in Fence at Erosion Area

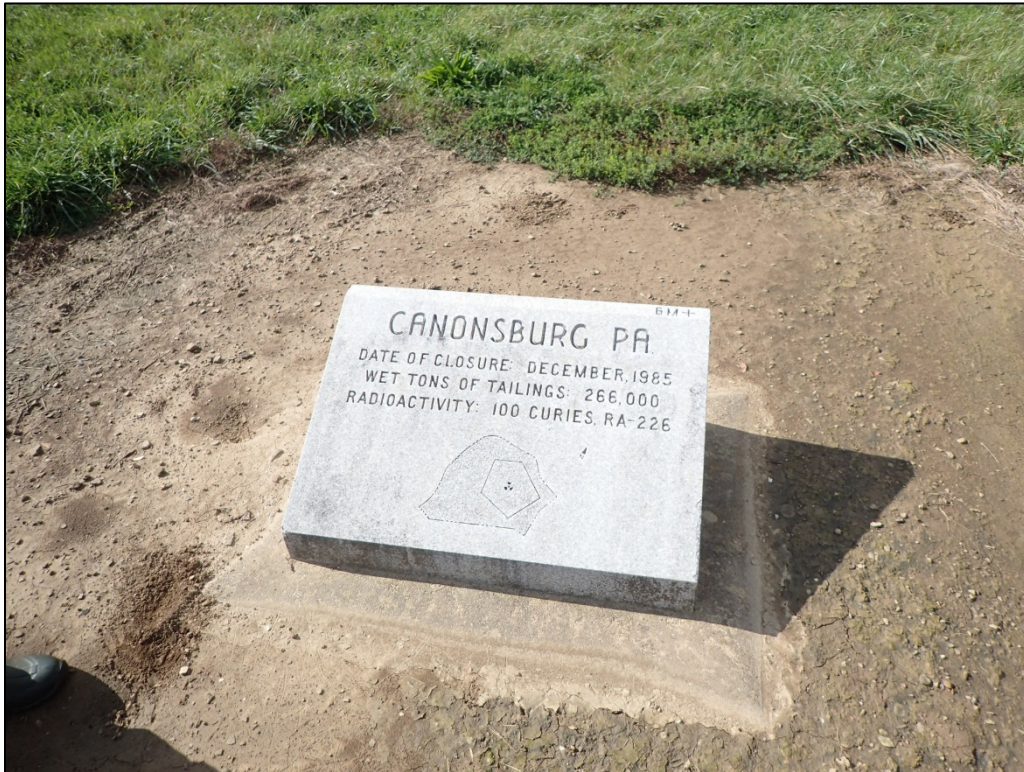
The site has two granite site markers. Site marker SMK-1 is just inside the main entrance gate, and site marker SMK-2 is on the top slope of the disposal cell (PL-5). No maintenance needs were identified.

PL-5. Site Marker SMK-2

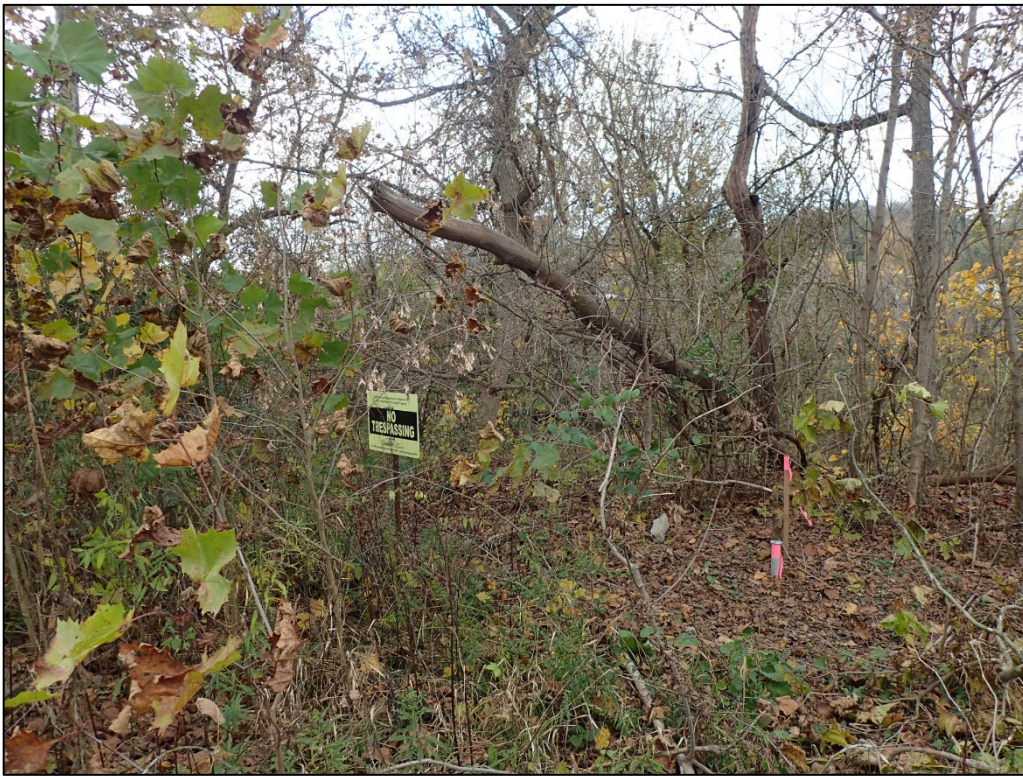
PL-6. New Southwest Boundary Monument BM-5

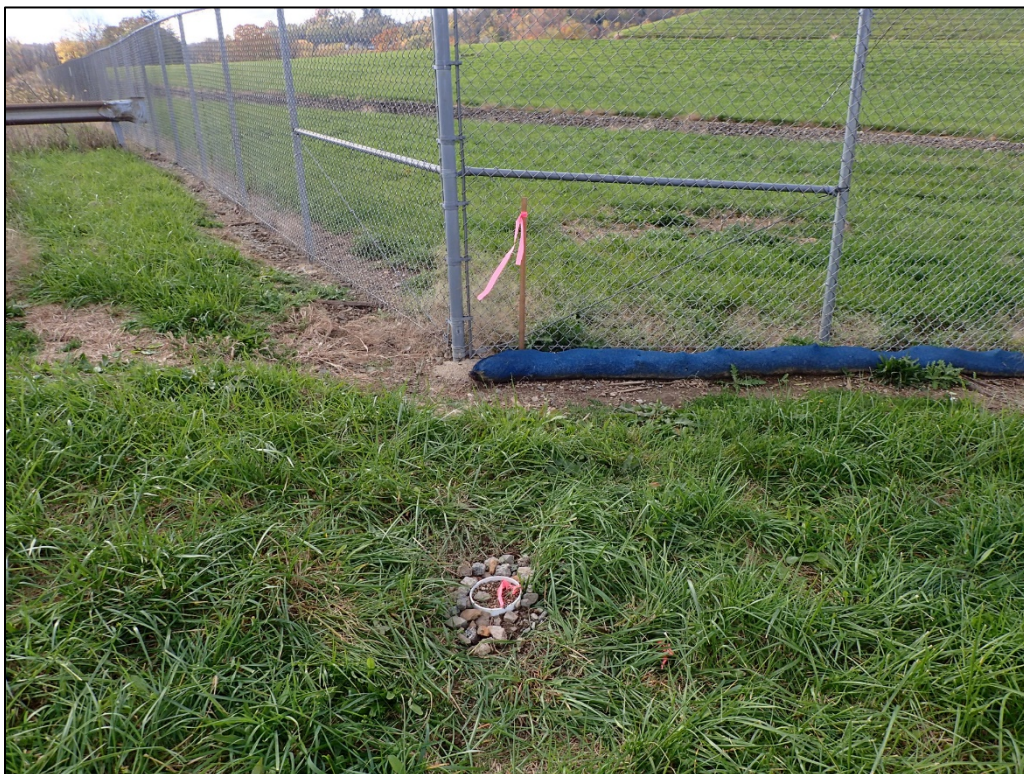
Before 2021, the site had three survey monuments and four boundary monuments. In 2021, a fifth boundary monument was installed at the southwest corner of the property (PL-6). All five boundary monuments were located during the inspection. Boundary monuments BM-1, BM-2, and BM-3 have all sunk approximately 6 inches below the present grade of the ground surface. A surveying crew located them in summer 2021 using GPS coordinates on file. Rather than raise the boundary monuments, it was decided to mark their locations with a section of PVC pipe filled with pea gravel (PL-7). No other maintenance needs were identified.

PL-7. Boundary Monument BM-3

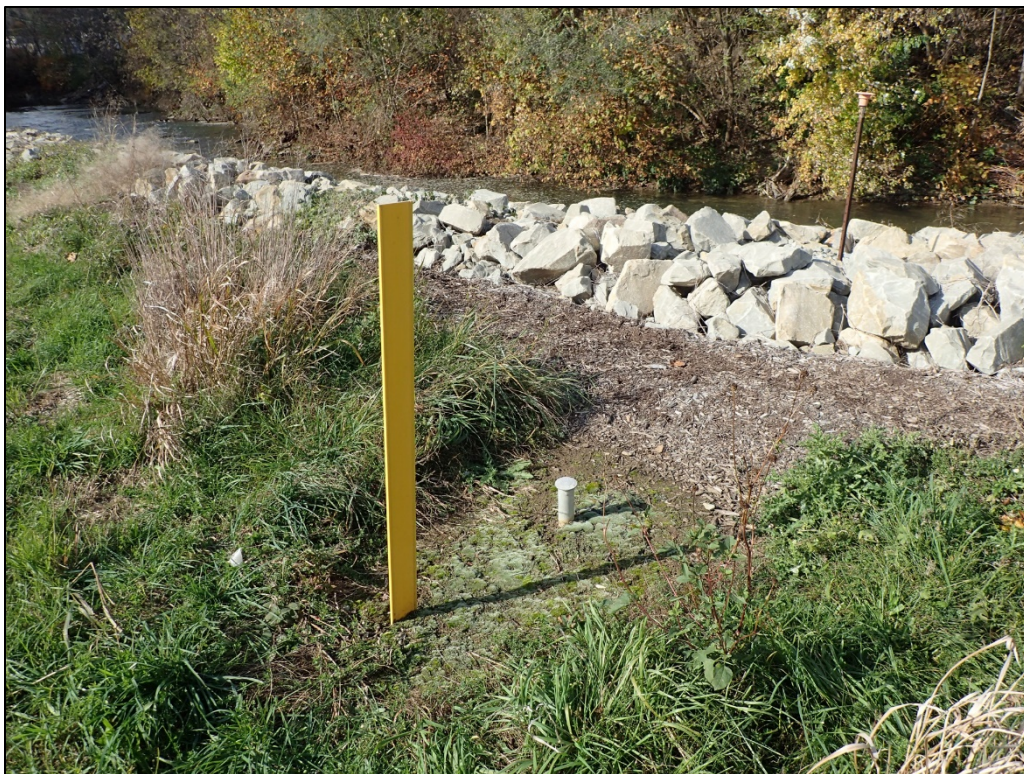
The site has four pairs of erosion control markers along the bank of Chartiers Creek. No maintenance needs were identified (PL-8).

PL-8. Erosion Control Markers 2 and 2A

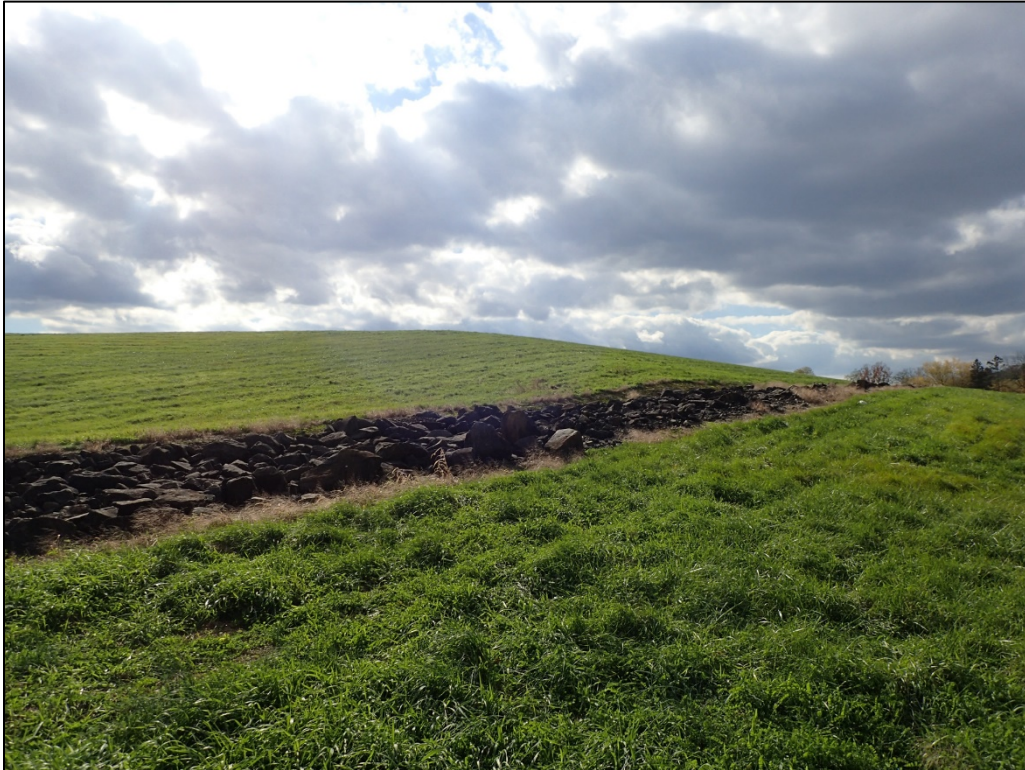
The disposal cell, completed in 1985, occupies 6.8 acres and is covered in grass (PL-9). There was no evidence of erosion, settling, slumping, or other modifying processes that might affect the integrity of the disposal cell. Animals burrow on the disposal cell cover, but such burrows should not pose a risk to disposal cell integrity or public health because the buried tailings are overlain by a 36-inch-thick clay layer (radon barrier), an 18-inch-thick biointrusion rock layer, and a 12-inch-thick topsoil layer. Biointrusion down to or through the radon barrier is unlikely. No new significant burrows were noted on the disposal cell during the inspection. Inspectors will continue to monitor the location and significance of burrows. No maintenance needs were identified.

PL-9. Northwest Side of Disposal Cell

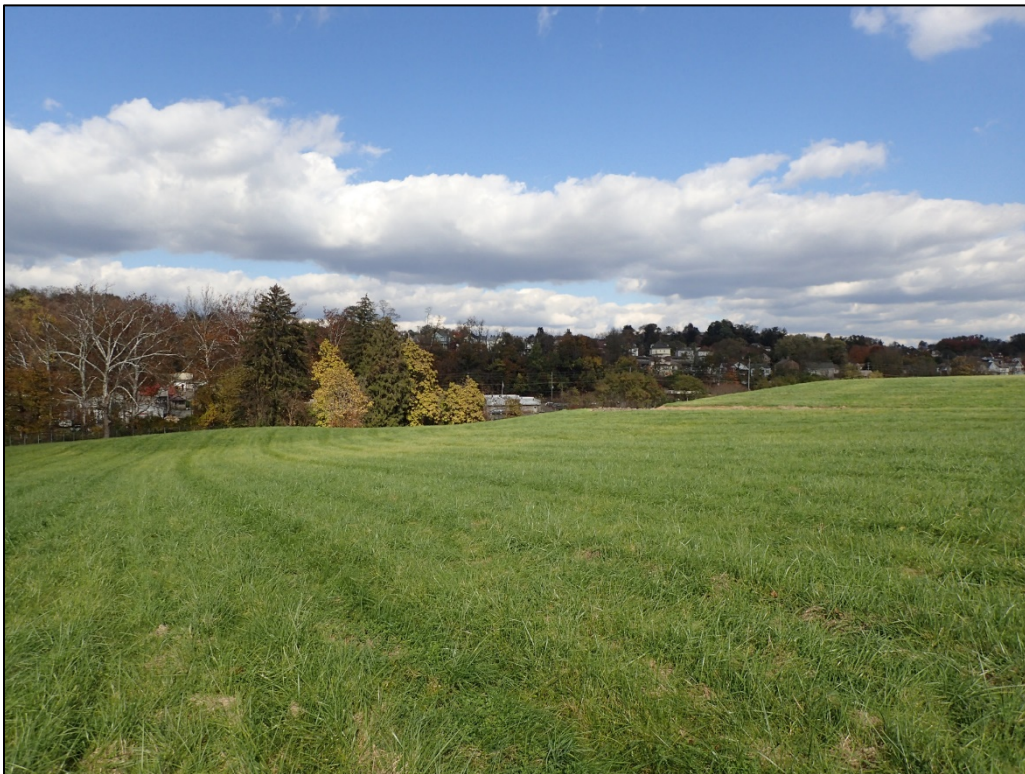
The site consists primarily of mowed grasses within the security fence and on the disposal cell cover. Seeded fescues and crown vetch are the most prevalent species. The spray-and-mow approach to vegetation management at the site continues to be effective. Noxious weeds within the security fence area are limited to resprouting seedlings that were observed in portions of mowed areas (PL-10). No maintenance needs were identified.

PL-10. West Side of Disposal Cell

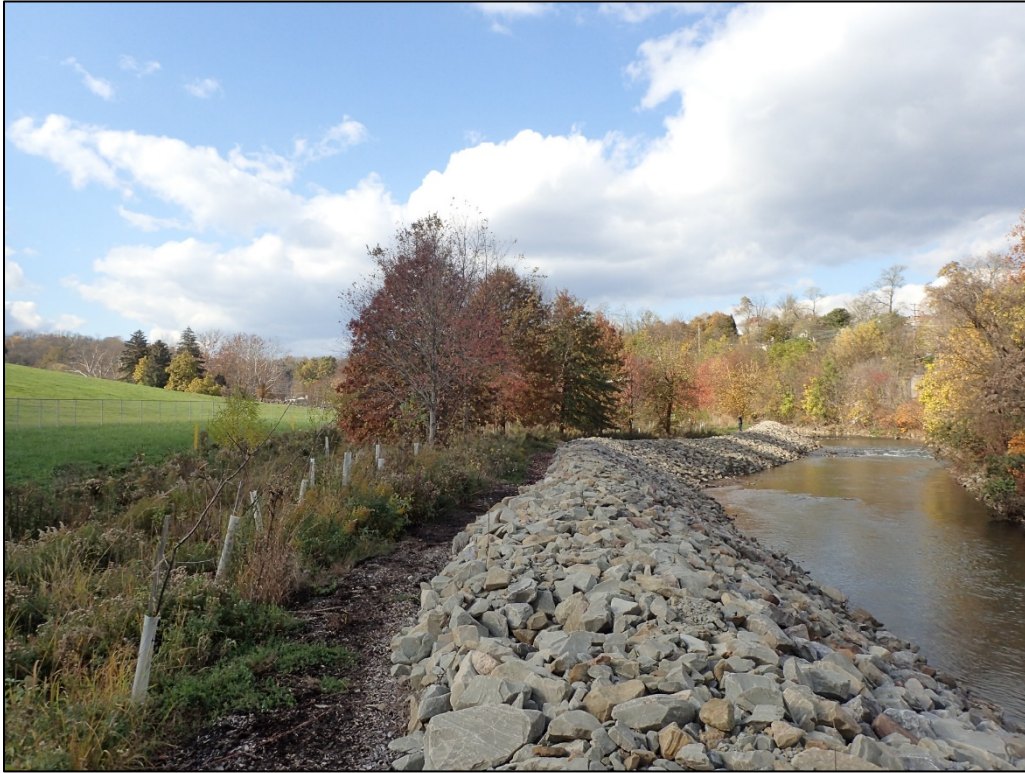
Between 2001 and 2008, several streambank-stabilization projects were conducted north and east of the site. The projects consisted of installing riprap armoring along the streambanks. Years of flow and heavy flow events in Chartiers Creek in late 2017 and early 2018 damaged those riprap installations. In late summer 2019, the entire length of the riprap embankment along Chartiers Creek north of the disposal cell (approximately 1200 linear feet) was repaired during low streamflow conditions. The work consisted of minor grading, replacing geotextile filter fabric, and importing and placing 2-foot-thick R6 riprap slopes (PL-11).

PL-11. Riparian Area and Riprap-Armored Streambank

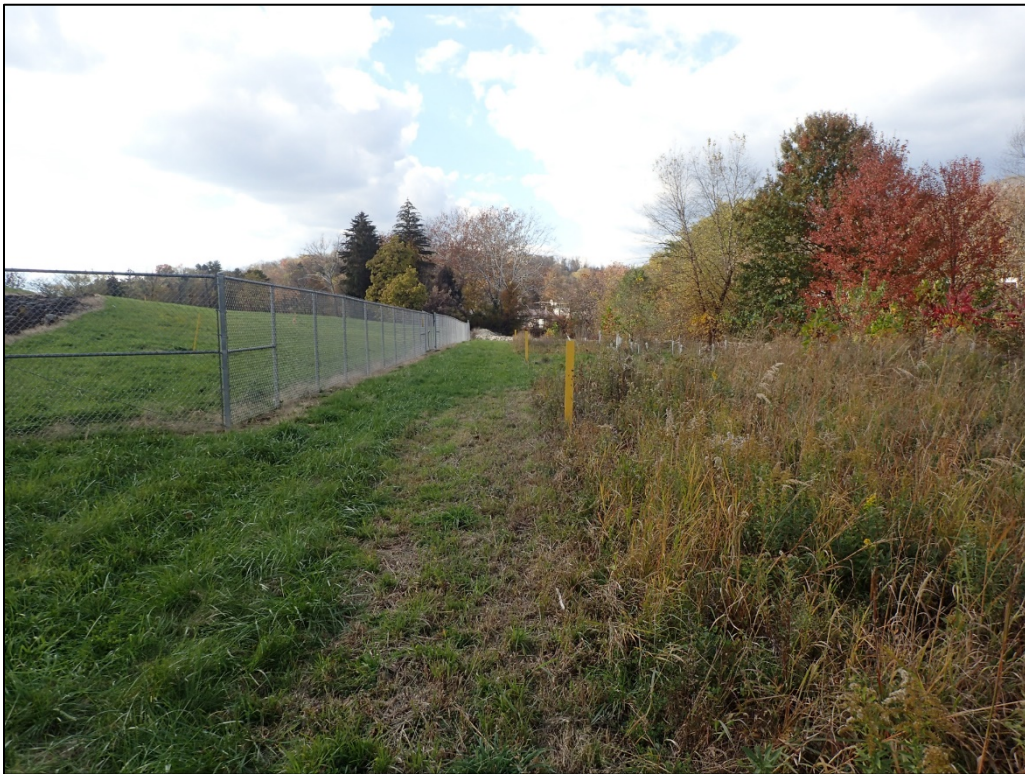
As part of that project, a riparian forest buffer was planted above and along the embankment. Disturbed areas were seeded with a pollinator-friendly native grass and wildflower mix. This riparian forest buffer corridor will work with the engineered riprap embankment to further stabilize the area against future stream flooding events and reduce erosion along the top edge of the riprap embankment. No concerns with the riprap embankment were noted during the inspection. Plantings in the riparian forest buffer experienced a 2-year survival rate of approximately 90%. The main challenge for the young plants is being damaged by deer (PL-12).

PL-12. Edge of Tall Grass Prairie and Riparian Area

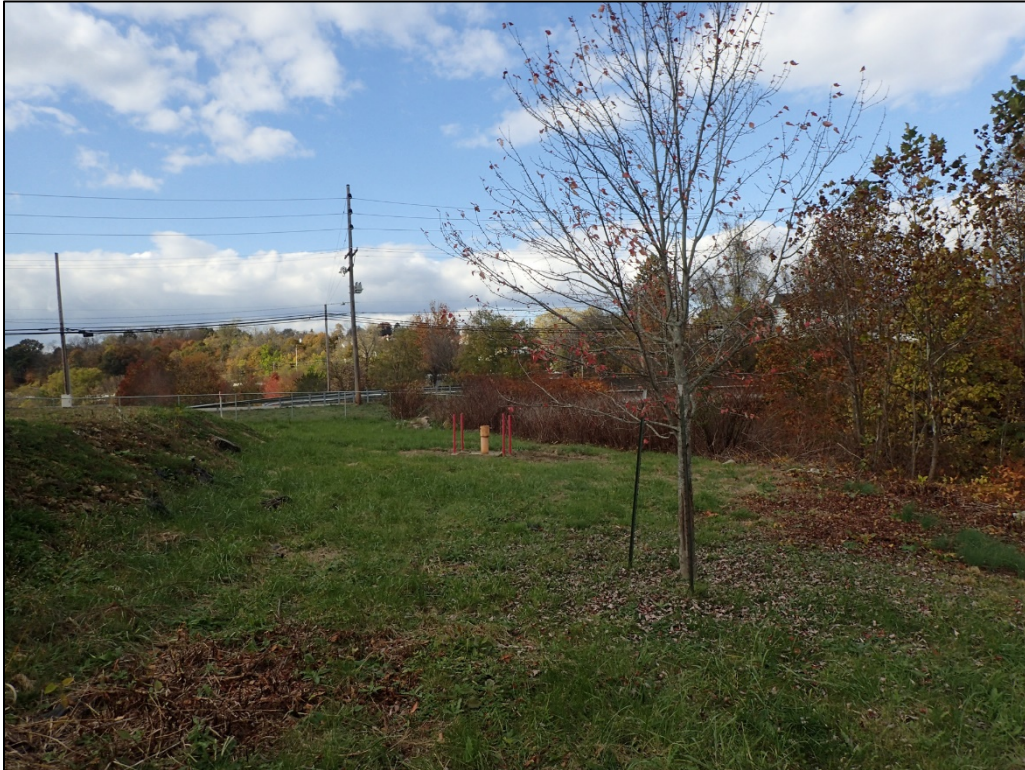
The site has five groundwater monitoring wells; the insides of these wells are inspected when they are sampled. Monitoring wells were last sampled and inspected in October 2018. During the 2021 inspection, the areas outside the wells were inspected, and the wellhead protectors were found to be undamaged and locked. There is a crack in the well pad of monitoring well 0424.

The pad remains serviceable. It will be evaluated for replacement or repair during the next regularly scheduled sampling. No other maintenance needs were identified.

PL-13. Monitoring Well 0424

The well pad at monitoring well 0424 will be replaced or repaired during the next sampling event.
