3.0 Canonsburg, Pennsylvania, Disposal Site

3.1 Compliance Summary

Figure 3-1. 2022 Annual Inspection Drawing for the Canonsburg, Pennsylvania, Disposal Site

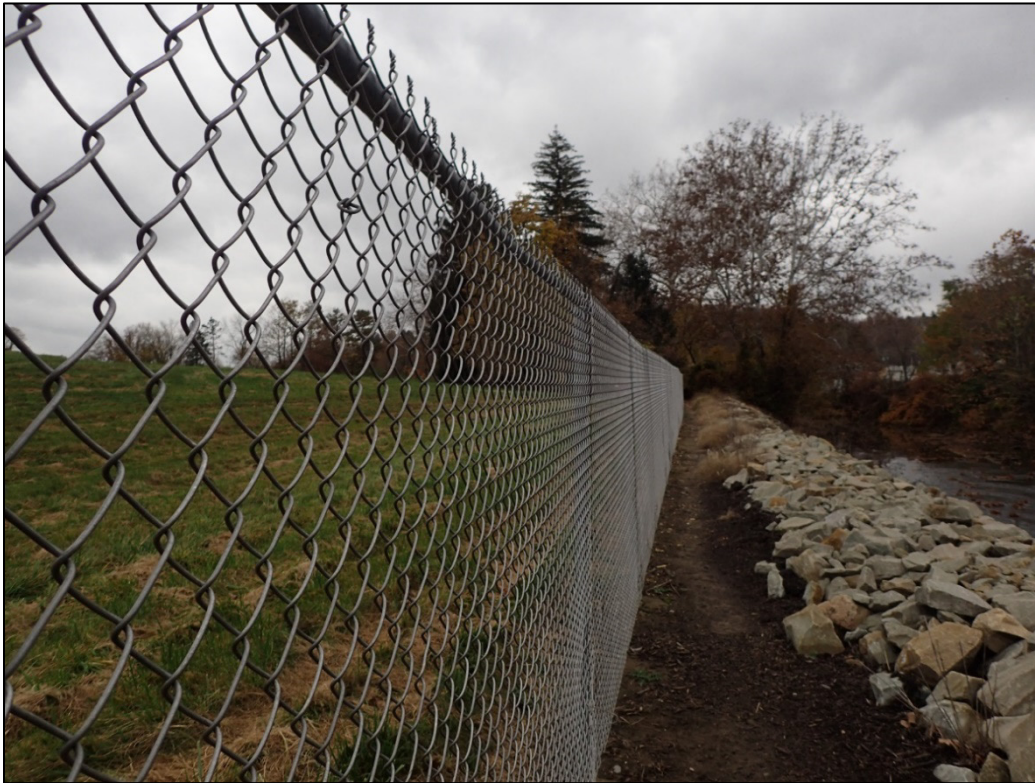
A chainlink security fence encloses most of the site. A vegetation-free buffer zone is maintained around the entire security fence (PL-1). An eroded area remains under the west security fence. The area appears to be stable; the erosion area has not expanded in several years. For added security, slats were installed in 2016 in the area beneath the fence to help close the gap. Inspectors noted that the slats were undisturbed (PL-2).

PL-1. Riprap Along Streambank

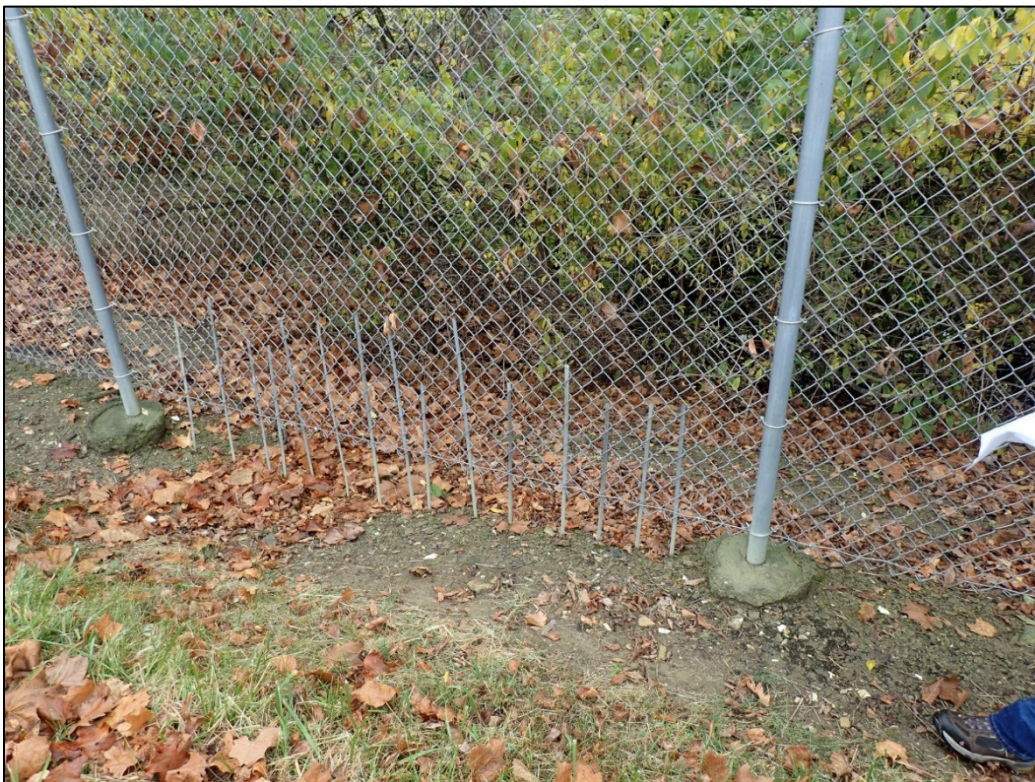
PL-2. Slats in Fence at Erosion Area

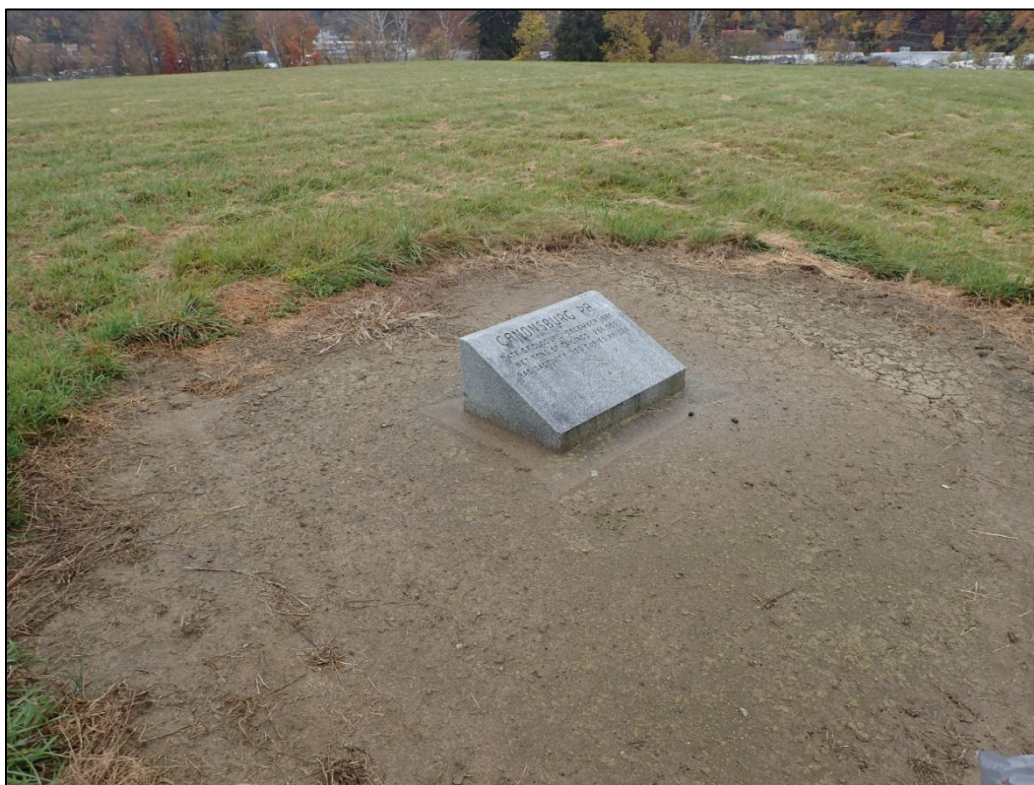
The site has two granite site markers. Site marker SMK-1 is just inside the main entrance gate, and site marker SMK-2 is on the top slope of the disposal cell (PL-3). No maintenance needs were identified.

PL-3. Site Marker SMK-2

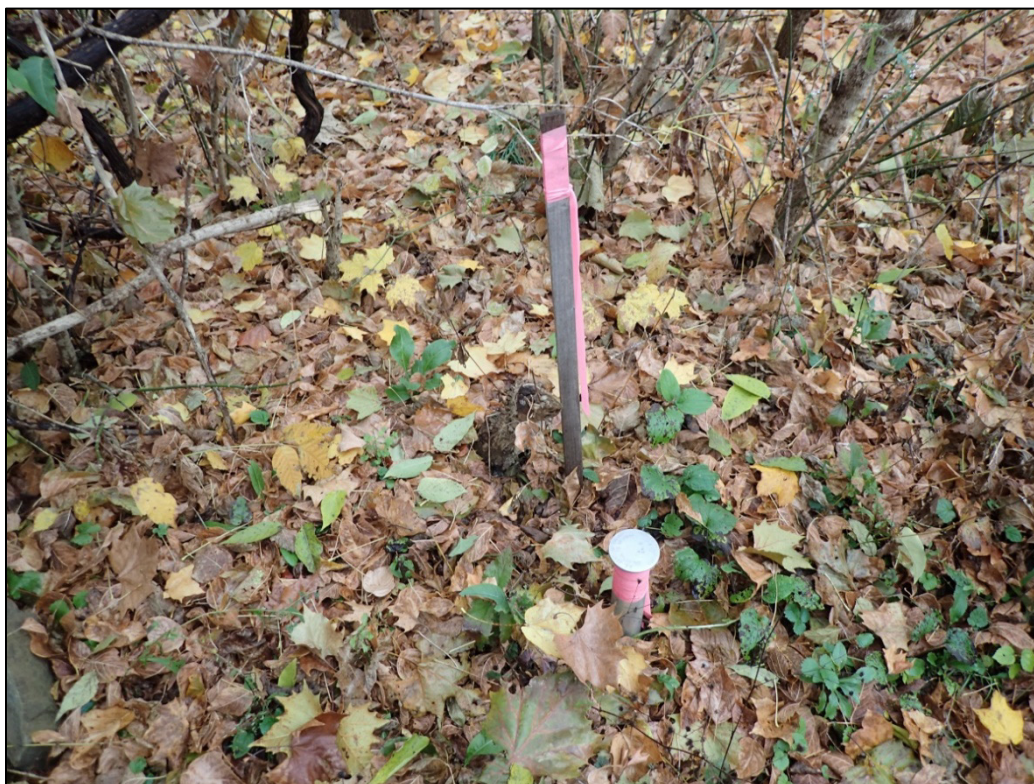
Before 2021, the site had three survey monuments and four boundary monuments. In 2021, a fifth boundary monument was installed at the southwest corner of the property (PL-4). All five boundary monuments were located during the inspection. Boundary monuments BM-1, BM-2, and BM-3 have all sunk approximately 6 inches below the present grade of the ground surface. A surveying crew located them in summer 2021 using GPS coordinates on file. Rather than raise the boundary monuments, it was decided to mark their locations with a section of PVC pipe filled with pea gravel. The PVC pipe marking the location of boundary monument BM-2 had been removed and needs to be reinstalled. The top of the PVC marker at boundary monument BM-3 was hard to locate due to grass growth. Arrangements will be made to have the grass around the marker sprayed to make the marker more visible. No other maintenance needs were identified.

PL-4. Newly Installed Boundary Monument BM-5

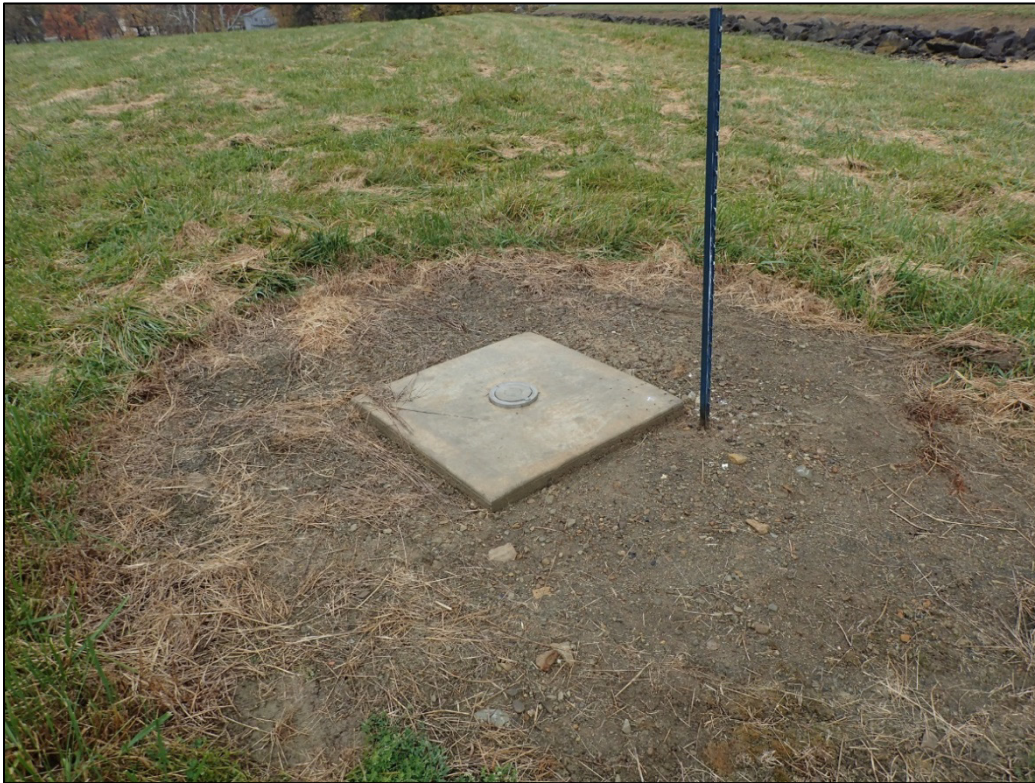
Four aerial survey quality control monuments used for ground control for aerial surveys were inspected during the 2022 annual inspection (PL-5). No maintenance needs were identified.

PL-5. Quality Control Monument QC-2

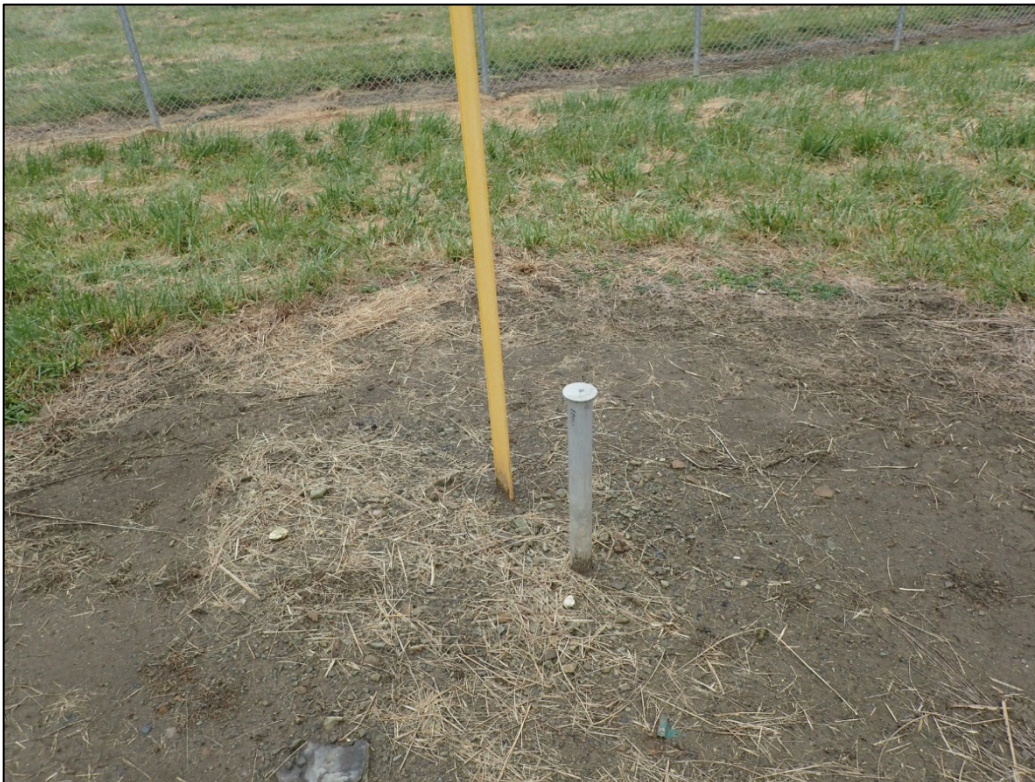
The site has four pairs of erosion control markers along the bank of Chartiers Creek. No maintenance needs were identified (PL-6).

PL-6. Erosion Control Marker 3

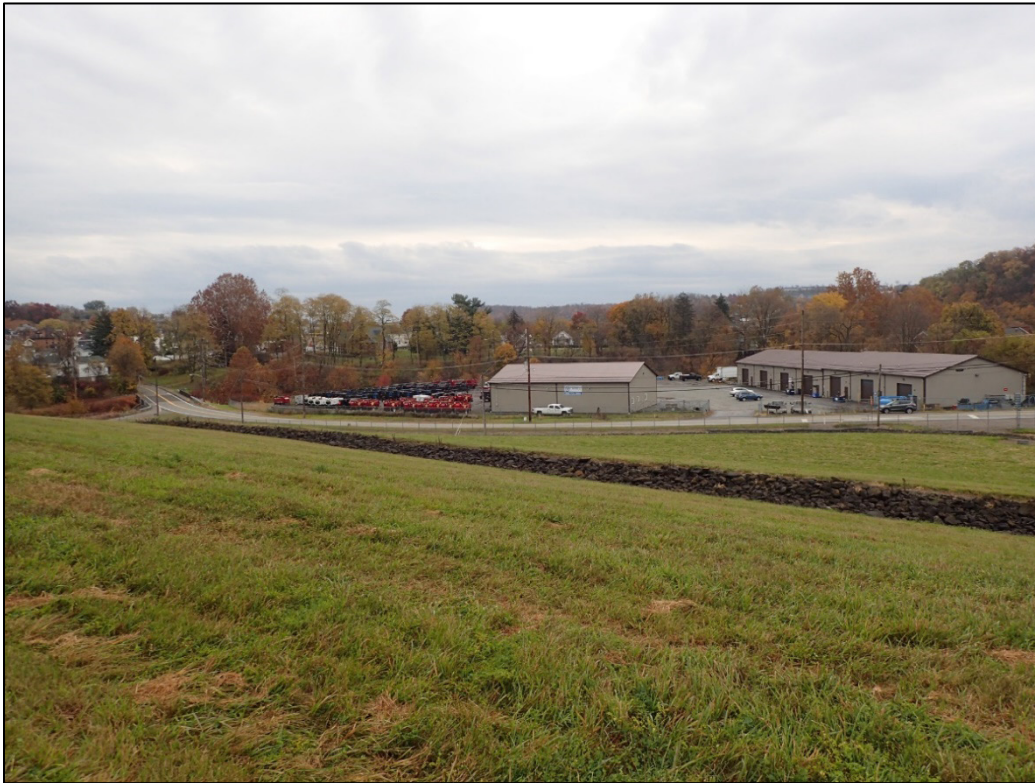
The disposal cell, completed in 1985, occupies 6.8 acres and is covered in grass (PL-7). There was no evidence of erosion, settling, slumping, or other modifying processes that might affect the integrity of the disposal cell. Animals burrow on the disposal cell cover, but such burrows should not pose a risk to disposal cell integrity or public health because the buried tailings are overlain by a 36-inch-thick clay layer (radon barrier), an 18-inch-thick biointrusion rock layer, and a 12-inch-thick topsoil layer. Biointrusion down to or through the radon barrier is unlikely. No new significant burrows were noted on the disposal cell during the inspection. Inspectors will continue to monitor the location and significance of burrows. No maintenance needs were identified.

PL-7. Top of Disposal Cell

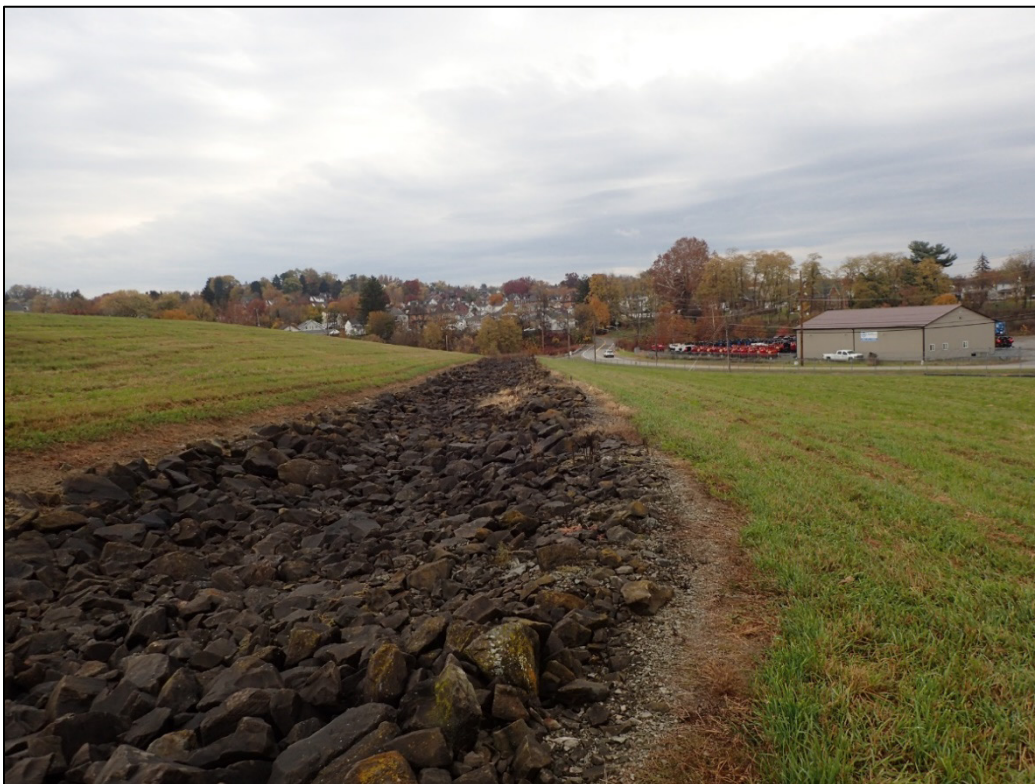
There was no evidence of rock deterioration or woody vegetation in the diversion channels and perimeter ditches (PL-8). Periodic physical removal and spot herbicide applications have been effective at reducing woody vegetation and will continue to be conducted as needed. No maintenance needs were identified.

PL-8. Riprap-Armored Diversion Channel

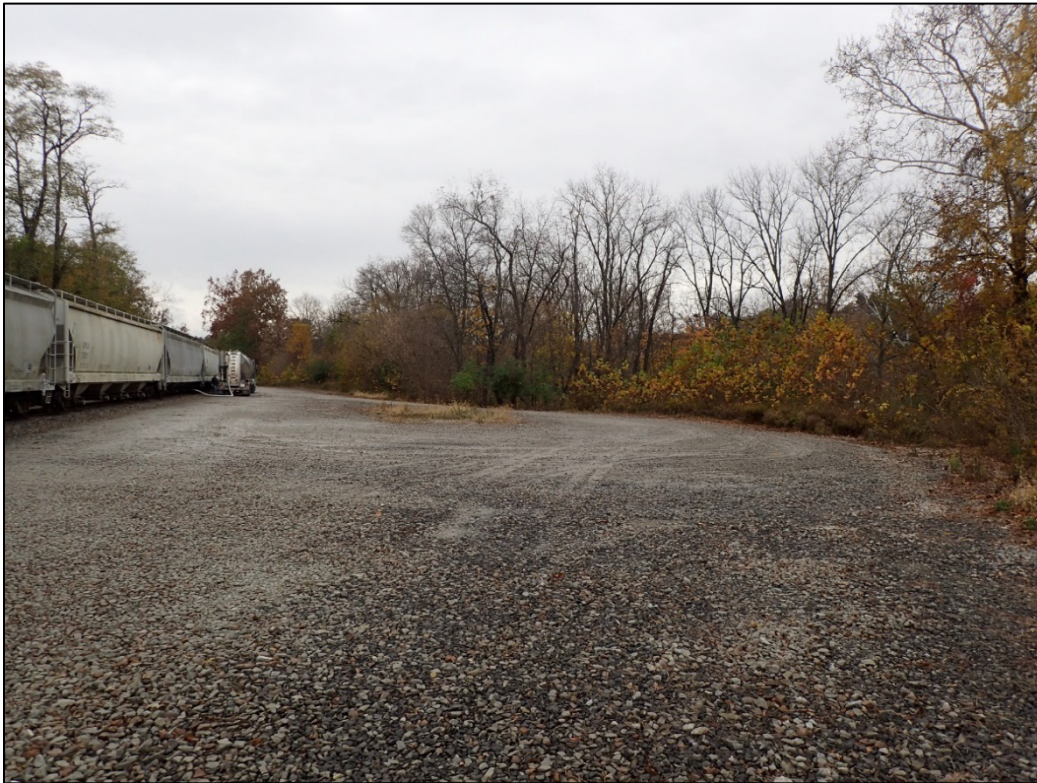
A local plastics company has cleared some of DOE's property north of the railroad tracks and spread gravel to create a turnaround for its trucks. No-trespassing signs are now posted around this area to prevent unauthorized expansion of the turnaround. A 5-year access agreement was established in 2017 with the plastics company for continued use of the turnaround. The agreement was renewed for another 5 years in 2022. No changes to the size of the turnaround were observed in 2022 (PL-9). No-trespassing signs marking the edge of the turnaround are faded and worn and in need of replacement.

PL-9. Gravel Turnaround Area

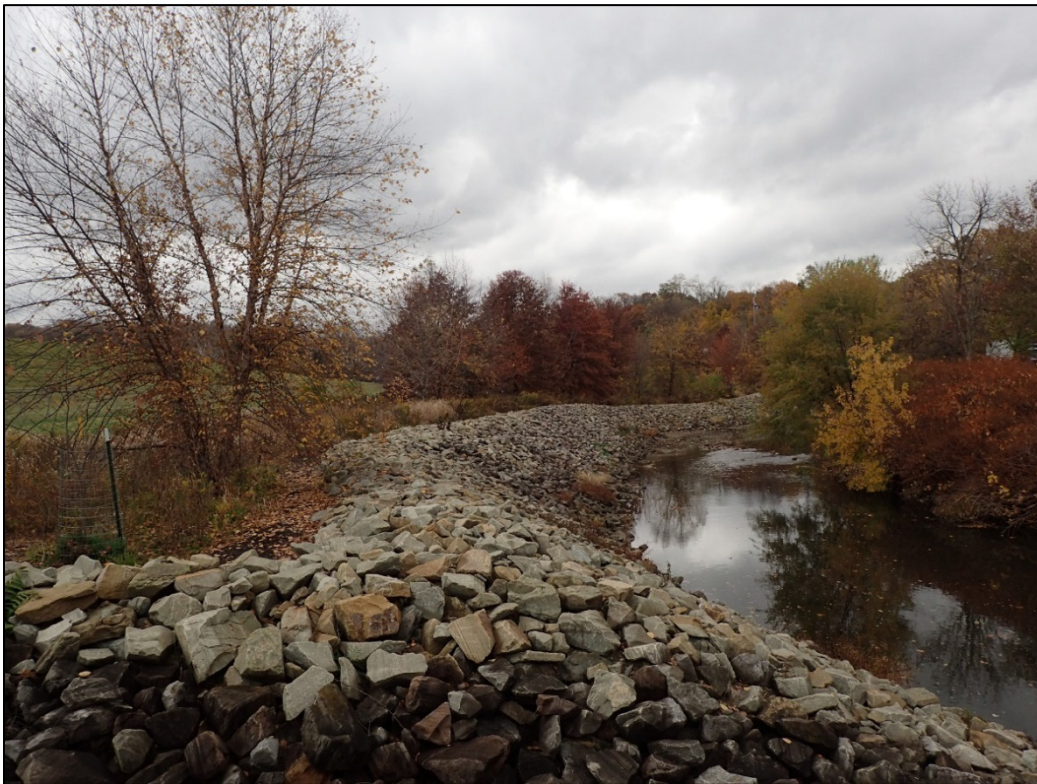
Several riprap streambank stabilization projects have been conducted north and east of the site. From 2001 to 2008, riprap armoring was installed along the streambanks. Years of flow and heavy flow events in Chartiers Creek in late 2017 and early 2018 damaged those riprap installations. In late summer 2019, the entire length of the riprap embankment along Chartiers Creek north of the disposal cell (approximately 1200 linear feet) was repaired during low streamflow conditions. The work consisted of minor grading, replacing geotextile filter fabric, and importing and placing 2-foot-thick riprap slopes. No concerns with the current riprap embankment were noted during the inspection (PL-10).

PL-10. Riprap-Armored Streambank

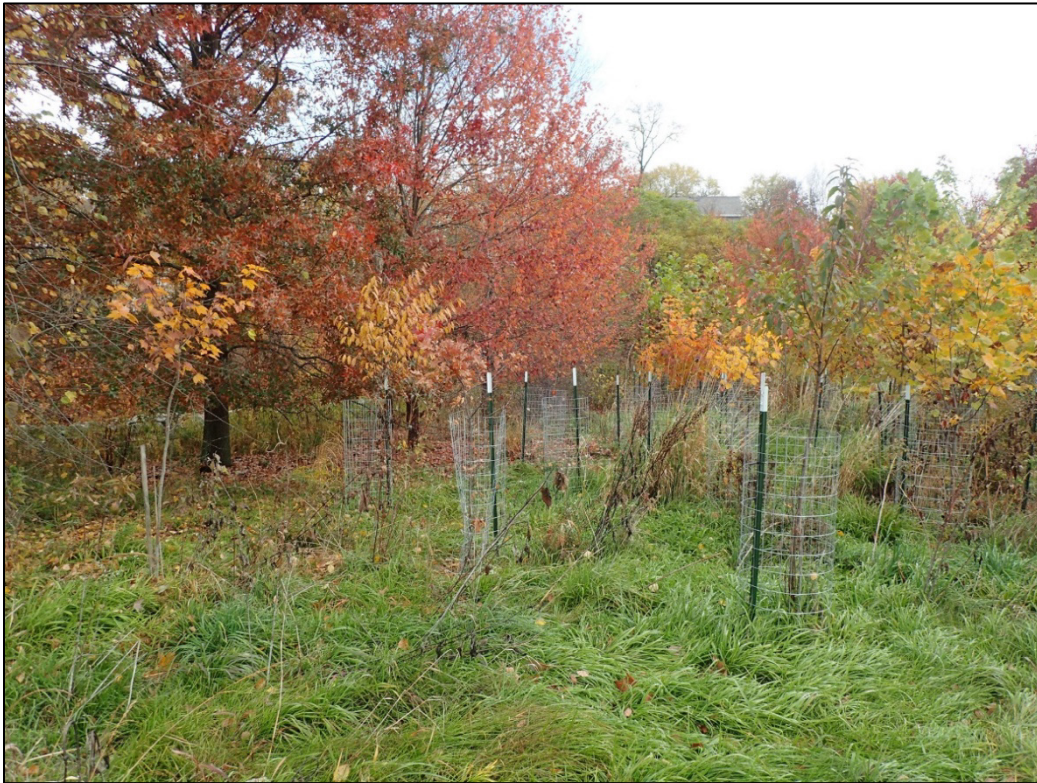
As part of the 2019 repair project, a riparian forest buffer was planted above and along the embankment. Disturbed areas were seeded with a pollinator-friendly native grass and wildflower mix. This riparian forest buffer corridor will work with the engineered riprap embankment to further stabilize the bank against future stream flooding events and reduce erosion along the top edge of the riprap embankment. Plantings in the riparian forest buffer have experienced a 3-year survival rate of approximately 90%. The main challenge for the young plants is being damaged by deer. In 2022, the plastic sleeves (originally installed when the trees were planted) protecting the trees from deer rub were removed and replaced with larger wire cages. The cages, made from welded wire fencing mounted on metal T-posts, are more durable and offer better protection than plastic deer tubes and wooden stakes (PL-11).

PL-11. Newly Installed Tree Cages

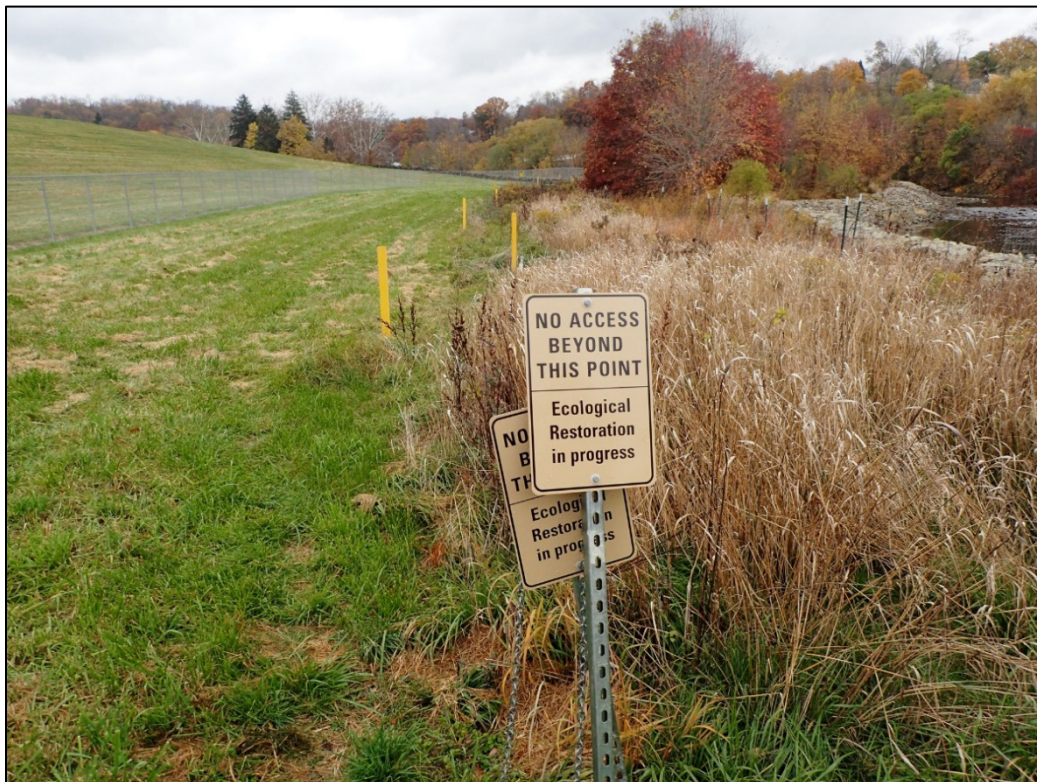
The riparian forest buffer is also recognized as a means to improve stream quality. This effort is part of the Commonwealth's goal to establish 95,000 acres of riparian forest buffer by 2025. The Pennsylvania Department of Conservation and Natural Resources was notified of the project. The general long-term health prospect is good for the young plants in the riparian buffer given the installation of the protective wire cages. A chain that limits vehicle access to the site near the riparian forest buffer and reuse prairie was down because the post it was attached to had been removed (PL-12). Repair to this access point will be implemented before the next inspection.

PL-12. Restoration Signage at the Riparian Forest Buffer and Reuse Prairie
