3.0 Canonsburg, Pennsylvania, Disposal Site

3.1 Compliance Summary

The Canonsburg, Pennsylvania, Uranium Mill Tailings Radiation Control Act (UMTRCA) Title I Disposal Site was inspected on October 30, 2024. No changes were observed on the disposal cell or in the associated drainage features. No evidence of site trespassing was observed. A tree was down on the perimeter fence, the result of a recent windstorm. The integrity of the fence appears to be functional but will need to be assessed further once the tree is removed. A few minor maintenance items were identified. No cause for a follow-up inspection was identified.

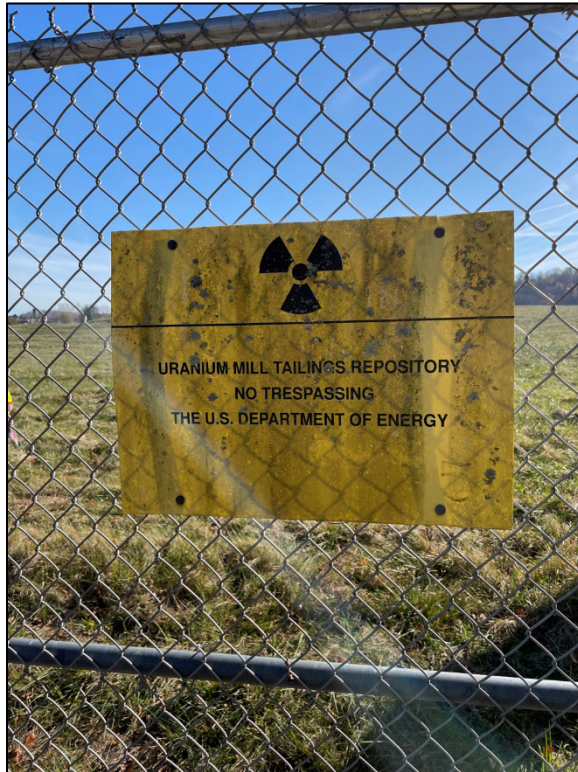
There are 11 perimeter signs attached to the security fence. Theft of perimeter signs from the southwest fence line that borders the railroad tracks is an ongoing challenge. Since the 2020 inspection, two signs have been cut out of the fence fabric on the southwest fence line and replaced. During this year's inspection, perimeter sign P11 on the southeast fence line that borders Strabane Avenue was missing. The fence fabric around the sign had been cut and the sign removed. During the 2023 inspection, a new perimeter sign (P6A) was installed between perimeter signs P5 and P6 to improve coverage. Perimeter sign P5 is weathered to a point where it needs to be replaced (PL-1). A few signs were observed to have outdated emergency contact numbers. These were corrected by placing a sticker with the current number over the outdated number. A few signs still have the wrong emergency contact number posted and will need to be corrected in 2025. Perimeter sign P3 has a few bullet holes in it but is still serviceable. No other maintenance needs were identified.

PL-1. Perimeter Sign P5

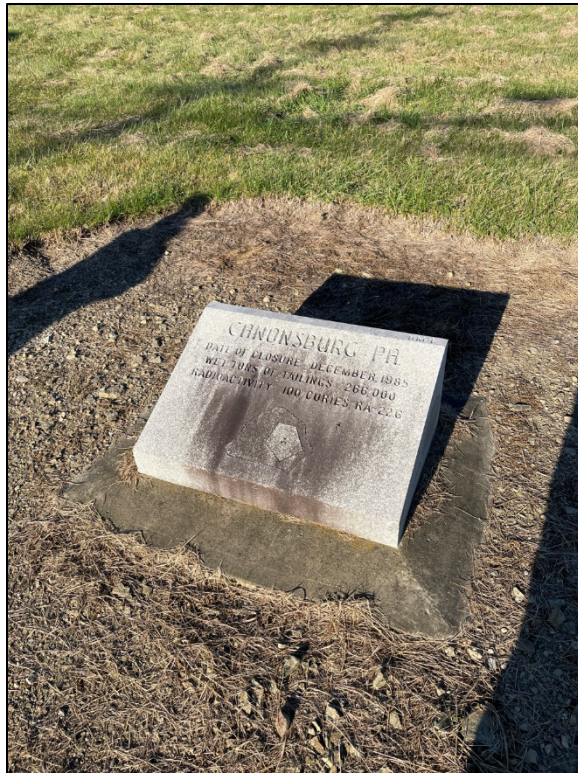
The site has two granite site markers. Site marker SMK-1 is just inside the main entrance gate (PL-2), and site marker SMK-2 is on the top slope of the disposal cell. No maintenance needs were identified.

PL-2. Site Marker SMK-1

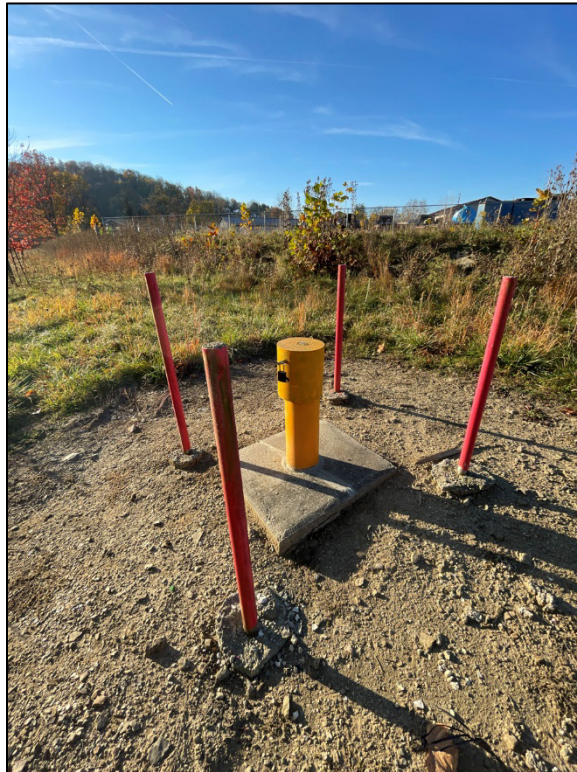
The site has five groundwater monitoring wells that are sampled every 5 years (Figure 3-1); 2023 was the most recent sampling year. All wells were locked. Well locks were replaced in 2023 with new locks. In 2024, repairs were made to cracks at well pad 0424 (PL-3). The well pad of monitoring well 0412 is leaning. The interior of the protective casing is encroaching on the actual well casing. A field crew was sent in 2024 to straighten the protective casing but, upon further assessment, determined that additional equipment would be needed to perform the task safely and effectively. LM is planning to send a crew back out to straighten the casing in 2025. No other maintenance needs were identified.

PL-3. Repaired Well Pad at Monitoring Well 0424

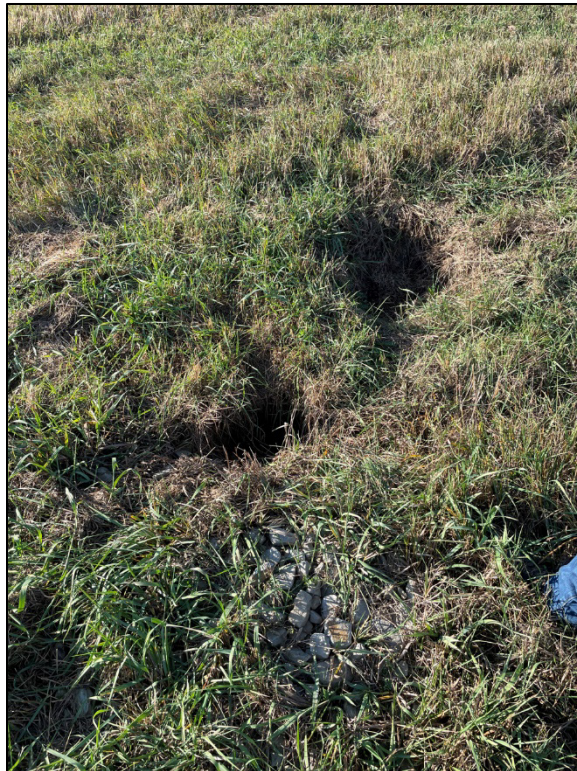
Noxious weeds within the security fence area are limited to resprouting seedlings that were observed in portions of mowed areas. A new animal burrow was identified west of the disposal cell. It was noted on the inspection map and will be monitored for changes. No maintenance needs were identified.

PL-4. New Animal Burrow

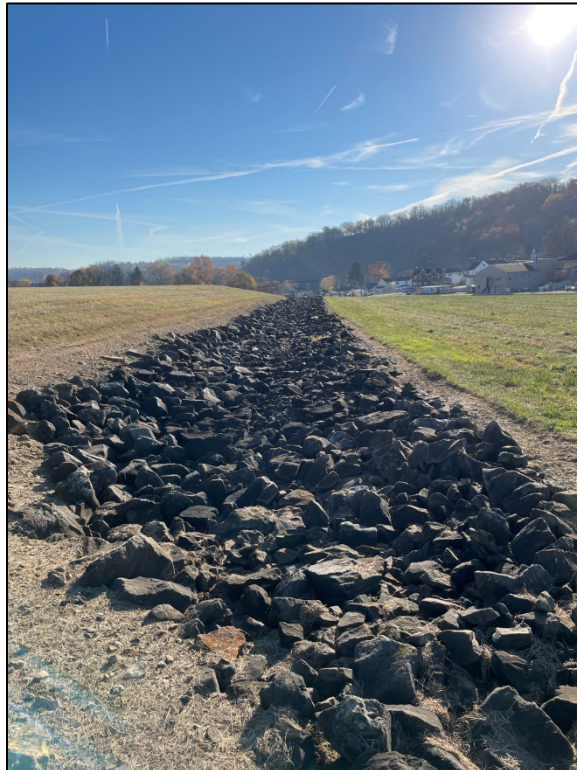
There was no evidence of rock deterioration or woody vegetation in the diversion channels and perimeter ditches (PL-5). Periodic physical removal and spot herbicide applications have been effective at reducing woody vegetation and will continue to be conducted as needed. No maintenance needs were identified.

PL-5. Riprap-Armored Diversion Channel

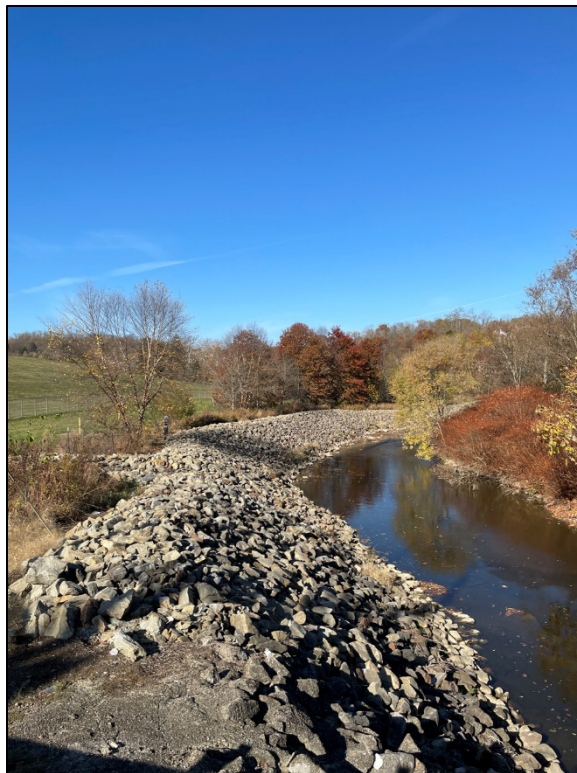
Chartiers Creek north of the disposal cell (approximately 1200 linear feet) was repaired during low streamflow conditions. The work consisted of minor grading, replacing geotextile filter fabric, and importing and placing 2-foot-thick riprap slopes. A minor concern was observed with the current riprap embankment during the inspection (PL-6). Flooding over the past year had moved some of the riprap from the top edge of the embankment. This riprap should be relocated back to the top of the embankment.

PL-6. Riprap-Armored Streambank

- Repair of the protective casing and well pad at monitoring well 0412
- Removal of the small pile of trash west of the turnaround area
- Removal of the downed tree from the perimeter fence and assessment of the integrity of the damaged fence
- Complete replacement of emergency phone numbers on perimeter signs
- Replacement of missing perimeter sign P11
- Replacement of faded no-trespassing signs in the turnaround area
- Replacement of perimeter sign P3 due to bullet holes
- Replacement of perimeter sign P5 due to weathering
- Replacement of the disturbed riprap on the top edge of the embankment

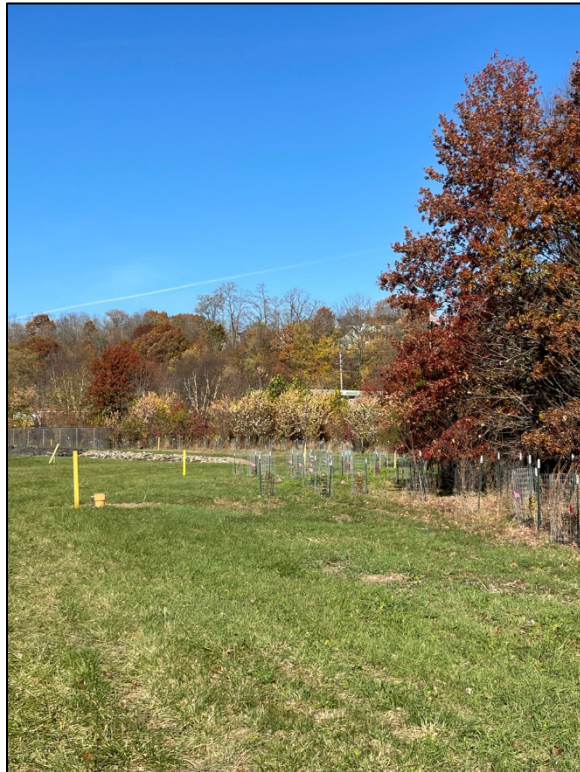
In its study of the Canonsburg site, LBNL found that increased flooding of Chartiers Creek, adjacent to the site, posed a potential risk to the long-term integrity of the disposal cell at the site. In response to LBNL recommendations, two projects were completed at the Canonsburg site in 2024 to help address the risk of increased flooding. In June 2024, water level transducers were installed in monitoring wells 0412, 0413, 0424, and 0414B to measure changes in water table elevations beneath the disposal cell. The transducers will help to better monitor changes in groundwater elevation and understand the impact of extreme precipitation events. In September 2024, approximately 50 flowering trees and shrubs were planted along Chartiers Creek to further stabilize a riparian forest buffer area that was established in 2019 (PL-7).

The planting of 50 additional flowering trees and shrubs in the pollinator grass area will begin a transition of the prairie grass area into a pollinator-friendly, wooded edge habitat. The habitat will require less long-term maintenance than the pollinator prairie and will better compliment the natural progression of the area back to being wooded. The forested edge habitat will better protect the upper edge of the riparian corridor, provide a pollinator-friendly habitat, and lower long-term maintenance costs for the care and maintenance of the streambank against future flooding events predicted as a risk due to climate change.

PL-7. Newly Planted Flowering Trees and Shrubs
