Postclosure Inspection and Monitoring Report for Surface Corrective Action Unit 417 at the Central Nevada Test Area, Nevada, Site

March 2018

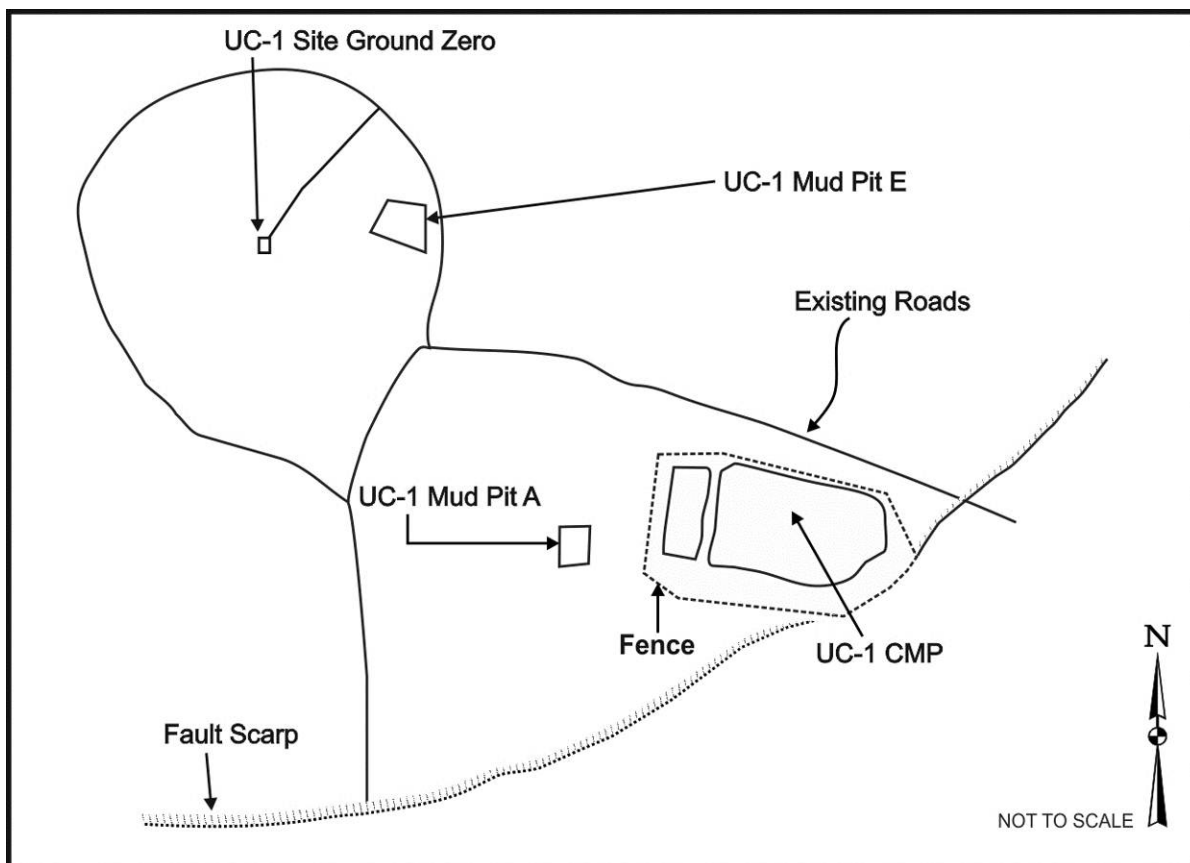
Figure 3. Location of UC-1 Significant Features

The locks, fencing, and signs associated with the CMP were in good condition. One minor crack on the cover was repaired during the inspection. No issues that affected the integrity of the cover, including new cracks, fractures, or extensions of existing cracks and fractures, were noted. The vegetation on the cover continued to look healthy and stable. All signs and monuments at Mud Pits A and E (Figure 3) were in good condition. No additional maintenance or repairs are recommended. Photographs 1 through 3 in Appendix B show the condition of the UC-1 site at the time of the inspection.

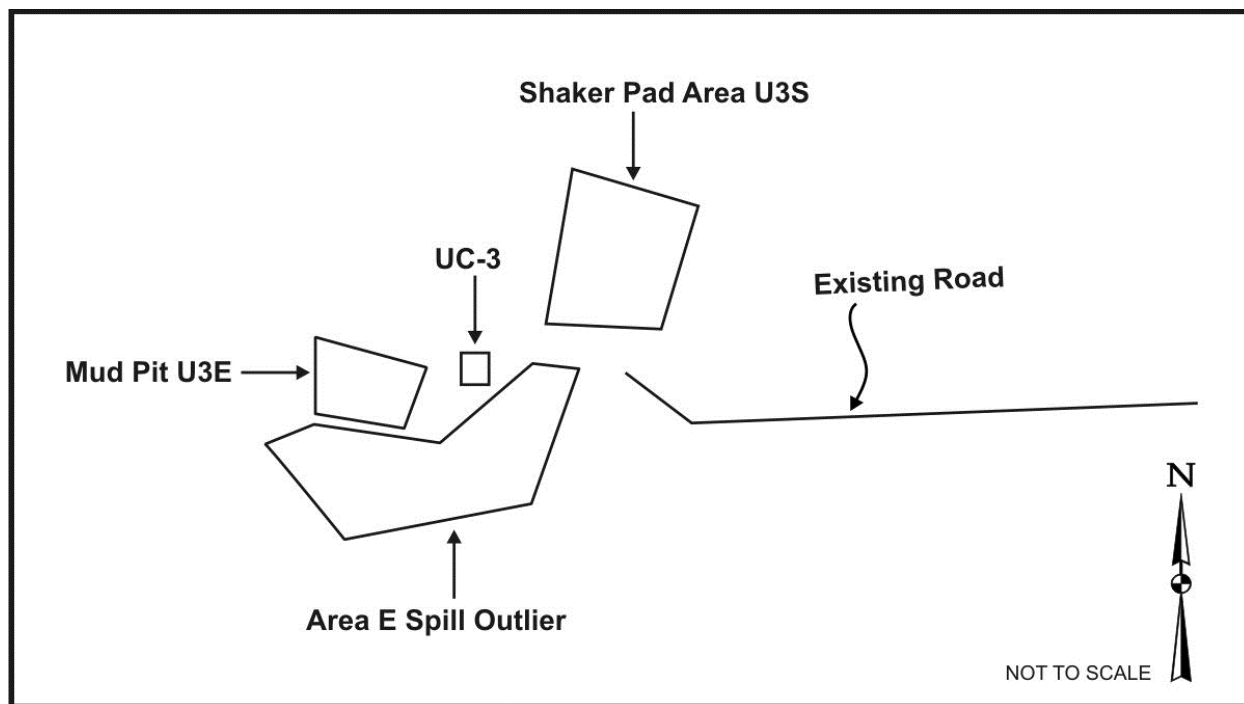
Figure 4. Location of UC-3 Significant Features

The site was in good condition (Figure 4). One monument was found tipped over and was returned to a standing position during the inspection. No other issues with the monuments or signs were identified at the time of the inspections, and no additional maintenance or repairs are recommended. Photographs 4 through 6 in Appendix B show the condition of the UC-3 site at the time of the inspection.

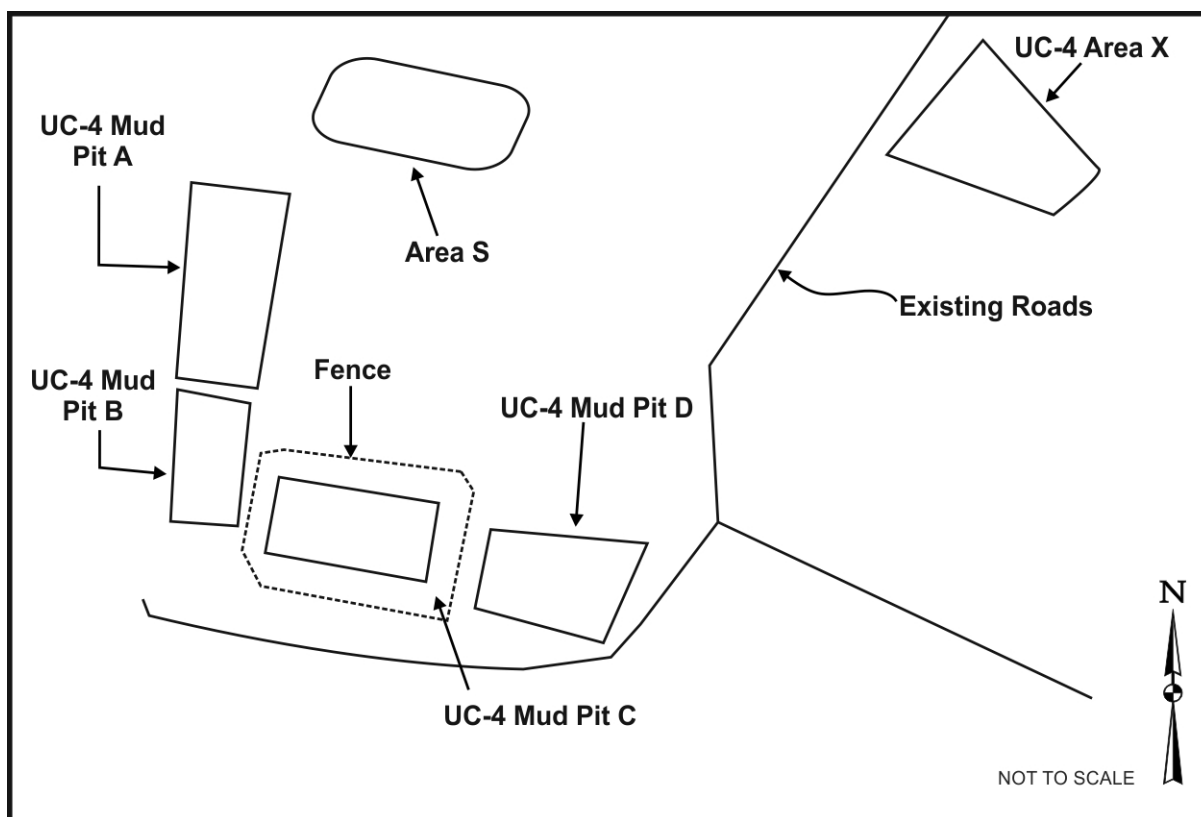
Figure 5. Location of UC-4 Significant Features

The Mud Pit C fence, signs, and monuments were in good condition at the time of the inspections. No erosion rills were identified, and previously identified rills showed no further signs of activity. No new erosion concerns were apparent at the time of the inspections. No issues that affected the integrity of the cover, including new cracks or fractures or extensions of existing cracks and fractures, were noted. All signs and monuments at Mud Pits A, B, and D were in excellent condition, and no issues were identified with Area S or Area X (Figure 5). No maintenance or repairs are recommended. Photographs 7 through 11 in Appendix B show the condition of the UC-4 site at the time of the inspection.

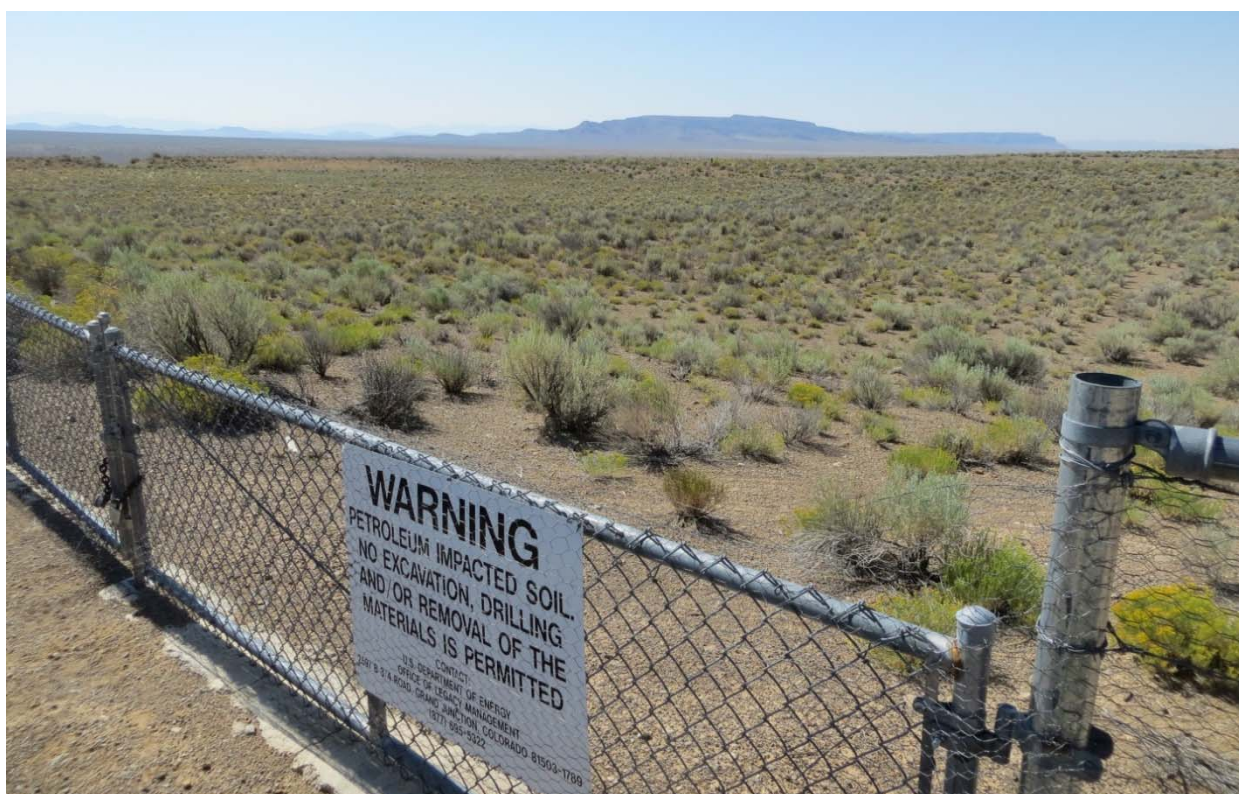
Photograph 1. UC-1 CMP, view from entrance gate on north fence line, looking southeast

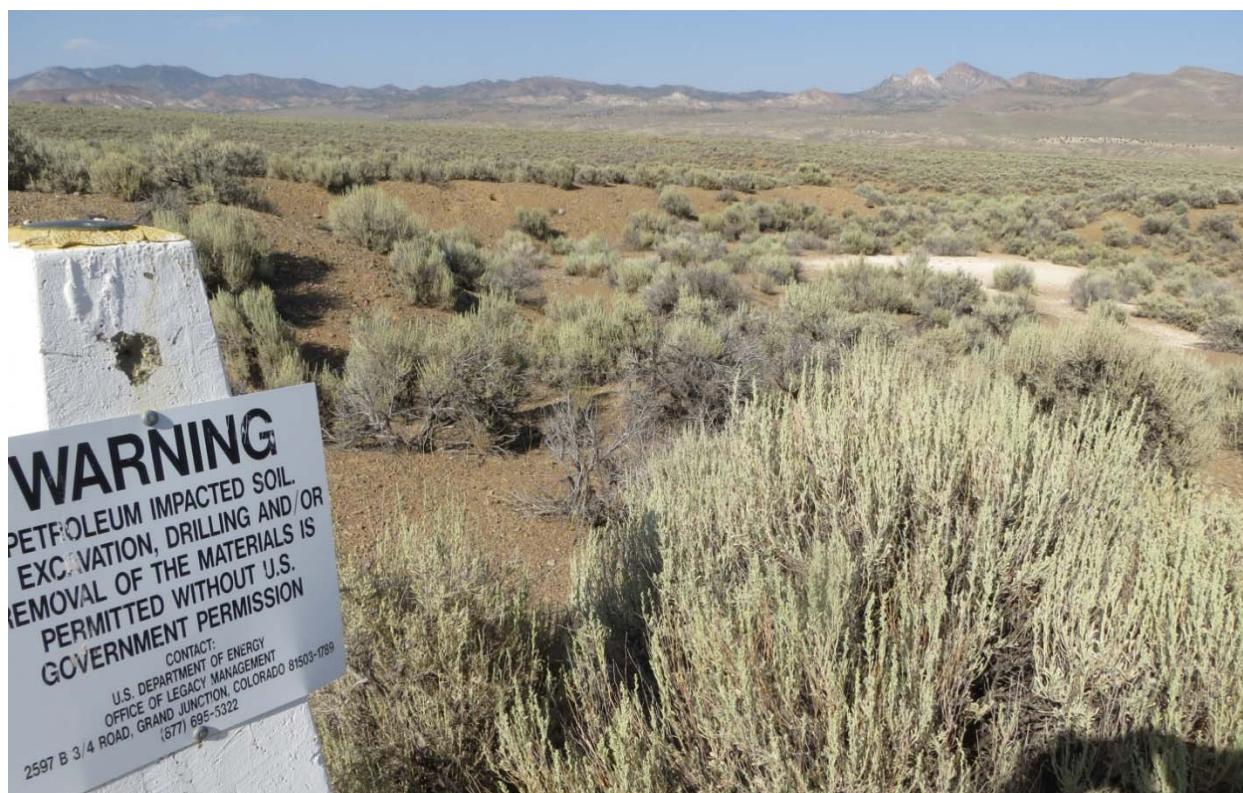
Photograph 2. UC-1 Mud Pit E, view from western monument, looking northeast

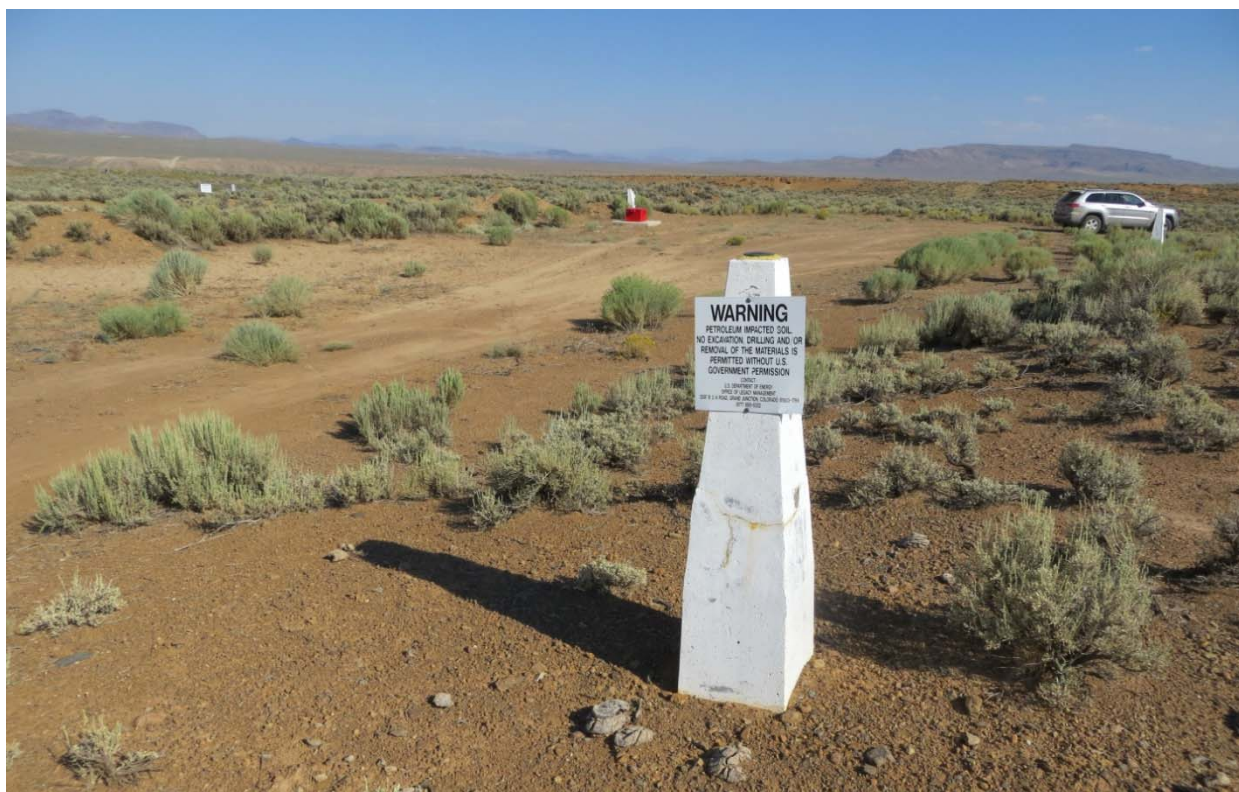
Photograph 3. UC-1 Mud Pit A, view of northwest monument, looking southeast

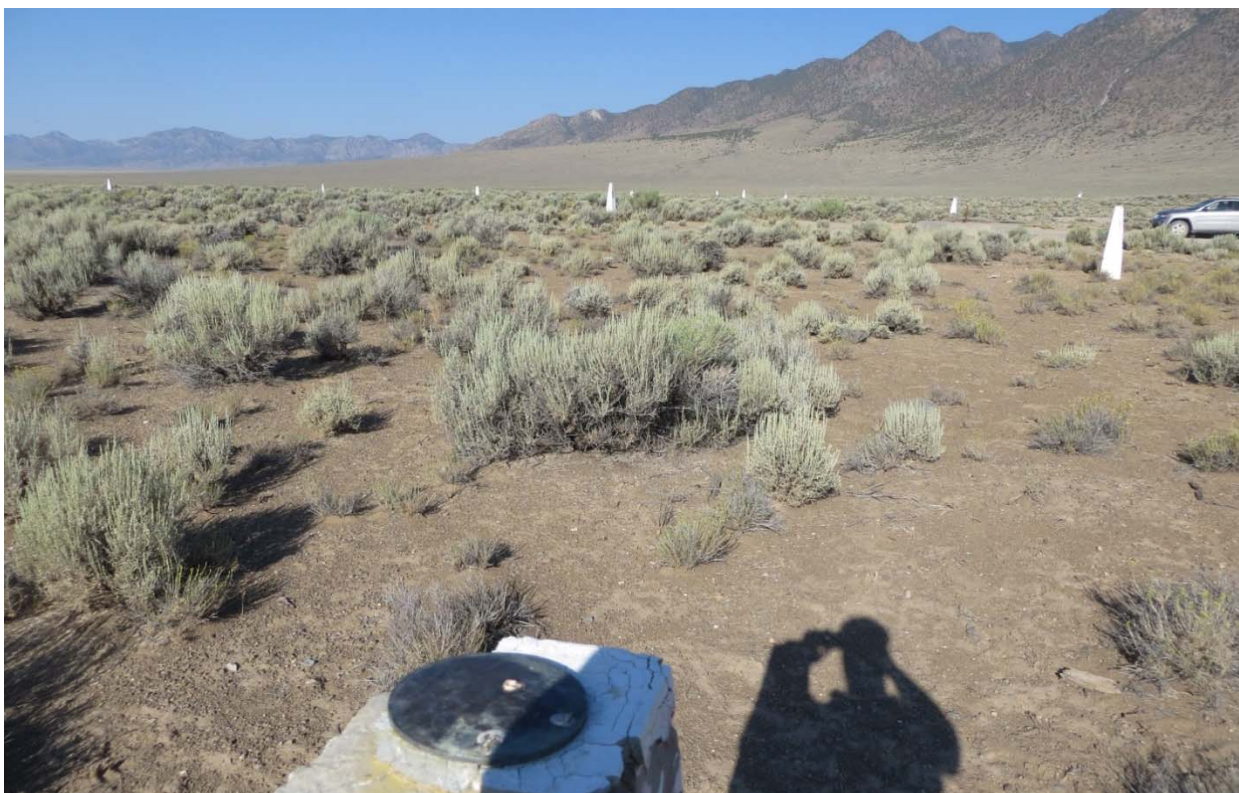
Photograph 4. UC-3 Area E Spill Outlier, view from northeast monument, looking southwest

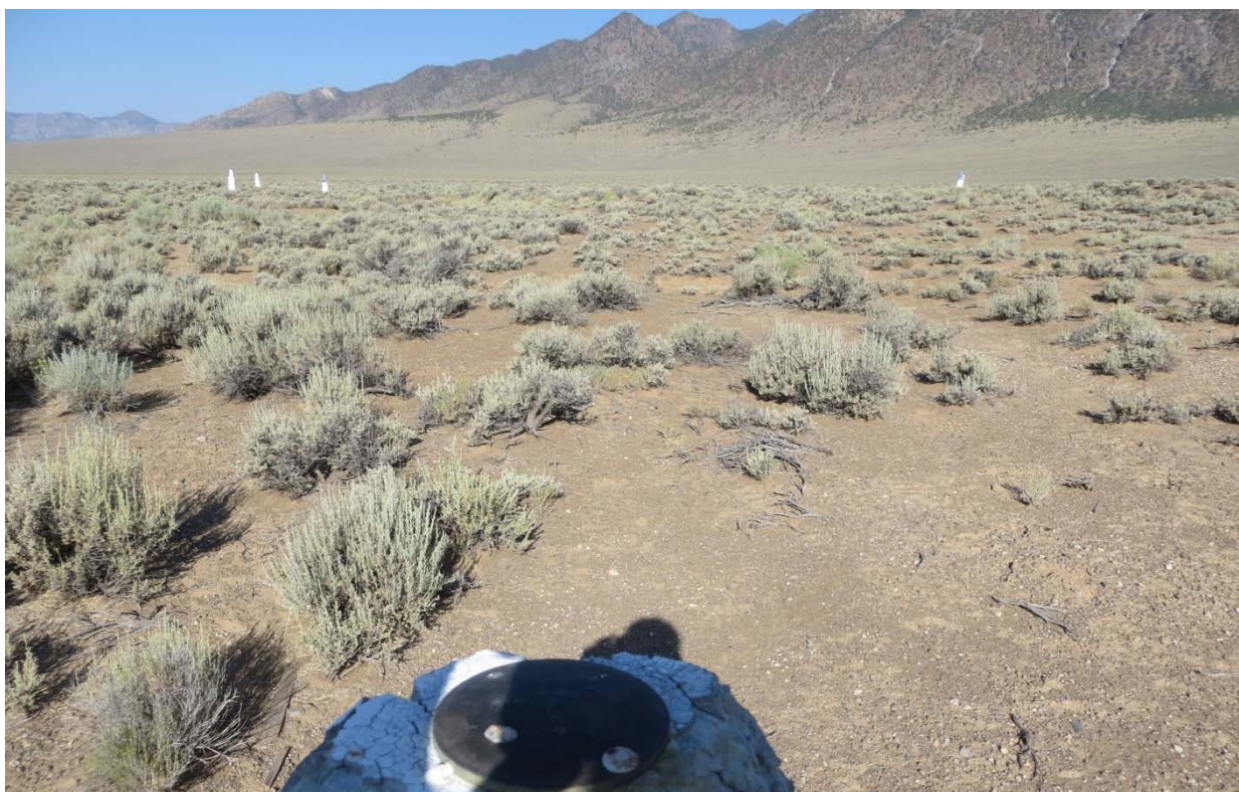
Photograph 5. UC-3 Mud Pit U3E, view from northeastern monument, looking west

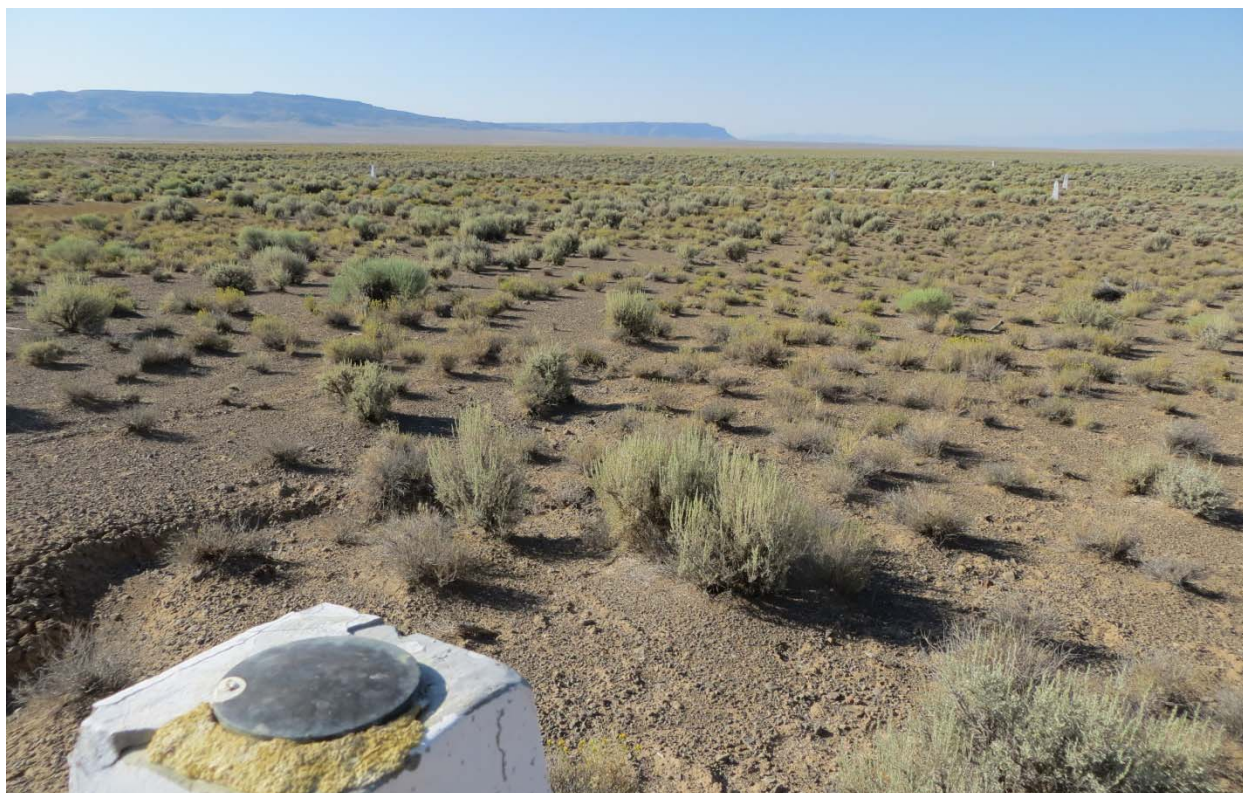
Photograph 6. UC-3 Shaker Pad Area U3S, view from northwest monument, looking southeast

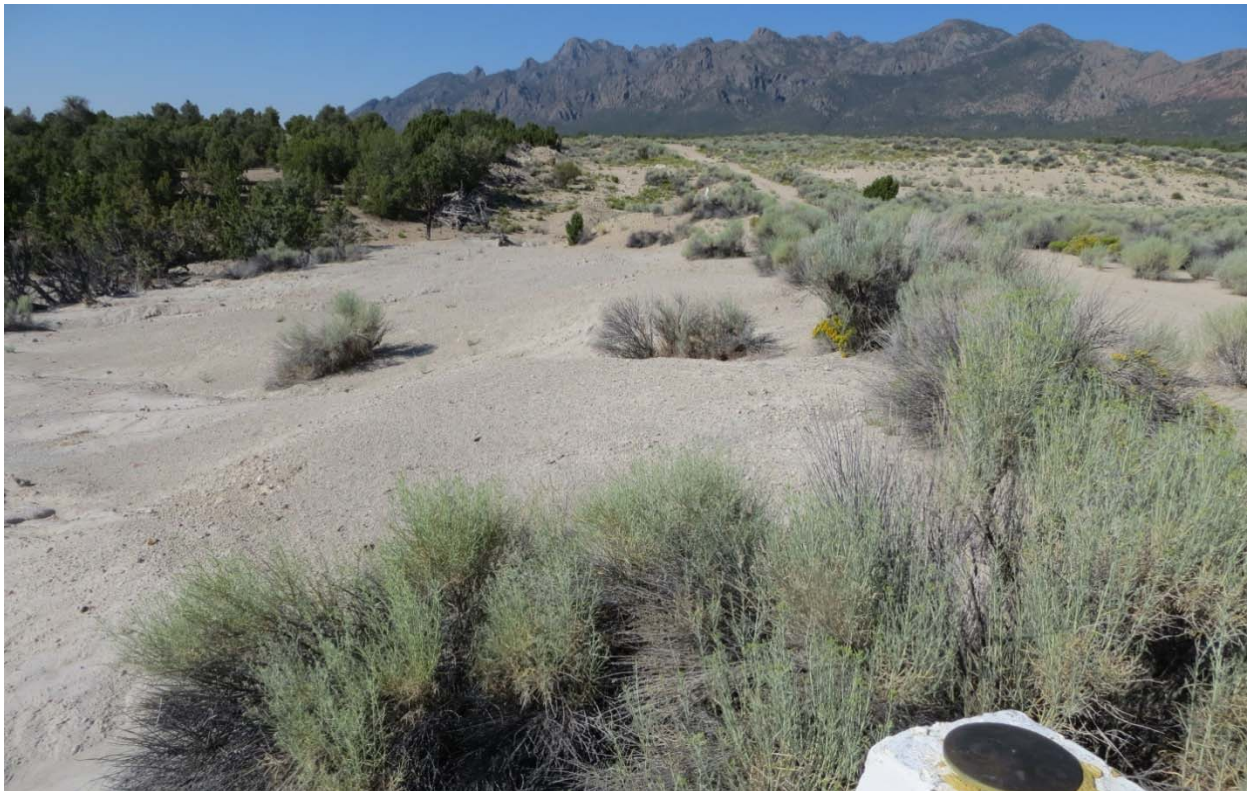
Photograph 7. UC-4 Area X, view from north monument, looking southwest

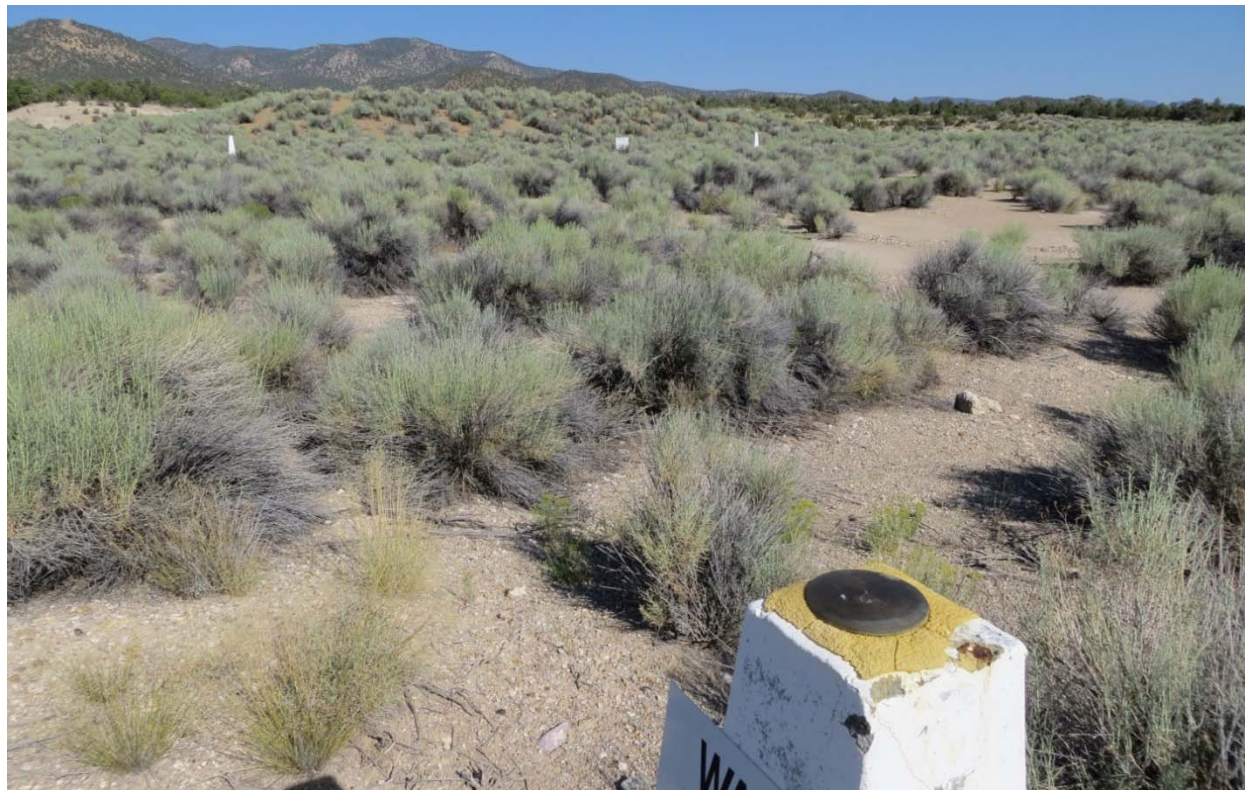
Photograph 8. UC-4 Mud Pit D, view from south monument, looking northwest

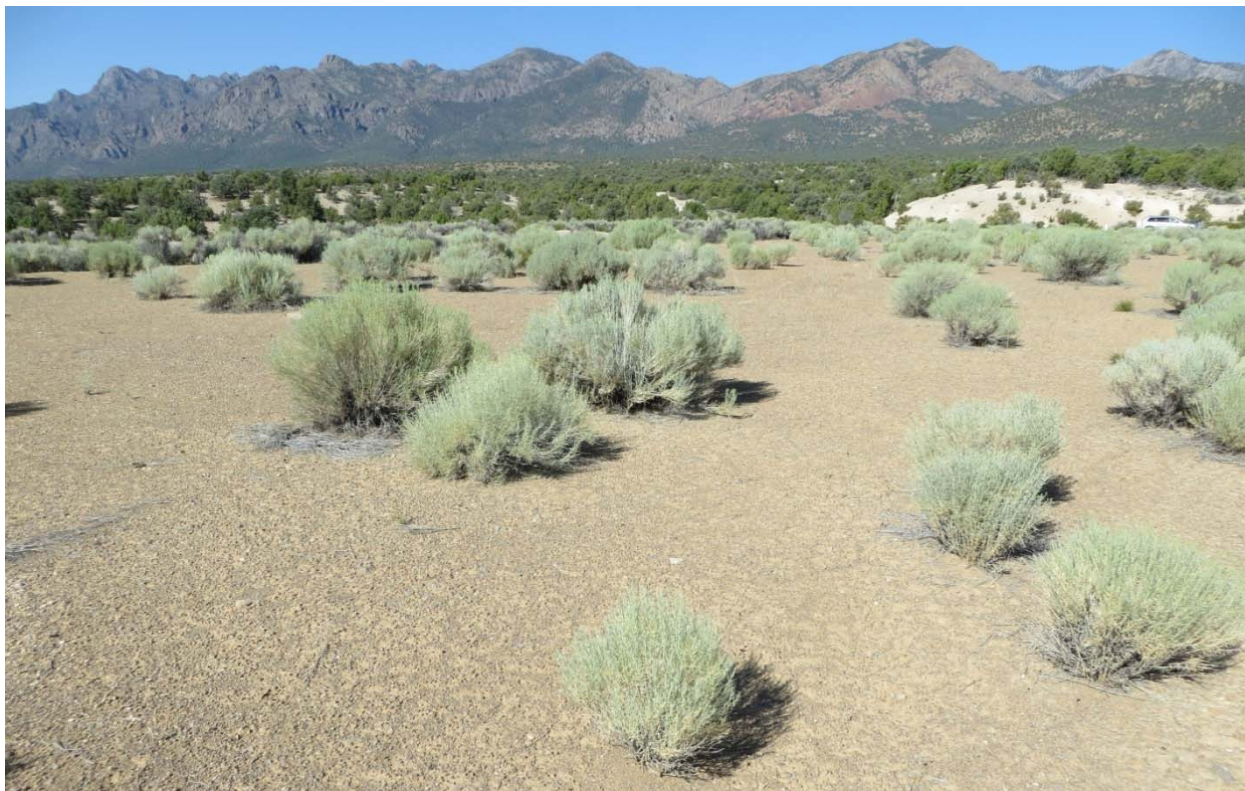
Photograph 9. UC-4 Mud Pit C, view from northeast corner of mud pit cover, looking west

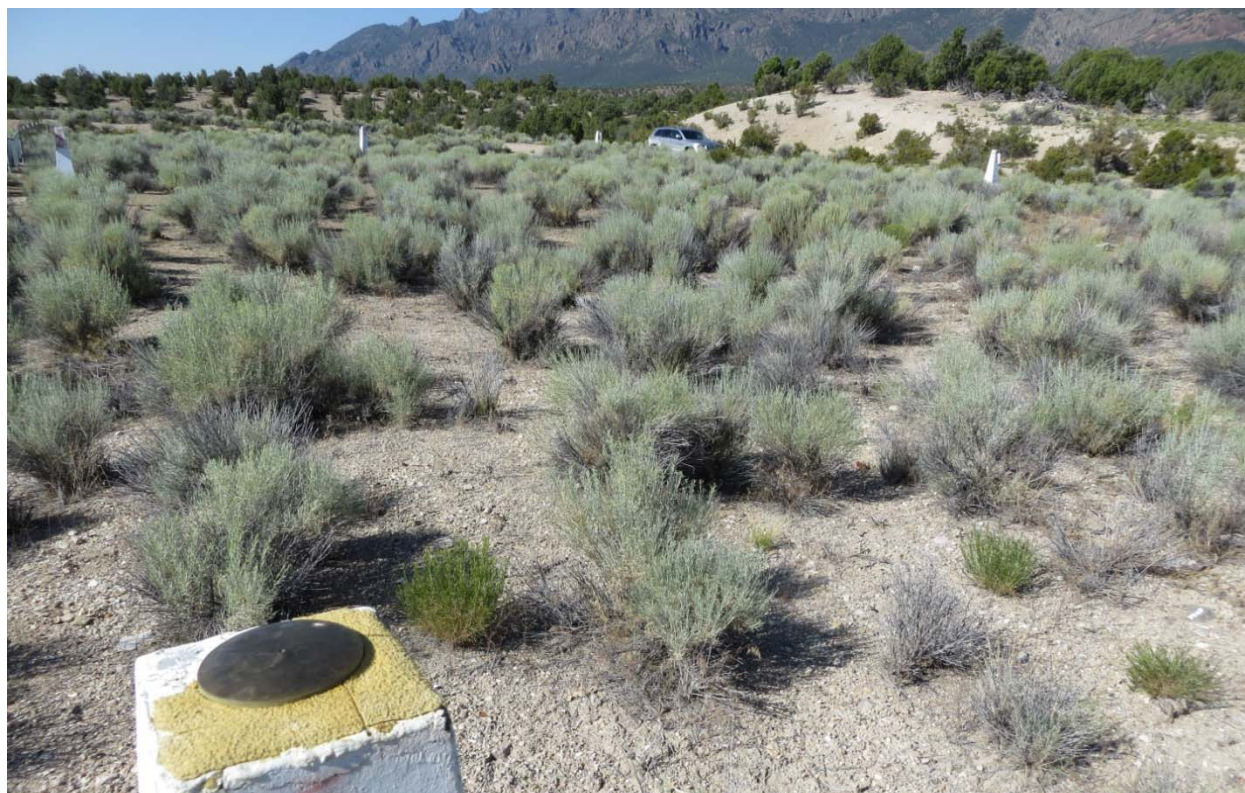
Photograph 10. UC-4 Mud Pit B, view from northeast monument, looking southwest

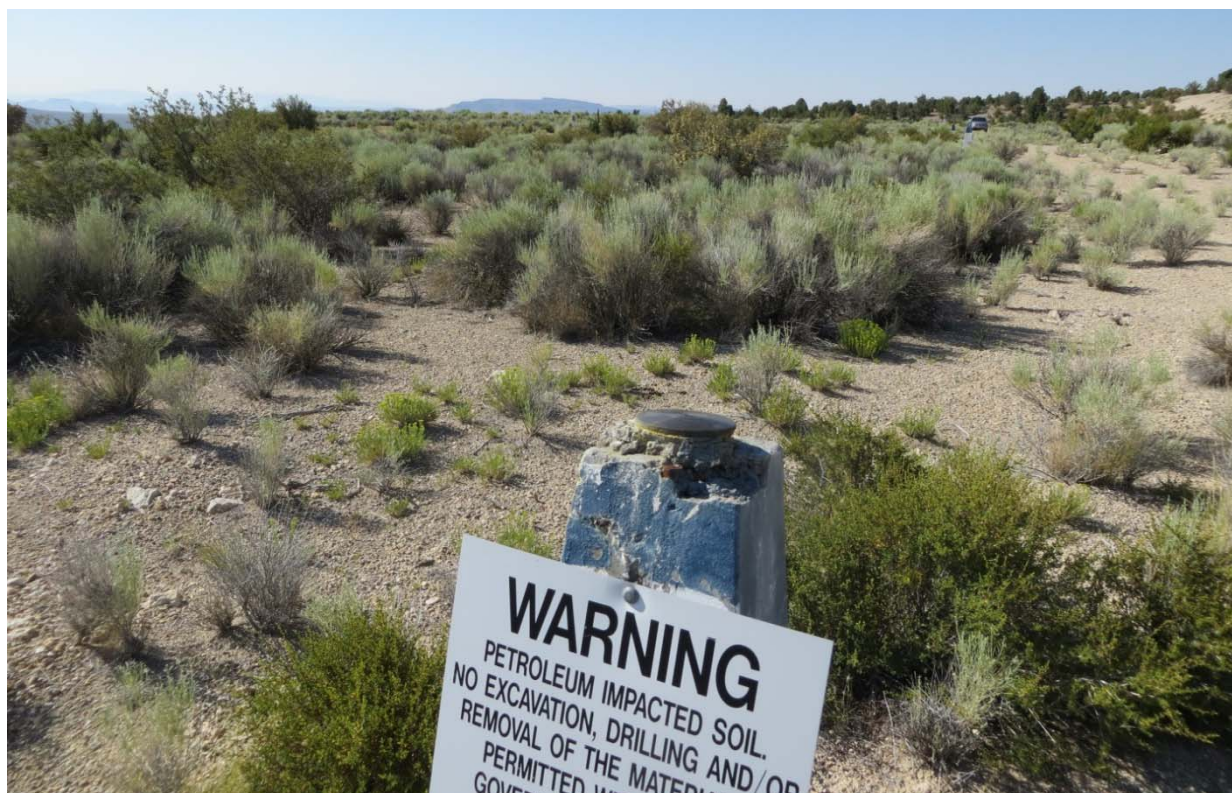
Photograph 11. UC-4 Mud Pit A, view from northwest monument, looking south
