2018 Annual Inspection Report for the DOE Monticello, Utah, Mill Tailings Site and Monticello Vicinity Properties

December 2018

U.S. DEPARTMENT OF
ENERGY

Legacy
Management

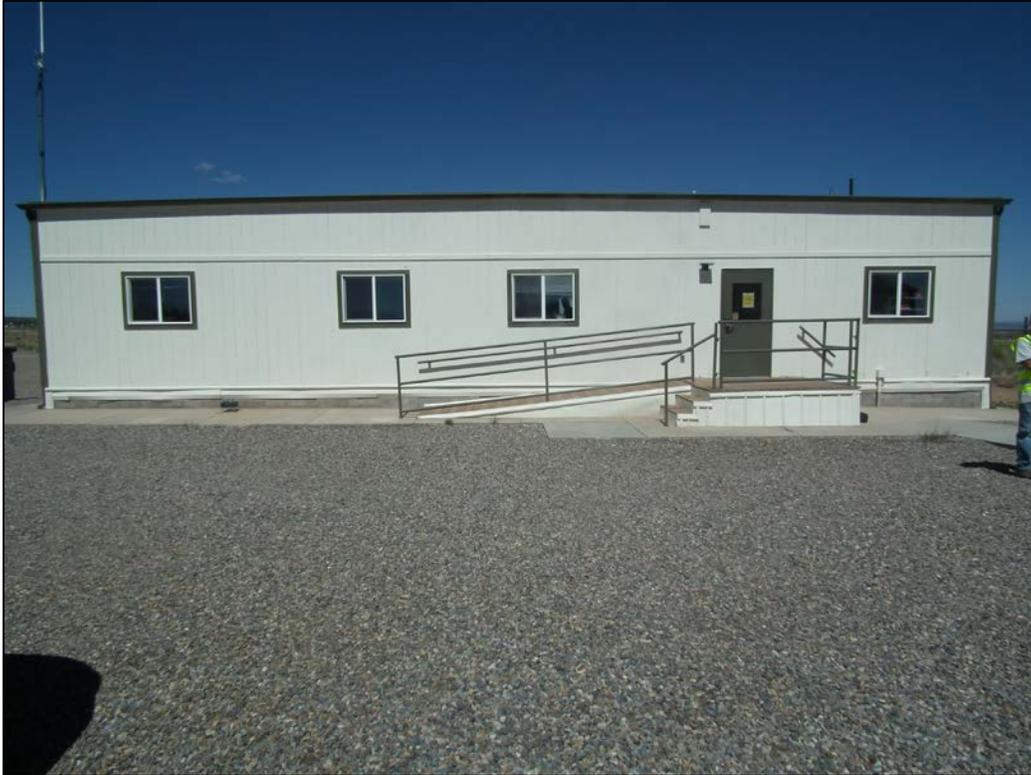
PL-1. Monticello Field Office Building

The Monticello field office buildings and associated structures were in excellent condition and well-maintained (PL-1). A new electric front gate to the administrative building was installed the week of August 27 (PL-2). Safety bollards were installed in front of the electrical panels. Site access signs displaying contact information were visible, and the new signs containing updated information were in place and in good condition. The site's paved access road was in very good condition.

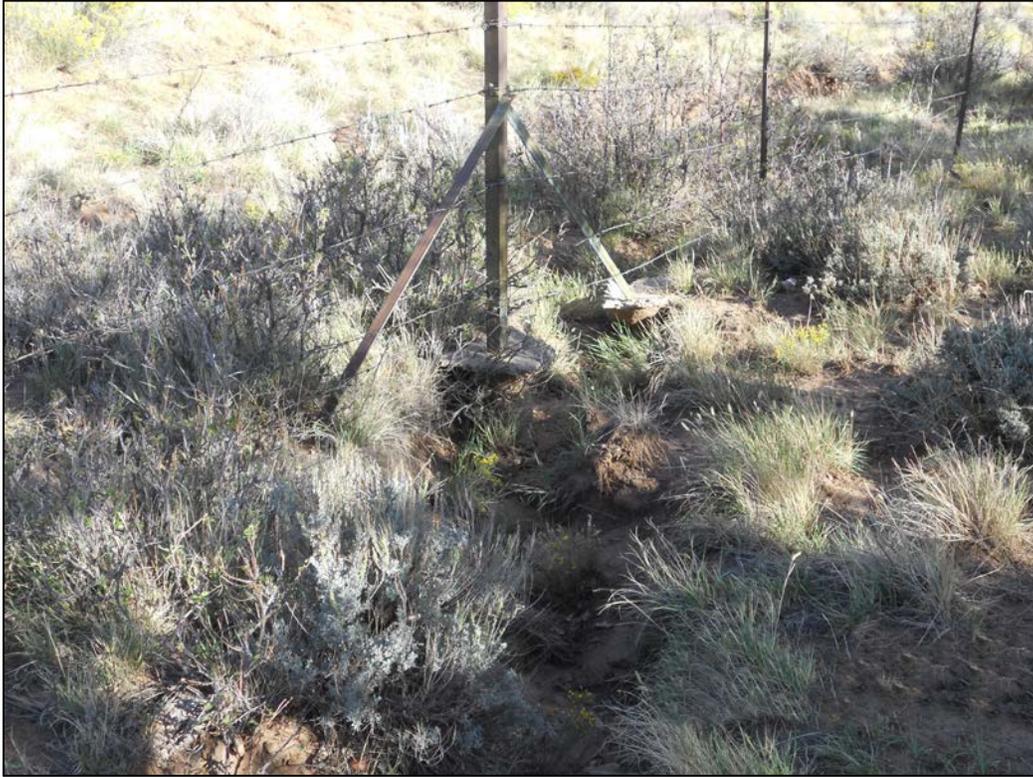
PL-5. Repaired Gap in Northwest Fence Line

Two sections of the northwest perimeter fence (PL-5 and PL-6) have been repaired. No evidence of vandalism or areas of excessive tumbleweed or debris buildup were present.

All the signs have been replaced and numbered with sticker decals to reference the signs. The outer fencing between signs P3 and P4 and P7 and P8 has been repaired.

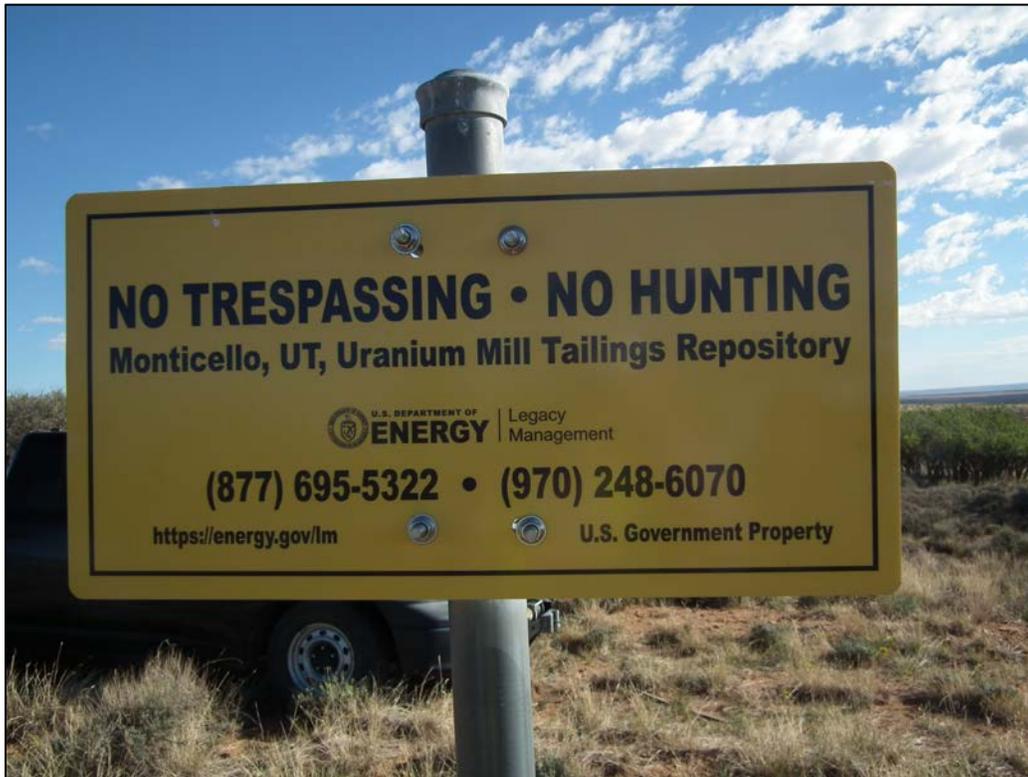
PL-7. New Perimeter Sign P32

All perimeter signs were replaced in 2018 (PL-7). Black numbered decal stickers to identify the sign number are now used, replacing the black marker identification that ended up faded by exposure to the elements.

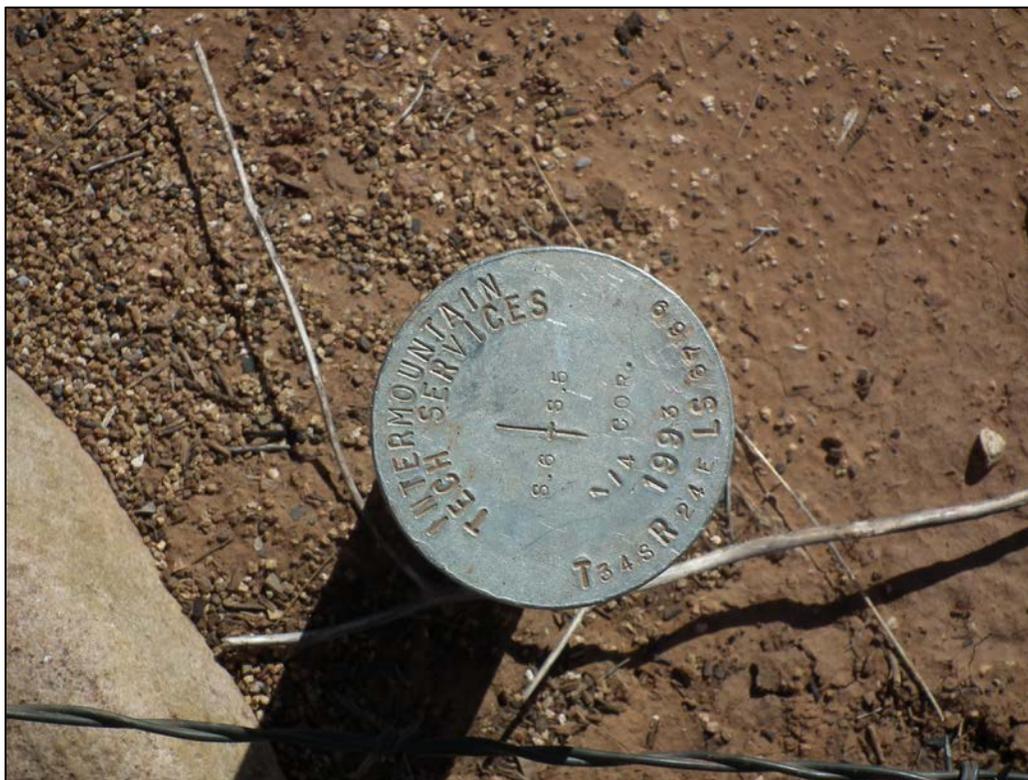
PL-8. Boundary Survey Marker S-6

All six boundary markers were located during the inspection, and all were in good condition (PL-8).

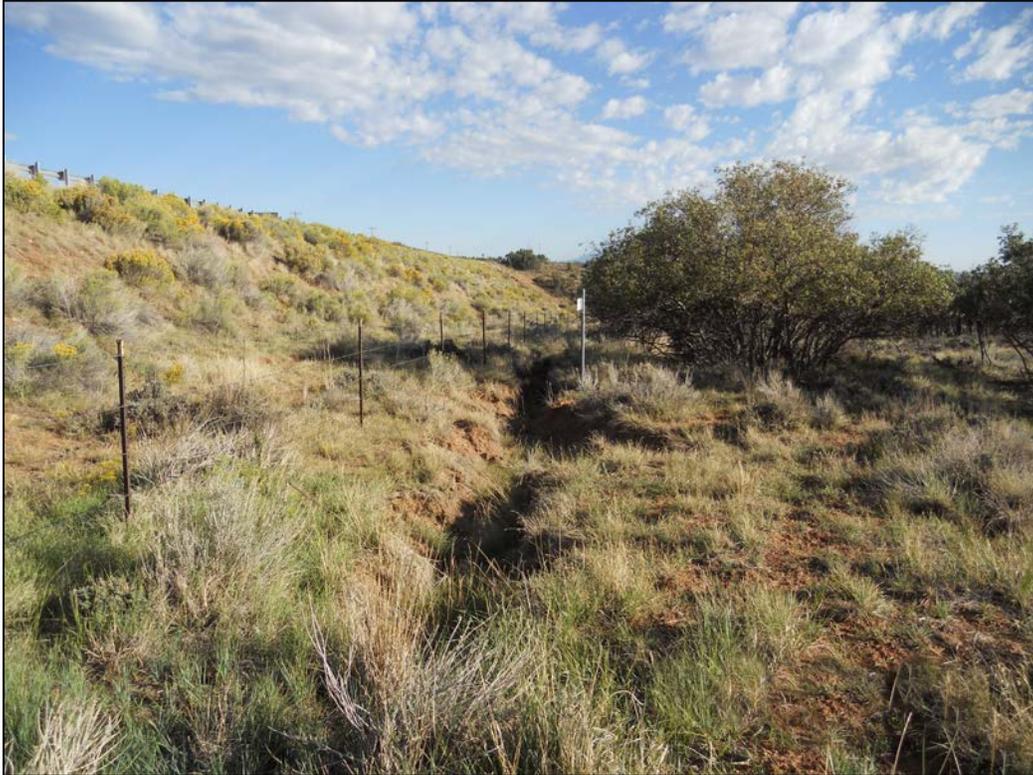
Erosion channels and drainages around the site perimeter were generally well-vegetated and had not significantly changed since the 2017 annual inspection. Erosion controls and revegetated areas related to the groundwater remedy optimization system were in good condition, and no major erosional areas were noted. The deep gully on the west edge of the disposal site described in previous inspection reports had not changed significantly since 2017 (PL-9). The gully does not threaten the integrity of site features but will continue to be monitored.

PL-9. Looking North Toward Perimeter Sign 1 Where Erosion Channel Shows Little Change

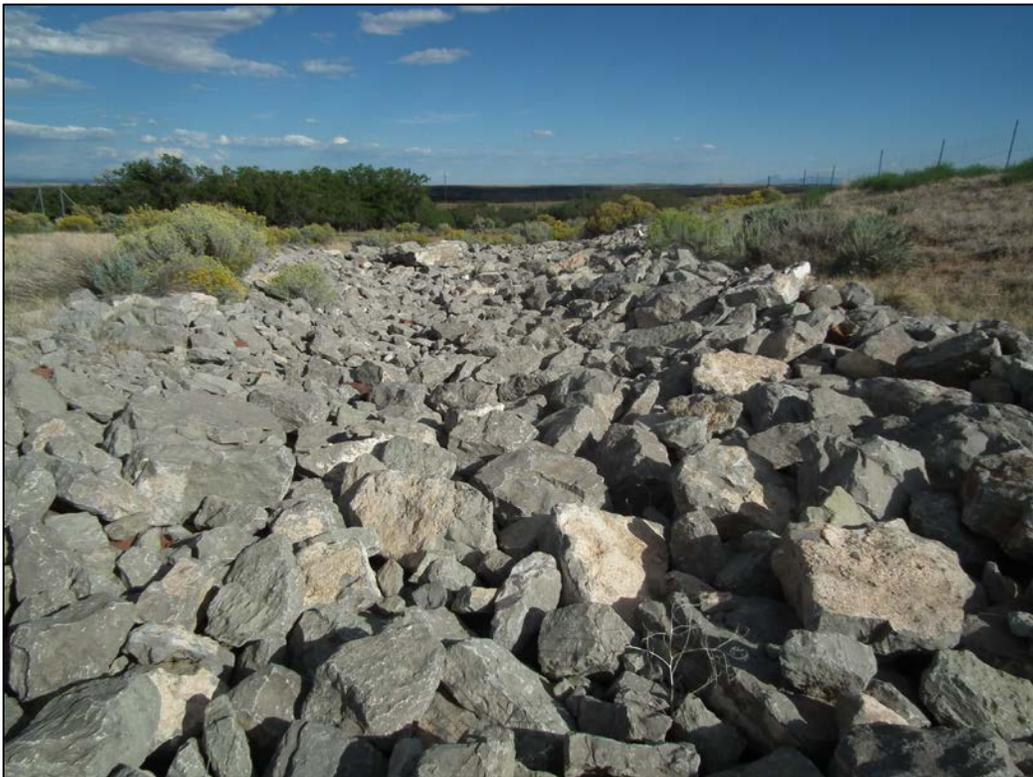
PL-10. South Drainage Channel, Looking East

The South and West Drainage Channels were in very good condition, with no evidence of new erosion (PL-10 and PL-11). Shrubs observed in portions of the ditches do not block potential flow, and burrows from small rodents that are found in places along the margin of the ditches do not threaten their integrity.

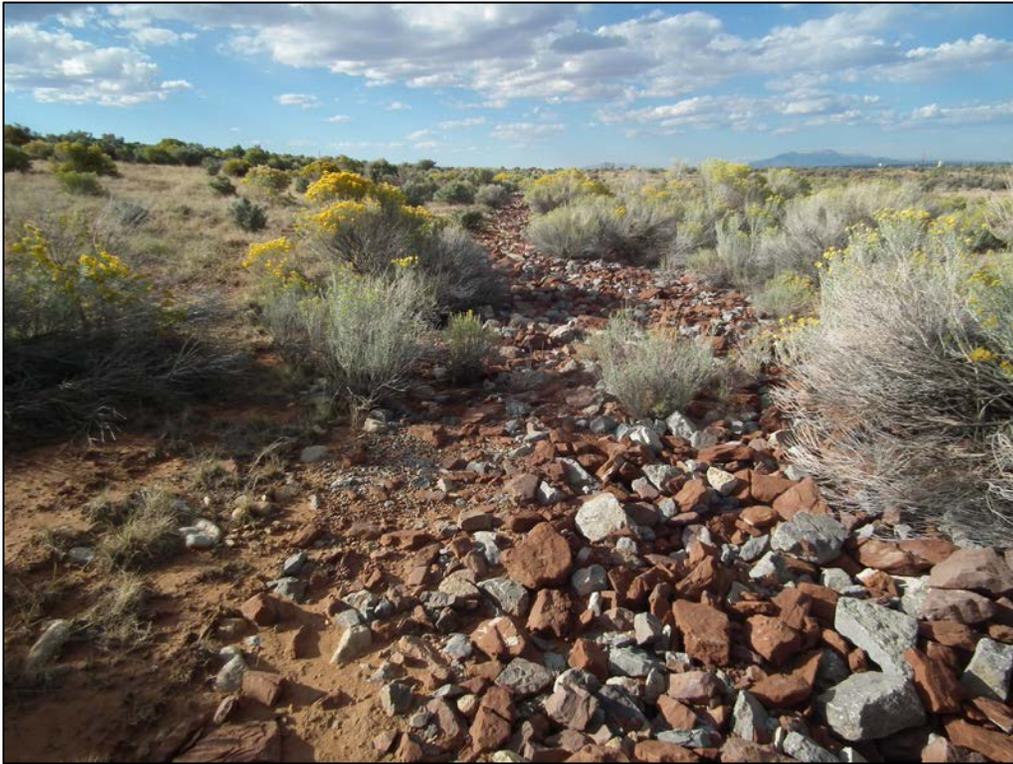
PL-12. East Toe Trench, Looking North

The East Toe Trench and North Toe Trench were in good condition. No erosion of these trenches was evident. Beginning in 2013, inspectors observed increased siltation from the repository side slope into both toe trenches during heavy rainfall events. The siltation does not impair the functioning of the trenches. PL-12 shows additional lighter-colored rock within the toe trench. There are no erosional features upgradient of this rock indicating that the rock has been displaced.

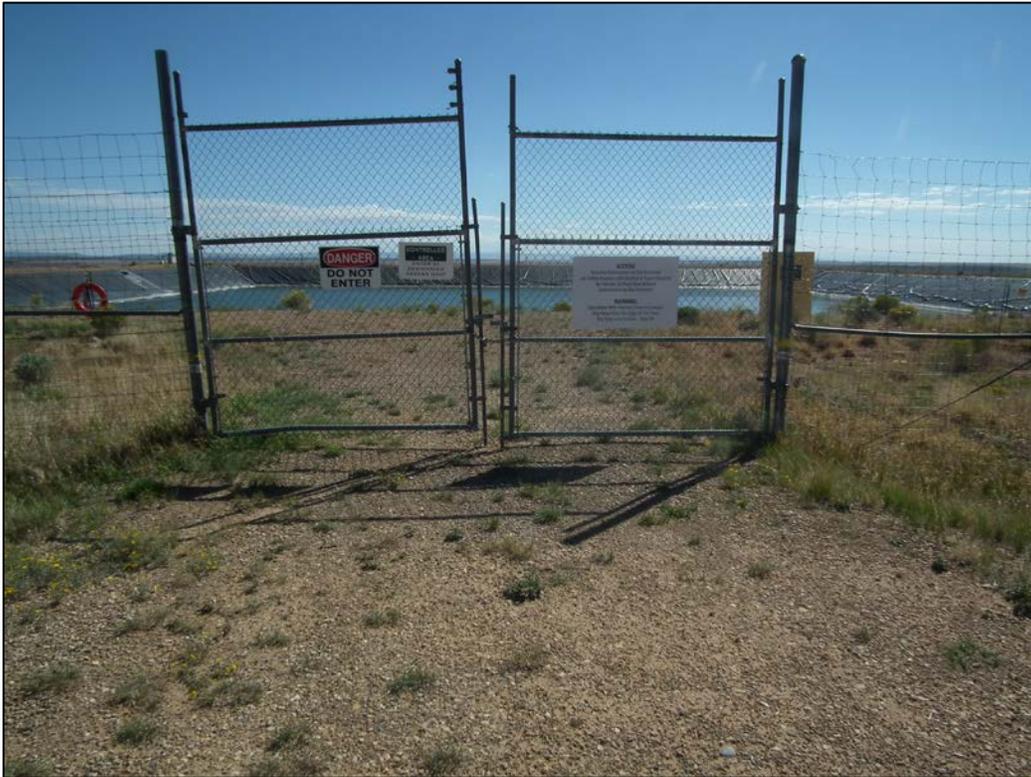
PL-13. Pond 4 Entry Gate

All gates were in good working condition. Warning signs on the perimeter fence were easily visible and legible. There was no evidence of vandalism or trespass, and all gates were locked at the time of the inspection (PL-13).

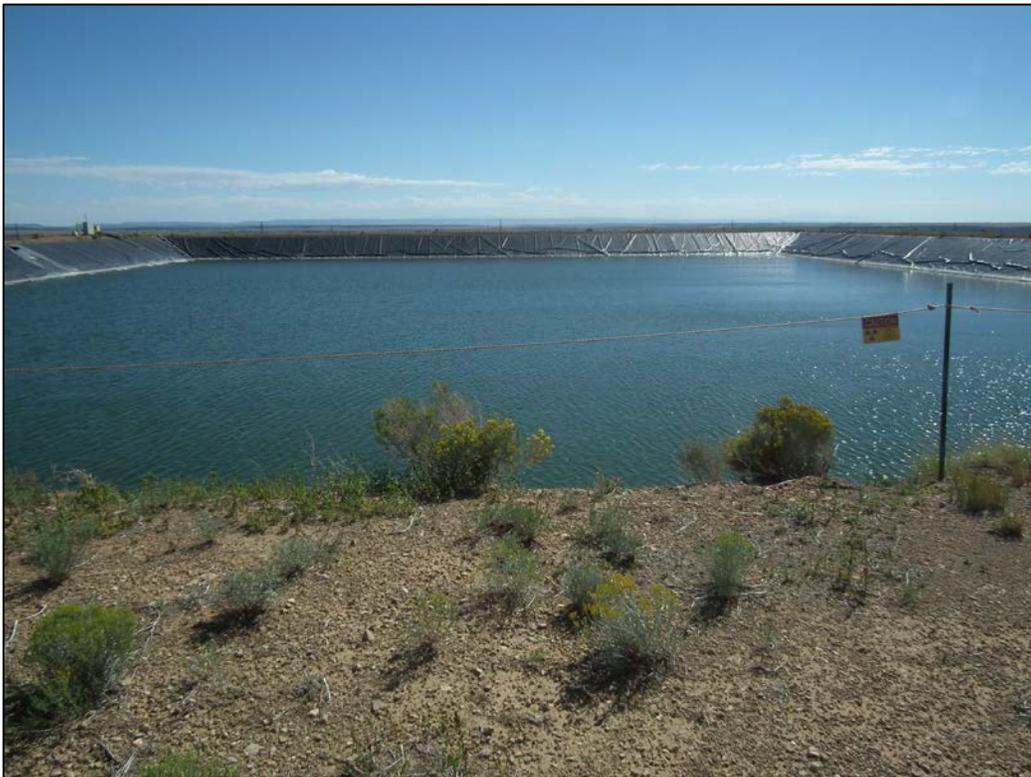
PL-14. Pond 4, Looking East

The pond's radiological rope barrier was intact and in good condition. Animal burrows made by voles and other small rodents were visible on and below the pond's berm on all sides. However, no large burrows that might threaten the berm's integrity were found. Vegetation on the slopes of the berm was well-established and healthy. Pond 4 is shown in PL-14.

Evidence of rodent biointrusion on the north and west sides, but liner function is not impaired. Continued monitoring is recommended.

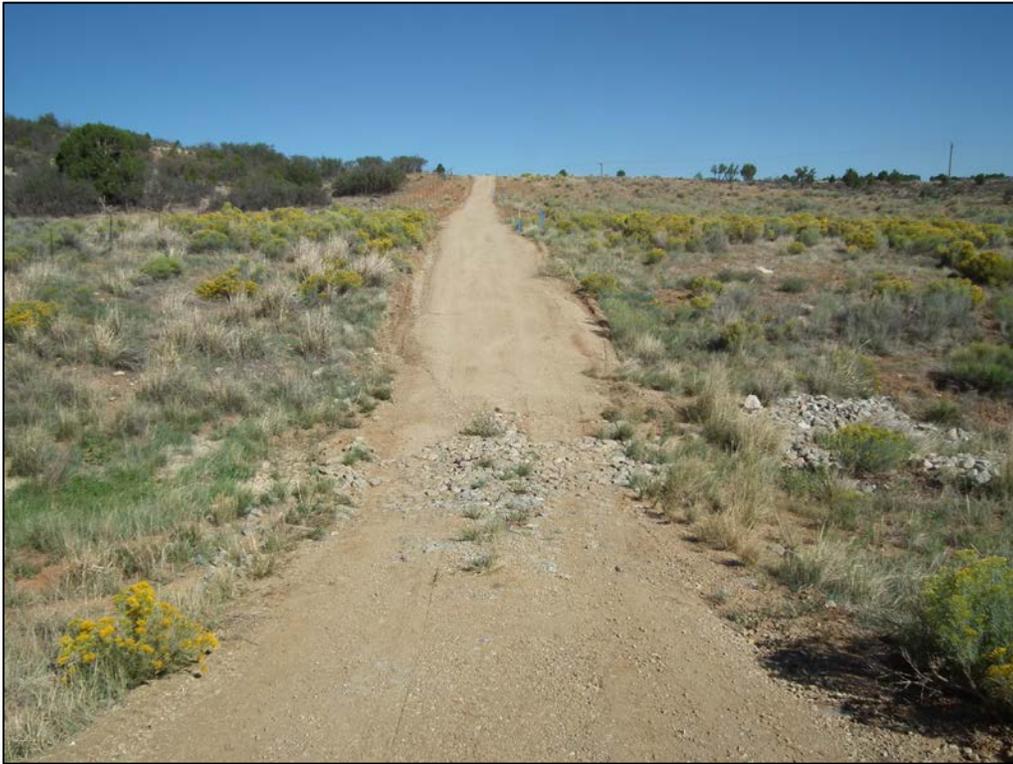
PL-15. Access Road and Transmission Pipeline, Looking North

The gravel road surrounding the disposal cell and the road to Pond 4 were in very good condition. To address erosion issues, new water bars were constructed on the access road to the transfer building (PL-15). The wildlife fence and gate apertures were functional and showed no evidence of vandalism. Damaged sections of the wildlife fence were apparent, but the fence remained functional, and repairs were not required. All gates in the wildlife fence were open. Both site monuments—one at the west access gate inside the wildlife fence and one at the apex of the disposal cell (PL-16)—were present and intact. Six raptor perches, installed near the disposal cell cover in 2007, were also in good condition, and the supporting beam brace on one perch is still detached, but that does not interfere with its function.

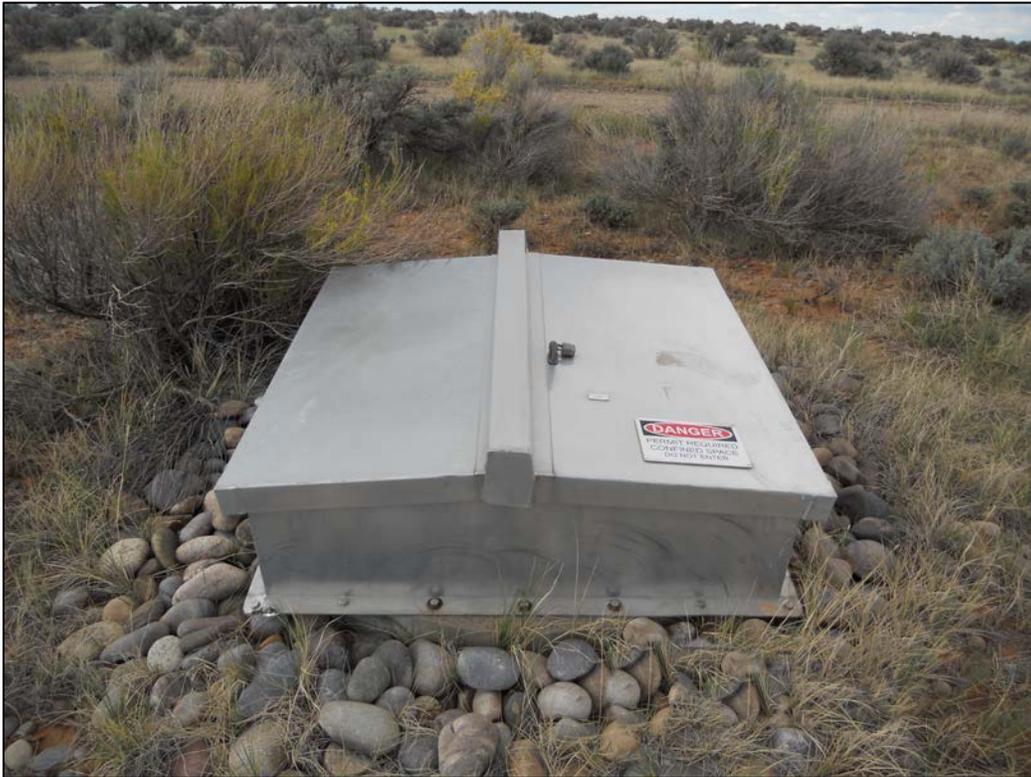
PL-17. Looking North from Manhole 1

The manholes are restricted areas and were not entered during the annual inspection, but the exteriors were observed and were in good condition (PL-17). All five manhole covers were secure and operable. Appropriate safety warnings and entry procedures were posted on all of the manholes (PL-18), exterior pump access ports were undamaged, telemetry surface installations were in good condition, and no leakage or drainage was evident. Covers of the inoperable video ports were locked and secure.

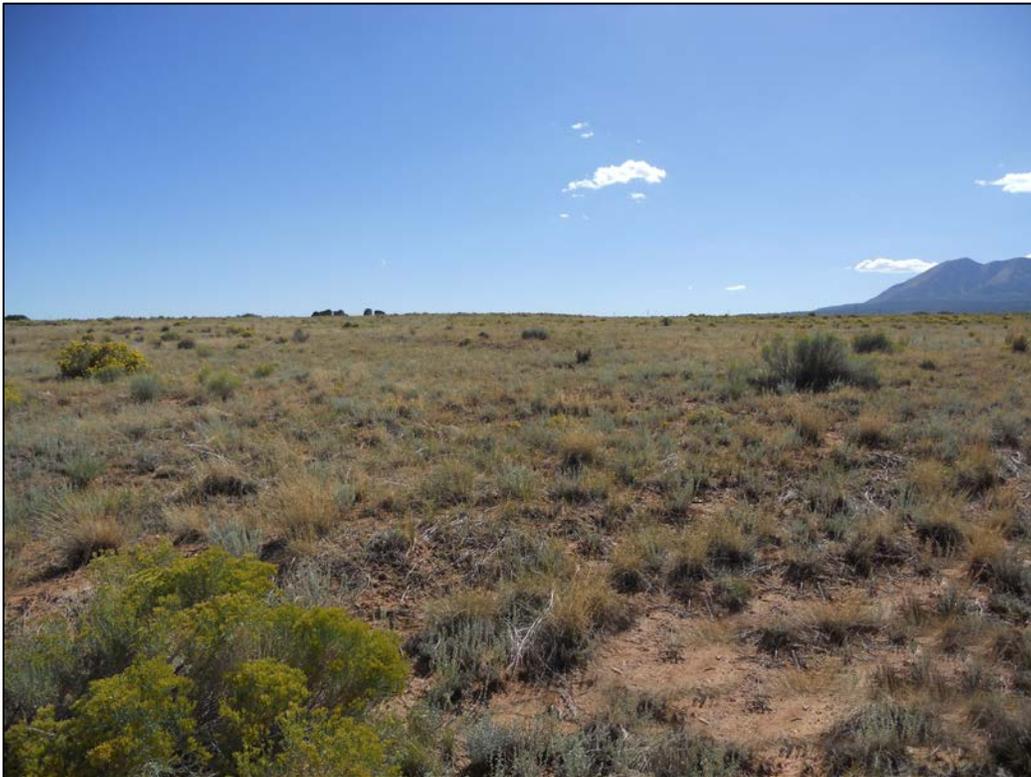
The City-owned properties transferred from DOE are accessible to the public. Access roads were serviceable, although roads on property MP-01040 were eroded and may not be accessible by two-wheel-drive vehicles. Some signs on these properties that post ICs (such as a prohibition against overnight camping) continue to be difficult to read. The signs were also outdated, as bow hunting is now allowed on the properties. Replacement of signs is being addressed. No evidence of overnight camping was observed on any of the properties. Mountain bike trails were in good condition, and they appeared to be regularly used by the public.

PL-20. Well-Established Vegetation and Check Dams on City-Owned Property MP-01040

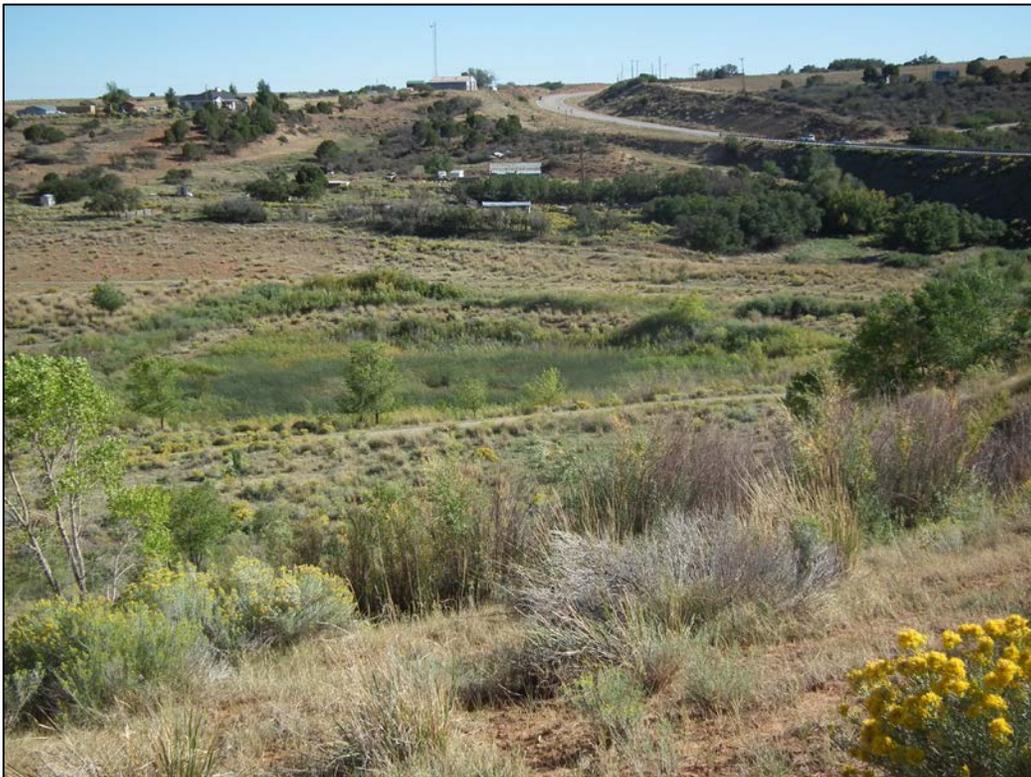
PL-22. View of Wetland 1 on Former Mill Site

Wetlands 1, 2, and 3 on the former mill site (Figure 4) were ecologically healthy, and no evidence of damage by human activity or natural causes was apparent (PL-22, PL-23, and PL-24).

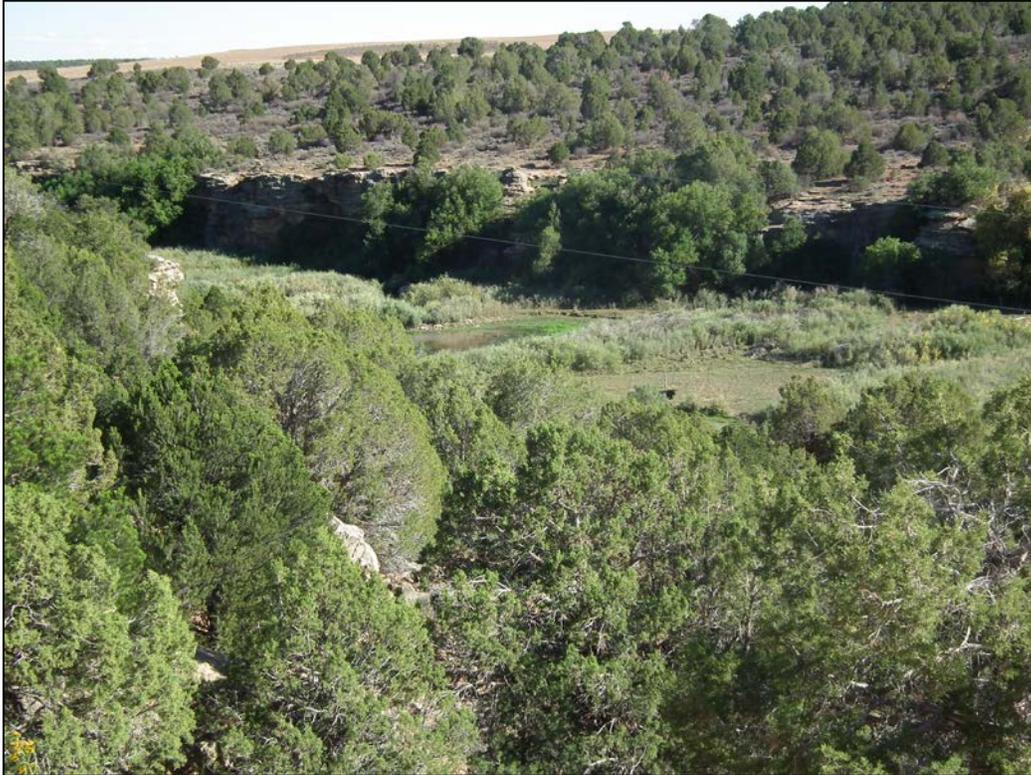
PL-27. Montezuma Canyon, View Downstream

Properties in the Montezuma Creek Restrictive Easement Area are inspected on a regular basis by onsite and water sampling personnel; during these visits, no evidence of significant erosion or soil removal from the restricted areas of these properties was noted. In 2018, portions of Montezuma Canyon were inspected from observation points above the area, and no evidence of land-use changes or disturbance to the easement area was found. Observations in the easement area (PL-27) are recorded in Appendix A, Section V.

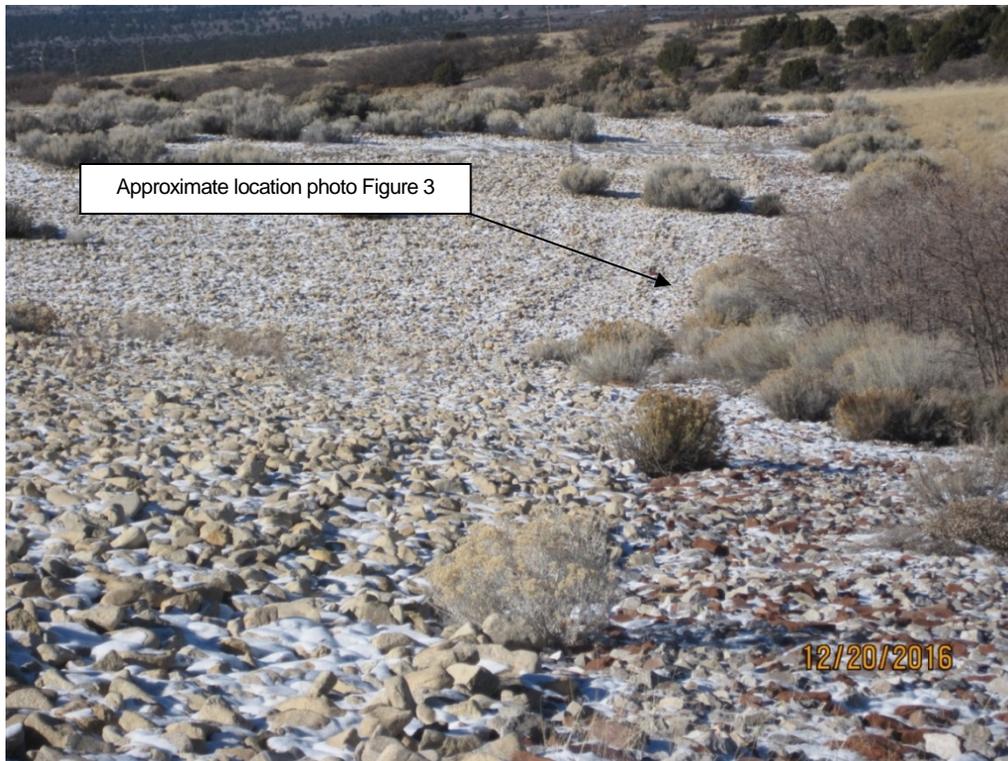
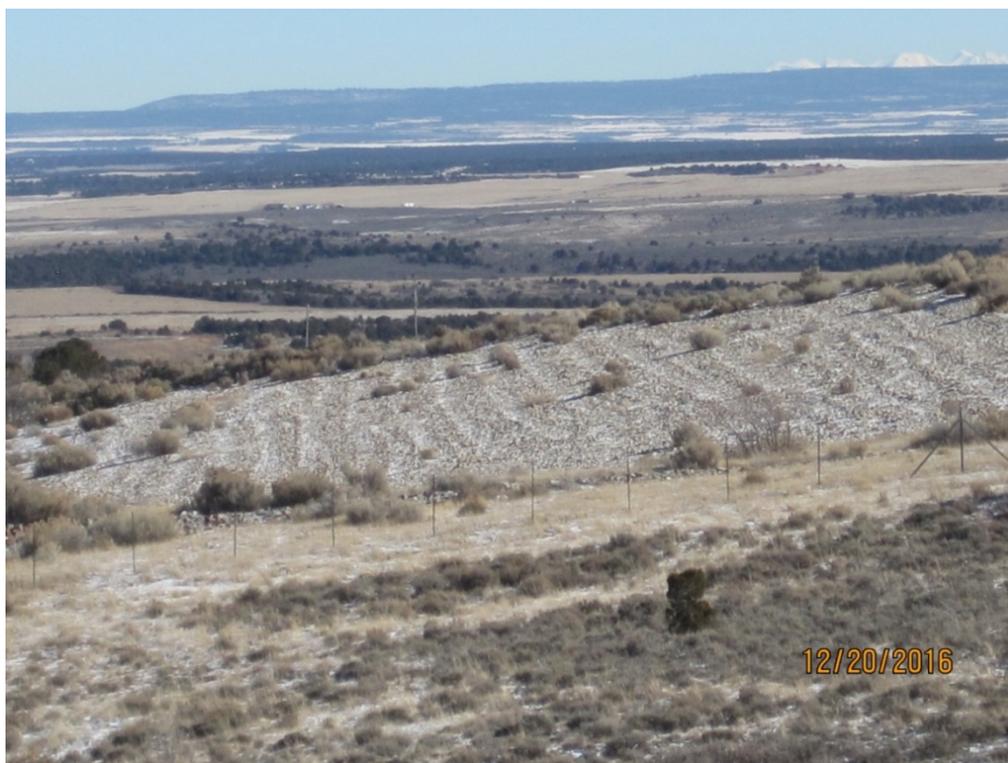
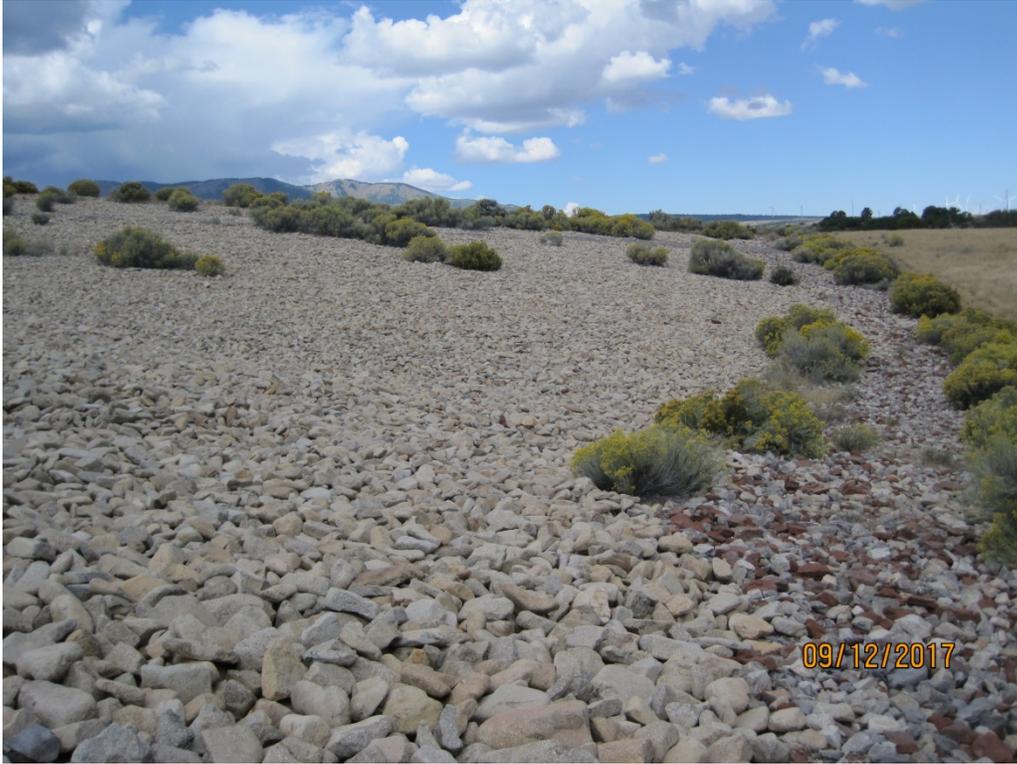
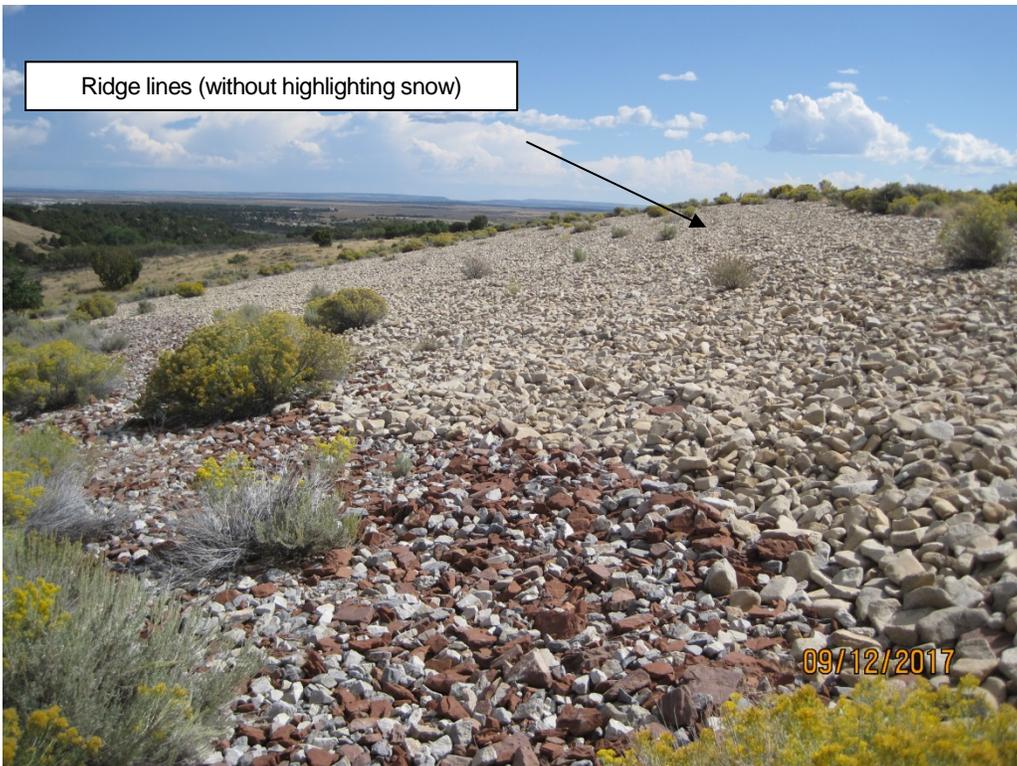
The north facing riprap slope was visited to investigate and to verify reported rock movements had not occurred (reported in annual site inspection reports: 2015 and 2016). Rock movement previously reported as horizontal features, have not changed during the course of 2018 since the last annual site inspection in 2017 (see Figure No. 1, note: the same photo obtained in 2016 supports suspected movement reported in 2017). Suspected rock movement expressed as horizontal features is seen as ridges in the slope surface and is the result of construction equipment tracks (for example see Figure No. 2). Inspections in 2017 and 2018 revealed no change in the rock surface as shown in Figure No's 3 and 4, therefore no change nor adverse conditions exist.

Figure No. 1, Slope in question, construction tracks (parallel ridges) shown lower slope, upper-middle-right [obtained in 2016, reported again in 2017 & 2018 report]

Figure No. 2, Horizontal ridges on a Northwest riprap slope, Monticello, UT, [from 2016 & 2017 report]

Figure No. 3, North Slope [from 2017 report]

Figure No. 4, Track marks (ridge lines), northwest slope [from 2017 report]

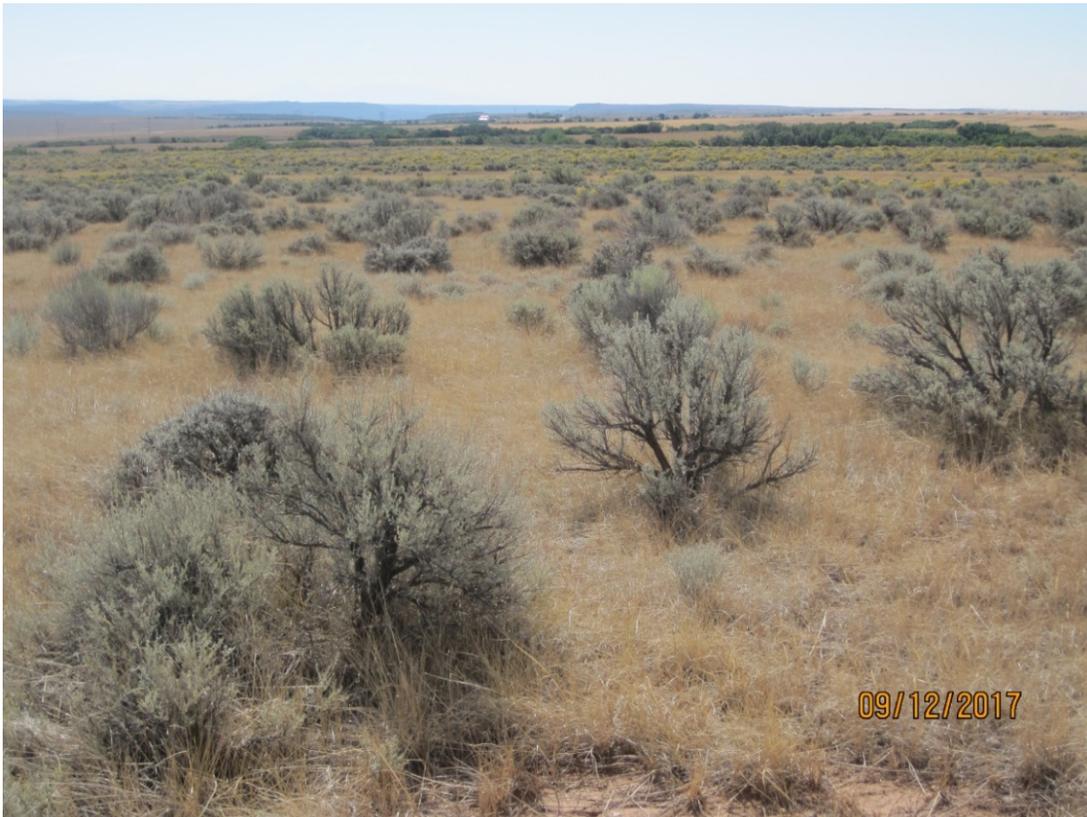
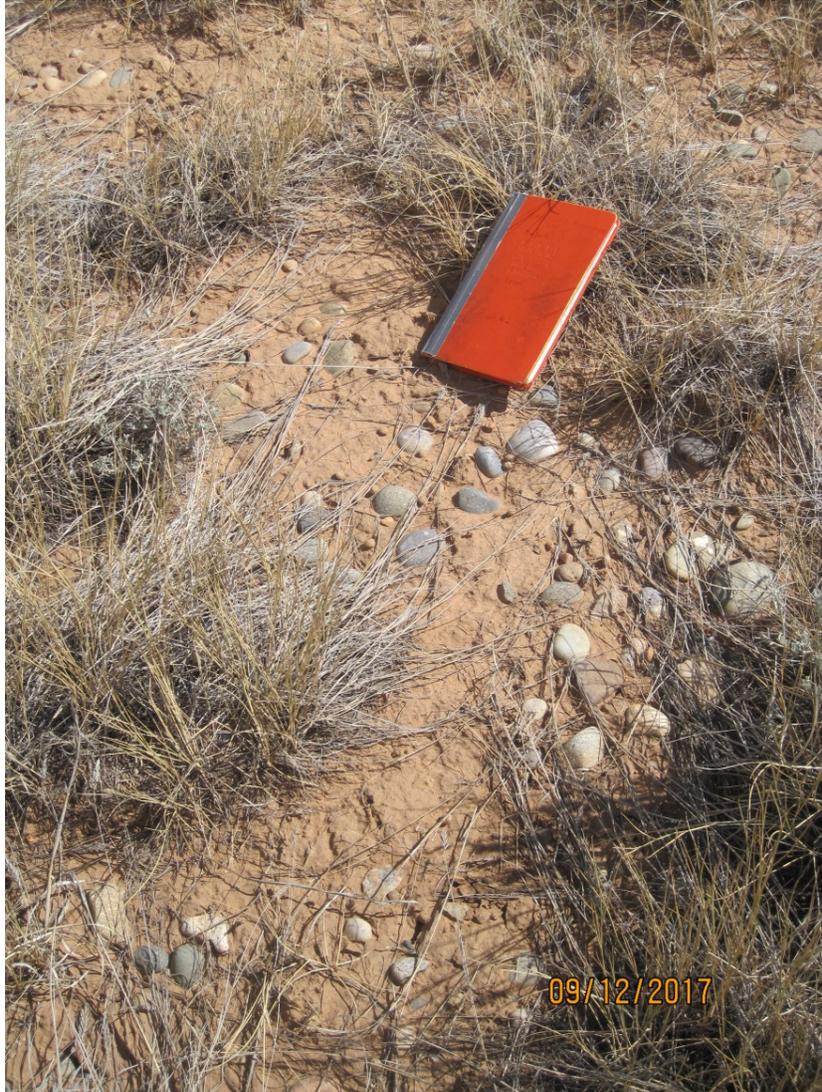
During the inspection the condition of the top slope cover was assessed. Vegetation and soils continue to be in a dry condition, reflecting a continued lack of rainfall. Again, no erosion was observed on the cover, the soil/rock matrix in combination with vegetation have resisted erosion and the 2017 photos shown in Figures No's 5 and 6 adequately represent the 2018 inspected cover conditions.

Figure No. 5, Top slope cover, general view from crest (2017 photo)

Figure No. 6, Top slope cover, soil/rock matrix and vegetation, (2017 photo)

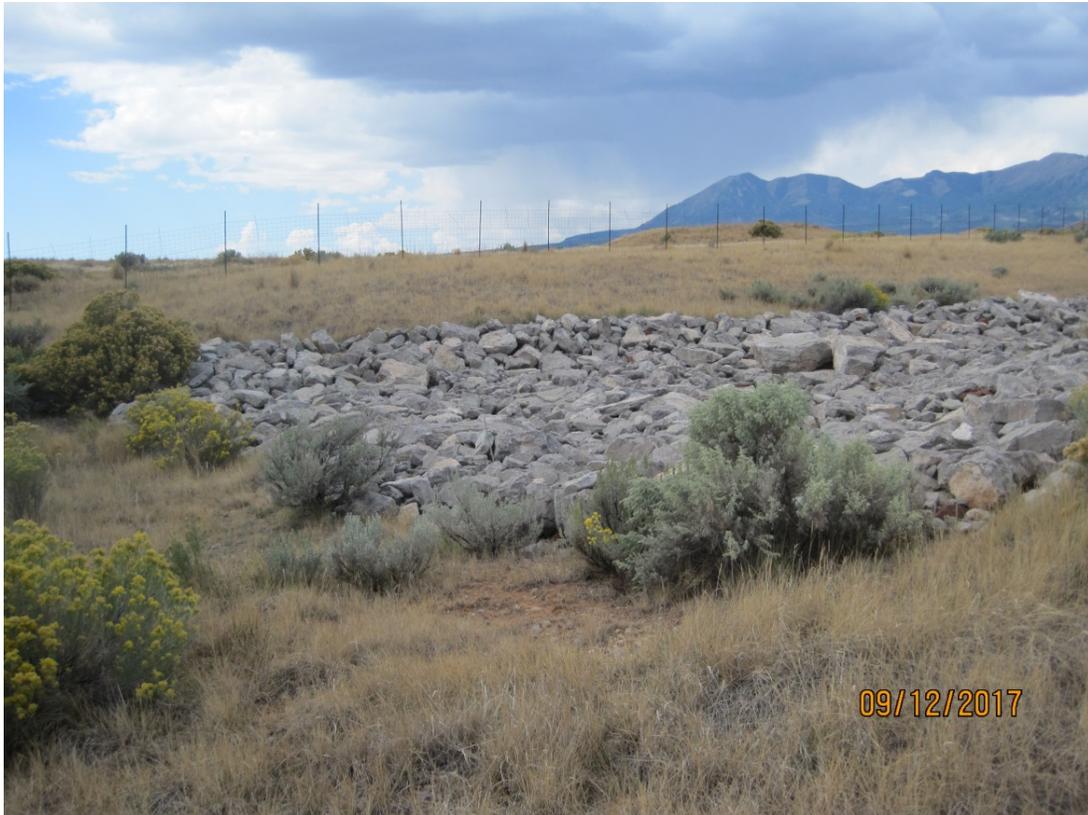
Both west and south diversion ditches were observed to be in excellent condition. No erosion was seen at either outfall. Buried rock cutoff aprons were not exposed at the southern diversion ditch that would indicate erosion had occurred, (the western diversion ditch has been extended to the north to intersect the natural drainage of North Draw). Additionally, no rock degradation was evident and the 2017 photo provided in Figure No. 7 adequately represents the 2018 inspection conditions.

Figure No. 7, Outfall, South diversion ditch (2017 photo)
