# 7.0 Green River, Utah, Disposal Site

# 7.1 Compliance Summary

The Green River, Utah, Uranium Mill Tailings Radiation Control Act (UMTRCA) Title I Disposal Site, was inspected on March 26, 2008. The disposal cell and all associated surface water diversion and drainage structures were in excellent condition and functioning as designed. Three damaged perimeter signs were replaced. Groundwater monitoring continued for the purpose of evaluating cell performance; no constituents of concern exceeded their respective proposed alternate concentration limits (ACLs), although current standards continued to be exceeded for uranium, nitrate, and selenium. No additional maintenance needs or cause for a follow-up or contingency inspection were identified.

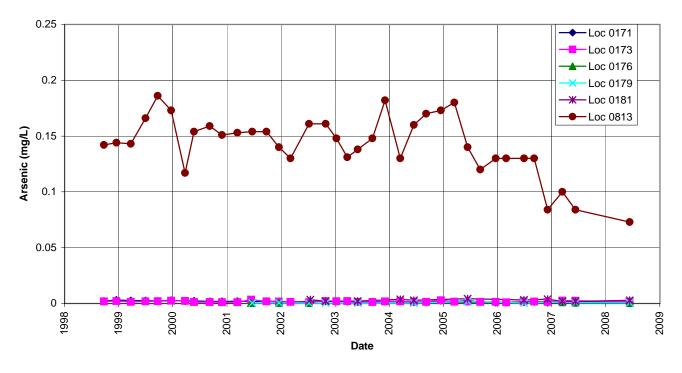
Figure 7–2. Time-Concentration Plots of Arsenic in Groundwater at the Green River Disposal Site

Arsenic concentrations in groundwater remain below the EPA MCL of 0.05 mg/L in all POC wells except MW–0813, and considerably below the proposed ACL of 5.0 mg/L in all POC wells. In well MW–0813, levels have exceeded the MCL since completion of the cell in 1998 as shown on Figure 7–2 but are substantially below the proposed ACL. The results for this well indicate that arsenic concentrations are trending downward in the last few years.

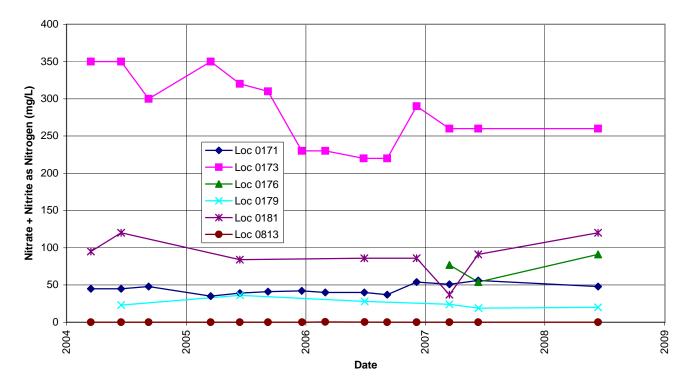
Figure 7–3. Time-Concentration Plots of Nitrate in Groundwater at the Green River Disposal Site

Nitrate concentrations have been measured as nitrate plus nitrite as nitrogen since early 2004 (prior to that time, nitrate was measured as NO<sub>3</sub>). Concentrations have continued above the EPA MCL of 10 mg/L in all POC wells except MW–0813, but they are considerably below the proposed ACL of 1,000 mg/L in all wells; values for MW–0813 continue to be reported below the laboratory detection limit (Figure 7–3). An overall downward trend of nitrate concentrations has been occurring in well MW–0173.

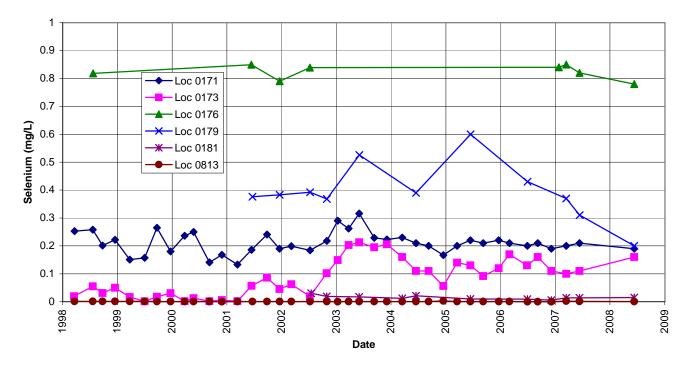
Figure 7–4. Time-Concentration Plot of Selenium in Groundwater at the Green River Disposal Site

Except for well MW–0813, which remains near the laboratory detection limit, selenium concentrations in groundwater continued above the Utah groundwater standard of 0.05 mg/L but below the proposed ACL of 5.0 mg/L in well MW–0176 (Figure 7–4). Selenium concentrations have been decreasing in well MW–0179 for the past 2 years; otherwise, no trends are apparent in the POC wells.

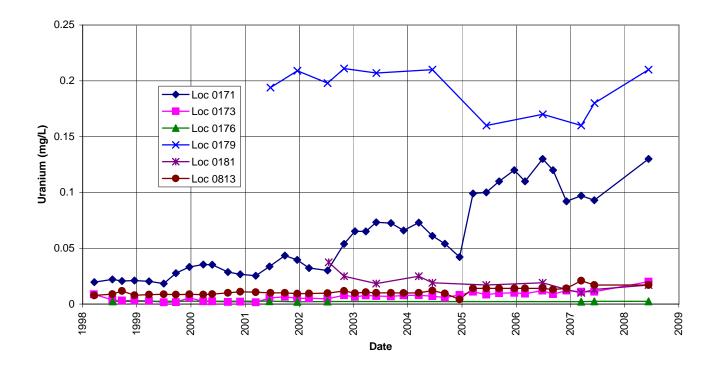
Figure 7–5. Time-Concentration Plot of Uranium in Groundwater at the Green River Disposal Site

Uranium concentrations in groundwater remain below the EPA MCL of 0.044 mg/L in all POC wells except MW–0171 and MW–0179, and considerably below the proposed ACL of 4.4 mg/L in all POC wells. Concentrations of uranium continue to remain essentially constant in wells MW–0173, MW–0176, MW–0181, and MW–0813. The highest uranium concentrations continue to occur at well MW–0179 (0.21 mg/L), which is upgradient of the disposal cell. The reason for the elevated concentration of uranium in well MW–0179 has not been determined but may be due to natural causes. At well MW–0171, concentrations exceed the MCL and continue to exhibit an overall upward trend (Figure 7–5). Because uranium is the only constituent of concern in well MW–0171 that has indicated an upward trend, no conclusions regarding the cause of the trend have been reached at this time.

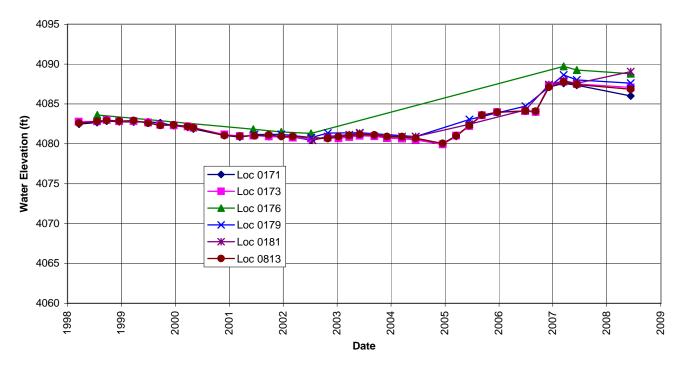
Figure 7–6. Groundwater Elevations at the Green River Disposal Site

Water-level hydrographs of the POC wells, completed in the middle sandstone aquifer, indicate that an overall decrease in the groundwater elevation of approximately 3 feet occurred from 1998 through 2004, followed by an increase of approximately 8 feet since then (Figure 7–6). This rapid increase in groundwater elevation, which appears to be leveling off, may be the result of local and regional aquifer recharge through fractures in the Cedar Mountain Formation and nearby outcrops located southeast of the site, as numerous heavy rainfall events have occurred at the site since 2004. Erroneous manual measurements, likely due to equipment problems, occurred on several occasions (continuous measurements indicated essentially no change at those times); these measurements are not shown on Figure 7–6.

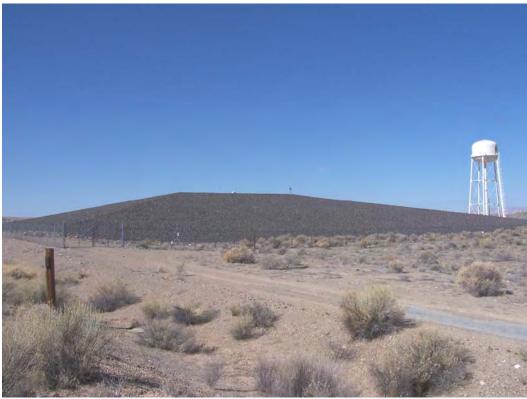
**Disposal Cell and Adjacent Area Inside the Security Fence**—The 6-acre disposal cell was completed in 1989. The slopes of the disposal cell cover are armored with basalt rock. The cell cover was in excellent condition (PL–1). The riprap-filled apron trench along the base of the disposal cell on all sides was in excellent condition.

GRN 3/2008. PL-1. Disposal cell viewed from the east.

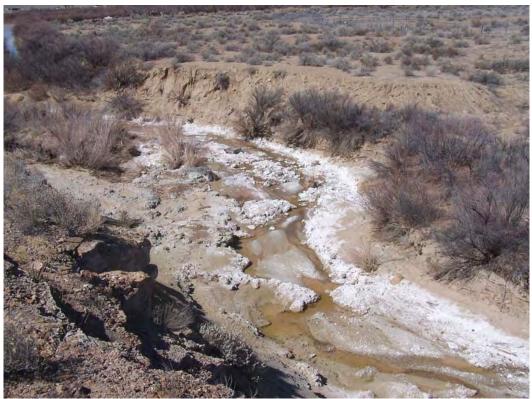
Browns Wash conditions were observed during the inspection. The channel bottom between the bridge and the backwater area near the confluence with the Green River was incised due to a recent runoff event. Although it is dry much of the year, minor flow was occurring in this reach of the wash due to the recent storm, and several of the scour holes contained small pools of water (PL–2); Browns Wash upstream of the bridge was dry. Some bird and animal tracks were present near a couple of pools. The incised channel appears to be capturing some of the alluvial groundwater flow, and some of the flow is likely from seeps. Browns Wash seeps have been identified as potential discharge locations for the contaminated middle sandstone unit aquifer of the Cedar Mountain Formation (the aquifer is contaminated under the disposal cell). However, the middle sandstone unit is not present under the principal seep area (seep location 0718). Although the source of the seep water at that location has not been determined, it may be derived from aquifers underlying the Cedar Mountain Formation.

GRN 3/2008. PL–2. Main outcrop area in Browns Wash at seep location 0718; pools and flowing water in the channel.

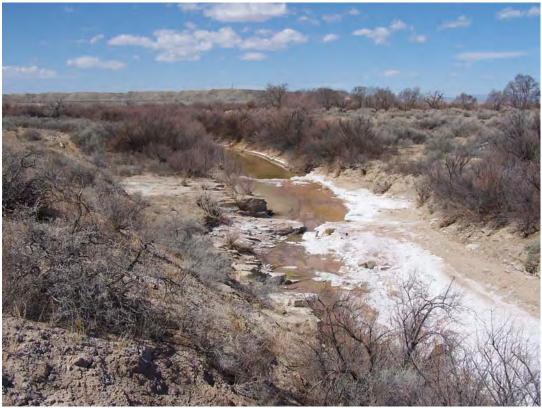
The backwater area near the mouth of Browns Wash was investigated because of its potential as a fish-spawning location. Green River water had moved up the Browns Wash channel as far as surface sampling location 0847 (PL–3). In most of the backwater area, the water was less than 1 foot deep. A scour hole formed at location 0847 during the latest runoff event and contained up to 3 feet of water. Several small fish (less than 2 inches long) were observed in the small pool. At the time of a site visit in February 2008, and prior to the most recent runoff event, the Browns

Wash channel was dry, the backwater area was filled with sediment, and only a couple of inches of water were present in a much shallower scour hole at location 0847. The conditions of Browns Wash channel and the backwater area change substantially after each runoff event as sediment is either scoured or deposited along the channel bottom.

GRN 3/208. PL-3. Browns Wash backwater area and surface sample location 0847.

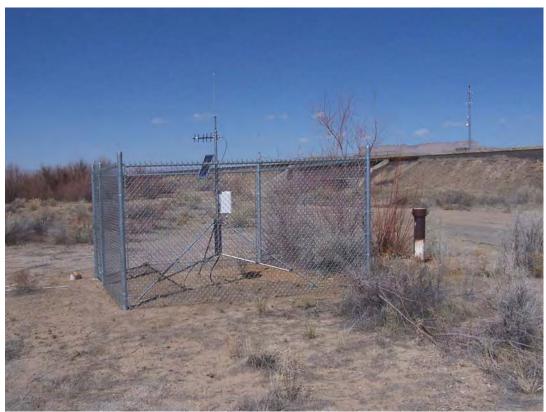
GRN 3/2008. PL-4. Telemetry tower and enclosure at well MW-0817.
