15.0 Salt Lake City, Utah, Disposal Site

15.1 Compliance Summary

The Salt Lake City, Utah, Uranium Mill Tailings Radiation Control Act (UMTRCA) Title I Disposal Site was inspected on April 2, 2008. The disposal cell and all associated surface water diversion and drainage structures were in excellent condition and functioning as designed. No change was observed in the three slight depressions found on the disposal cell top; monitoring for settlement will continue. The area that flooded with potentially contaminated non-contact storm water in June 2007—from a breach in the containment berm for the adjacent EnergySolutions Incorporated (EnergySolutions) low-level radioactive waste (LLRW) container pad—was in good condition; no contamination from the release was reported, and the berm had been repaired. No waste debris or indication of windblown or spillover contamination from EnergySolutions adjacent radioactive waste disposal operations was noted. Disposal operations by EnergySolutions adjacent to the Disposal site resulted in damage to the site perimeter fence and the covering of a boundary monument. EnergySolutions subsequently remedied both conditions. No other maintenance needs

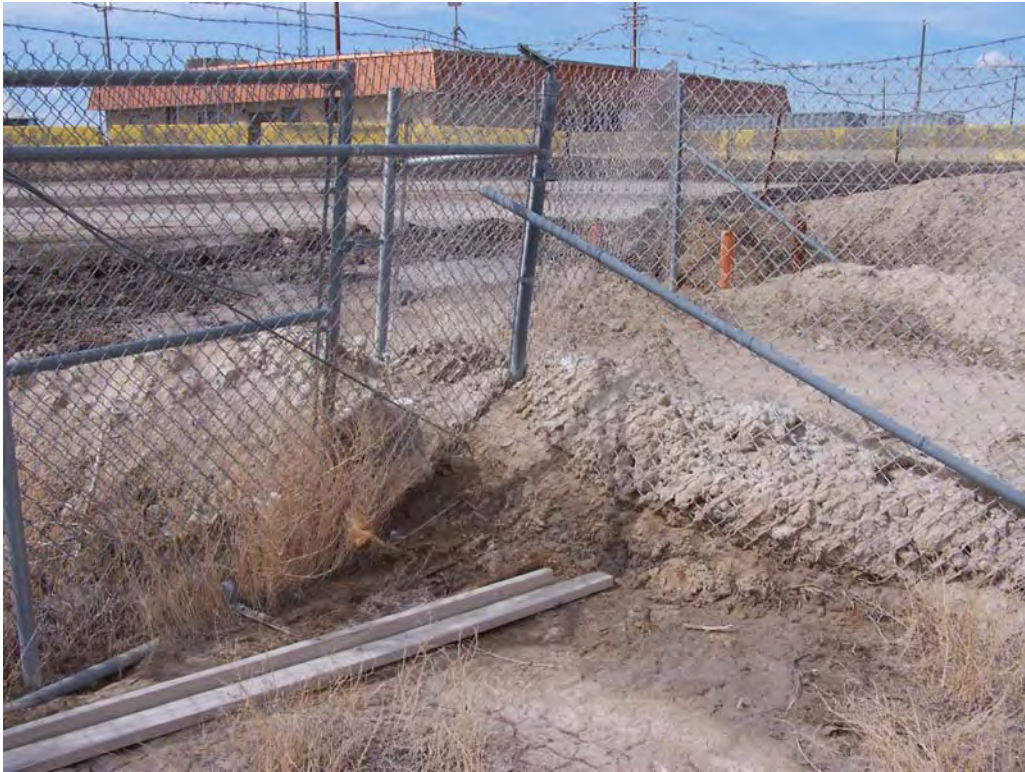
15B In 2008, fence damage caused by EnergySolutions’ adjacent waste disposal operations was observed in both the southwest and northwest corners (PL–1) of the site. EnergySolutions repaired the fence (PL–2). The remaining portions of the fence were in good condition.

Site Markers and Monuments—Two granite site markers are placed at the site. Site marker SMK-1 is located at the site entrance in the northwest corner, and SMK-2 is located on the disposal cell top (PL-3); both were in excellent condition. Four boundary monuments are located on the property, one in each corner of the site. All were in good condition, except boundary monument BM-1, which was buried by EnergySolutions' adjacent waste-haul-road grade work. Subsequent to the inspection, EnergySolutions uncovered the boundary monument (PL-2).

SLC 4/2008. PL-1. Fence damage and buried boundary monument BM-1.

In 2008, routine maintenance and repairs included uncovering boundary monument BM-1 in the northwest corner of the site and repairing the perimeter fence in both the northwest and southwest corners of the site.

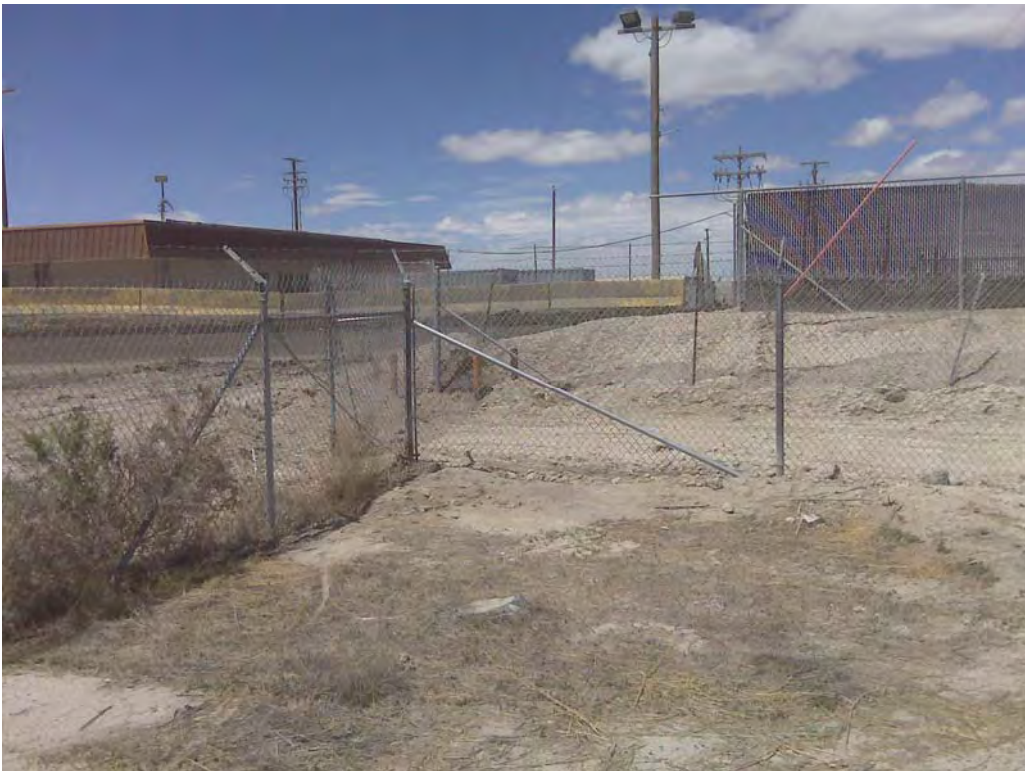
SLC 4/2008. PL-2. Repaired fence and uncovered boundary monument BM-1.

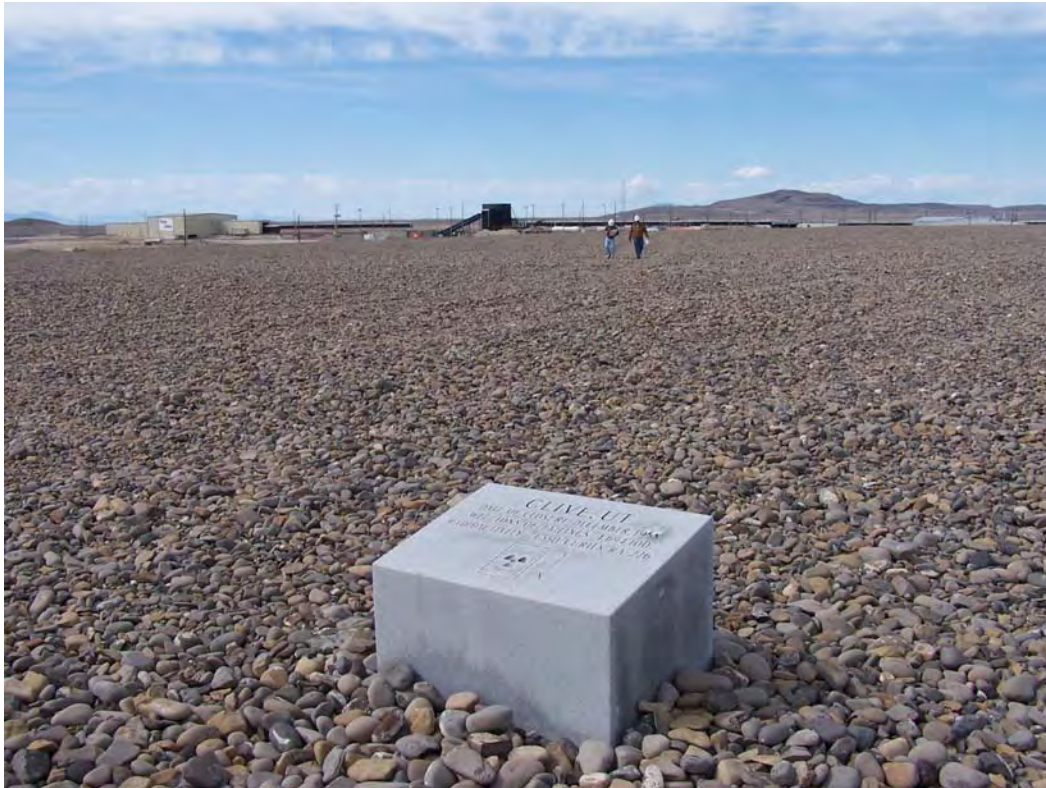
SLC 4/2008. PL-3. Site marker SMK-2 on the disposal cell top.

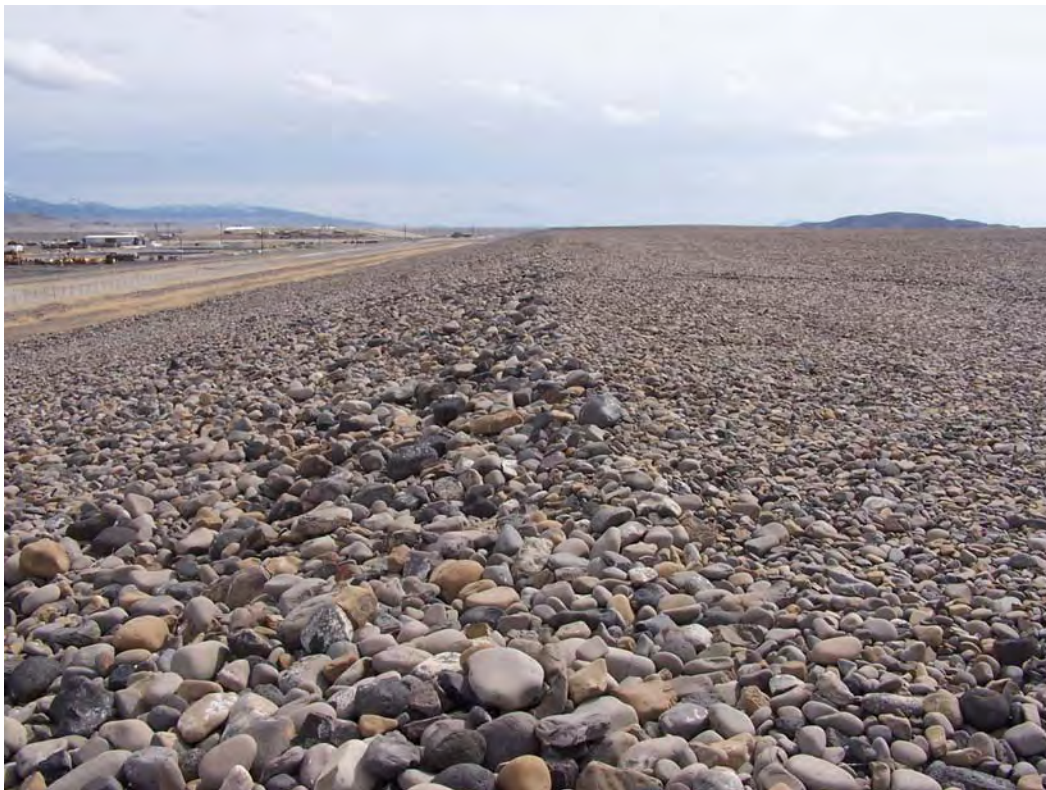
Top and Side Slopes of the Disposal Cell—The top and side slopes of the disposal cell are armored with riprap (PL-3 and PL-4). The riprap was in excellent condition, and no evidence of settling, slumping, or instability was noted on the top or side slopes of the disposal cell during the inspection. No deep-rooted plants were growing on the disposal cell cover.

SLC 4/2008. PL-4. East side slope and top of the disposal cell.

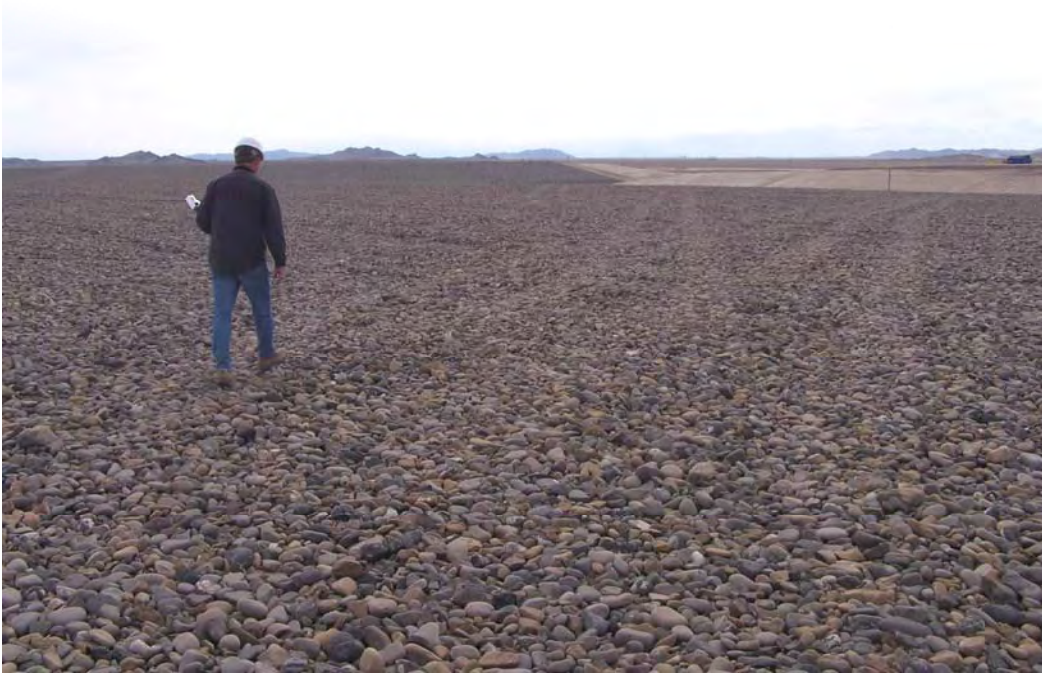
Three minor depressions first noted in 2006 on the cell top were inspected; no change was observed (PL-5). These slight depressions are likely from irregularities in the surface grading that occurred during the construction of the disposal cell, rather than from settling. They currently do not present a problem and will continue to be monitored. There was no evidence of surface water ponding in any of the depressions and no evaporates were observed.

SLC 4/2008. PL-5. Slight depression on cell top.

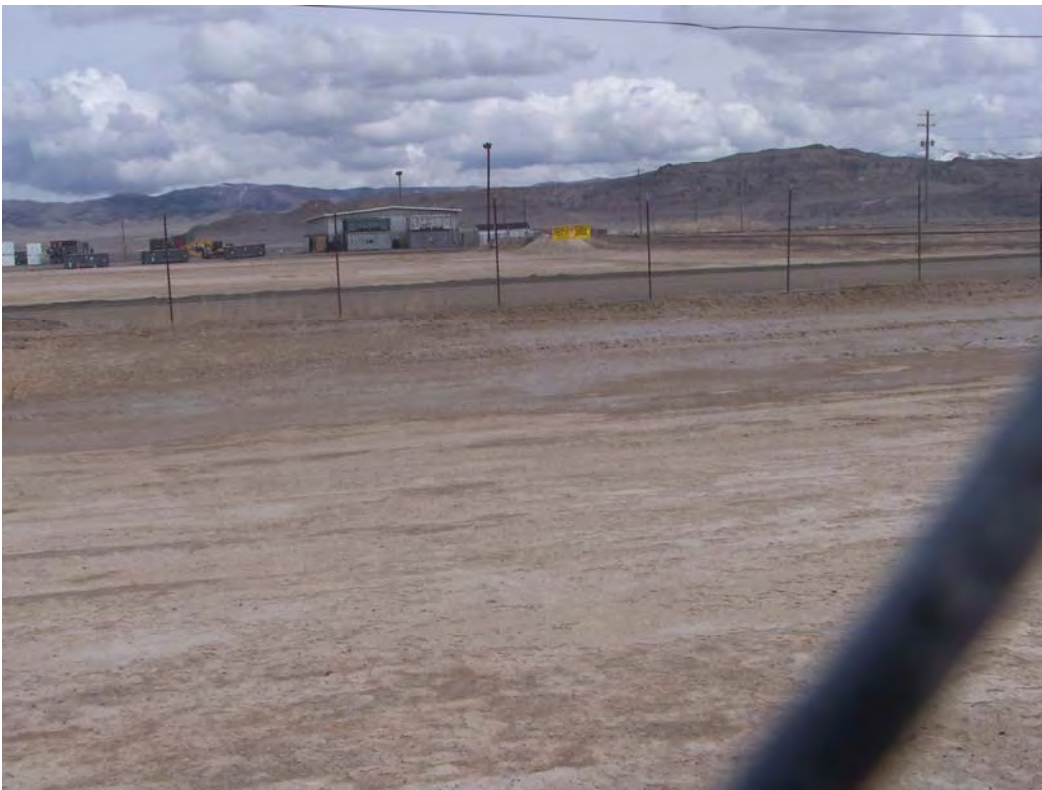
In June 2007, DOE was notified that EnergySolutions implemented their Emergency Response Plan to address a breach in a containment berm west of its LLRW container pad. The breach, caused by a significant precipitation event, allowed an estimated 500 gallons of potentially contaminated non-contact storm water to flow onto the disposal site. The non-contact storm water flowed into an estimated 84,000-gallon pool of standing surface water (approximately 25 feet wide by 450 feet long by 1 foot deep) that was located on the east side of DOE's property between the security fence and the perimeter fence, also caused by the precipitation event. EnergySolutions collected samples of the ponded storm water. Results reported background levels for all radiological parameters measured. EnergySolutions pumped the storm water from the disposal site and gave DOE a copy of follow-up correspondence with the Utah Division of Radiation Control to document the event. In 2008, this area was inspected, and no adverse conditions were noted; the berm was intact, and no standing water was present (PL-6).

SLC 4/2008. PL-6. Area flooded in June 2007 and repaired berm east of the cell.
