# **2003 Annual Inspection of the Weldon Spring Site St. Charles, Missouri**

The Weldon Spring Site, located in St. Charles, Missouri, was inspected on October 28 and 29, 2003. This was the first annual surveillance and maintenance inspection at the Weldon Spring site and serves as a baseline for future inspections. The inspection was conducted in accordance with the draft *Long-Term Surveillance and Maintenance Plan for the Weldon Spring, Missouri, Site* (May 30, 2003), and associated inspection checklist. Representatives from the U.S. Environmental Protection Agency (EPA) and Missouri Department of Natural Resources (MDNR) participated in the inspection. A representative of the Missouri Department of Conservation (MDC) participated in a half-day portion of the inspection. The Weldon Spring Site is a Comprehensive Environmental Response, Compensation, and Liability Act (CERCLA) site.

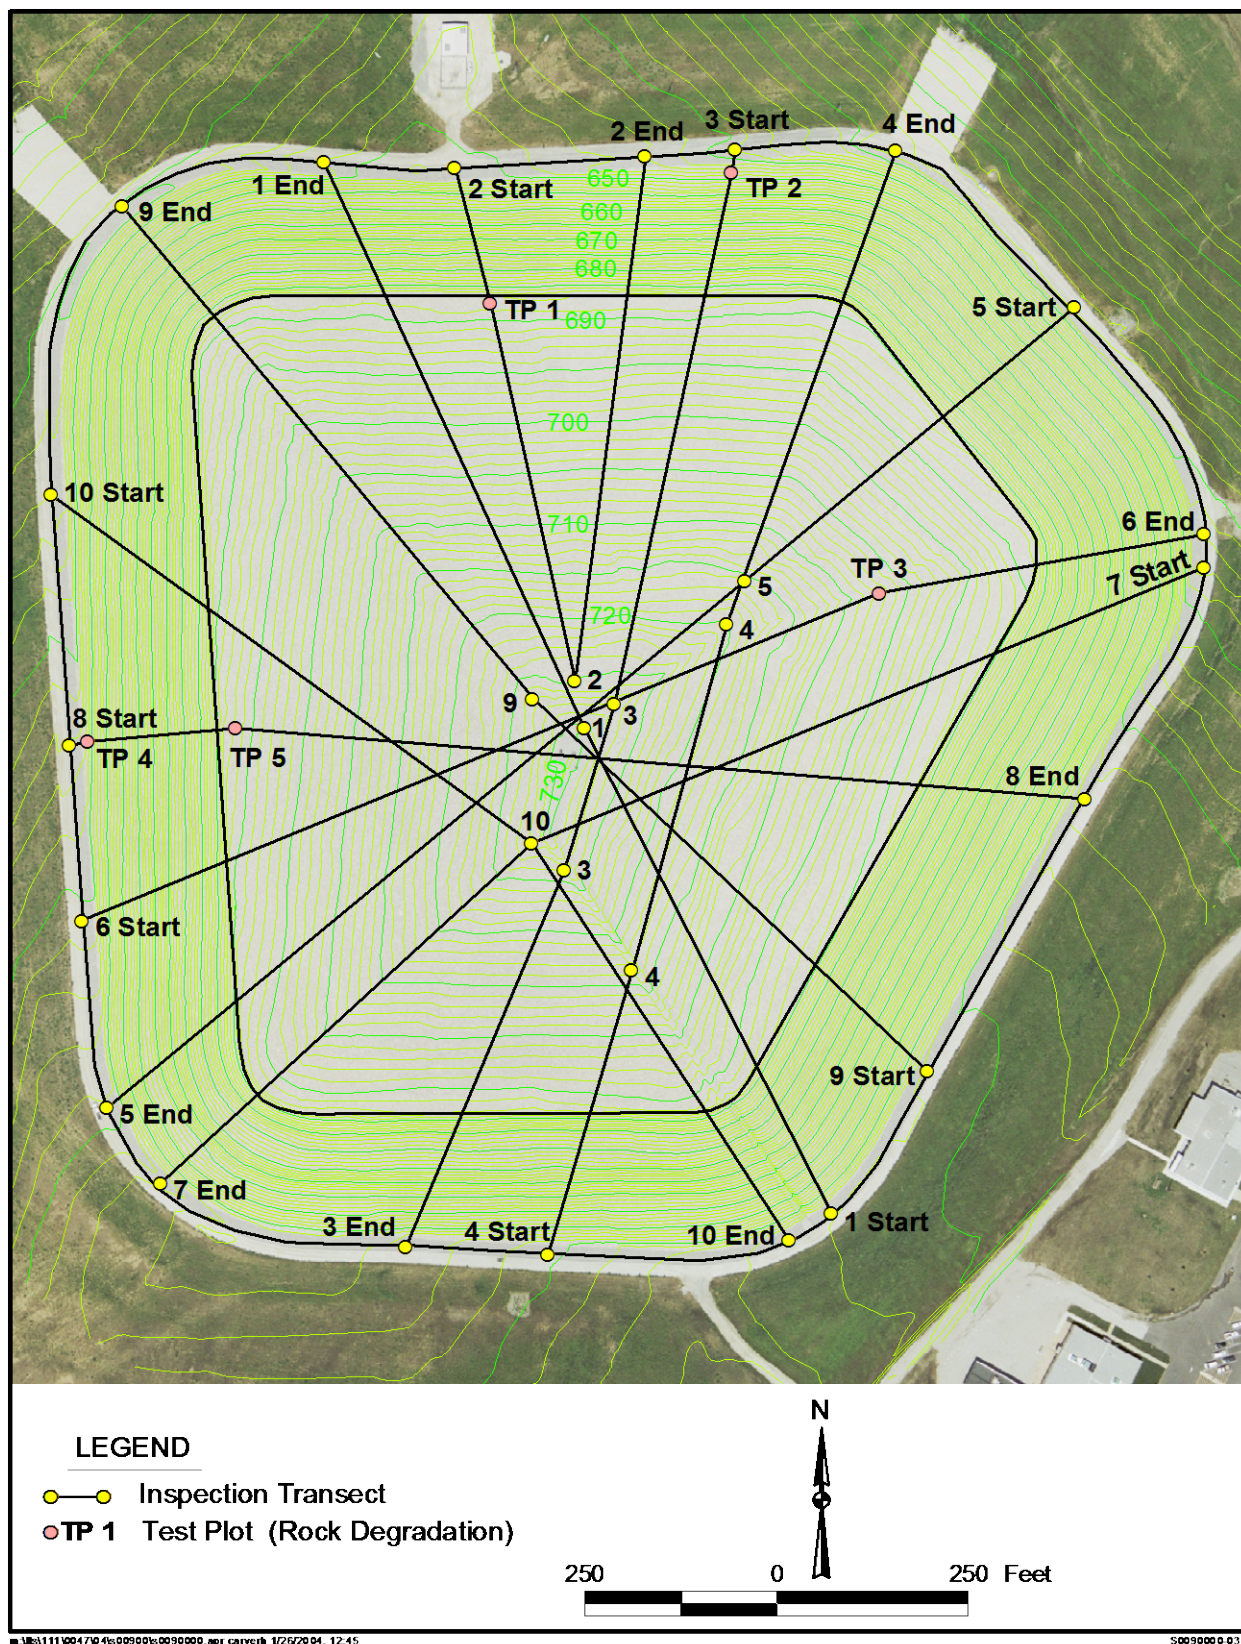
Figure 6. Disposal Cell Inspection Transects and Rock Test Plot Locations at the Weldon, Spring, Missouri, Site

Remarks Inspectors walked 10 transects and marked 5 areas  
to document annually for rock degradation (See figure in report).  
Rock was in good condition. No evidence of post-construction  
degradation.

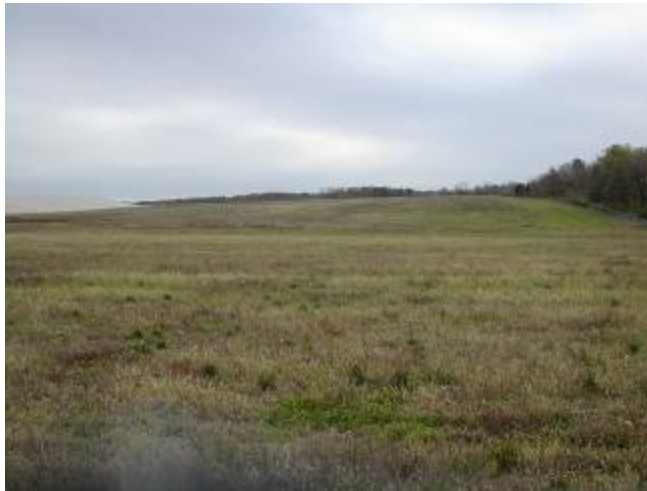
**Inspection Results:** This area was inspected and no indications of excavations into soil or bedrock or groundwater withdrawal or use were observed (Photo 1). MDC has been granted use and maintenance of the Hamburg Trail across DOE property. Lindenwood University has been granted use of the Administration Building. Current land use remains consistent with the planned institutional controls.

Photo 1: Photo taken from northwest corner of the site boundary facing south. Shows portion of proposed institutional control area within site boundary outside the disposal cell buffer zone.

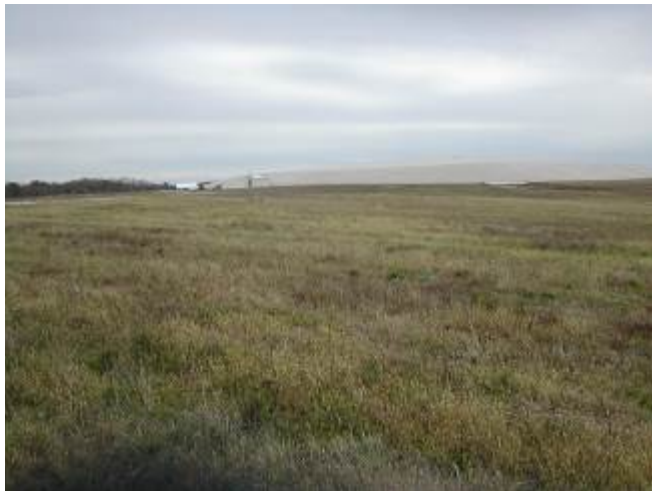
**Inspection Results:** This area was inspected and no indications of excavations into soils and bedrock and no residential use of the shallow groundwater within the buffer zone were observed (Photo 2). Current land use remains consistent with planned institutional controls.

Photo 2: Shows area west of the disposal area, including portion of proposed institutional control area buffer zone.

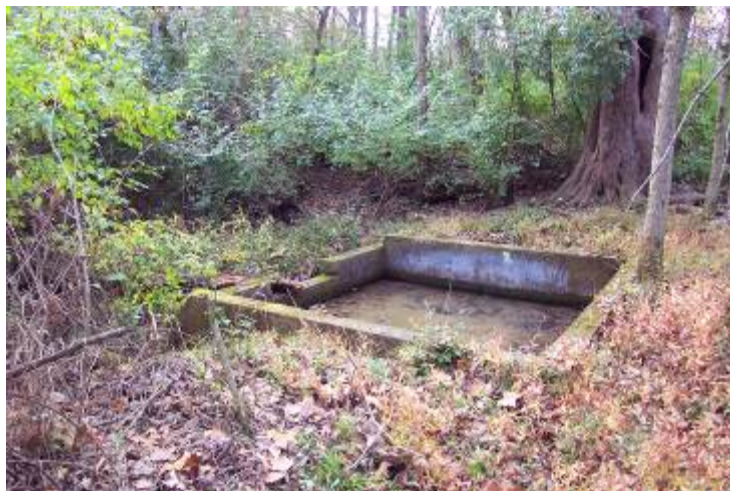
**Inspection Results:** The surrounding area where groundwater use will be restricted was inspected. No evidence of groundwater use was observed. Burgermeister Spring and Spring 6303 were inspected and there were no indications of spring water use (Photos 3 and 4). Current land use remains consistent with planned institutional controls.

Photo 3: Burgermeister Spring.

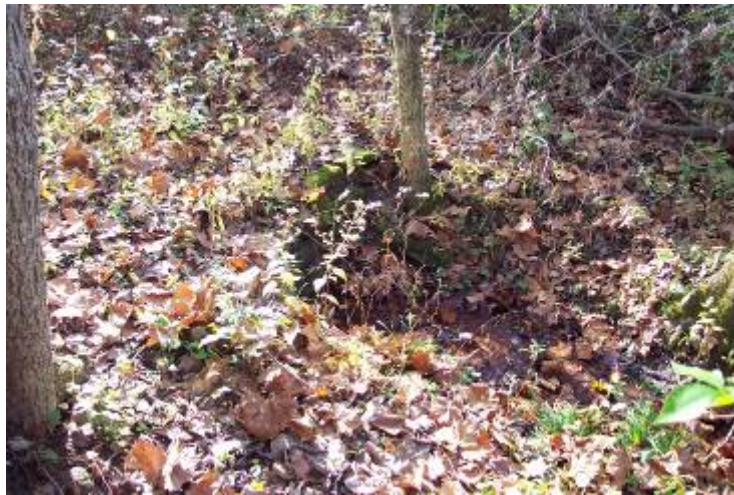
Photo 4: Spring 6303.

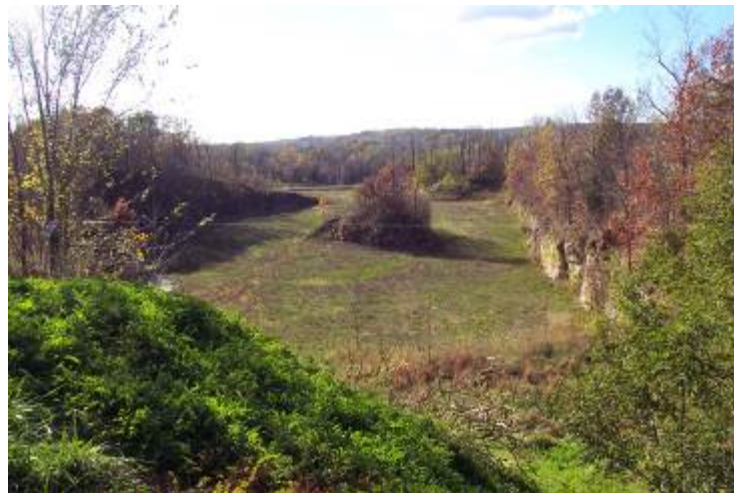
**Inspection Results:** The Quarry Property was inspected and no indications of excavation into soil or bedrock or groundwater withdrawal or use were observed. Also, no party has been granted use or portions of the Quarry area. Quarry backfill continues to provide positive drainage from the quarry to the Little Femme Osage Creek and vegetative cover remains well established (Photo 5). Current land use remains consistent with planned institutional controls.

Photo 5: The Quarry proper.

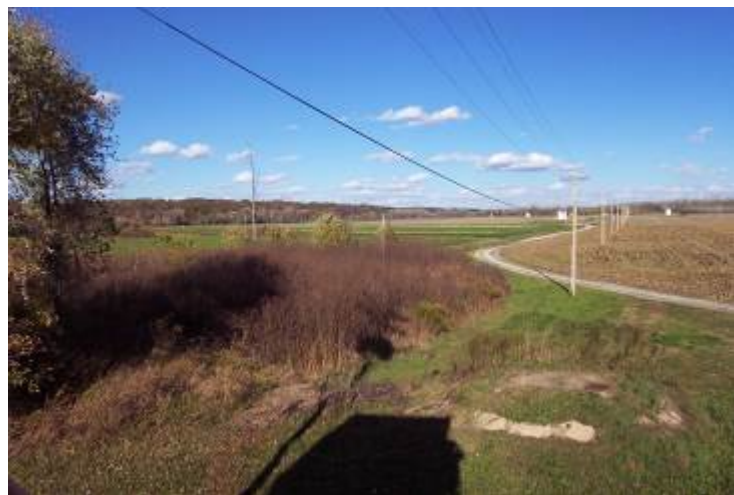
**Inspection Results:** The groundwater restricted area was inspected and no evidence of groundwater withdrawal or use in the area was observed (Photo 6). Several old wells owned by the county, used as test wells and which are not properly secured, were noted near and in the Quarry groundwater restriction area. Current land use remains consistent with planned institutional controls.

7. **Finding:** Several old wells owned by the county, used as test wells and which are not secure, were noted near and in the Quarry groundwater restriction area.

Photo 6: The outer edge of the quarry groundwater restriction institutional control area.

**Recommendation:** Transmit a copy of the inspection report to the County, pointing out the unsecured wells.

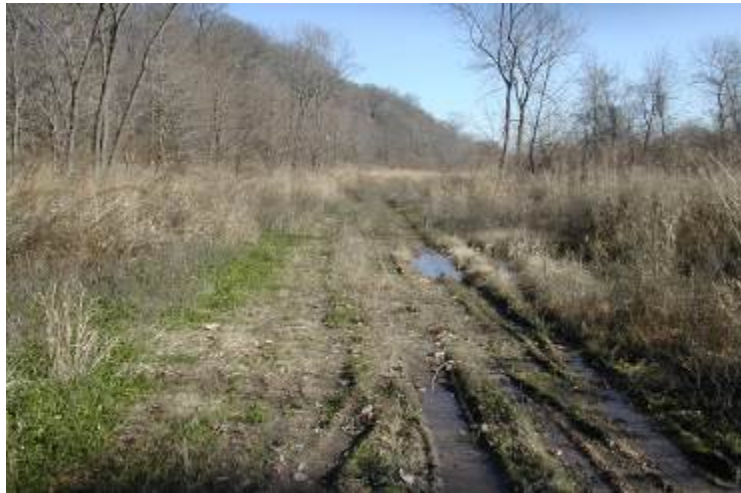
**Inspection Results:** The quarry reduction zone area was inspected and no indications of excavation into soils and bedrock were observed. Land use remains consistent with planned institutional controls (Photo 7).

Photo 7: Quarry Area Reduction Zone facing east just south of Katy Trail.

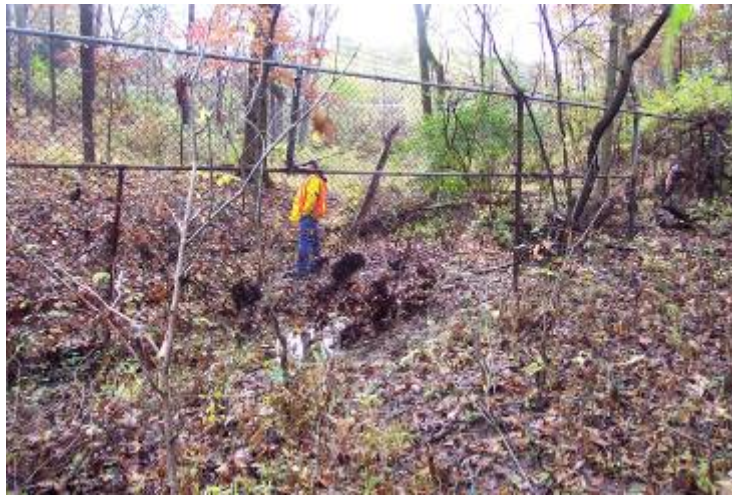
**Inspection Results:** The inspectors walked down the entire Southeast Drainage and no indications of residential use or construction or any other activity that would indicate non-recreational use of the area was observed. The springs also were inspected and no indication of residential, commercial, or agricultural use of the springs was observed (Photos 8, 9, and 10). Current land use remains consistent with planned institutional controls.

Photo 8: Fence across the Southeast Drainage upstream of Highway 94.

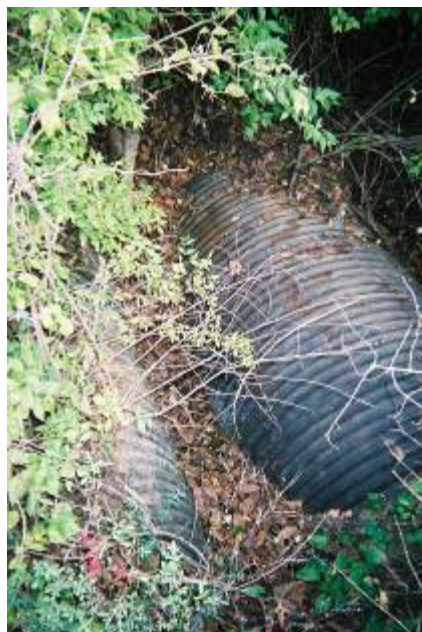
Photo 12: Eroded area where culverts are exposed in ditch between Highway D and outlet end.

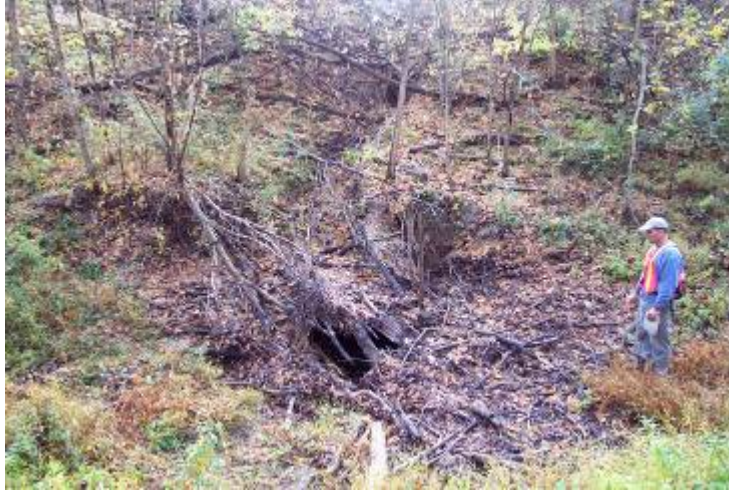
**Inspection Results:** The State Route 94 culvert was inspected and the upstream end was partially blocked with debris. Erosion was occurring on the embankment. The downstream end of the culvert was corroded on the bottom and the last section of pipe was partially separated from the rest of the culvert, causing runoff to leak through and erode beneath the final segment of culvert. MoDOT is adding pavement as a shoulder on State Route 94 and this construction activity could be contributing to additional erosion on the embankments (Photos 13 and 14).

5. **Finding:** The downstream end of the State Route 94 culvert was corroded on the bottom and the last section of pipe has partially separated from the rest of the culvert causing runoff to leak through and erode beneath the final segment of culvert. MoDOT is adding pavement as a shoulder on State Route 94 and this construction activity could be contributing to additional erosion on the embankments.

Photo 13: Inlet end of State Route 94 culvert.

Note any observations: Upstream end partially blocked with debris  
and erosion occurring on embankment. The downstream end of  
the culvert is corroded on the bottom and the last section of  
pipe has partially separated from the rest of the culvert  
causing runoff to leak through and cause erosion of the embankment

**Recommendation:** Transmit a copy of this inspection report to MoDOT for consideration.

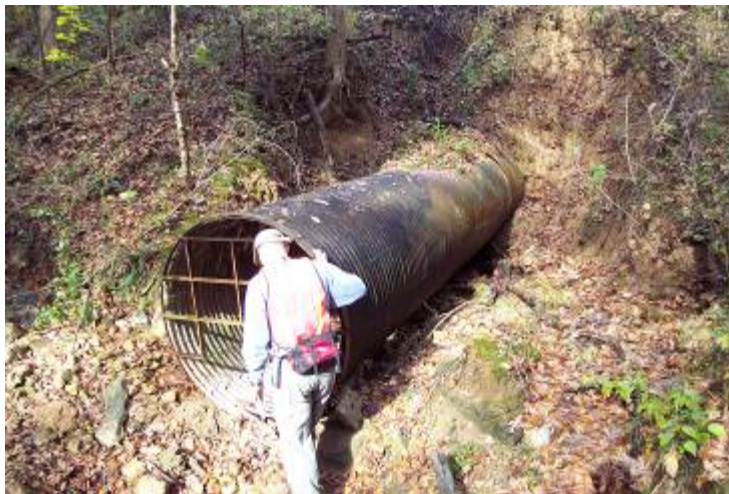
Photo 14: Outlet end of State Route 94 culvert.

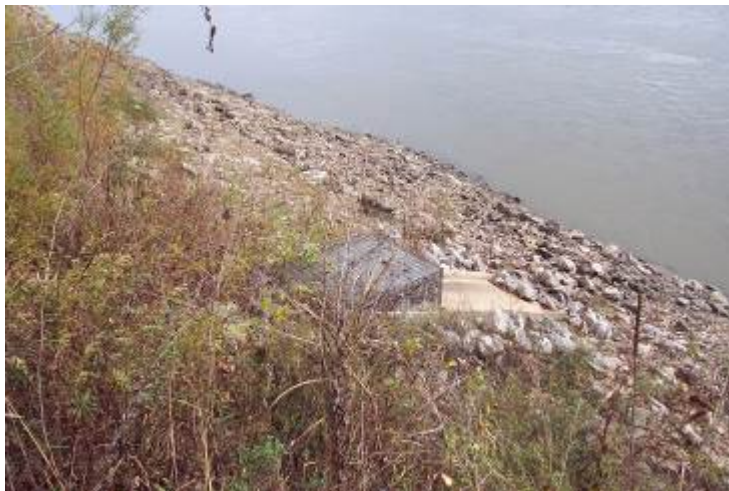
the off-site areas. During the inspection it was observed that significant vegetative growth had covered the majority of the manhole locations and they could not be located. It was recommended in the memorandum to conduct another walkover in the fall or winter of 2003/2004 when the vegetation is not as dense and to use global positioning system (GPS) surveying equipment to establish the locations of the manholes and cleanouts (Photo 15).

Photo 15: The weir that discharges from the LCRS Pipeline into the Missouri River.

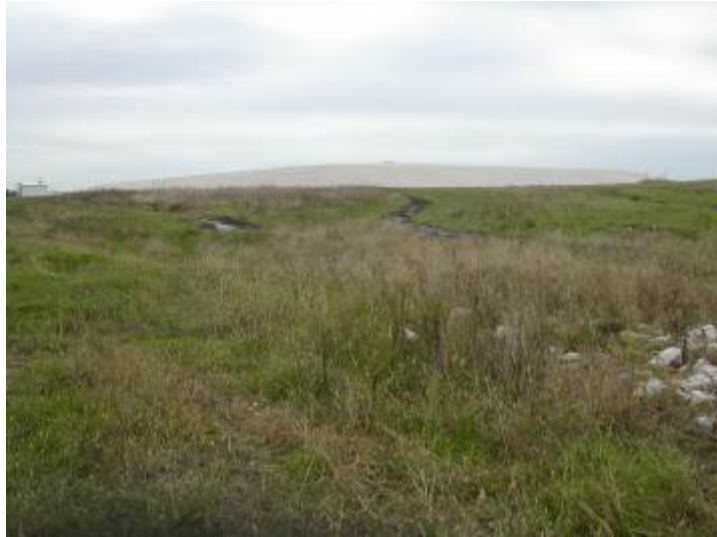
There were two areas of erosion identified at the chemical plant area. The first areas were north and northwest of the disposal cell (Photo 25). As demonstrated by the photograph, erosion repairs have been conducted in these areas. The second area of erosion was observed during the inspection of the monitoring wells on the Army property. The erosion is next to the riprap that was installed for outfall NP-0050. The erosion comes from the chemical plant property under the fence onto the Army property and has eroded out a gravel road used to travel around the Army property. The erosion has produced a ditch about 2 feet in depth (Photo 28). Repair of this area will be coordinated with the Army in order to assure good road access to monitoring wells. The eroded area does not impact the disposal cell.

Photo 25: Erosion areas behind the disposal cell.

Erosion areas noted north and northwest of the cell that had been repaired. No land use changes.

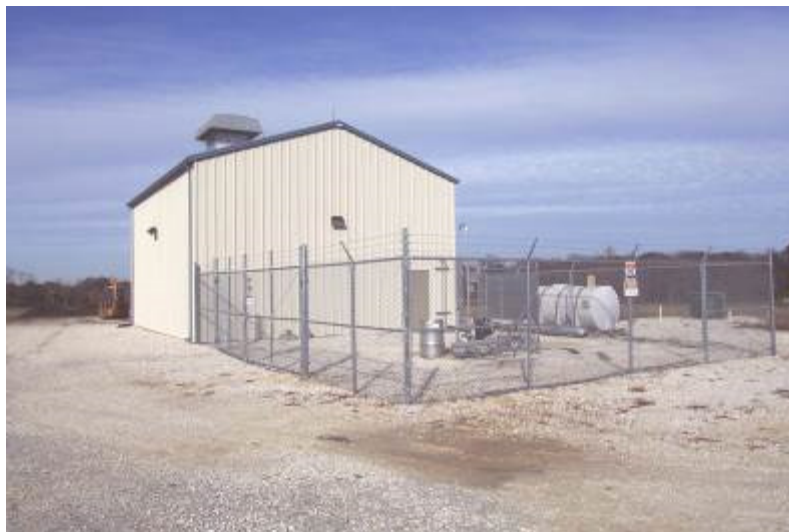
The LCRS was discussed and inspected (Photos 26 and 27). The fences and doors were locked and in good condition. The system was functioning as designed. The LCRS data and documentation were reviewed during the document review period of the inspection and the following information was checked and verified that it was available: sampling data, LCRS flow rates, action leakage rate information, “burrito” system flow rates, periodic alarm tests, and shipping records and data. As committed by the LTS&M Plan the leachate production rates, analytical results, and disposal information are provided in Appendix C.

Photo 26: Outside of LCRS building.

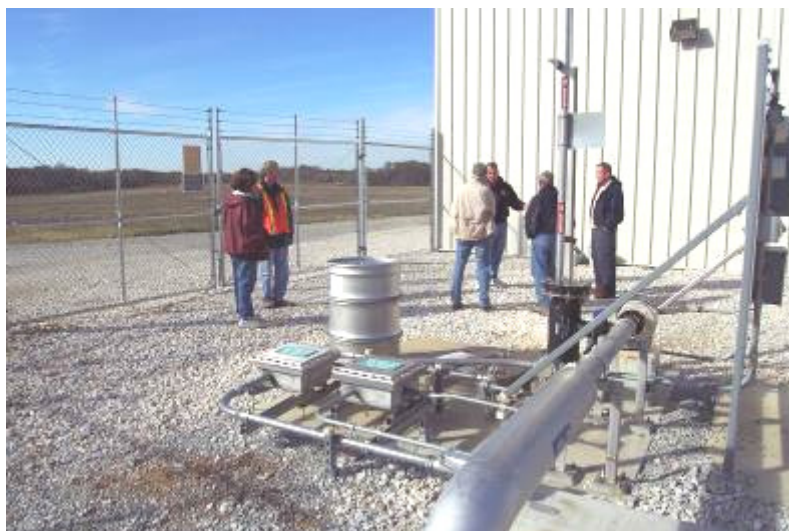
Photo 27: LCRS sump area with manhole in center of photo.

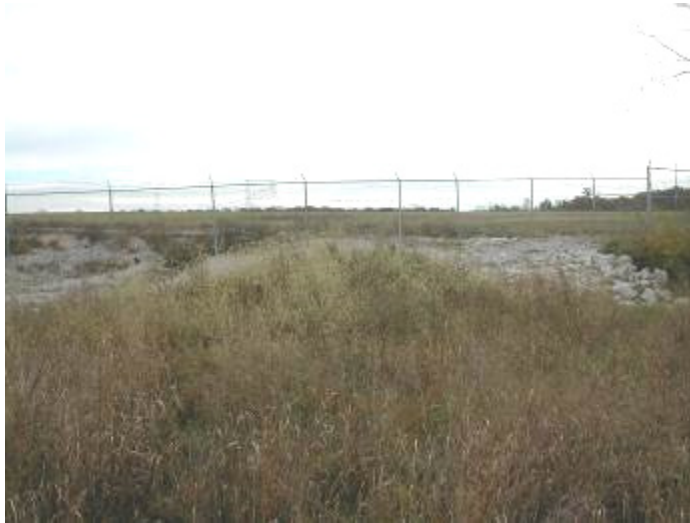
6. **Finding:** An area of erosion was observed which originates from the chemical plant and continues onto the Army property. The erosion is next to the riprap that was installed for Outfall NP-0050. The erosion has produced a ditch about 2 feet in depth and has eroded out a gravel road used to travel around the Army property. The eroded area does not impact the disposal cell.

Photo 28: Area of erosion onto the Army property.  
The eroded ditch is to the left and outfall NP-0050 is to the right.

**Recommendation:** Transmit a copy of this report to the local representative of the Army Reserves for consideration. Repair of this area will be coordinated with the Army.

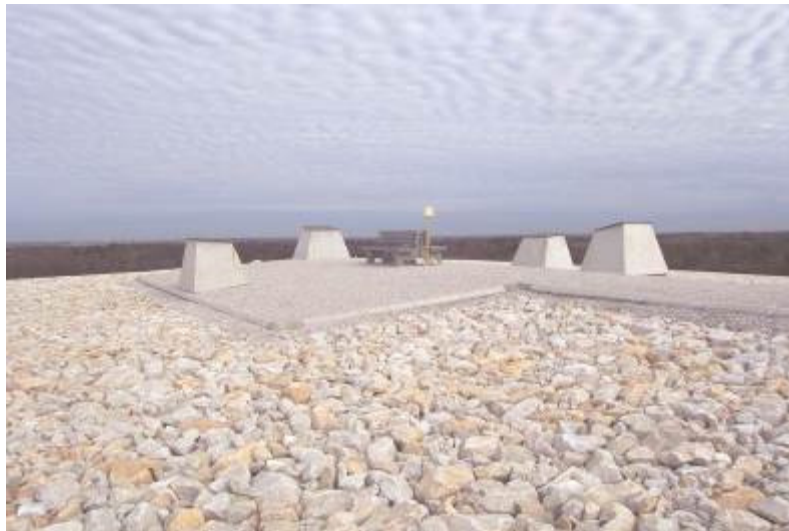
The four information plaques on top of the cell were in good condition (Photo 29). The historical markers planned for the site have not been installed yet.

Photo 29: Information plaques on top of the disposal cell.

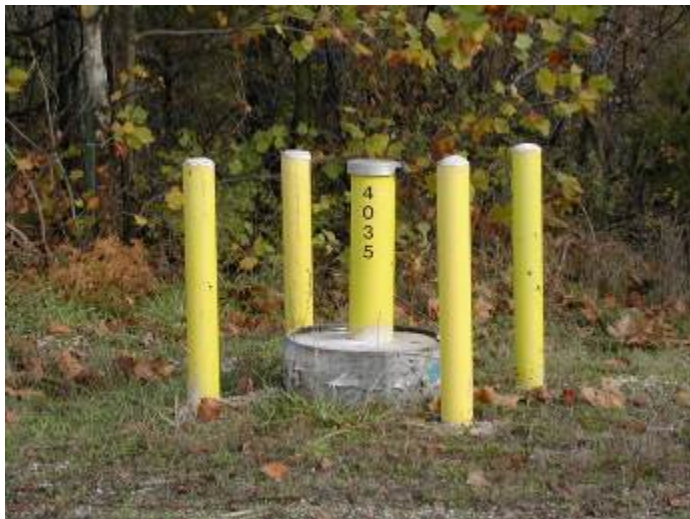
The monitoring wells in the Disposal Cell Monitoring Well Network, Chemical Plant Monitoring Well Network, and Quarry Monitoring Well Network were inspected (Photo 30). The inspection checklist required all the disposal cell wells to be inspected and greater than 10 percent of the chemical plant and quarry wells to be inspected. The checklist required the wells to be inspected to ensure they are properly secured and locked, in good condition, and to check if they need maintenance and have the proper ID number on the well.

Photo 30: An example of a site groundwater monitoring well. This well is secured (locked), maintained, and properly identified.
