4.0 Durango, Colorado, Disposal Site

4.1 Compliance Summary

The U.S. Department of Energy (DOE) Office of Legacy Management (LM) conducted the Durango, Colorado, Uranium Mill Tailings Radiation Control Act (UMTRCA) Title I Disposal Site annual inspection on June 15, 2021, and the annual groundwater monitoring event in June 2021. No cause for a follow-up inspection was identified.

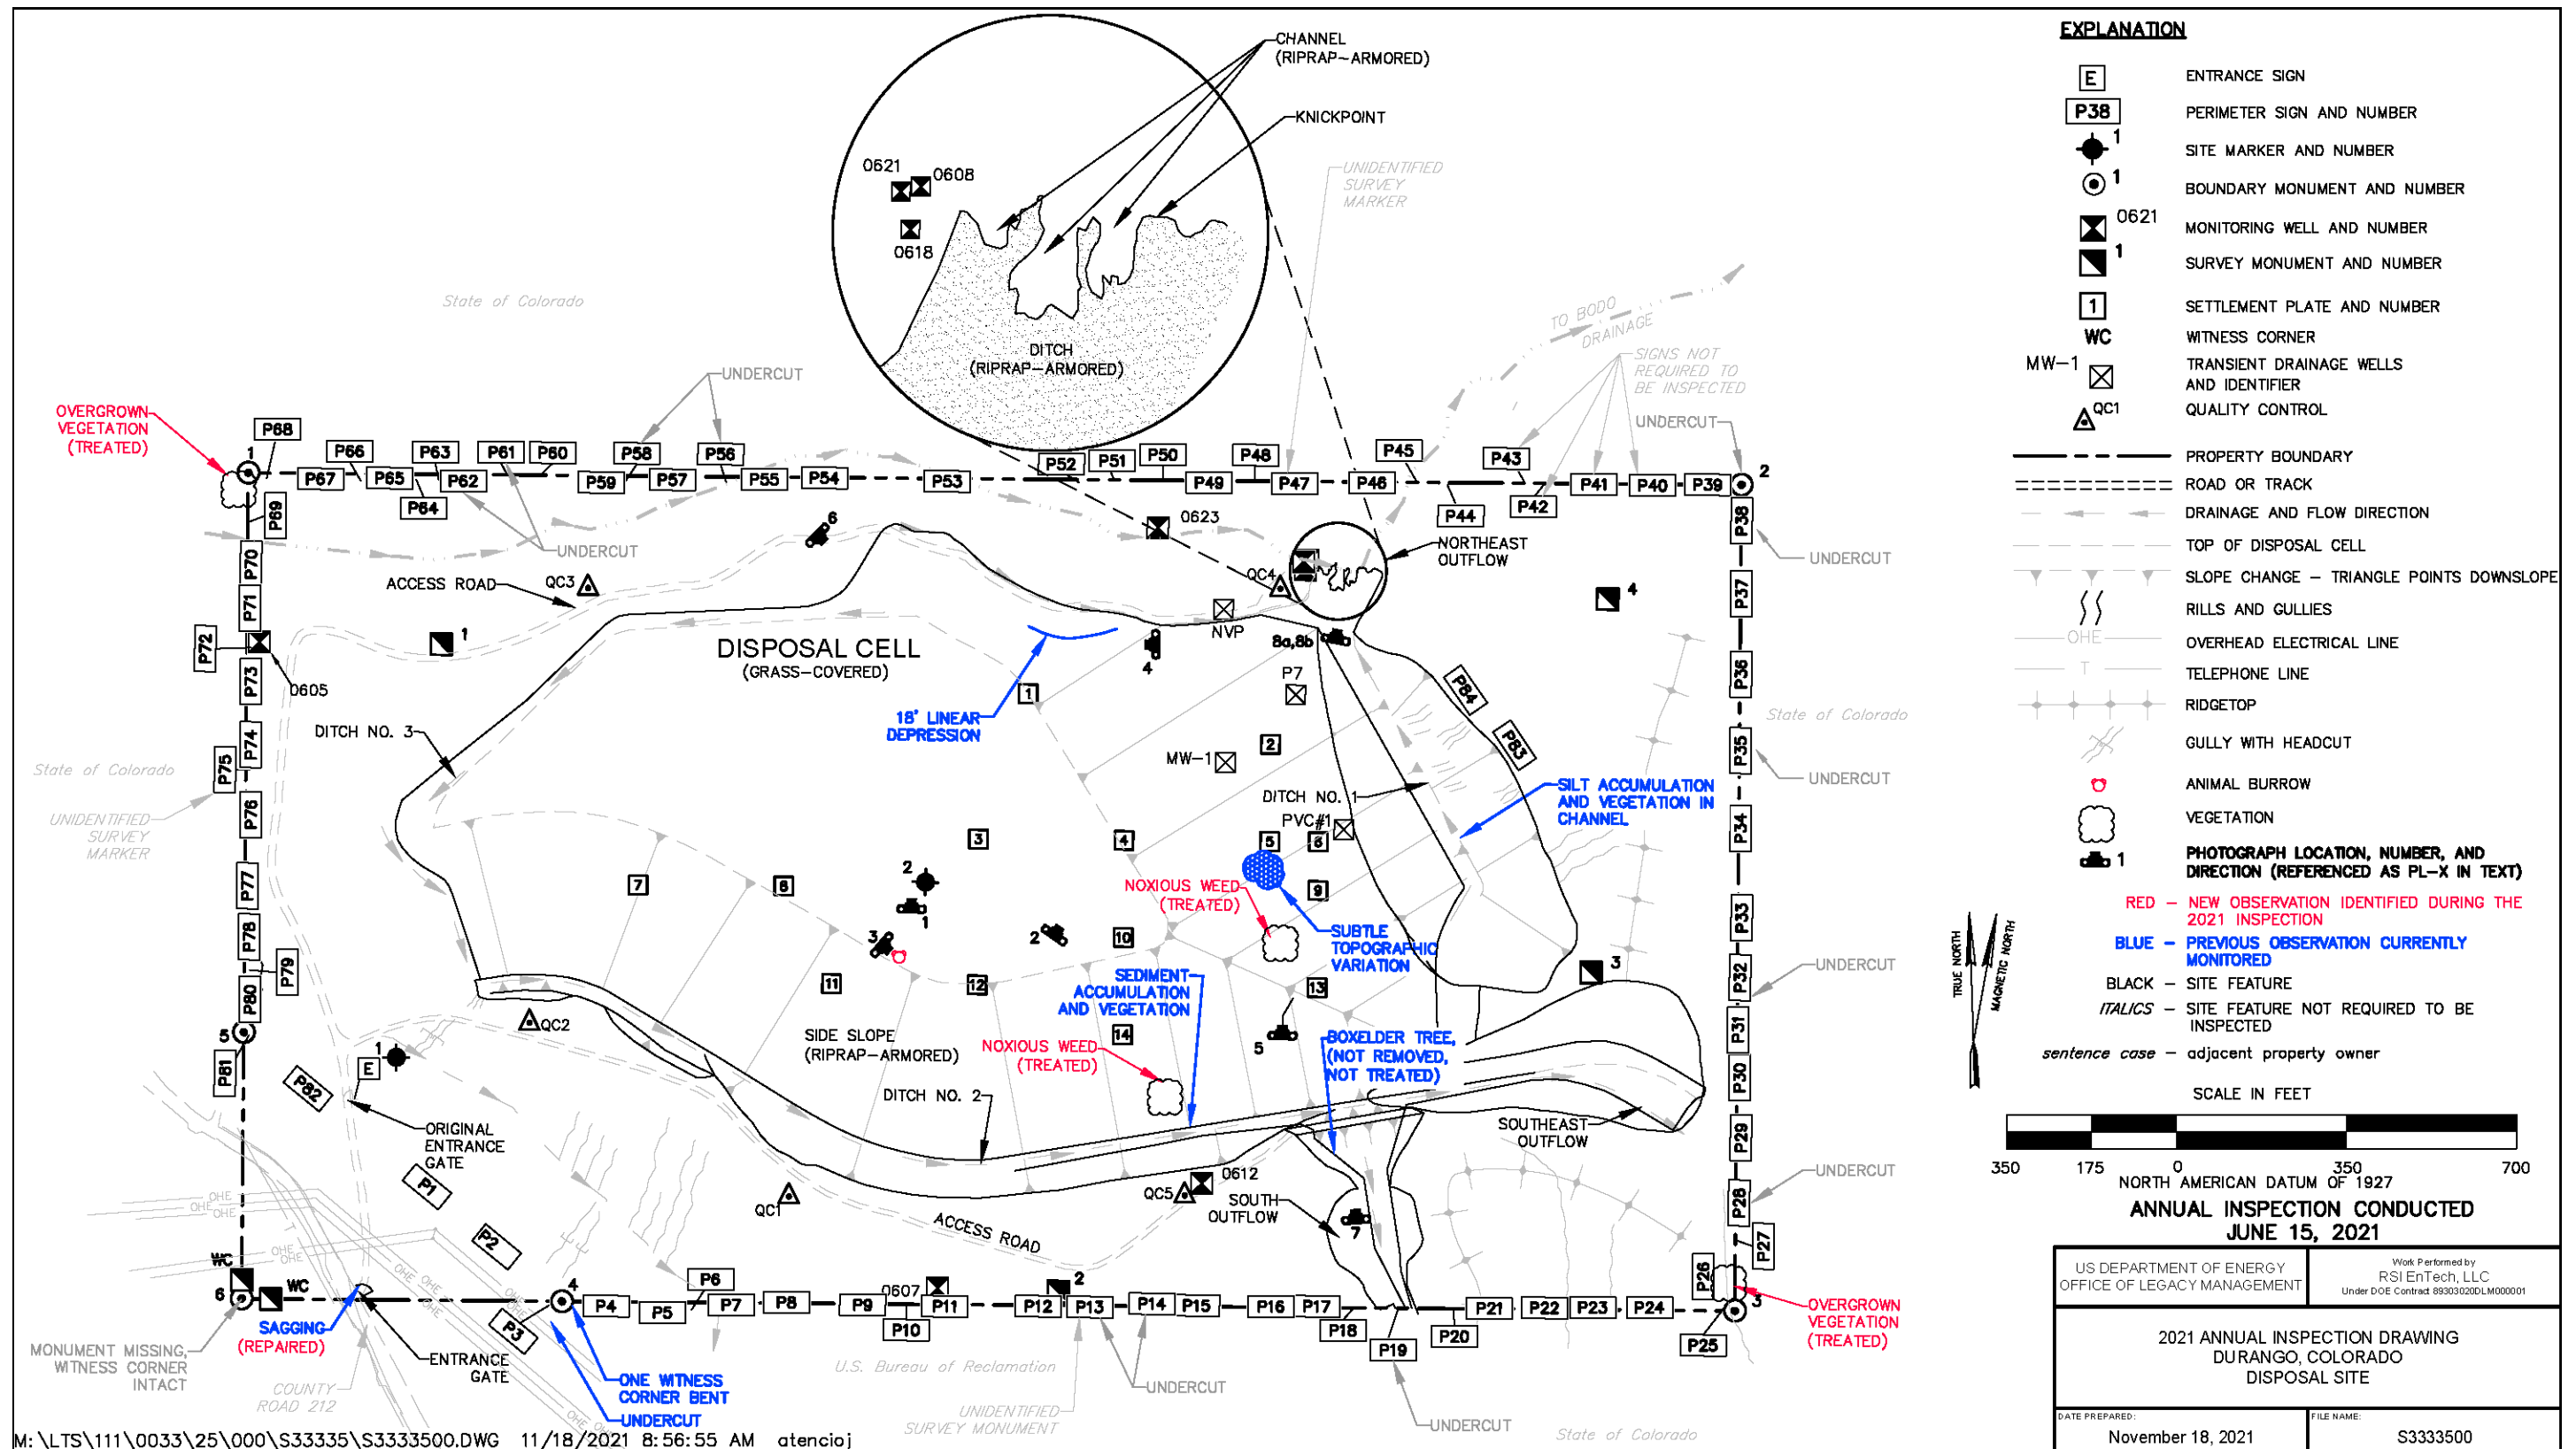
Figure 4-1. 2021 Annual Inspection Drawing for the Durango, Colorado, Disposal Site

Inspectors noted that perimeter sign P26 is surrounded by vegetation that was treated after the inspection. The concrete bases of several perimeter signs continue to be undercut, but the positions of the signs remain uncompromised. No other maintenance needs were identified.

- Removed vegetation around perimeter sign P26 and boundary monument BM-1
- Treated noxious weeds on the side and top slopes of the disposal cell

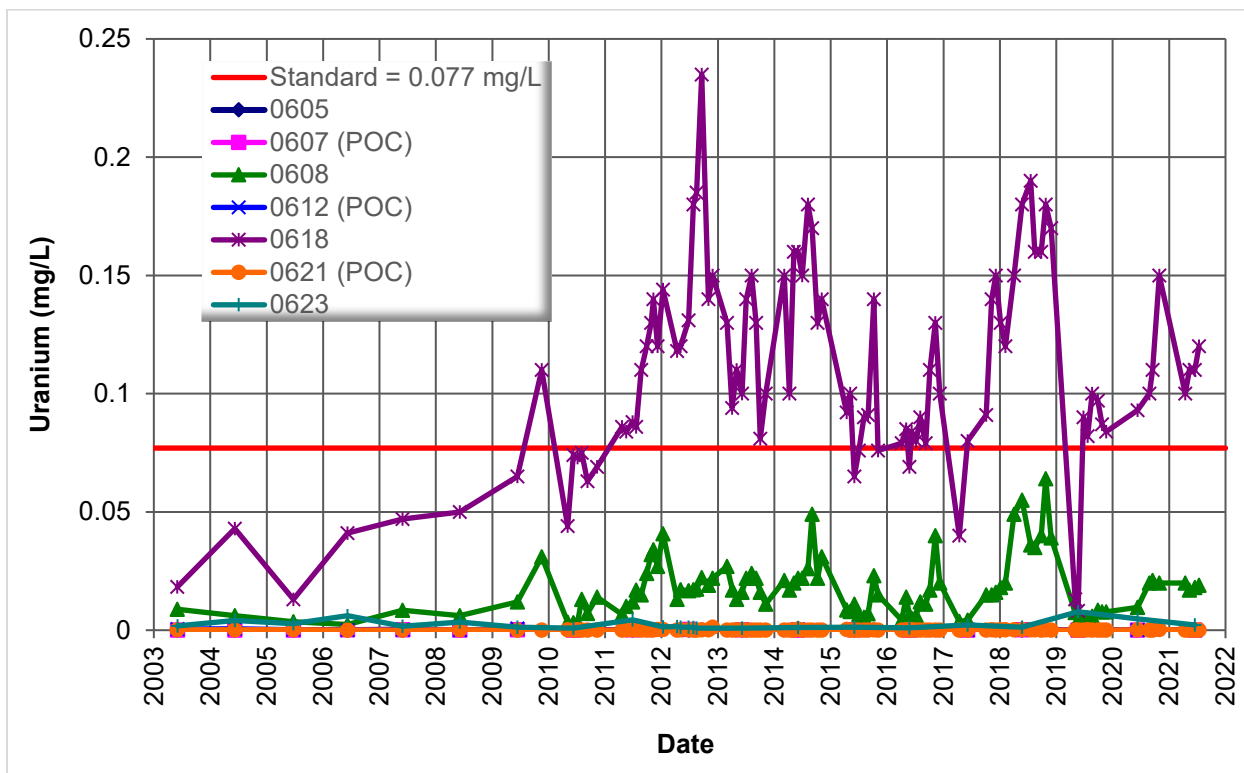
Figure 4-5. Uranium Concentrations in Groundwater at the Durango, Colorado, Disposal Site

Wells completed in the alluvium are sampled as a BMP. Uranium concentrations in well 0618 have consistently been higher than concentrations in the other onsite wells. To monitor and compare the elevated and variable uranium concentrations observed in this well, BMP wells 0608, 0618, and 0621 are sampled monthly as weather permits. Figure 4-5 shows variable uranium concentrations between 0.0082 milligrams per liter (mg/L) and 0.235 mg/L in well 0618 beginning in 2009 and continuing to the present. Uranium concentrations in well 0618 were measured at 0.12 mg/L in July 2021, which is within the range of measured historical concentrations. The cause of the variability in uranium concentration at well 0618 will be a focus of further investigation.

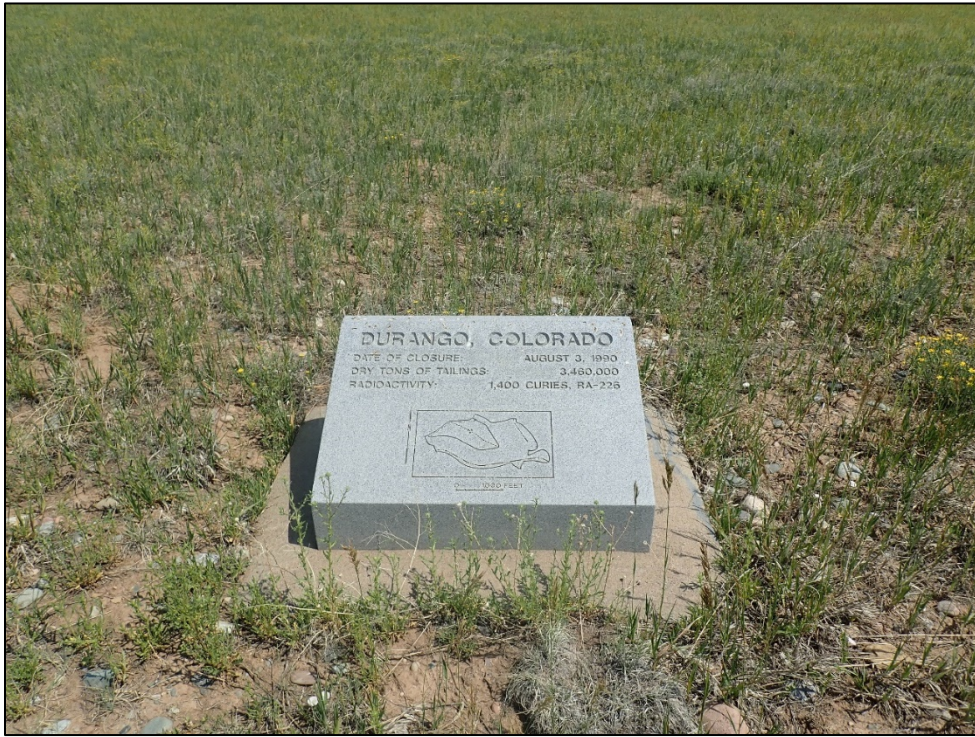
The site has two site markers. Site marker SMK-1 is just inside the original entrance gate and was in good condition. Site marker SMK-2 (PL-1) is on the top slope of the disposal cell. No new maintenance needs were identified.

PL-1. Site Marker SMK-2

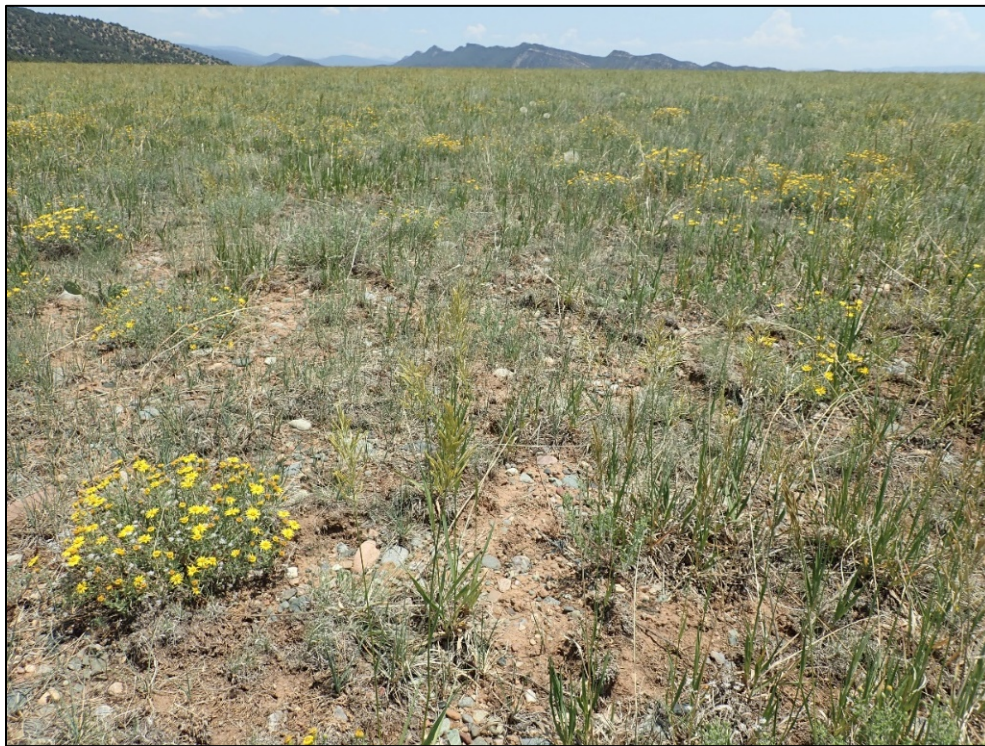
The disposal cell, completed in 1990, occupies 60 acres (PL-2). It has a vegetated cover consisting primarily of perennial grasses and broadleaf plants. There was no evidence of erosion, settling, slumping, or other modifying processes on top of the disposal cell. Several small animal burrows were observed on the cell top-slope (PL-3) but are shallow and do not require repairs. Several noxious weeds were found on the top slope and will be treated following the inspection. No other maintenance needs were identified.

PL-2. Diverse Vegetation on Top Slope

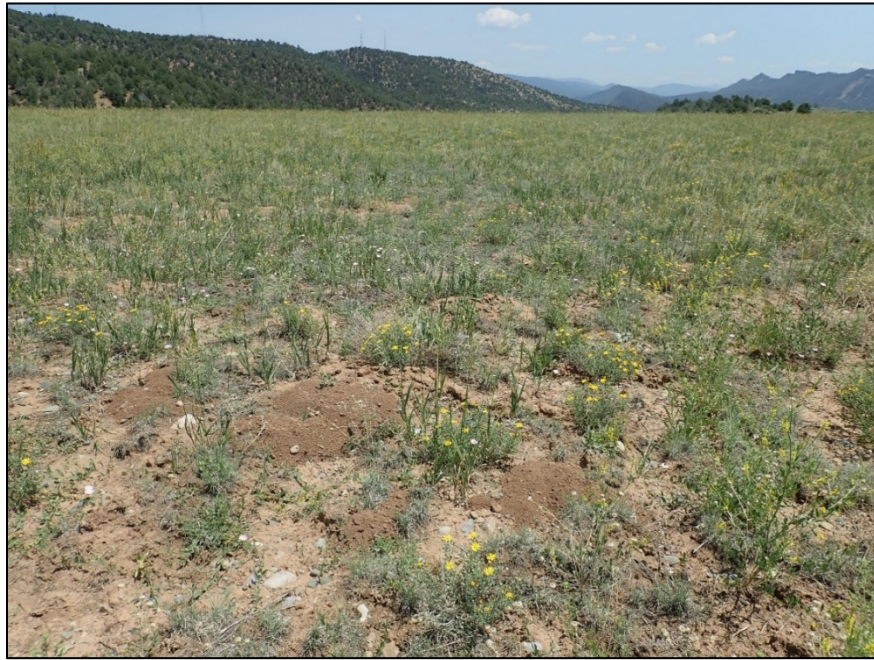
PL-3. Animal Burrows on Top Slope

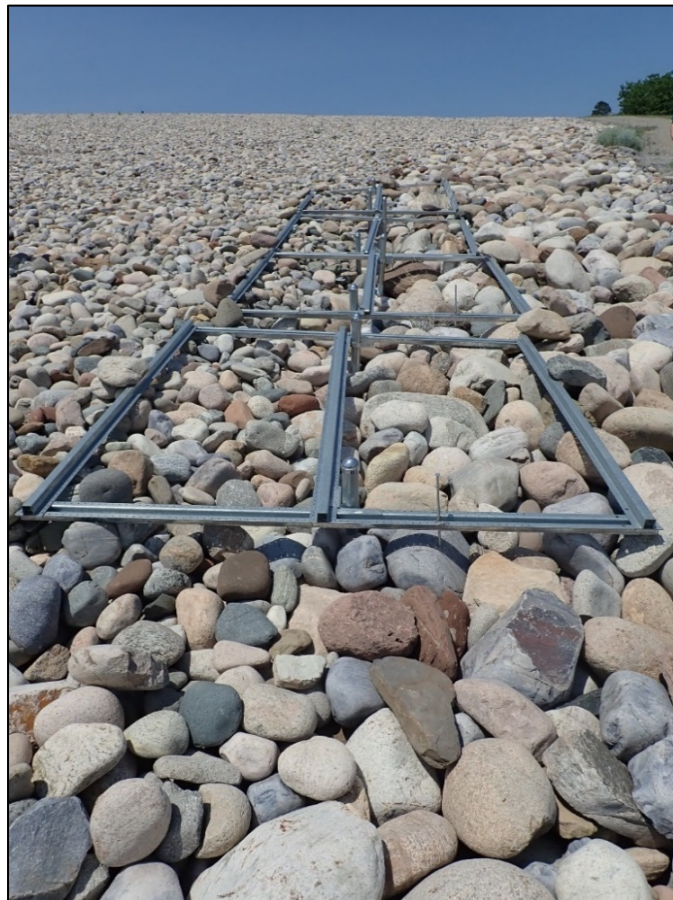
The side slopes of the disposal cell are armored with rock riprap. Rock has moved along the north toe of the disposal cell, resulting in a linear depression approximately 18 feet (ft) long (PL-4) that first was observed in 2015 and continues to be monitored. Inspectors did not observe significant changes to the depression. Inspectors will continue to monitor this area.

PL-4. Monitoring Grid over Linear Depression

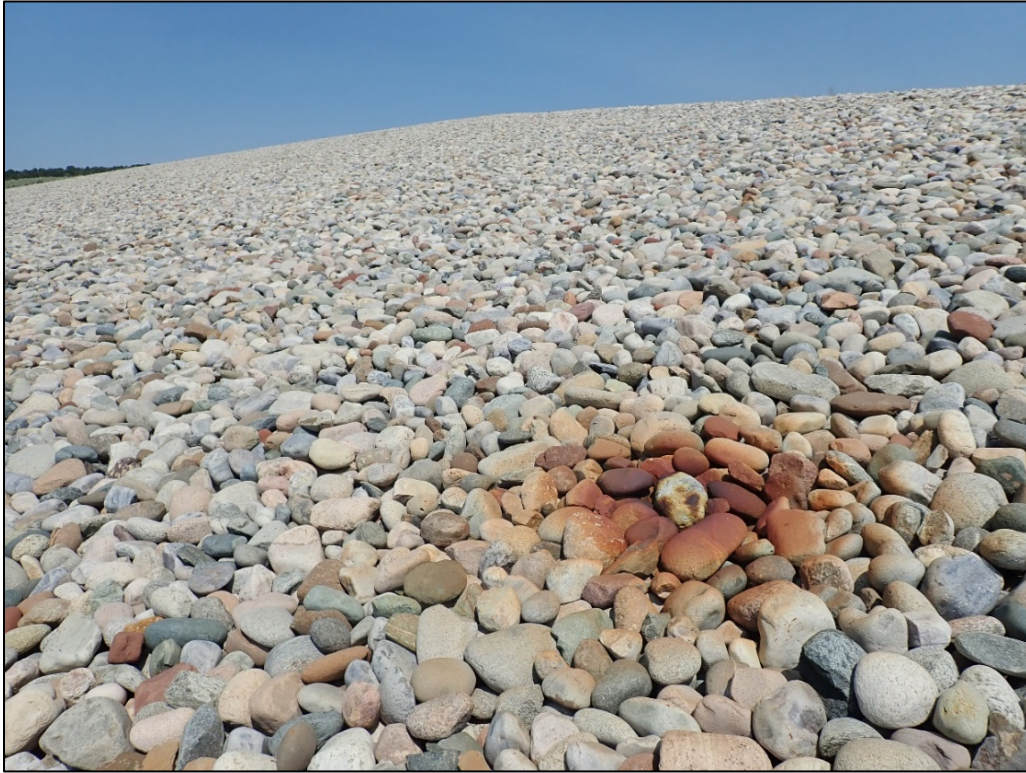
Inspectors found several young volunteer trees and several noxious weeds growing on the side slopes. The noxious weeds were treated after the inspection. Inspectors noted several points on the side slopes that had sustained lightning strikes (PL-5). No other maintenance needs were identified.

PL-5. Lightning Strike on Side Slope

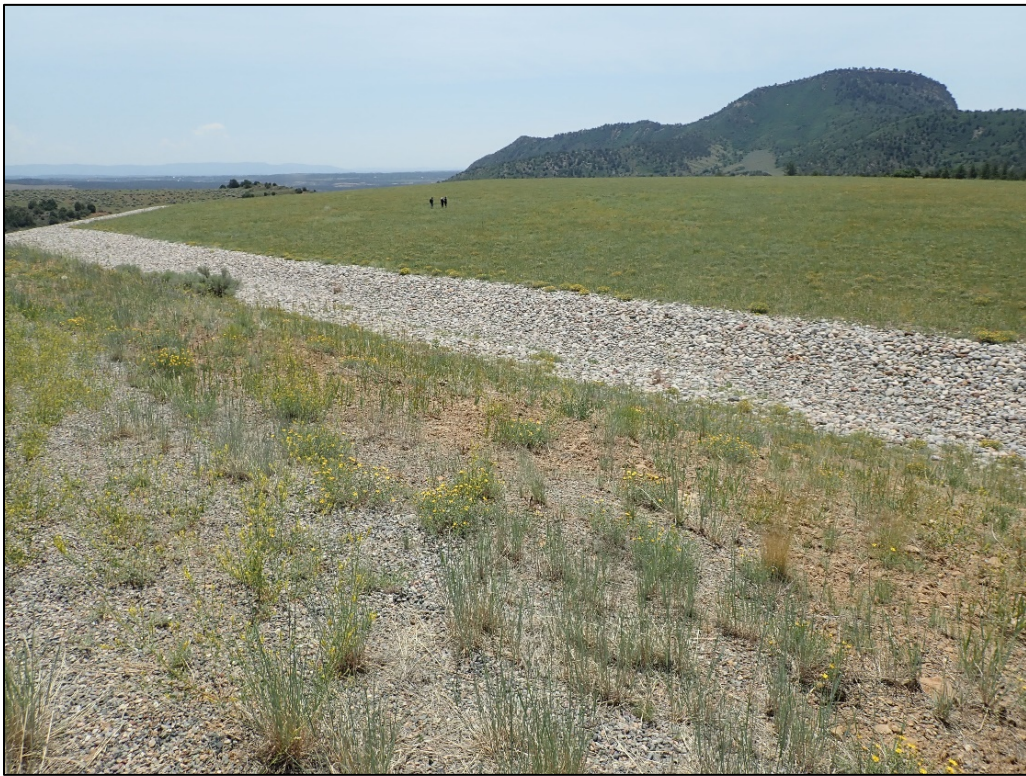
Rock-armored drainage ditches are constructed at the toes of the side slopes on the east (Ditch No. 1), south (Ditch No. 2), and northwest and west (Ditch No. 3) sides of the disposal cell (PL-6). Stormwater is directed into these ditches and conveyed away from the site into natural drainages. The ditches have sufficient depth and rock protection to carry stormwater runoff from a probable maximum precipitation event. Erosion occurs on some of the steep slopes above the ditches, depositing sediment in the riprap-armored channel. This sediment favors plant establishment but does not adversely affected the performance of the ditches, so maintenance is not needed at this time.

PL-6. Northeast Drainage Channel

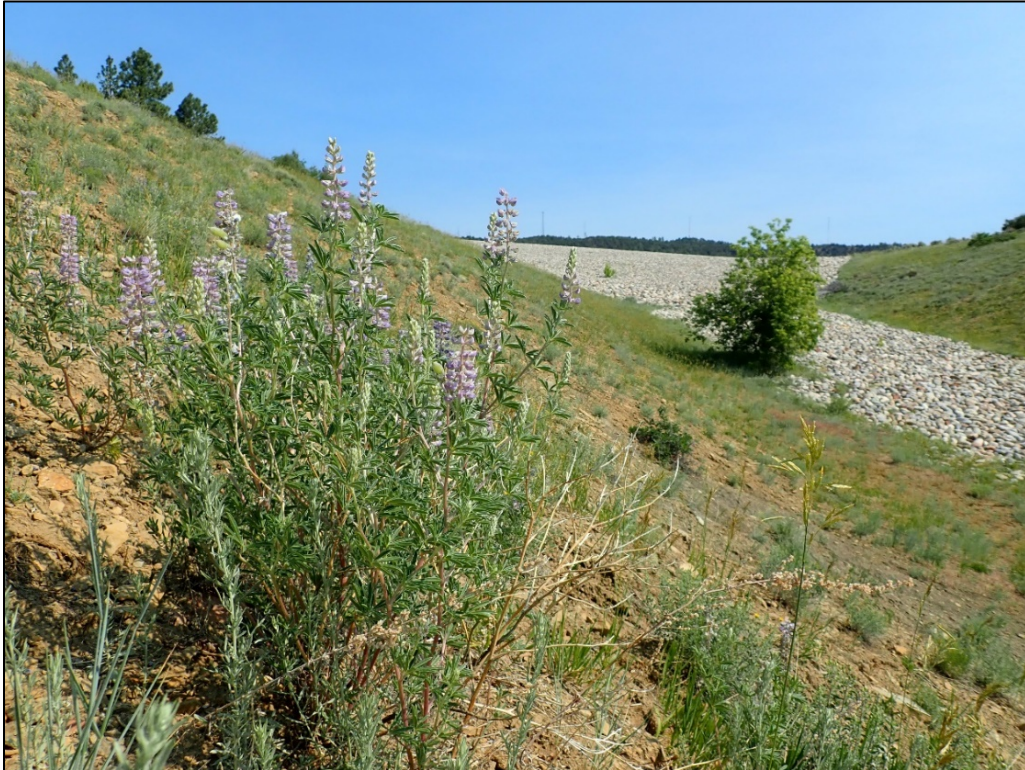
The riprap-covered outflows of the drainage ditches were designed to self-armor over time. The outflows and drainage channels below them are monitored annually. A larger boxelder tree is growing along the edge of the south outflow channel but does not affect the stability or effectiveness of the channel. A large arroyo has formed below the southeast outflow (PL-7), which indicates the drainage ditch is functioning properly. The uplands above the northeast outflow are steadily eroding (PL-8(a) and PL-8(b)), but this is not affecting the stability or effectiveness of the outflow area. No maintenance needs were identified.

PL-7. Southeast Outflow

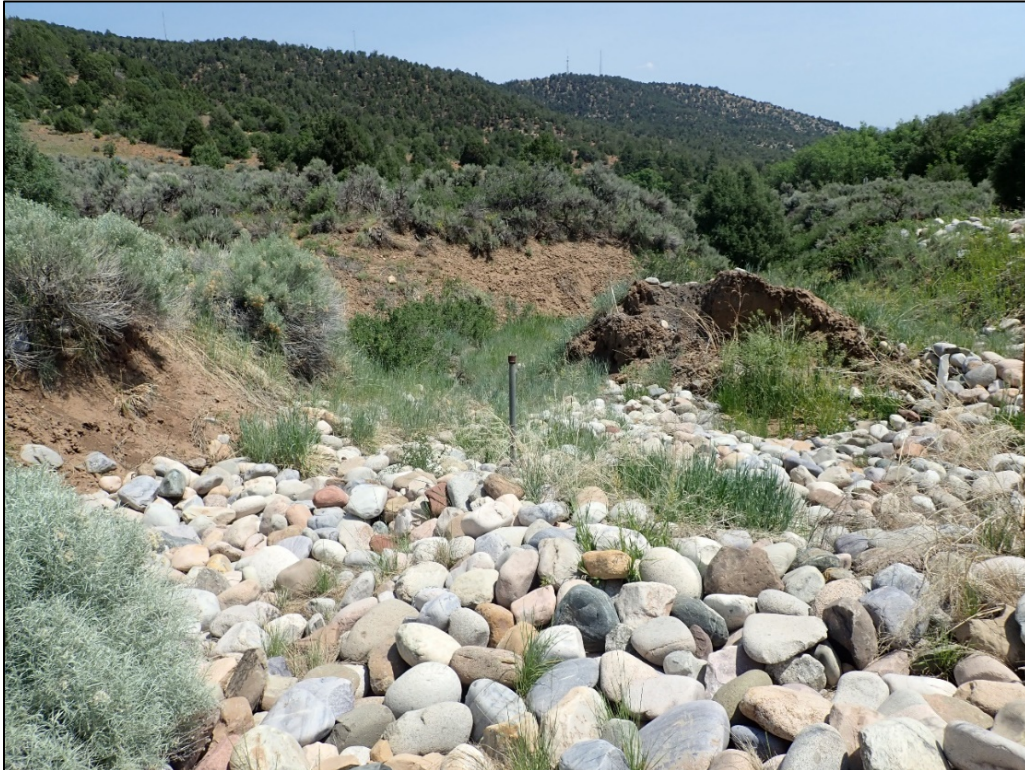
PL-8(a). Northeast Outflow in 2021

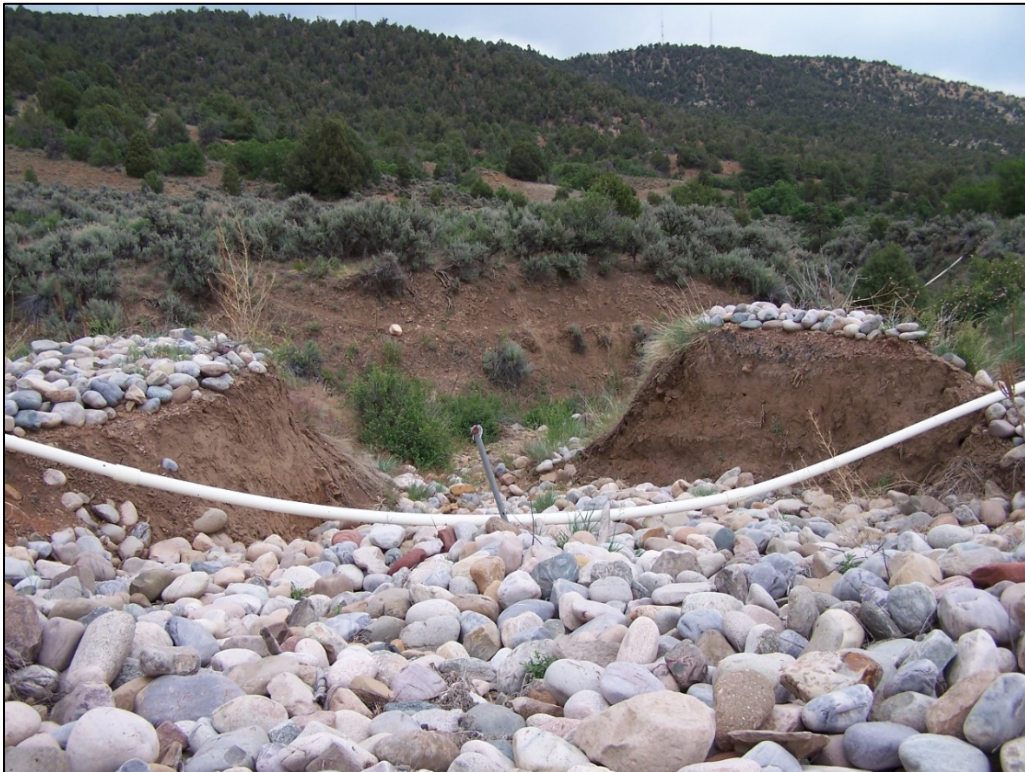
PL-8(b). Northeast Outflow in 2006 (Photo for Comparison)
