4.0 Durango, Colorado, Disposal Site

The U.S. Department of Energy (DOE) Office of Legacy Management (LM) conducted the Durango, Colorado, Uranium Mill Tailings Radiation Control Act (UMTRCA) Title I Disposal Site annual inspection on May 15, 2024, and the annual groundwater monitoring event in June 2024. No cause for a follow-up inspection was identified.

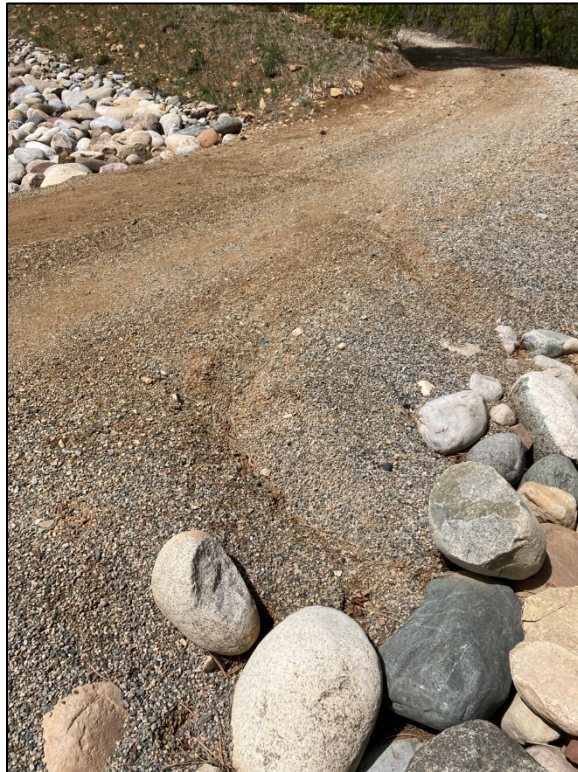
Access to the site is via La Plata County Road 212, an improved dirt road that is accessed via a locked gate along La Plata County Road 210. Entrance to the site is through the locked steel entrance gate along La Plata County Road 212 and an older, original entrance gate. All gates were locked and functional. The entrance sign is at the older entrance gate inside the property boundary. A minor erosional feature is forming on the northern portion of the access road within the site boundary (PL-1), and maintenance will be conducted before the next site inspection.

PL-1. Access Road Erosion

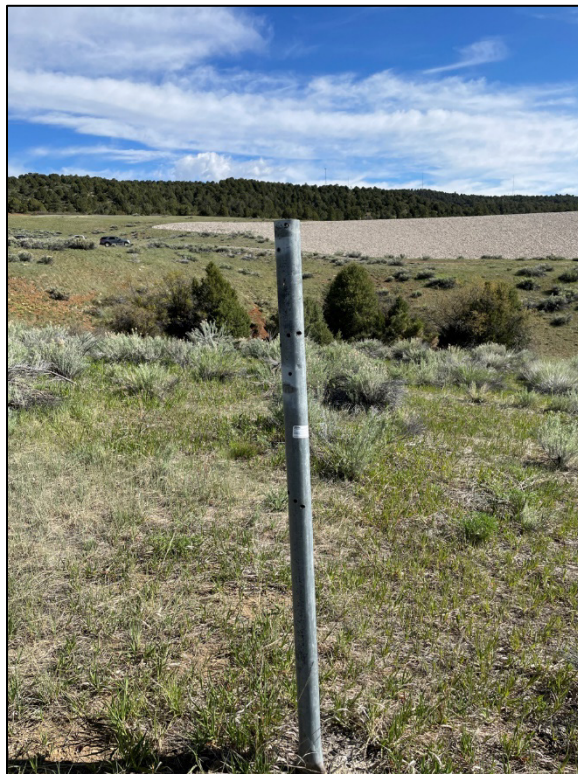
Inspectors noted that perimeter signs P1 (PL-2) and P82 (PL-3) were missing and will be replaced before the next inspection. Before the 2024 annual inspection, perimeter signs P13–P18 were chosen to be the test subjects for the water diversions installed above the signs to try to prevent undercutting. This maintenance effort was successful, and new erosion was minimal. The concrete bases of perimeter signs P6, P29 (PL-4) and P35 are undercut but stable. The undercutting at perimeter signs P56 (PL-5), P61, P62 (PL-6), and P79 is advanced enough that the signs require repair. Perimeter sign P57 was previously fixed for erosional issues and will need further repair. Maintenance will be done before the next inspection.

PL-2. Perimeter Sign P1 Missing

- Replace perimeter signs P1 and P82
- Treat new woody vegetation on the side slopes of the disposal cell
- Repair undercut perimeter signs P56, P57, P61, P62, and P79

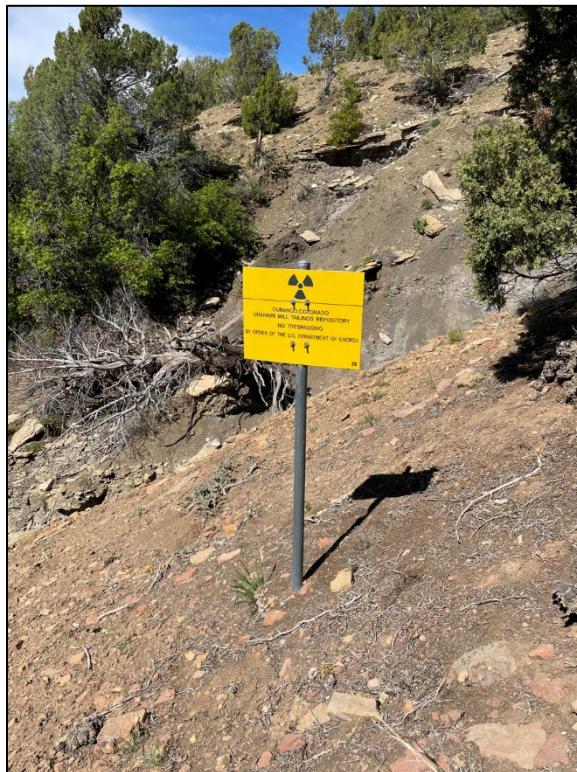
PL-4. Perimeter Sign P29 with Undercut Base but Stable

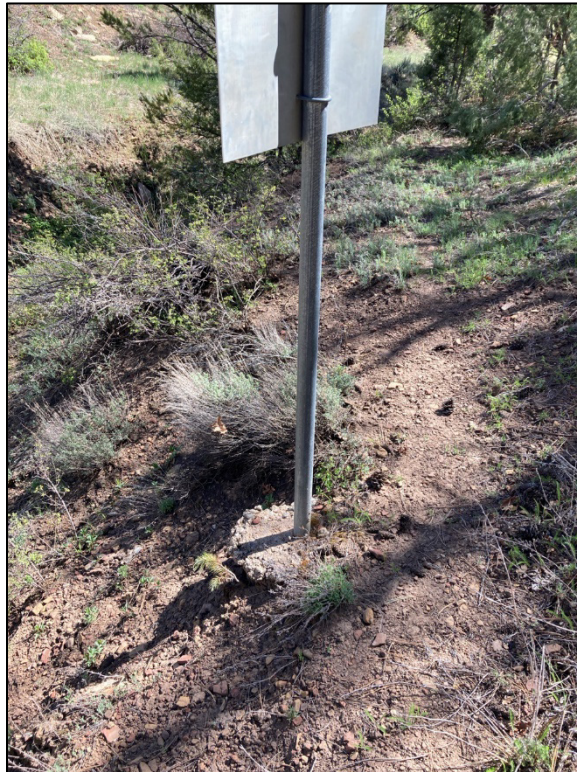
PL-5. Perimeter Sign P56 with Undercut Base and Unstable

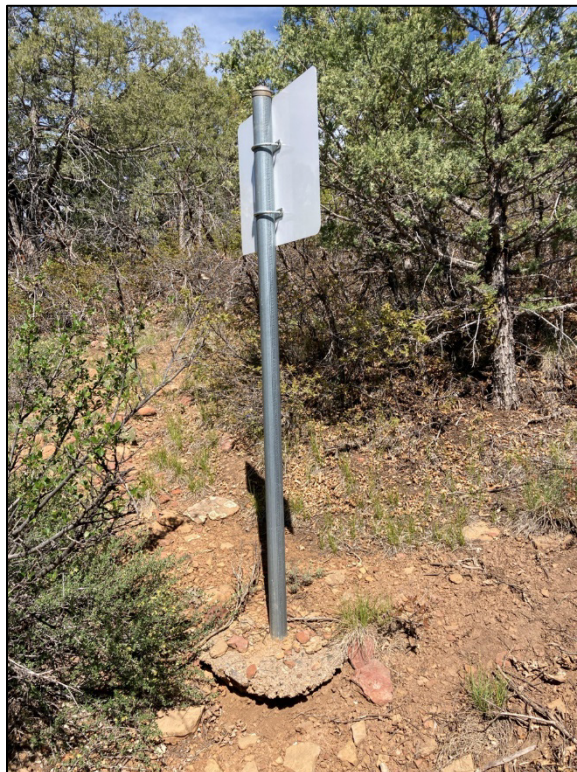
PL-6. Perimeter Sign P62 with Undercut Base and Unstable

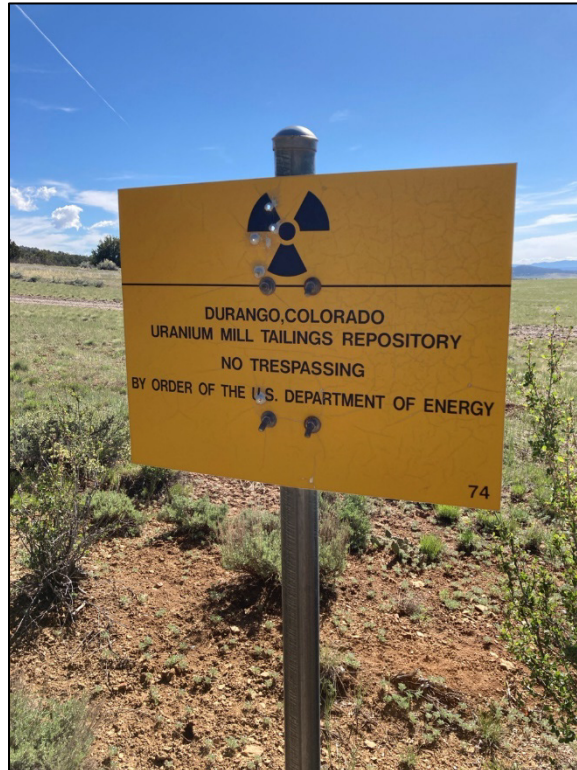
Perimeter signs P69, P74 (PL-7), P79, and P80 have new bullet holes but are still legible. No other maintenance needs were identified.

PL-7. Perimeter Sign P74 with Bullet Holes

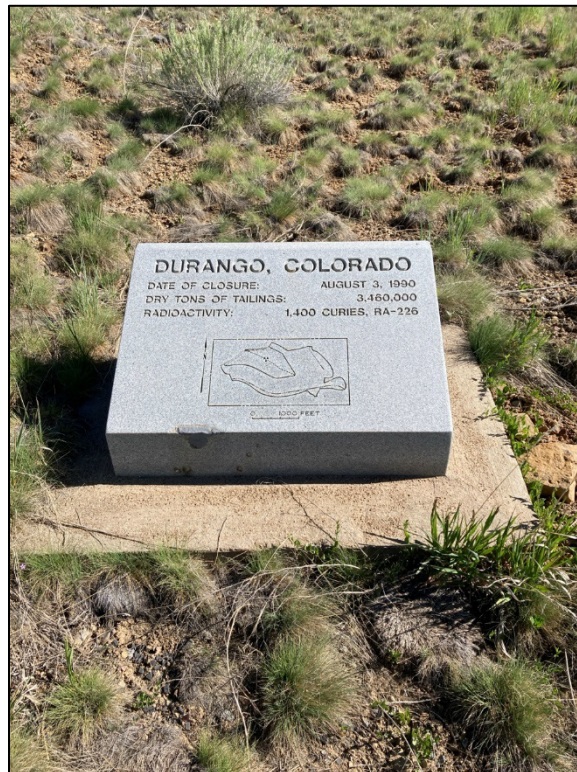
The site has two site markers. Site marker SMK-1 is just inside the original entrance gate and was in good condition (PL-8). Site marker SMK-2 is on the top slope of the disposal cell and was also in good condition. No maintenance needs were identified.

PL-8. Site Marker SMK-1 at Entrance Gate

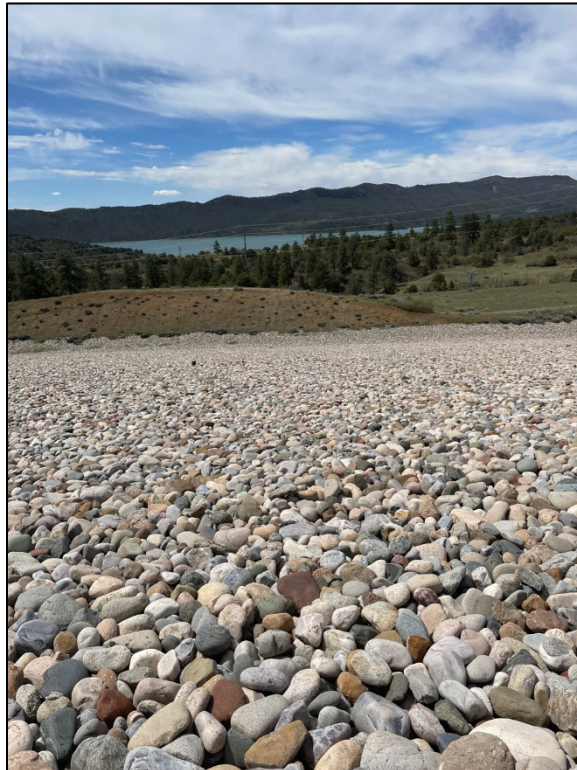
The side slopes of the disposal cell are armored with rock riprap (PL-9). A linear depression, approximately 18 feet long, was first observed along the north toe of the disposal cell in 2015. The depression was repaired in October 2022, and inspectors have been unable to detect any settling or other changes since the repair.

PL-9. South Side Slope

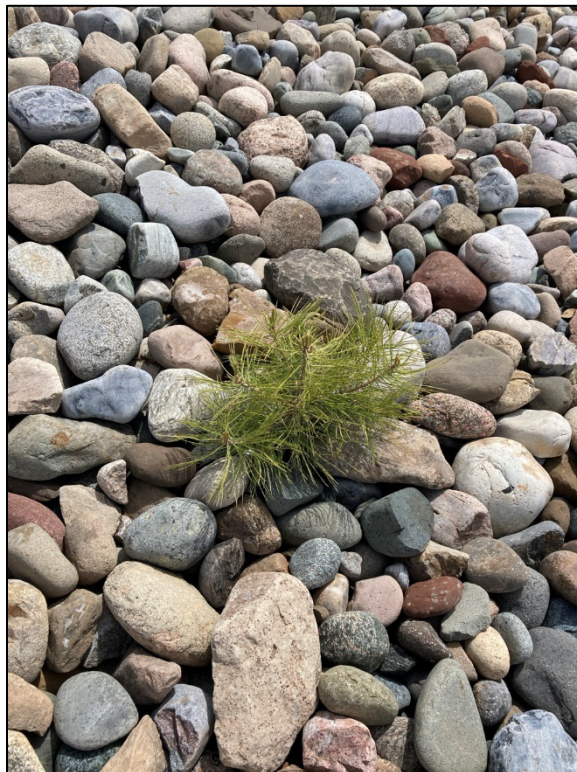
Inspectors found several new young woody plants growing on side slopes of the disposal cell (PL-10). The plants will be cut or treated, or both, before the next inspection. Sediment accumulation and nonwoody vegetation growth was observed on the east side slope and will be monitored (PL-11). No other maintenance needs were identified.

PL-10. Woody Plant Growing in Riprap

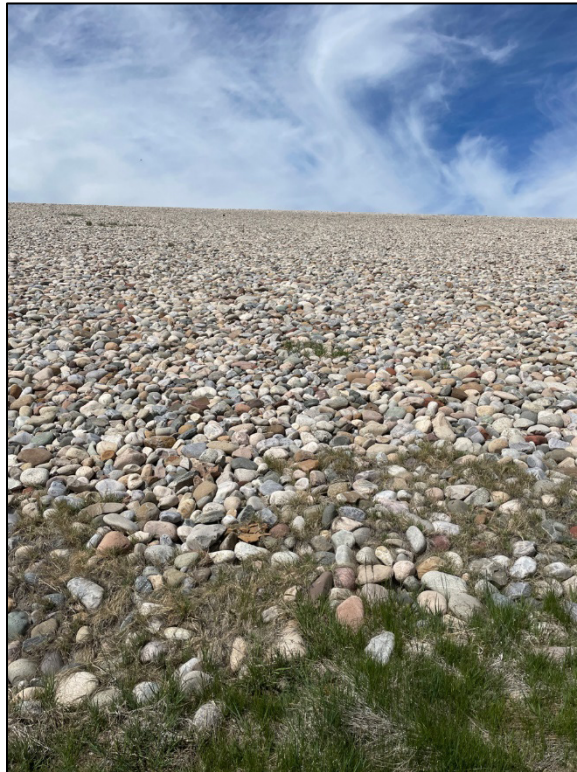
PL-11. East Side Slope—Sediment Accumulation and Vegetation Growth

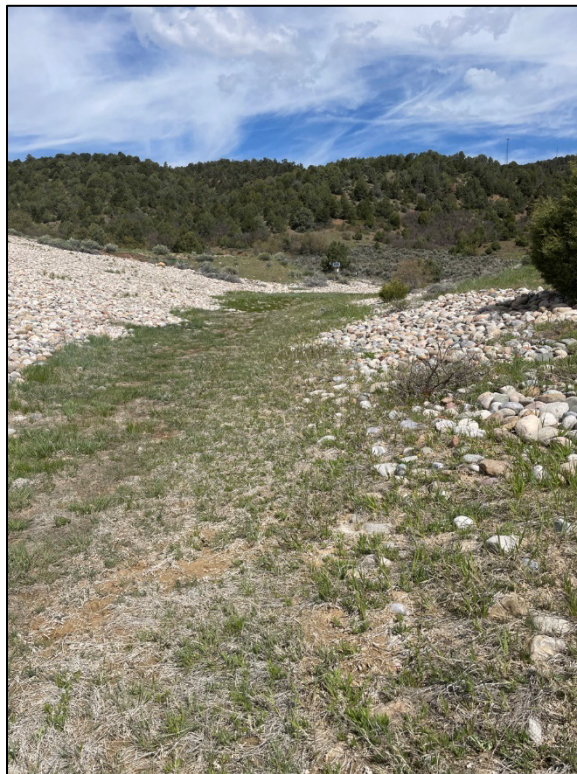
Inspectors observed silt accumulation and vegetation growth along Ditch No. 1 (PL-12), but no more than in previous years. Inspectors observed silt accumulation and vegetation growth (PL-13) along Ditch No. 2, but no more than previous years. A large boxelder tree is still growing along the edge of the south outflow channel but does not affect the stability or effectiveness of the channel. Grass and other plants are growing in the south outflow, and sediment accumulation was observed (PL-14). Ditch No. 3 was inspected, and no new findings were observed.

PL-12. Ditch No. 1—Silt Accumulation and Vegetation Growth

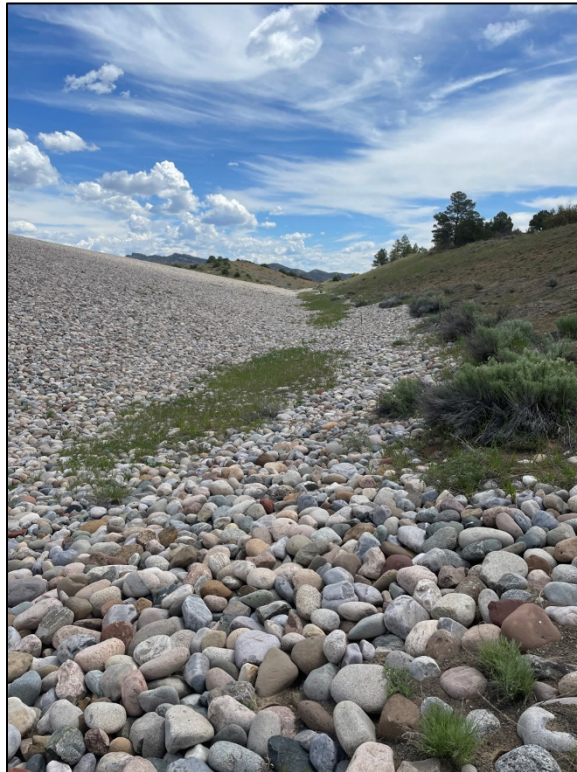
PL-13. Ditch No. 2—Nonwoody Vegetation

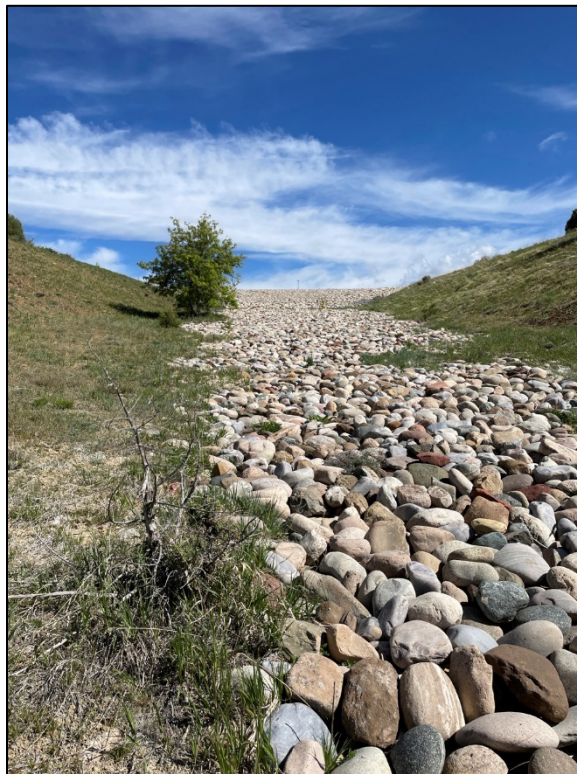
PL-14. South Outflow—Vegetation Growth
