**2022 Inspection and Status
Report for the Boiling Nuclear
Superheater (BONUS)
Decommissioned Reactor Site,
Rincón, Puerto Rico**

September 2022

U.S. DEPARTMENT OF
ENERGY

Legacy
Management

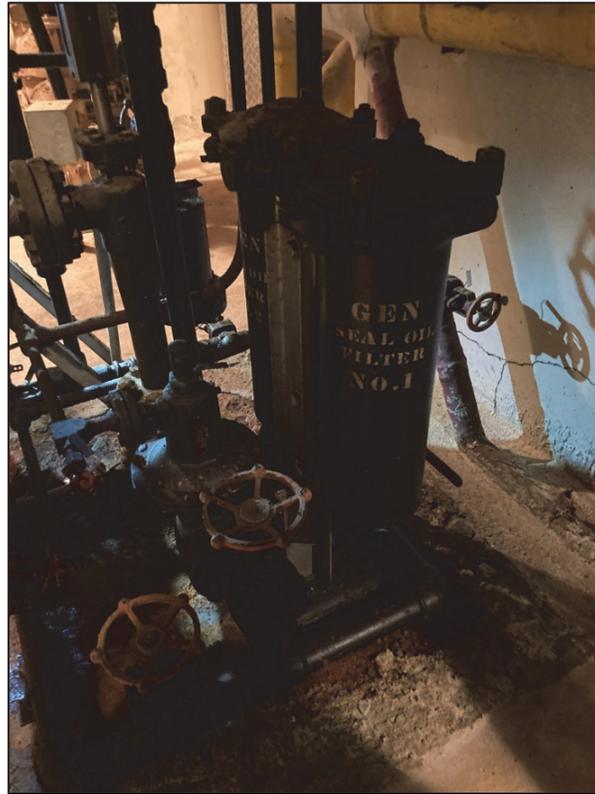
A small area of fluid was observed at the base of the Gen. Seal Oil Filter No. 1 in the basement of the containment building. DOE requested that PREPA further investigate the nature of this fluid, which resembles oil (PL-1).

PL-1. Oily Substance Noted at Base of Gen Seal Oil Filter No. 1

It needs to be confirmed that the unknown oily substance at the base of the Gen. Seal Oil Filter No. 1 is merely oil that has leaked to the floor.

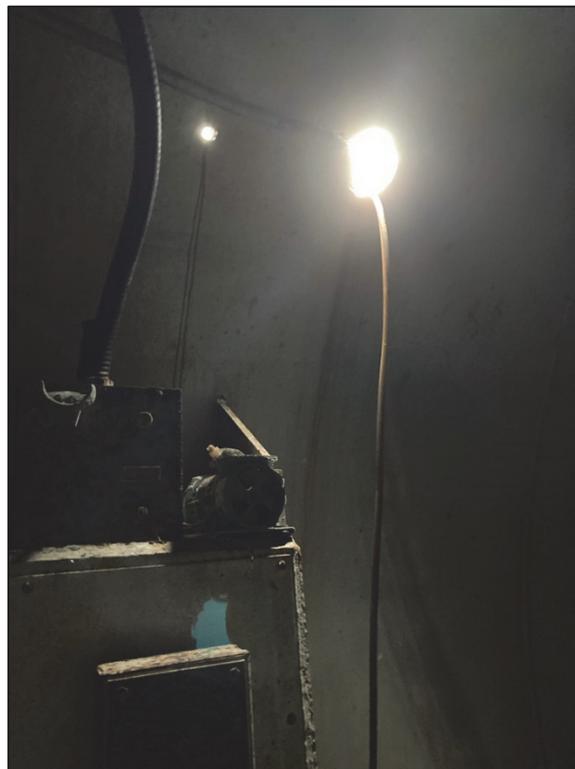
Inspectors observed that an opening in the side of airlock 2 has what appears to be an electric cord running through it. This opening should be closed to protect the interior of the containment dome (PL-2).

PL-2. Opening to Outside in Airlock 2

The opening in Airlock 2 should be closed.

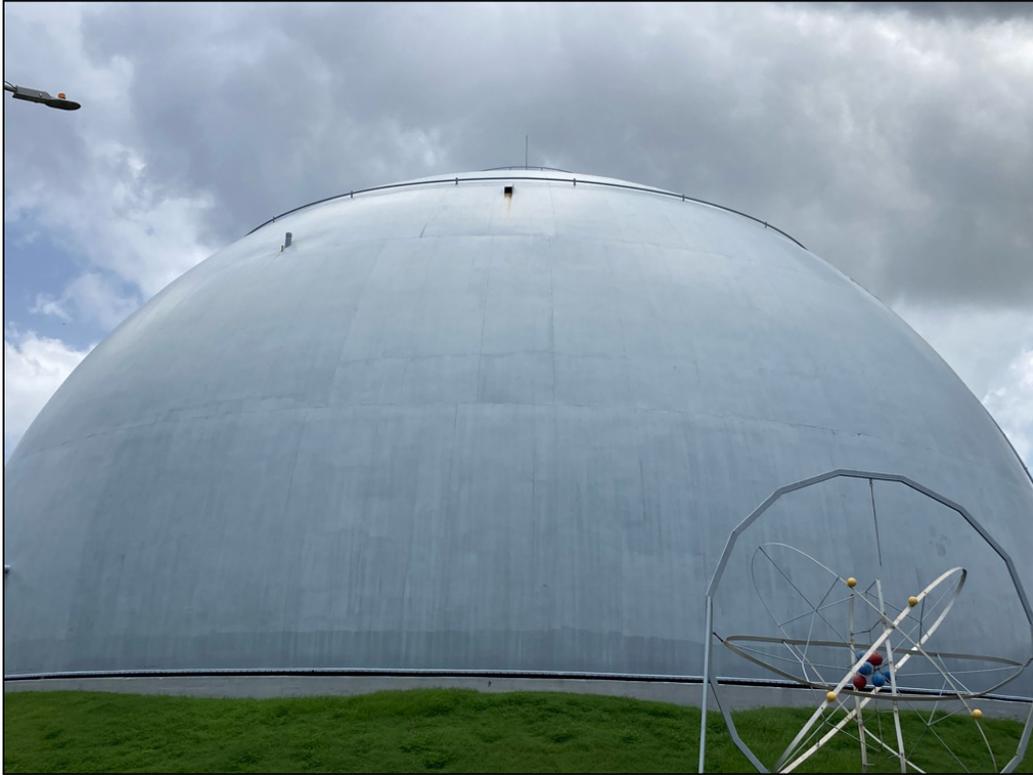
The outer surface of the dome was reconditioned and painted in 2013 (PL-3). Paint in one area of the dome was damaged during the hurricane and needs to be repainted.

PL-3. Containment Dome

One small area of the dome should be repainted to help protect the dome from corrosion.

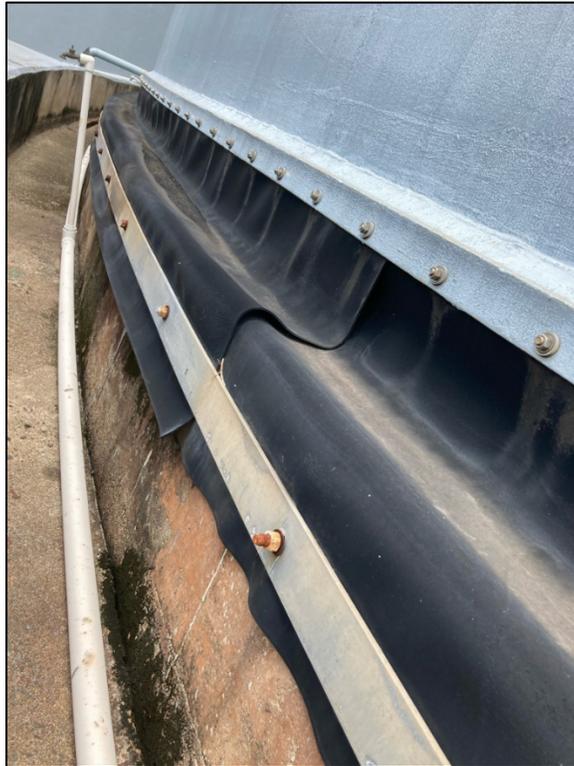
A rubber seal is installed around the base of the containment dome to keep water from seeping into the building. In 2010, the seal was observed to be cracked, ripped, and missing in some spots. Evidence of water seepage was observed in a few spots along the top of the basement wall inside the containment dome, which indicated that the seal was leaking in those areas. PREPA installed a secondary rubber seal over the damaged primary seal to carry water away from the underlying damaged seal. During this site inspection, inspectors noted that overlaps of the secondary seal should be caulked (PL-4) and the ends of the secondary seal need to be trimmed and better secured to the dome, perhaps using a caulking compound to prolong the life of the seal. No evidence of recent water seepage was observed along the top of the basement wall in the containment building during this year's inspection, which indicates that the secondary seal is functioning properly.

PL-4. Gap in Seal at Base of Dome

To better ensure the long-term integrity of the secondary rubber seal at the base of the containment dome, overlaps of the seal should be caulked, and the ends should be better attached to the wall of the building.

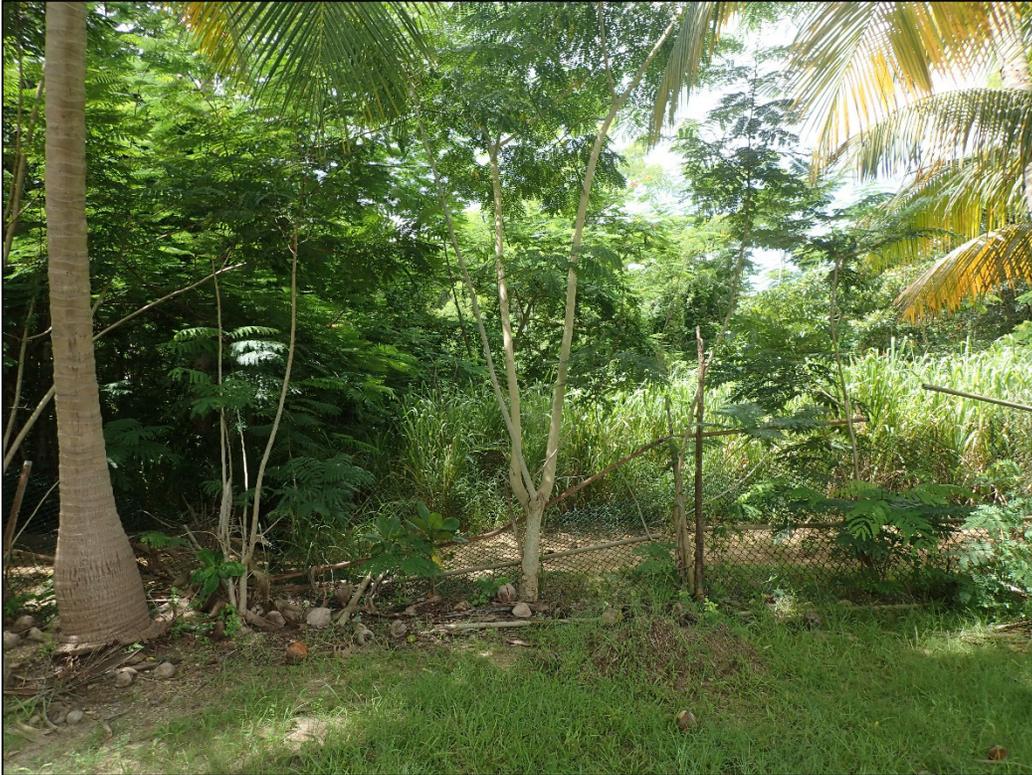
Upon arrival, the security guard was present and the gate was closed and locked. The on-duty security guard allowed the inspection team to enter the grounds. The perimeter security fence was found to be in poor condition. Numerous downed trees resulting from the 2017 hurricanes damaged the fence in several areas (PL-5, PL-6, PL-7). The fence is entirely down in some areas (PL-8). For security purposes, the fence needs to be repaired as soon as possible.

PL-5. Damaged Perimeter Fence

Hurricane damage to the perimeter fence and the retaining wall along the beach should be repaired.

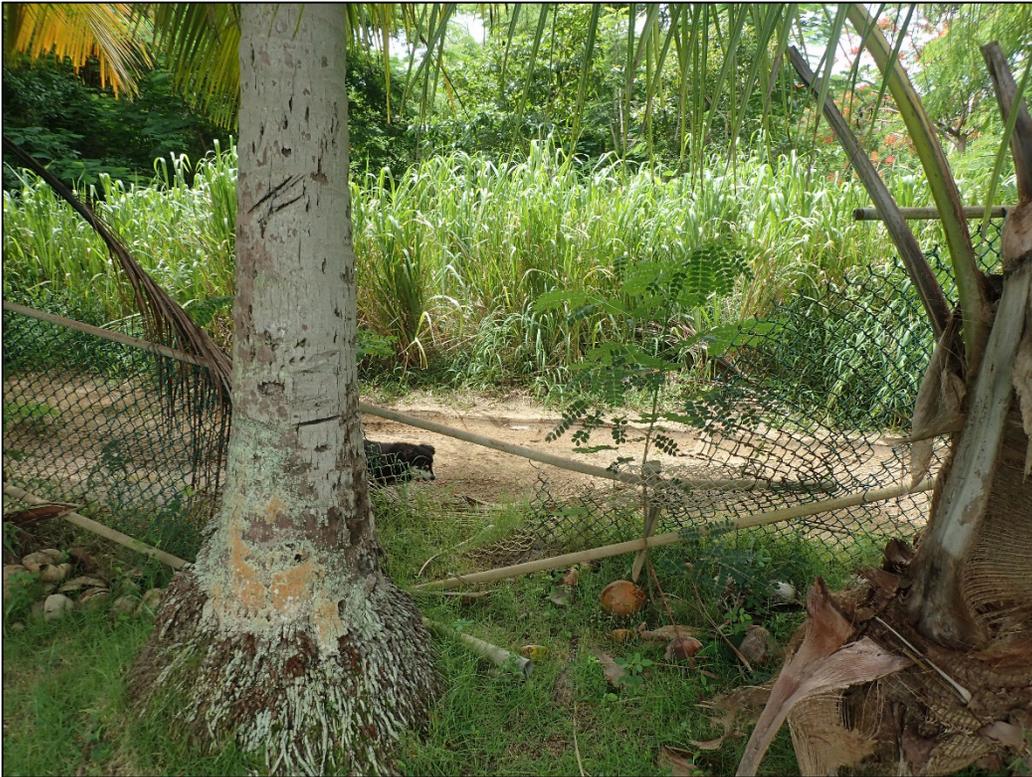
PL-6. Damaged Perimeter Fence

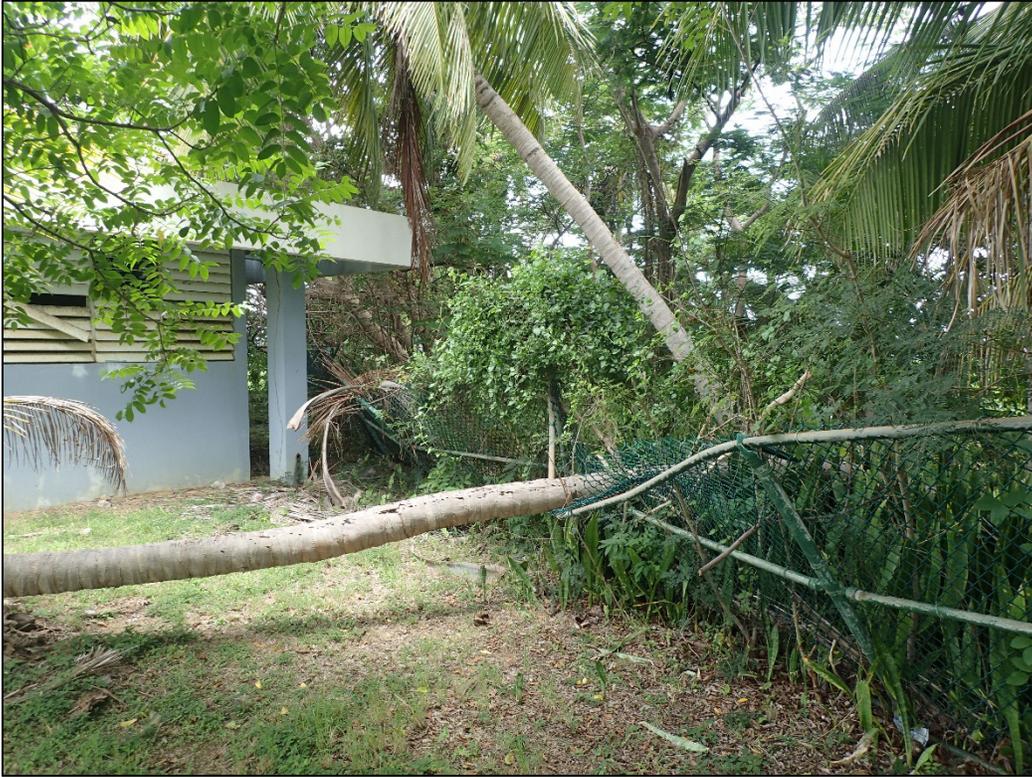
PL-7. Tree Down on Perimeter Fence

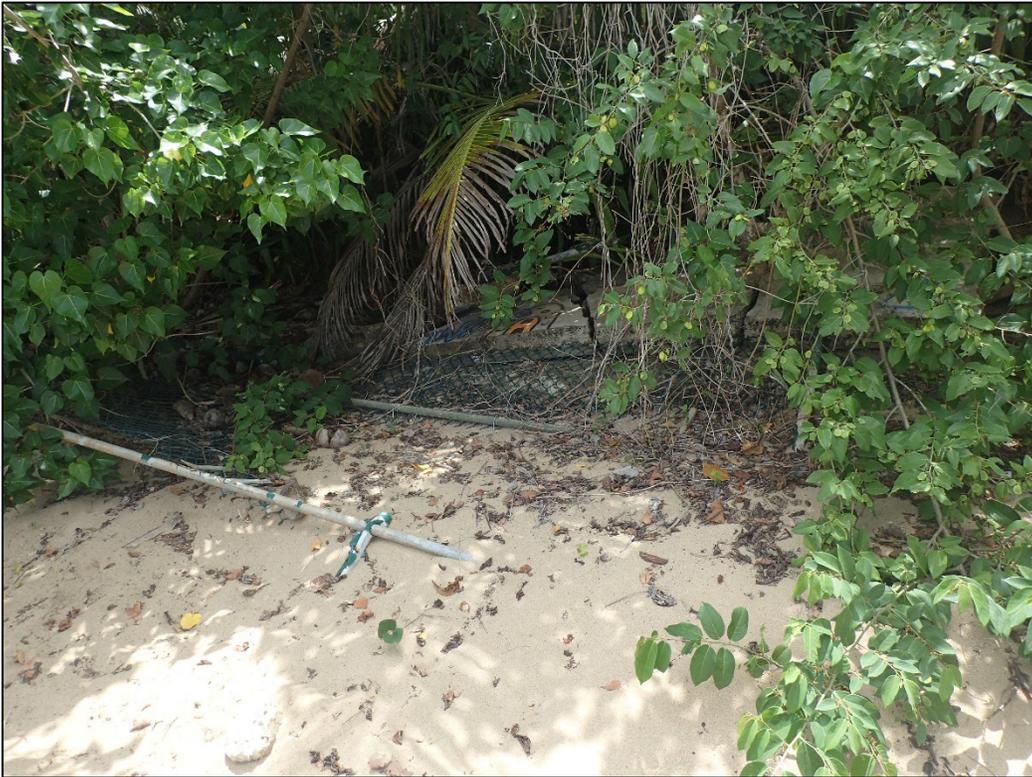
PL-8. Damaged Beach Barrier Wall and Downed Security Fence

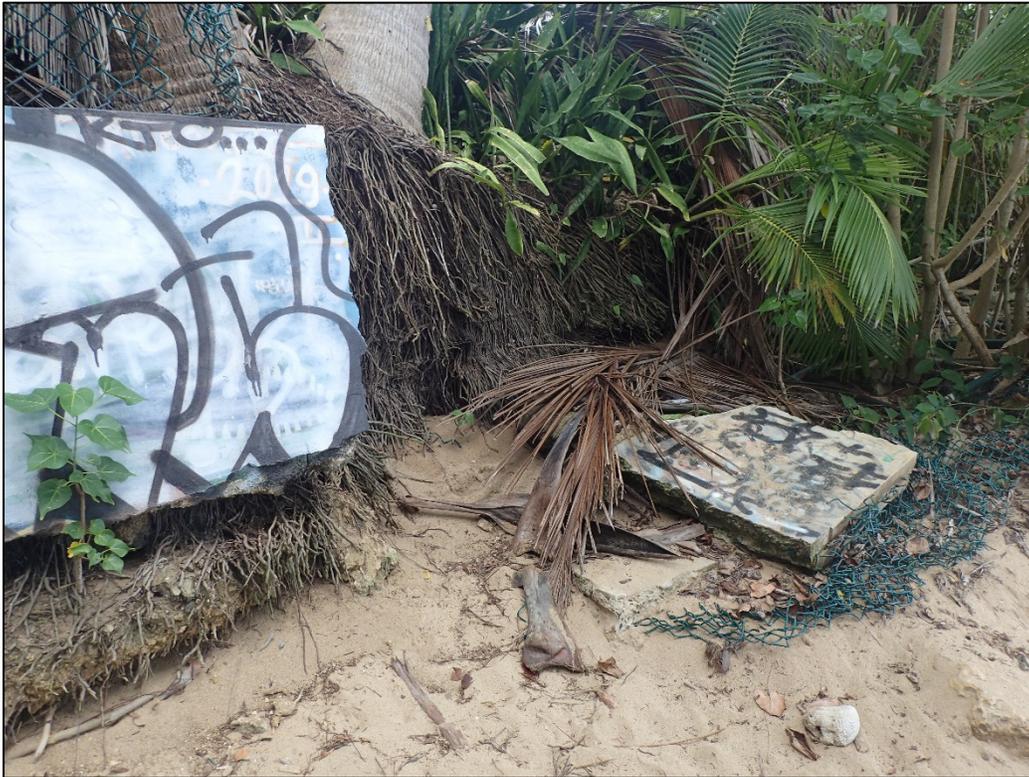
The barrier wall along the beach on the west side of the property (and the security fence that was installed along the top of the wall) are significantly deteriorated (PL-9 and PL-10). The steep hillside and dense vegetation will discourage trespass, but this area is no longer secured by a perimeter fence.

PL-9. Damaged Beach Barrier Wall

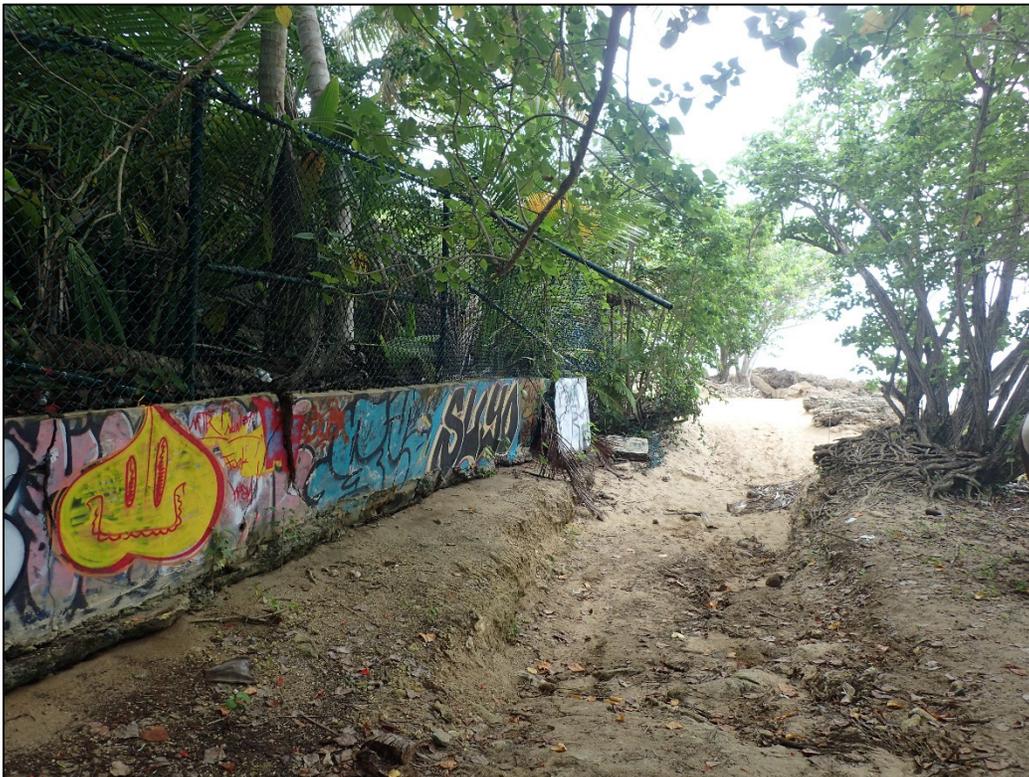
PL-10. Damaged Beach Barrier Wall

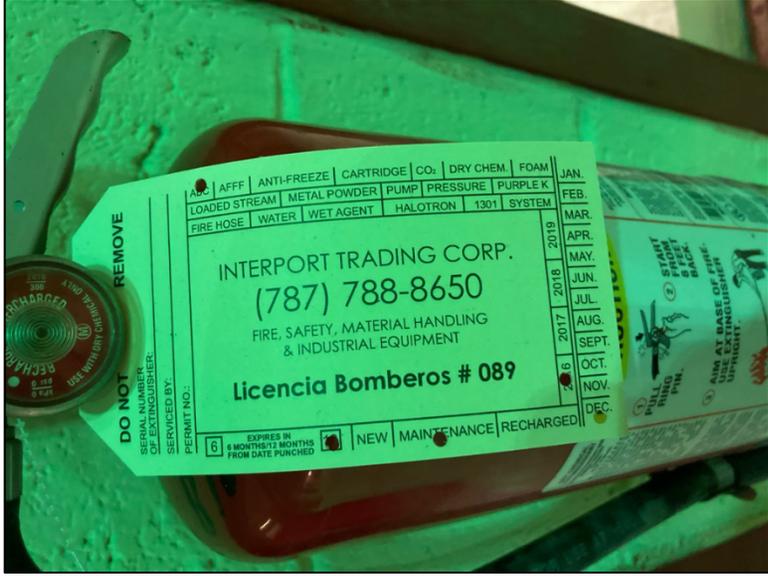
General housekeeping around the site was excellent. Areas between buildings and along the fence line were free of trash. Except for vegetation damage from the 2017 hurricanes, the landscaping was well maintained. Inspectors observed that some fire extinguishers had expired (PL-11).

PL-11. Expired Fire Extinguisher Inspection Card

All fire extinguishers should be inspected.

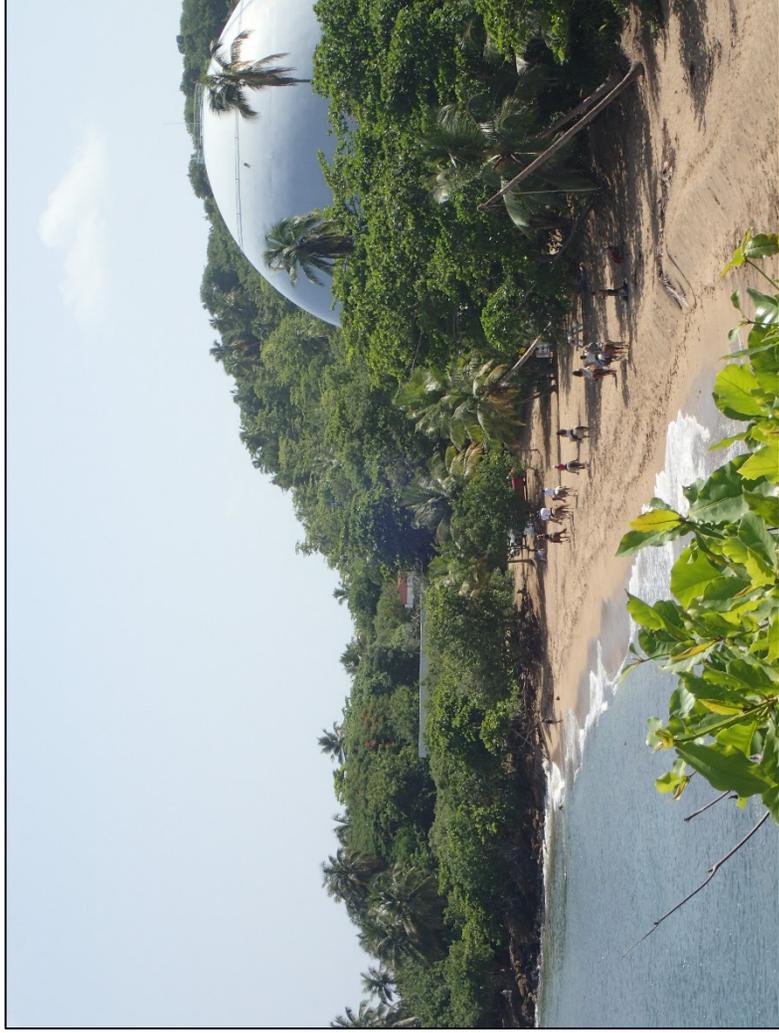
The retaining wall on the west side of the facility, near the beach, has significantly deteriorated since the 2019 inspection. Storm drains leading from the site were found to be clear and free of debris. The beach west of the facility is readily utilized by the public (PL-12).

PL-12. View from Lighthouse, Horses on Beach
