**2022 Annual Land-Use Covenant
Inspection Report
for DOE Areas at the
Laboratory for Energy-Related
Health Research/Old Campus
Landfill Superfund Site
University of California, Davis**

January 2023

U.S. DEPARTMENT OF
ENERGY

Legacy
Management

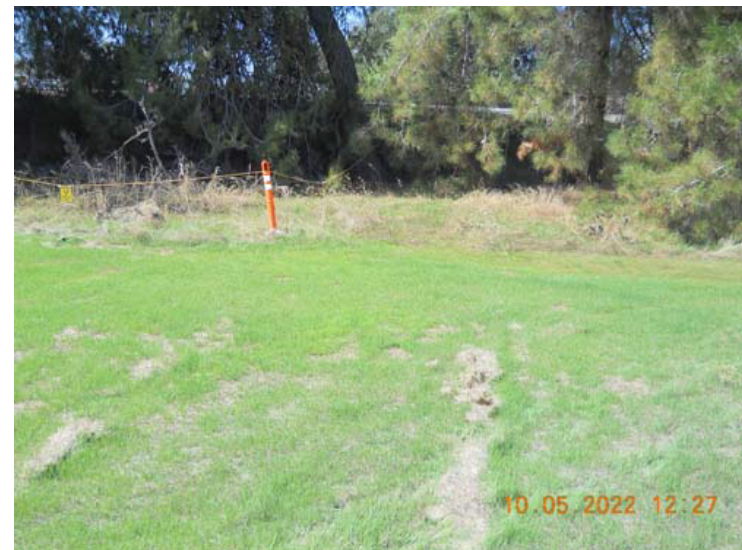
On October 5, 2022, DOE replaced the signage in the area surrounding the fallen limbs from two Aleppo pine trees in the SWT Area (specimens 16219 and 16220), one Aleppo pine tree in the EDPs Area (specimen 16236), and one Elderberry shrub in the EDPs Area (specimen 16233) (see Appendix E2 for locations). These limbs had fallen during a wind event on January 26 and 27, 2021 (UC Davis 2021). The area surrounding the fallen limbs has been posted as a radiologically

View West from Center of SWT Area; Tree 16220 Fallen Limbs Behind Stanchion, Posting, and Rope in Upper Left of Photo (Photo No. 4765)

controlled area and the limbs are being stored onsite until a disposal or reuse plan is approved by DOE, EPA, DTSC, and the California Regional Water Quality Control Board.

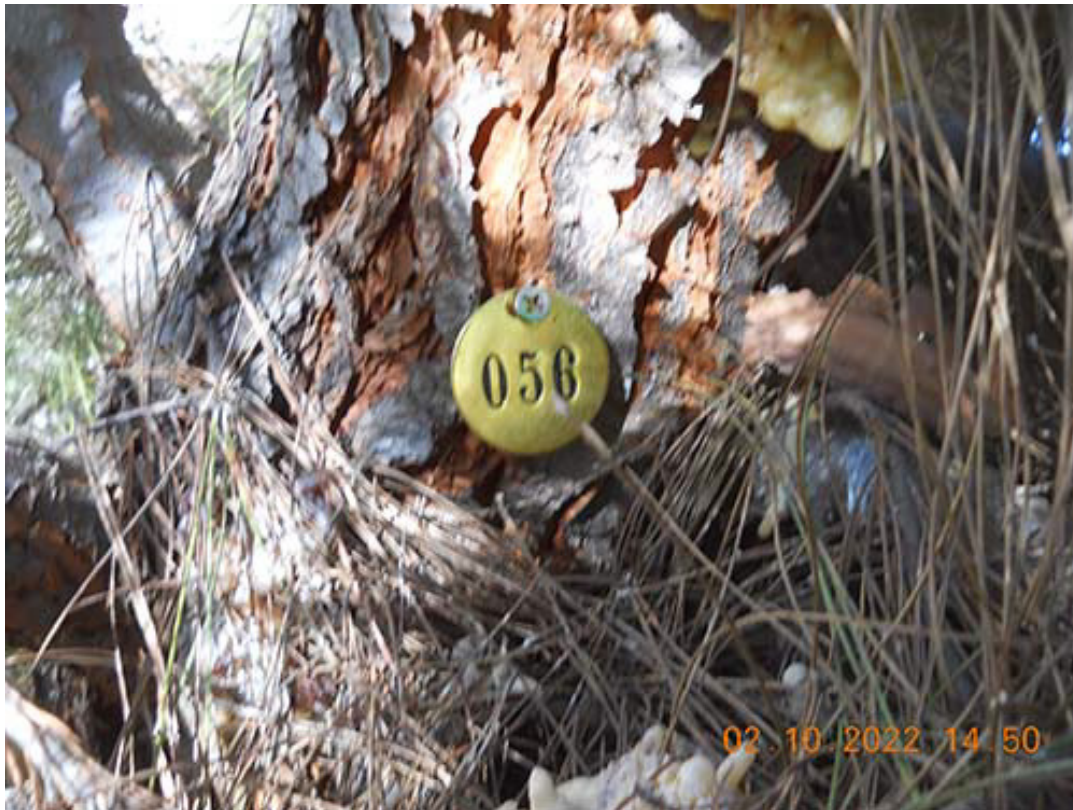
Sapling in SWT Area: New Tag Installed (Photo No. 4686)

Maintenance Item	Date Identified	Description of Completed or Planned Repair	Date Completed	Completion Photo No.
Sapling in SWT Area: No tag	11/4/2021	Repair completed: New tag installed	2/10/2022	4686
Tree 16210: Missing tag	11/4/2021	Repair completed: New tag installed	2/10/2022	4685
Well UCD1-072: Vault lid bolt hole threads worn off; well vault bolt hole flanges ruptured on 10/6/2022	11/3/2021, 10/6/2022	Initial repair failed: Well vault bolt hole flanges ruptured upon attempt to install new bolts Revised repair planned: Install new well vault flange ring	TBD	NA
Well UCD1-013: Water level port plug missing	11/3/2021	Repair completed: Installed new plug	10/6/2022	4844
Well UCD1-018: Water level and pump port plugs missing	11/4/2021	Repair completed: Installed pump manufacturer's waterproof cap	10/6/2022	4909
Well UCD1-023: Pump port plugs missing	11/3/2021	Repair completed: Installed pump manufacturer's waterproof cap	10/6/2022	4826

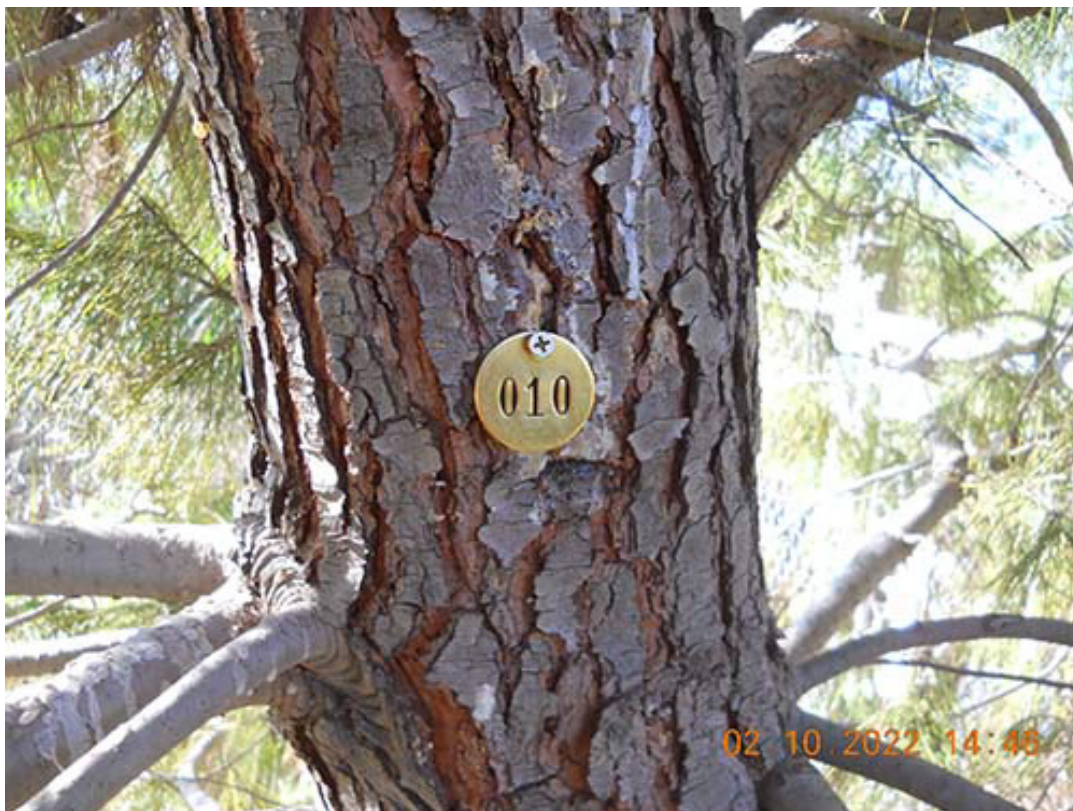
Tree 16210: New Tag Installed (Photo No. 4685)

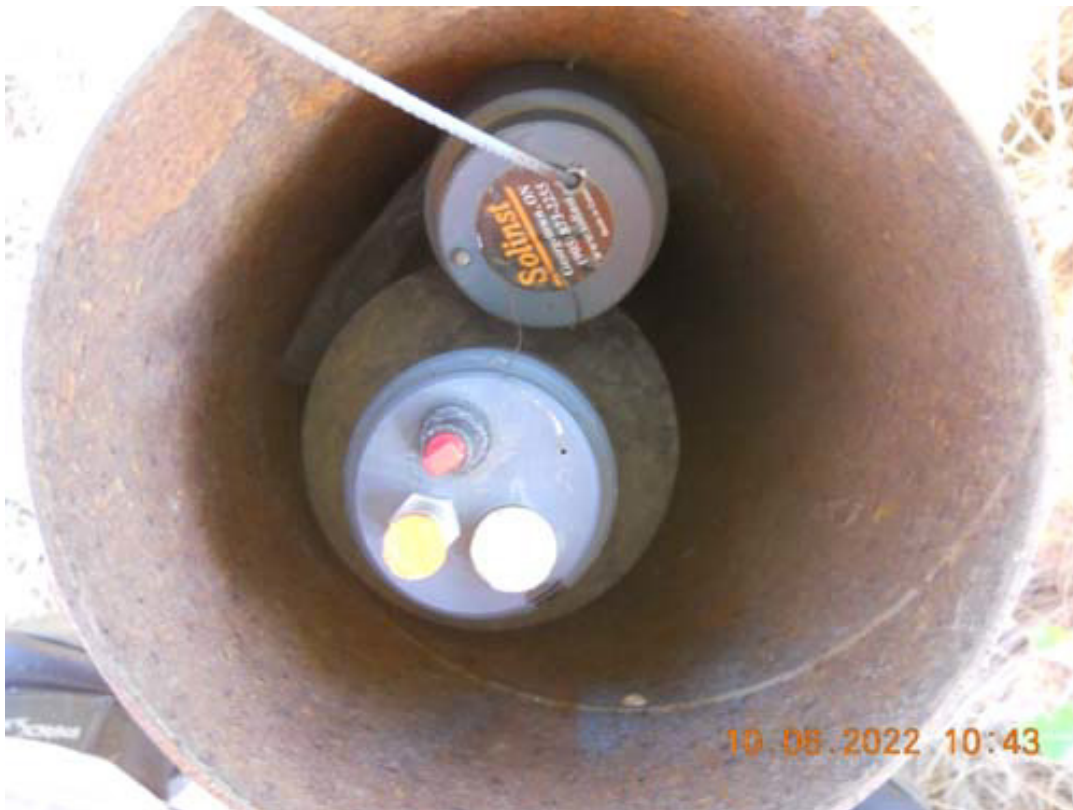
Well UCD1-013: New Water Level Port Plug Installed (Photo No. 4844)

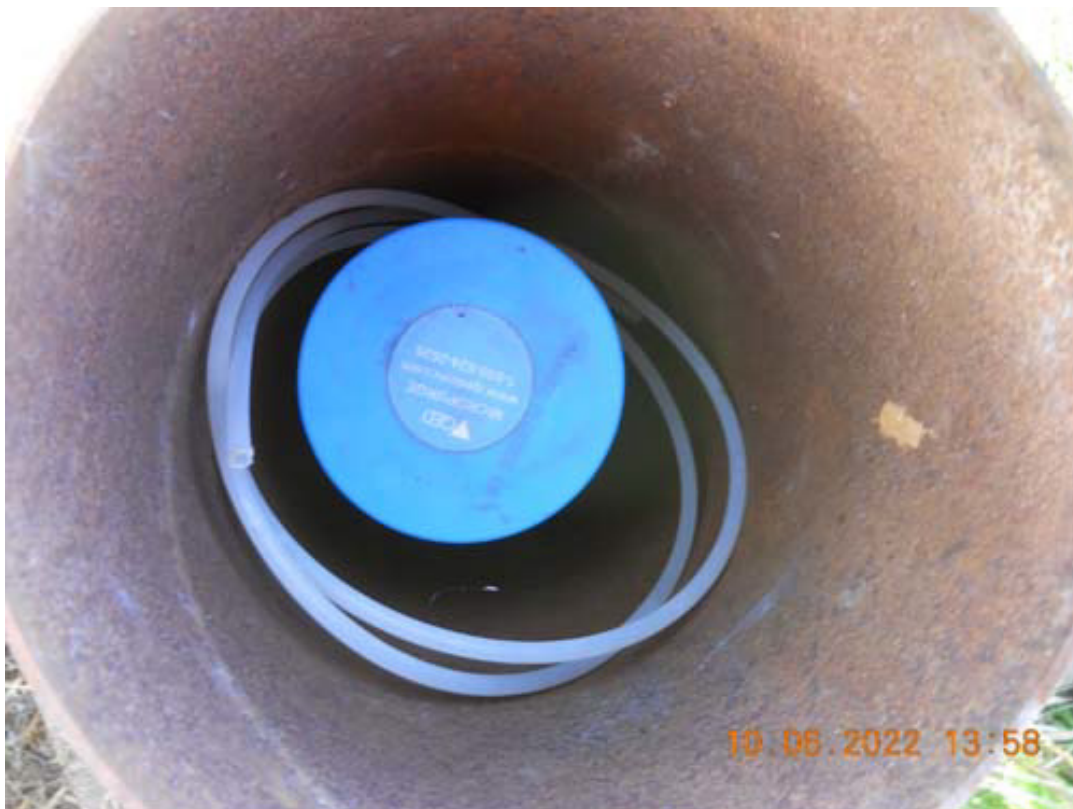
Well UCD1-018: Pump Manufacturer's Waterproof Cap Installed (Photo No. 4909)

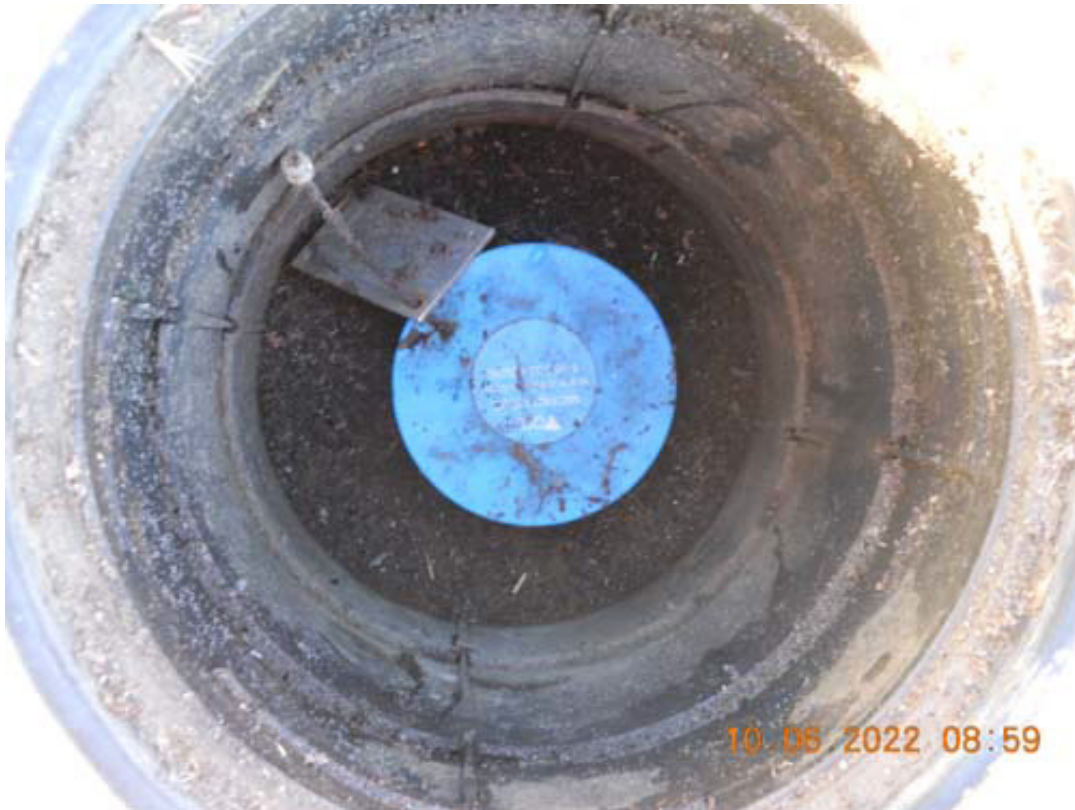
Well UCD1-023: Pump Manufacturer's Waterproof Cap Installed (Photo No. 4826)

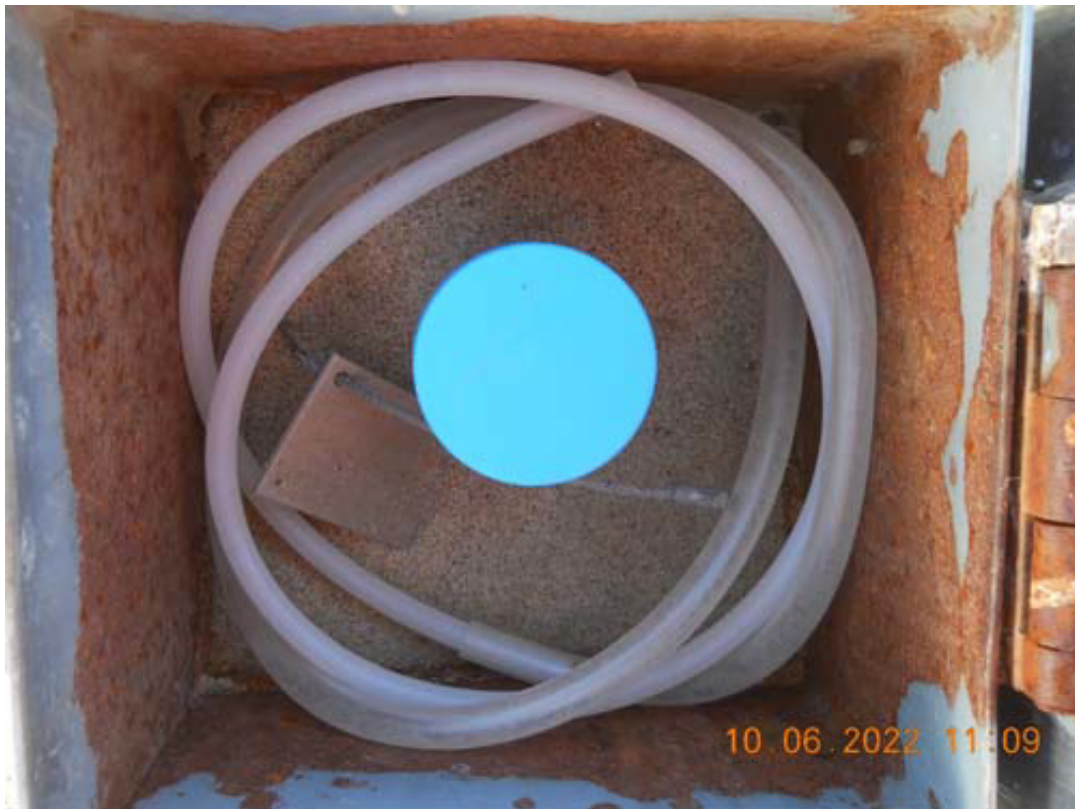
Well UCD1-063: Pump Manufacturer's Waterproof Cap Installed (Photo No. 4853)

Well UCD1-063: Water level and pump port plugs missing	11/4/2021	Repair completed: Installed pump manufacturer's waterproof cap	10/6/2022	4853
Well UCD1-070: Water level and pump port plugs missing	11/3/2021	Repair completed: Installed pump manufacturer's waterproof cap	10/6/2022	4848
Well UCD1-072: Water level and pump port plugs missing	11/3/2021	Repair completed: Installed pump manufacturer's waterproof cap	10/6/2022	4832
Well UCD1-021: Asphalt roadway receding around concrete apron at well head	10/6/2022	Repair planned: Patch asphalt surrounding concrete apron	TBD	NA
Well UCD1-068: Crack in concrete apron at well head	10/6/2022	Repair planned: Patch crack in concrete apron	TBD	NA
Wells UCD1-021, -054, -068, -069, -071, -072: Well vault maintenance to prevent storm water entry	10/6/2022	Repair planned: Clean seal surfaces, replace seals, and install washers and seals on bolts	TBD	NA

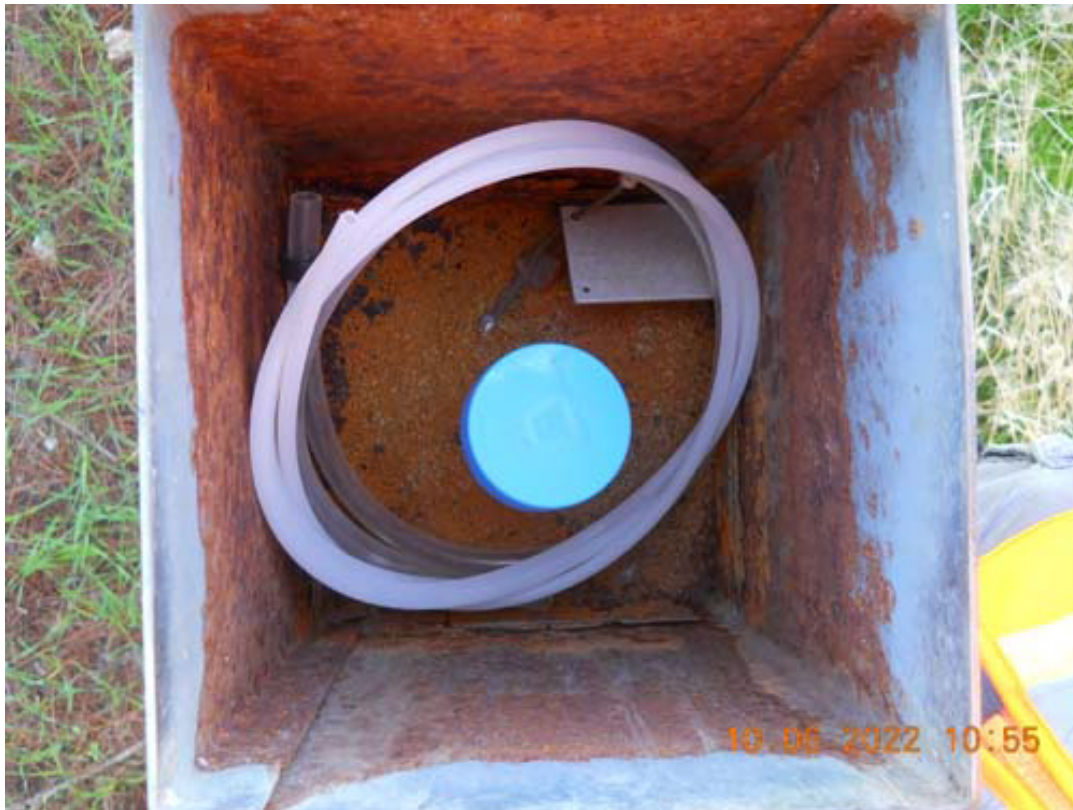
Well UCD1-070: Pump Manufacturer's Waterproof Cap Installed (Photo No. 4848)

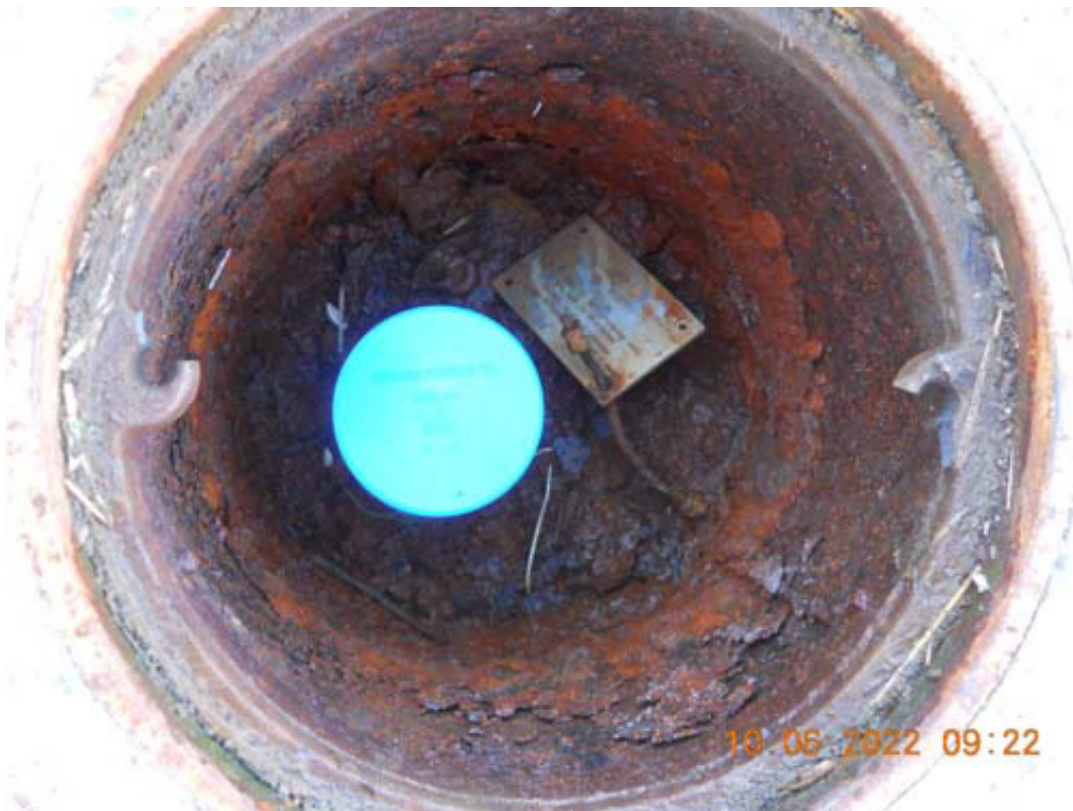
Well UCD1-072: Pump Manufacturer's Waterproof Cap Installed (Photo No. 4832)
