1.0 Ambrosia Lake, New Mexico, Disposal Site

1.1 Compliance Summary

The Ambrosia Lake, New Mexico, Uranium Mill Tailings Radiation Control Act (UMTRCA) Title I Disposal Site was inspected on August 27, 2008. The disposal cell and all associated surface water diversion and drainage structures were in excellent condition and functioning as designed. The site access road, owned by Rio Algom Mining LLC (Rio Algom), was temporarily realigned in 2006 to allow for construction of a waste haul road; waste hauling operations are complete, and the site access road is scheduled for restoration in 2009. Slight settlement may be recurring at a location on the cell cover that was repaired in 2005; this location will continue to be monitored. No maintenance needs or cause for a follow-up or contingency inspection were identified.

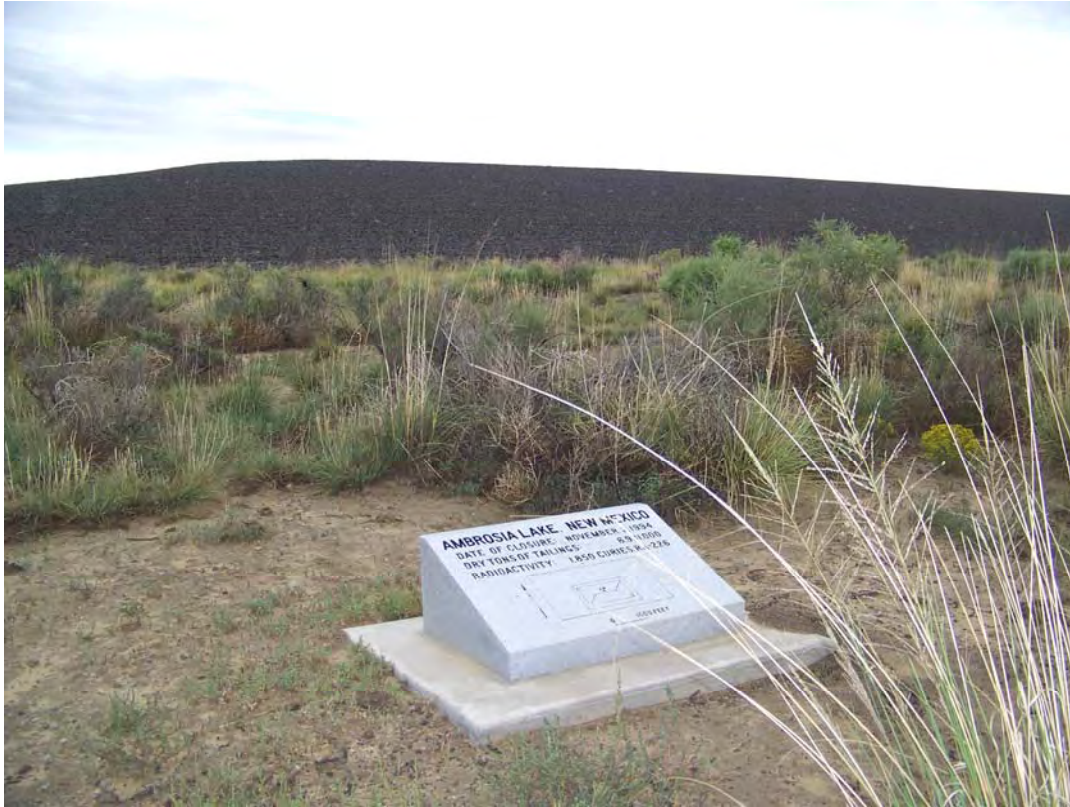
Site Markers, and Survey and Boundary Monuments—The two granite site markers (PL–1), three combined survey and boundary monuments (PL–2), and five additional boundary monuments were all undisturbed and in excellent condition.

AMB 8/2008. PL-1. Site marker SMK-1.

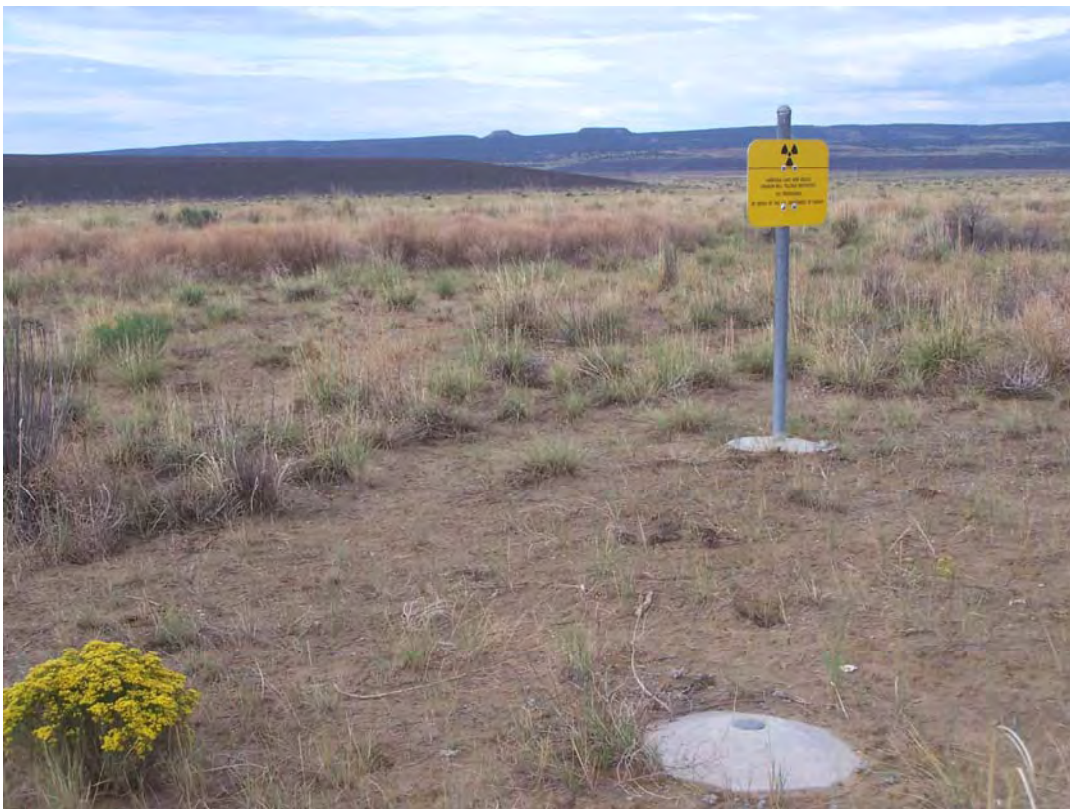
AMB 8/2008. PL-2. View southwest from combined survey/boundary monument BM-3.

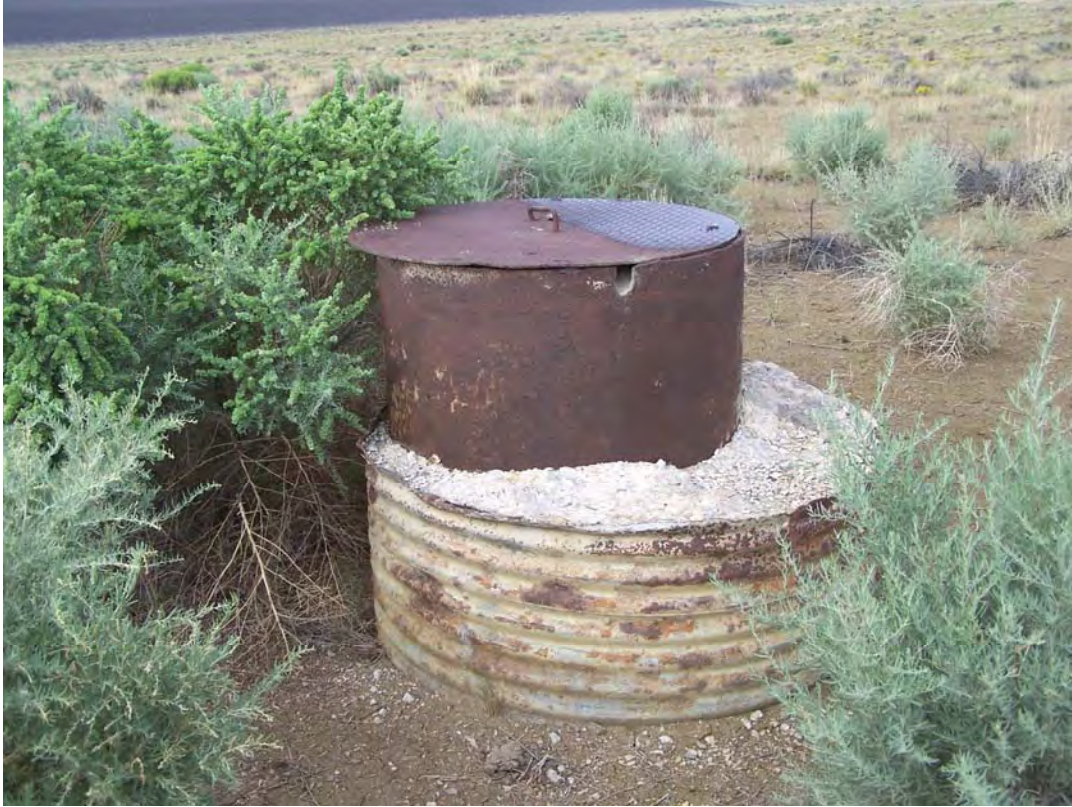
Mine Vents—One mine vent shaft, associated with abandoned underground mines, is within the site boundary in the northern portion of the site; a second vent shaft lies just outside the site boundary in the southwest corner. The vents have casings that rise approximately 3 feet above the ground and were secure at the time of the inspection. The mine vent north of the disposal cell has a spot-welded cover (PL–3), and the other vent located just outside the southwest corner of the site has a bolted-on cover. The vents were secure at the time of the inspection.

AMB 8/2008. PL-3. Concrete-filled vent shaft cover.

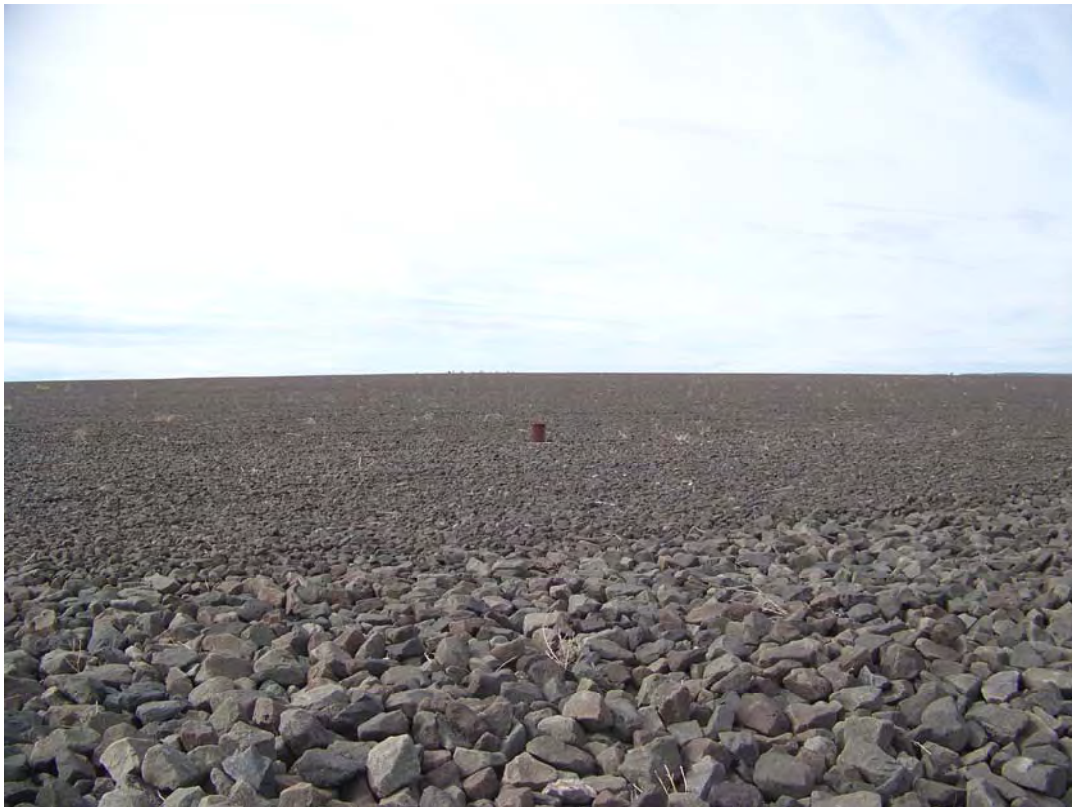
1A Top of Disposal Cell—The 91-acre disposal cell was completed in 1994. The basalt riprap-covered top of the disposal cell was in good condition. There was no evidence of cracking, slumping, or erosion. In August 2005, repairs were made to a shallow depression in the cell cover around settlement plate SP-4. Surveys of the settlement plates in 2005, 2006, and 2007 indicated no change in the surface elevations. However, visual observations during the 2008 inspection indicated that slight settlement may be recurring at SP-4 (PL-4). This location will continue to be visually monitored.

A shallow depression around settlement plate SP-4, near the northeast corner of the disposal cell cover, was first noted during the 1997 inspection and continued to grow in depth and area in subsequent years. The depression was repaired in August 2005. Surveys of the eight settlement plates were conducted in September 2005, September 2006, and September 2007 to monitor for continued settlement at SP-4. The surveys indicated no significant changes at the repaired location. Although apparently slight settlement was observed in 2008, additional surveys will be conducted only if significant settlement is observed.

AMB 8/2008. PL-4. Repaired surface at settlement plate SP-4.

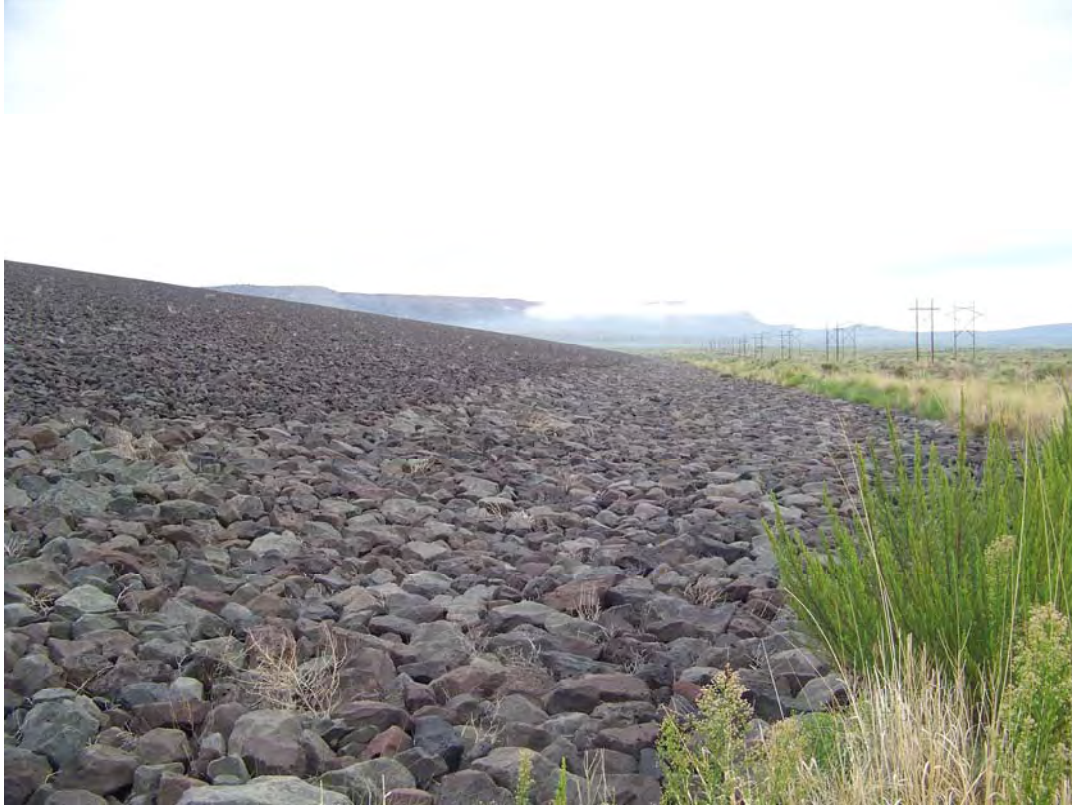
Side Slopes and Apron—The basalt riprap-covered side slopes and apron were in excellent condition and showed no evidence of cracking, settling, slumping, or erosion (PL-5). Desiccation cracks occur in the clay-rich backfill soil parallel to the apron along the south side of the cell. The cracks do not pose a threat to the disposal cell.

AMB 8/2008. PL-5. View east along the south side slope and apron.
