2022 Annual Inspection Report for the Parkersburg, West Virginia, Disposal Site

January 2023

U.S. DEPARTMENT OF
ENERGY

Legacy
Management

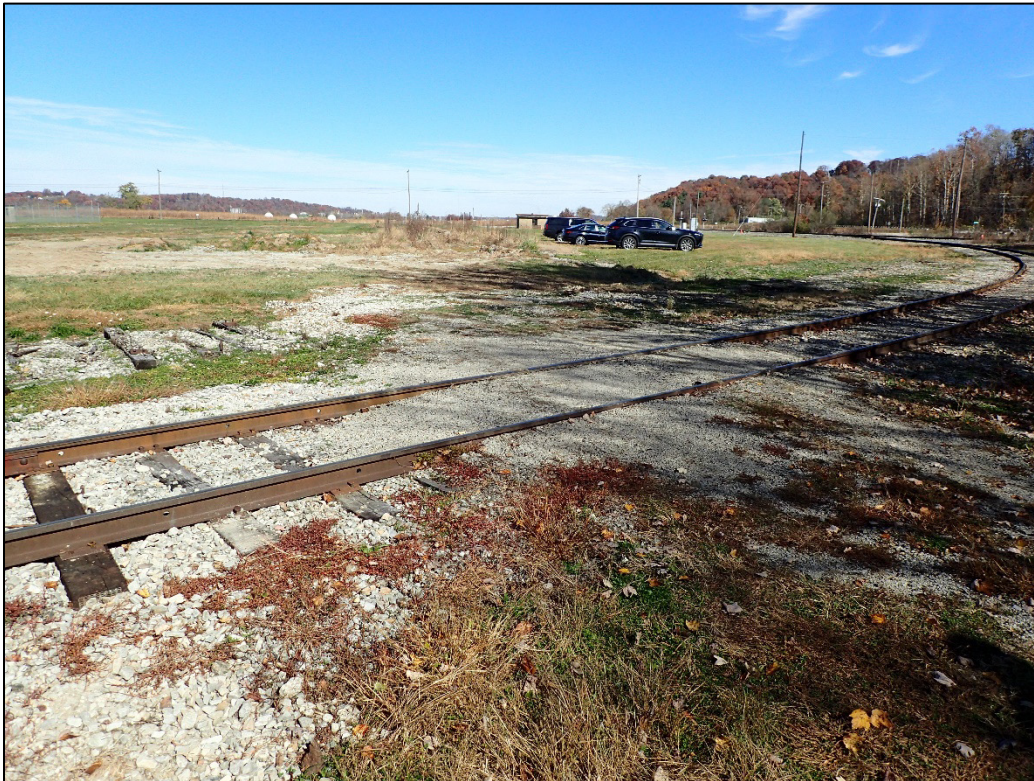
A Northwest Pipe Company rail spur that crosses the site right-of-way was replaced in 2016. Northwest Pipe Company maintains a gravel crossing where the rail spur crosses the site right-of-way to provide vehicle access to the site. The gravel crossing was found to be well maintained (PL-1).

PL-1. Railroad Tracks Across Site Access Right-of-Way

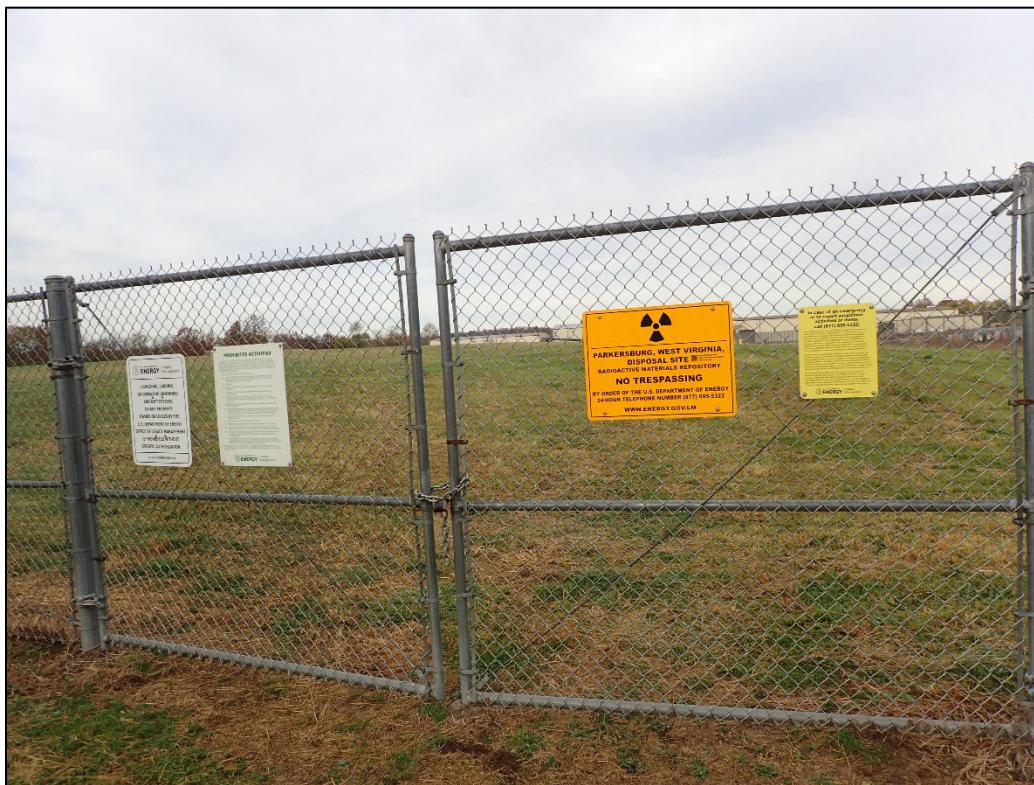
All entrance gates were properly secured (PL-2).

PL-2. Main Vehicle Entrance Gate

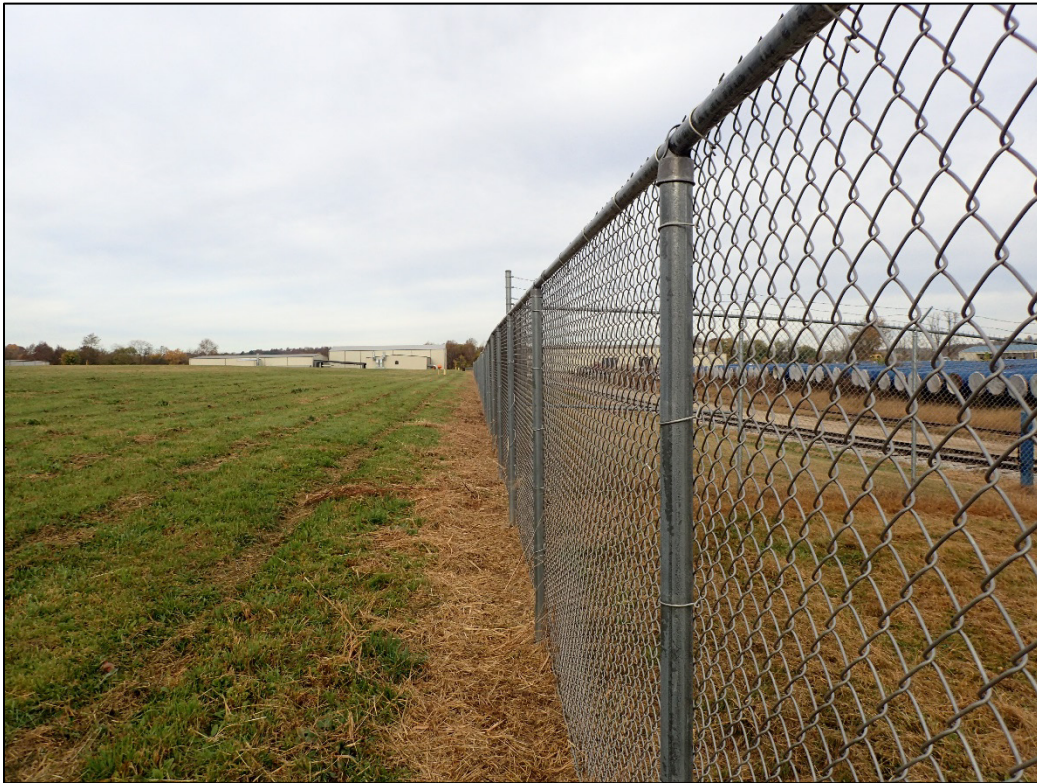
The perimeter fence was replaced in 2007. The site maintenance subcontractor maintains a vegetation-free zone along the base of the fence line and ensures that vegetation does not grow on the fence fabric. The vegetation-free zone along the fence line was being maintained (PL-3), and the fence fabric was free of vegetation.

PL-3. Looking Northwest Down North Fence Line

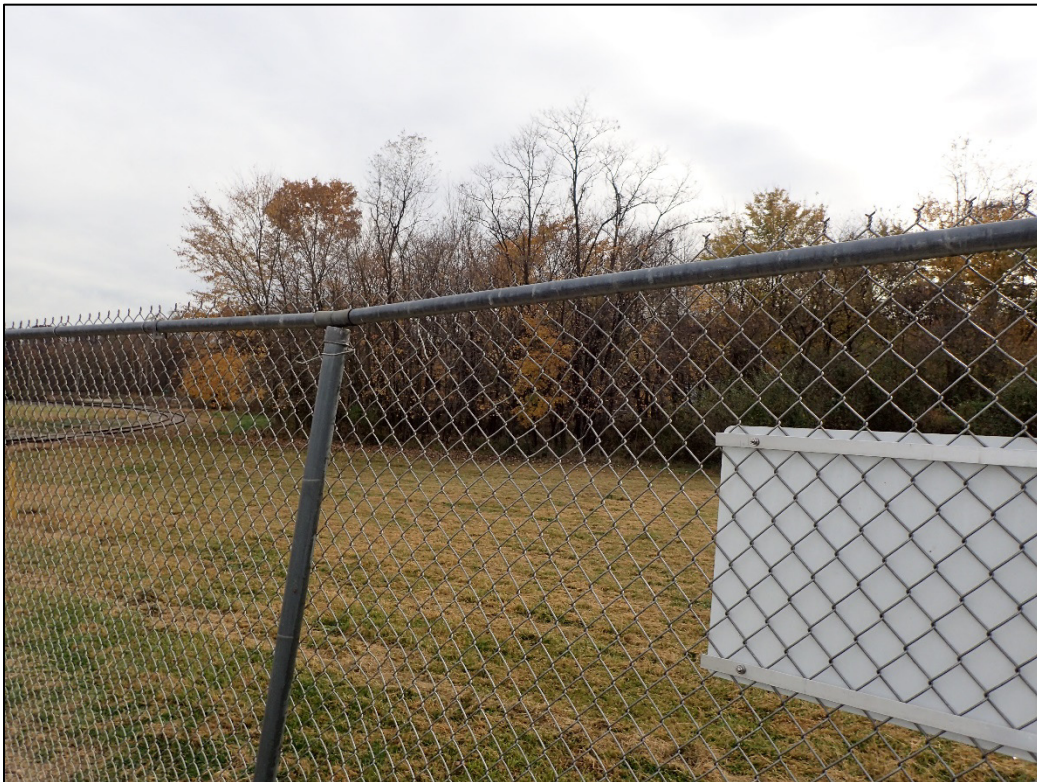
It appears that something ran into the fence in 2020 causing one of the vertical posts to lean slightly. The fence remains serviceable; no action is needed to repair the damage (PL-4).

PL-4. Leaning Fence Post of Perimeter Fence

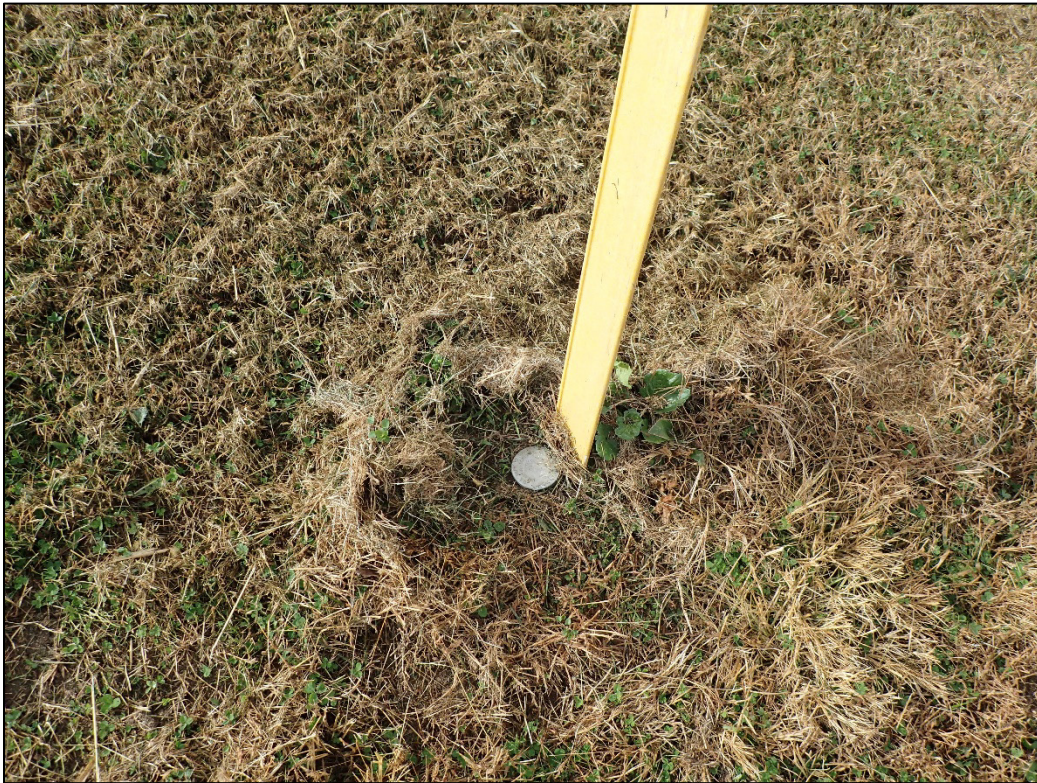
All boundary monuments were located during the inspection (PL-5). Boundary monument BM-3 is about 6 inches beneath ground surface. A 6-inch section of PVC pipe was installed around the monument and filled with pea gravel to make it flush with the ground surface (PL-6).

PL-5. Boundary Monument BM-2

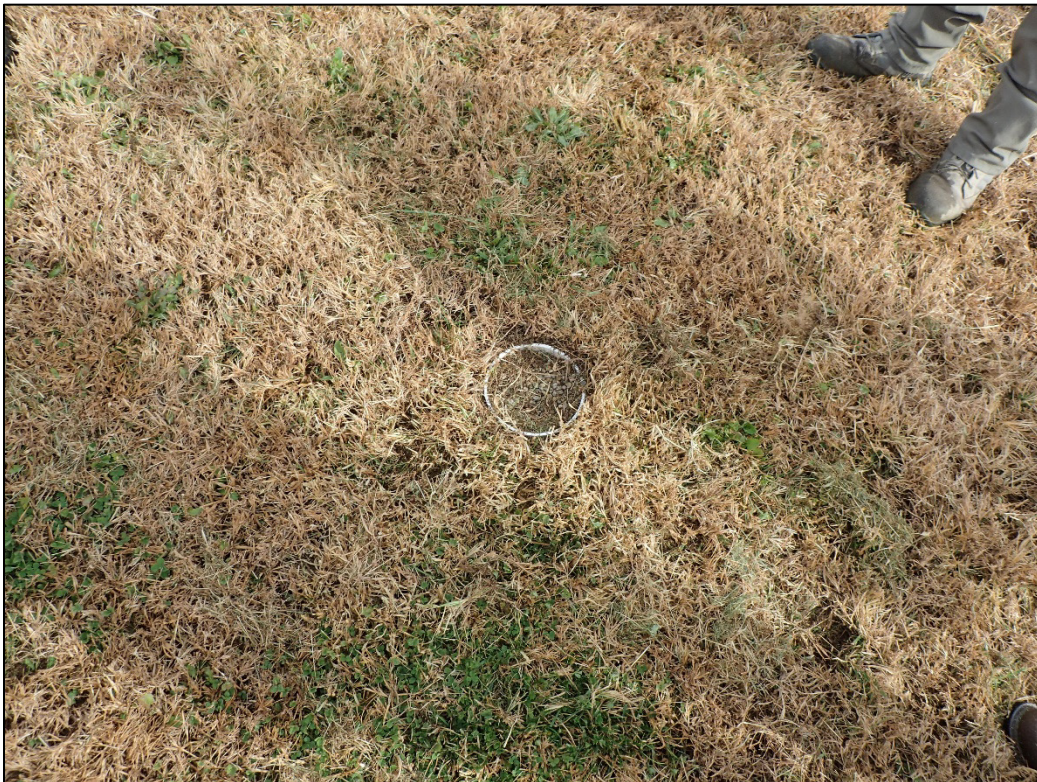
PL-6. Top of PVC Pipe Marking Boundary Monument BM-3

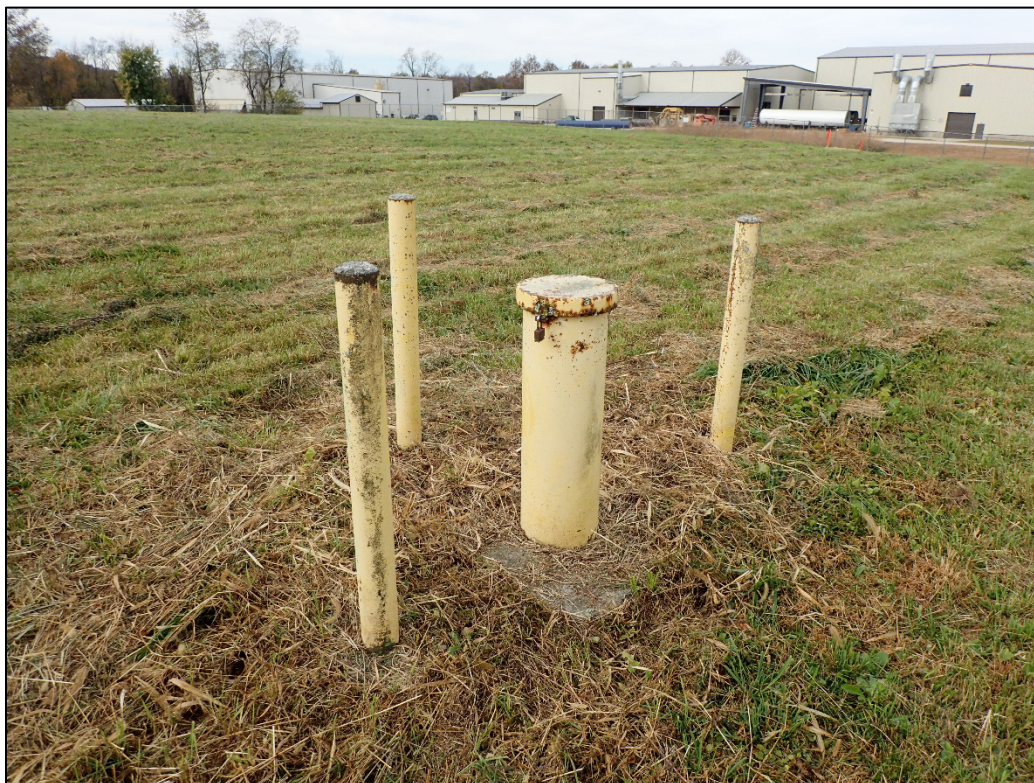
There are six groundwater monitoring wells at the Parkersburg site. All six wells are inside the security fence. The wells are numbered in the chronological order in which they were drilled and installed. All six wells were properly locked. The site maintenance subcontractor clears vegetation around the monitoring wells. Vegetation was being properly controlled around the monitoring wells (PL-7).

PL-7. Monitoring Well MW-5

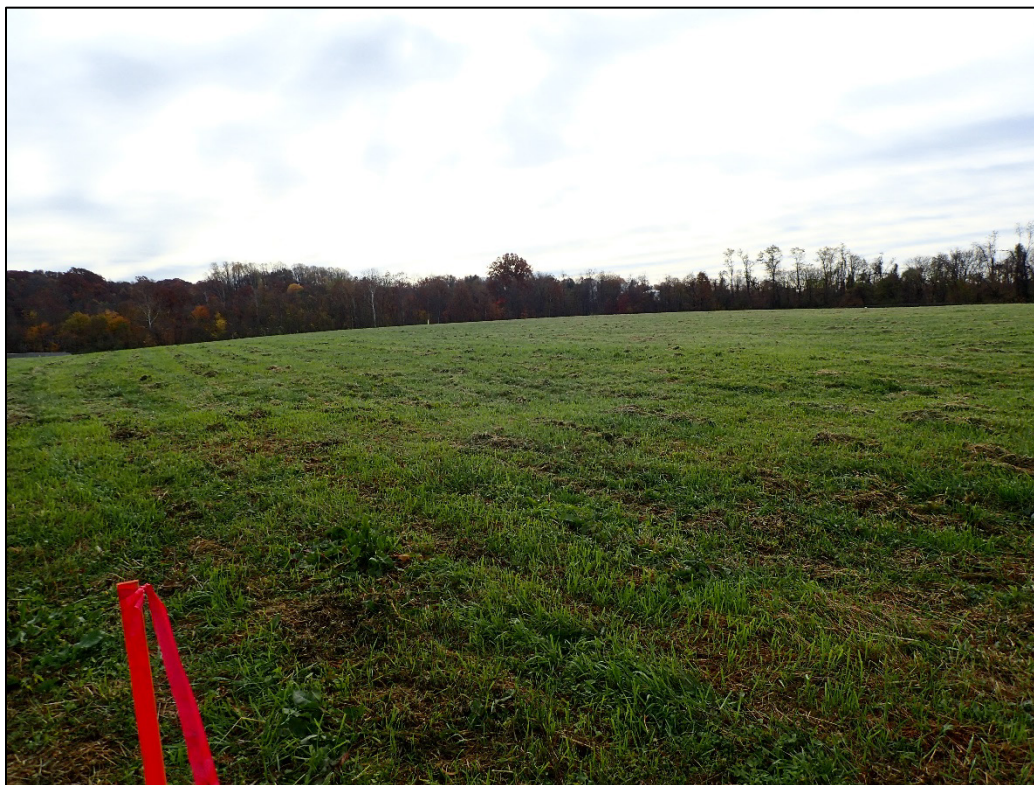
At the time of the inspection, vegetation on top of the disposal cell had been recently mowed. No evidence of erosion or slope instability on the disposal cell was noted during the inspection (PL-8).

PL-8. Looking South Across Top of Disposal Cell

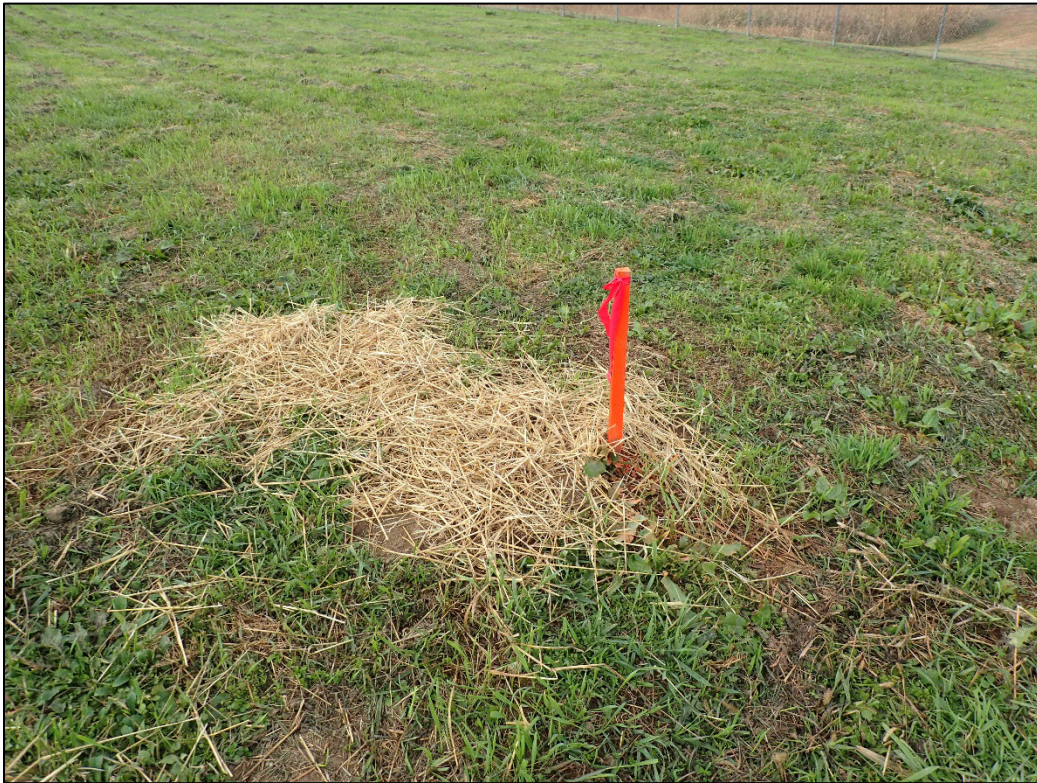
Animal burrowing activity at the site continues. In 2021, 2 weeks of trap-and-release were conducted to humanely remove two groundhogs from the site. Existing burrows were collapsed, filled with clean soil, and reseeded. Additional burrows were collapsed, filled with clean soil, and reseeded in 2022 (PL-9). Also, in 2022, a coyote den was found and collapsed. During the site inspection, new additional animal burrows were discovered. Their locations are identified on the site map. These new burrows will be collapsed, filled with clean soil, and reseeded as deemed appropriate. Inspectors also noted that some of the recently collapsed burrows showed signs of new animal activity, indicating that another round of trap-and-release is needed.

PL-9. Collapsed and Repaired Animal Burrow

LM needs to be vigilant about addressing animal burrows on the disposal cell. As burrows are located, they need to be collapsed, filled with clean soil, and reseeded. Additional rounds of trap-and-release will be needed as long as animal burrow activity is observed at the site.

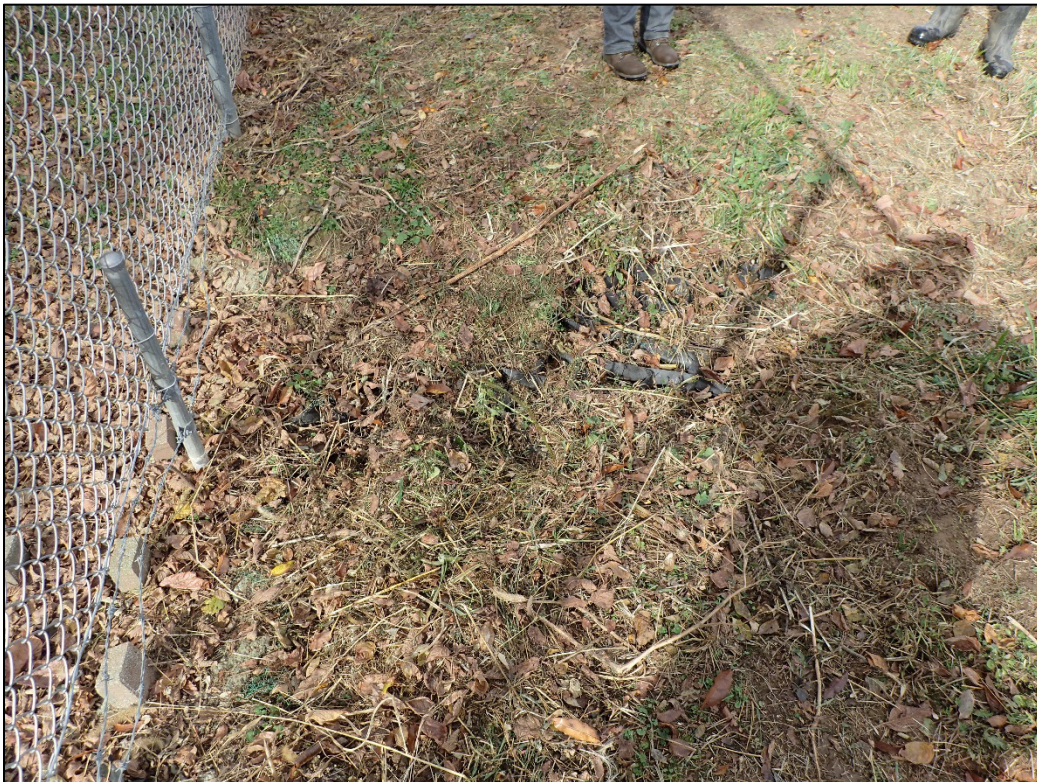
The drainage channel in the southwest corner of the site, lined with high-density polyethylene honeycomb baffles and brick energy-dissipation baffles in August 1996, is functioning as designed. Erosion in the channel appears to be unchanged from 2021 (PL-10).

PL-10. Erosion Control Area
