# **Rocky Flats Site, Colorado, Quarterly Report of Site Surveillance and Maintenance Activities, First Quarter, Calendar Year 2023**

**July 2023**

**U.S. DEPARTMENT OF  
ENERGY**

Legacy  
Management

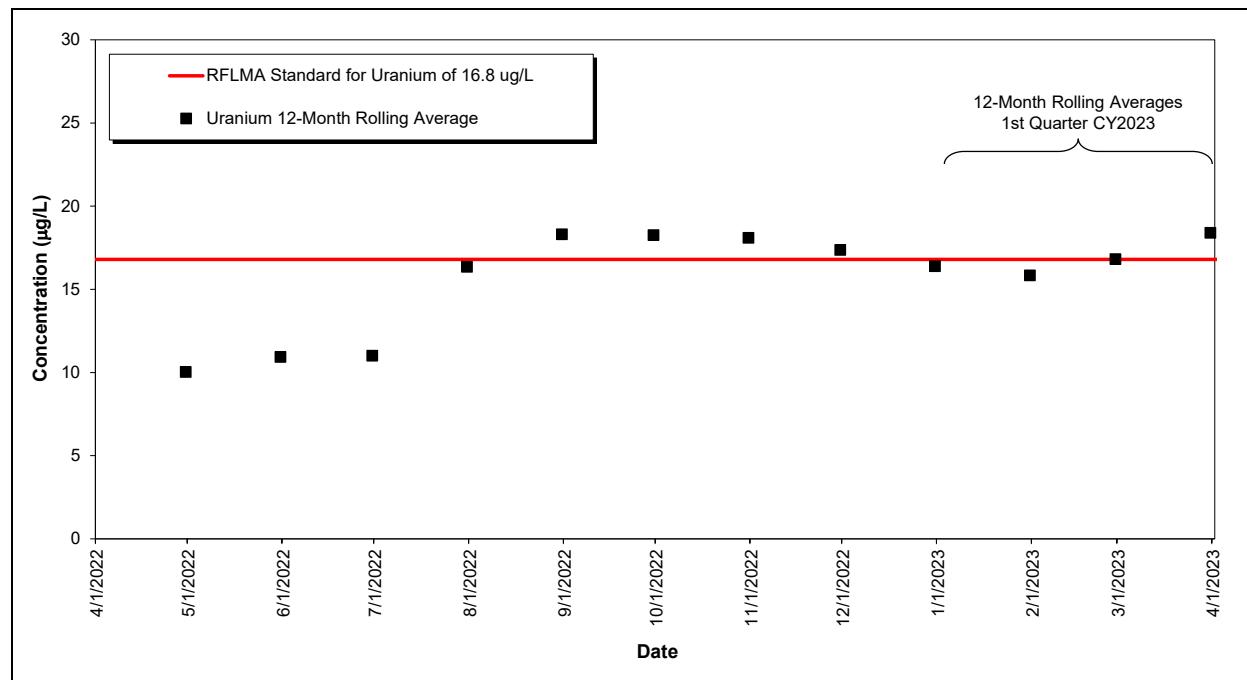
*Figure 13. Volume-Weighted 12-Month Rolling Average Uranium Concentrations at GS10: Year Ending First Quarter 2023*

A reportable condition at POE GS10 for the uranium 12-month rolling average was determined upon receipt of recently validated analytical results. Validated results were received on May 9, 2023, with formal notification to regulators and stakeholders made on May 17, 2023. The RFLMA Parties (DOE, CDPHE, and EPA) held a consultation regarding this reportable condition on June 8, 2023. Once finalized, the plan and path forward will be described in a contact record that will be posted on the Rocky Flats website. See Section 3.1.3.1 for a detailed discussion.

Figure 13 shows a reportable condition at GS10 for the uranium 12-month rolling average starting on March 31, 2023. This reportable condition was determined upon receipt of validated analytical results for uranium from the composite sample collected during the period January 23, 2023, to April 10, 2023; the uranium concentration was 24.9 micrograms per liter ( $\mu\text{g}/\text{L}$ ). Validated results were received on May 9, 2023. Formal notification to regulators and stakeholders was made on May 17, 2023.

The RFLMA Parties (DOE, CDPHE, and EPA) held a consultation regarding this reportable condition on June 8, 2023. Once finalized, the plan and path forward will be described in a contact record that will be posted on the Rocky Flats website.

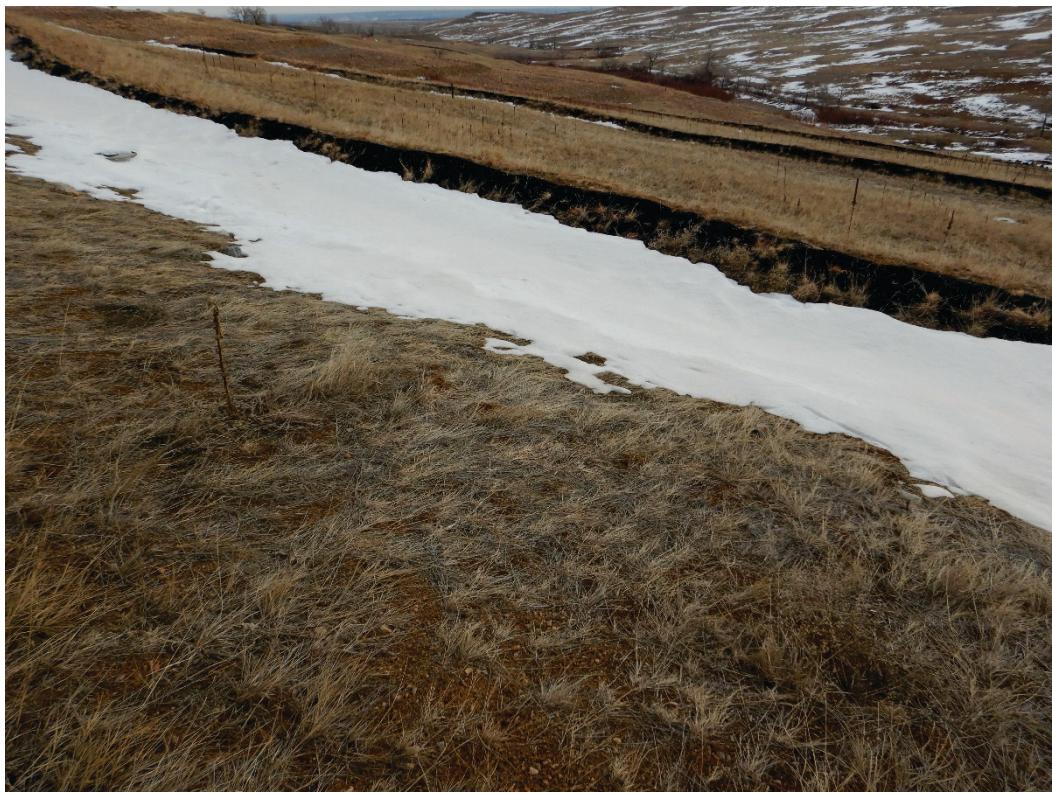
No issues were noted during the inspection. Snow remained in channels and shaded areas as a result of a December 28 snowstorm of approximately 9 inches. Berms 1–3 (**Figure 2**) and Berms 4–7 (**Figure 3**) were in good condition. The East Perimeter Channel (EPC) was in good condition (**Figure 4**). The West Perimeter Channel (WPC) was in good condition (**Figure 5**).

*Figure 2. Looking Southeast at Berms 1–3, Which Were in Good Condition*

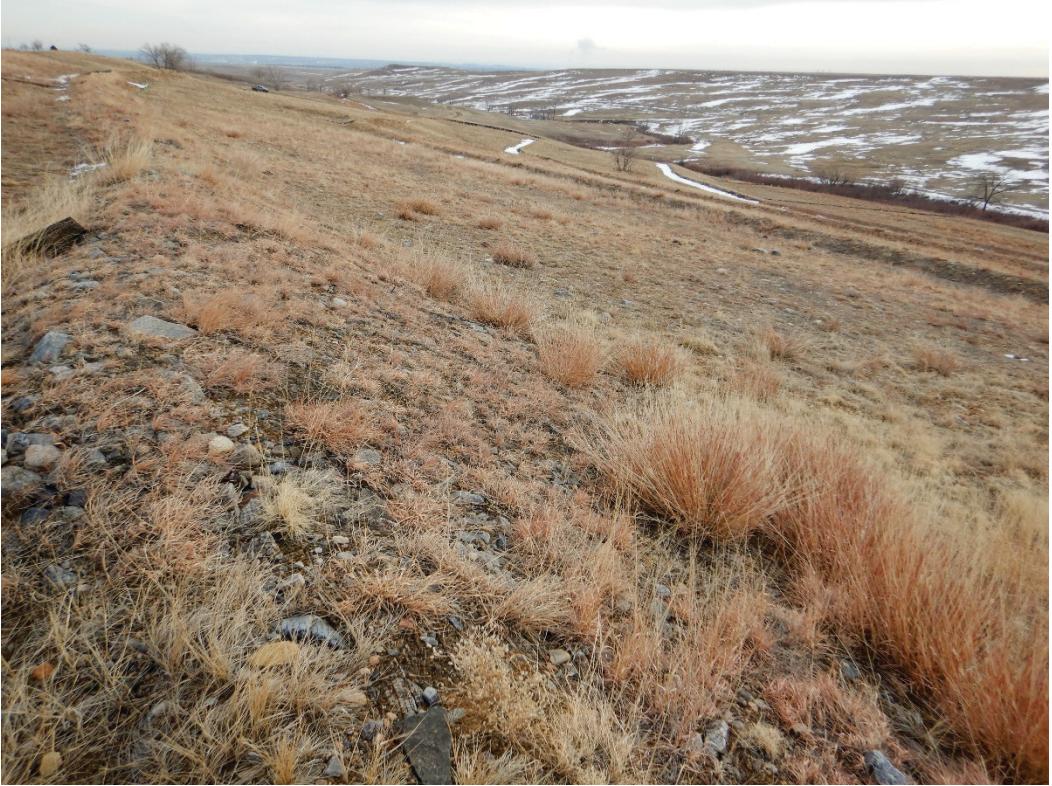
*Figure 3. Looking Southeast at Berms 4–7, Which Were in Good Condition*

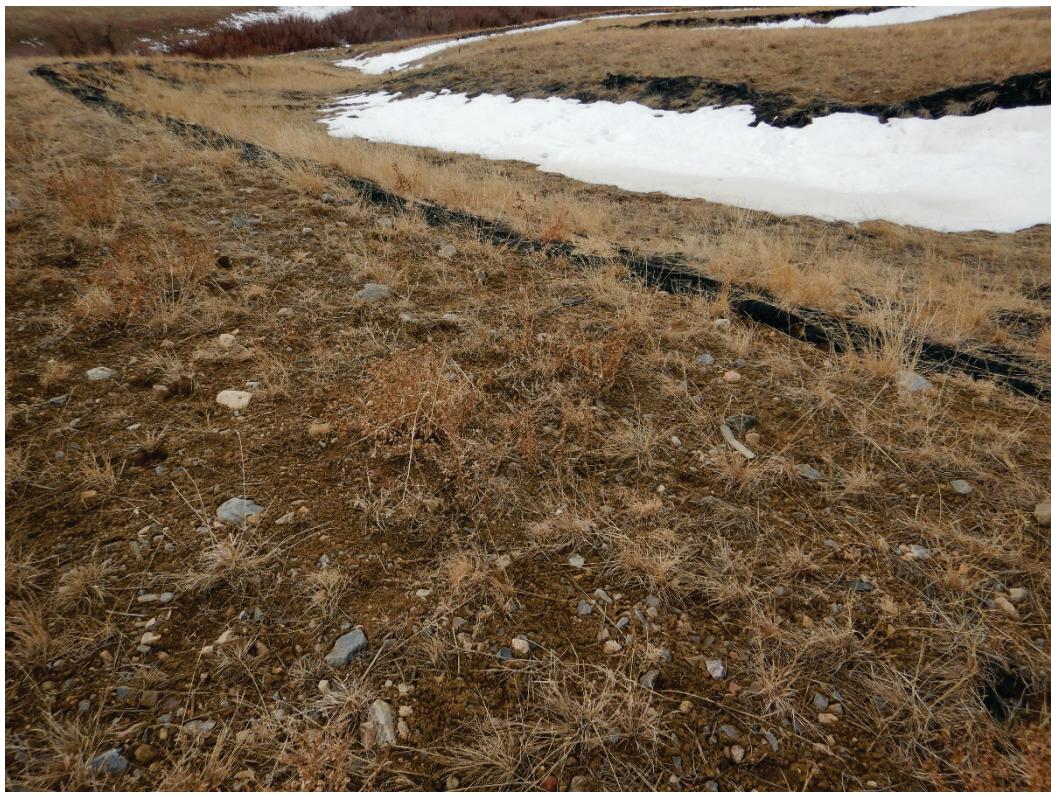
*Figure 4. Looking Southwest at the EPC, Which Was in Good Condition*

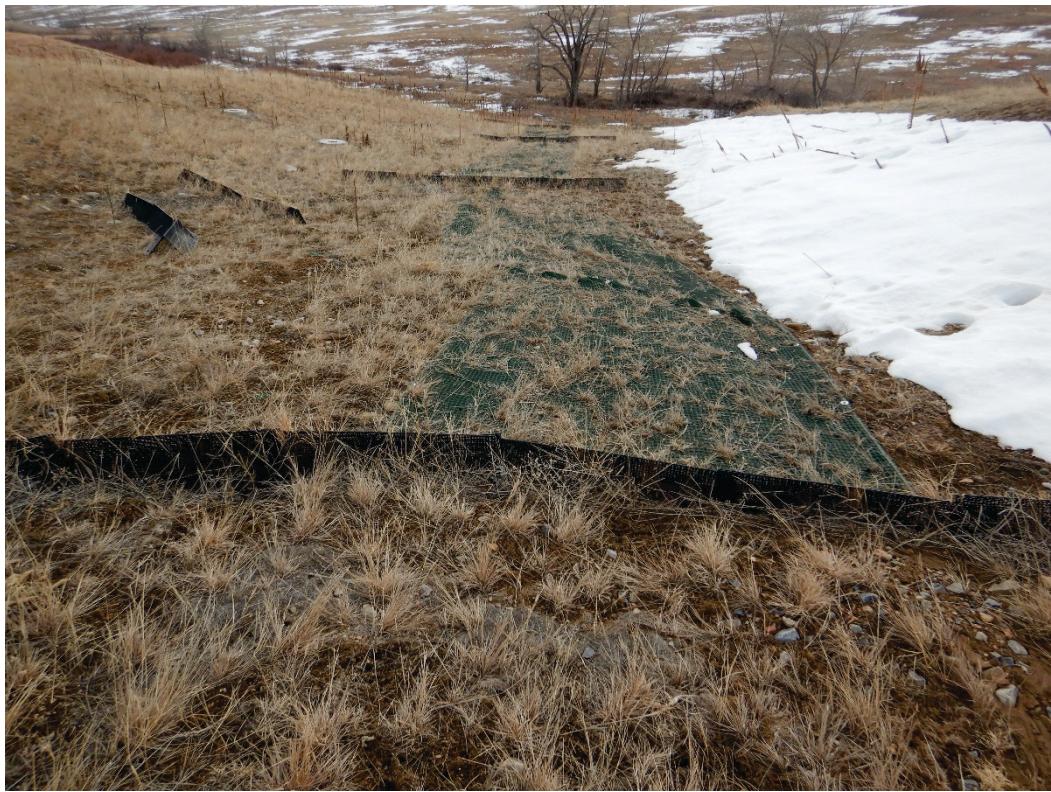
*Figure 5. Looking South-Southeast at the WPC, Which Was in Good Condition*

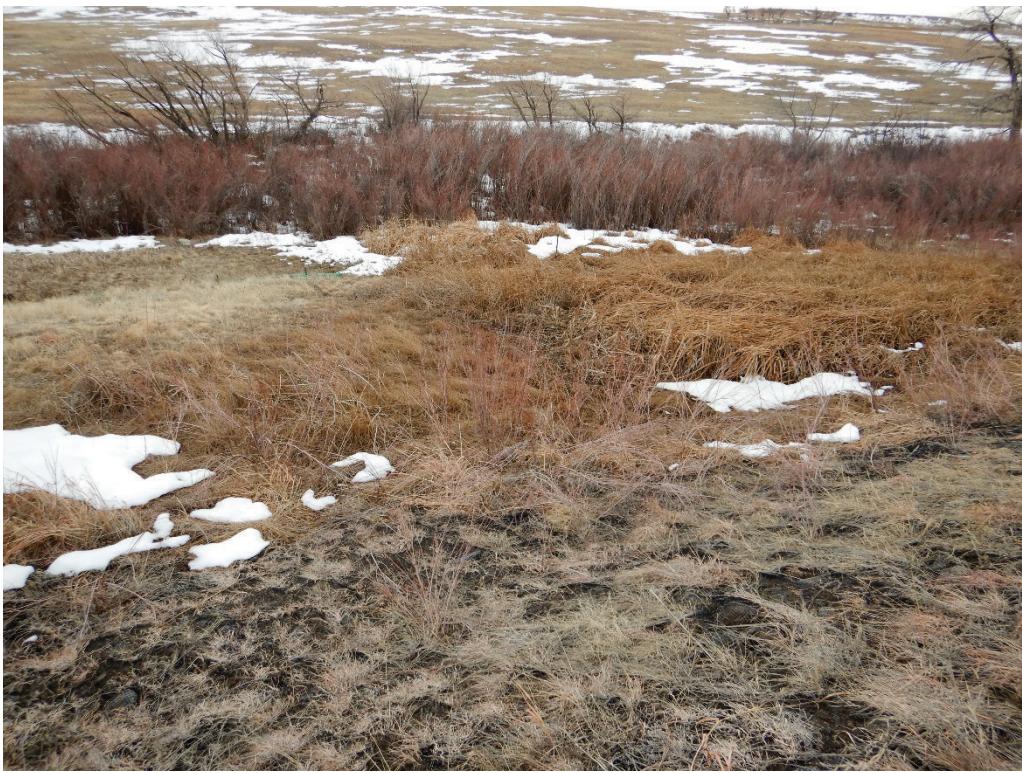
Figure 6. Looking South-Southwest at Seep 8 and the Surrounding Area, Which Had a Flow of Approximately 1 gpm

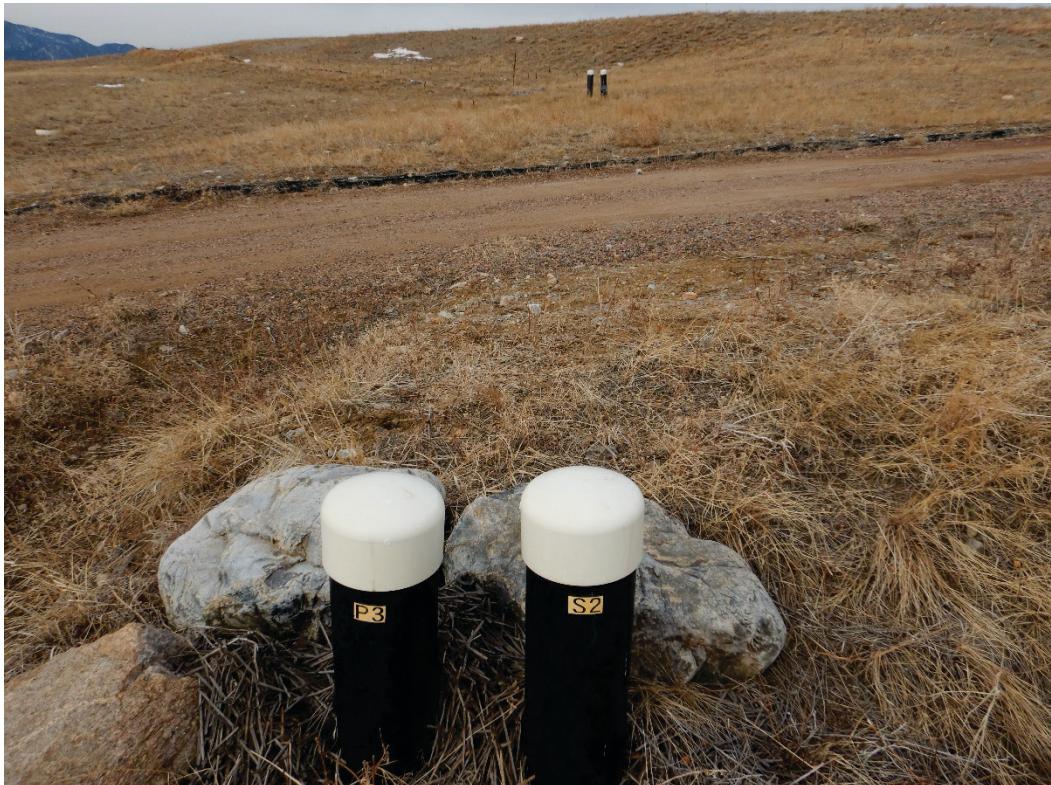
No issues were noted with the East Subsurface Drain (ESSD) (**Figure 7**). No issues were noted with the South Interceptor Ditch (SID) (**Figure 8**), which receives groundwater from the ESSD outfall and an interceptor drain on the eastern hillside. Flow rates could not be estimated due to snow cover.

Figure 7. Looking West-Northwest at the ESSD and the Surrounding Area, Which Was in Good Condition

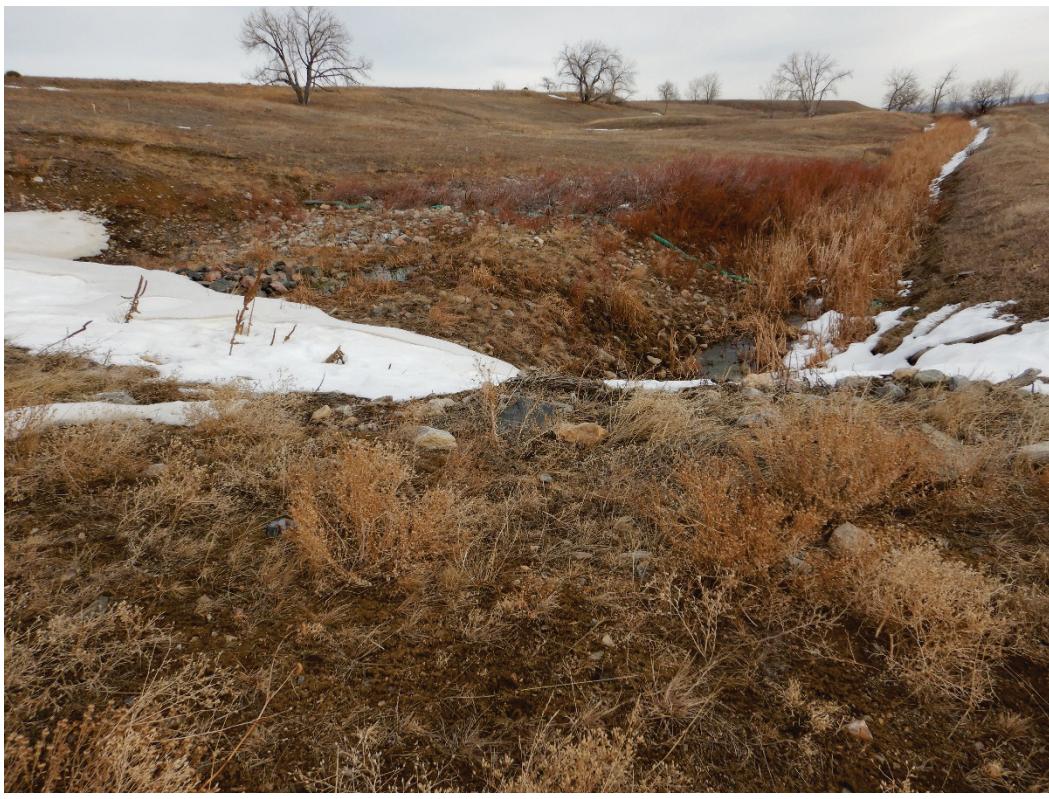
*Figure 8. Looking East-Northeast at the SID, Which Receives Groundwater from the ESSD Outfall and an Interceptor Drain on the Eastern Hillside*

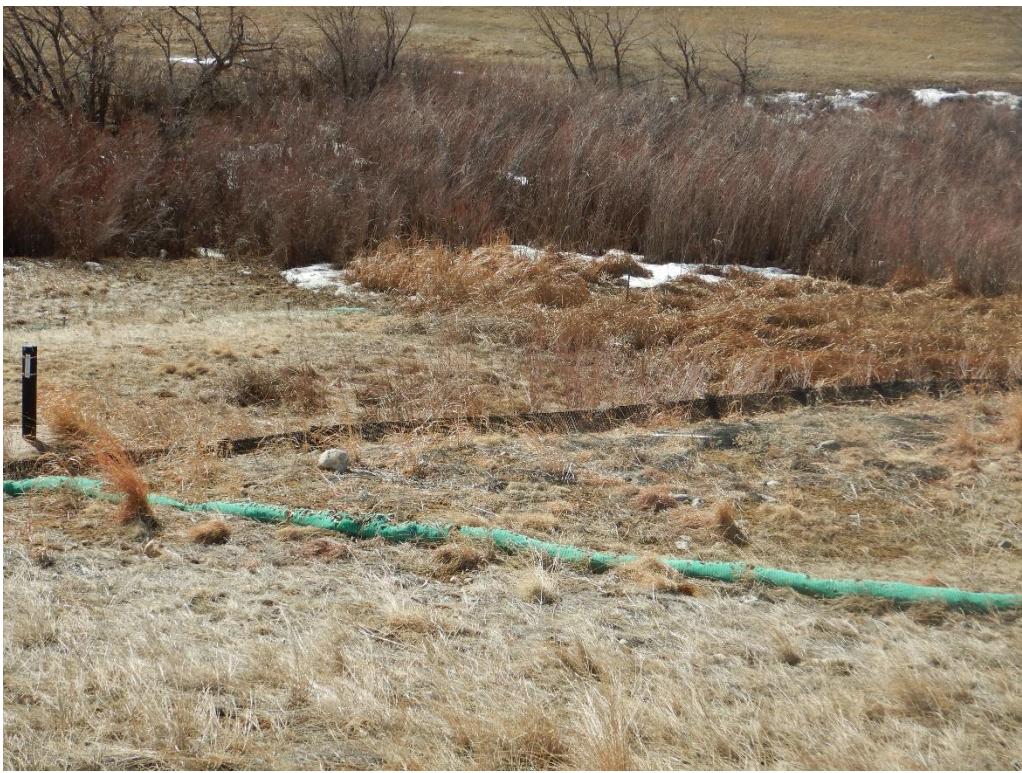
*Figure 6. Looking South-Southwest at Seep 8 and the Surrounding Area, Which Had a Flow of Approximately 1 gpm*

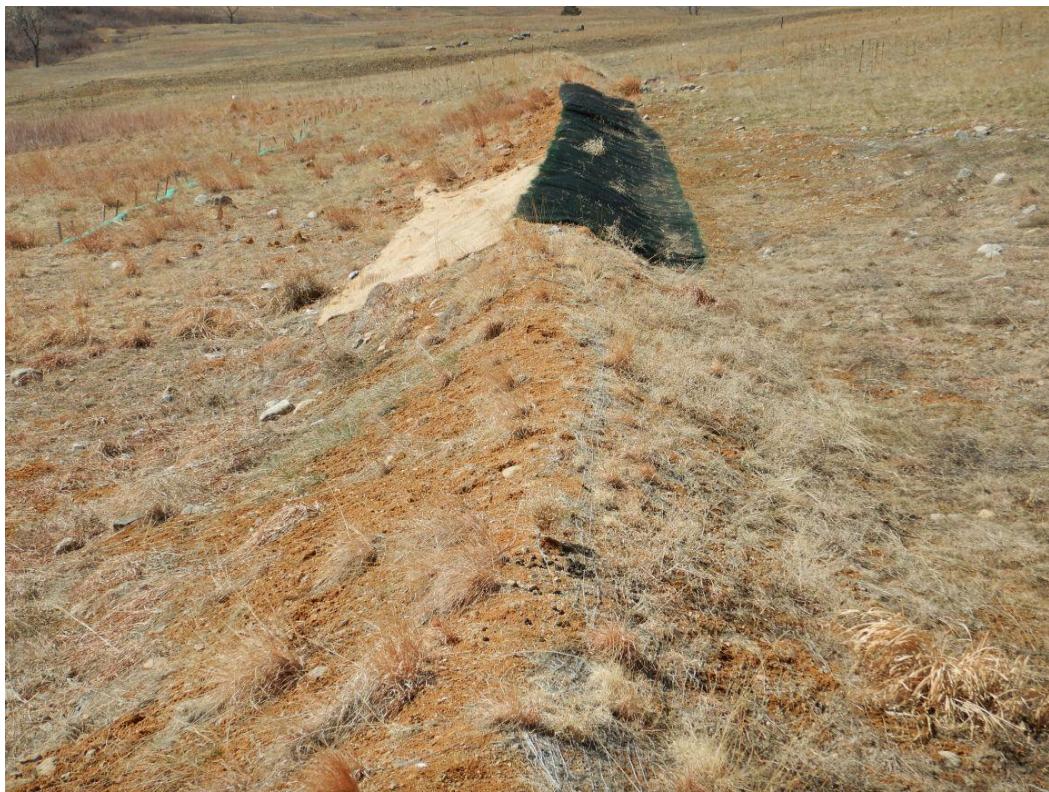
*Figure 4. Looking Southwest at Erosion Control Blankets Along Eastern Berm 2, Which Were Displaced by Elk Passing Through the Area in Early March; the Blankets Were Restaked in March and April*

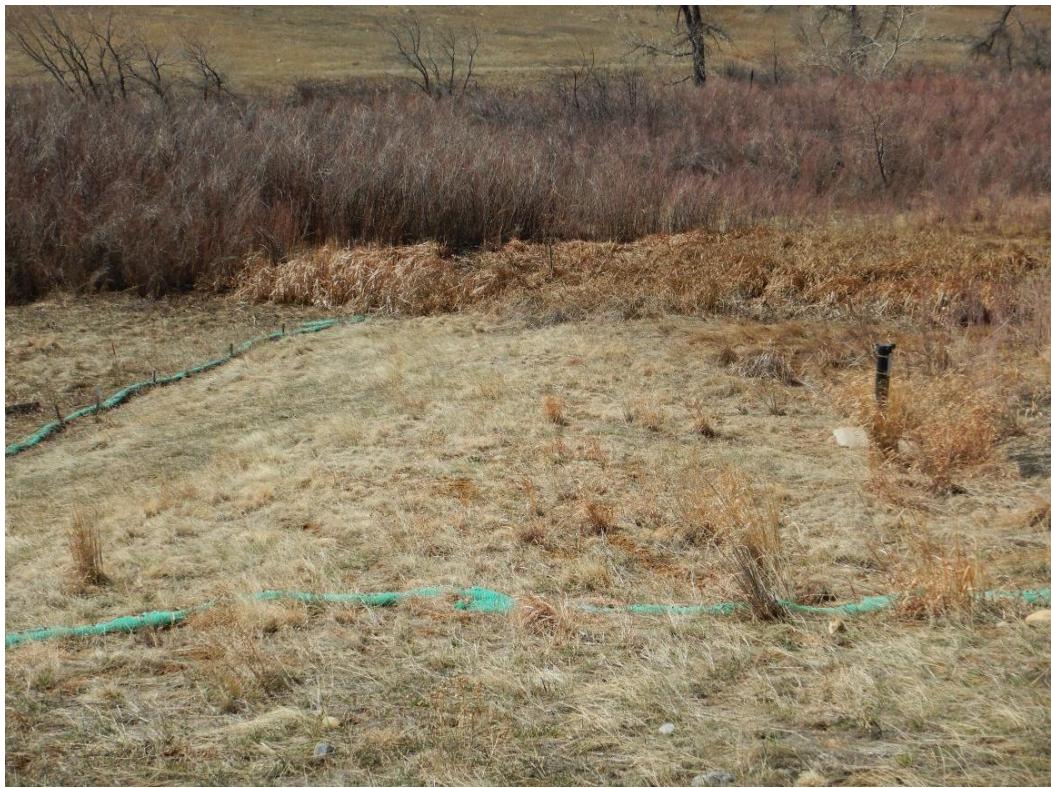
condition. The Seep 8 location had a flow of approximately 1 gpm. The Seep 4 and Seep 7 locations had damp soils. No issues were noted with the ESSD, which had no flow during the inspection. No issues were noted with the SID, which receives groundwater from the ESSD outfall and an interceptor drain on the eastern hillside, which had a flow of less than 1 gpm during the inspection.

*Figure 9. Looking South-Southwest at Seep 8 and the Surrounding Area, Which Had a Flow of Approximately 1 gpm*

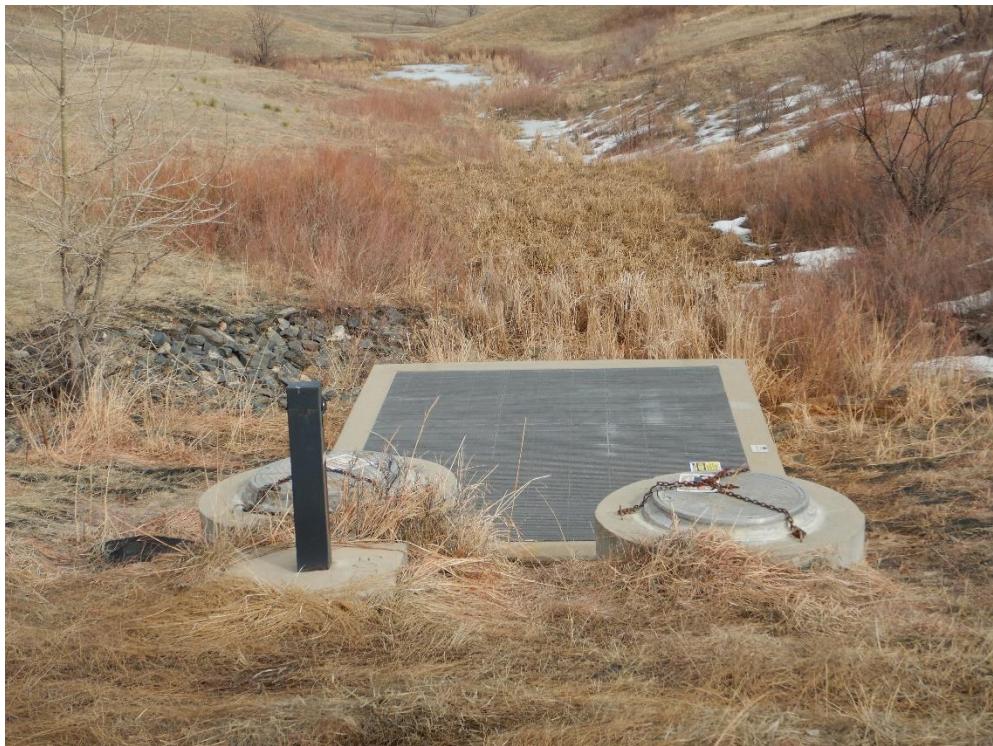
Routine maintenance during the first quarter of CY 2023 at the PLFTS included inspecting the system for potential problems, primarily by checking flow conditions. Influent piping was cleaned of biological growth using a mechanical pipe cleaner. No other issues were identified.

*Figure 1. Looking East at the Present Landfill Treatment System. Small amounts of Bio-growth were removed from the North and South Manhole Outlet Pipes, treatment unit outlet pipe, and system outfall using a mechanical pipe cleaner as part of routine preventative maintenance. Bio-growth in the manholes is not currently being inspected, but lighter covers are scheduled to be installed in 2023 to make inspection of the manholes easier and safer.*

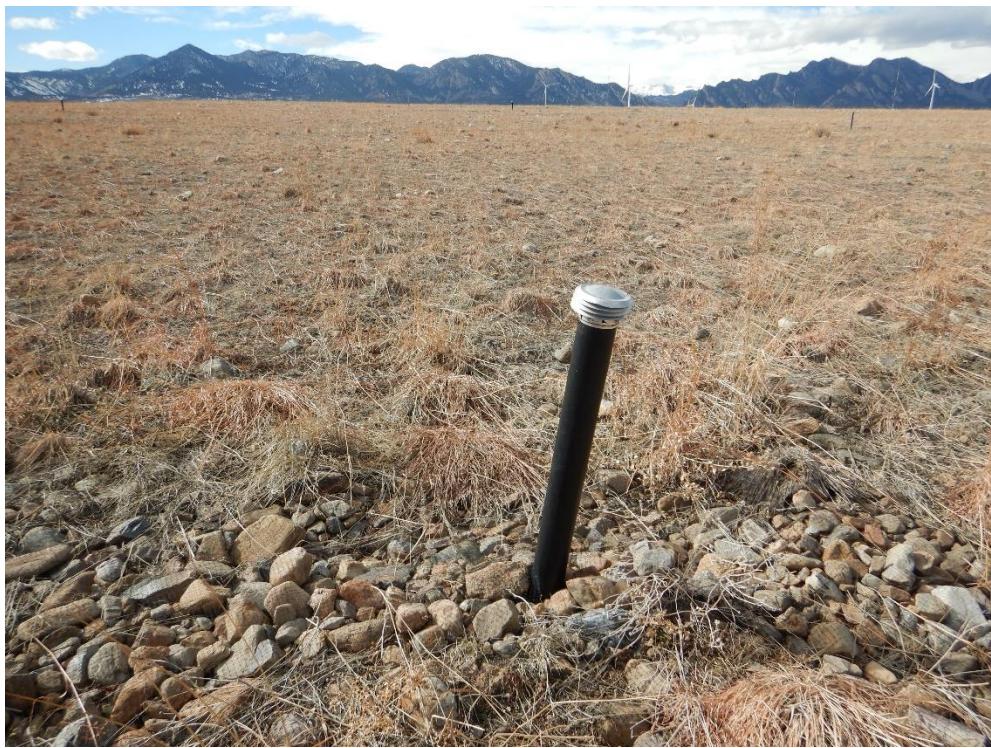
*Figure 4. Looking West-Northwest at a Barometric Gas Vent. No issues were found with survey markers or barometric gas vents.*

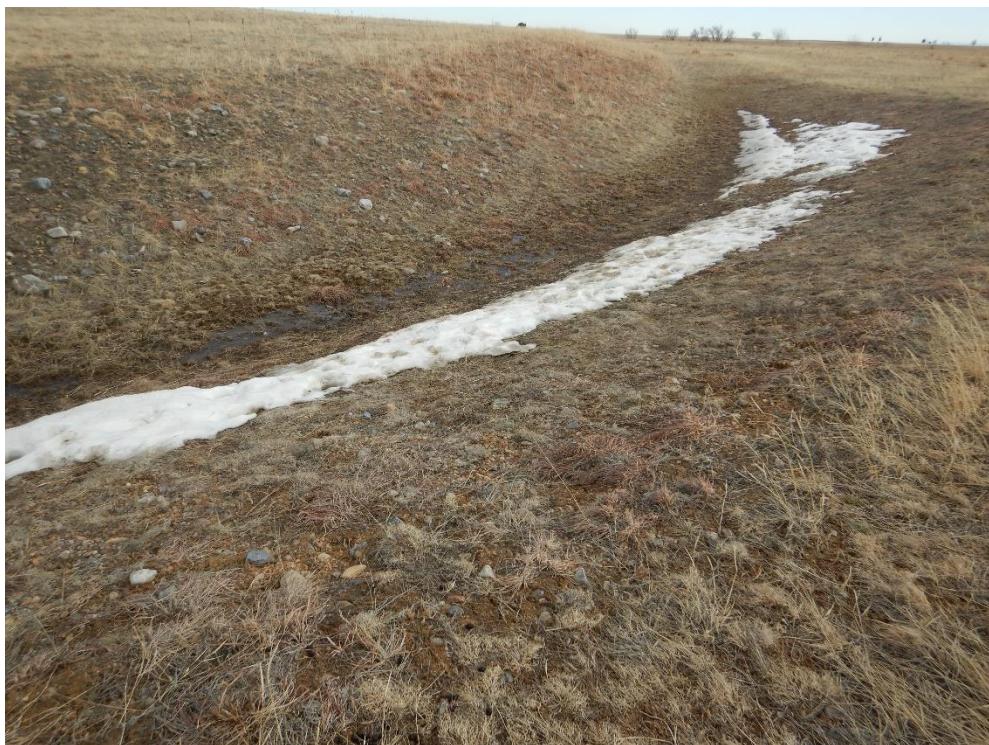
*Figure 6. Looking Southeast at the Southern Vegetation-Lined Perimeter Channel. Snow remains in a few areas from the previous week. All channels and culverts appear to be functioning properly.*
