16.0 Shiprock, New Mexico, Disposal Site

16.1 Compliance Summary

The Shiprock, New Mexico, Uranium Mill Tailings Radiation Control Act (UMTRCA) Title I Disposal Site was inspected on June 1, 2011. The disposal cell and all associated surface water diversion and drainage structures remain in good condition and were functioning as designed.

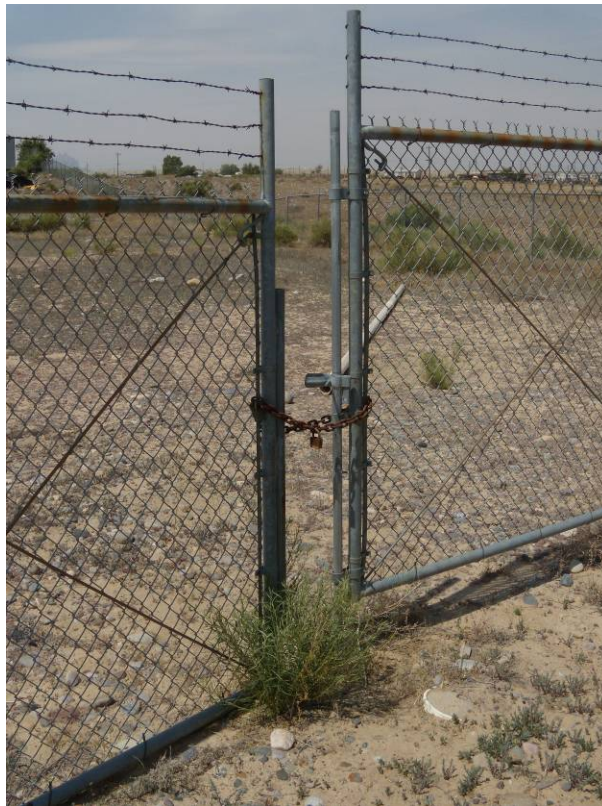
All three vehicle access gates—the main entrance gate at the east corner of the site (near the terrace escarpment), the gate providing terrace access at the northwest corner of the site, and the former entrance gate at the west corner of the site—were locked, intact, and functional. However, a gap has formed in the northwest gate (PL–1). This gap will be repaired, as will eroded areas under the gate that could allow animals or small children access to the site. Near each gate, entrance signs are placed in pairs—one text and one pictorial. One pair is placed near each of the east and northwest gates (E3 and E4, respectively), and two are placed near the west gate (E1 and E2). At the time of the inspection, the pictorial sign was missing from the northwest gate, and the pictorial sign from E1 was missing from the west gate. The remaining entrance signs were in good condition; on the signs, contact information for DOE and the Navajo Abandoned Mine Lands/Uranium Mill Tailings Remedial Action Office was correct.

SHP 6/2011. PL-1. Gap in northwest gate.

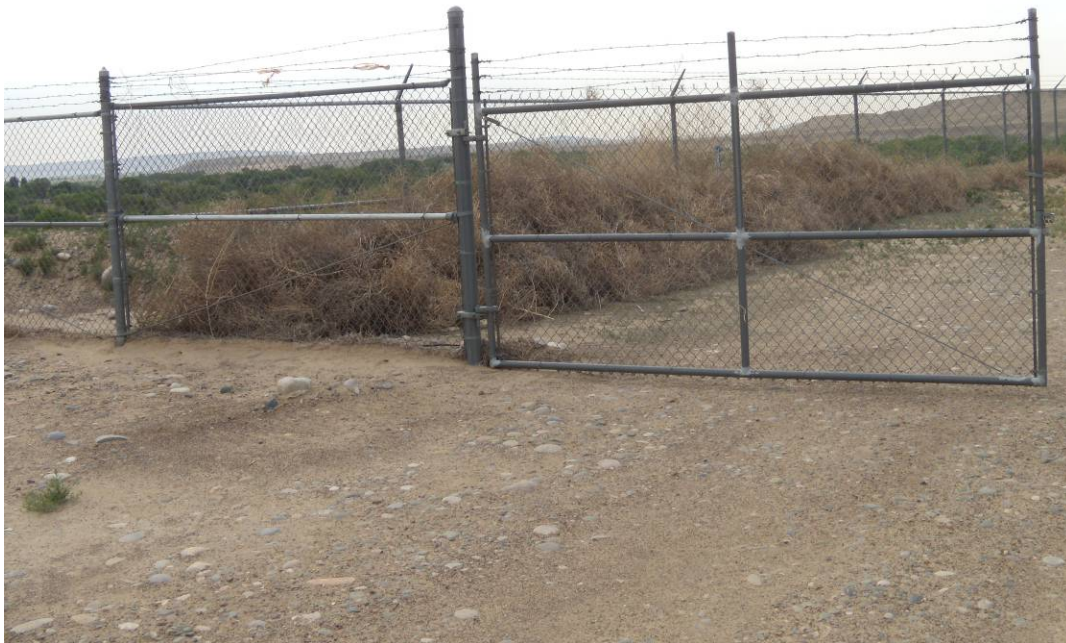
Tumbleweeds have accumulated in many places along the perimeter fence, particularly near the east gate (PL–2) and perimeter sign P8. These accumulations potentially represent a fire hazard and increase the possibility of damage to the fence, particularly during high winds. Trash has also accumulated along, and become entangled in, the fence. To improve the safety and appearance of the site, tumbleweed and trash around all site fences will be removed before the next annual inspection.

SHP 6/2011. PL-2. Tumbleweed accumulation near east gate.

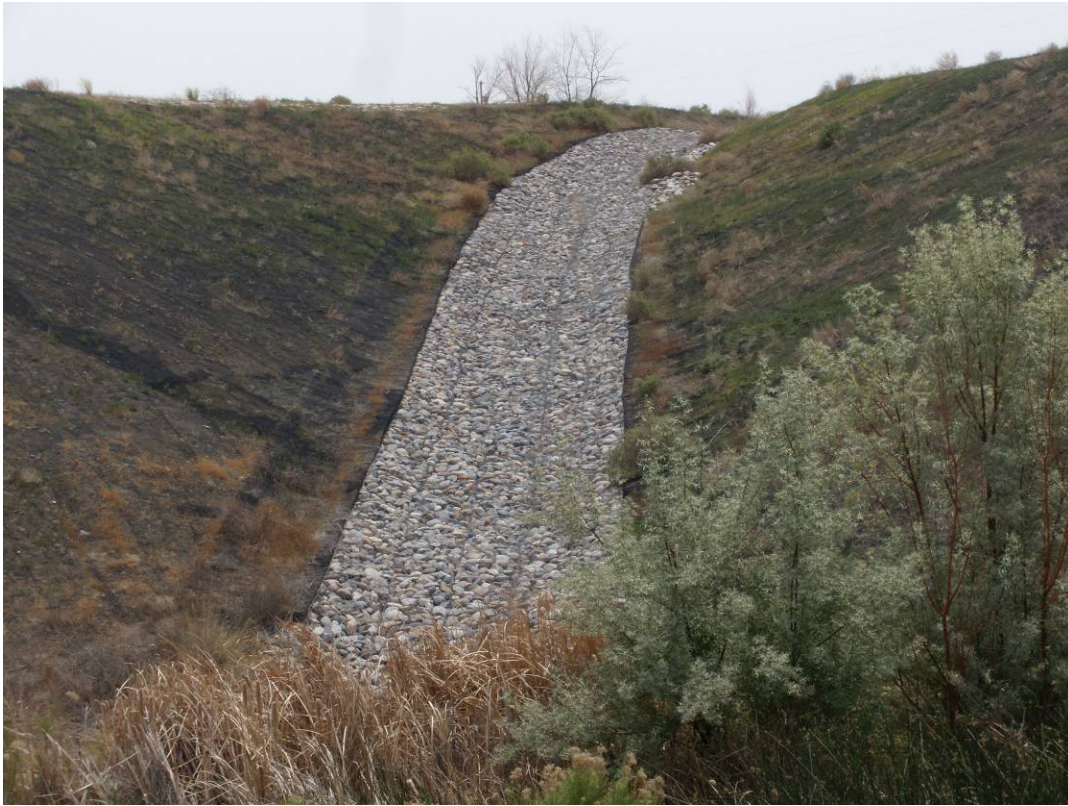
Diversions channels around the base of the disposal cell were in good condition and contained little vegetation. Small quantities of non-woody vegetation were growing in the outflow channel, and woody vegetation was growing on the banks of the channel; neither is expected to obstruct flow. However, tumbleweeds and trash have accumulated along the perimeter fence where it crosses the outflow channel and could potentially obstruct flow. Removal of this material is recommended. The off-site portion of the outflow channel remained in good condition (PL-3). To prevent potential entanglement of wildlife and remove a tripping hazard, it is recommended that a loose portion of erosion control fabric on the side slopes of the lower channel be removed.

SHP 6/2011. PL-3. Outflow channel.

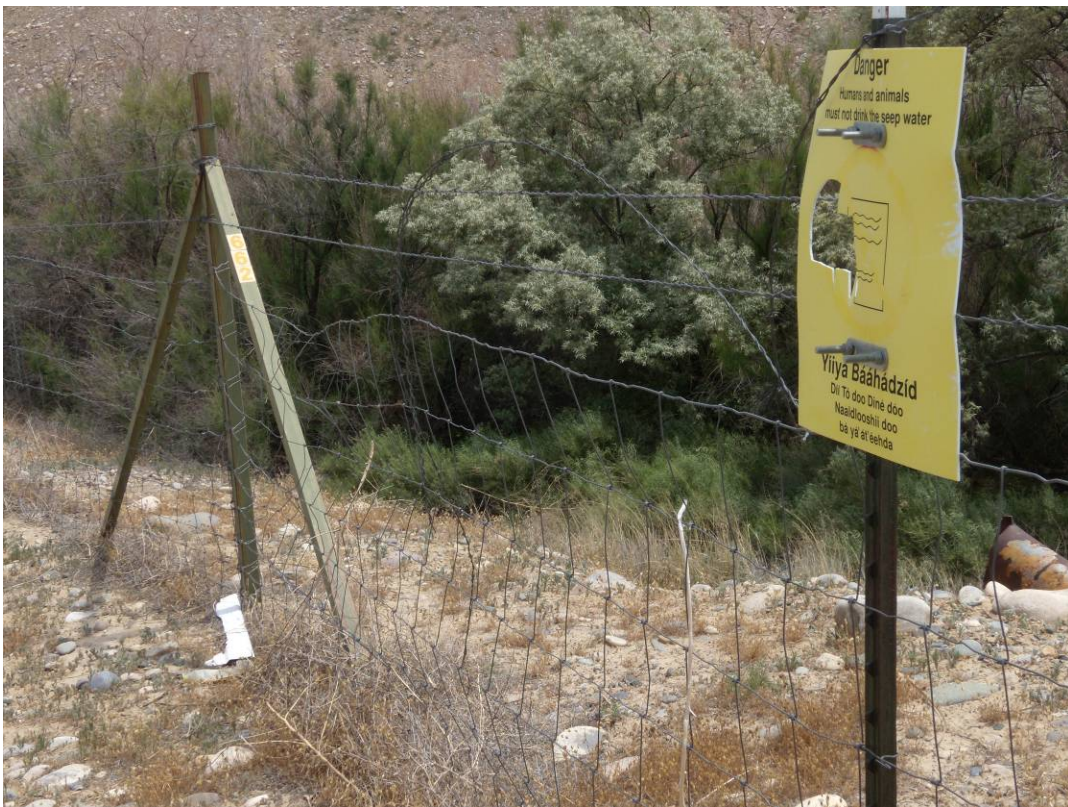
A barbed-wire fence runs parallel to the disposal site along Bob Lee Wash, and signs with warnings not to drink the water are posted on the fence. In 2011, a section of the fence was broken, and a warning sign was damaged (PL-4). Fence repair and sign replacement is recommended.

SHP 6/2011. PL-4. Broken fence wire and warning sign.
