## 16.0 Shiprock, New Mexico, Disposal Site

### 16.1 Compliance Summary

The Shiprock, New Mexico, Uranium Mill Tailings Radiation Control Act (UMTRCA) Title I Disposal Site was inspected on May 28, 2013. The disposal cell and all associated surface water diversion and drainage structures remained in good condition.

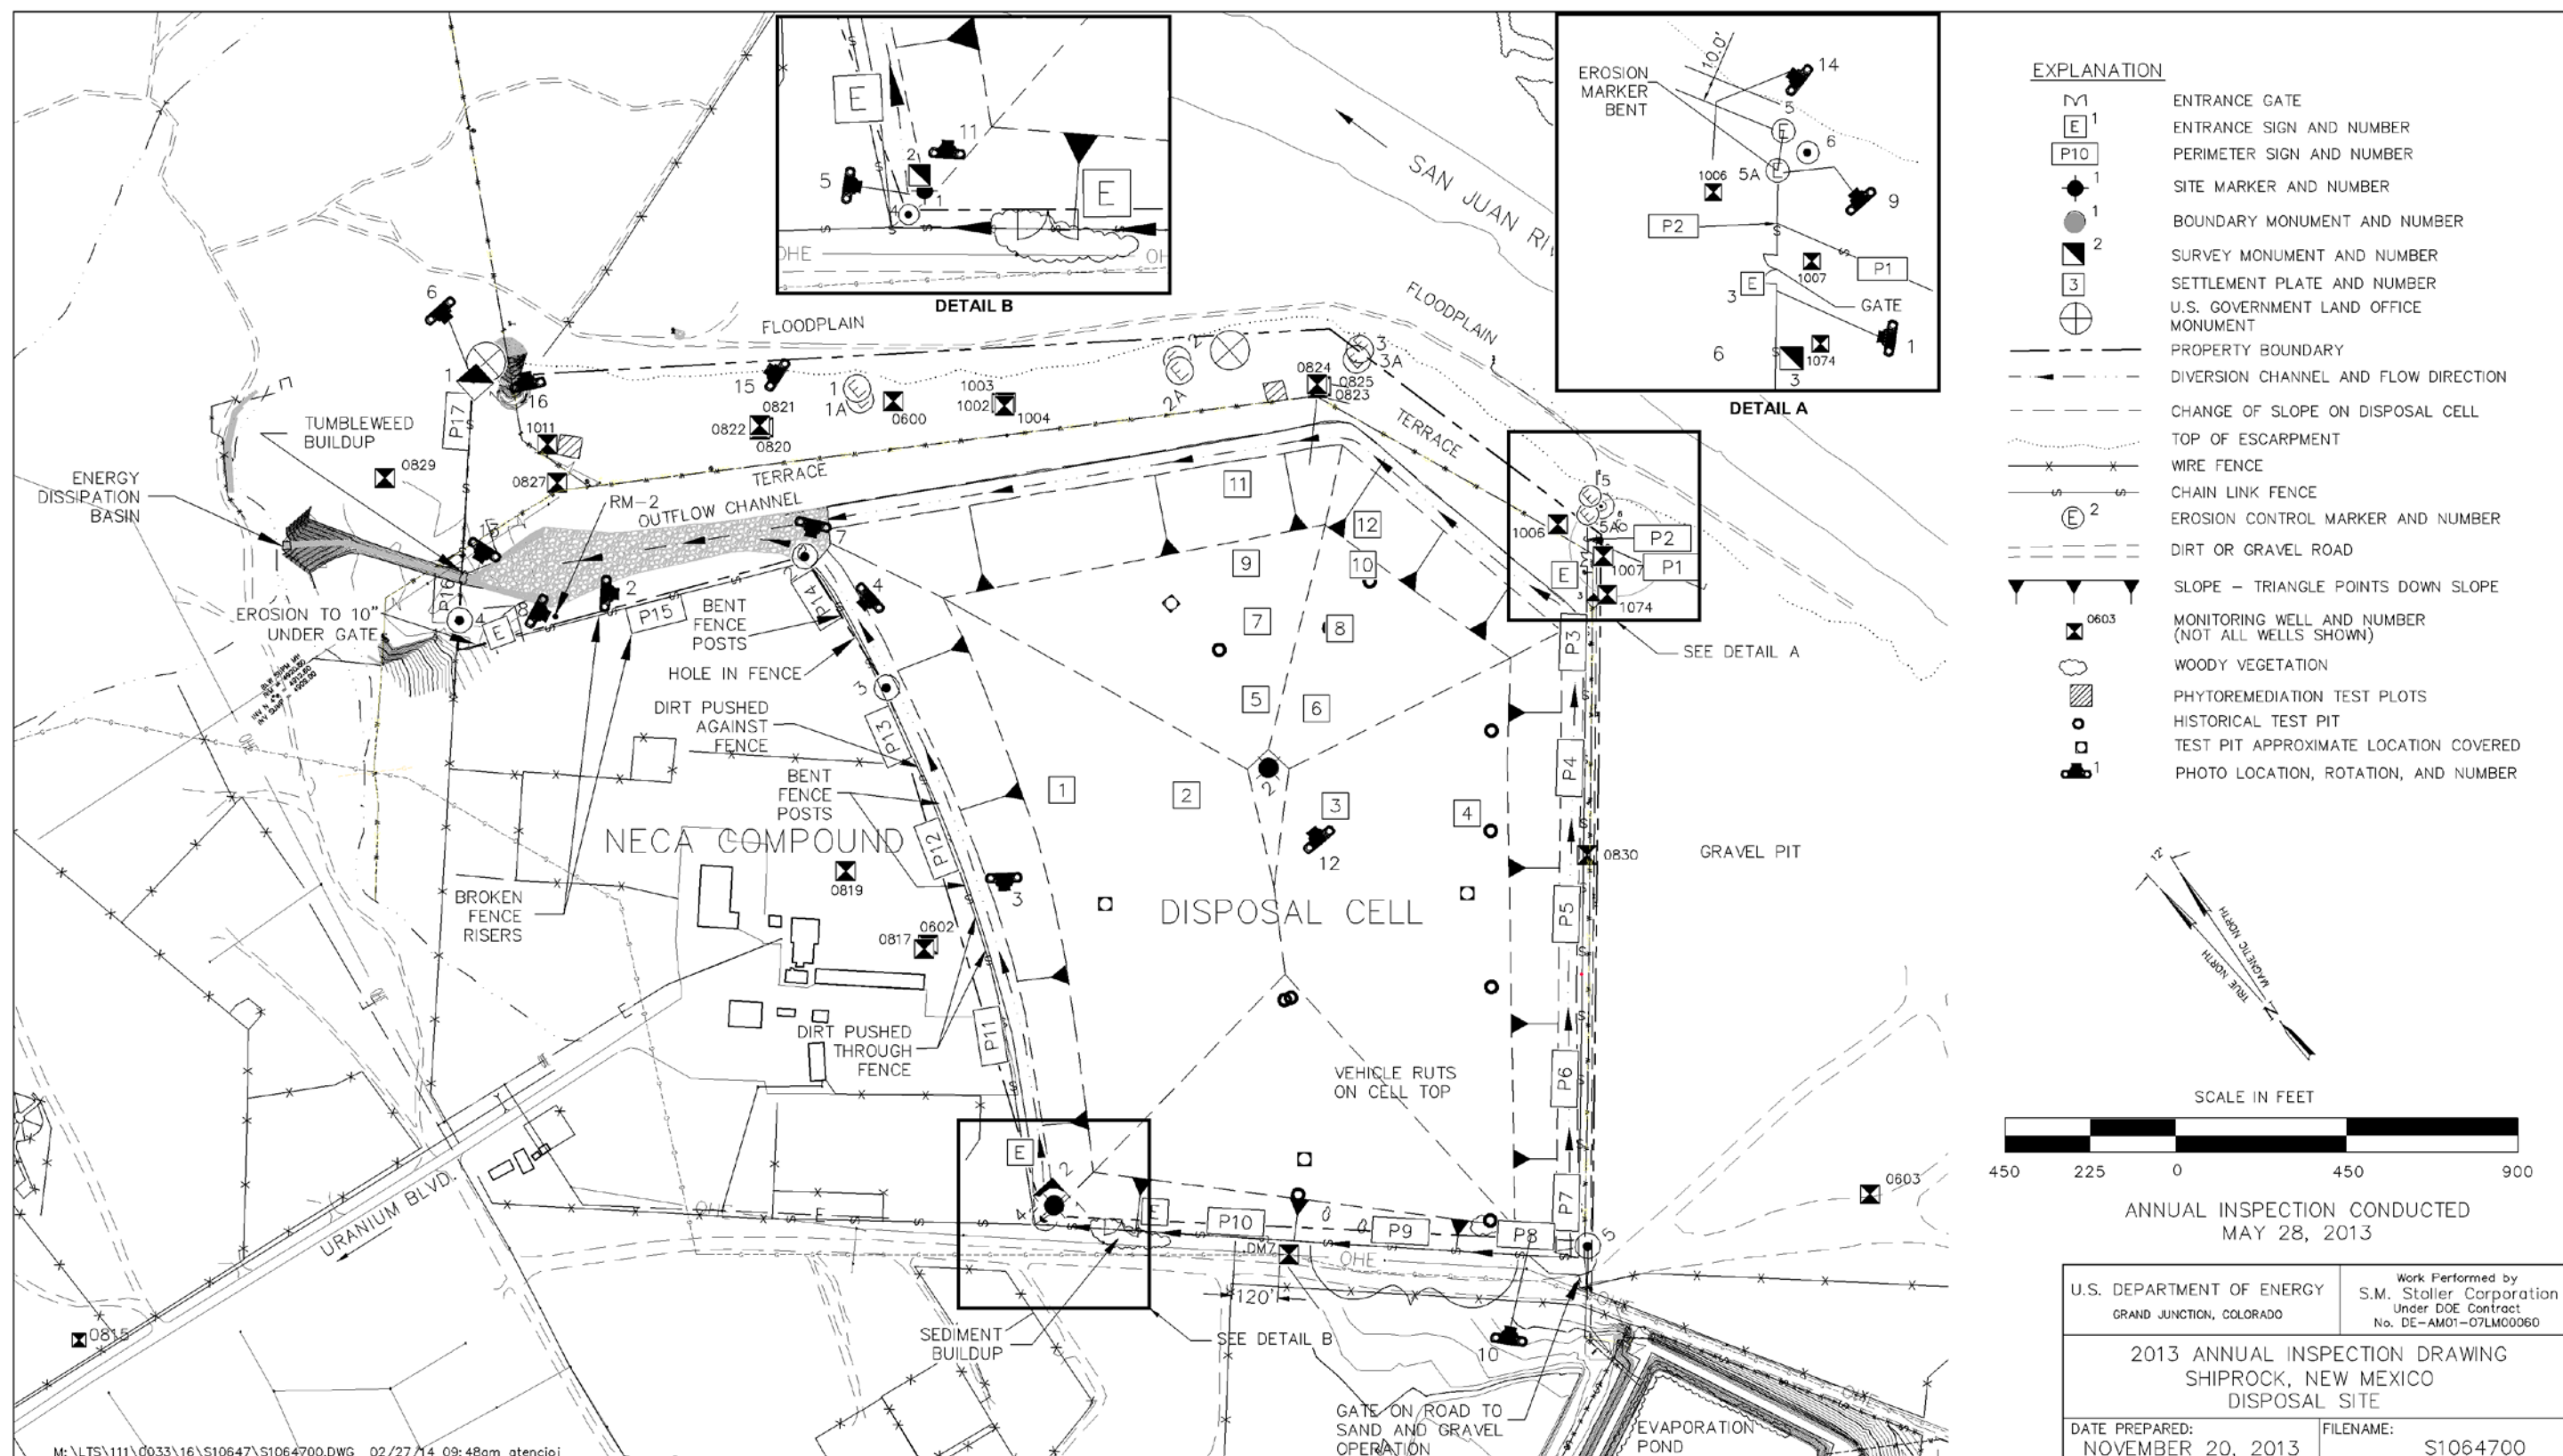
Figure 16-1. Annual Inspection Drawing for the Shiprock Disposal Site

Figure 16-1 shows the locations of site surveillance features. Inspection results and recommended maintenance activities associated with site surveillance features are included in the following subsections. Photographs to support specific observations are identified in the text and on Figure 16-1 by photograph location (PL) numbers.

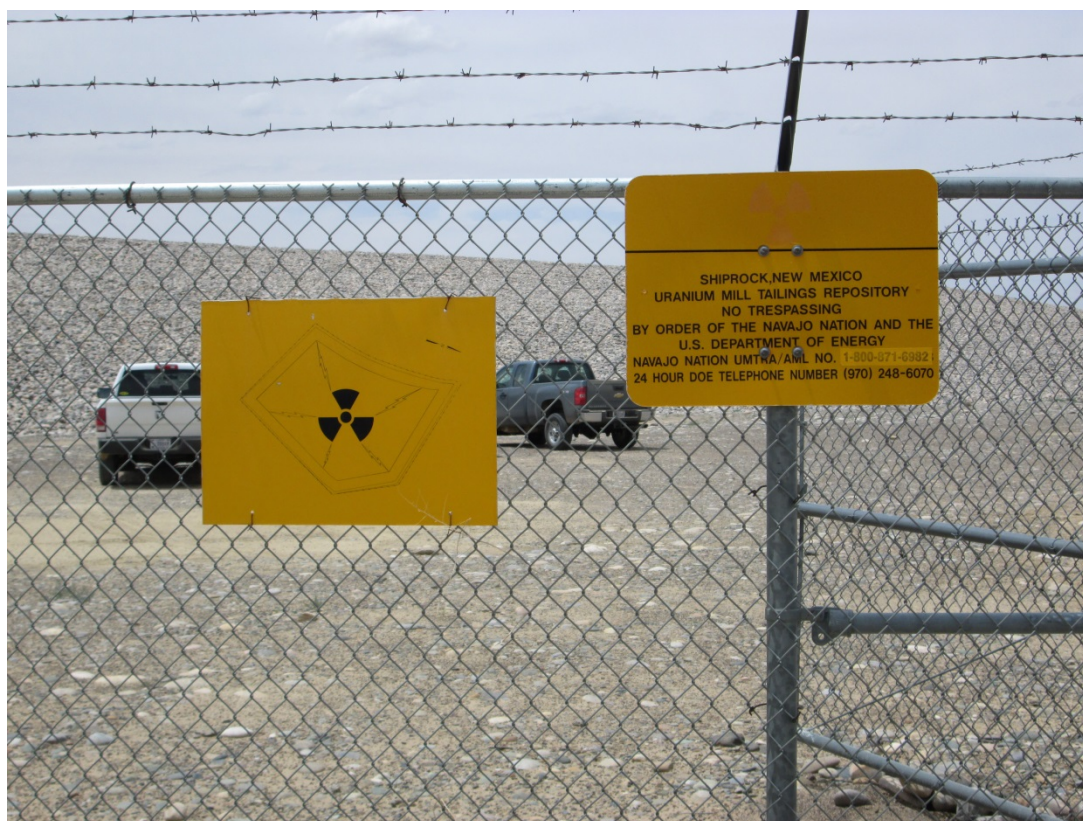
Three gates allow entrance to the site: the east gate (the current main entrance gate near the terrace escarpment), the northwest gate (an auxiliary access gate), and the southwest gate (the former entrance gate). Near each gate, entrance signs are placed in pairs, one text and one pictorial (PL-1). The pictorial sign was missing from the northwest gate. The remaining entrance signs were in good condition; on the signs, contact information for the DOE and the Navajo AML/UMTRA Department was correct. The east and northwest gates were intact and functional. Sediment continually accumulates along the bottom of the southwest gate, which can make the gate difficult to open. Access to the main (east) entrance gate is gained by traveling through a gravel pit. All access roads were in good condition.

*SHP 5/2013. PL-1. Entrance sign at main access gate.*

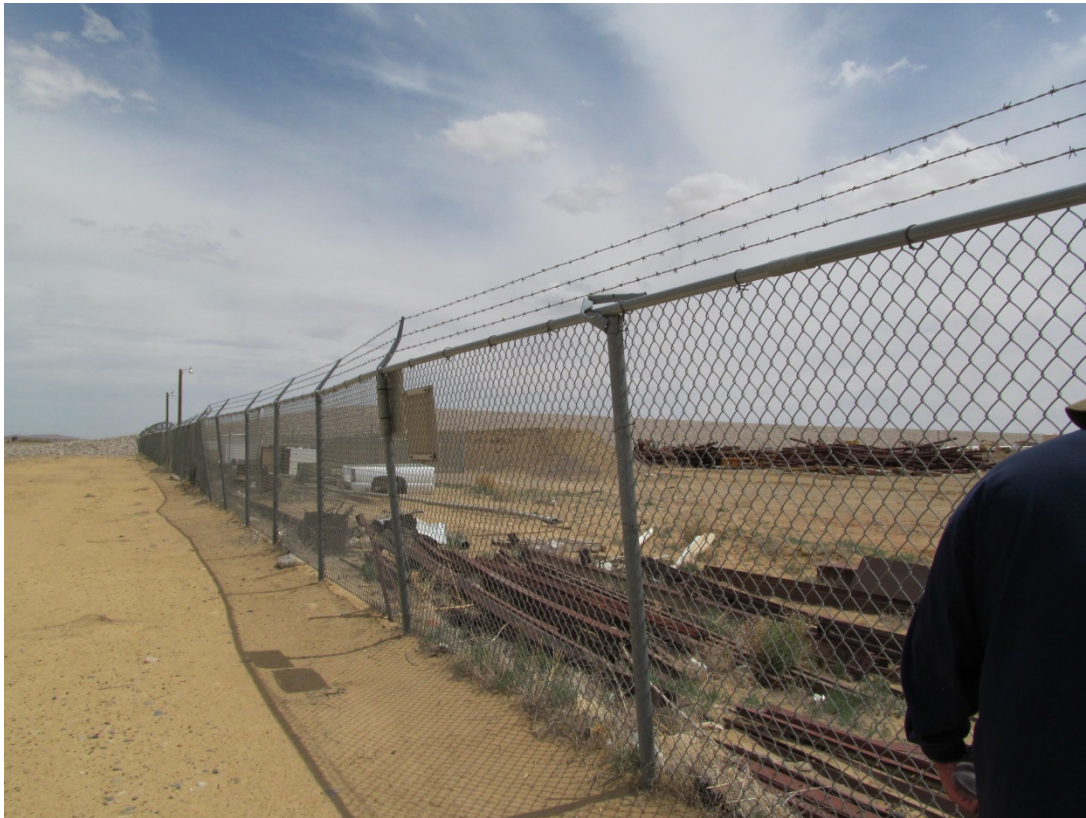
As observed in previous years, the perimeter fence was damaged in many areas (PL-2). Damaged fence sections reported in previous years include bent posts and bent fence fabric between perimeter signs P11 and P12, dirt mounded against the fence and a section of bent fence near P13, bent posts near P14, a broken fence riser near P15, and fence risers separated from posts between P15 and P16. New damage consists of two areas where dirt was pushed through the fence between P11 and P12 (PL-3) and a hole cut in the fence near P14 (PL-4). The hole requires repair. Other damaged fence sections will continue to be monitored.

*SHP 5/2013. PL-2. Damaged fence line near perimeter sign P15.*

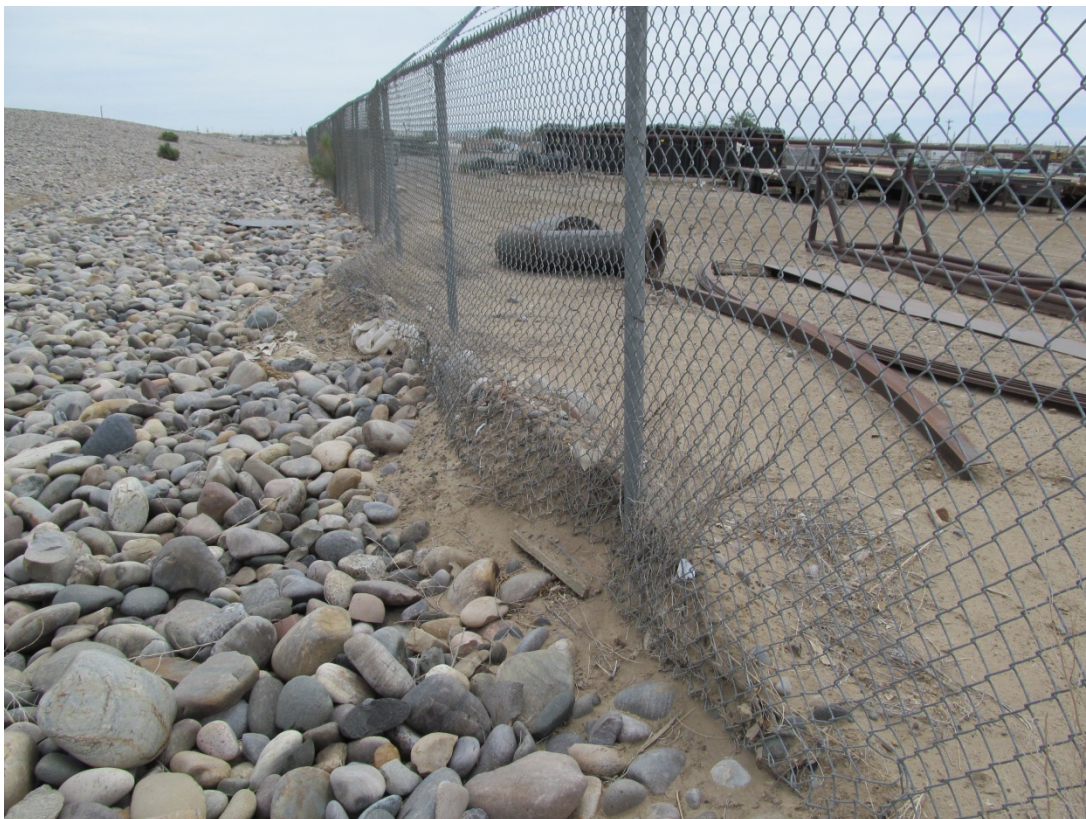
*SHP 5/2013. PL-3. Dirt pushed under fence between P11 and P12.*

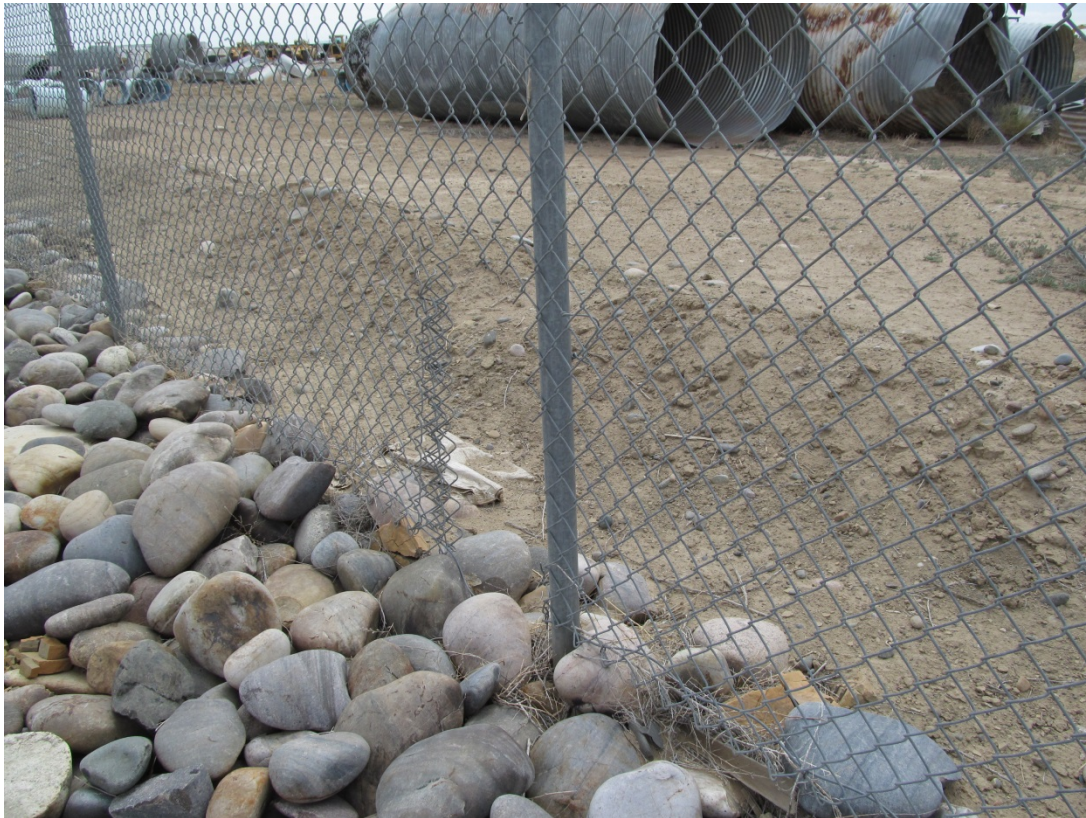
*SHP 5/2013. PL-4. Hole cut into fence near perimeter sign P14.*

- 16A** 1. Replace the pictorial sign missing from the northwest entrance gate.
- 16B** 2. Repair the hole in the perimeter fence near P14.
- 16C** 3. Remove accumulations of tumbleweeds and trash from the perimeter fence if accumulations are large enough to represent a fire hazard or potentially damage the fence.

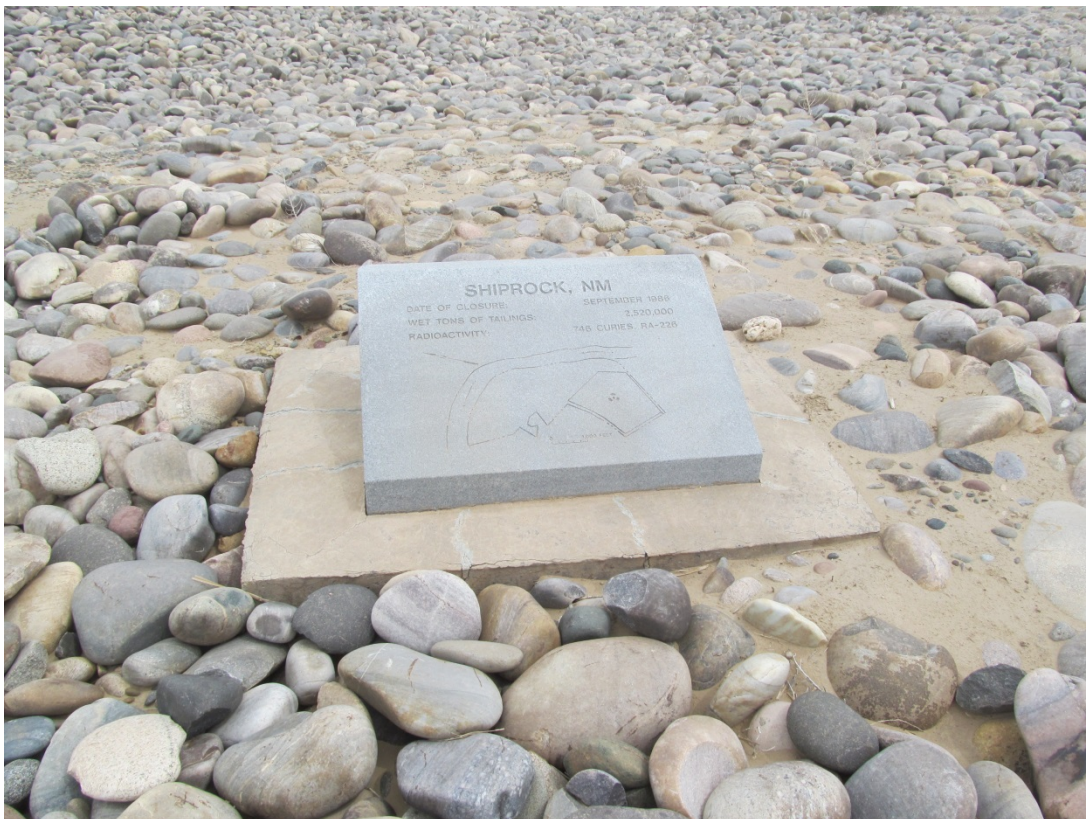
Site marker SMK-1, located just inside the southwest gate, and site marker SMK-2, located on top of the disposal cell, were both in good condition. Minor cracks in the concrete base of SMK-1 were sealed in May 2003 and have not changed significantly (PL-5).

*SHP 5/2013. PL-5. Site marker SMK-1.*

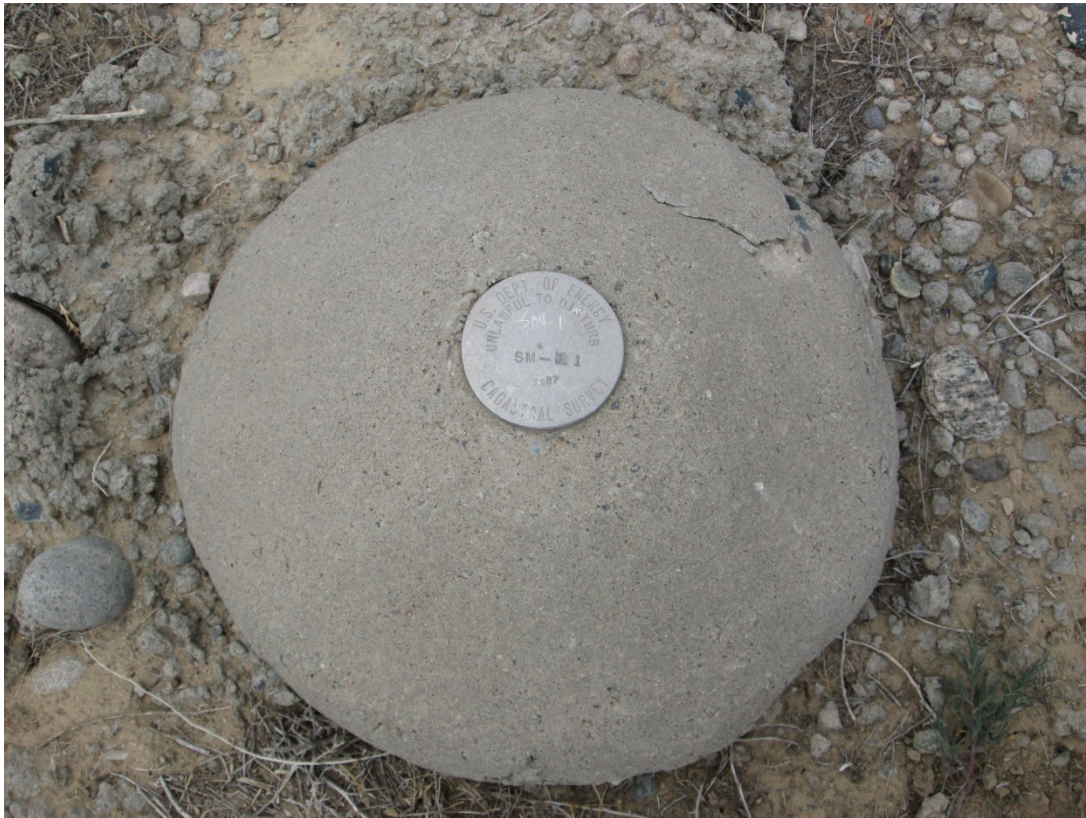
All three survey monuments (SM-1, SM-2, and SM-3) were located and in good condition. The concrete was cracked at SM-1 (PL-6), but the crack did not threaten the integrity of the marker. Eight boundary monuments were originally installed at the site. Inspection of monument BM-7 was discontinued in 1999 because it is located offsite, on the unsafe, steep embankment below the terrace. Inspection of monument BM-8, also located beyond the site's boundary, was discontinued in 2003. Because they are offsite, inspection of these monuments will not resume. In winter 2013, the remaining six onsite boundary monuments were surveyed and uncovered as necessary. In accordance with the LTSP, reference posts were installed by each monument to facilitate future inspections (PL-7). In 2001, monument BM-1 was lost to flooding. Its reference monuments (RM-1, installed in 2003, and RM-2 [PL-8], installed in 2013) were both present and in good condition.

*SHP 5/2013. PL-6. Survey monument SM-1.*

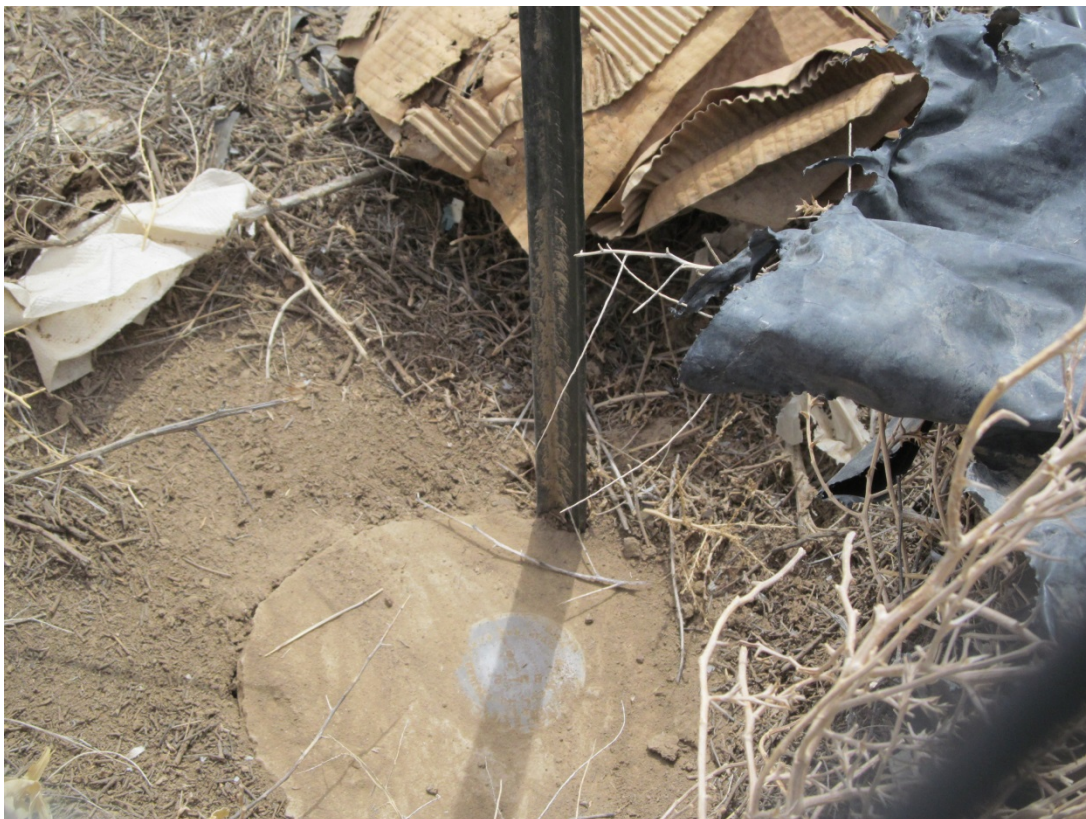
*SHP 5/2013. PL-7. Boundary monument 2 with reference post..*

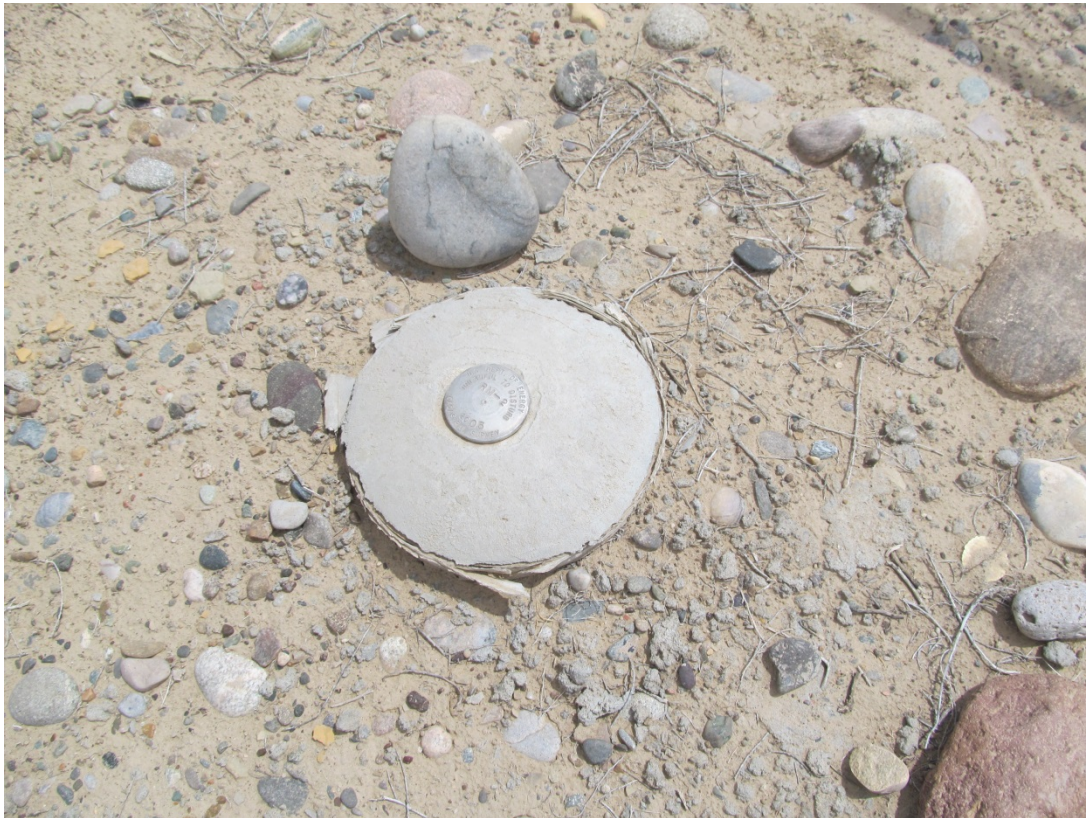
*SHP 5/2013. PL-8. "Reference monument RM-2, installed in 2013.*

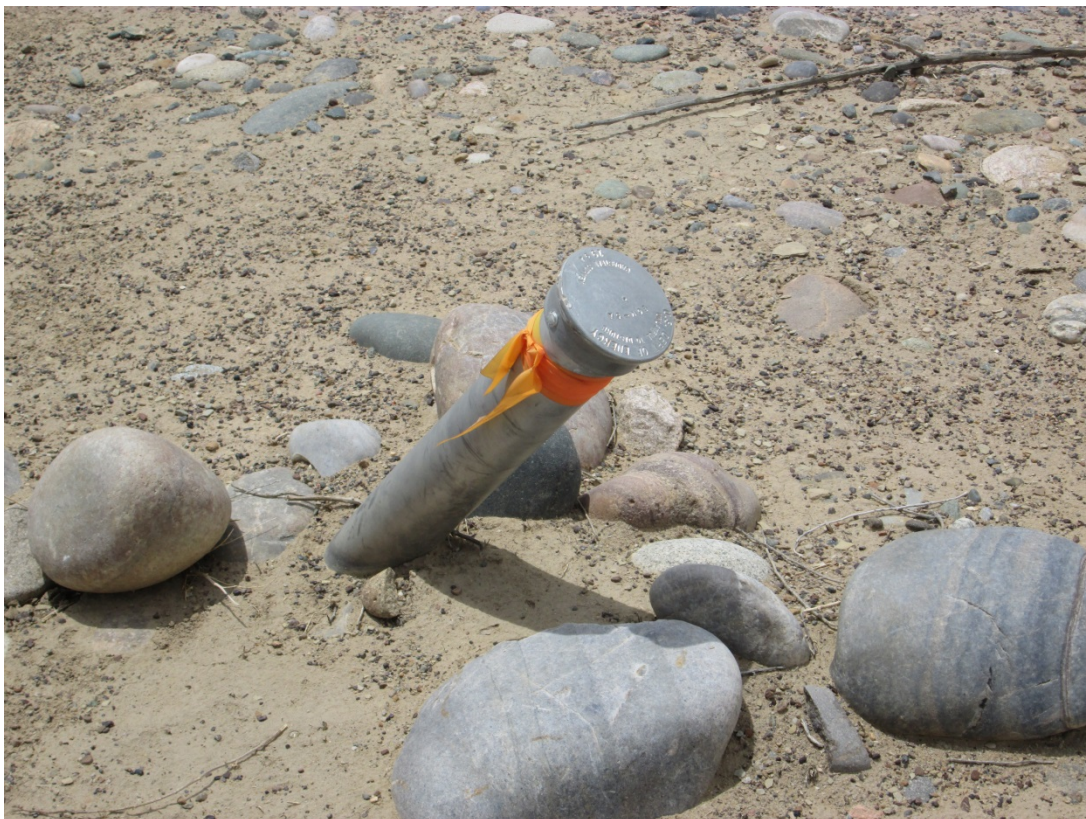
The four pairs of erosion control markers along the edge of the terrace escarpment (1, 1A, 2, 2A, 3, 3A, 5, and 5A) were in good condition except for marker 5A near the east entrance gate. This marker was previously damaged by a vehicle, but it is still functional and does not require repair (PL-9). Erosion control markers 4 and 4A are not inspected. They were installed on the terrace east of the disposal site, in the gravel pit. Markers 5 and 5A replaced Markers 4 and 4A.

*SHP 5/2013. PL-9. Erosion marker ECM-5A, bent but functional.*

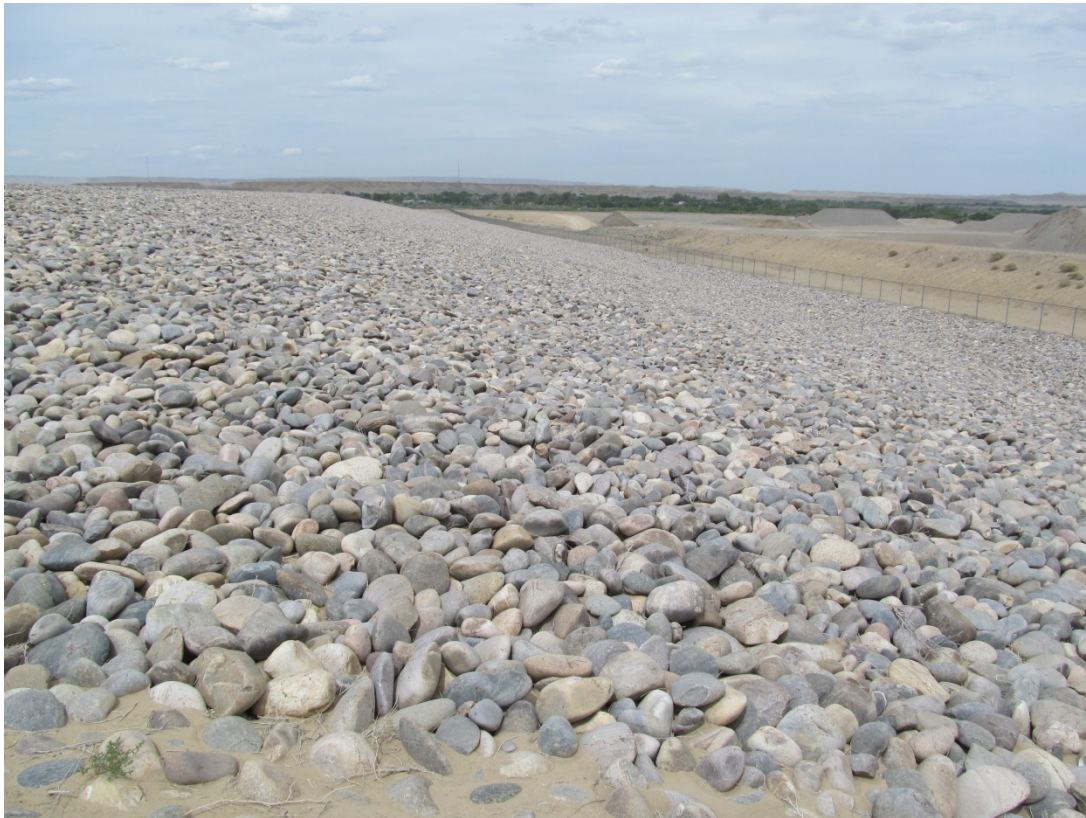
The riprap-covered top and side slopes of the cell were in good condition (PL-10). No evidence of settling, slumping, erosion, animal intrusion, riprap deterioration, or other significant disturbance was found. Five open research pits, described in previous annual inspection reports, were covered in fall 2012, and these areas were also in good condition. Piezocones associated with a different research project were installed on the cell cover in the past (*2004 Annual Inspection Report for the Shiprock, New Mexico, UMTRCA Title I Disposal Site*). Some of the filled piezocone pits have subsided slightly, forming conical depressions in the cover. As previously reported, the surface of the cell was covered with vehicle ruts. The condition of the depressions and vehicle ruts is monitored annually and had not changed significantly since the 2012 inspection. These features will continue to be monitored and photographed to document any changes. Inspectors noted the locations and species of plants as stipulated in the LTSP. Several small woody shrubs were growing on the northwest side slope of the disposal cell (PL-11), and one small shrub was observed on the cell top. Sediment has accumulated in the rock cover in several places (PL-12), but this is a natural, expected process.

*SHP 5/2013. PL-10. Southeast slope of disposal cell.*

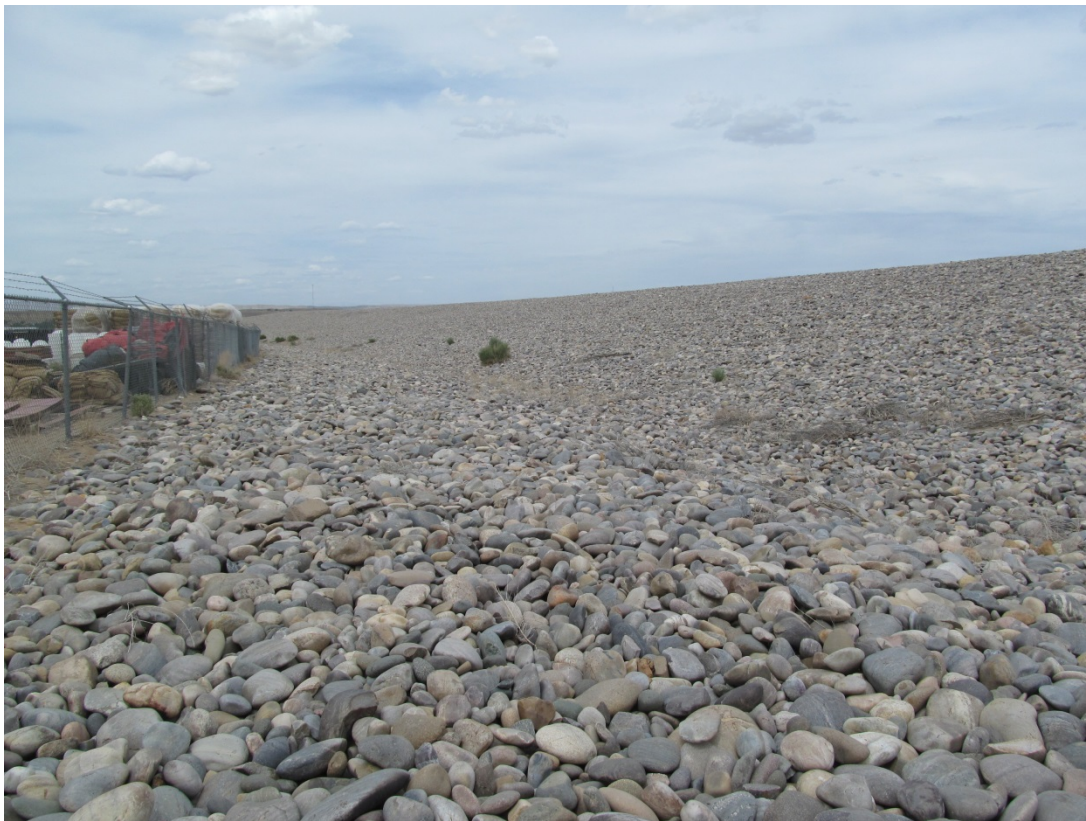
*SHP 5/2013. PL-11. Northwest slope of disposal cell showing vegetation.*

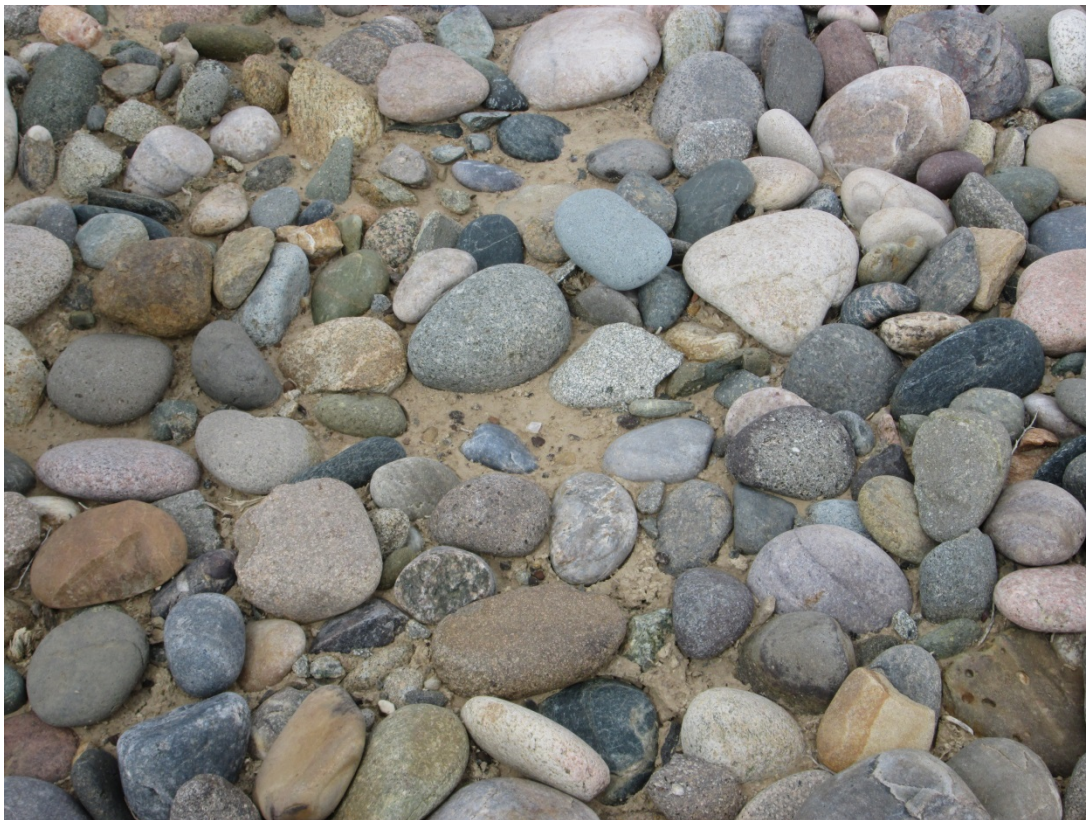
*SHP 5/2013. PL-12. Sediment deposition on cell top.*

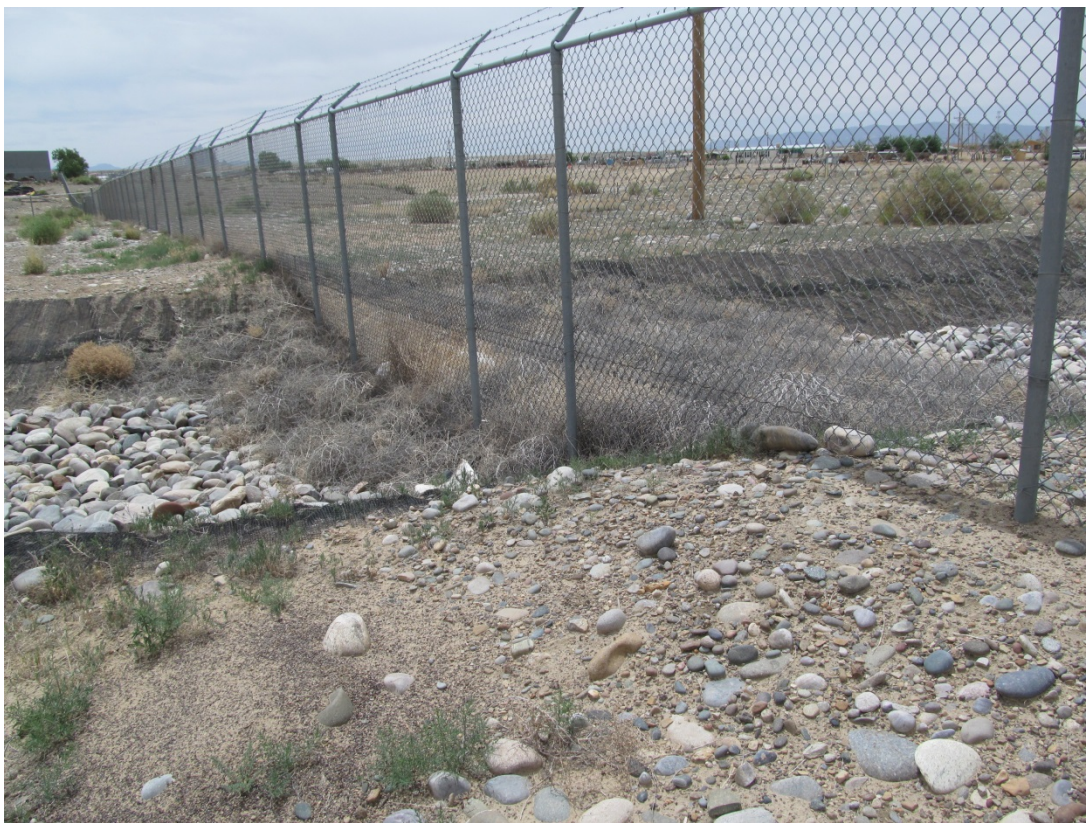
Diversion channels around the base of the disposal cell were in good condition and contained little vegetation. Non-woody plants were growing in the outflow channel, and woody vegetation was growing on the banks of the channel; neither is likely to obstruct flow. However, tumbleweeds and trash have accumulated along the perimeter fence where it crosses the outflow channel and could potentially obstruct large flows (PL-13).

*SHP 5/2013. PL-13. Fence across outflow channel with debris buildup.*

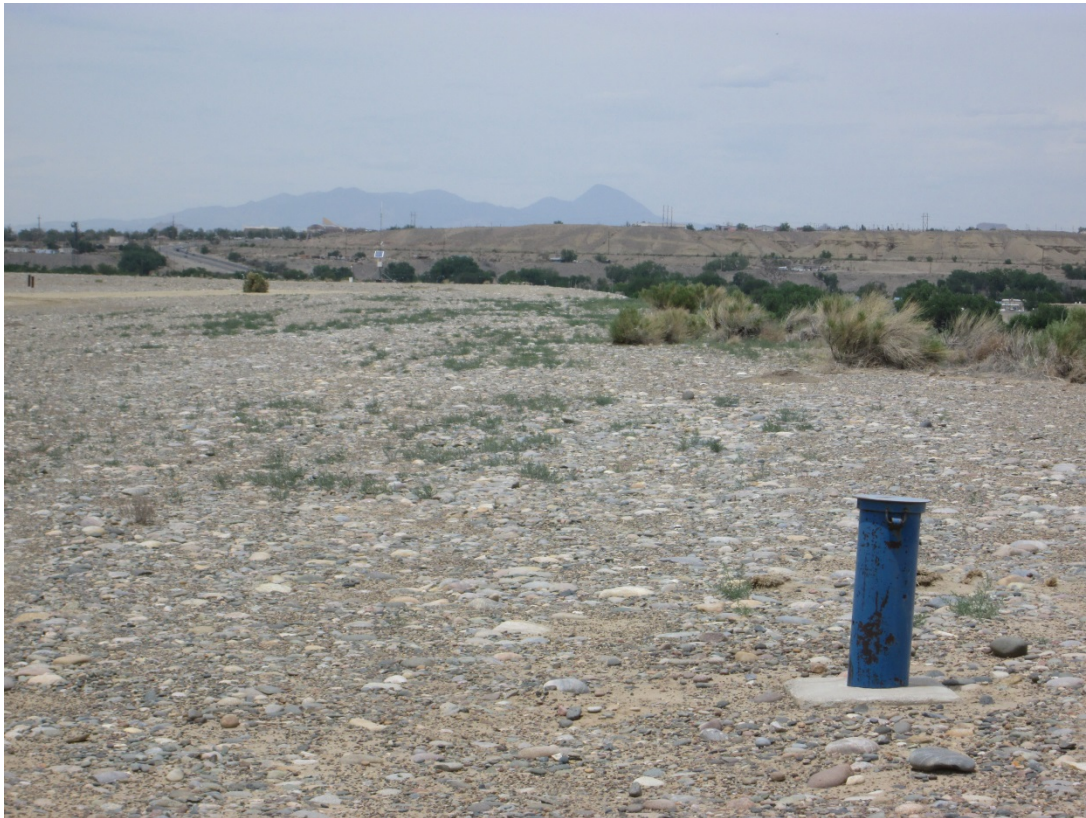
The terrace area is located north and northeast of the disposal cell along the top of a steep escarpment. Little vegetation grows on the terrace (PL-14). The escarpment, approximately 300 feet from the eastern edge of the disposal cell, is prone to slumping (PL-15). No new erosion was evident in 2013 (PL-16). The LTSP states that the base of the terrace escarpment should be inspected for signs of seepage. Seeps were identified during early site inspections. However, this

*SHP 5/2013. PL-14. Terrace, view north-northeast.*

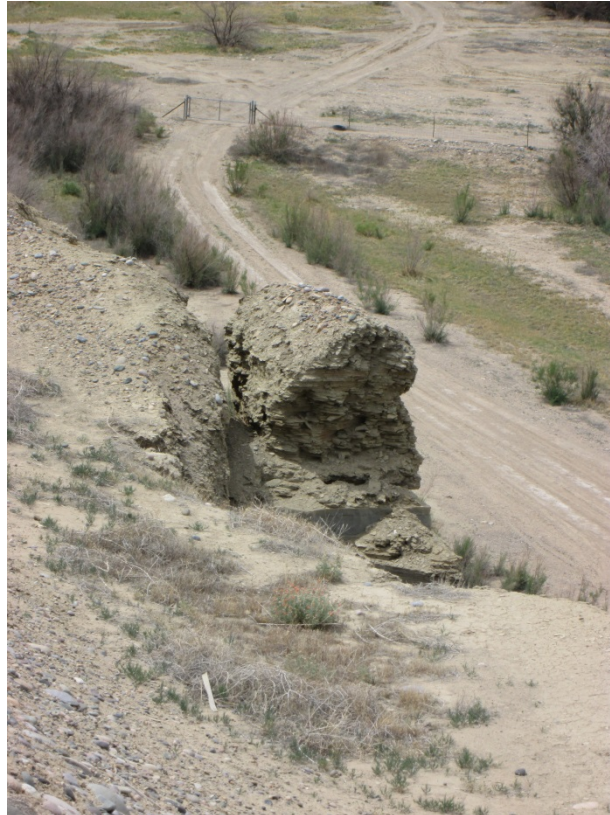
*SHP 5/2013. PL-15. Terrace escarpment pedestaling; piping was also observed.*

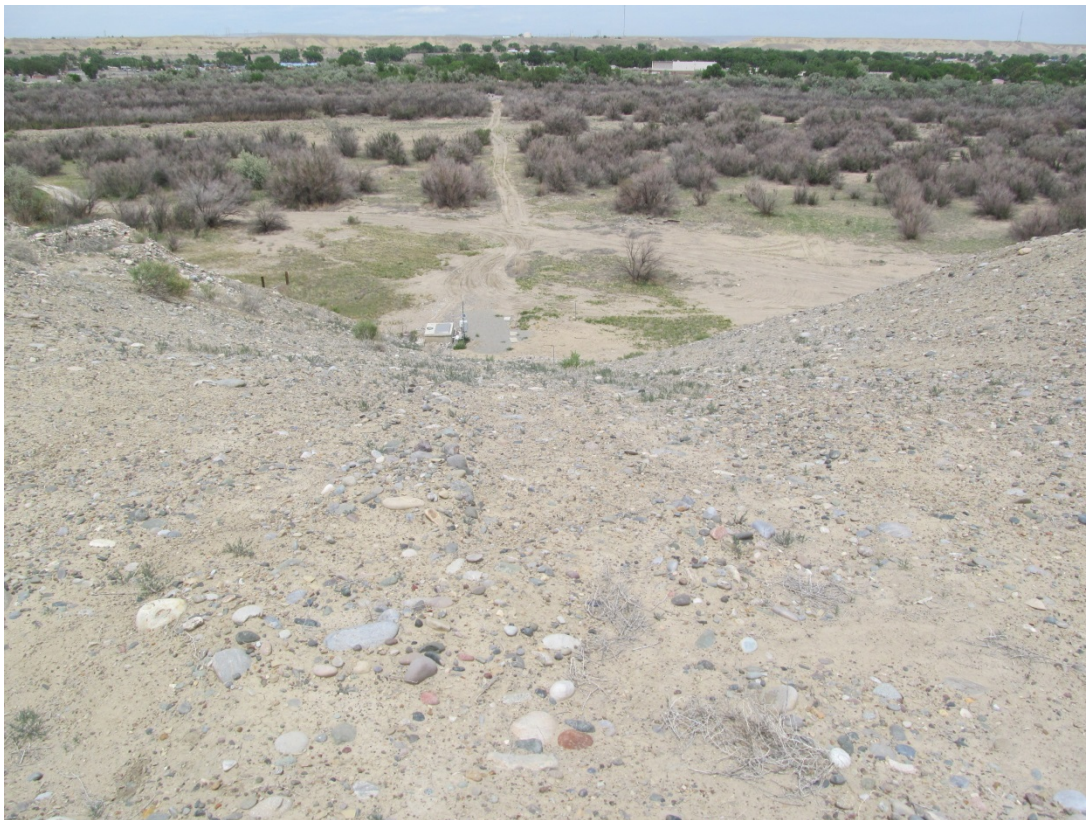
*SHP 5/2013. PL-16. View down repaired section of escarpment; no new erosion.*
