16.0 Shiprock, New Mexico, Disposal Site

16.1 Compliance Summary

16.4 Inspection Results

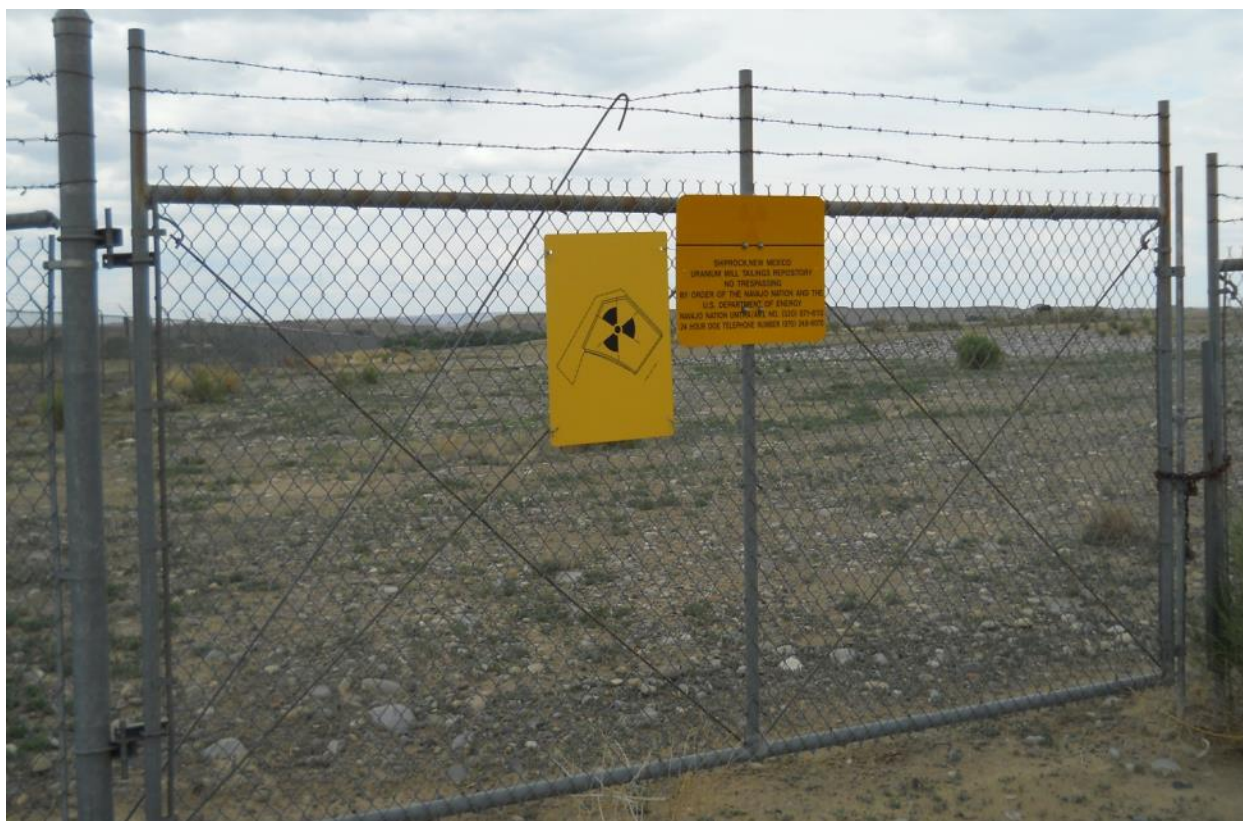
- 16A Entrance signs are present in pairs—one pictorial and one textual—near each gate. A missing pictorial sign at the north gate was replaced prior to the inspection. All entrance signs were in place and legible at the time of the 2014 inspection, but some had faded or cracked surfaces or had bullet damage (PL-1 through PL-4). These signs will be replaced in the next few years as they become illegible.

SHP 5/2014. PL-1. North entrance gate; note faded radiation symbol on textual sign.

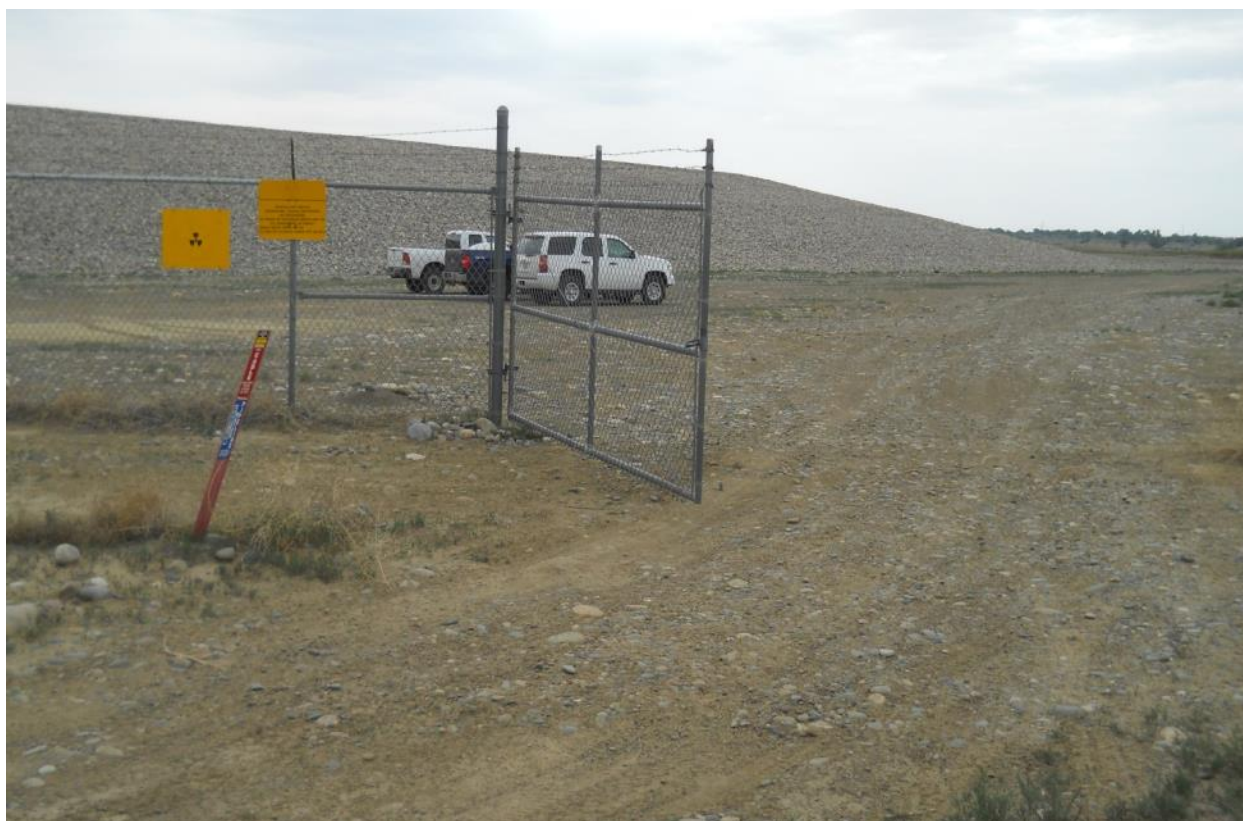
SHP 5/2014. PL-2. Main (east) entrance gate.

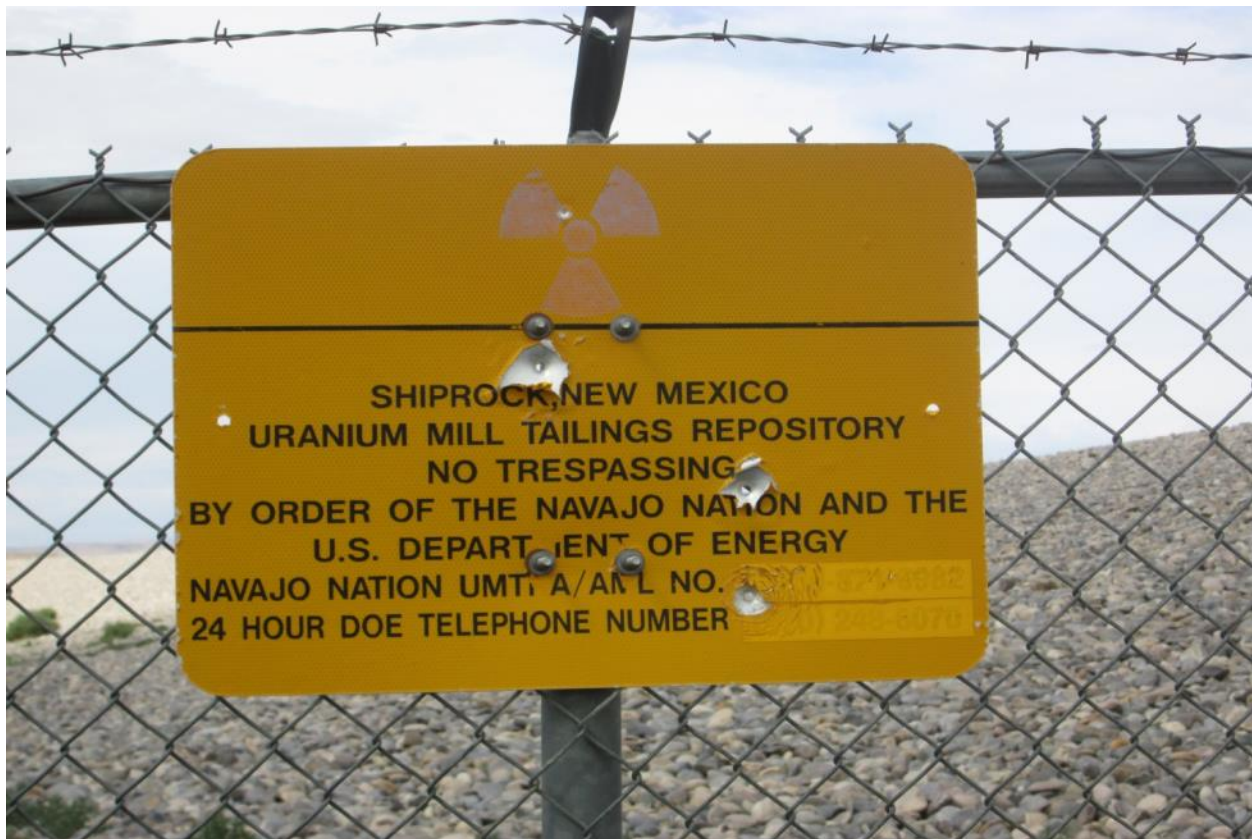
SHP 5/2014. PL-3. Bullet holes in west entrance textual sign; note faded radiation symbol and phone numbers.

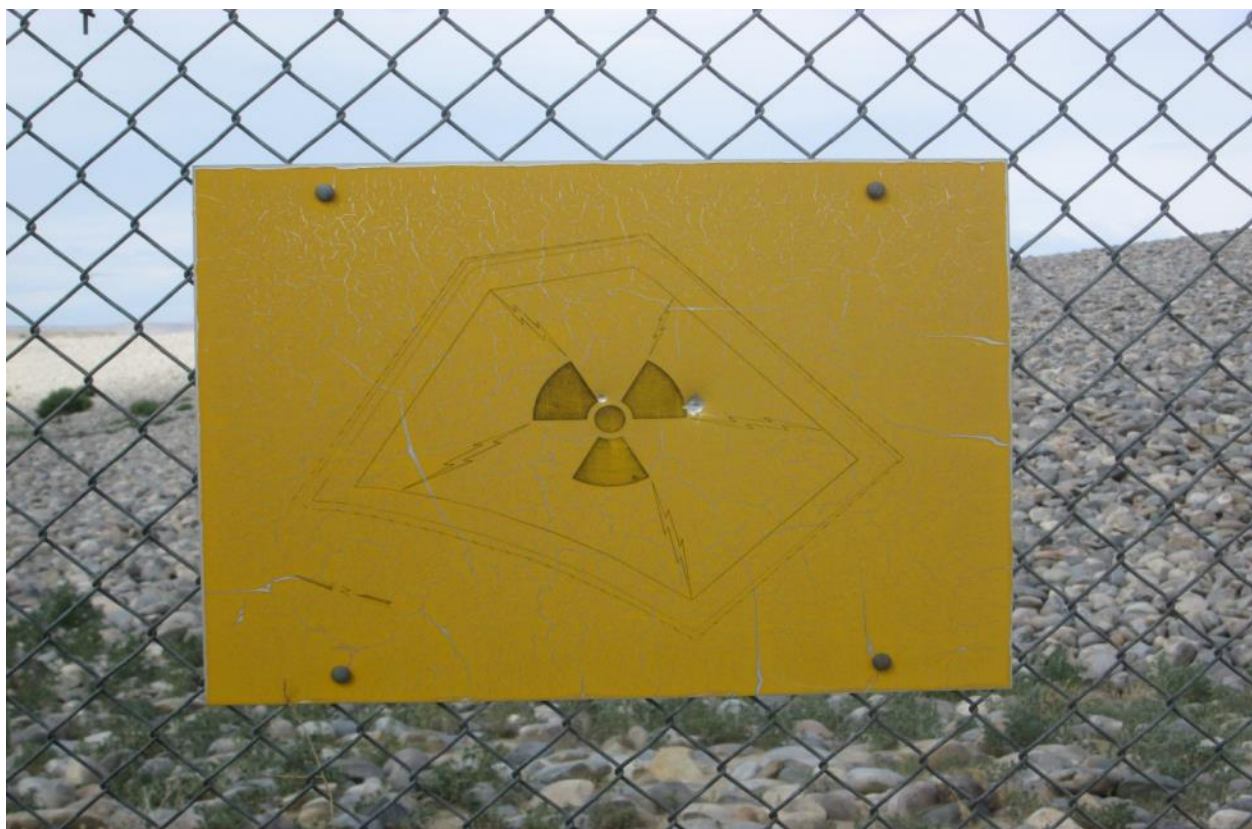
SHP 5/2014. PL-4. Bullet holes in west entrance pictorial sign; note cracked and faded surface.

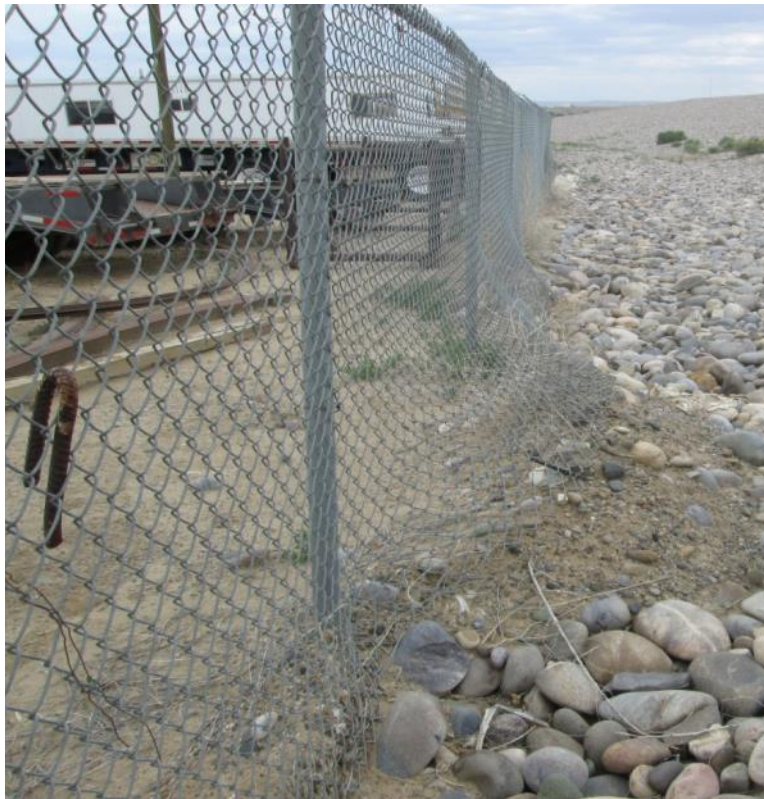
- 16B A chain-link security fence surrounds the disposal cell and drainage features. As observed in previous years, this perimeter fence was damaged in many areas. Damaged fence sections reported in previous years include bent posts and bent fence fabric between perimeter signs P11 and P12, dirt pushed through the fence between P11 and P12 (PL-5), dirt mounded against the fence and a section of bent fence near P13, bent posts near P14, a broken fence riser near P15, and fence risers separated from posts between P15 and P16. During the 2013 inspection, a large hole in the fence was found between signs P13 and P14. This hole was repaired prior to the 2014 inspection (PL-6). Damaged fence sections will continue to be monitored and repaired when necessary to maintain site security.

SHP 5/2014. PL-5. Dirt pushed through fence fabric between perimeter signs P11 and P12; no change from previous years.

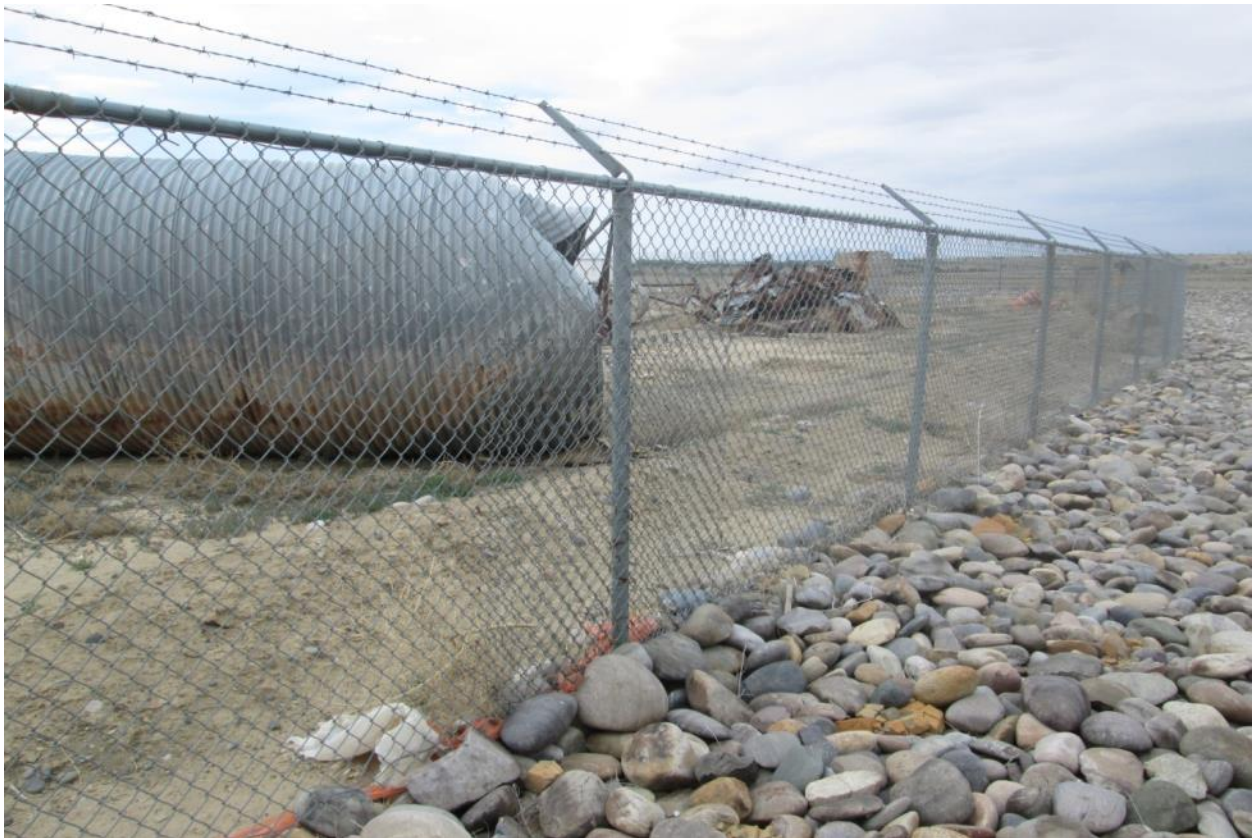
SHP 5/2014. PL-6. Repaired hole in fence, between perimeter signs P13 and P14.

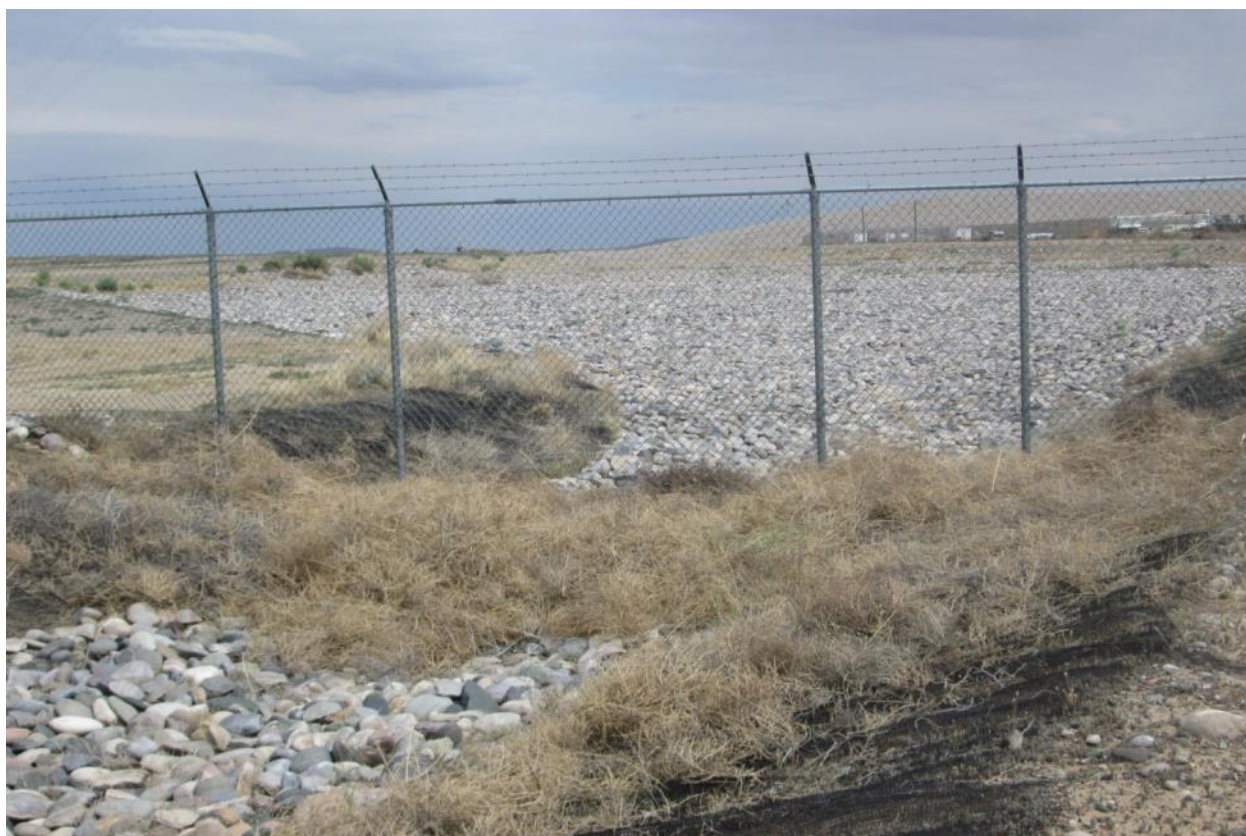
Trash and tumbleweeds continually accumulate in many places along the perimeter fence, particularly along the southwest fence line and a section of fence across the outflow channel (PL-7). Accumulations large enough to represent a fire hazard or increase the possibility of damage to the fence will be removed. During the inspection, inspectors picked up trash along the inside of the perimeter fence and also placed rocks in several gaps beneath the fence that were potentially large enough to allow site access.

SHP 5/2014. PL-7. Tumbleweed accumulation in outflow channel.

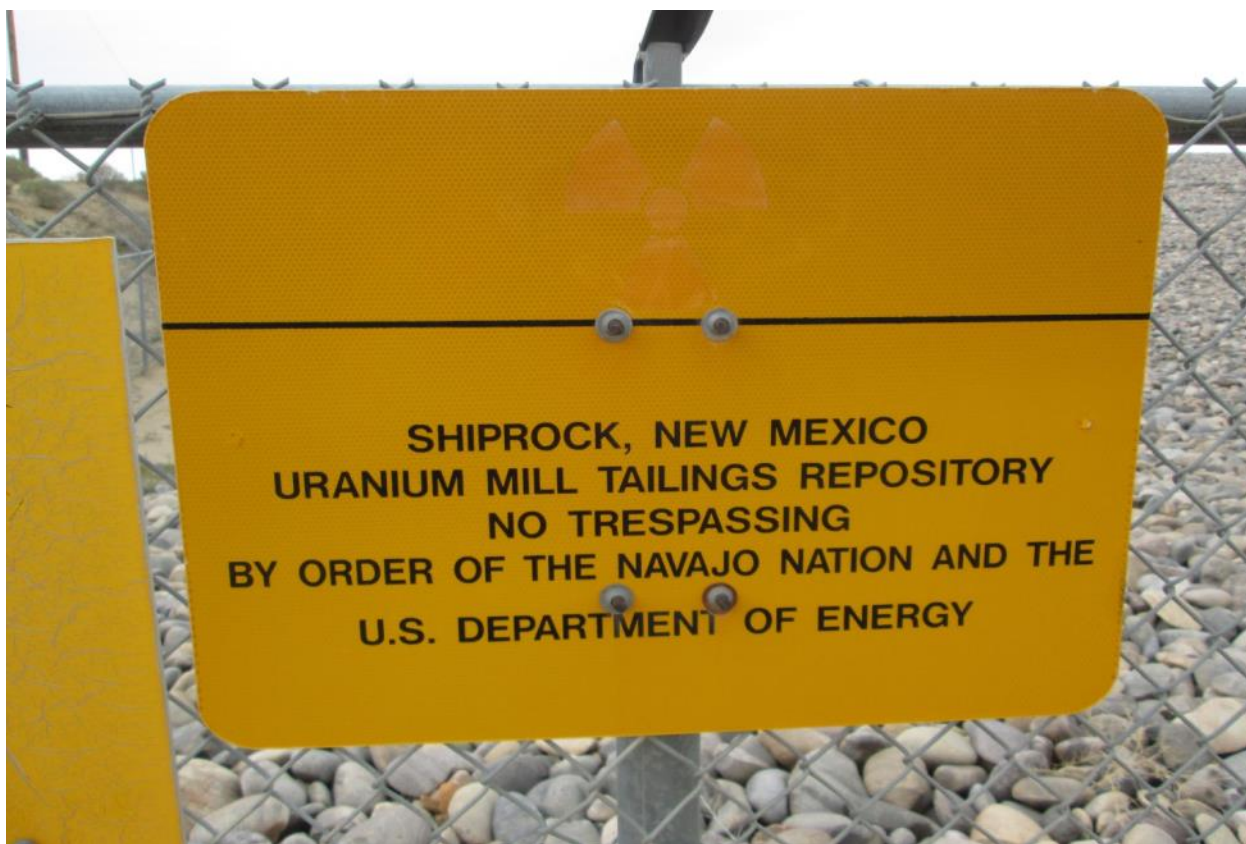
Seventeen pairs of signs, designated P1 through P17 (each pair consisting of one pictorial and one textual sign), are located on the fence around the perimeter of the site. All perimeter signs were in place and legible, and they showed no evidence of vandalism. However, most of the southeast- and southwest-facing textual signs had faded radiation symbols (PL-8), and many of the pictorial signs had cracked and faded surfaces (PL-9). These signs will be replaced as they become illegible.

SHP 5/2014. PL-8. Textual perimeter sign P4, showing faded radiation symbol.

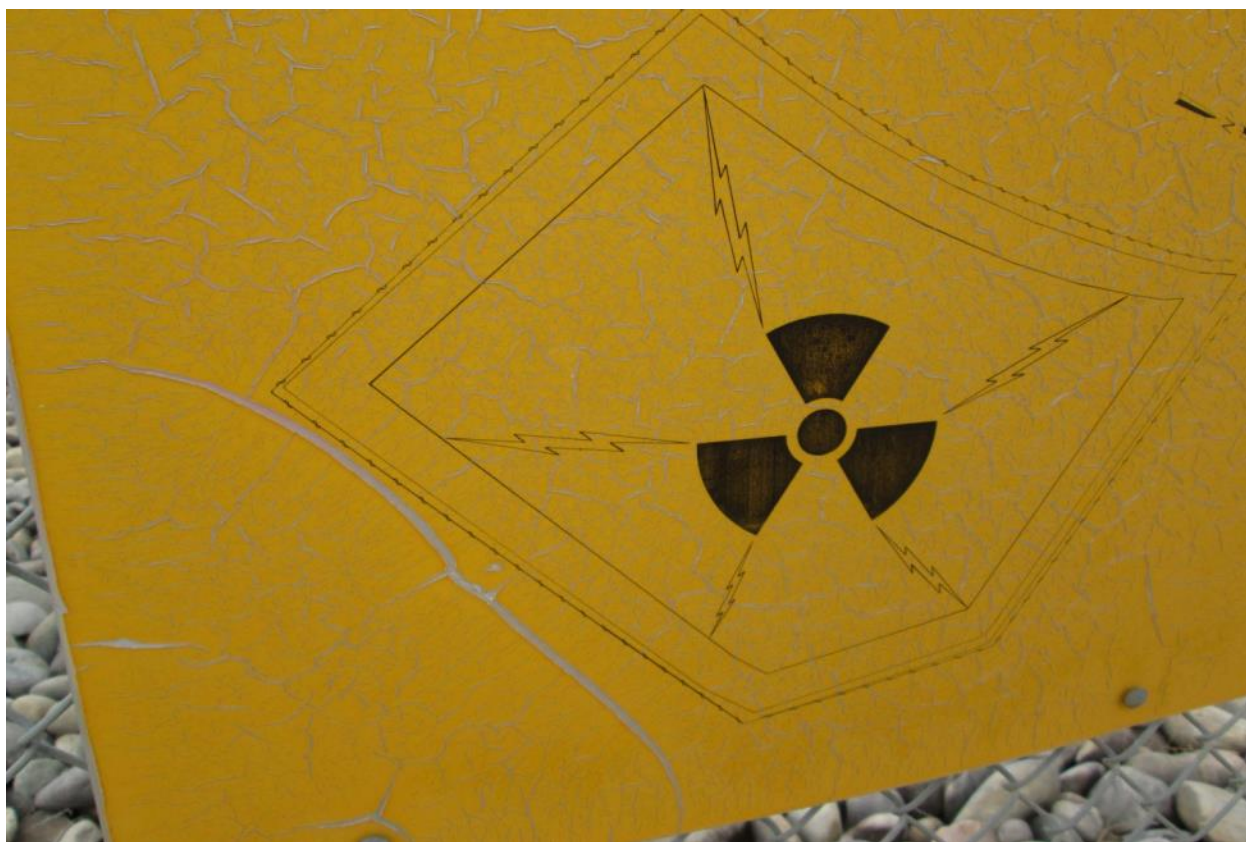
SHP 5/2014. PL-9. Pictorial perimeter sign P4, showing faded and cracked surface.

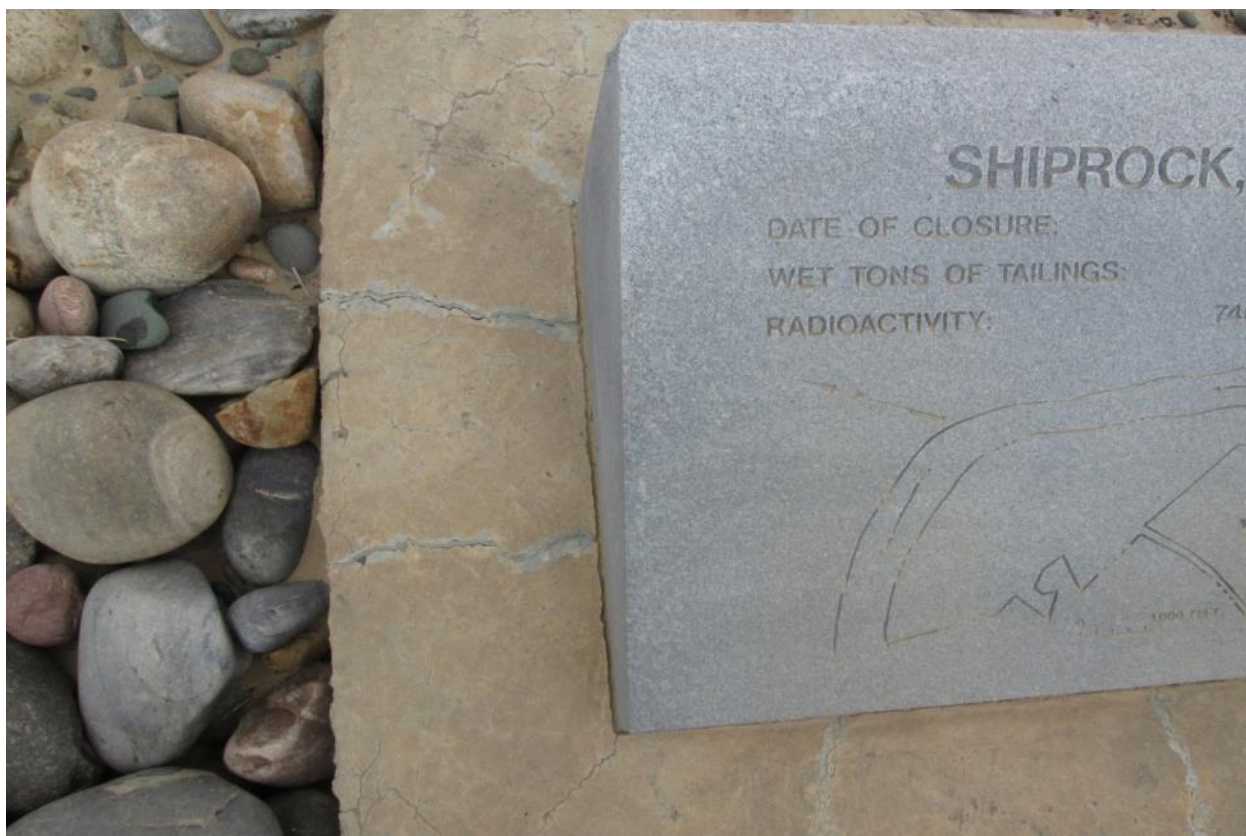
Site marker SMK-1, located just inside the southwest gate, and site marker SMK-2, located on top of the disposal cell, were both in good condition. Minor cracks in the concrete base of SMK-1 were sealed in May 2003 and have not changed significantly (PL-10).

SHP 5/2014. PL-10. Repaired cracks in base of site marker SMK-1.

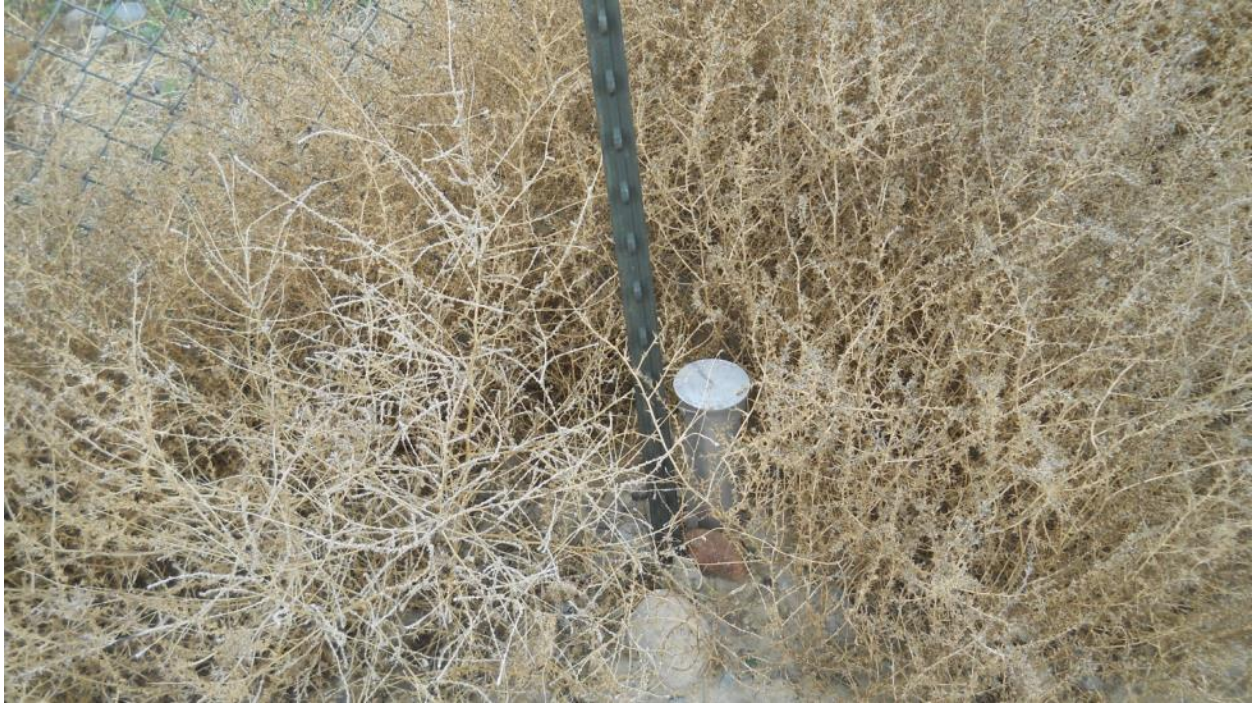
All three survey monuments (SM-1, SM-2, and SM-3) were located and in good condition. The concrete has been cracked at SM-1, but the crack does not threaten the integrity of the marker. Eight boundary monuments were originally installed at the site. Inspection of monument BM-7 was discontinued in 1999 because it is located offsite, on the unsafe, steep embankment below the terrace. Inspection of monument BM-8, also located beyond the site's boundary, was discontinued in 2003. Because they are offsite, inspection of these monuments will not resume. The remaining boundary monuments, marked with a reference post to help inspectors find them, were in good condition (PL-11).

SHP 5/2014. PL-11. Boundary monument BM-1.

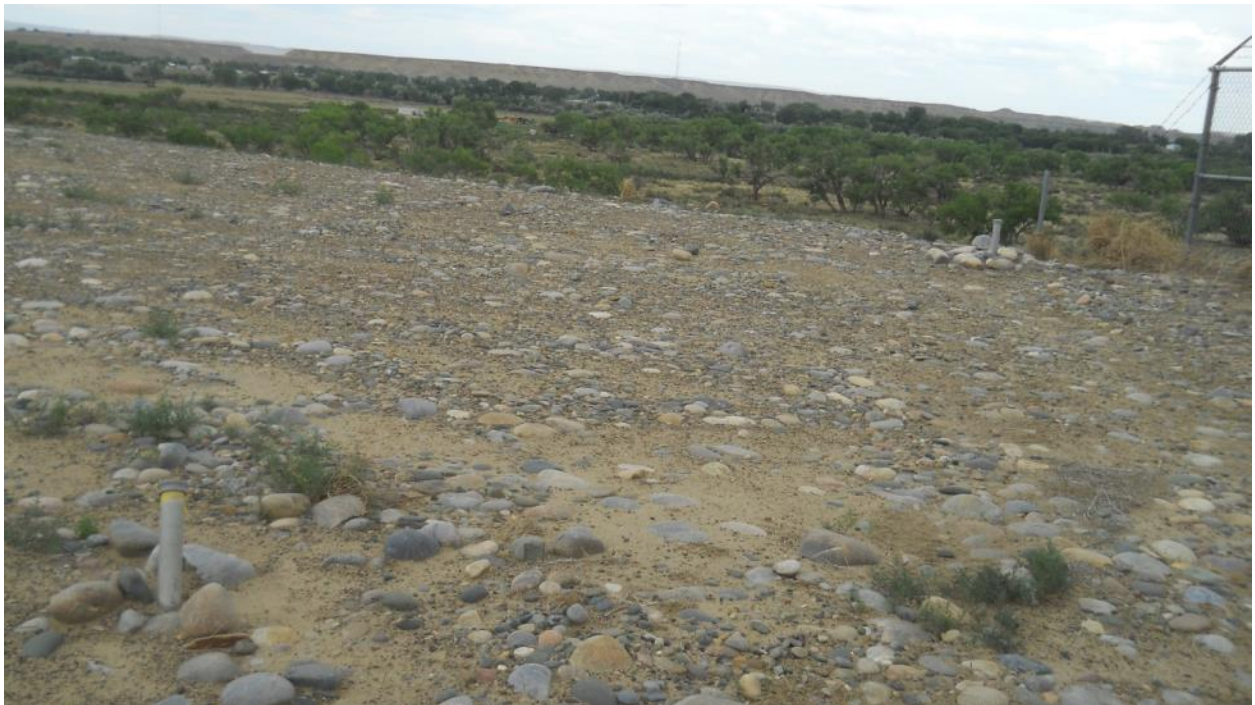
The four pairs of erosion control markers along the edge of the terrace escarpment (1, 1A, 2, 2A, 3, 3A, 5, and 5A) were in good condition except for marker 5A near the east entrance gate. This marker was previously bent by a vehicle, but it is still functional and does not require repair (PL-12). Erosion control markers 4 and 4A are not inspected; they were installed on the terrace east of the disposal site, in the gravel pit. Markers 5 and 5A replaced Markers 4 and 4A.

SHP 5/2014. PL-12. Erosion control markers 5A and 5; 5A (foreground) is bent.

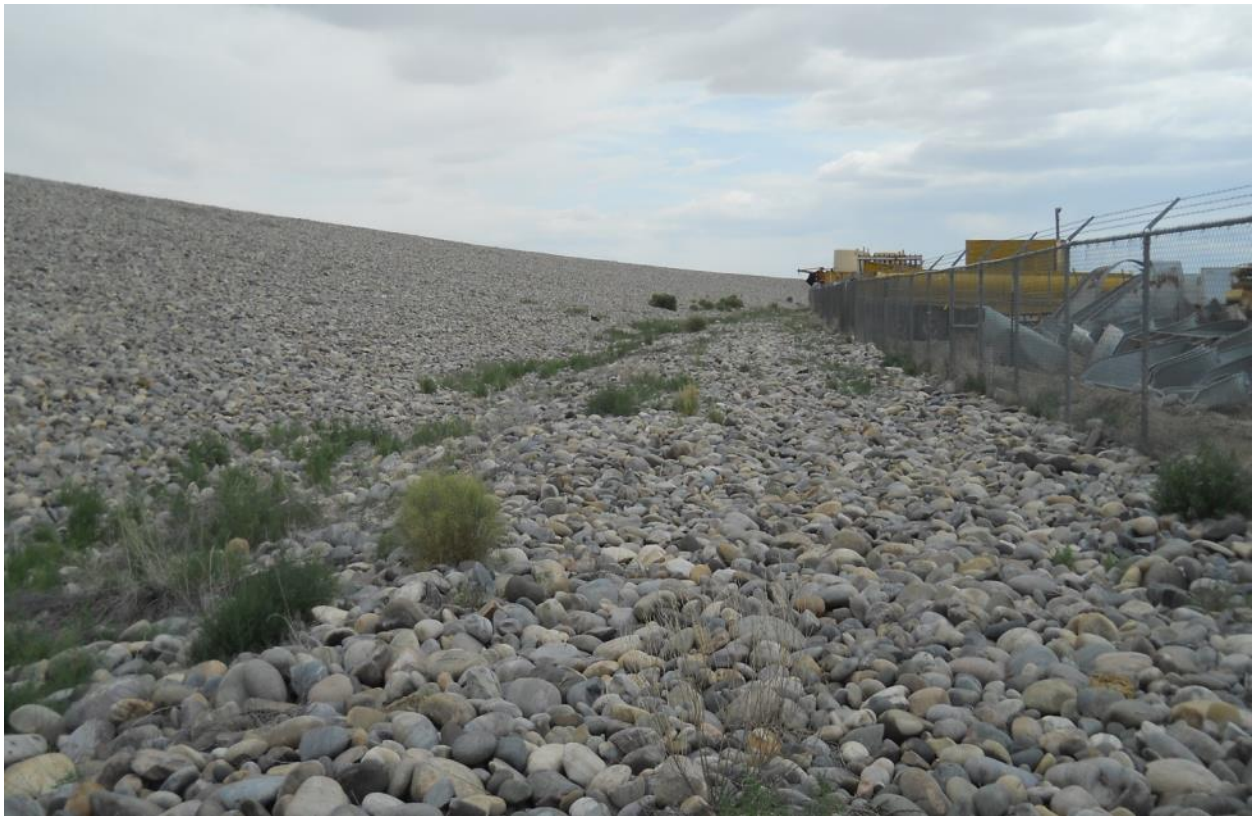
The riprap-covered top and side slopes of the cell were in good condition (PL-13). No evidence of slumping, erosion, animal intrusion, riprap deterioration, or other significant disturbance was

SHP 5/2014. PL-13. Cell side slope and fence near perimeter sign P14.

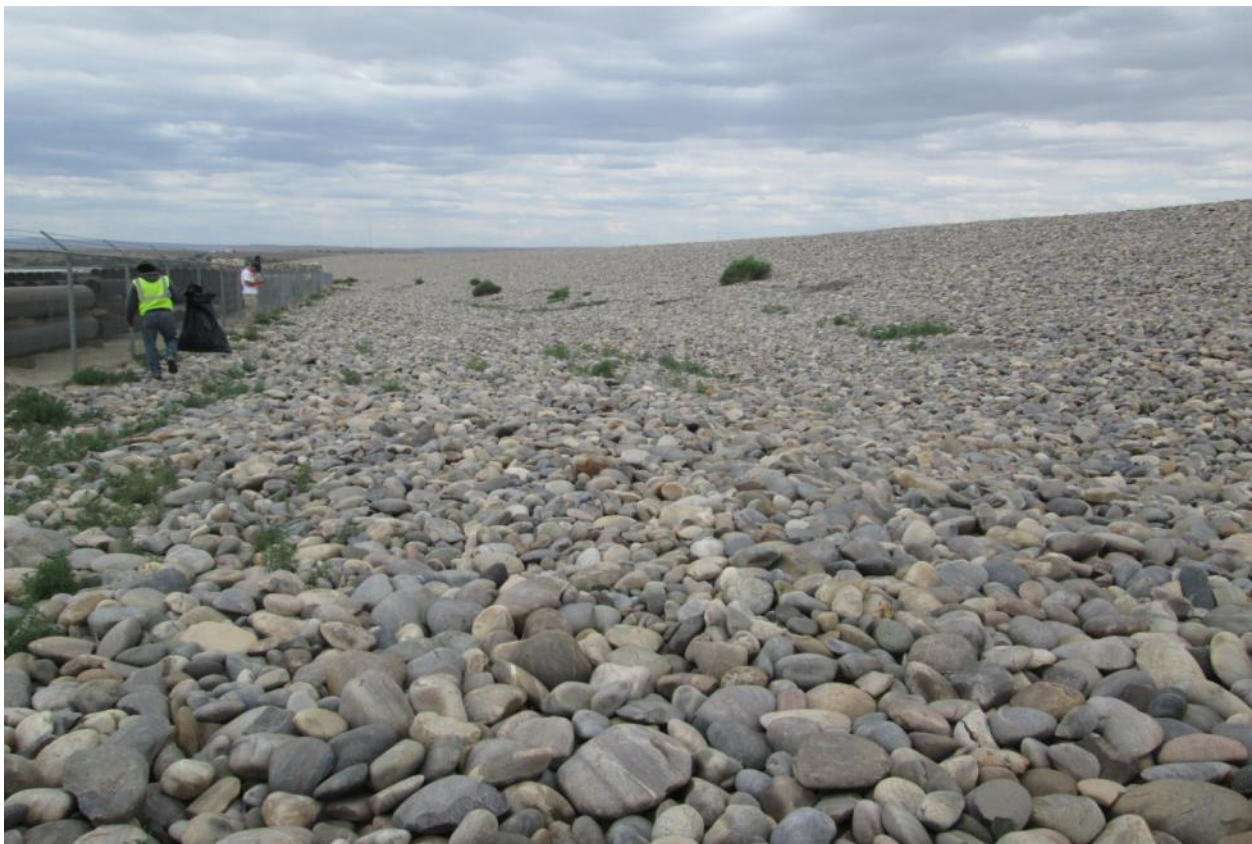
SHP 5/2014. PL-14. Diversion ditch and northwest side slope of disposal cell.

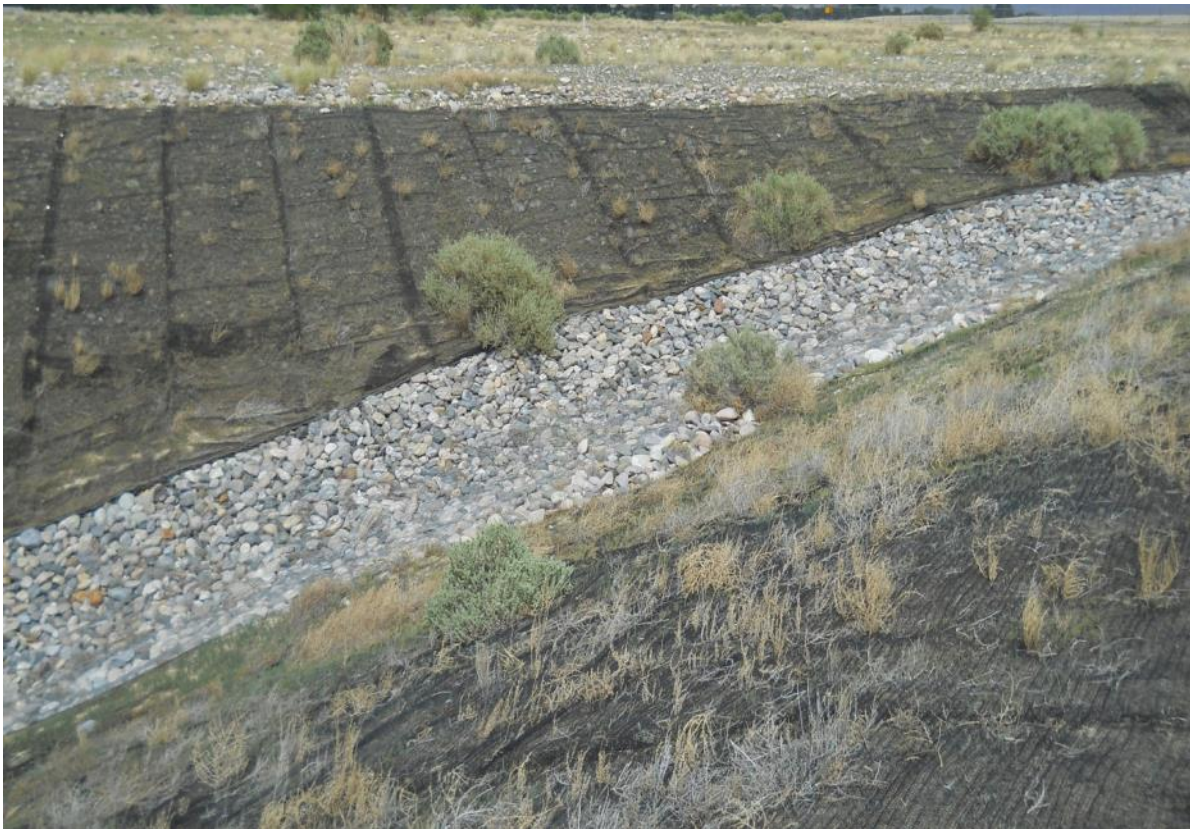
The offsite portion of the outflow channel was functional and in good condition (PL-15). A portion of erosion control fabric had previously come loose and been removed from one of the side slopes of the channel (PL-16). This area remained stable and does not need to be re-covered. Fences and warning signs posted in Bob Lee Wash are maintained under the groundwater compliance strategy and are not examined during the annual inspection.

SHP 5/2014. PL-15. Outflow channel.

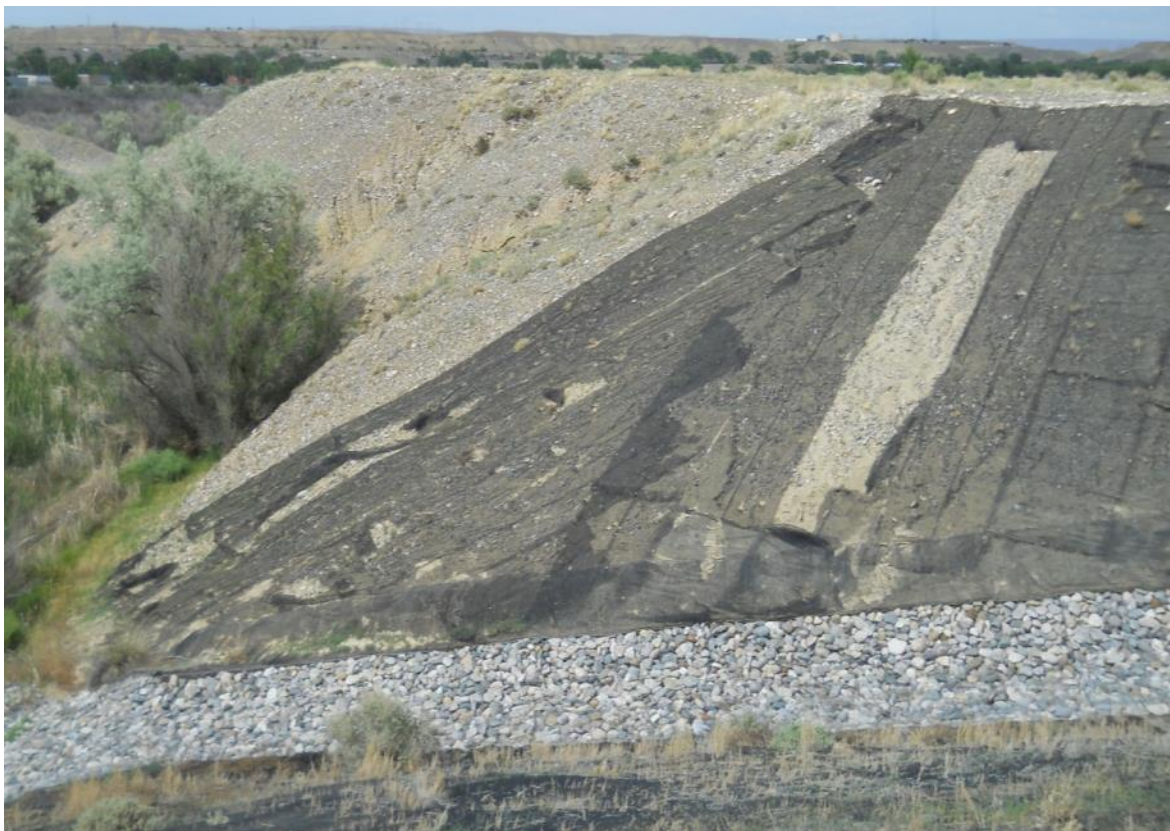
SHP 5/2014. PL-16. Loose erosion control fabric along outflow channel side slope.
