16.0 Shiprock, New Mexico, Disposal Site

16.1 Compliance Summary

16.4 Inspection Results

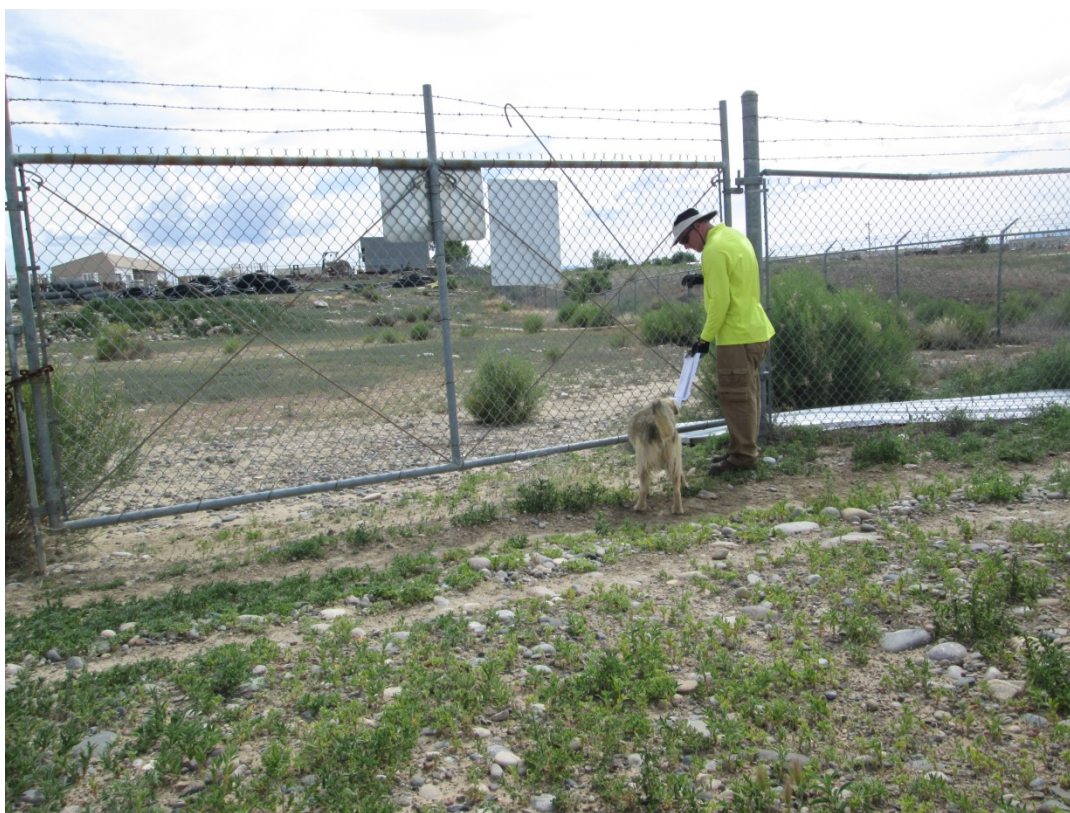
16A All access roads were in good condition. Three gates allow entrance to the site through the perimeter fence: the east gate (the current main entrance gate near the terrace escarpment), the north gate (an auxiliary access gate), and the west gate (the former entrance gate). Access to the main (east) entrance gate is gained by traveling through a gravel pit. The three gates were intact and operable, although an unacceptably wide gap was discovered below the north gate (PL-1). Two local dogs entered the site through this gap during the inspection. The gate was lowered to reduce the gap.

SHP 5/2015. PL-1. View of 12-inch gap under north gate before repair; the gap allowed trespass by local dogs.

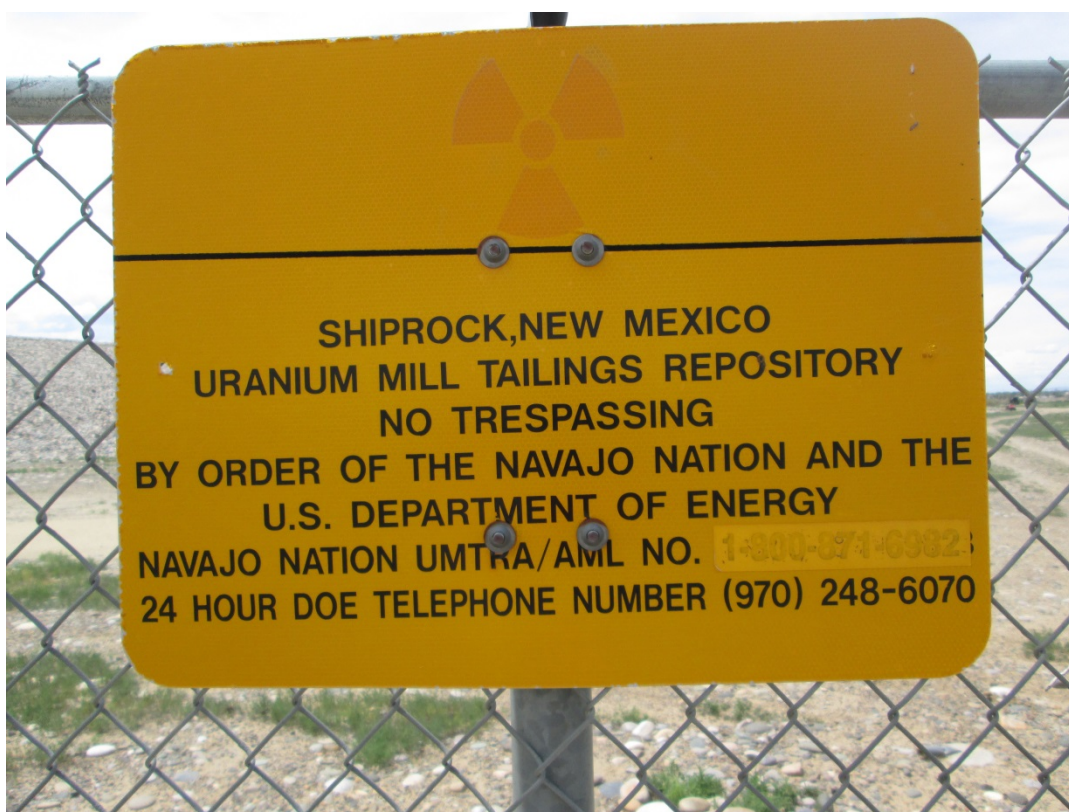
Entrance signs are present in pairs—one pictorial and one textual—near each gate. All entrance signs were intact, but signs at the east (PL-2) and west gates had faded radiation symbols and were missing the Navajo Nation AML/UMTRA phone number, and the north gate had a faded radiation symbol (PL-3). Faded radiation symbols with missing phone numbers are in the process of being replaced.

SHP 5/2015. PL-2. Entrance sign at east gate; new radiation symbol and Navajo Nation UMTRA/AML phone number will be added.

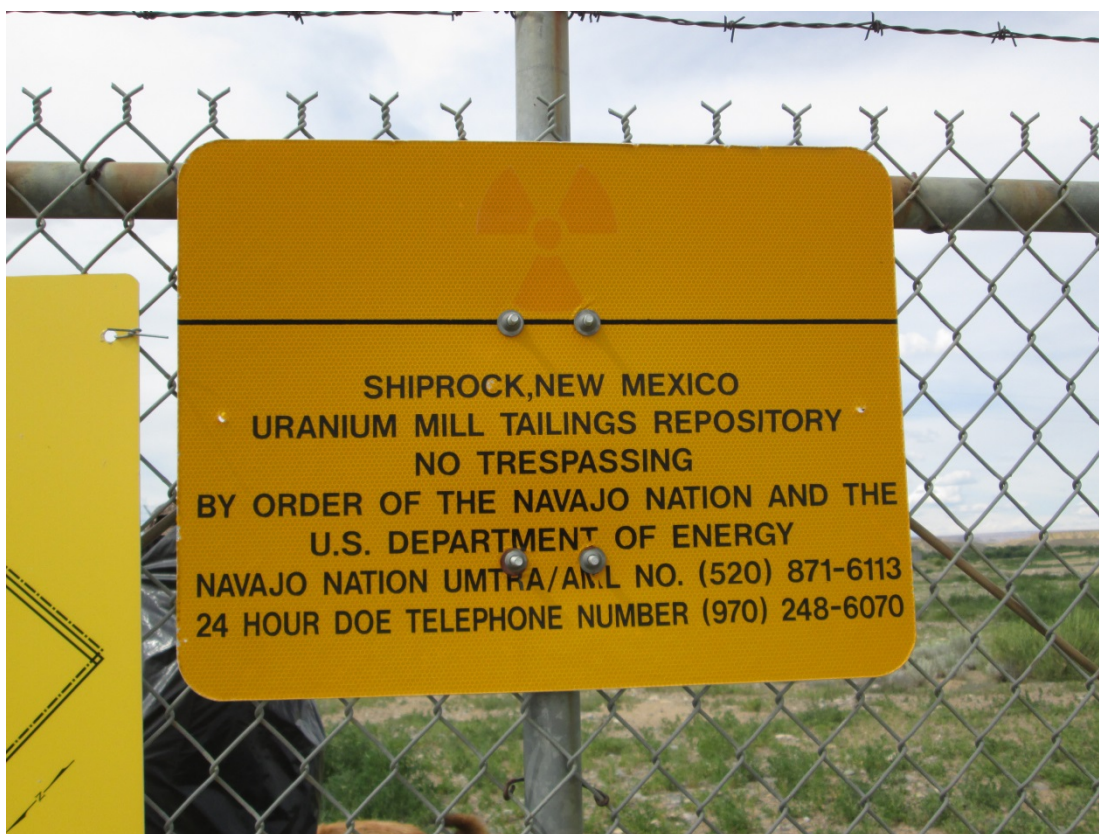
SHP 5/2015. PL-3. Entrance sign on north gate; note faded radiation symbol.

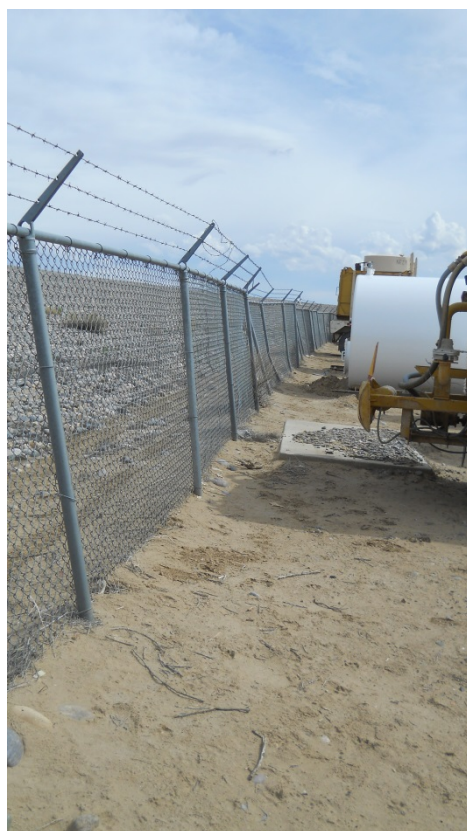
SHP 5/2015. PL-4. Perimeter fence between perimeter signs P12 and P13, next to Navajo Engineering and Construction Authority (NECA) yard.

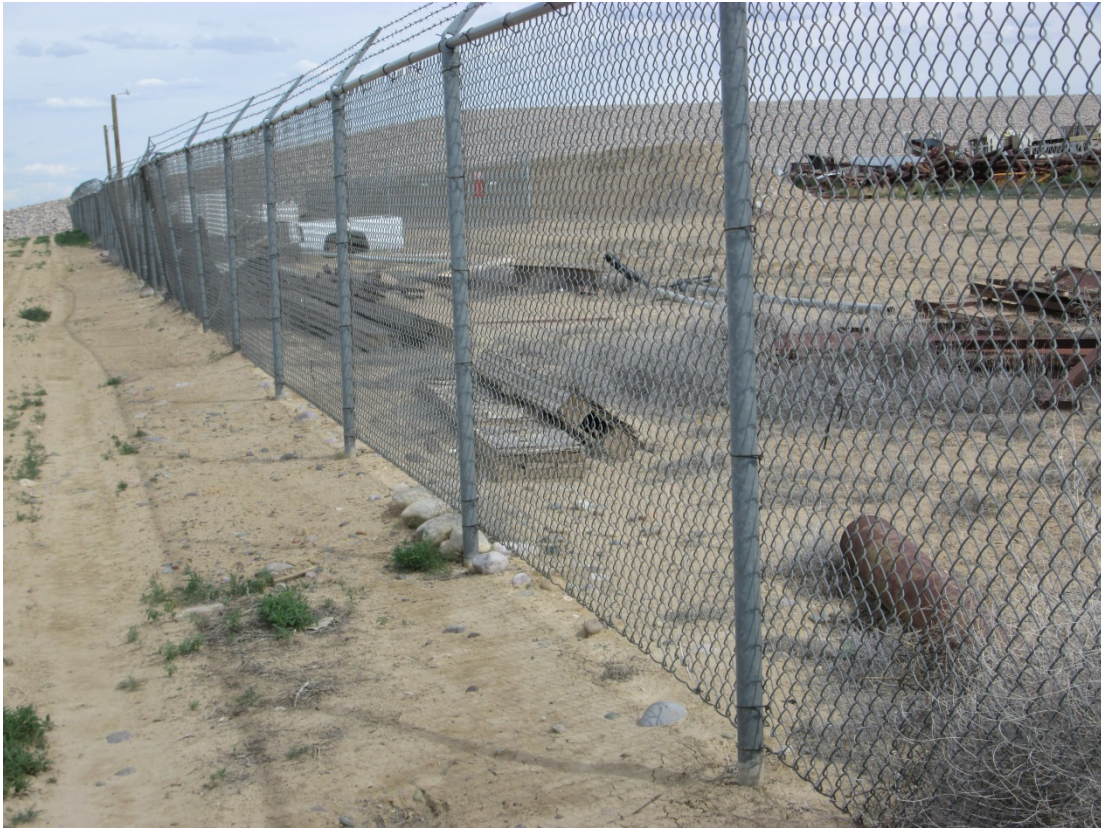
16B A relatively long section of fence by perimeter sign P15 has a 3- to 6-inch gap beneath it (PL-5). The gap is not a concern at this time, and inspectors will continue to monitor this area to determine if the gap has widened and needs to be repaired. In several other places along the perimeter fence, inspectors placed rocks in gaps that were potentially large enough to allow site access by animals.

SHP 5/2015. PL-5. Perimeter fence with 3- to 6-inch gap on bottom.

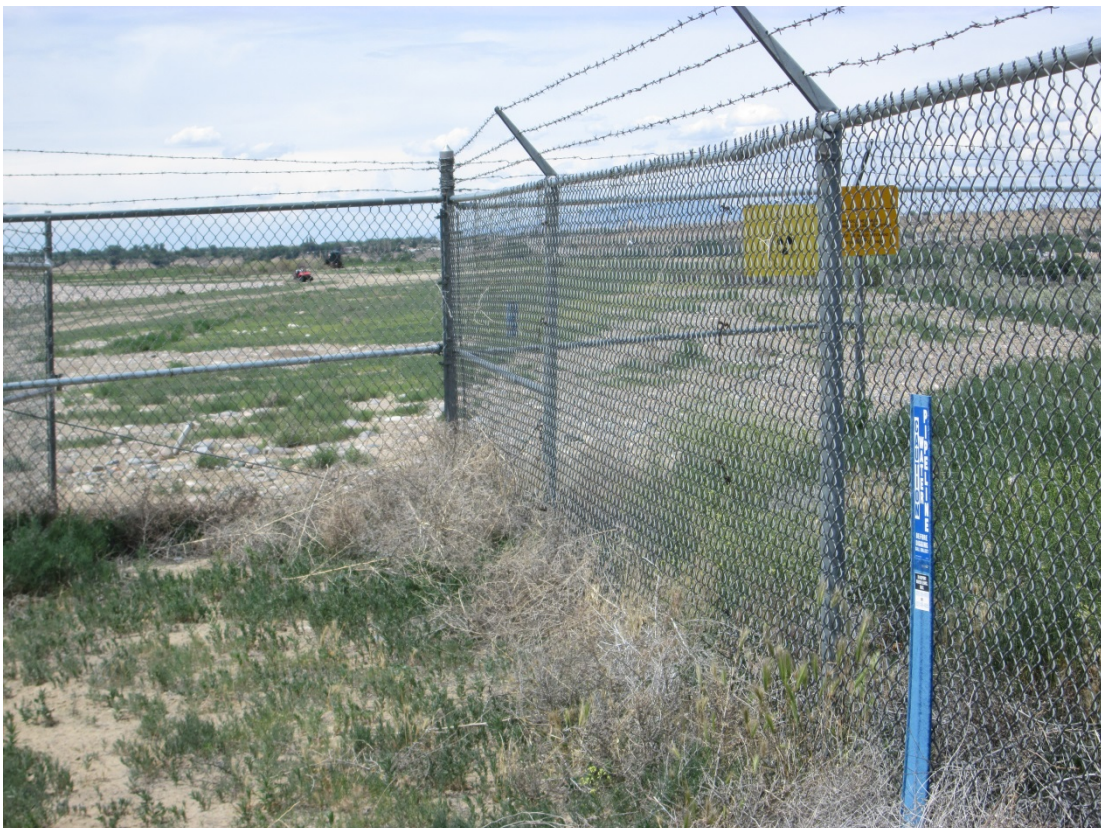
Trash and tumbleweeds continually accumulate in many places along the perimeter fence, although regular maintenance in recent years has kept both to a minimum. During the 2015 inspection, small accumulations of tumbleweed were noted in the perimeter fence corner by the east entrance gate (PL-6) and along the fence near perimeter sign P6 and across the outflow channel (PL-7). Accumulations large enough to represent a fire hazard or increase the possibility of damage to the fence will continue to be removed. During the inspection, inspectors picked up trash along the inside of the perimeter fence.

SHP 5/2015. PL-6. Minor buildup of tumbleweed in perimeter fence corner near the east gate.

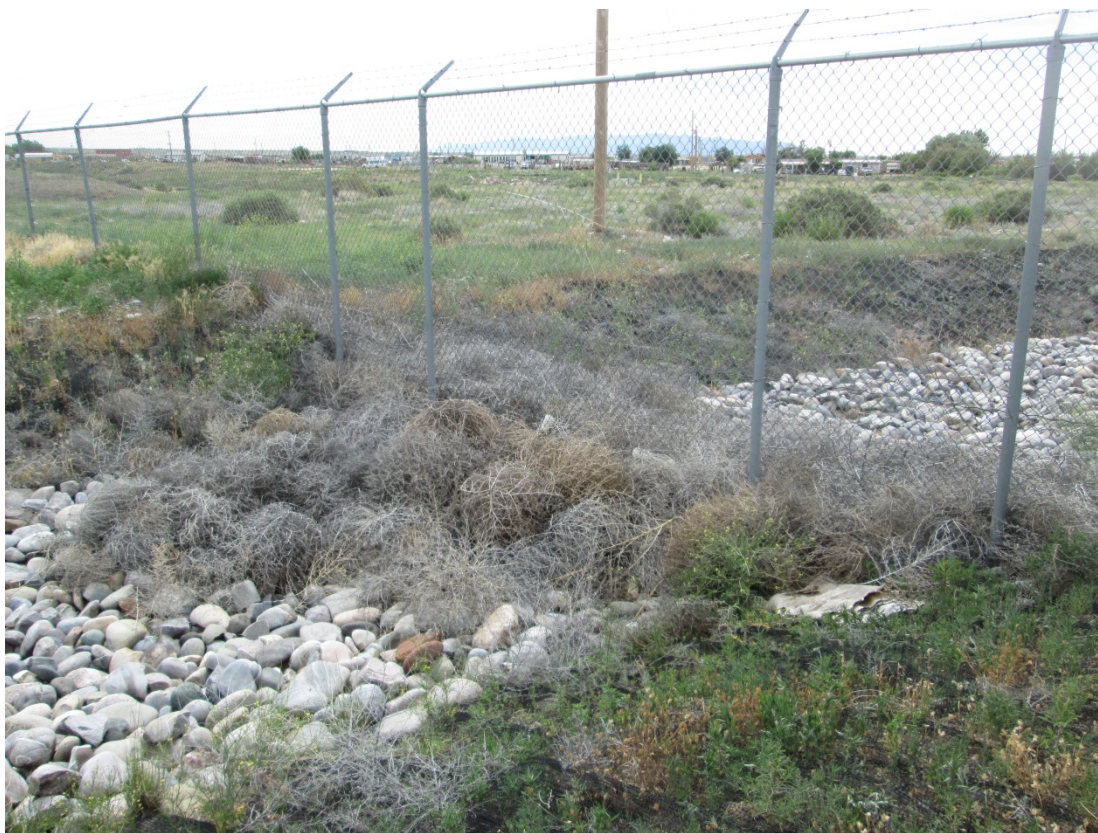
SHP 5/2015. PL-7. Tumbleweed buildup in outflow channel next to perimeter fence.

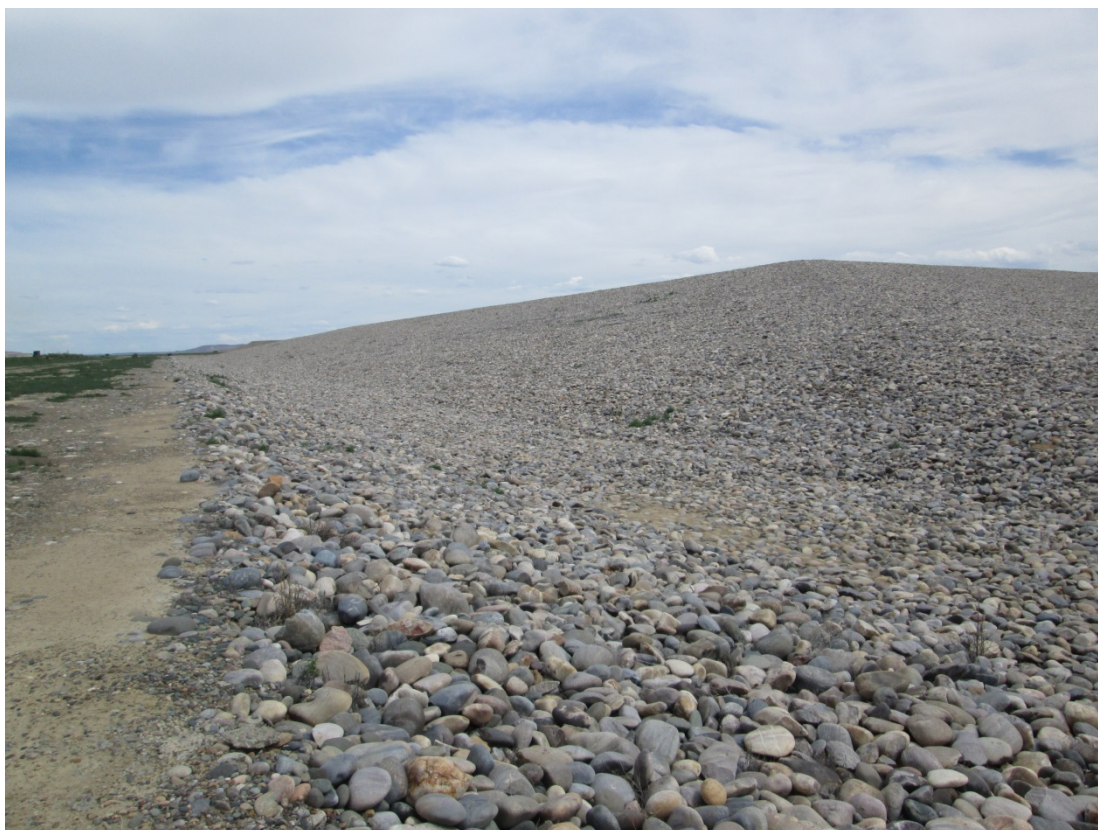
The riprap-covered top and side slopes of the cell were in good condition (PL-8). No evidence of slumping, erosion, animal intrusion, riprap deterioration, or other significant disturbance was found. Piezocones associated with a research project were installed on the cell cover in the past. Some of the filled piezocone pits have subsided slightly, forming shallow conical depressions in the cover. As previously reported, the surface of the cell is covered with vehicle ruts. The condition of the depressions and vehicle ruts is monitored annually and has not changed significantly since the 2014 inspection.

SHP 5/2015. PL-8. Northeast-facing side slope of disposal cell.

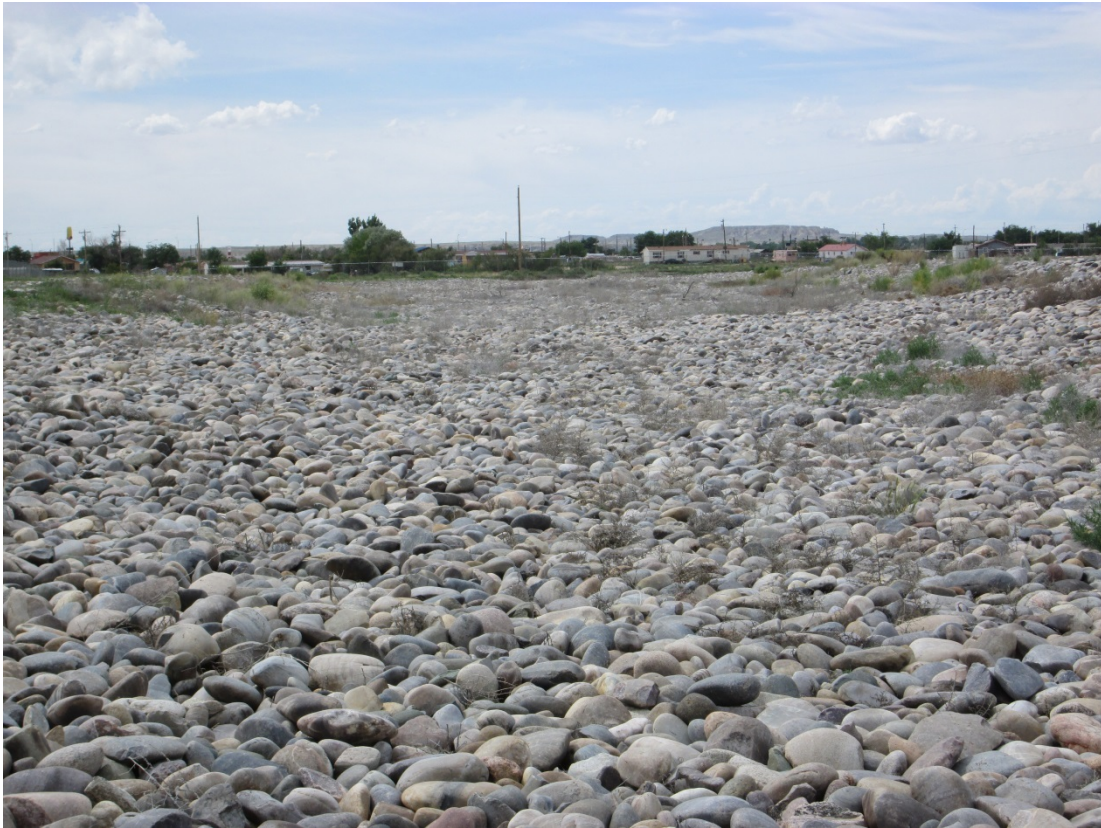
Diversion channels around the base of the disposal cell were in good condition and contained scattered vegetation, including several woody shrubs. These shrubs do not affect the integrity of the channel at this time and are not a concern. In the outflow channel, non-woody plants were growing within the channel, and woody vegetation was growing on the banks of the channel. The channel itself was in excellent condition (PL-9).

SHP 5/2015. PL-9. Unobstructed outflow channel.

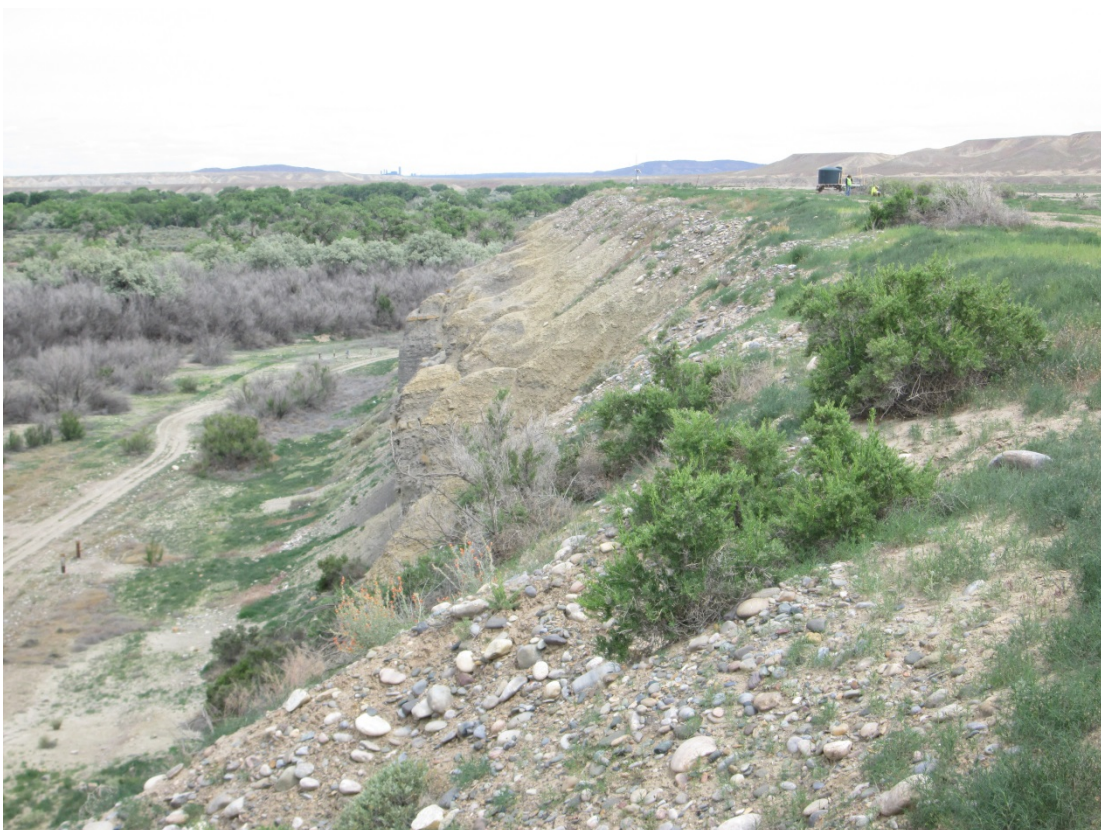
SHP 5/2015. PL-10. View southeast of escarpment face.

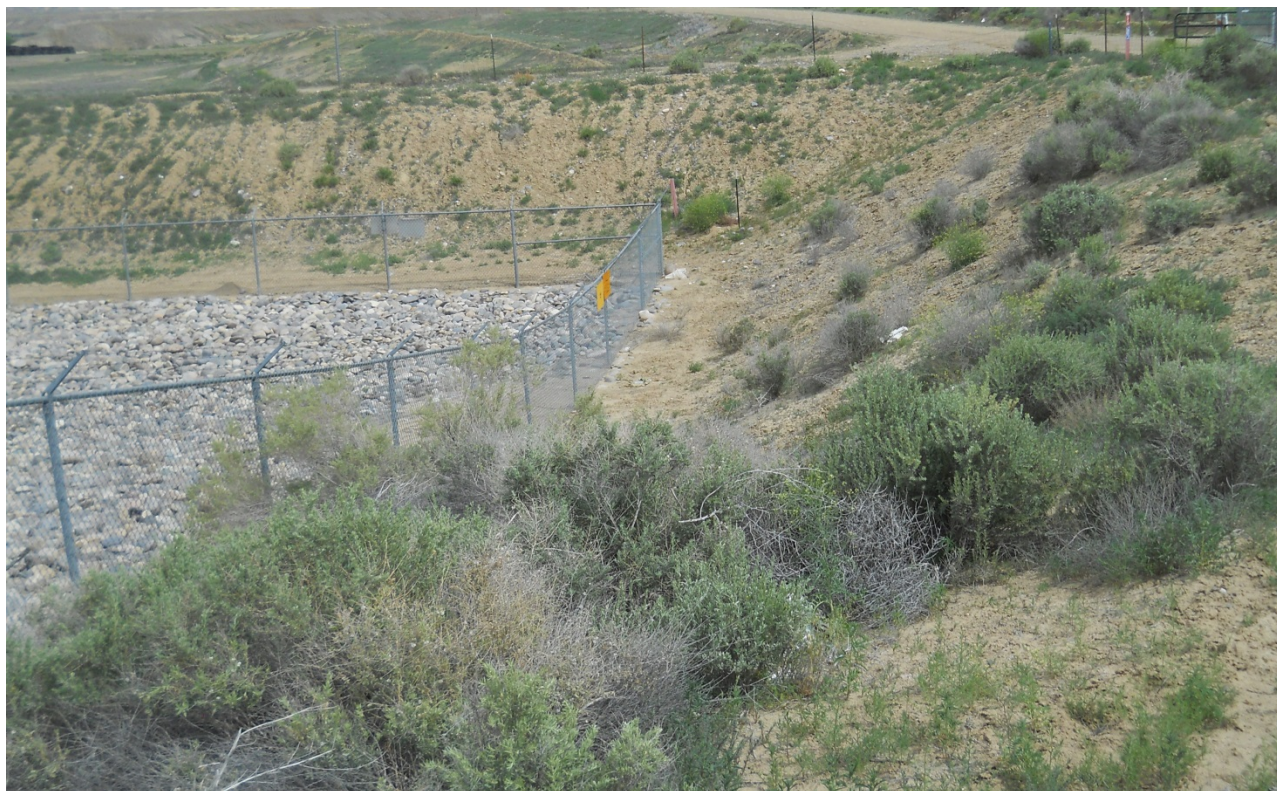
Inspectors discovered newly eroded areas associated with the steep side slopes adjacent to the southern portion of the disposal cell (PL-11, PL-12). Sediment is eroding from the side slopes and being deposited on the riprap surrounding the disposal cell. Currently, this process does not

threaten the integrity of the disposal cell but will encourage the growth of weeds and vegetation along the base of the cell.

SHP 5/2015. PL-11. View of eroding slopes adjacent to the southeast and southwest perimeter fences.

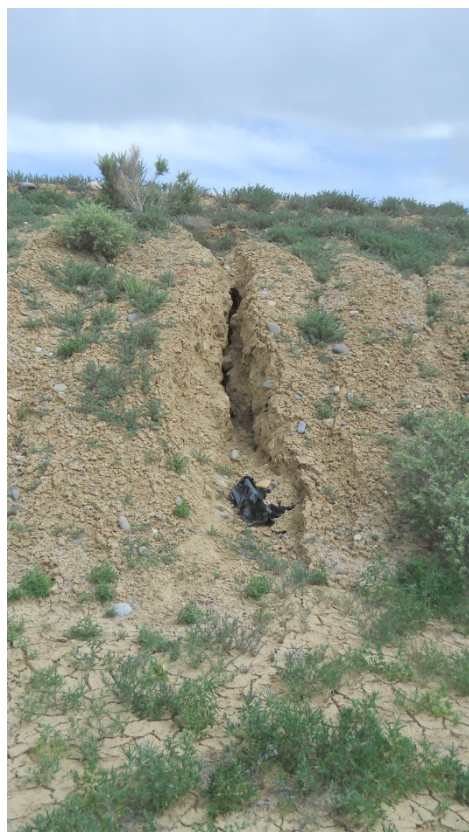
SHP 5/2015. PL-12. Eroding steep slope adjacent to southeast perimeter fence.

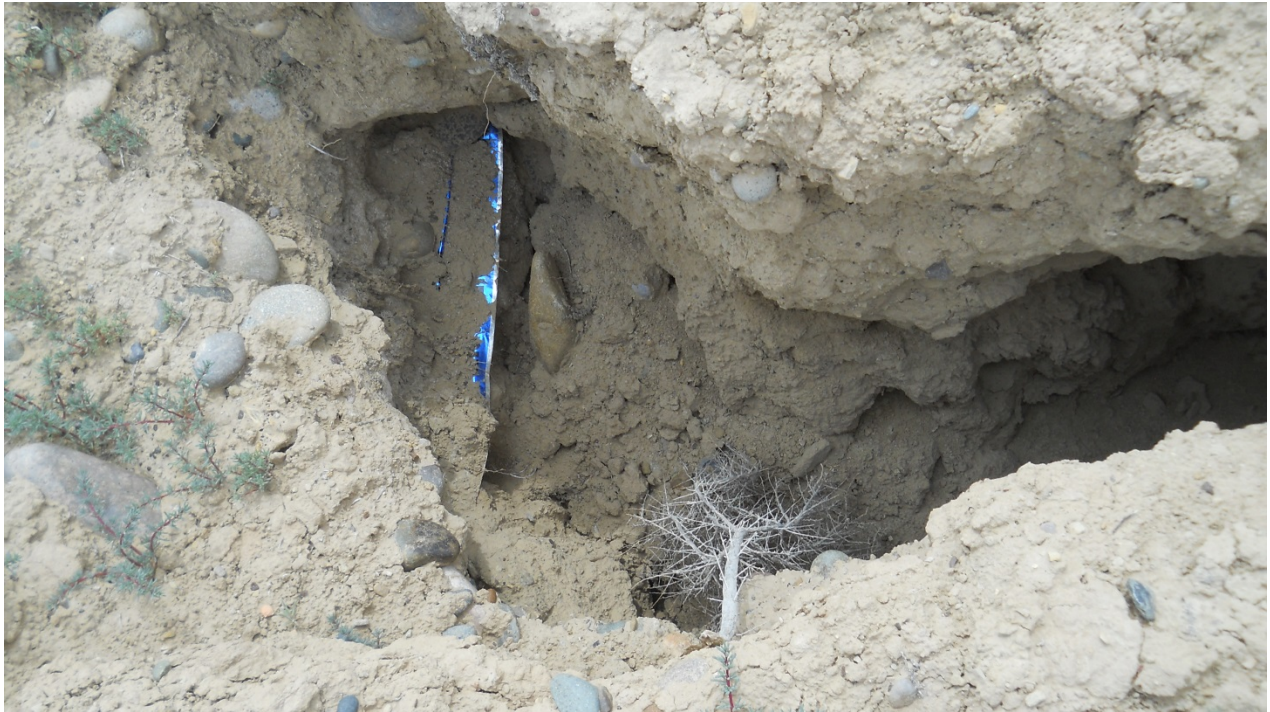
Inspectors also discovered that side slope erosion near perimeter sign P6 had uncovered a buried water pipeline used to transport contaminated water from the floodplain to the evaporation pond (PL-13). The pipeline is a feature associated with the groundwater compliance strategy and typically is not part of the annual inspection. The pipeline is located within Navajo Engineering and Construction Authority (NECA) property. NECA was consulted about the erosion damage and the pipeline and made the necessary repairs.

SHP 5/2015. PL-13. Soil erosion exposing buried water pipeline.

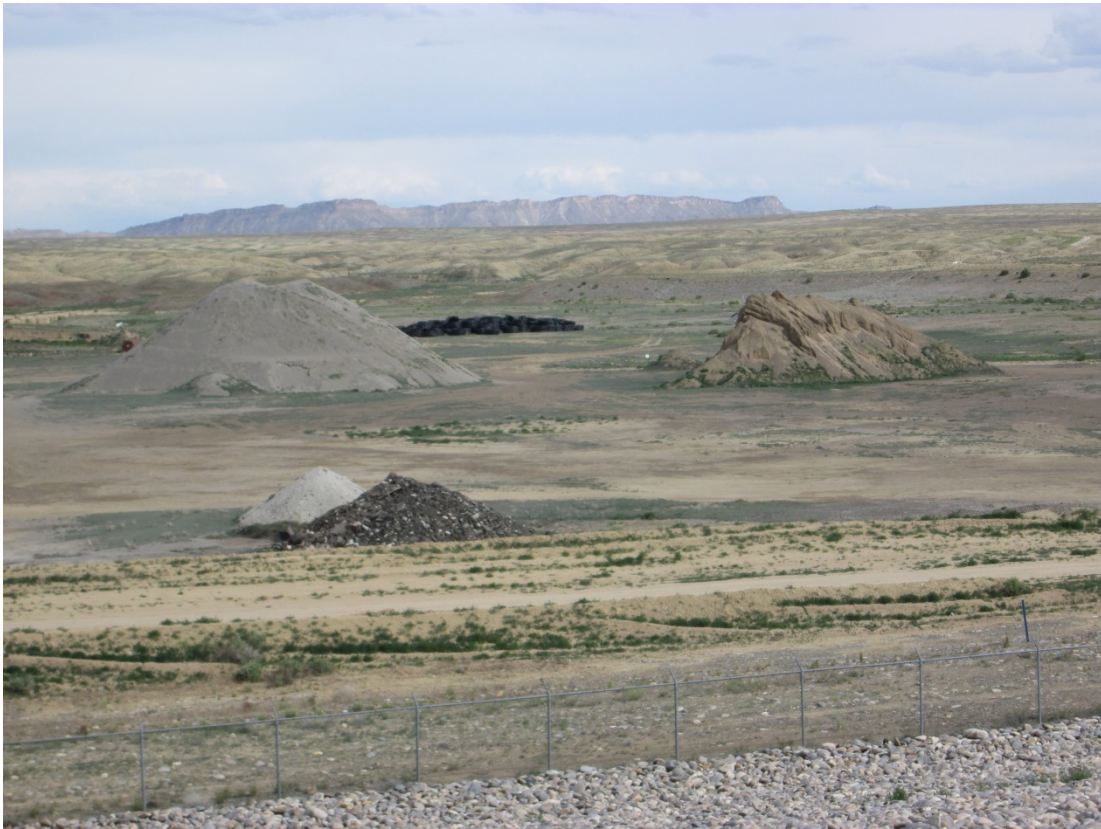
A gravel pit is located immediately southeast of the disposal cell (PL-14). No significant changes in land use associated with the gravel pit or with other outlying areas near the disposal cell were identified.

SHP 5/2015. PL-14. Adjacent gravel pit area.

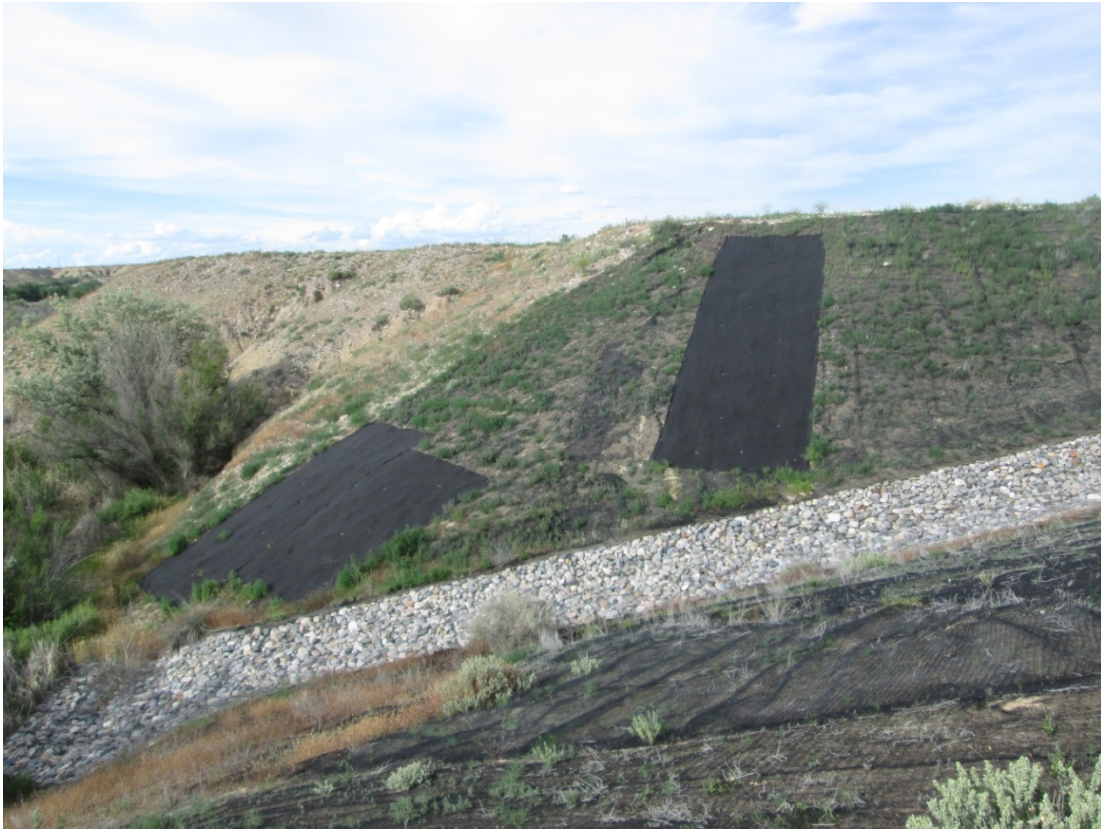
The offsite portion of the outflow channel was functional and in good condition. A portion of erosion control fabric had previously come loose from one of the side slopes of the channel and was repaired in 2014 (PL-15). Fences and warning signs posted in Bob Lee Wash are maintained under the groundwater compliance strategy and are not examined during the annual inspection.

SHP 5/2015. PL-15. Recent repairs to erosion control fabric on lower end of outflow channel.

A hole in the erosion control fabric covering the offsite portion of the outflow channel was repaired prior to the 2015 inspection. Accumulations of tumbleweeds and trash along the site perimeter fence will continue to be removed regularly. The faded or damaged entrance and perimeter signs will be replaced as they become illegible. In 2015, the north gate was lowered to remove the wide gap beneath it; missing Navajo Nation AML/UMTRA phone numbers are in the process of being added to the entrance signs at the east and west gates; woody shrubs on the disposal cell cover were treated with herbicide; and NECA was consulted about the exposed water pipeline and the pipeline was reburied.
