## 16.0 Shiprock, New Mexico, Disposal Site

### 16.1 Compliance Summary

## **16.4 Inspection Results**

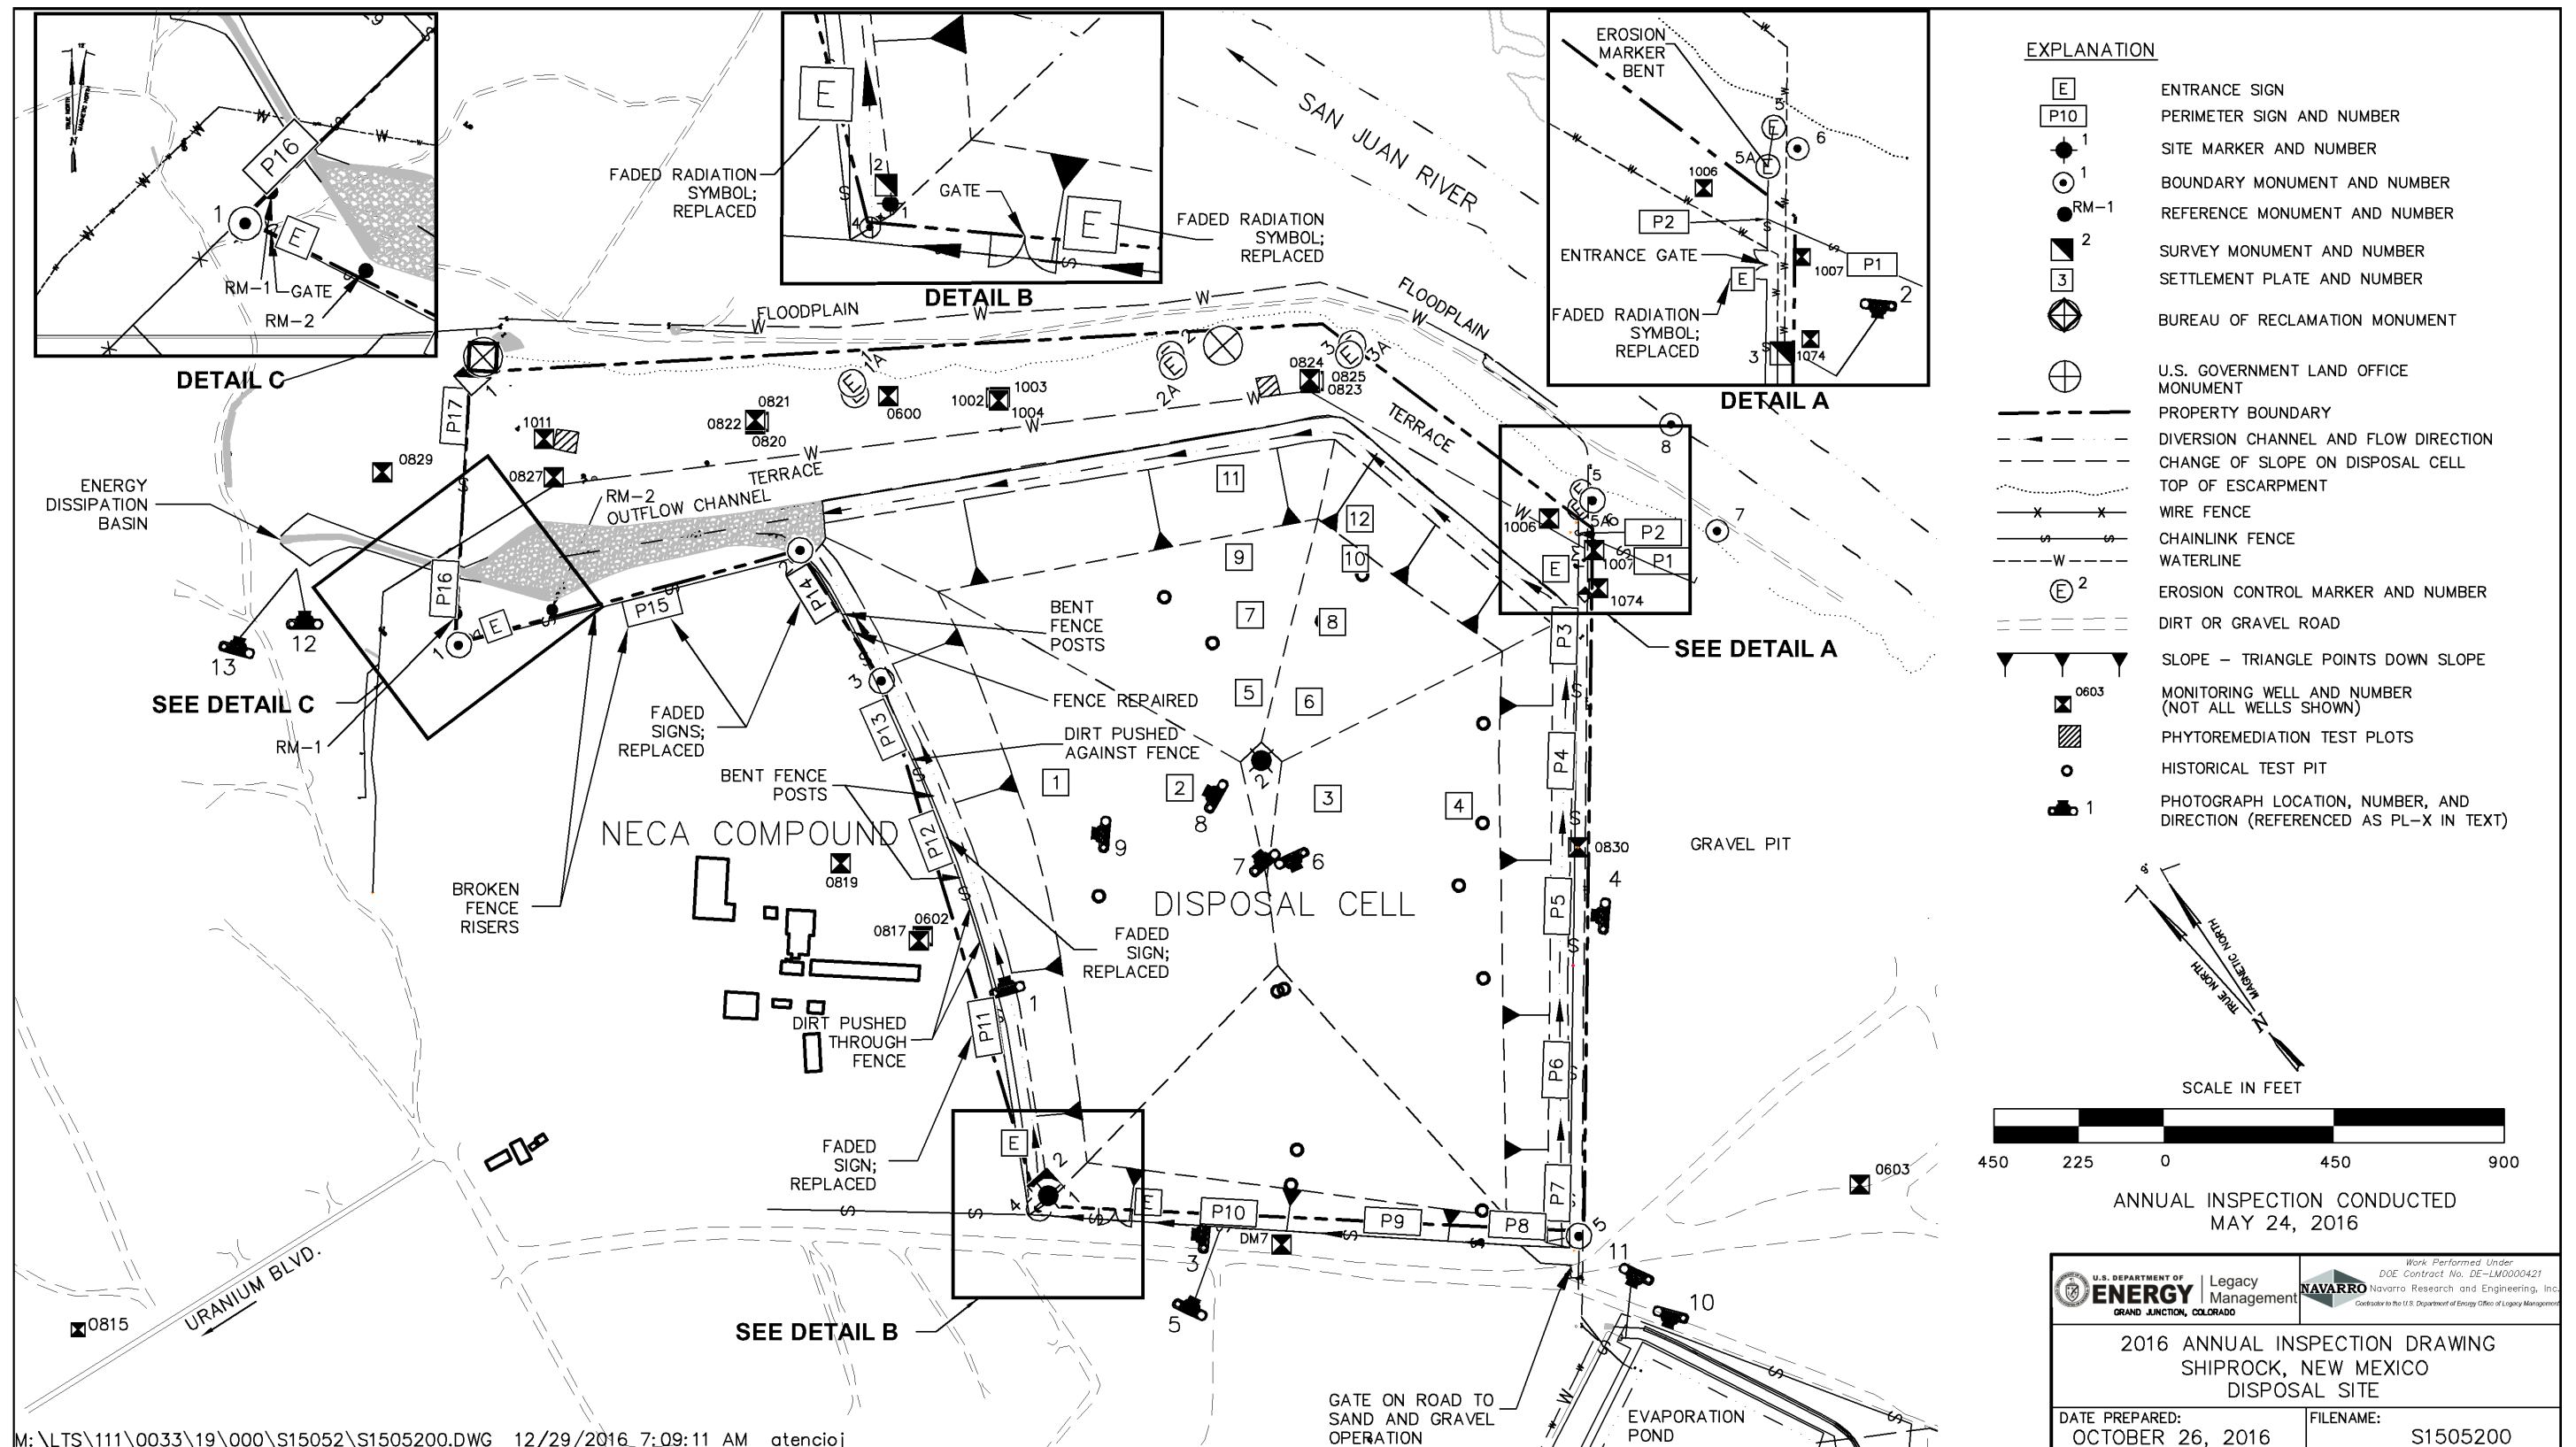
Figure 16-1. 2016 Annual Inspection Drawing for the Shiprock Disposal Site

Figure 16-1 shows the locations of site surveillance features. Inspection results and recommended maintenance activities associated with site surveillance features are described in the following subsections. Photographs to support specific observations are identified in the text and in Figure 16-1 by photograph location (PL) numbers.

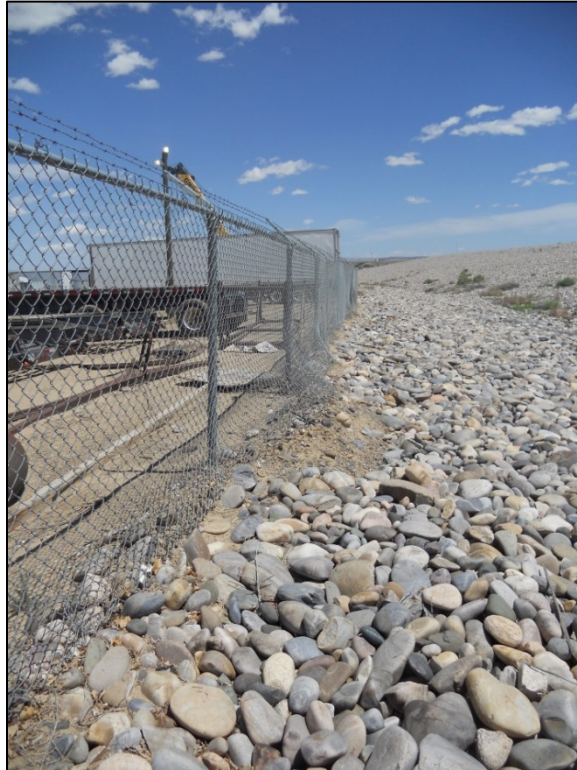
A chainlink fence encloses the disposal cell and drainage features. As observed in previous years, damage to the perimeter fence was noted in several places, all of which are along the adjacent NECA property. Damage includes: bent posts and bent fence fabric between perimeter signs P11 and P13, dirt pushed through the fence between perimeter signs P11 and P12 (PL-1), dirt mounded against the fence and a section of bent fence near perimeter sign P13, bent posts near perimeter sign P14, a broken fence riser near perimeter sign P15, and fence risers separated from posts between perimeter sign P15 and P16. Damaged fence sections will continue to be monitored and repaired when necessary to maintain site security. DOE has requested that NECA repair those sections damaged by NECA activities.

*PL-1. West Perimeter Fence Along NECA Yard; Note Historical Damage to Fence Fabric*

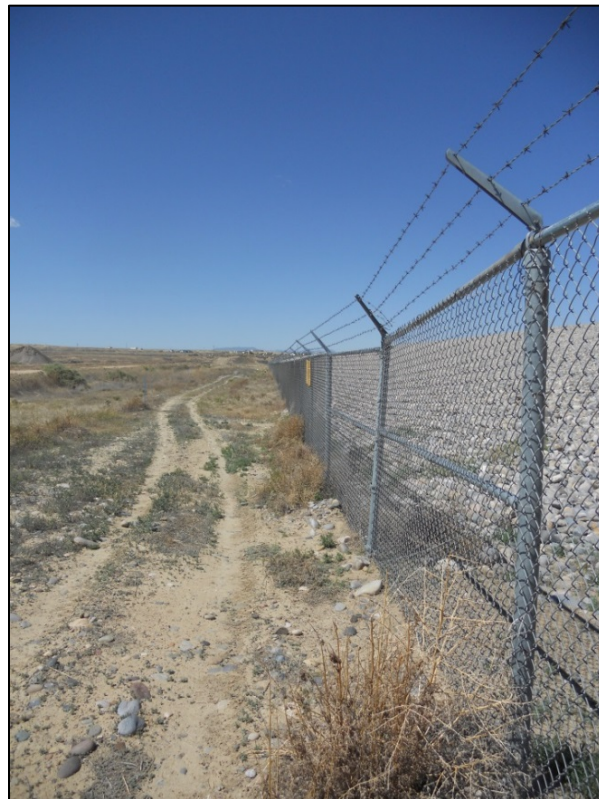
Trash and tumbleweeds continually accumulate in many places along the perimeter fence, although regular maintenance in recent years has kept both to a minimum. Inspectors noted that all fence lines, with the exception of those along the inside of the NECA yard, were unobstructed and relatively free of trash and tumbleweeds (PL-2 and PL-3). No other maintenance needs were identified.

*PL-2. Southeast Perimeter Fence*

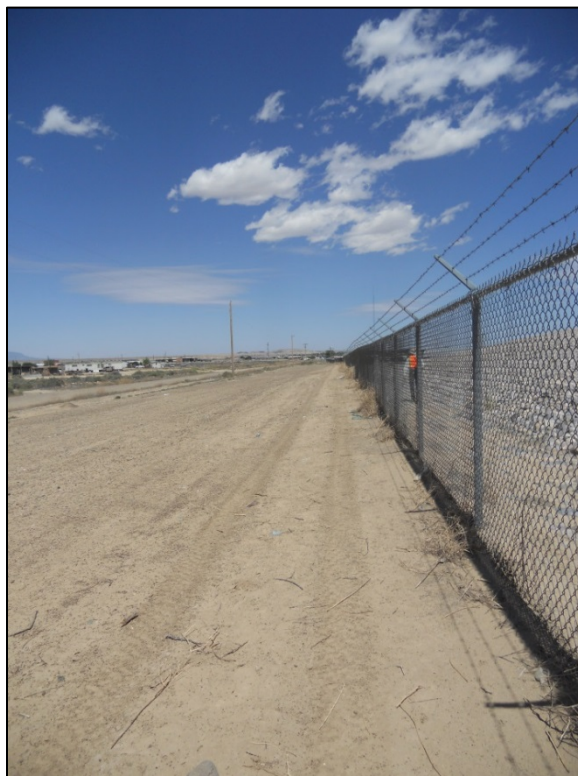
*PL-3. Southwest Perimeter Fence and Outlying Area*

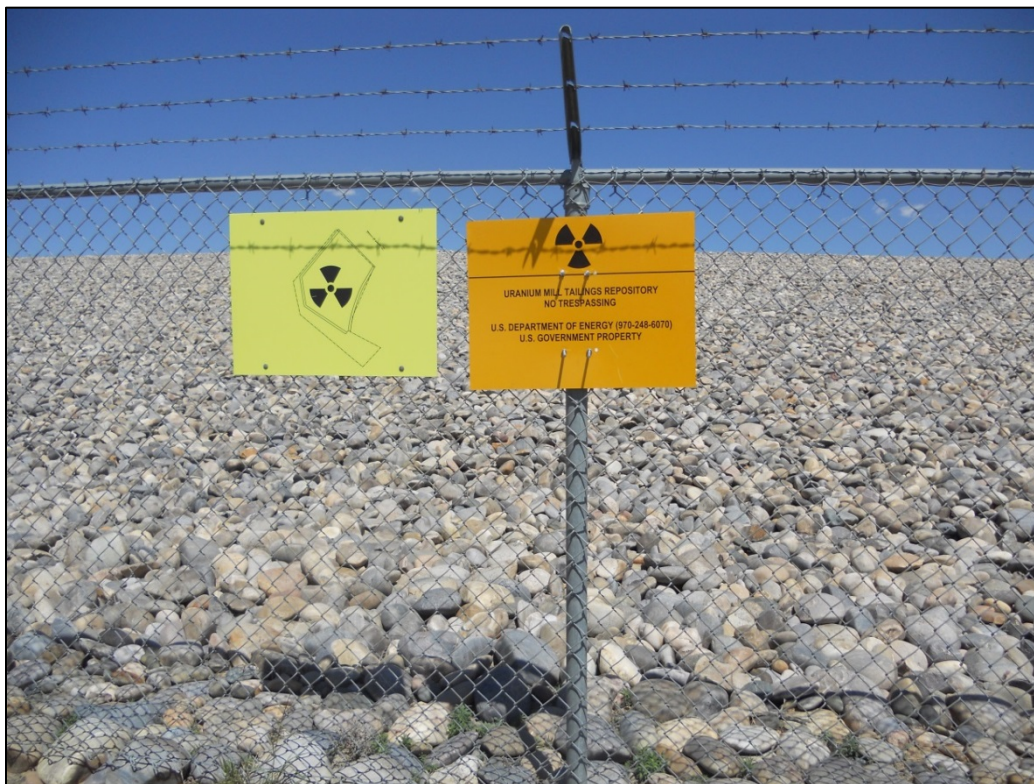
There are 17 pairs of perimeter signs, designated P1 through P17 (each pair consisting of one pictorial and one textual sign), installed along the perimeter fence.<sup>1</sup> Perimeter signs P1 through P10, previously noted to have faded radiation symbols and cracked surfaces, were all repaired or replaced before the 2016 inspection (PL-4 and PL-5). Perimeter signs P11 through P15, on the side of the fence within the NECA yard, still had faded radiation symbols on the textual signs and cracked surfaces on the pictorial signs; these symbols and pictorial signs were replaced in a later visit. Some of the perimeter signs (perimeter signs P1 through P5 [PL-4]) have the DOE phone number listed on them, some have no phone number (perimeter signs P6, P7, P10 [PL-5]), and a few have the Navajo Nation phone number (perimeter signs P9, P14). Sign specifications in the LTSP indicate that the Navajo Nation phone number is not required, but the LTSP does indicate a requirement for the DOE phone number. The DOE phone number is present on many of the perimeter and all of the entrance signs, which adequately addresses the LTSP specification. No other maintenance needs were identified.

*PL-4. Newly Replaced P5 Perimeter Signs*

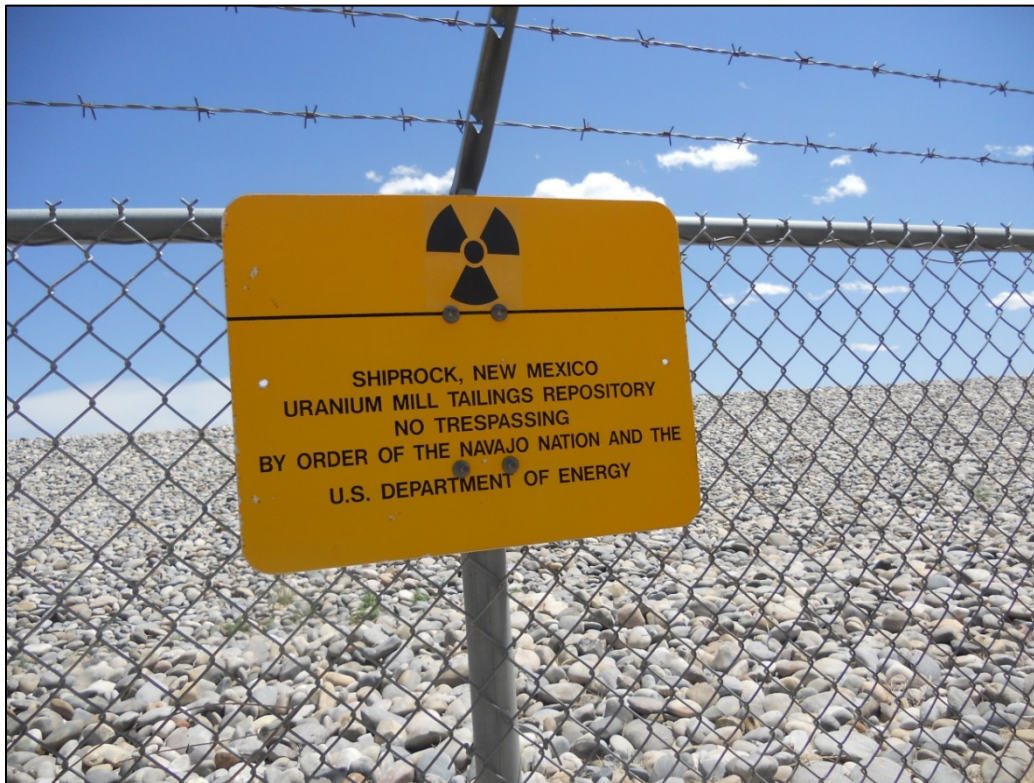
*PL-5. Newly Replaced Radiation Symbol on P10 Perimeter Sign*

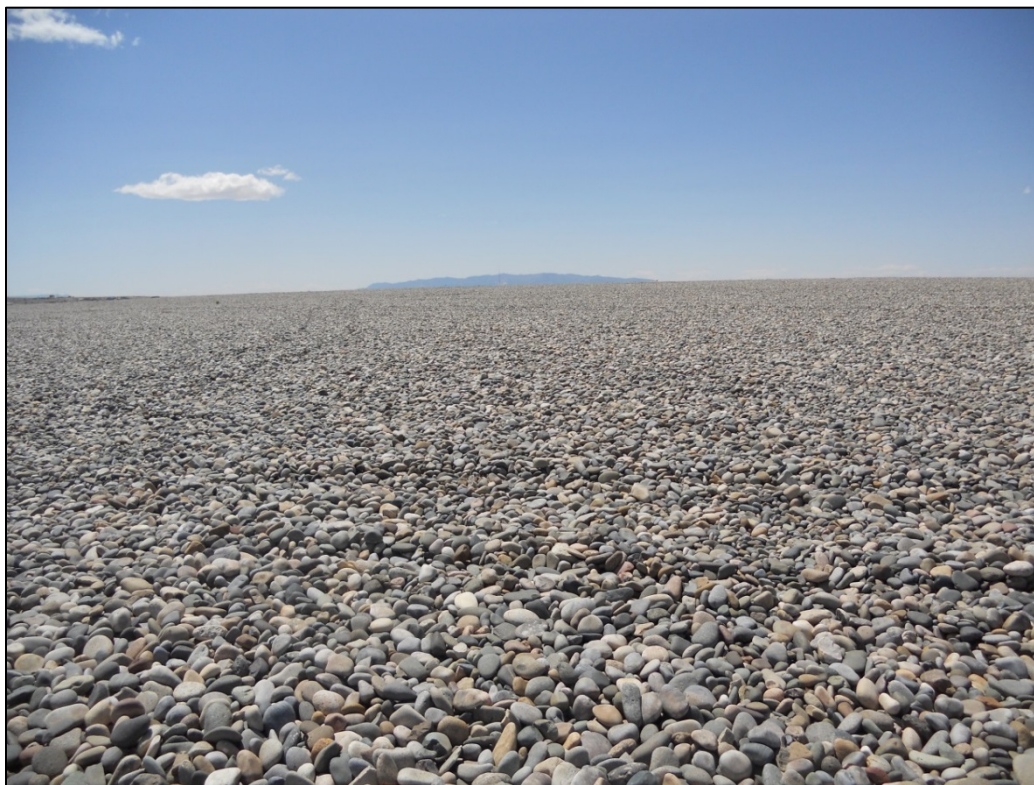
The disposal cell, completed in 1986, occupies 77 acres. The top and side slopes of the disposal cell are covered in riprap and were intact and functional. No evidence of slumping, erosion, animal intrusion, or riprap deterioration was found. Piezocones associated with a research project were installed on the disposal cell cover in the past. Some of the filled piezocone pits have subsided slightly, forming shallow conical depressions in the cover. As previously reported, the surface of the disposal cell is covered with vehicle ruts. The condition of the depressions and vehicle ruts is monitored annually and has not changed significantly since the 2014 inspection.

*PL-6. Numerous Tracks on Disposal Cell Top, Made by a Full-Sized Vehicle*

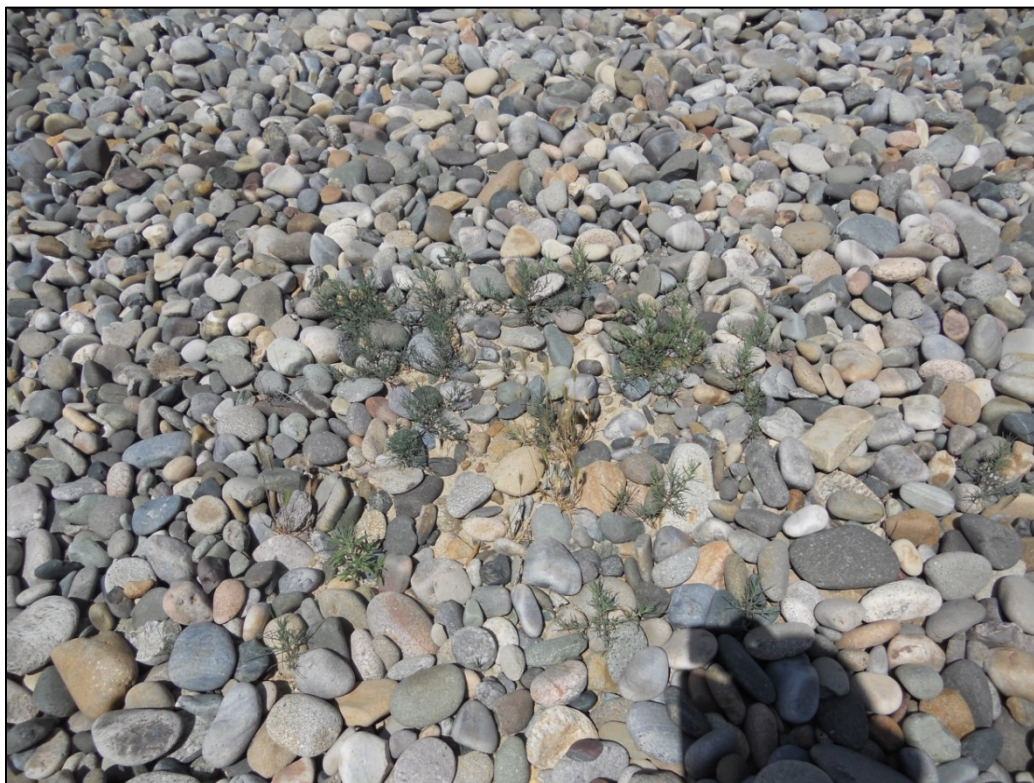
Windblown sediment has accumulated in the rock cover in several places, affecting 1% to 5% of the total cover and enhancing vegetation establishment (PL-7). Woody, deep-rooted shrubs are controlled because they potentially could damage the radon barrier. Only a few woody shrubs were growing on the northwest side of the disposal cell. These plants were treated with herbicide in a later visit.

*PL-7. Typical Annual Weed Cover on Disposal Cell Top Slope*

In a 1999 letter to the Navajo AML/UMTRA Department (Bergman-Tabbert, 1999), DOE committed to spraying annual weeds on the disposal cell top. Patches of annual weeds observed growing on the disposal cell top were treated with herbicide following the inspection.

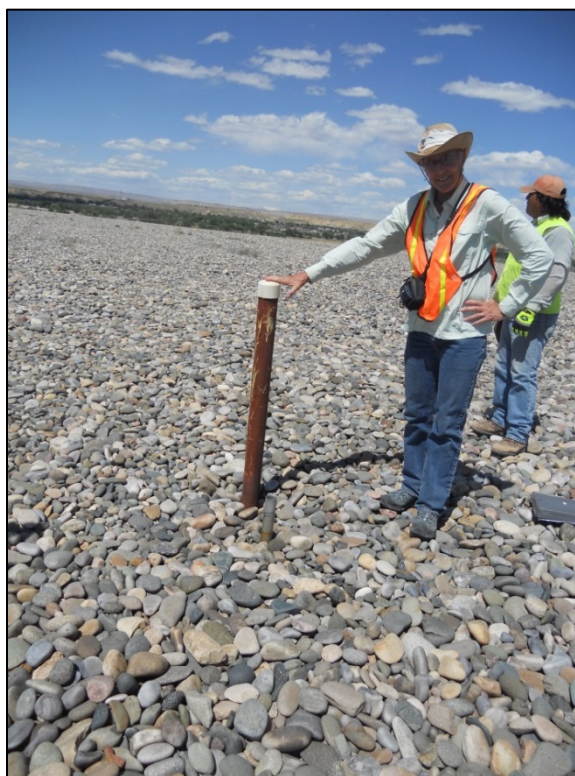
Inspectors discovered two old buried pipe features on the disposal cell top that were covered by larger-diameter, rusted metal pipes (PL-8 and PL-9). These are historical neutron hydroprobe ports that were installed in the 1980s to measure soil moisture in the cover. The one uncovered port will be capped before the 2017 inspection to prevent precipitation from entering the port.

*PL-8. Historical Neutron Hydroprobe Port on Disposal Cell Top Slope*

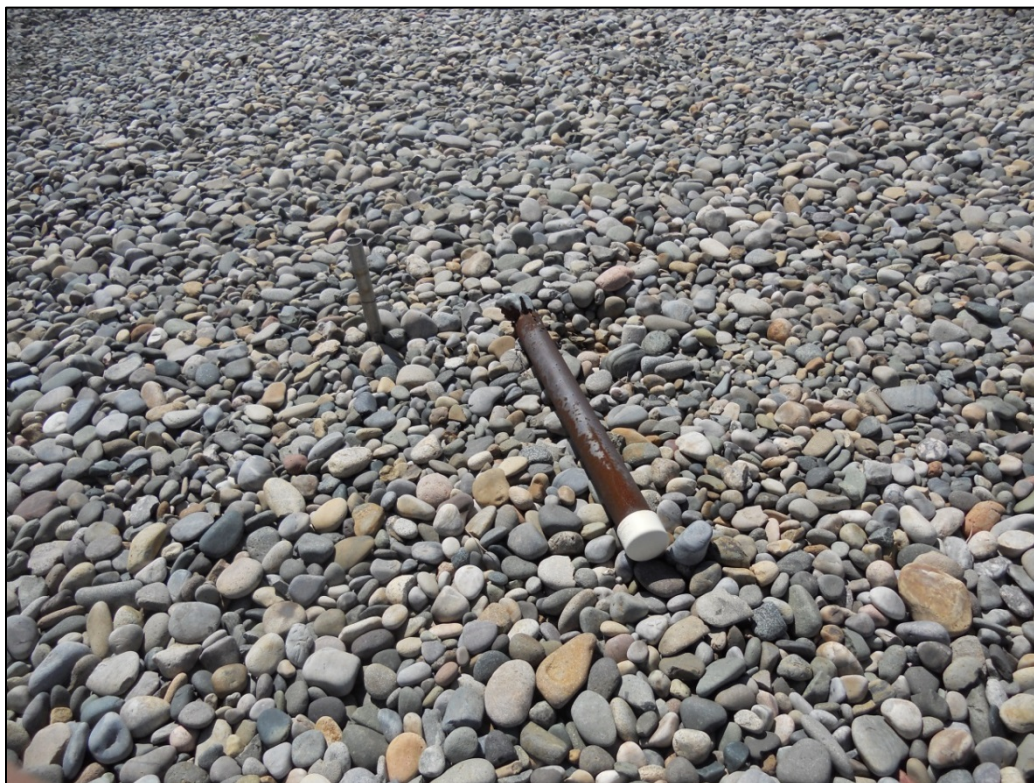
*PL-9. A Second Neutron Hydroprobe Port on Disposal Cell Top Slope*

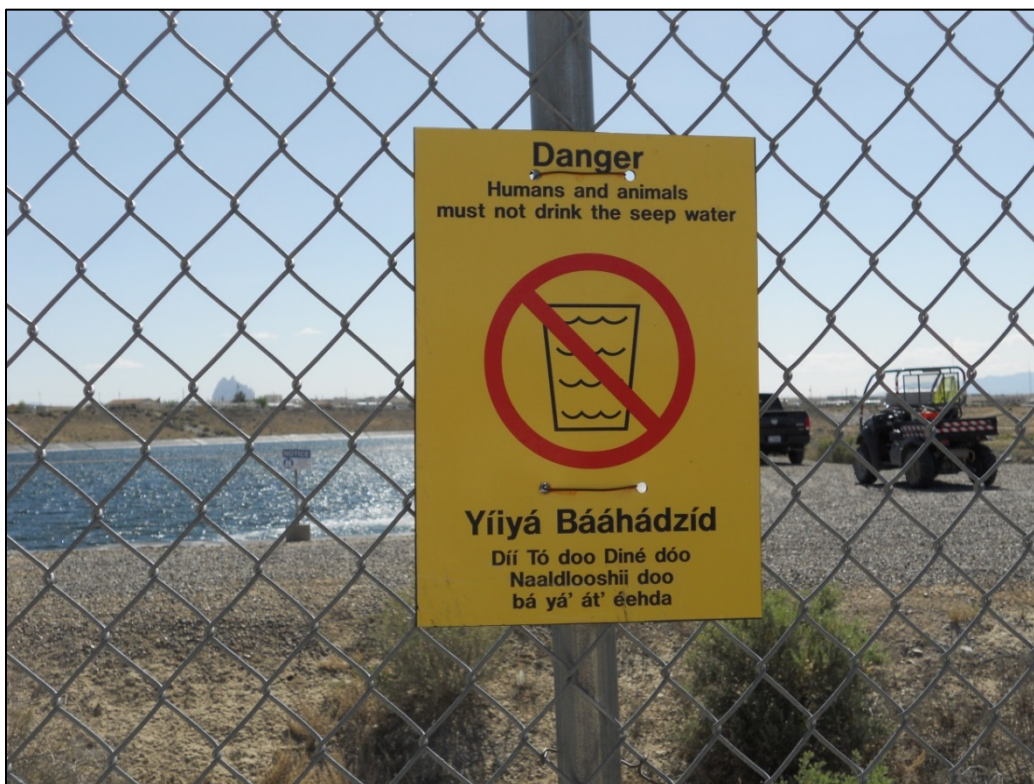
*PL-10. Newly Replaced Warning Signs on Evaporation Pond Fence*

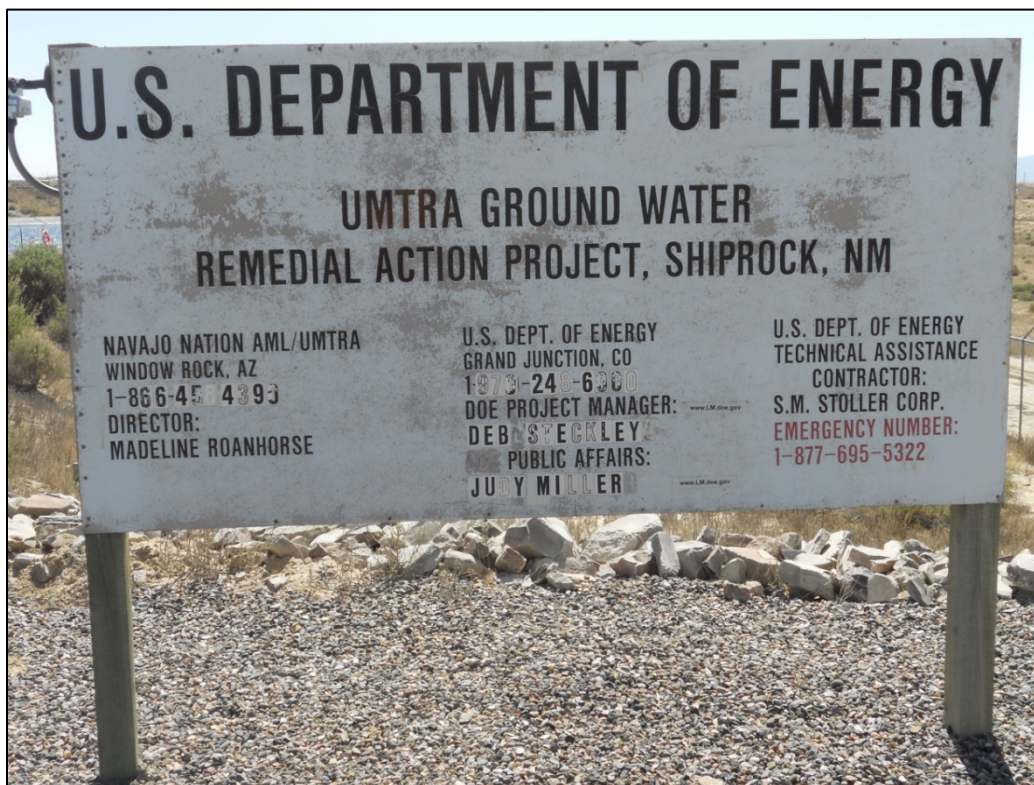
In 2002, DOE constructed an 11-acre lined evaporation pond near the disposal cell as part of the groundwater compliance strategy. The pond, surrounded by a chainlink security fence, is maintained under the groundwater compliance strategy. Both the fence and pond were intact and functional at the time of the 2016 inspection. New warning signs had been affixed to the fence fabric (PL-10), but the entrance sign contained old and outdated information (PL-11). This plywood sign, 4 × 8 feet in size, will be completely replaced before the 2017 inspection and include, at a minimum, the following information:

*PL-11. Old, Out-of-Date Information Sign at Evaporation Pond*

- U.S. Department of Energy, Office of Legacy Management, Grand Junction, CO
- Uranium Mill Tailings Remedial Action (UMTRA) Groundwater Remedial Action Project, Shiprock, NM
- Work supported by Navajo Nation Abandoned Mine Lands (AML)/UMTRA Office

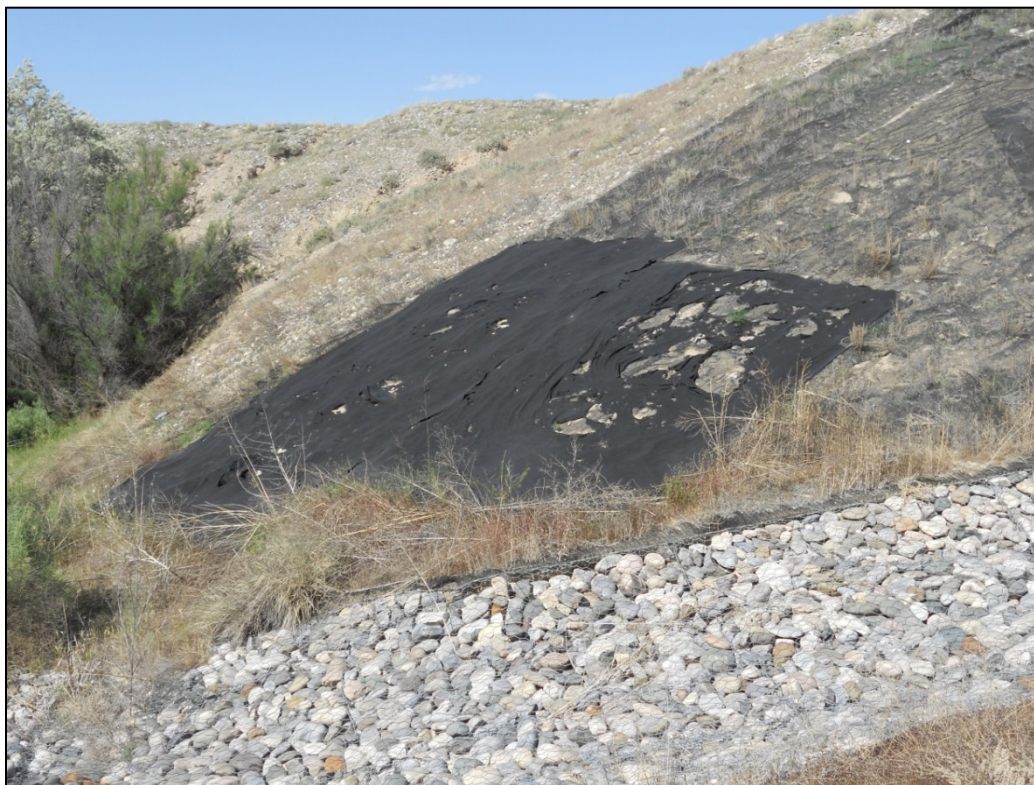
Inspectors noted that the offsite portion of the outflow channel was functional and clear of debris. Several portions of erosion control fabric had previously come loose from one of the side slopes of the channel and were repaired in 2014. By the time of the 2016 inspection, the replacement fabric had become shredded and ineffective (PL-12 and PL-13). It will be removed and replaced with a longer-lived, plastic-based, erosion control fabric before the 2017 inspection.

*PL-12. Damaged Erosion Control Fabric on Lower Part of Outflow Channel Side Slope*

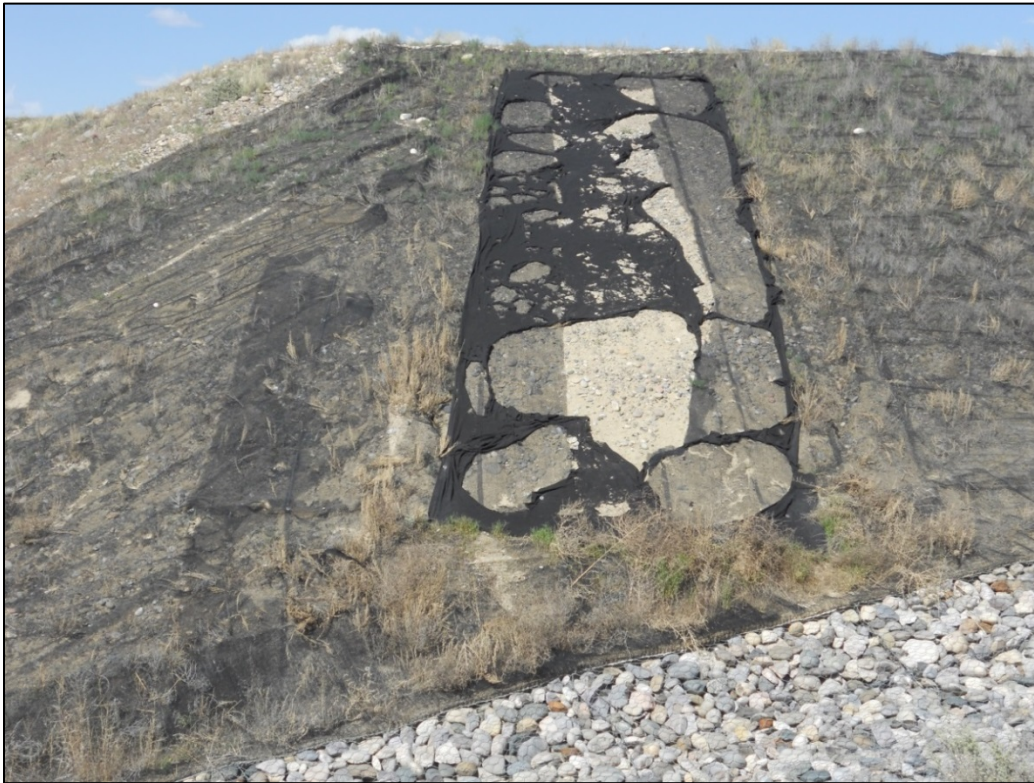
*PL-13. Damaged Erosion Control Fabric on Upper Part of Outflow Channel Side Slope*
