16.0 Shiprock, New Mexico, Disposal Site

16.1 Compliance Summary

16.4 Inspection Results

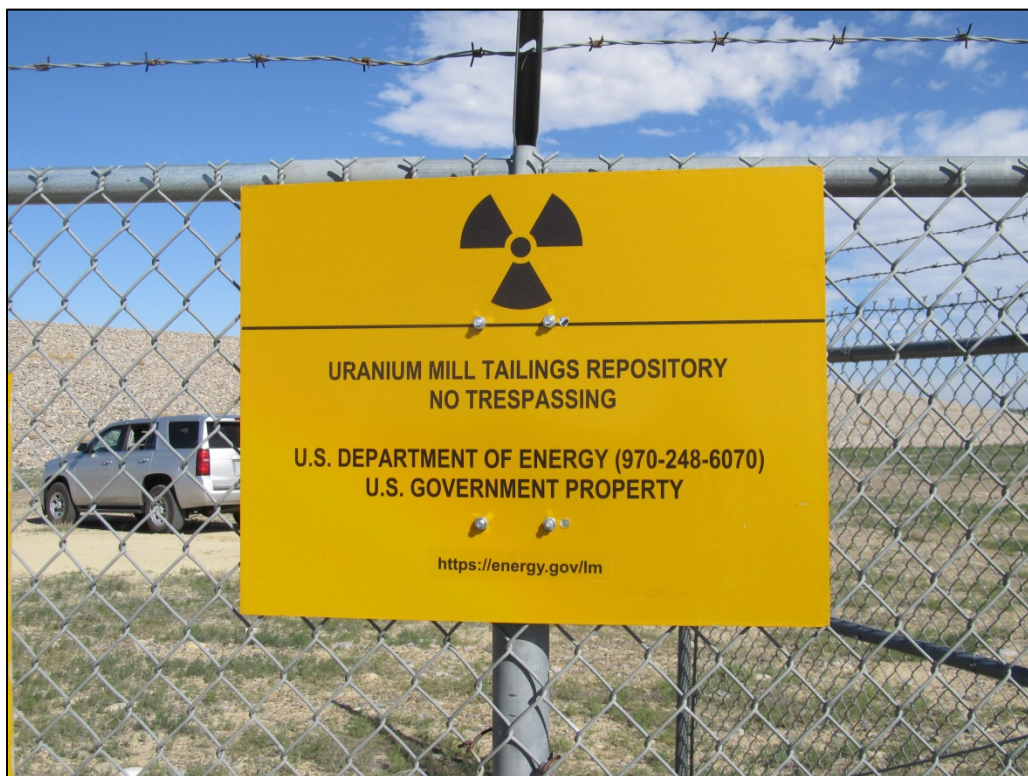
Access to the site is from a gravel road off U.S. Highway 491. Three gates allow access to the site through the perimeter fence: the east gate (the current main entrance gate near the terrace escarpment), the north gate (an auxiliary access gate), and the west gate (the former main entrance gate). Access to the east (main) entrance gate is through a gravel pit. The three gates were locked and functional. The sediment beneath the west gate noted during the 2016 annual inspection had been removed. Pairs of entrance signs—one pictorial and one textual—are present near each gate. One pair is present at the east and north gates, and two pairs are present at the west gate. The Office of Legacy Management website address on the entrance sign near the east entrance gate was updated during the inspection by affixing an adhesive label to the sign (PL-1). No maintenance needs were identified.

PL-1. Entrance Sign Showing New Legacy Management Website Address

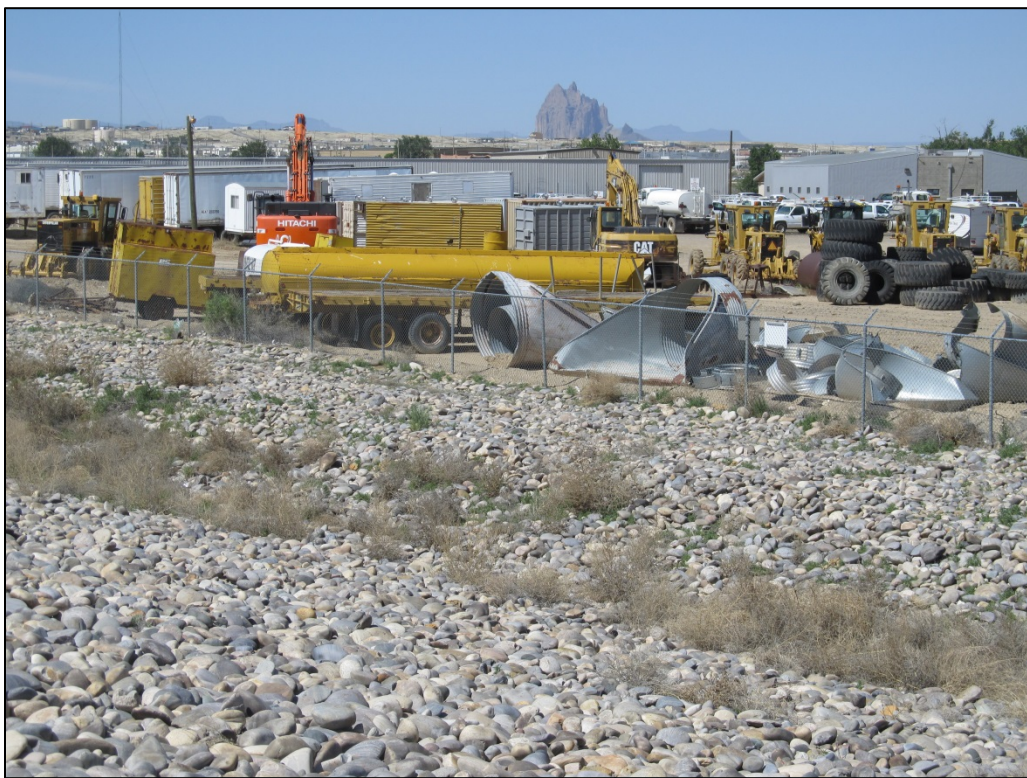
A chainlink perimeter fence encloses the disposal cell and drainage features. The perimeter fence adjacent to the Navajo Engineering and Construction Authority (NECA) property has been repaired since the 2016 annual inspection (PL-2). As observed in previous years, the perimeter fence near perimeter sign P15 has a 3- to 6-inch gap beneath it (PL-3). Near perimeter sign P15 the perimeter fence was broken at the top and had a 3- to 6-inch gap (PL-4). At this time, the observed perimeter fence gaps are not a concern, but inspectors will continue to monitor these areas to determine if they become worse and require repair.

PL-2. Perimeter Fence Along NECA Yard

Before the inspection, the sediment buildup underneath the west gate had been removed, the perimeter fence along the NECA compound was repaired, a new entrance sign with updated information was installed at the evaporation pond, and new erosion control fabric was installed at the offsite portion of the outflow channel.

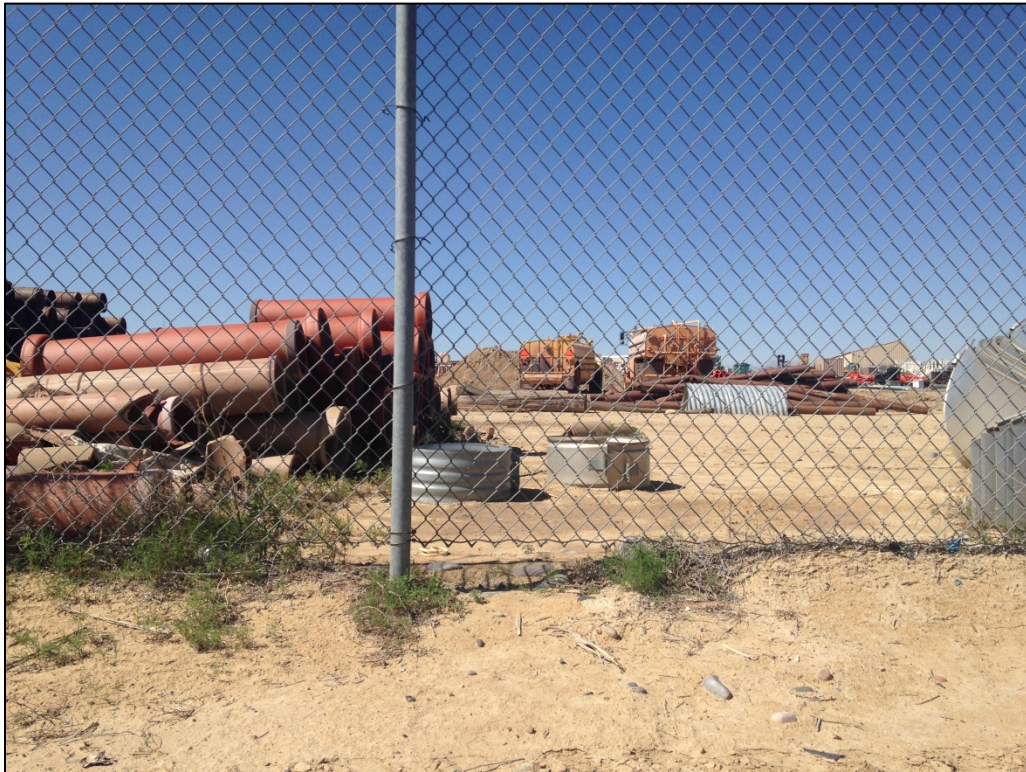
PL-3. North Perimeter Fence Along NECA Yard Near Perimeter Sign P15 with Gap Underneath

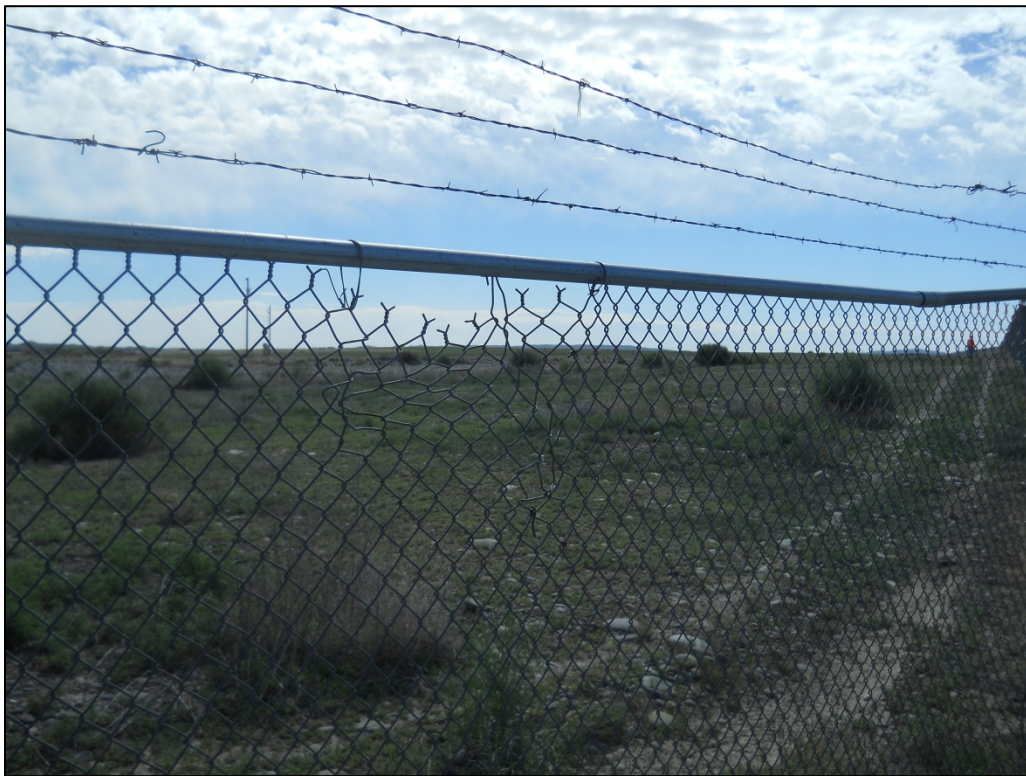
PL-4. North Perimeter Fence Along NECA Yard Near Perimeter Sign P15 with Gap on Top

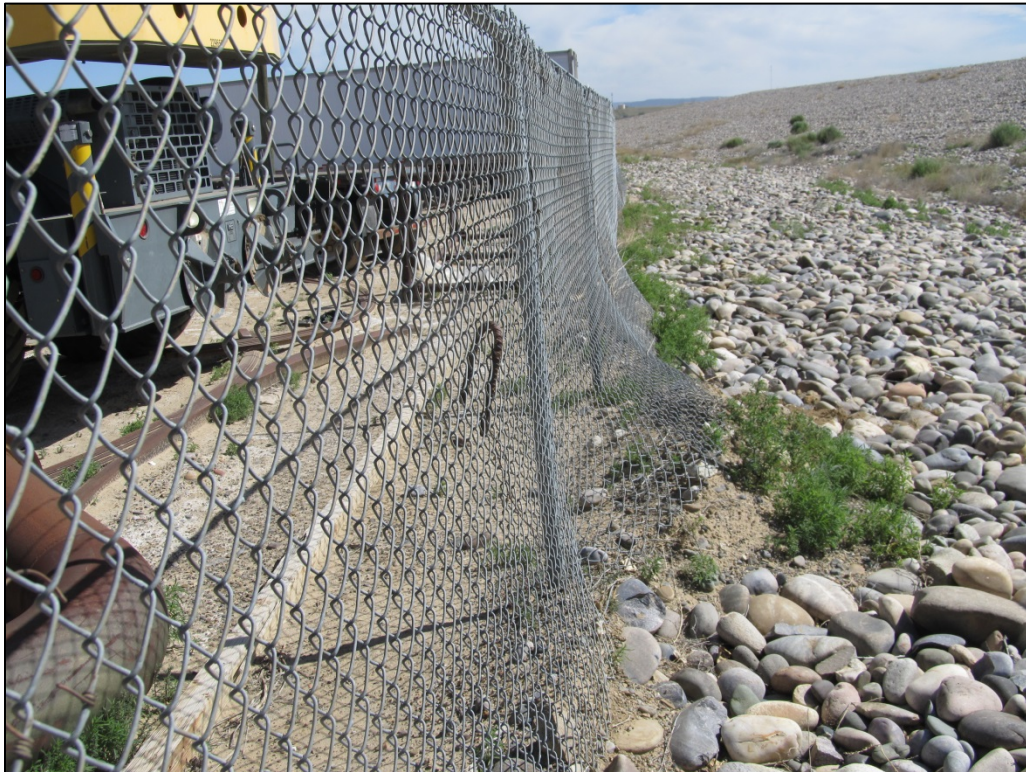
The perimeter fence fabric between perimeter signs P11 and P12 was bent, but the perimeter fence remains functional (PL-5). Trash and tumbleweeds continually accumulate in many places along the perimeter fence, although regular maintenance in recent years has kept both to a minimum. Inspectors noted a buildup of tumbleweeds along the southeast perimeter fence (PL-6) and in the outflow channel perimeter fence. A buildup of trash was also observed in the northeast corner of the NECA yard perimeter fence (PL-7). Maintenance to keep the perimeter fence lines clean will continue.

PL-5. Bent Fence Fabric on West Perimeter Fence Along NECA Yard Between Perimeter Signs P11 and P12

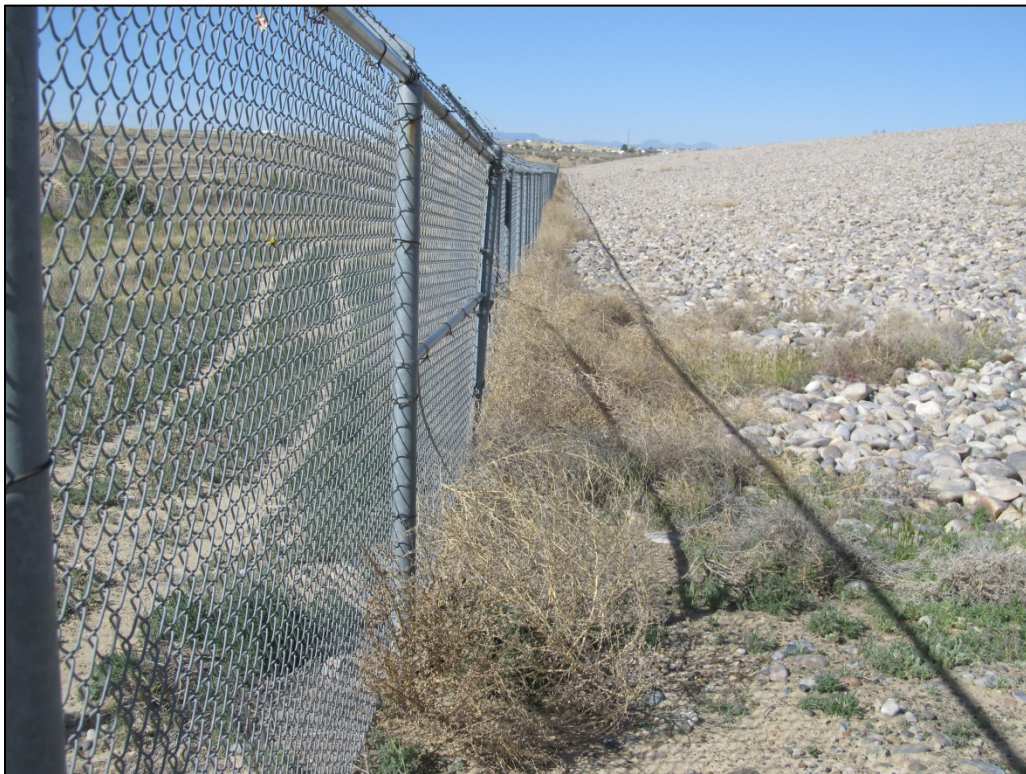
PL-6. Tumbleweed Buildup Along Southeast Perimeter Fence

During the inspection, new adhesive sign identification labels were applied to all perimeter signs. Tumbleweed buildup was observed along the southeast perimeter fence and outflow channel fence. Trash buildup was observed in the northeast corner of the NECA yard perimeter fence. Maintenance to keep the perimeter fence lines clean will continue. Boundary monuments BM-4, BM-5, and BM-6 were covered with sediment and vegetation and could not be located during the inspection; following the inspection, the sediment and vegetation were removed. The reference post at boundary monument BM-6 was missing and was replaced following the inspection; a protective casing was also installed around boundary monument BM-6. Site features on the disposal cell top slope will be inventoried and reviewed for their continued relevance. Site features no longer necessary will be abandoned, and remaining site features will be labeled before the 2018 annual site inspection. The missing neutron hydroprobe port cap will be replaced at that time. Several woody shrubs were growing on the disposal cell side slopes; these will be treated before the 2018 annual inspection. No other maintenance needs were identified.

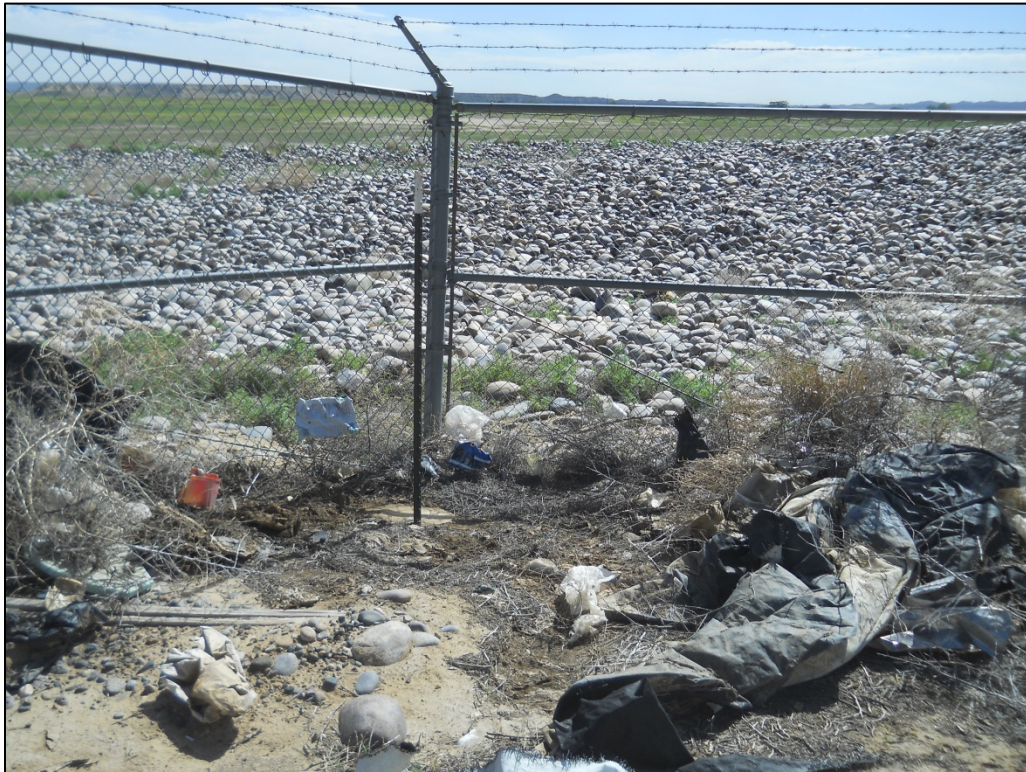
PL-7. Trash Buildup Along Northwest Perimeter Fence

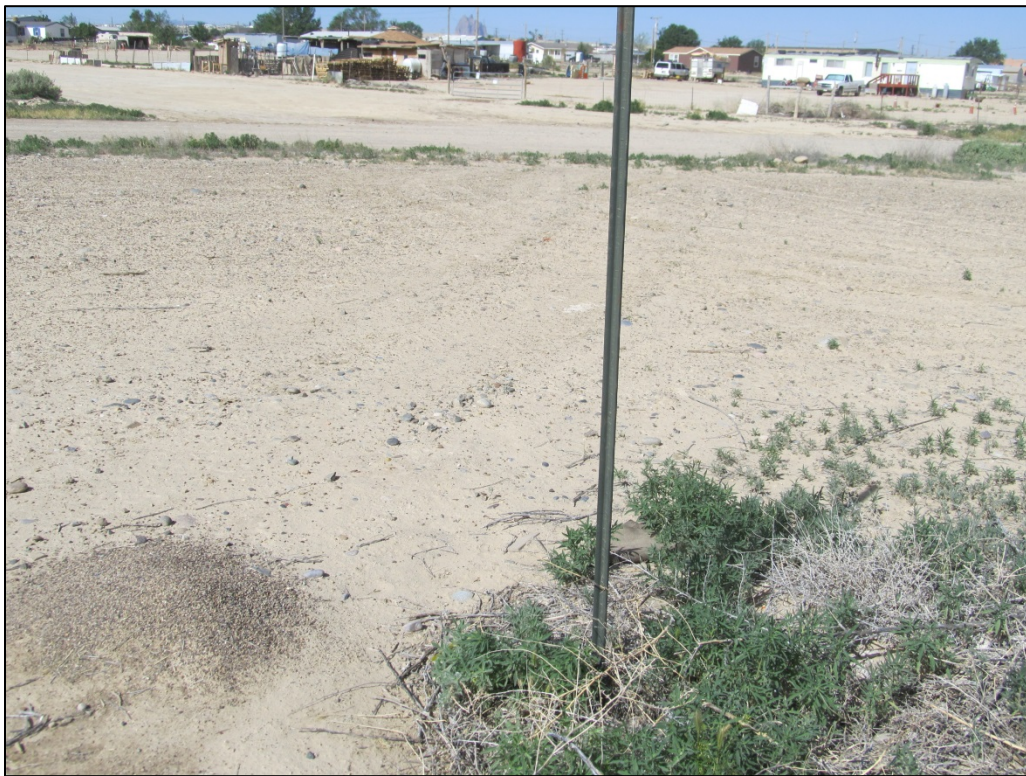
Three survey monuments and six boundary monuments delineate the property boundary. Two additional boundary monuments (BM-7 and BM-8) are offsite; monitoring of these monuments was discontinued in 1999 and 2003 because they are offsite. The concrete at survey monument SM-1 is cracked, but the crack does not threaten the integrity of the marker. Steel T-posts are installed next to boundary monuments to help inspectors locate the monuments. Boundary monuments BM-4, BM-5, and BM-6 were covered with sediment and vegetation and could not be located (PL-8). The T-posts were present at boundary monuments BM-4 and BM-5; however, the T-post at boundary monument BM-6 had been removed. Following the inspection, sediment and vegetation were removed; boundary monuments BM-4, BM-5, and BM-6 were located; and a new T-post was installed by boundary monument BM-6. LMS also installed a protective casing around boundary monument BM-6 to assist in locating it during future inspections; no other maintenance needs were identified.

PL-8. Boundary Monument BM-4 Covered by Vegetation and Sediment (Later Uncovered)

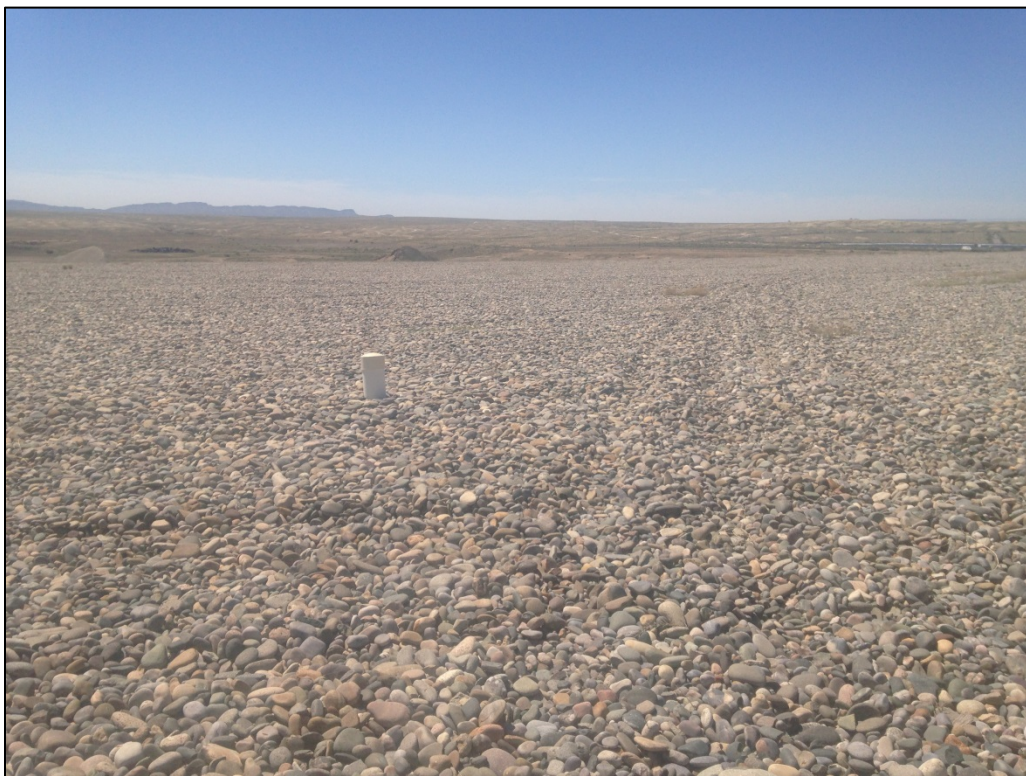
The disposal cell, completed in 1986, occupies 77 acres. The disposal cell is armored in riprap to control erosion. There was no evidence of erosion, settling, slumping, rock degradation, or other modifying processes that might affect the integrity of the disposal cell. Piezocones associated with a research project were installed on the disposal cell cover in the past and are no longer in use. Some of the filled piezocone pits have subsided slightly or were never completely backfilled, forming shallow conical depressions in the cover. As reported in previous site inspection reports, the surface of the disposal cell contains numerous ruts associated with past vehicle traffic. The condition of the depressions and vehicle ruts is monitored annually and has not changed significantly since the 2014 inspection (PL-9).

PL-9. Settlement Plate and Vehicle Tracks on Disposal Cell Top Slope

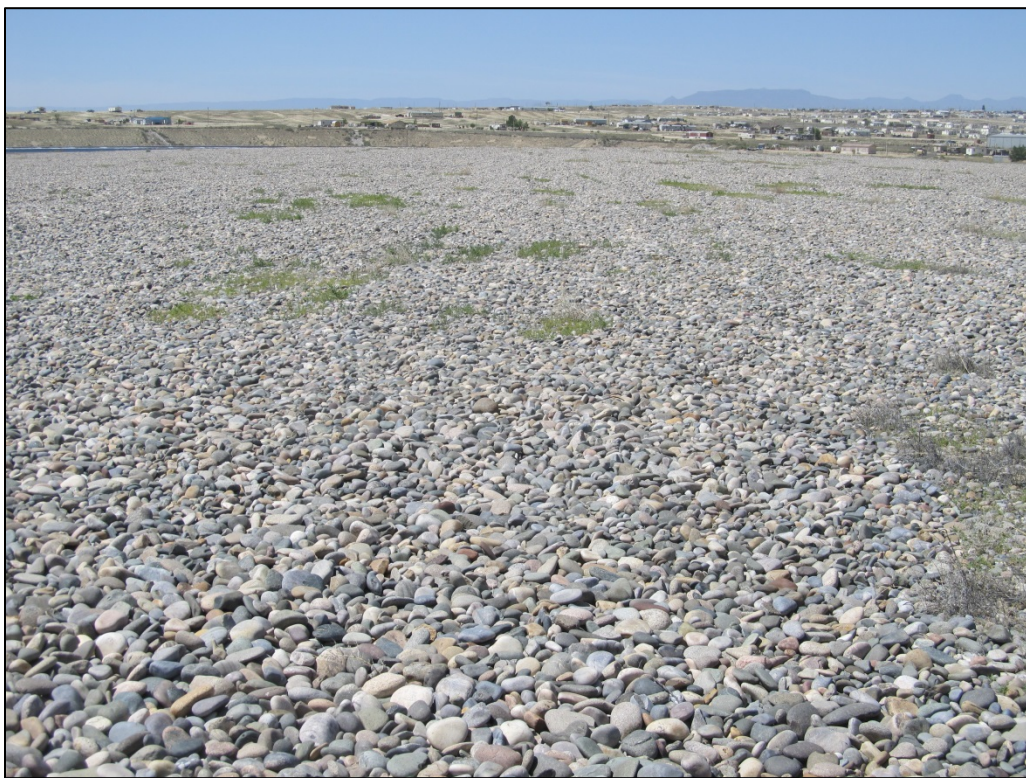
Windblown sediment has accumulated in the rock cover in several places, affecting approximately 1% to 5% of the total cover and enhancing vegetation establishment (PL-10). Woody, deep-rooted shrubs are controlled because they potentially could damage the radon barrier. Only a few woody shrubs were growing on the northwest and southwest side slopes of the disposal cell; these will be treated before the 2018 annual inspection.

PL-10. Scattered Vegetation on Disposal Cell Top Slope

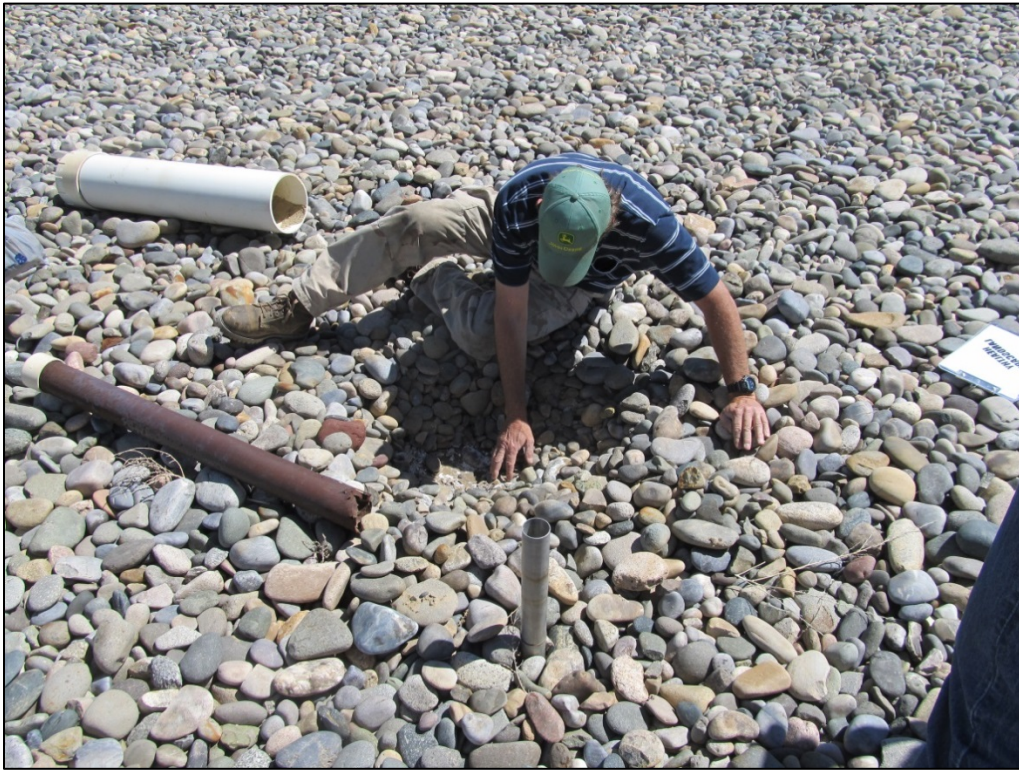
One of the two historical neutron hydroprobe ports identified during the 2016 inspection was uncapped (PL-11). In a previous visit, LMS personnel attempted to install a cap on the neutron hydroprobe port but were unsuccessful due to the presence of ponded water on the disposal cell top slope from heavy rains the day before. No ponded water was observed on the disposal cell top slope during the 2017 annual inspection. The DOE site manager recommended that all site features on the disposal cell top slope be inventoried and reviewed for their continued relevance. Site features no longer necessary will be abandoned, and remaining site features will be labeled before the 2018 annual inspection. A replacement cap will be placed on the neutron hydroprobe port at that time.

PL-11. Neutron Hydroprobe Port on Disposal Cell Top Slope Where Dug-Out Hole Previously Was Filled with Water

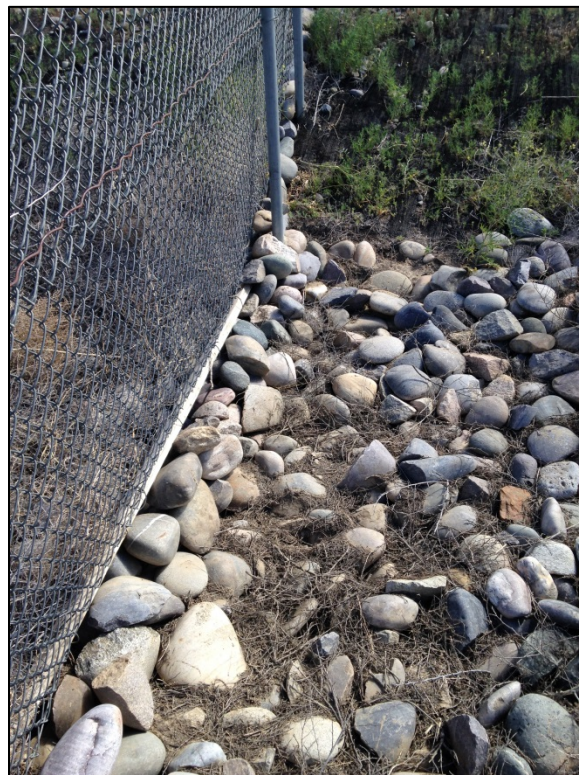
Diversion channels around the base of the disposal cell contained scattered vegetation, including several woody shrubs. These shrubs do not adversely affect the performance of the diversion channel at this time and are not a concern. Nonwoody plants were growing within the outflow channel, and woody vegetation was growing on the banks of the channel. Sediment buildup and a low spot were observed in the outflow channel near the perimeter fence (PL-12), but the channel remains functional. No other maintenance needs were identified.

PL-12. Sediment Buildup and Low Spot in Outlet Channel Before Perimeter Fence

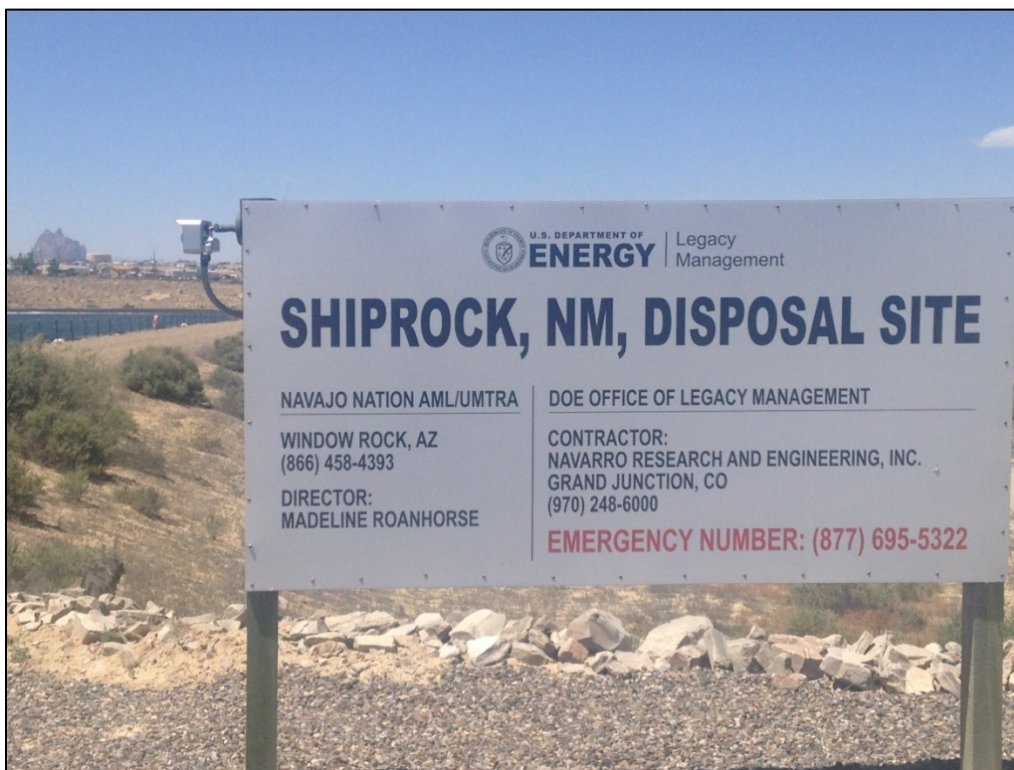
In 2002, DOE constructed an 11-acre lined evaporation pond near the disposal cell as part of the groundwater compliance strategy. The pond, surrounded by a chainlink security fence, is maintained under the groundwater compliance strategy. Both the security fence and pond were intact and functional at the time of the inspection. A new entrance sign with updated site information was installed before the inspection (PL-13).

PL-13. New Evaporation Pond Entrance Sign

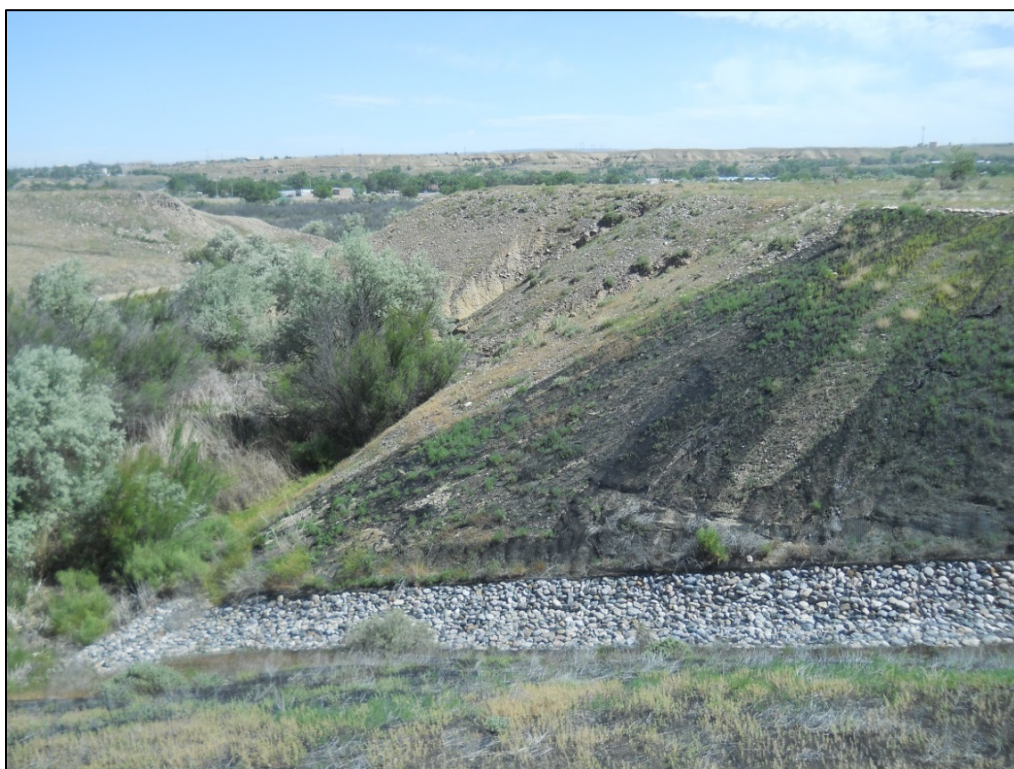
Inspectors noted that the offsite portion of the outflow channel was functional and clear of debris. The erosion control fabric, observed in 2016 to be shredded and ineffective, had been replaced. However new areas of degradation in the erosion control fabric were observed (PL-14). These areas will be repaired before the 2018 annual inspection.

PL-14. Replaced Erosion Control Fabric with New Areas Needing Repair
