16.0 Shiprock, New Mexico, Disposal Site

16.1 Compliance Summary

The Shiprock, New Mexico, Uranium Mill Tailings Radiation Control Act (UMTRCA) Title I Disposal Site (site) was inspected on June 21, 2018. No changes were observed on the disposal cell or in the associated diversion channels. Inspectors identified several minor maintenance needs but found no cause for a follow-up or contingency inspection. Groundwater monitoring to evaluate disposal cell performance is not required.

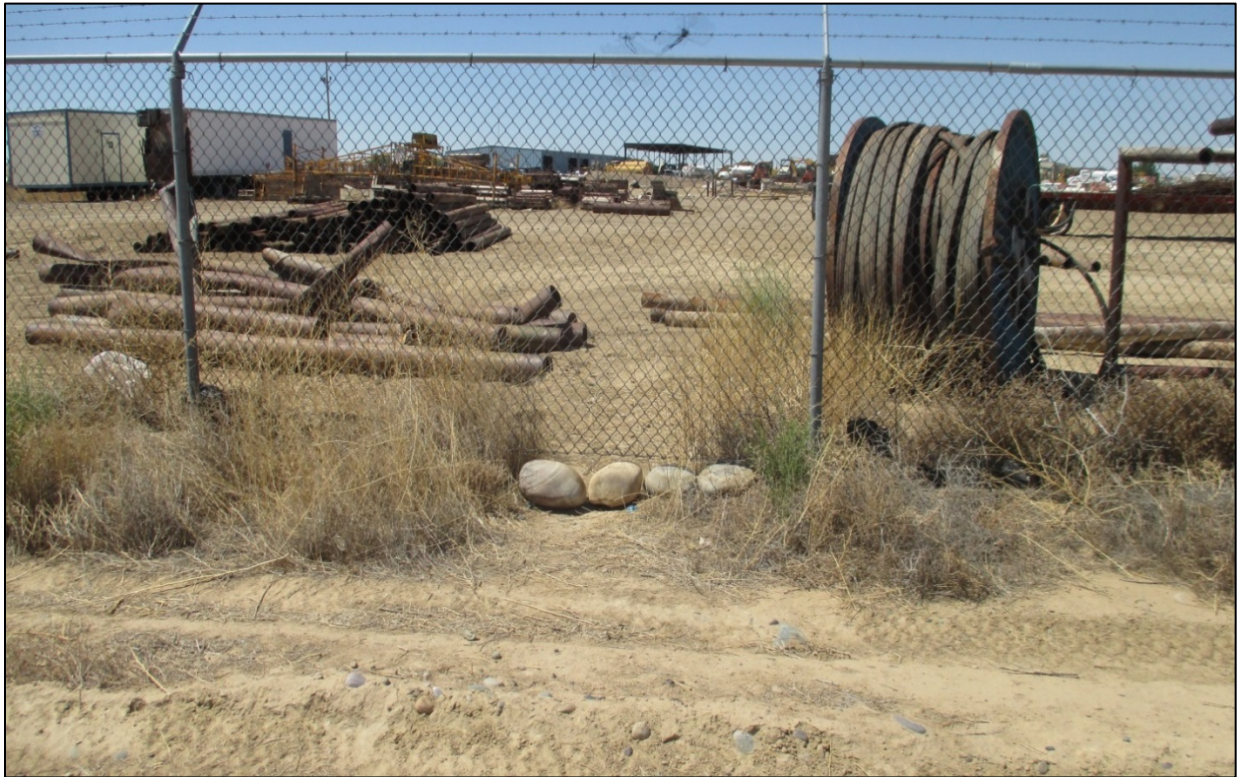
A chainlink perimeter fence encloses the disposal cell and drainage features. The perimeter fence adjacent to the Navajo Engineering and Construction Authority (NECA) property shows evidence of previous activity to repair gaps under the fence by placing rock in the gaps (PL-1). During the inspection, an 8-inch gap under the perimeter fence was observed near perimeter sign P15 (PL-2). Maintenance to repair the gap will be conducted in 2019. Near perimeter sign P15, construction materials were observed leaning against the perimeter fence in several locations on the NECA side (PL-3). NECA management will be contacted and requested to remove these materials in 2019.

PL-1. Repair of Gap Under Fence

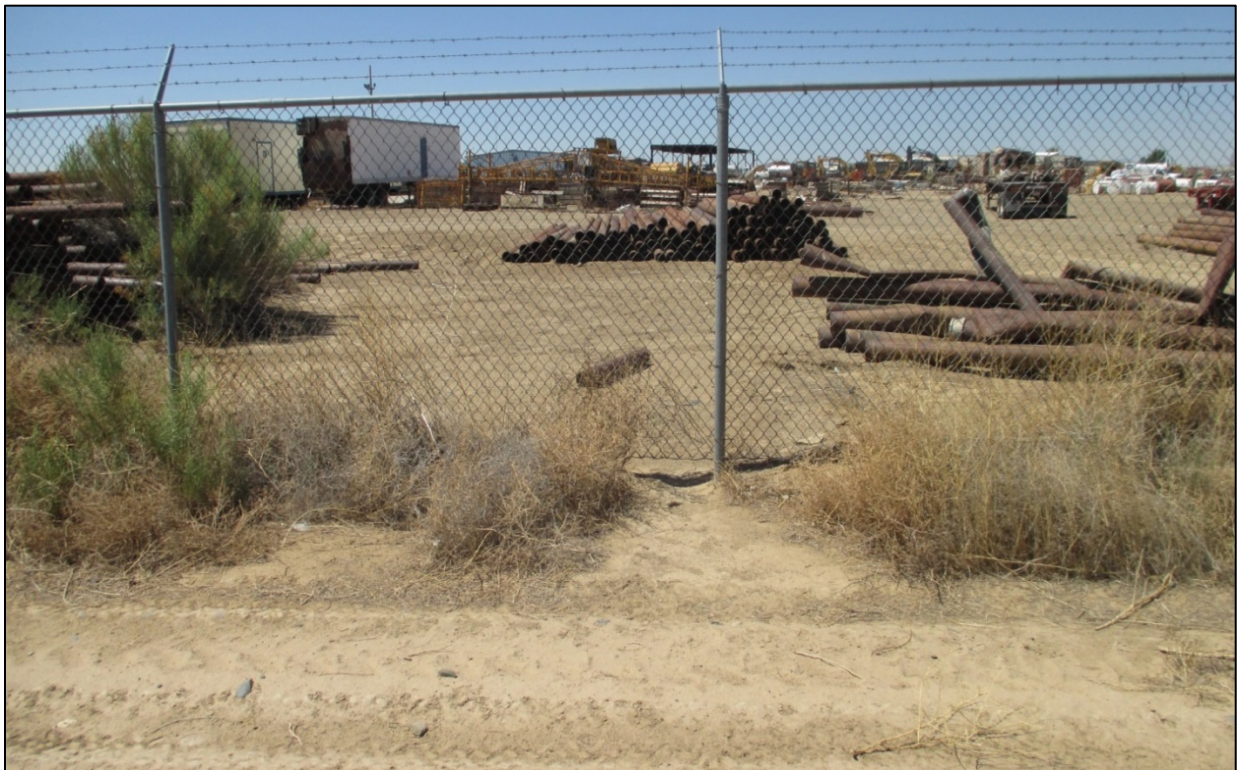
PL-2. Gap Under Fence Needing Repair

- Repairing the gap under the perimeter fence near perimeter sign P15
- Treating woody vegetation on the disposal cell top and side slopes
- Consulting LMS engineering to evaluate the need for repair of the erosion control fabric on the south-facing bank of the energy dissipation basin
- Contacting NECA management to request construction materials leaning against the fence near perimeter sign P15 be moved

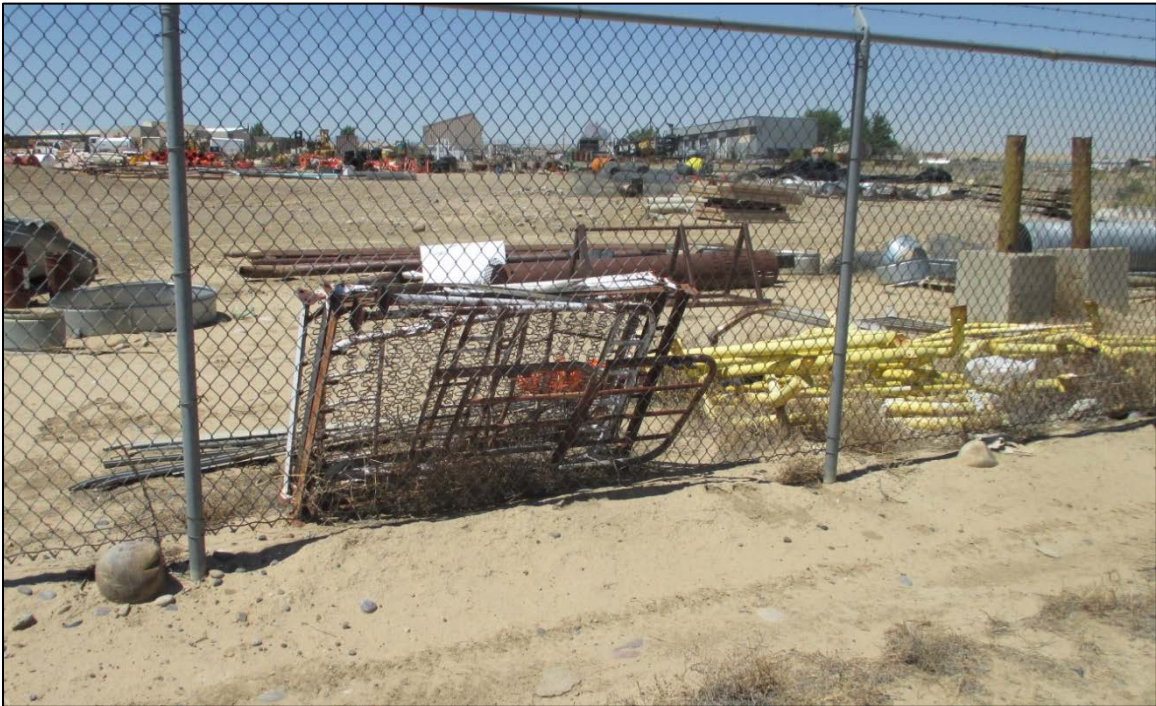
PL-3. NECA Hardware Leaning Against Fence

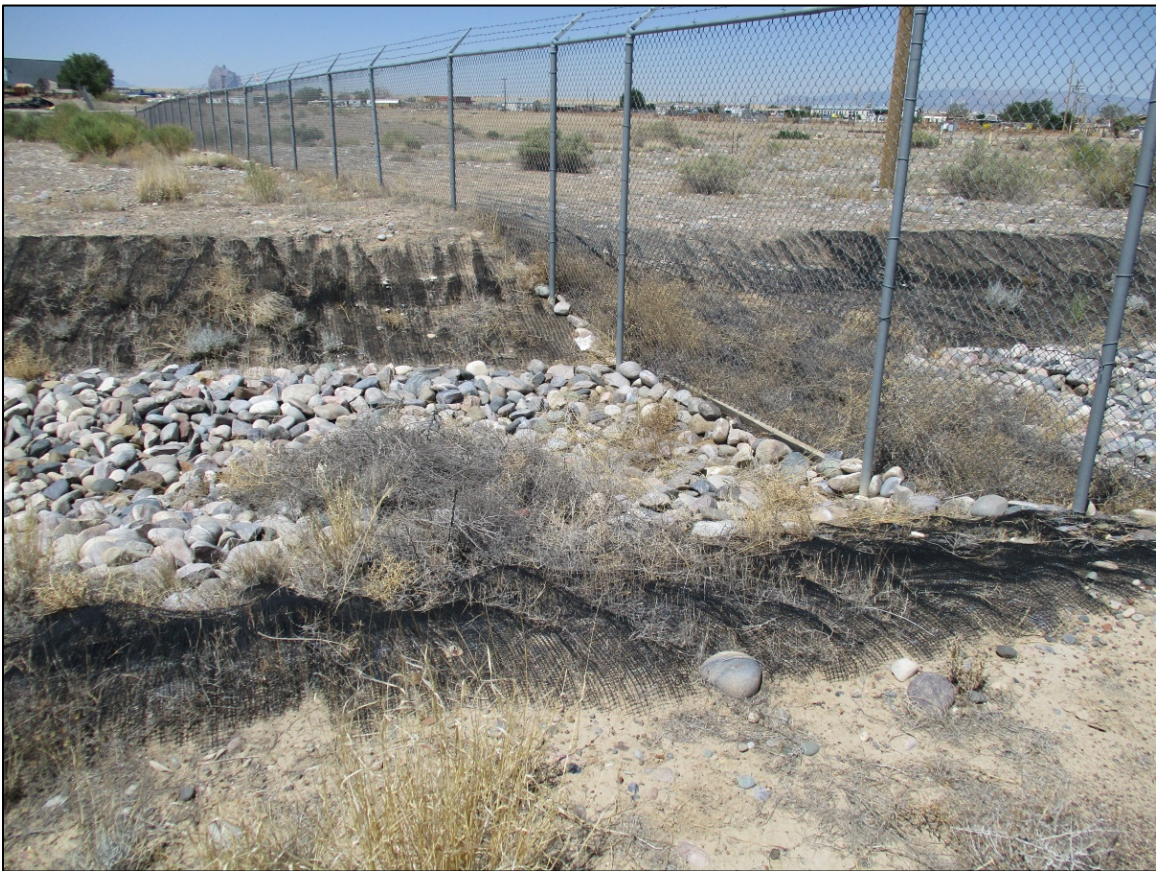
The perimeter fence fabric between perimeter signs P11 and P12 was bent, but the perimeter fence remains functional. Trash and tumbleweeds continually accumulate in many places along the fence, although regular maintenance in recent years has kept both to a minimum. Inspectors noted an accumulation of tumbleweeds on the northwest side of the perimeter fence within the outflow channel (PL-4). The tumbleweeds were removed following the inspection. Maintenance to keep the perimeter fence lines clean will continue.

PL-4. Tumbleweeds in Outflow Channel at Perimeter Fence

- Removing the accumulation of tumbleweeds on the northwest side of the perimeter fence within the outflow channel
- Replacing the perimeter sign P17 pictorial sign and radiation symbol decal on the textual sign
- Resealing the crack in the concrete base of site marker SMK-1
- Updating the phone number on the evaporation pond entrance sign
- Decommission site features on the disposal cell top slope no longer determined to be necessary (all but the settlement plates) in accordance with the decommissioning plan

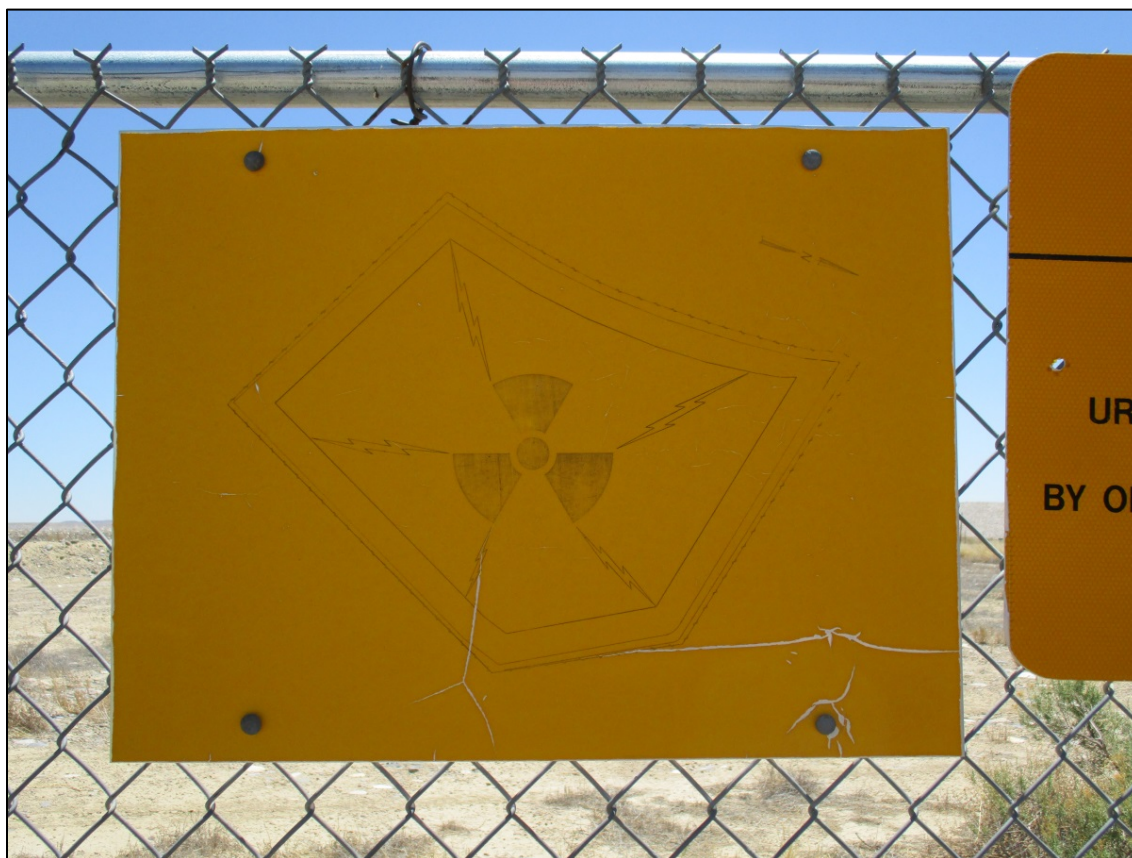
There are 17 pairs of perimeter signs, designated P1 through P17 (each pair consisting of one pictorial and one textual sign), positioned along the perimeter fence.¹ The pictorial sign at P17 and radiological symbol on the textual sign were faded (PL-5) and were replaced following the inspection. No other maintenance needs were identified.

PL-5. Faded Pictorial Perimeter Sign P17 (Replaced Following Inspection)

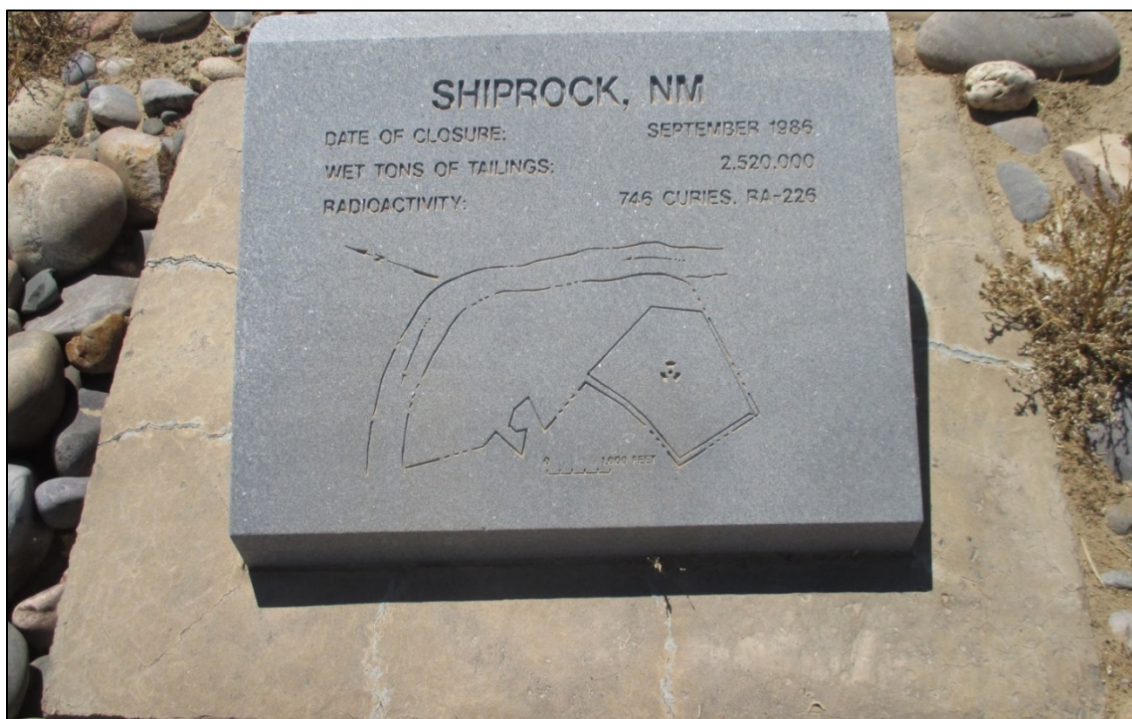
The site has two granite site markers. Site marker SMK-1 is just inside the west gate; minor cracks in its concrete base were sealed in May 2003. The 2003 seal has weathered (PL-6 and PL-7) and was repaired following the inspection. Site marker SMK-2 is on the top slope of the disposal cell. No other maintenance needs were identified.

PL-6. Site Marker SMK-1

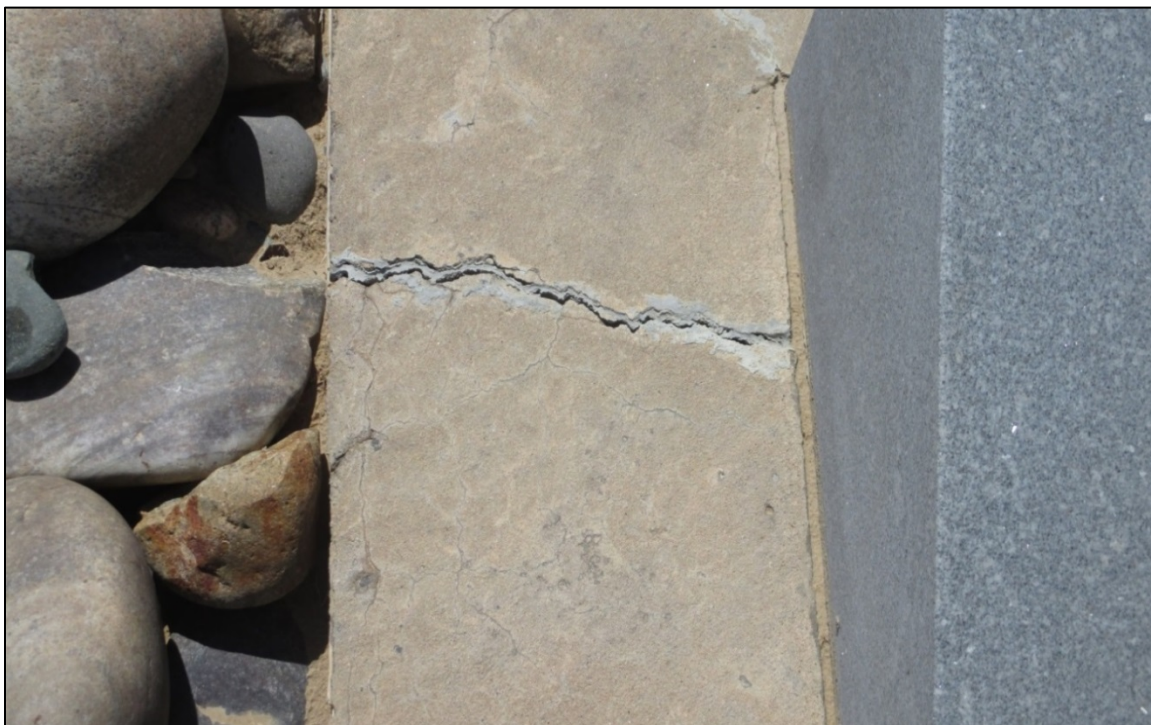
PL-7. Crack on Site Marker SMK-1 Concrete Base (Repaired Following Inspection)

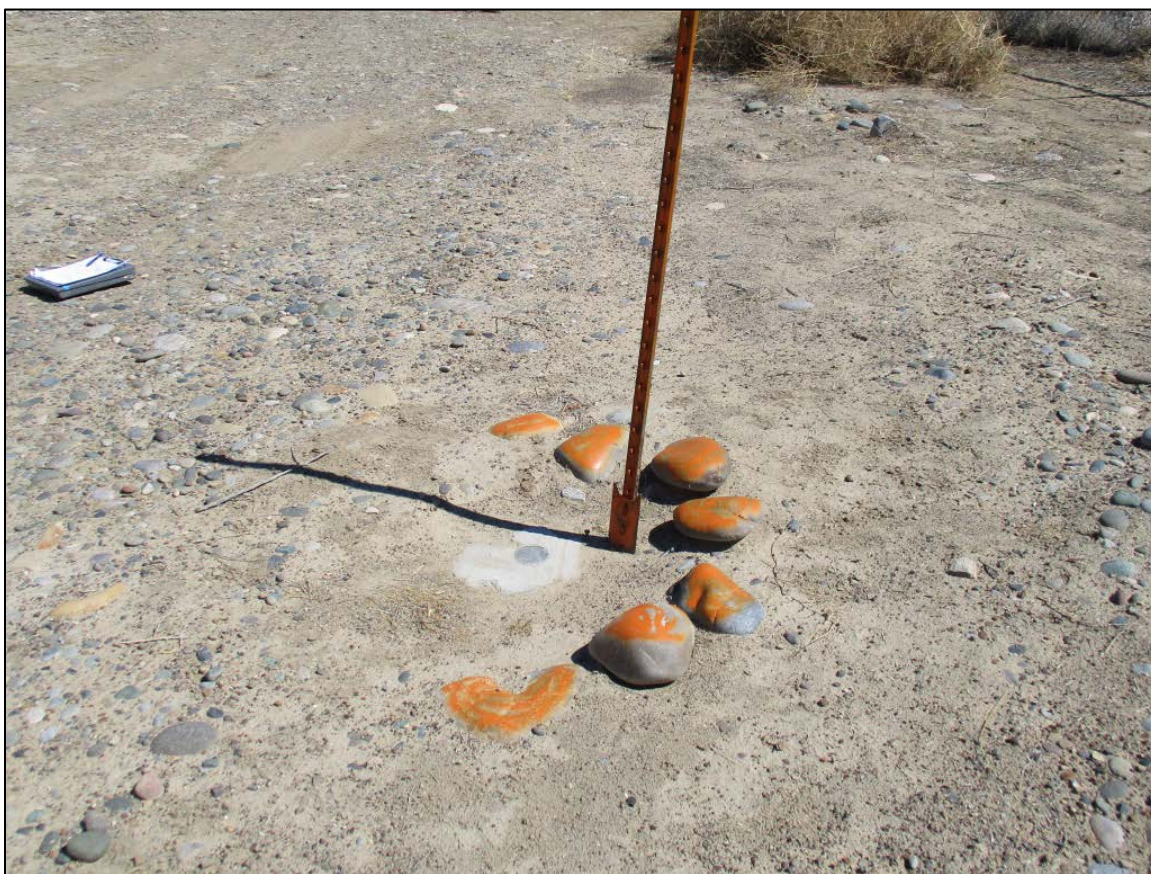
Three survey monuments and six boundary monuments delineate the property boundary. Two additional boundary monuments are offsite; monitoring of these monuments was discontinued in 1999 and 2003. Steel T-posts were installed next to all boundary monuments to help inspectors locate the monuments. Boundary marker BM-6 was resurveyed to obtain new GPS coordinates (PL-8). The site map was updated with the more recent coordinates for boundary marker BM-6 following the inspection. The concrete at survey monument SM-1 is cracked, but the crack does not threaten the integrity of the marker (PL-9). All boundary monuments were observed to be clear of vegetation and visible during the inspection. No other maintenance needs were identified.

PL-8. Boundary Monument BM-6 near Site Entrance

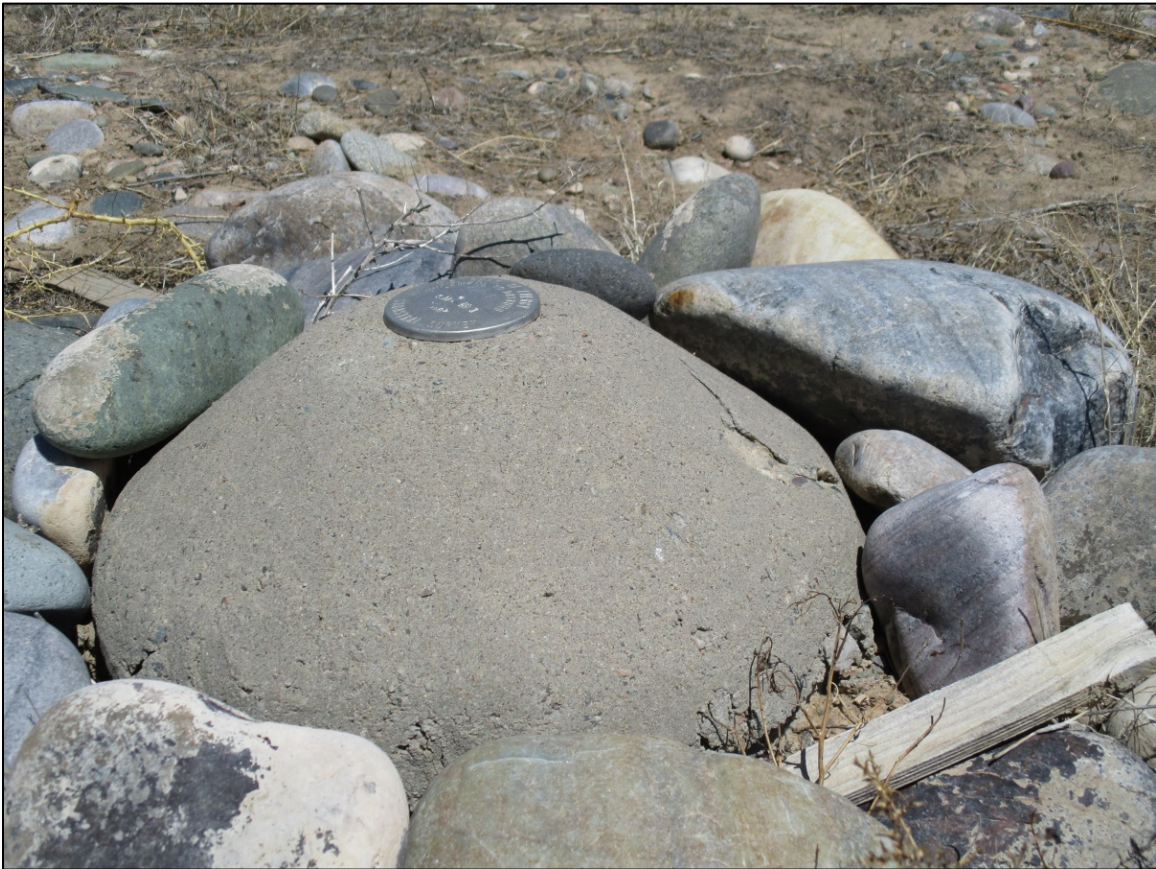
PL-9. Crack in Base of Survey Monument SM-1

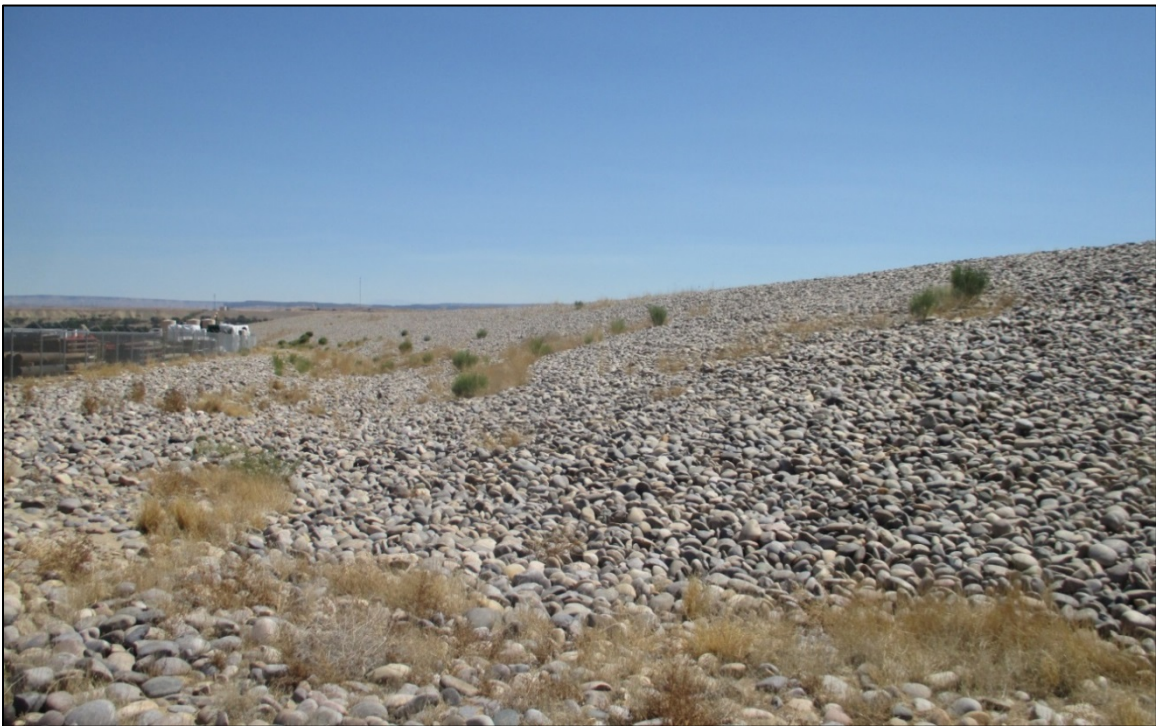
Windblown sediment has accumulated in the rock cover in several places, affecting approximately 1% to 5% of the total cover and enhancing vegetation establishment. In accordance with the LTSP, woody, deep-rooted shrubs are controlled. Only a few woody shrubs were growing on the northwest and southwest side slopes of the disposal cell (PL-10); these will be treated in 2019.

PL-10. Vegetation on Northwest Side Slope

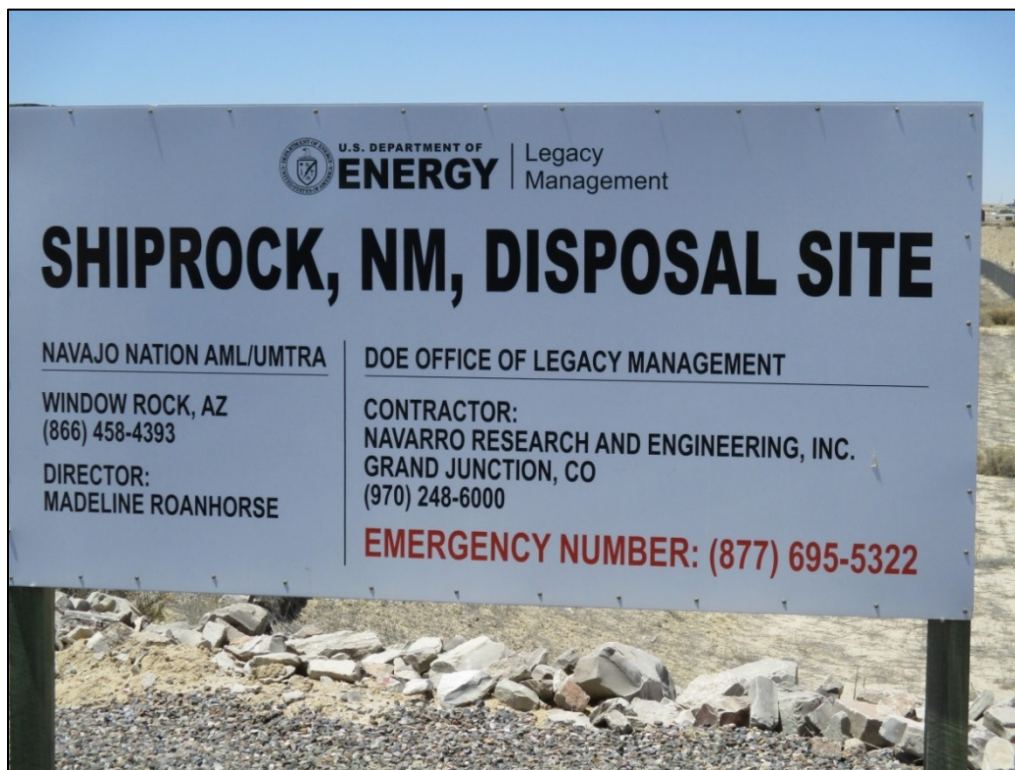
intact and functional at the time of the inspection. Phone numbers on the evaporation pond entrance sign were outdated (PL-11) and were updated following the inspection. Inspectors noted that the offsite portion of the outflow channel was functional and clear of debris. A portion of the erosion control fabric on the south-facing bank of the energy dissipation basin is damaged (PL-12). LMS engineering will be consulted to evaluate the need for repair of the erosion control fabric.

*PL-11. Evaporation Pond Entrance Sign Containing Outdated Phone Numbers
(Updated Following Inspection)*

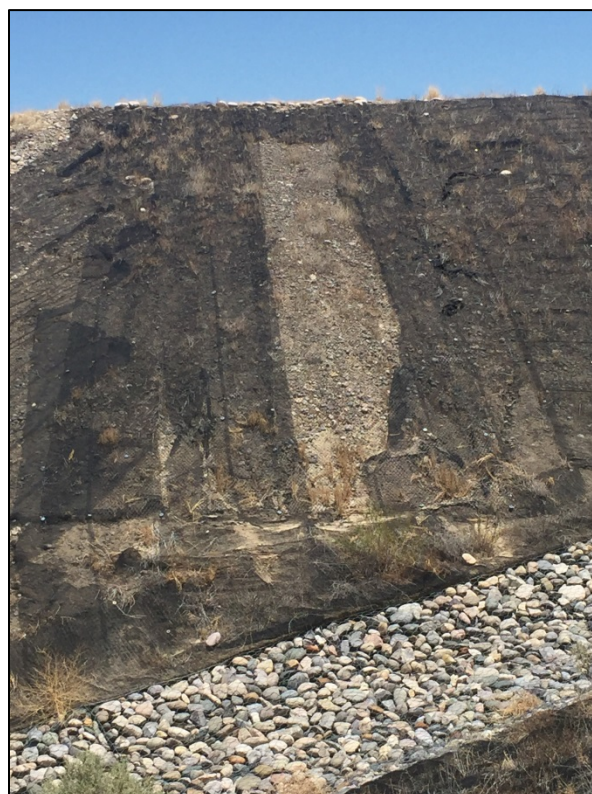
PL-12. Damaged Erosion Control Fabric (Need for Repair to Be Evaluated)
