16.0 Shiprock, New Mexico, Disposal Site

16.1 Compliance Summary

Figure 16-1. 2019 Annual Inspection Drawing for the Shiprock, New Mexico, Disposal Site

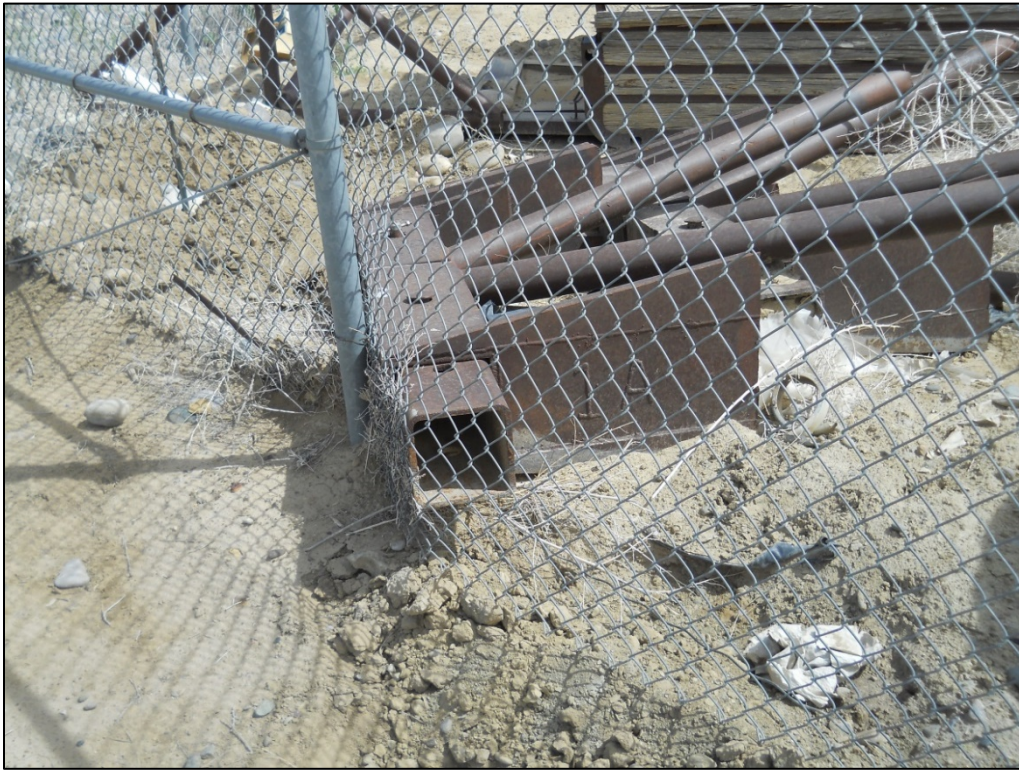
A chainlink perimeter fence encloses the disposal cell and drainage features. A gap was observed under the fence near perimeter sign P3. The 8-inch gap under the perimeter fence identified in 2018 was still present near perimeter sign P15. Maintenance to repair both gaps was completed in 2019 following the inspection. One perimeter fence post near perimeter sign P15 was disconnected, and a barbed-wire stanchion was damaged. These items were repaired following the inspection in 2019. Near perimeter sign P15, construction materials were again observed leaning against the perimeter fence in several locations on the Navajo Engineering and Construction Authority (NECA) side (PL-1). Dirt accumulation against the perimeter fence has bent the fence fabric between perimeter signs P11 and P12 (PL-2). NECA management was contacted following the inspection and requested to address both these maintenance needs.

PL-1. NECA Equipment Against Perimeter Fence Between Perimeter Signs P14 and P15

- Replacing the faded pictorial sign next to the entrance sign
- Repairing a fence post and stanchion near perimeter sign P15
- Contacting NECA management to request removal of construction material leaning against the perimeter fence near perimeter sign P15, repair of the fence fabric between perimeter signs P11 and P12, and assistance in fence repairs along the common fence
- Removing accumulating tumbleweeds on the southeast side of the perimeter fence
- Replacing the pictorial signs next to the southwest entrance sign and perimeter signs P11 and P12
- Treating new woody vegetation on the disposal cell top and side slopes

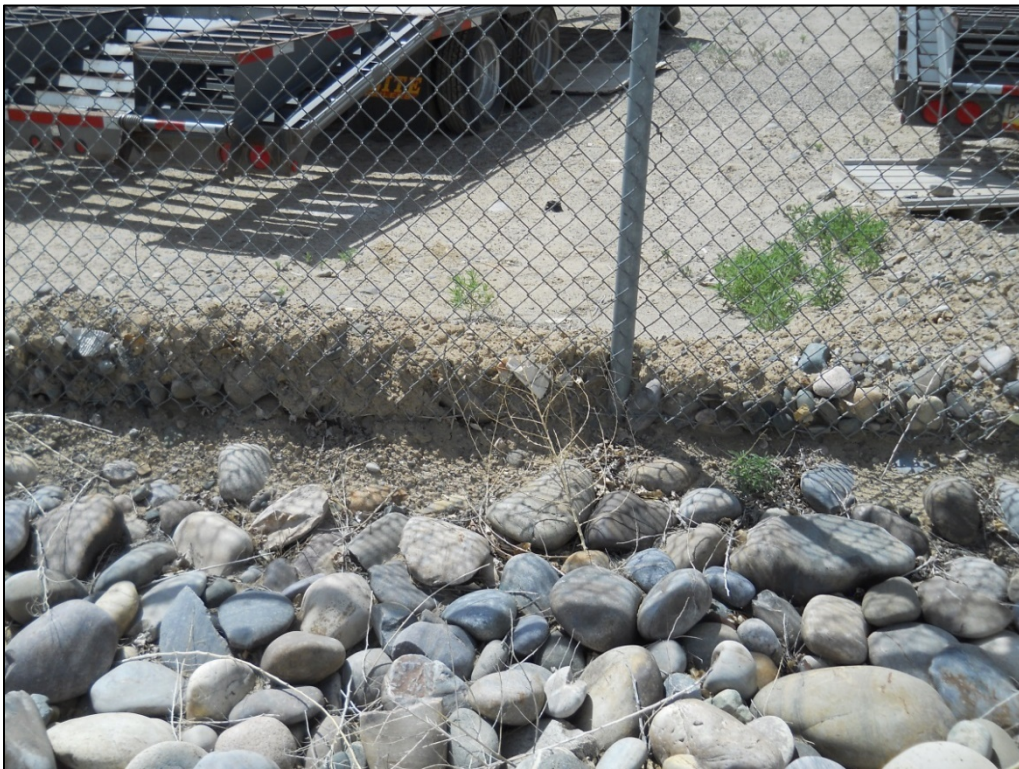
Dirt accumulation was also observed along the inside of the perimeter fence between perimeter signs P9 and P10. No maintenance is needed at this time. Inspectors will continue to monitor these areas. Regular maintenance continues to mitigate the accumulation of trash and tumbleweeds along the fence, although some minor tumbleweed accumulation was observed along the southeastern perimeter fence between perimeter signs P3 and P7. Maintenance to keep the perimeter fence lines free of debris will continue.

PL-2. Dirt Accumulation Against Perimeter Fence Between Perimeter Signs P11 and P12

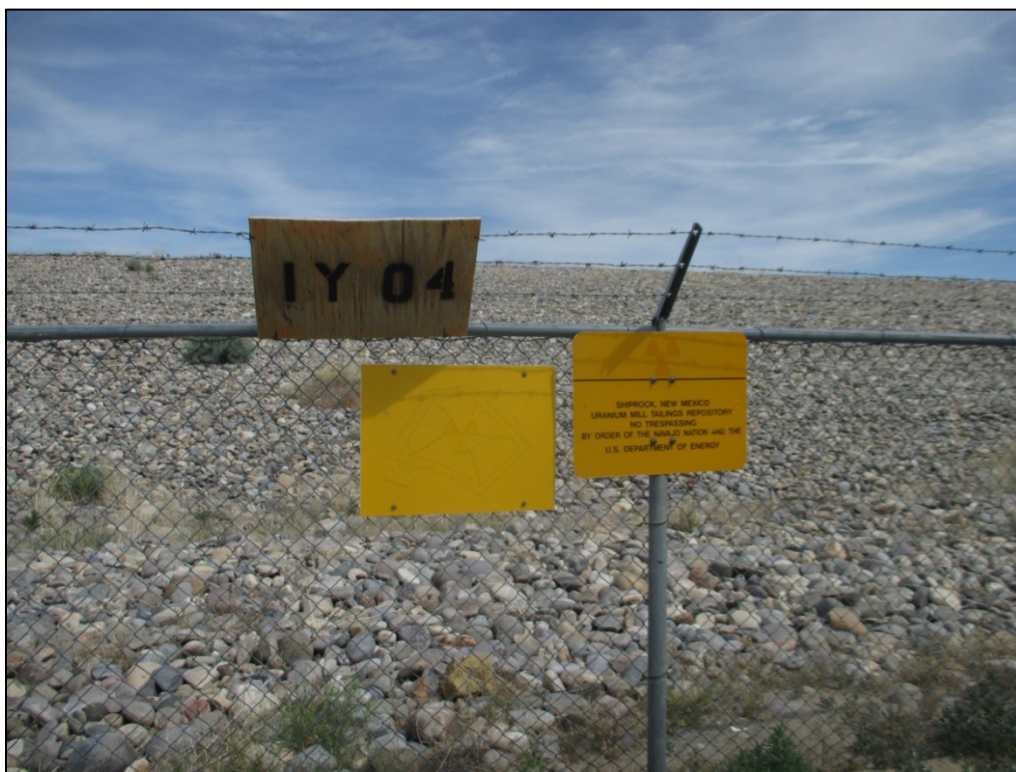
There are 17 pairs of perimeter signs, designated P1 through P17 (each pair consisting of one pictorial and one textual sign), positioned along the perimeter fence.¹ The pictorial signs near the southwestern entrance sign and perimeter signs P11, P12, and P17 were faded (PL-3) and were replaced following the inspection. The phone number on perimeter sign P8 was updated following the inspection. No other maintenance needs were identified.

PL-3. Faded Pictorial Perimeter Sign P11 at NECA Yard

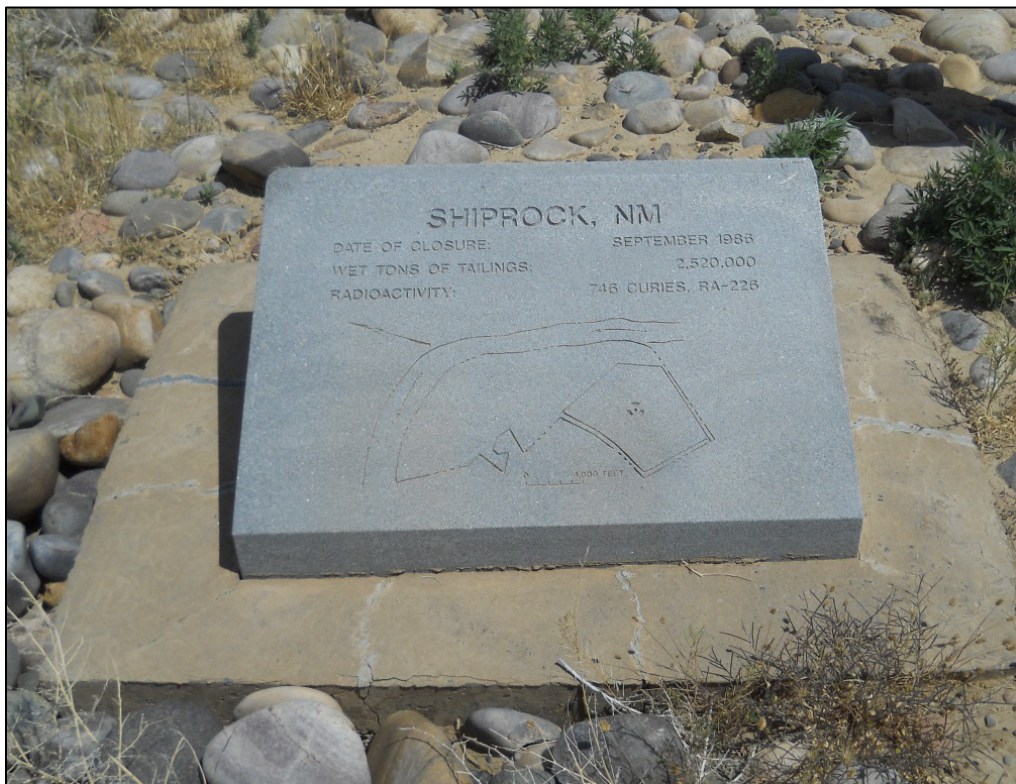
The site has two granite site markers. Site marker SMK-1 is just inside the west gate; minor cracks in its concrete base were resealed in 2018 (PL-4). Site marker SMK-2 is on the top slope of the disposal cell. No maintenance needs were identified.

PL-4. Site Marker SMK-1

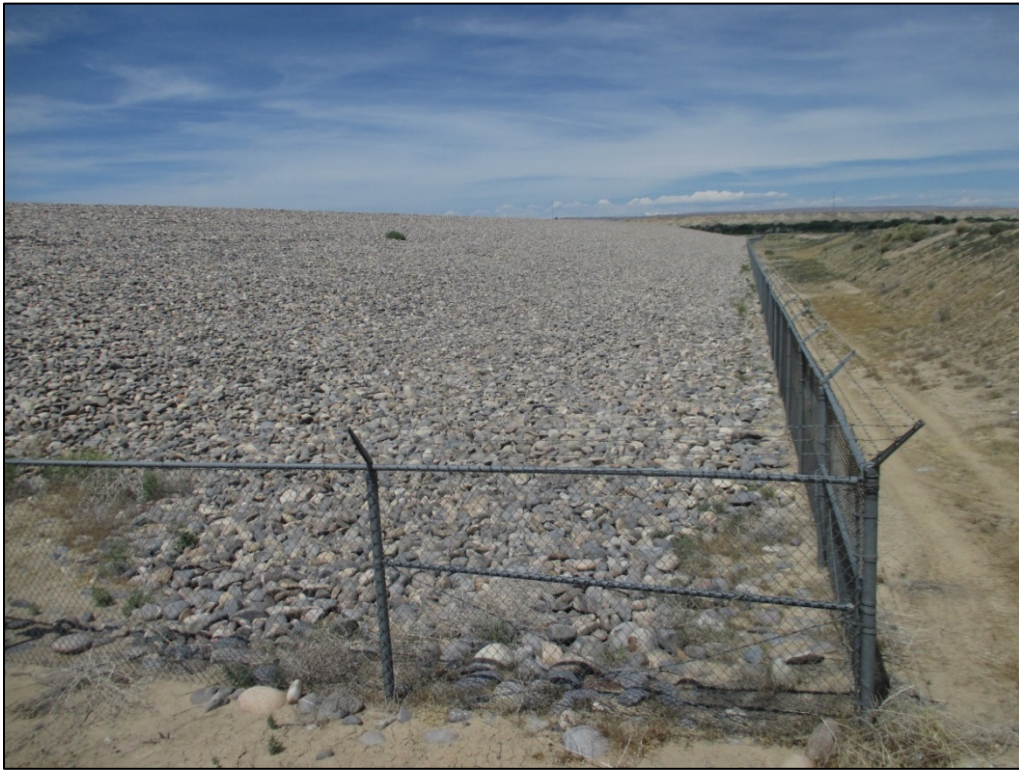
The disposal cell, completed in 1986, occupies 77 acres and is armored in riprap to control erosion and deter animal and human intrusion (PL-5). There was no evidence of erosion, settling, slumping, rock degradation, or other modifying processes that might affect the integrity of the disposal cell. Piezocones associated with a research project were installed on the disposal cell cover in the past and are no longer in use. Some of the filled piezocone pits have subsided slightly or were never completely backfilled, which resulted in shallow conical depressions in the cover. As reported in previous site inspection reports, the surface of the disposal cell contains numerous ruts associated with past vehicle traffic. An area where smaller riprap has been exposed was identified along the northern ridge of the disposal cell (PL-6). This area will be monitored for further changes that might indicate erosion or degradation of the cover. The condition of other depressions and vehicle ruts is monitored annually and has not changed significantly since the 2014 inspection.

PL-5. Perimeter Fence and Southern Corner of Disposal Cell

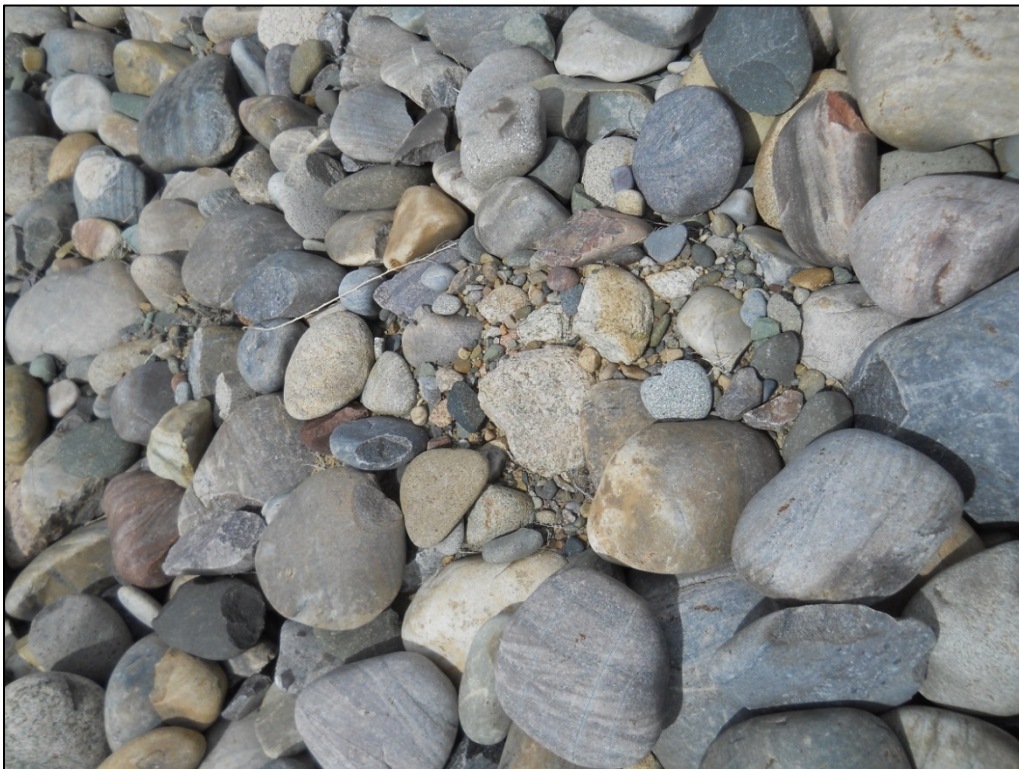
PL-6. Exposure of Smaller Cobbles and Gravels Along Ridge of Disposal Cell

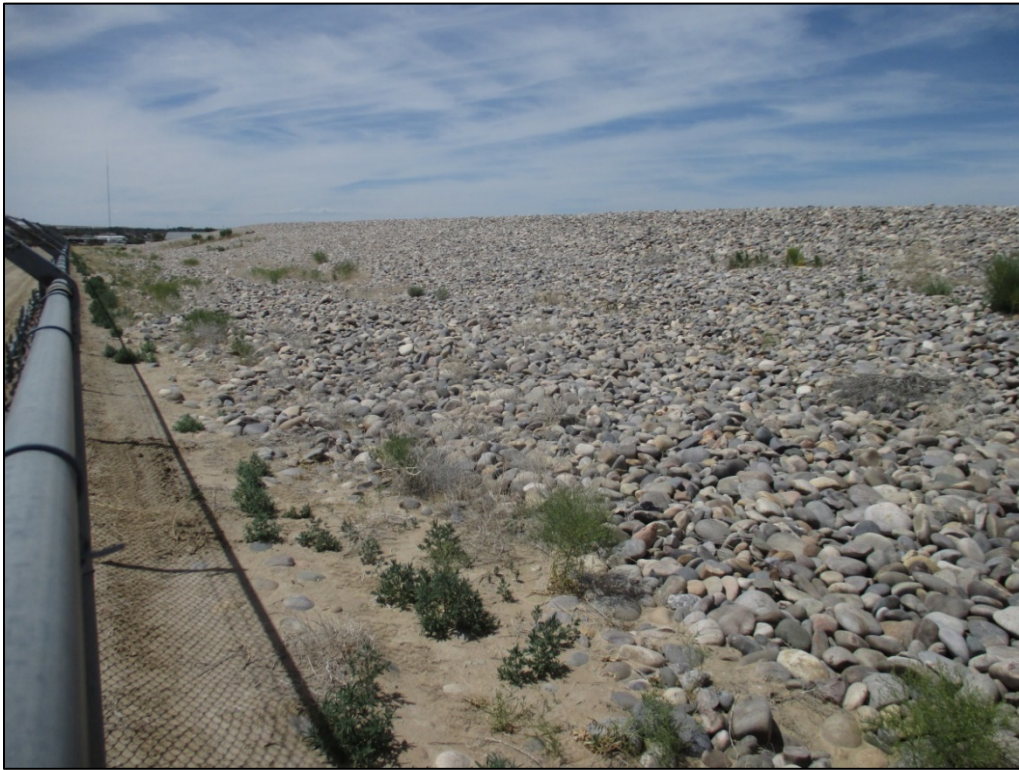
Diversion channels around the base of the disposal cell contained scattered vegetation, including several woody shrubs. The channel along the southwestern side of the disposal cell has accumulated sediment, and a significant amount of vegetation has grown (PL-7). It is possible that the sediment was generated from the maintenance of the road adjacent to the perimeter fence and has settled in the bottom of the channel. These shrubs do not adversely affect the performance of the diversion channel at this time and are not a concern, but they will continue to be monitored. Nonwoody plants were growing within the outflow channel, and woody vegetation was growing on the banks of the channel. No other maintenance needs were identified.

PL-7. Sediment Accumulation in Diversion Channel Along Southwest Slope of Disposal Cell

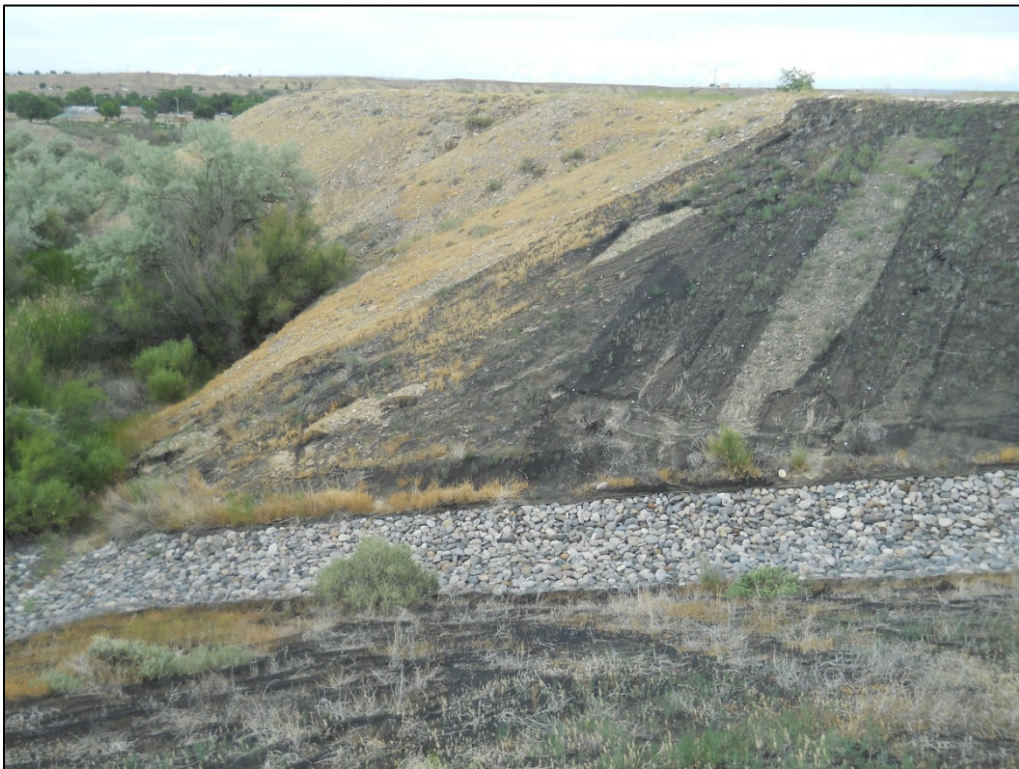
In 2002, LM constructed an 11-acre lined evaporation pond near the disposal cell as part of the groundwater compliance strategy. The pond, surrounded by a chainlink security fence, is maintained under the groundwater compliance strategy. Both the security fence and pond were intact and functional at the time of the inspection. Inspectors noted that the offsite portion of the outflow channel was functional and clear of debris. The degraded portion of the erosion control fabric on the south-facing bank of the energy dissipation basin identified during the 2018 inspection has been repaired and is functioning as intended (PL-8).

PL-8. Revegetated Slopes at Energy Dissipation Basin

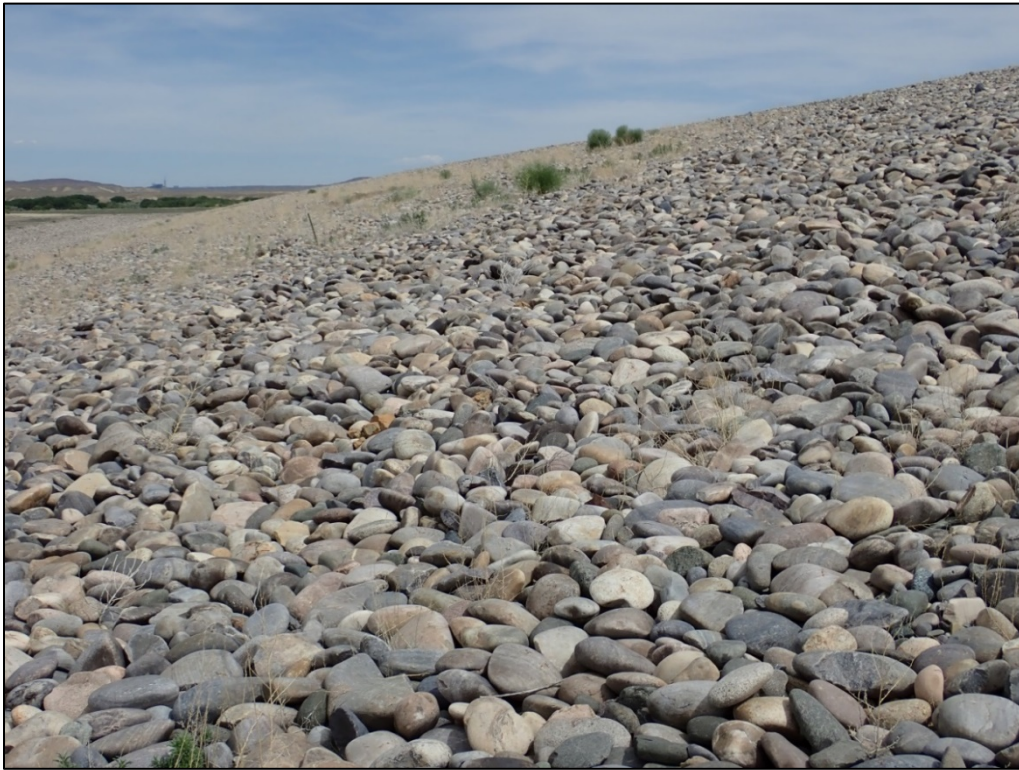
In a 1999 letter to the Navajo AML Reclamation/Uranium Mill Tailings Remedial Action Department (Bergman-Tabbert 1999), LM committed to spraying annual weeds on the disposal cell top slope. During the inspection, annual weeds were observed growing on less than 1% of the top slope. After discussion among LM, Navajo AML, and LMS ecologists, LM recommended that it cease treatment of nonnoxious weeds on the cell and allow natural plant succession to progress. LM wrote a new letter to Navajo AML outlining its proposed vegetation management plan. Under the plan, LM would continue to treat State of New Mexico– and Navajo Nation–listed noxious weeds (primarily *Halogeton glomeratus*) in accordance with applicable laws and deep-rooted woody species in accordance with the LTSP (Kautsky 2019). Vegetation will continue to be monitored to inform future management decisions (PL-9).

PL-9. Vegetation on Northeast Side Slope of Disposal Cell (Treated)
