2023 Annual Inspection Report for the DOE Monticello, Utah, Mill Tailings Site and Monticello Vicinity Properties

February 2024

Legacy
Management

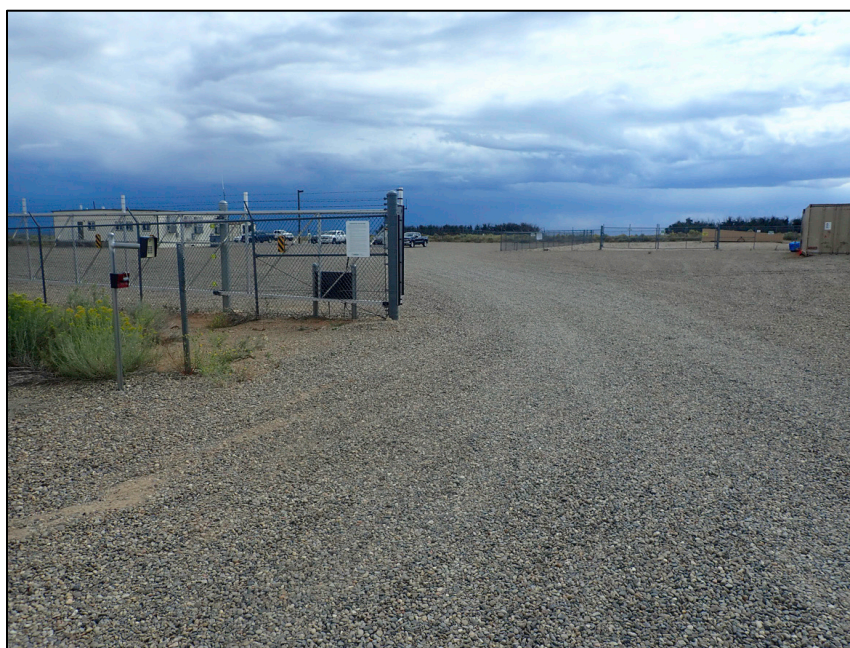
PL-1. Field Office and Associated Structures

The Monticello field office buildings and associated structures were in excellent condition and well maintained (PL-1). Video surveillance cameras are inside and outside of the main office building. Site access signs displaying contact information were visible, and the new signs containing updated information were in place and in good condition (PL-2). The site's paved access road was in very good condition.

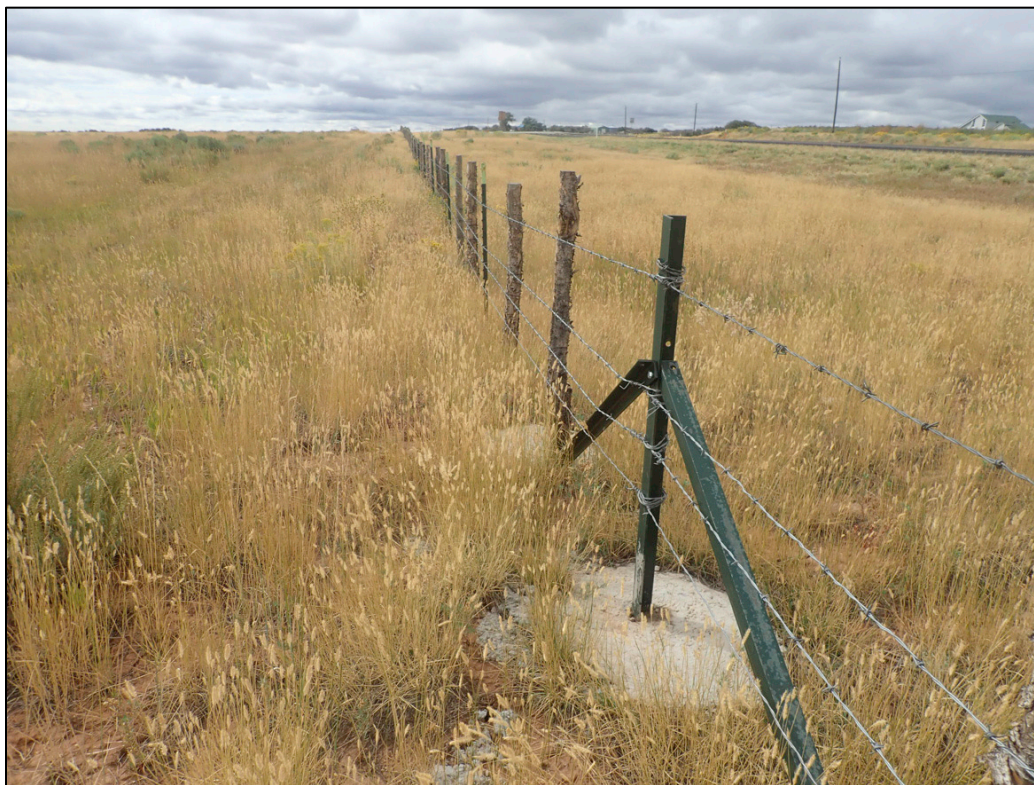
PL-3. West Fence Line Looking South

The north, south, east, and west perimeter fences were in good condition (PL-3, PL-4). There was no evidence of vandalism or areas of excessive vegetation or debris buildup.

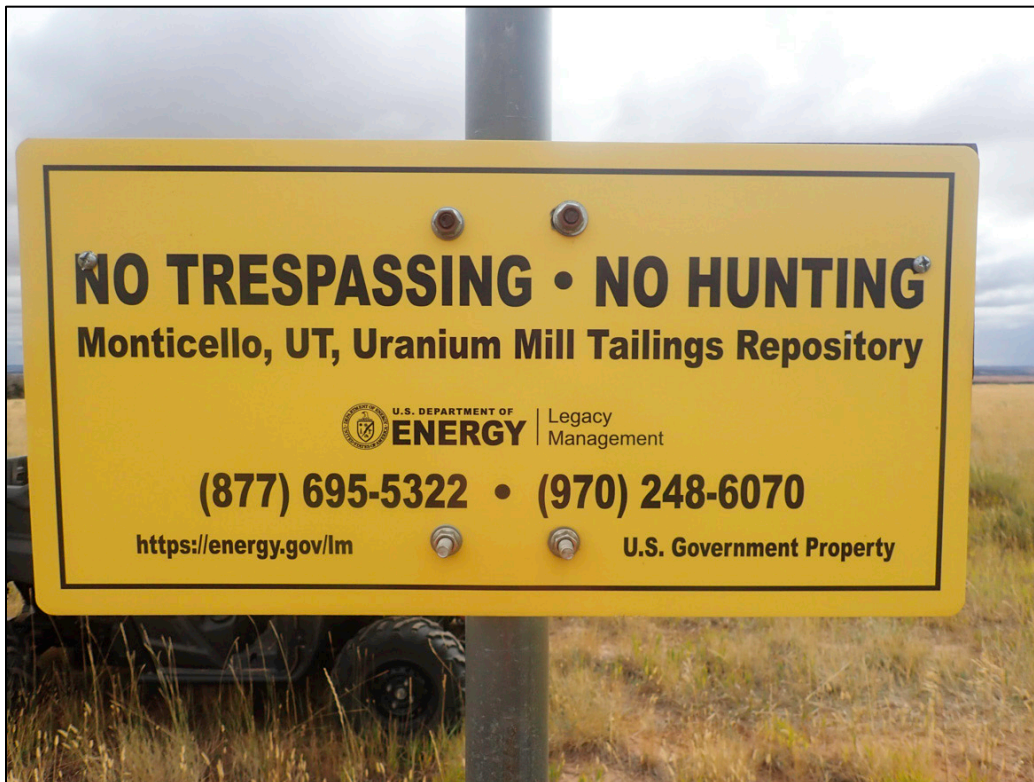
PL-5. Perimeter Sign P37

All perimeter signs were in good condition (PL-5, PL-6). Black-numbered decals to identify sign numbers were in good condition.

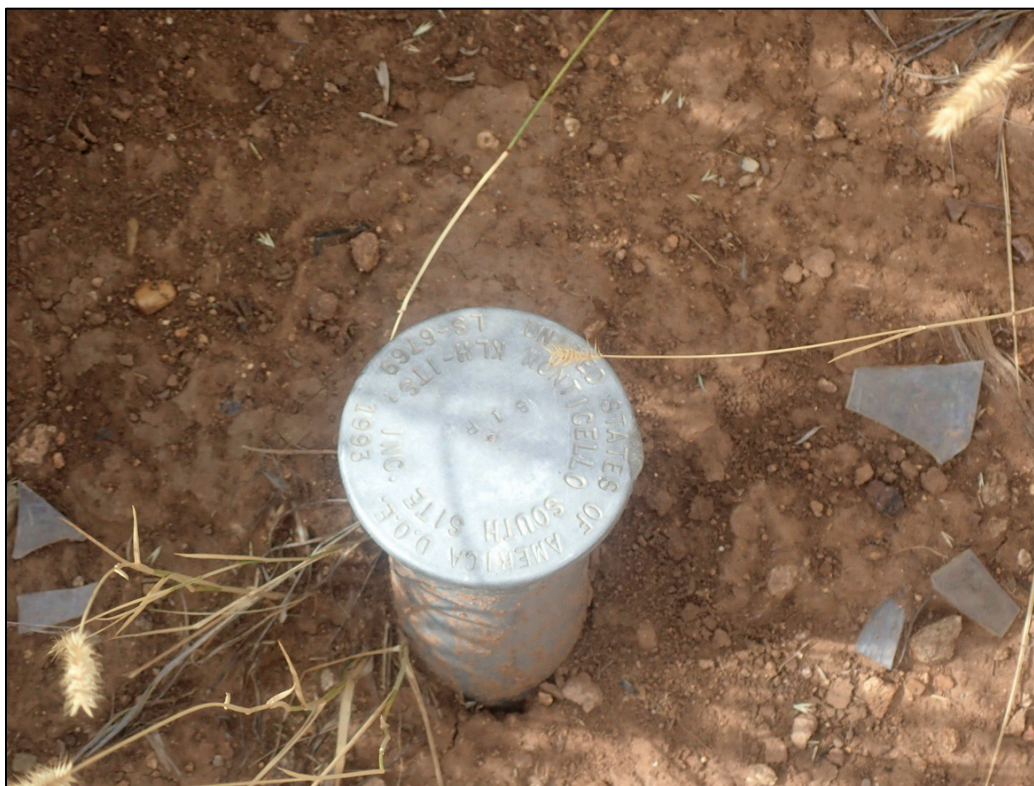
PL-7. Boundary Survey Marker S1R

All six boundary markers were located during the inspection, and all were in good condition (PL-7). All six boundary markers were accounted for during the annual inspection.

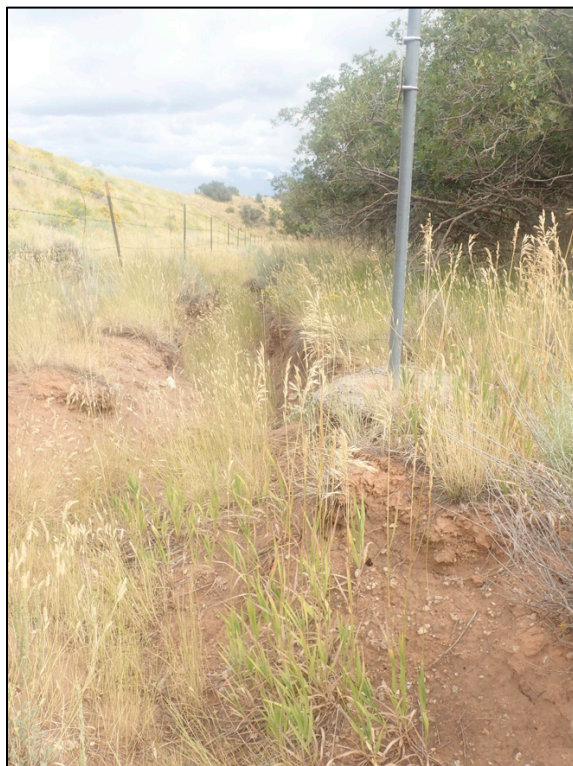
Erosion channels and drainages around the site perimeter were generally well vegetated and had not changed significantly since the 2022 annual inspection. Erosion controls and revegetated areas related to the GRO system were in good condition, and no major erosional areas were noted. The deep gully on the west edge of the disposal site described in previous inspection reports has not changed since 2022 (PL-8), as increased vegetation from a high-precipitation year has stabilized much of it. The gully does not threaten the integrity of site features but will continue to be monitored.

PL-8. Looking North Toward Perimeter Sign 1 (No Change in Erosion Channel)

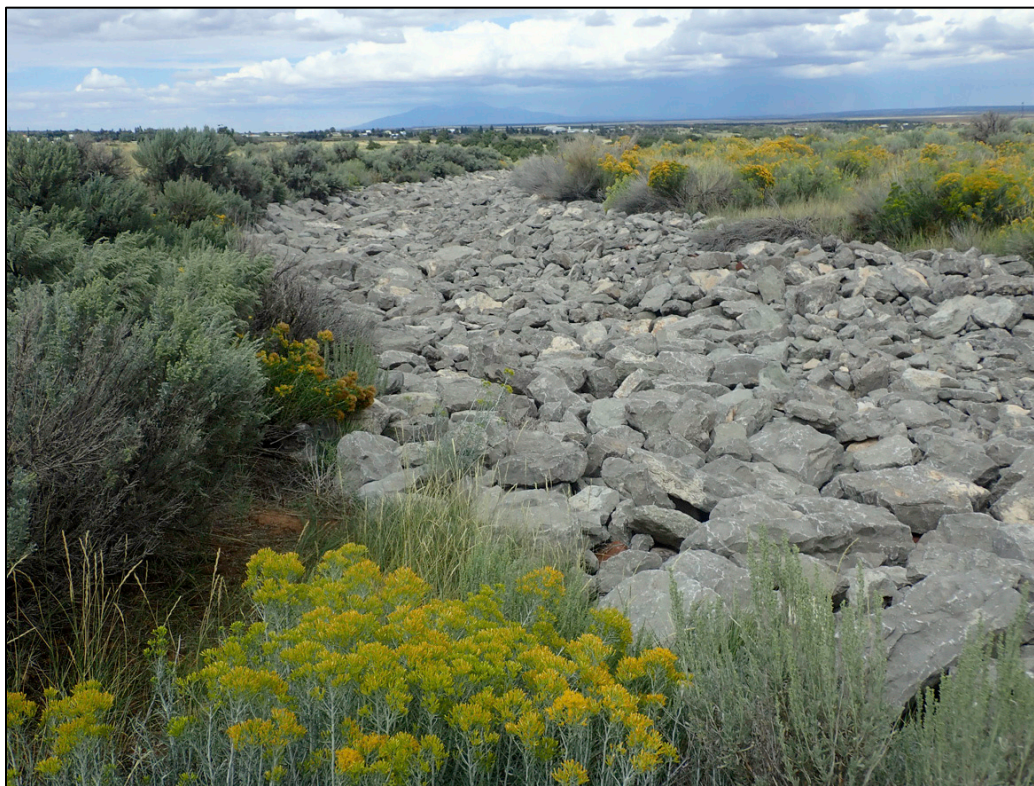
PL-9. West Drainage Channel

The South and West Drainage Channels were in good condition (PL-9, PL-10). Small erosion rills, repaired in October 2020, on the West Drainage Channel were in good condition. Burrows from small rodents that are found in places along the margin of the channels do not threaten the channels' integrity.

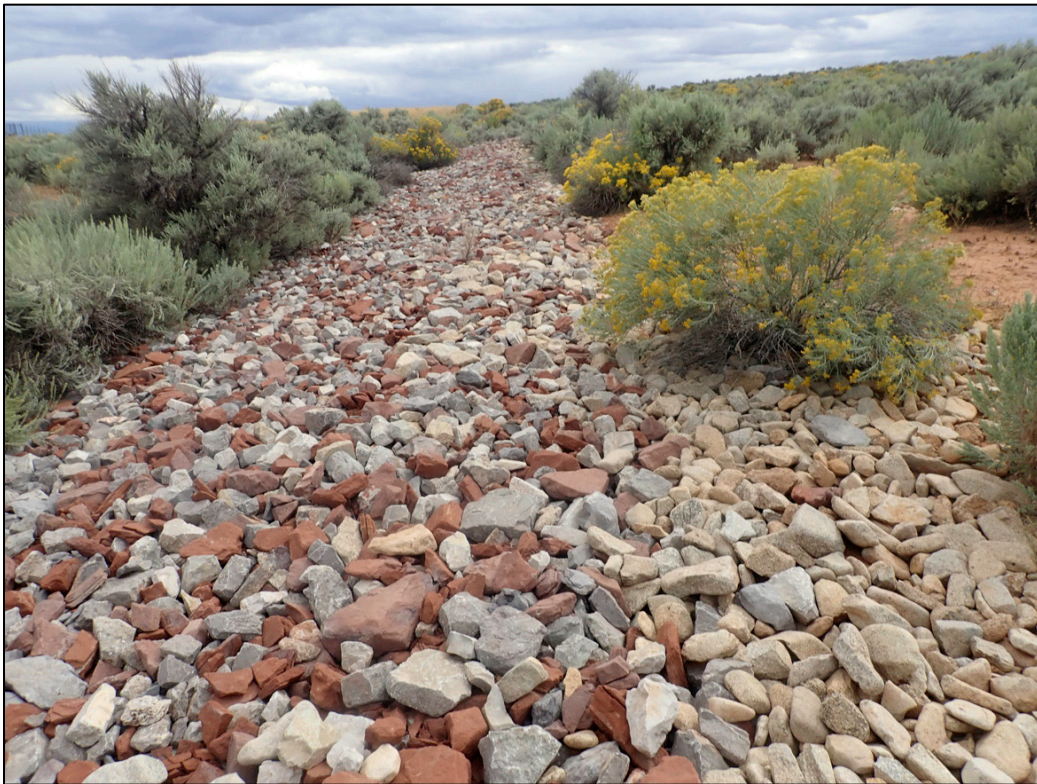
PL-11. East Toe Trench, Looking South

The East Toe Trench and North Toe Trench were in good condition. No erosion of these trenches was evident. Beginning in 2013, inspectors observed increased siltation from the repository side slope into both toe trenches during heavy rainfall events. The siltation does not impair the functioning of the trenches (PL-11).

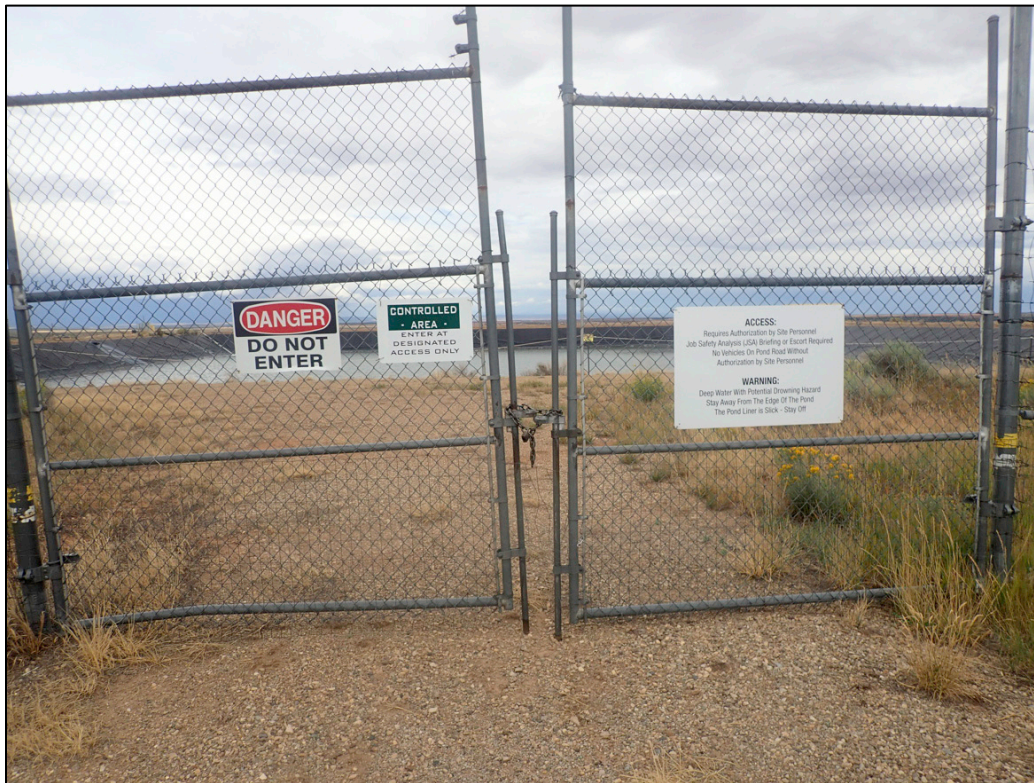
PL-12. Pond 4 Entrance Gate

All gates were in good working condition. Warning signs on the perimeter fence were easily visible and legible. There was no evidence of vandalism or trespassing, and all gates were locked at the time of the inspection (PL-12).

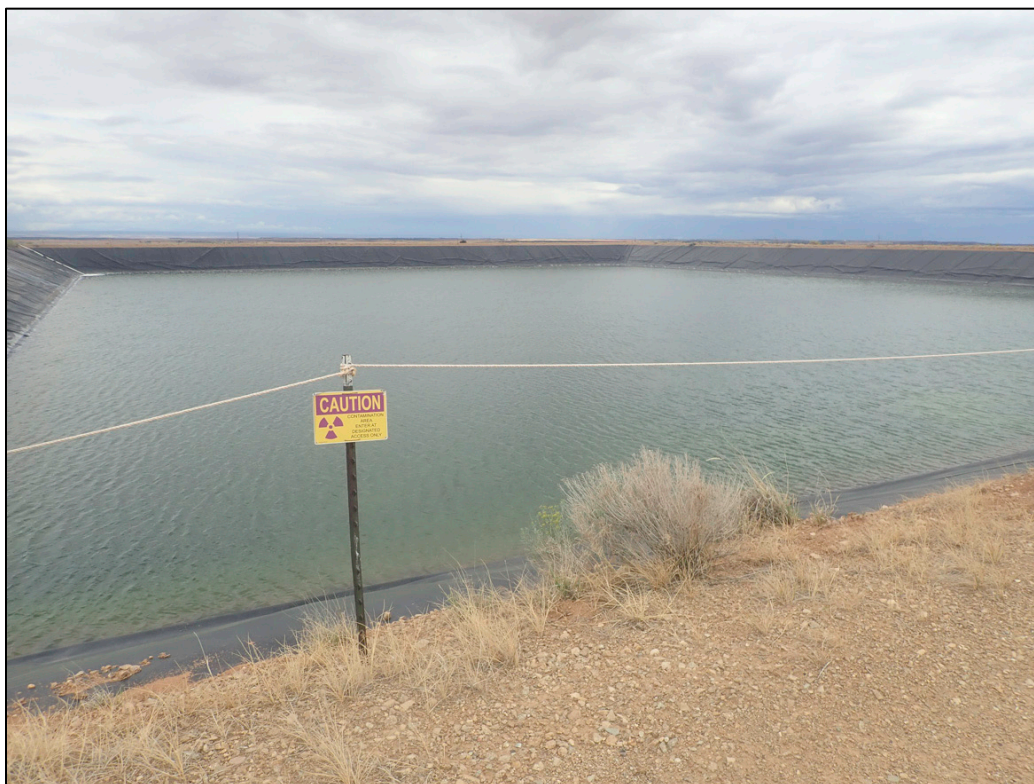
PL-13. Pond 4, Looking Southwest

The pond's radiological rope barrier was intact and in good condition. The excess vegetation along the pond's access road was mowed in June 2022. This year, animal burrows made by voles and other small rodents were visible on and below the pond's berm on all sides. However, no large burrows that might threaten the berm's integrity were found. Vegetation on the slopes of the berm was well established and healthy. Pond 4 is shown in PL-13. The fence around Pond 4 was in good condition.

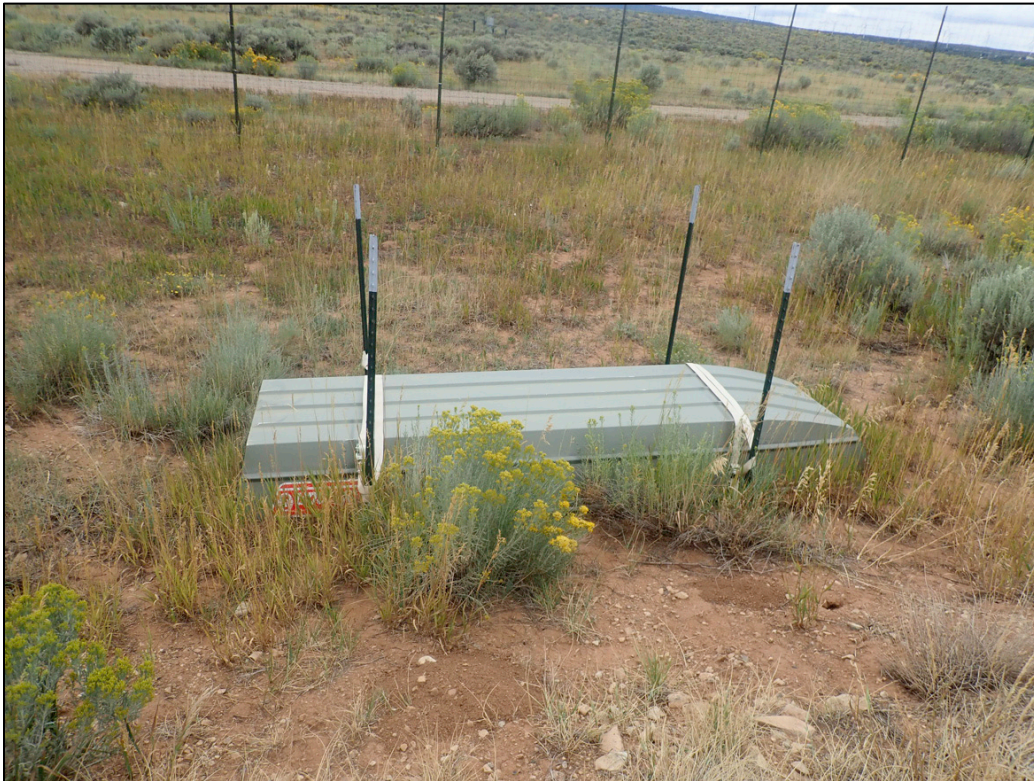
PL-14. Pond 4 Safety Skiff

Lifesaving rings and a rescue and work skiff were present and easily accessible near the pond. Cabinets containing water rescue equipment were also highly visible, adequately labeled, and in good condition (PL-14).

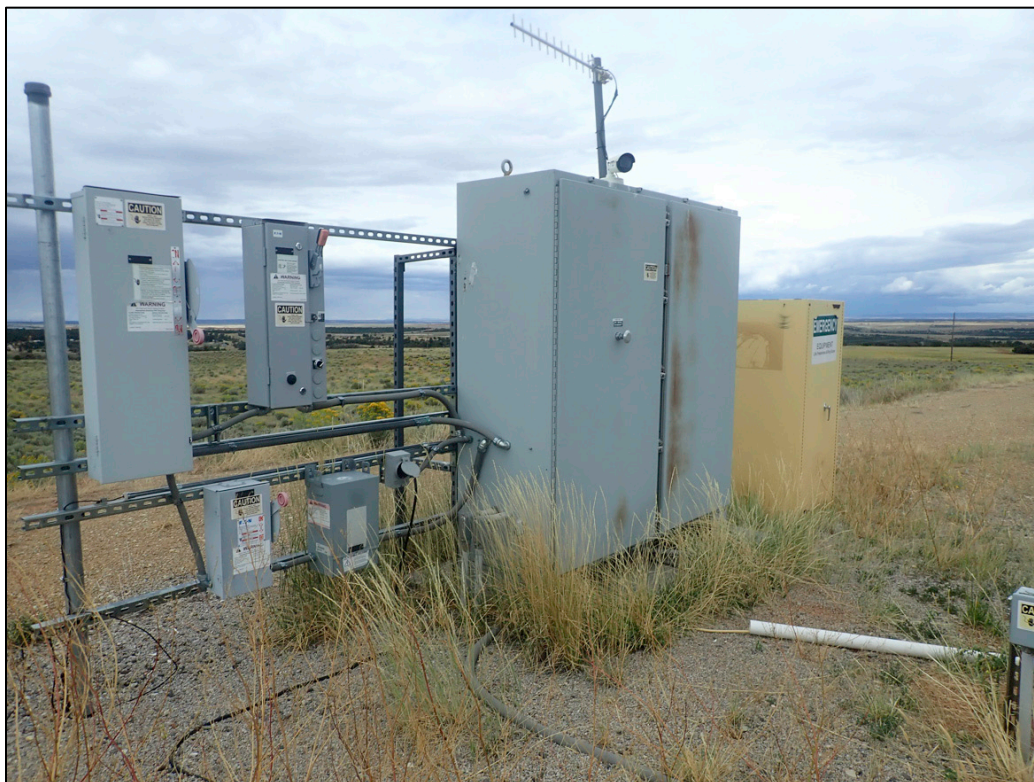
PL-15. Pond 4 LCRS and LDS Control Cabinet

The weatherproof LCRS and LDS control cabinet was in good condition (PL-15). Operation of the Pond 4 LCRS and LDS is described in Section 2.1.6.

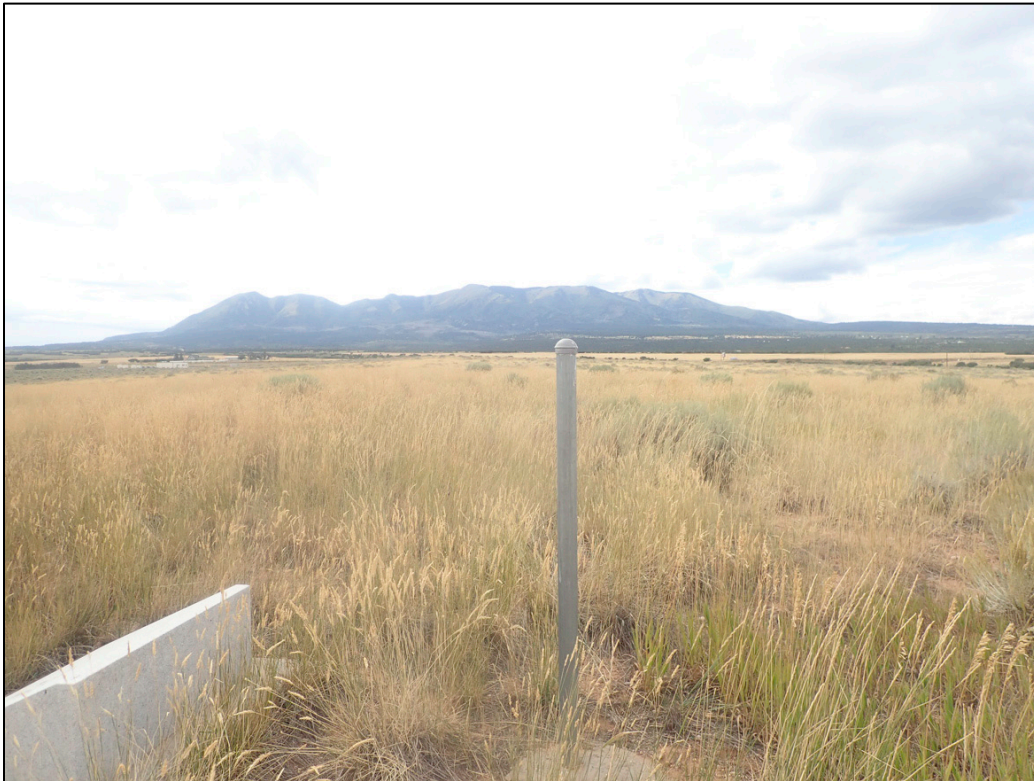
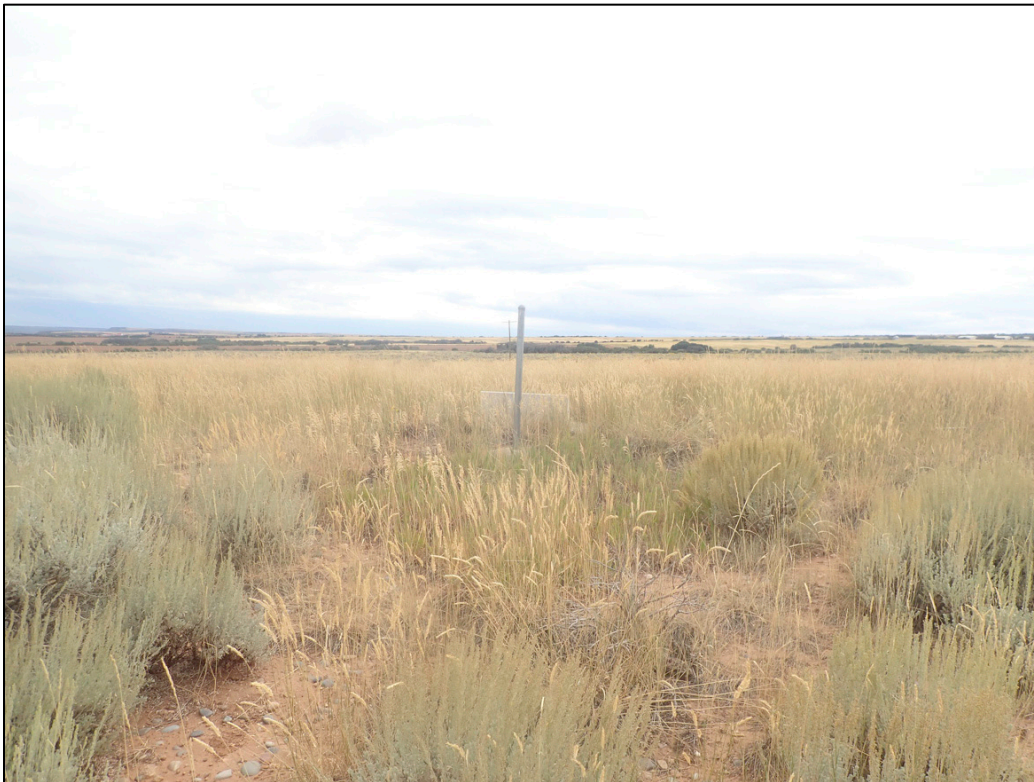
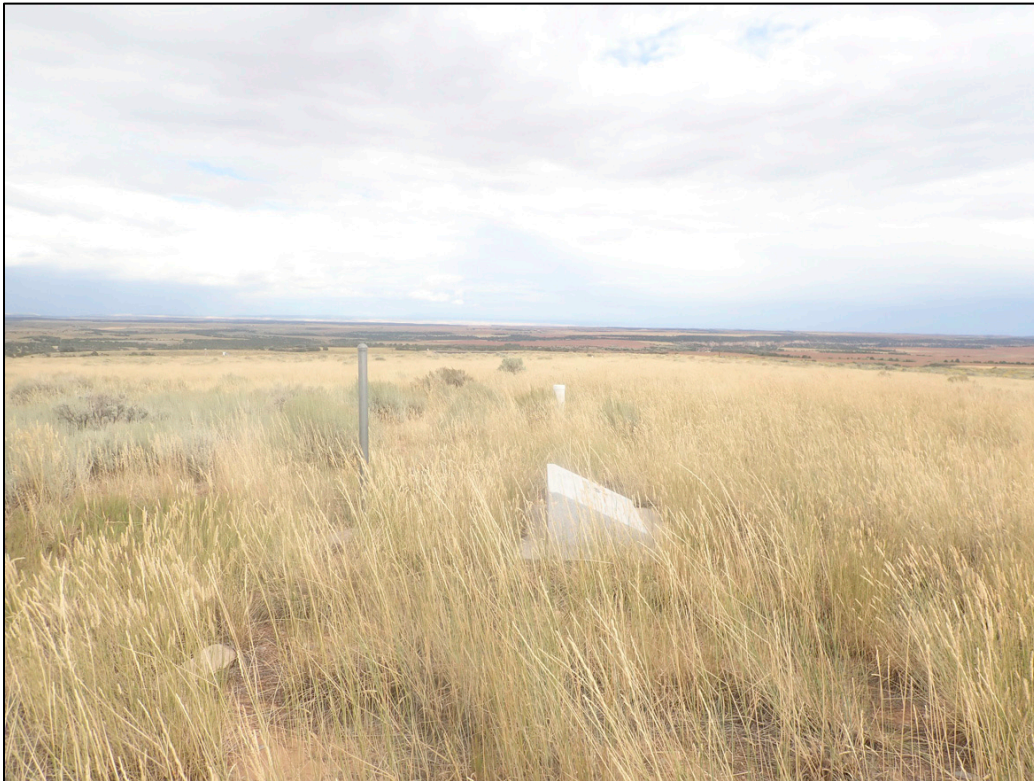
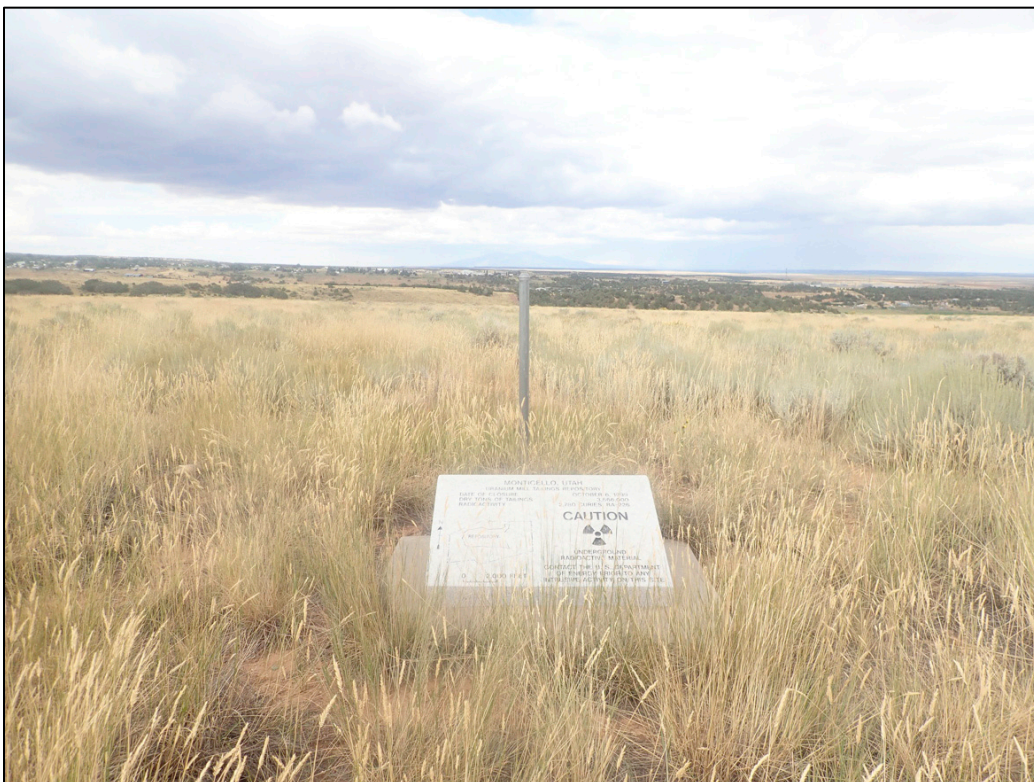
Desirable plants remained well-established on the cover, and no significant barren or eroded areas were identified (PL-18, PL-19, PL-20, PL-21). No damage to vegetation or soils from rainstorms was apparent, and no species of phreatophyte shrubs were growing on the cover. As in recent years, there were many healthy young sagebrush (*Artemisia tridentata*) plants. The small quantity of field bindweed (*Convolvulus arvensis*), which the State of Utah lists as a Class C noxious weed, was still present on the cover, but control was not necessary.

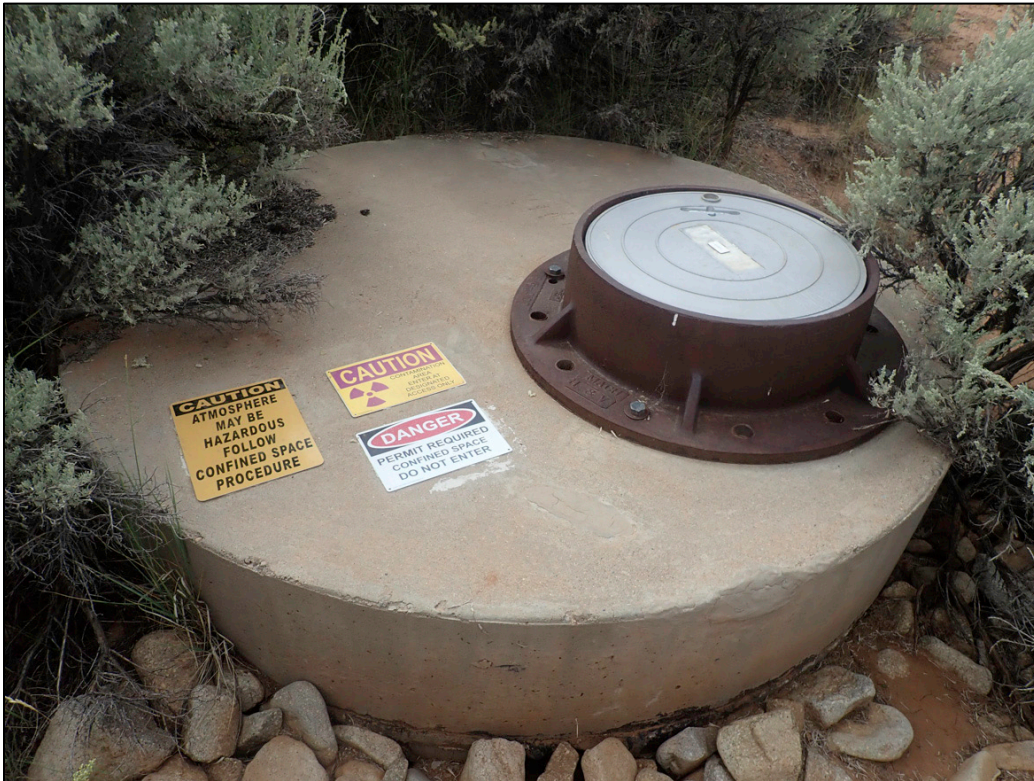
PL-22. Manhole 5, Exterior

The manholes are restricted areas and were not entered during the annual inspection, but the exteriors were observed (PL-22, PL-23). The other four manhole covers were secure and operable. Appropriate safety warnings and entry procedures were posted on all the manholes, exterior pump access ports were undamaged, telemetry surface installations were in good condition, and no leakage or drainage was evident. Covers of the inoperable video ports were locked and secure.

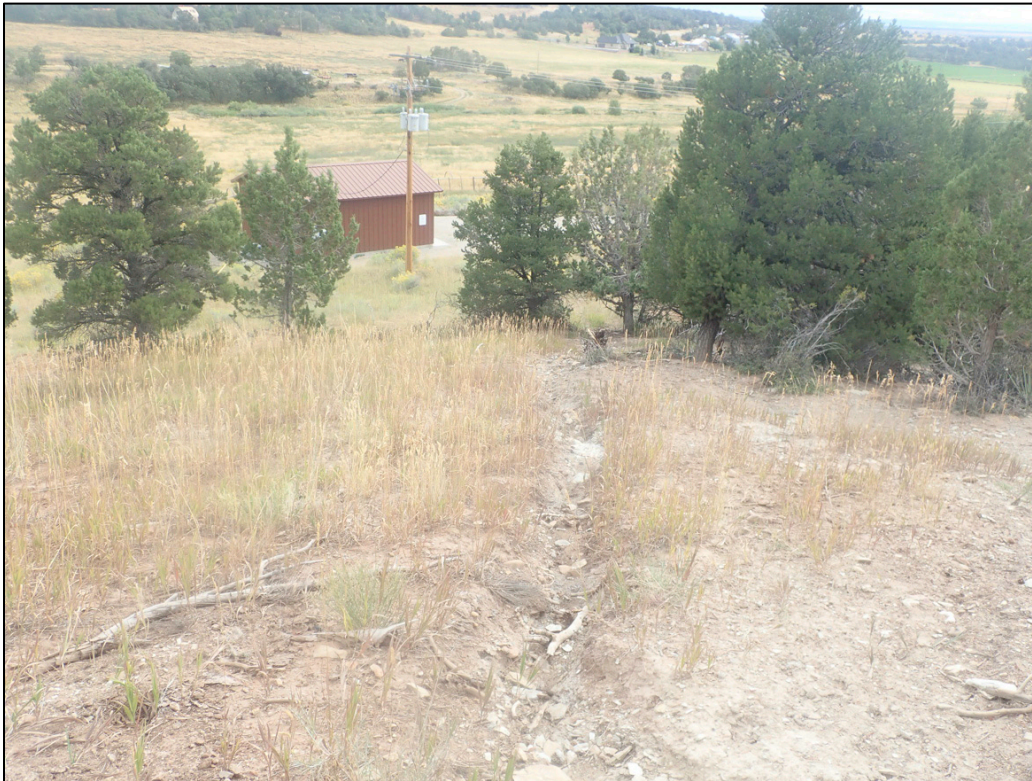
PL-26. Property MP-01077 Erosion Gully Toward Groundwater Transfer Building

The gully erosions on property MP-01077 will continue to be monitored due to their location uphill from the Groundwater Transfer Building. A leak occurred on property MP-01077 from vault CS-MNT-10; repairs are scheduled for October. There is new erosion on property MP-00181 and the Highway 191 embankment. The function of these areas is not impaired, but continued monitoring is recommended.

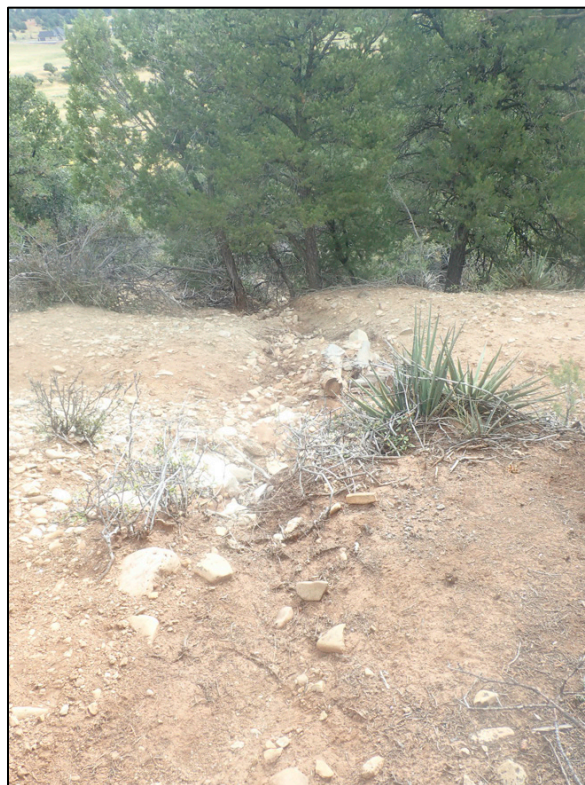
PL-27. Property MP-01077 Erosion Gully Southeast of Groundwater Transfer Building

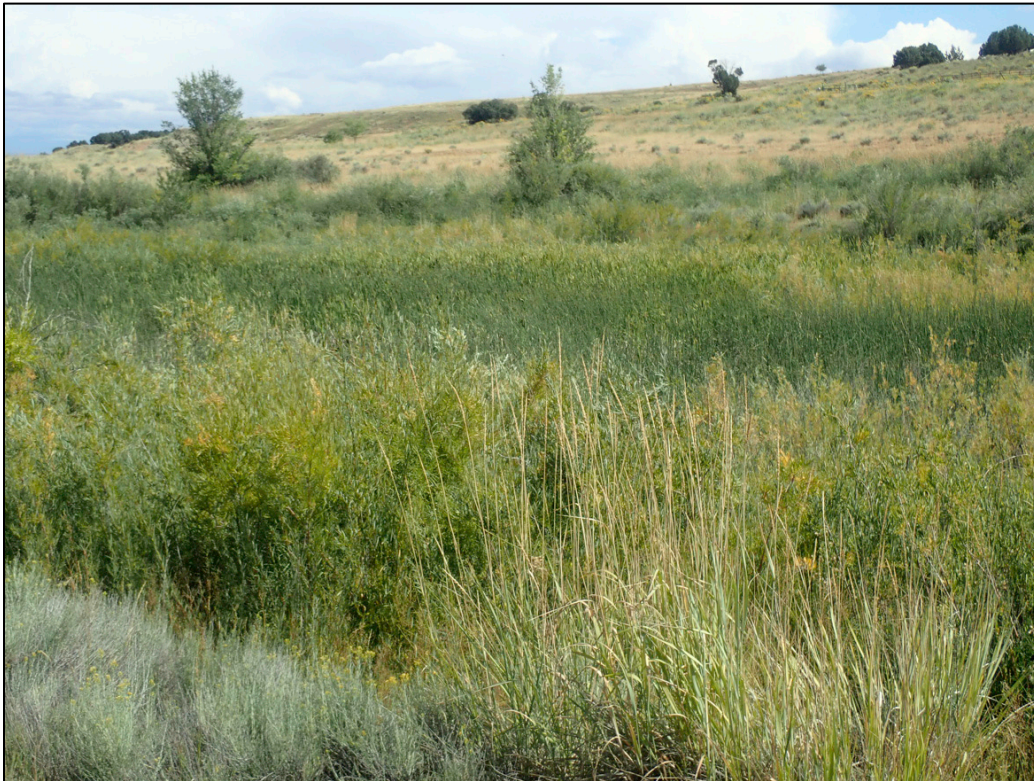
PL-28. Wetland 1

Wetlands 1, 2, and 3 are ecologically healthy and undamaged (PL-28, PL-29). There was no evidence of damage from human activity or natural causes. Erosion from the upgradient June 2020 waterline break will continue to be monitored due to its proximity to Wetland 2.

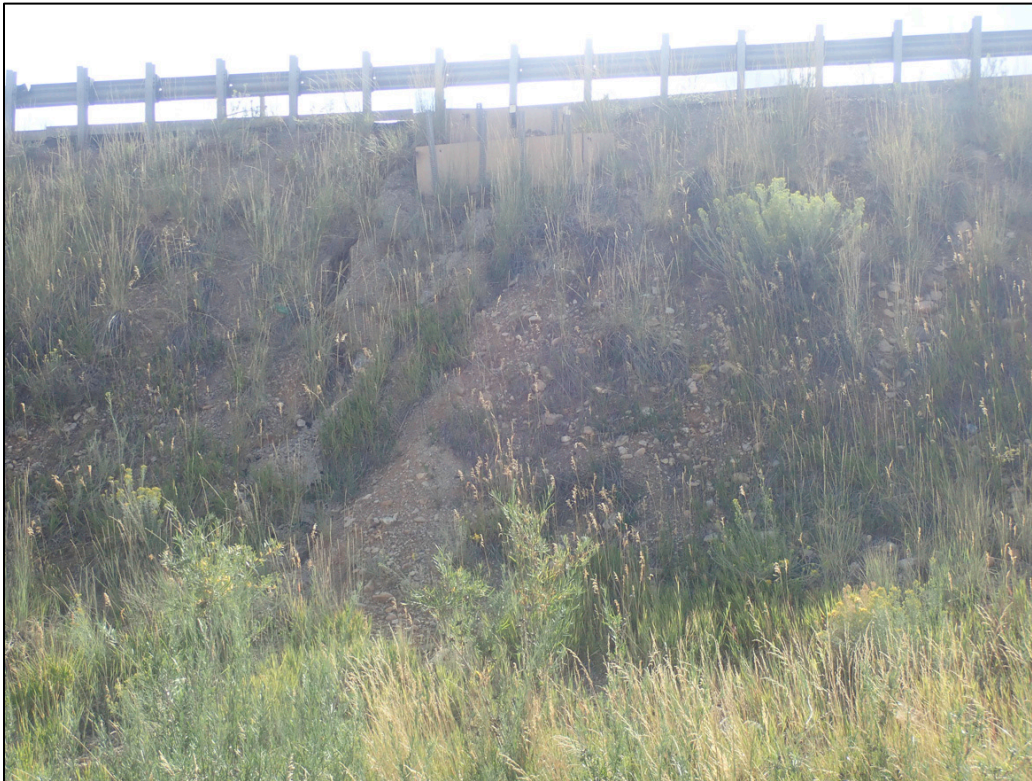
PL-30. UDOT Highway 191 Embankment Erosion

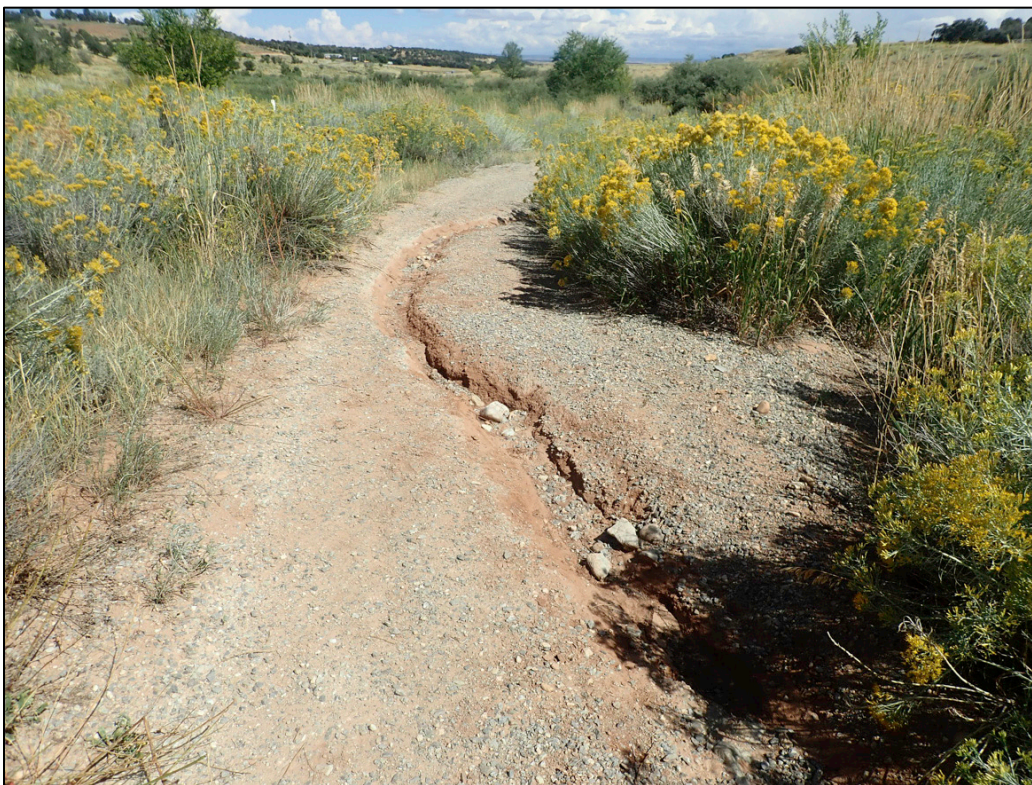
PL-31. Property MP-00181 Erosion Along Walking Path, Looking Southeast

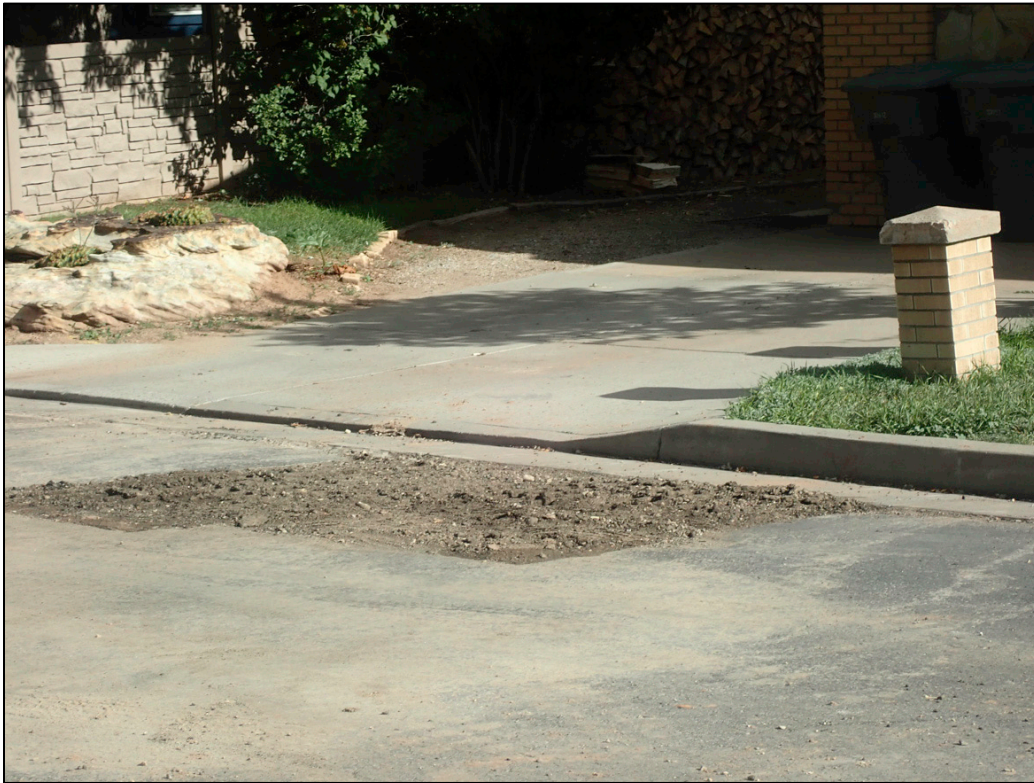
PL-32. City Utility Line Work at 349 S. Latigo Loop

Section VIII of Appendix A presents results of the 2023 annual inspection of UDOT rights-of-way within city limits and city streets and utility corridors. No unmonitored or unplanned excavations were identified. Onsite personnel were aware of all planned excavations, and excavations were monitored in accordance with the LTS&M Plan. PL-30 shows erosion and what appears to be a temporary repair on the U.S. Highway 191 embankment along the former mill site. New erosion was most likely caused by heavy rain events. The erosion continues down from the highway embankment into the walking path toward Montezuma Creek (PL-31). Eroded material was scanned the day of the inspection and no radiological contamination was discovered. PL-32 shows recently performed excavation work at 349 S. Latigo Loop.

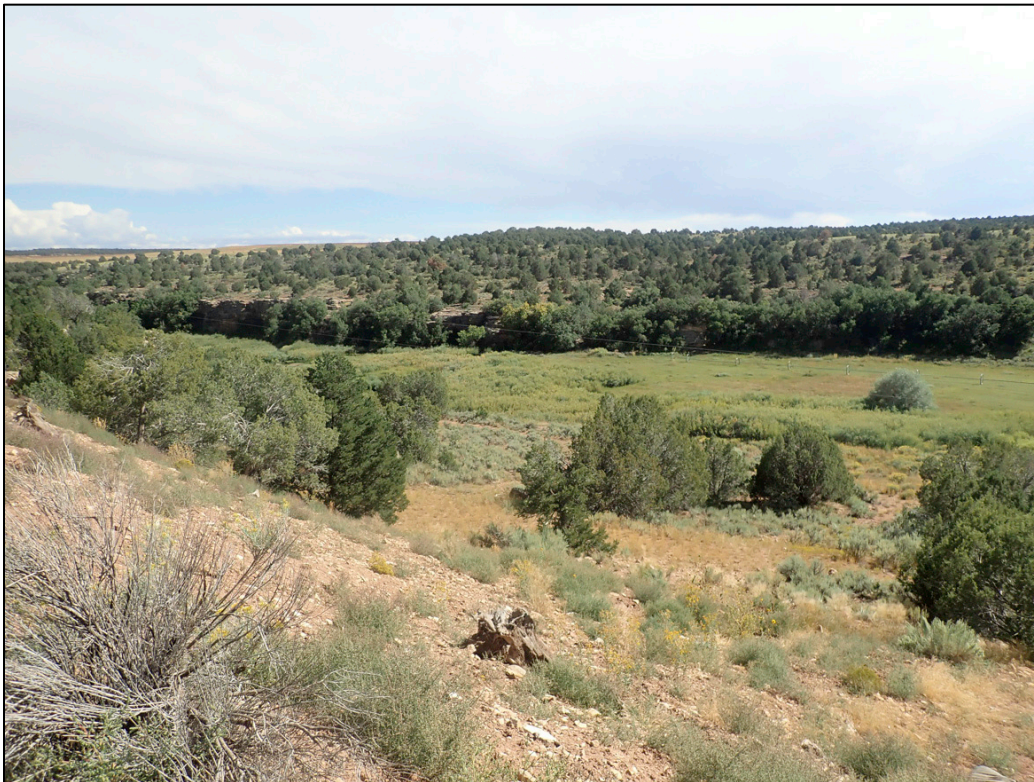
PL-33. Montezuma Canyon, View Downstream

Properties in the Montezuma Creek Restrictive Easement Area are inspected on a regular basis by onsite and water sampling personnel; during these visits, no evidence of significant erosion or soil removal from the restricted areas of these properties was noted. During the 2023 annual inspection, portions of Montezuma Canyon were inspected from observation points above the area, and no evidence of land-use changes or disturbance to the easement area was found. Observations in the easement area (PL-33) are recorded in Appendix A, Section V.

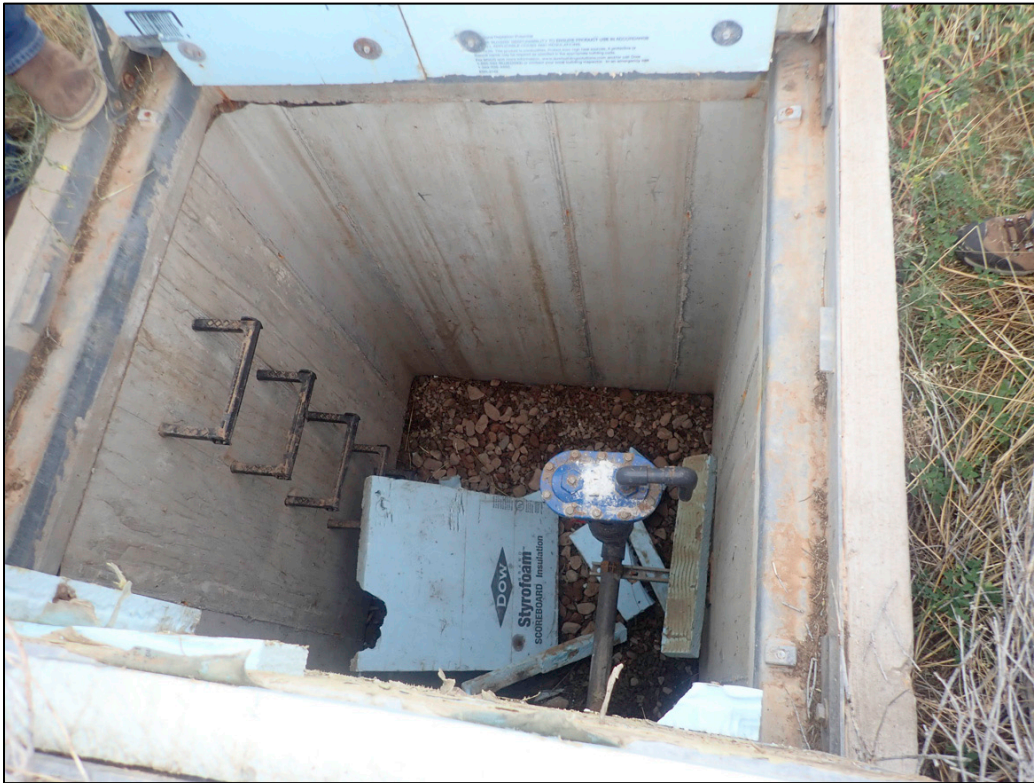
A leak occurred in vault CS-MNT-10 on City of Monticello property MP-01077 (PL-36, PL-37) and crossed the property boundary and onto adjacent property. The leak originated from a 3-inch high-density polyethylene line that transfers low-level uranium-contaminated groundwater from the Groundwater Transfer Building to the evaporation pond (Pond 4). The leak occurred approximately 1360 feet southeast of the Groundwater Transfer Building in vault CS-MNT-10. The affected area was approximately 440 feet long and approximately 60 feet wide near the head of the leak and gradually tapered to approximately 3 feet wide near the tail; the vertical extent is unknown. The surface/subsurface soil were the only environmental media affected. The cause of the leak was from mechanical failure from ground subsidence and possible vibration. Repair activities were completed the week of October 23, 2023. Additional engineering controls were installed, such as flowable fill concrete for compaction and additional bracing. Details about the leak have been communicated to EPA Region 8 and the Utah Department of Environmental

PL-36. Vault CS-MNT-10, Suspected Leak

Quality Division of Environmental Response and Remediation, both of which have overseen the CERCLA cleanup of the MMTS. A Soil Sampling and Analysis Plan is being developed to describe the sampling, analytical, and data evaluation requirements necessary to determine if soils have been adversely impacted from the leak of low-level uranium-contaminated groundwater.

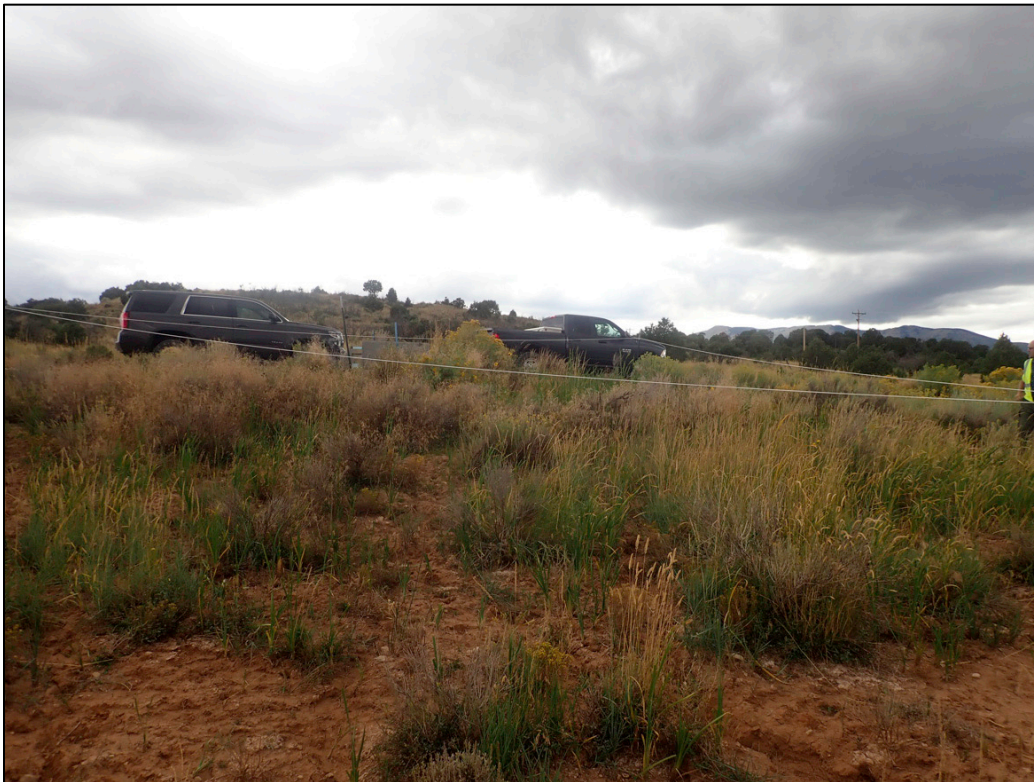
PL-37. Vault CS-MNT-10, Leak Boundary Area
