**2023 Annual Land-Use Covenant
Inspection Report
for DOE Areas at the
Laboratory for Energy-Related
Health Research/Old Campus
Landfill Superfund Site
University of California, Davis**

January 2024

U.S. DEPARTMENT OF
ENERGY

Legacy
Management

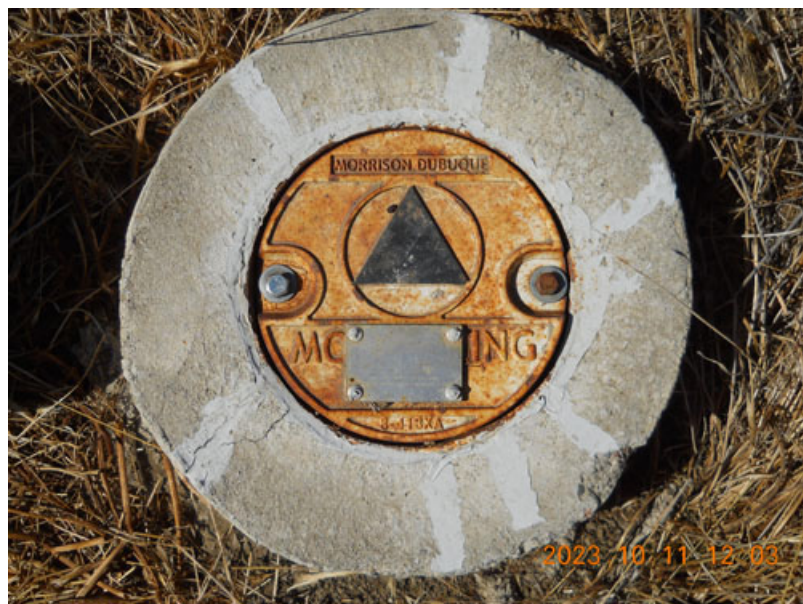
UCD1-068 Wellhead (Photo No. 5151)

UCD1-063 standpipe	5186 5190	5188 5189	No	Yes	Yes	Yes	Yes	No	
UCD1-068 flush	5151 5152	5153 5154	No	Yes	Yes	Yes	Yes	Yes	Pump controller port plug missing.
UCD1-069 flush	5146 5147	5150 5149	No	Yes	Yes	Yes	Not tested	No	Depth to water at top of pump (59 feet); too low to accurately test pump.
UCD1-070 standpipe	5142 5143	5144 5145	No	Yes	Yes	Yes	Not tested	No	Depth to water below top of pump (59 feet); too low to test pump.
UCD1-071 flush	5172 5173	5174 5175	No	Yes	Yes	Yes	Yes	No	
UCD1-072 flush	5155 5156	5157 5159	No	Yes	Yes	Yes	Yes	No	
UCD1-073 standpipe	5182 5183	5184 5185	No	Yes	Yes	Yes	Yes	Yes	Pump controller port plug missing.

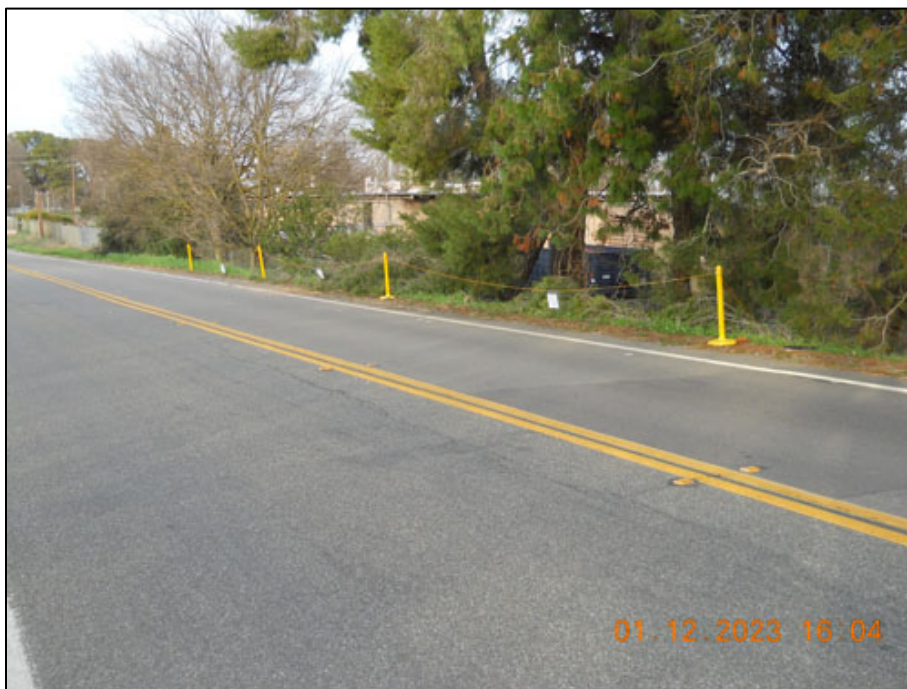
Photo F-1. Access Controls Installed Surrounding Fallen Tree Limbs on Shoulder of Old Davis Road (DSCN4935)

Maintenance Item	Date Identified	Description of Completed or Planned Repair	Date Completed	Completion Photo No.
Well UCD1-072: Vault lid bolt hole flanges ruptured	10/6/2022	Repair completed: Well vault replaced	12/22/2022	UCD1-072 #1
Well UCD1-021: Asphalt roadway receding around concrete apron at well head	10/6/2022	Repair completed: Asphalt patch installed surrounding concrete apron	12/22/2022	UCD1-021 #1
Well UCD1-068: Cracks in concrete apron at well head	10/6/2022	Repair completed: Cracks in concrete apron patched using PFAS-free sealing material	12/22/2022	UCD1-068 #1
Wells UCD1-021, -054, -068, -069, -071, -072: Well vault maintenance to prevent storm water entry	10/6/2022	Repair completed: Cleaned seal surfaces, replaced seals, and installed washers and seals on bolts	12/22/2022	UCD1-021 #2, UCD1-054 #2, UCD1-068 #2, UCD1-069 #2, UCD1-071 #2, and UCD1-072 #2
Tree limbs fallen along Old Davis Road	1/10/2023	Repair completed: Installed access controls around fallen limbs	1/12/2023	DSCN4935

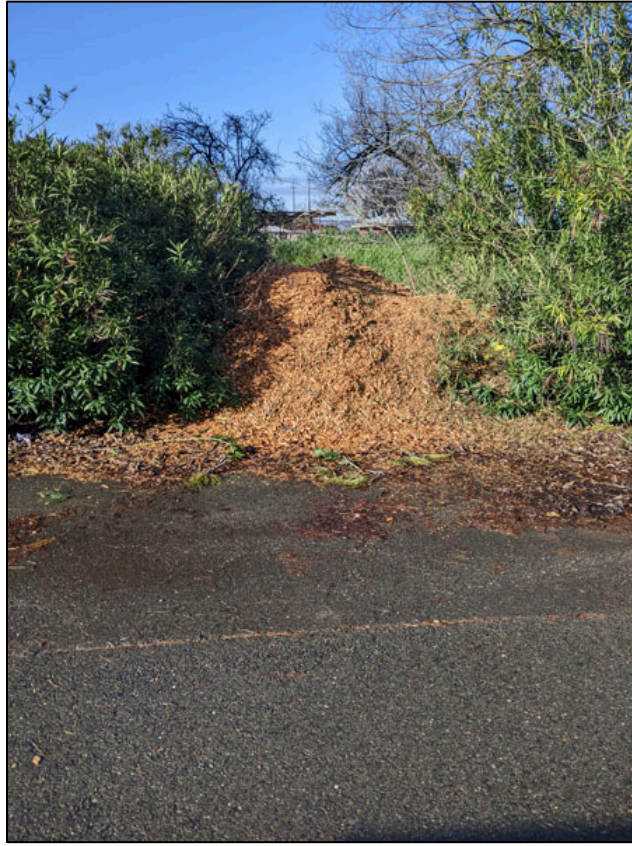
Photo F-2. Former Tree 16207 Cut and Debris Stockpiled in Ra/Sr Treatments Systems Area (PXL_20230119_174929258)

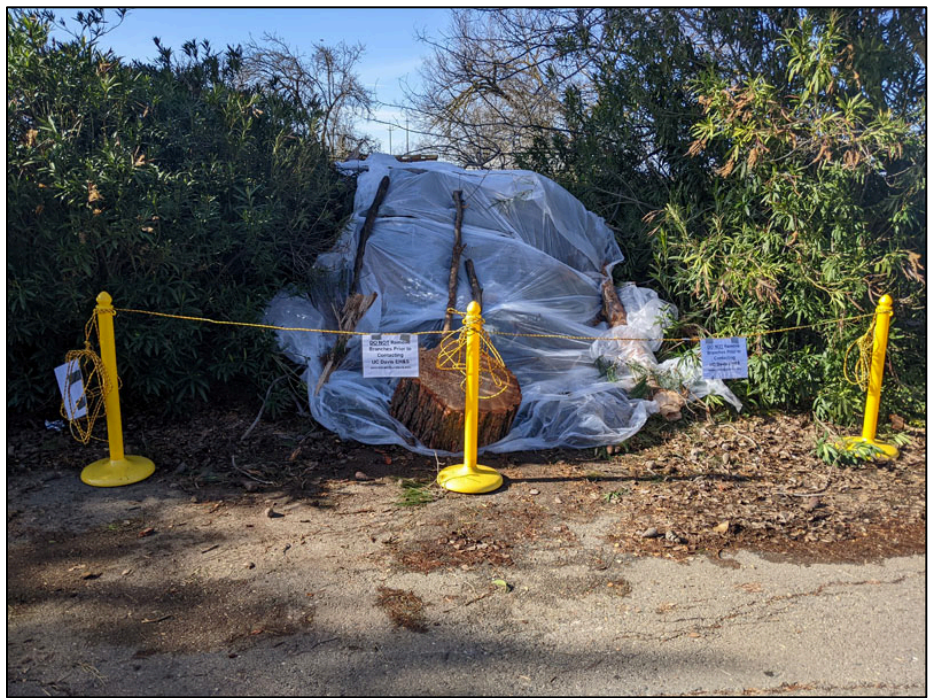
Photo F-3. Vegetation Debris Stockpile in Ra/Sr Treatments Systems Area Covered with Tarp and Surrounded by Access Controls (PXL_20230119_203637076)

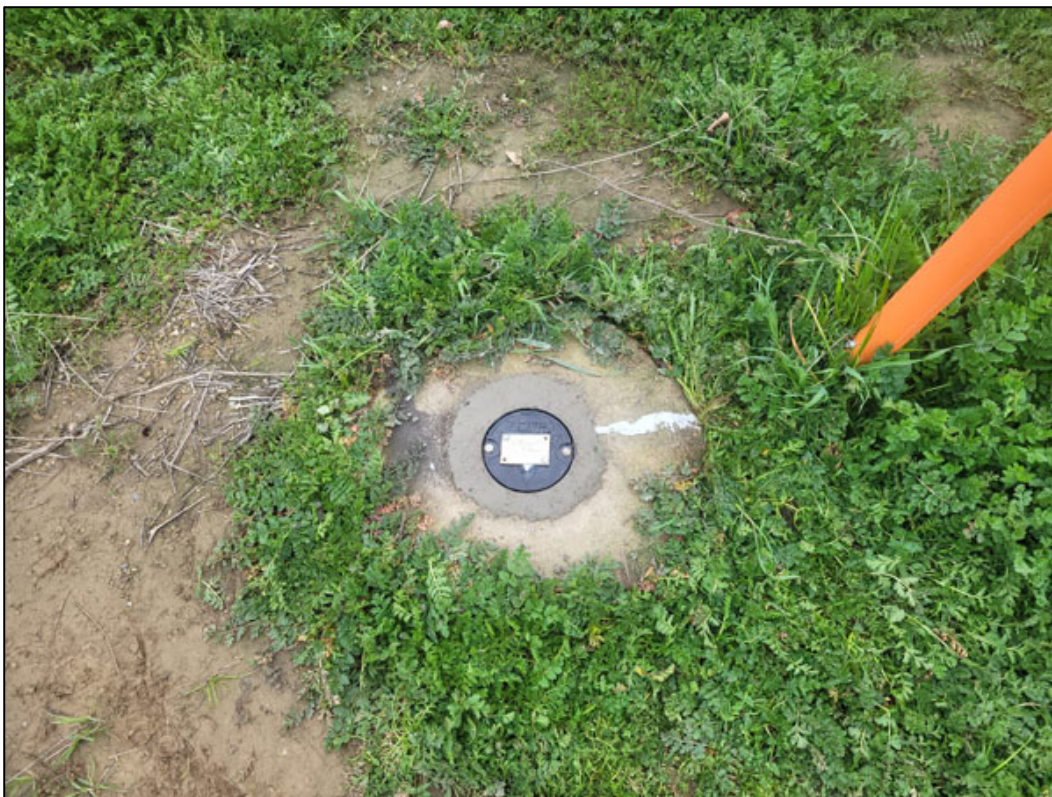
Photo F-4. Well UCD1-072: New Well Vault Installed (UCD1-072 #1)

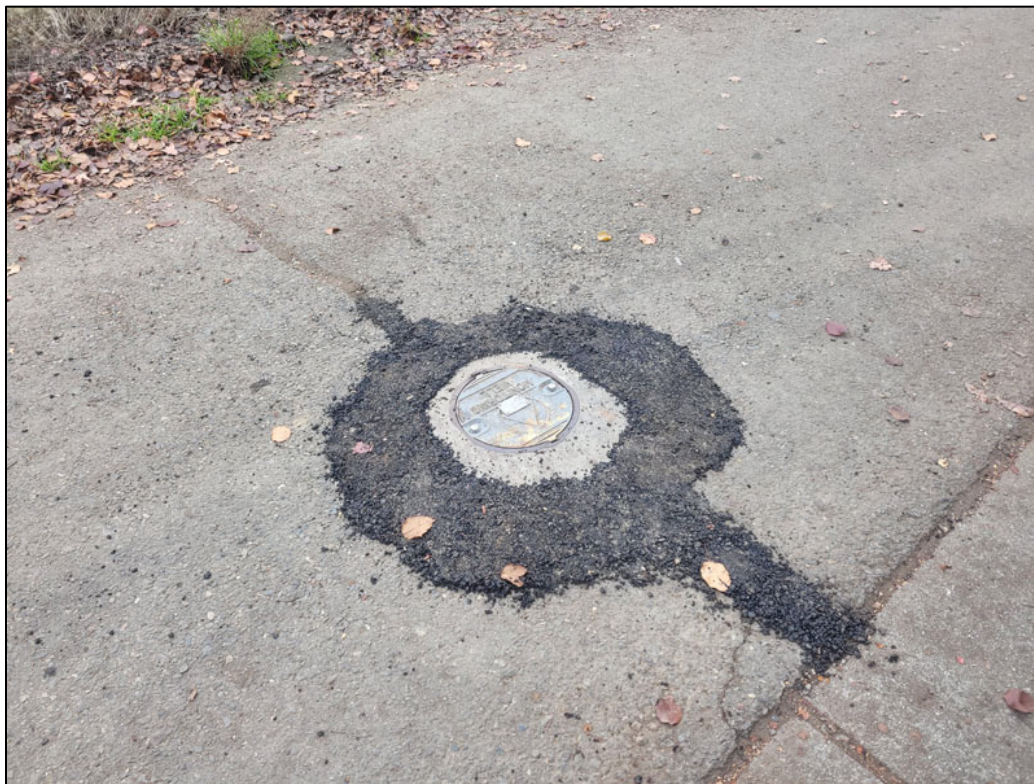
Photo F-5. Well UCD1-021: New Asphalt Patch Installed Surrounding Concrete Apron (UCD1-021 #1)

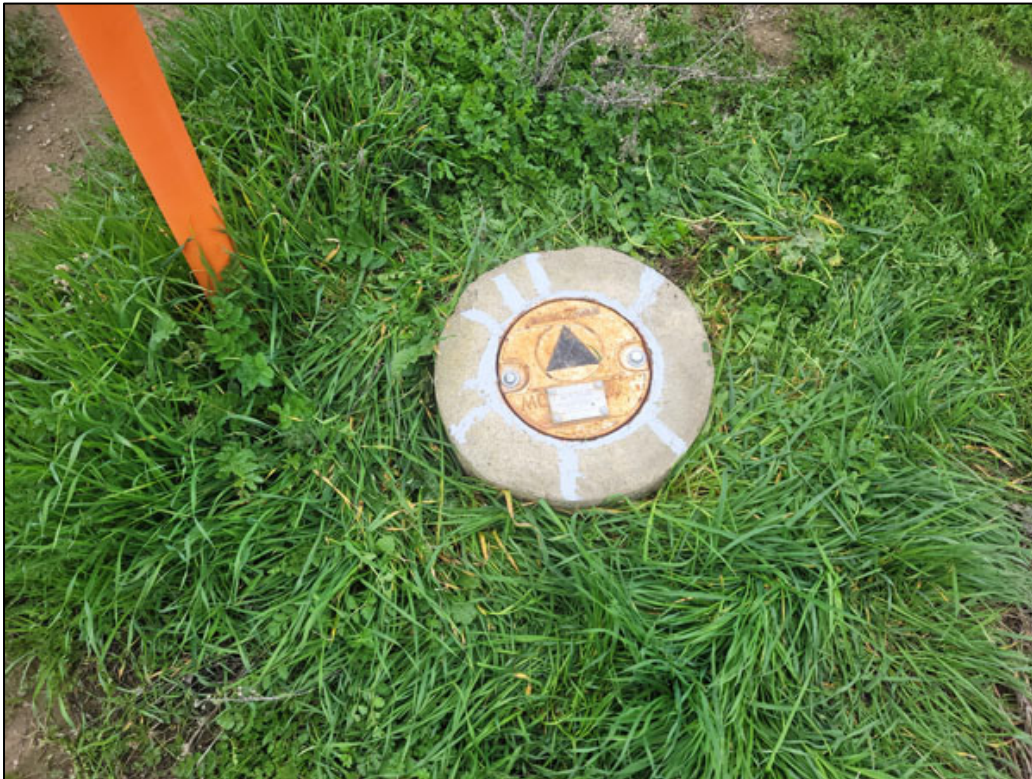
Photo F-6. Well UCD1-068: Cracks Patched in Concrete Apron (UCD1-068 #1)

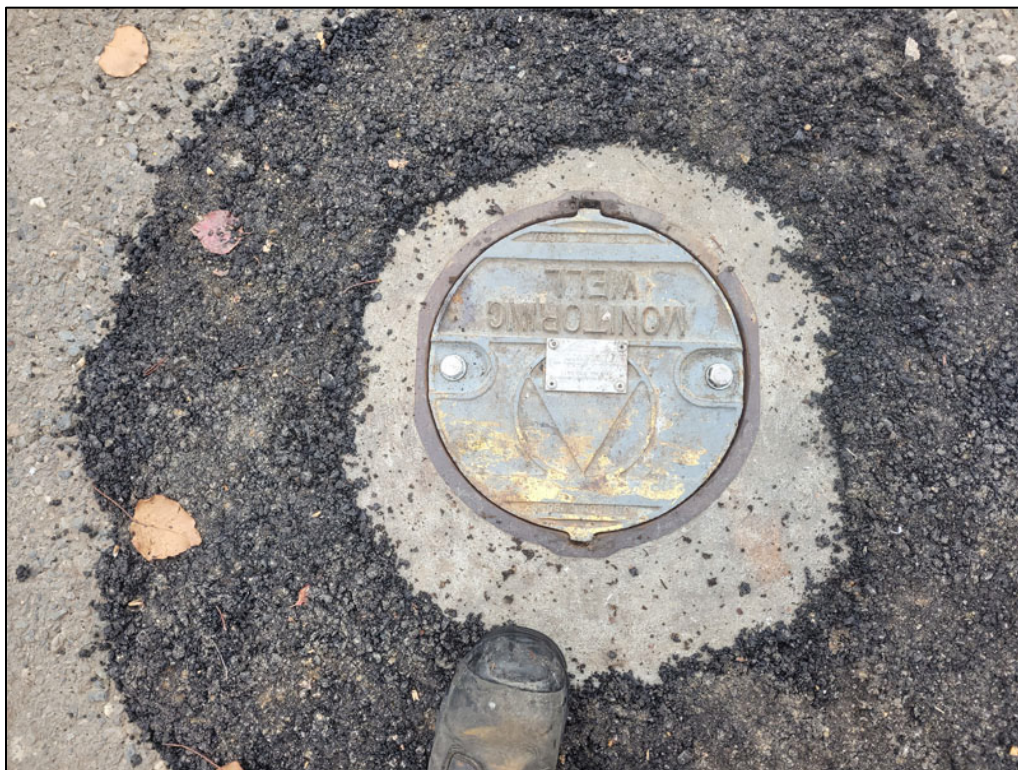
Photo F-7. Well UCD1-021: Seal Surfaces Cleaned, Seals Replaced, and Washers and Seals Installed on Bolts to Prevent Storm Water Entry (UCD1-021 #2)

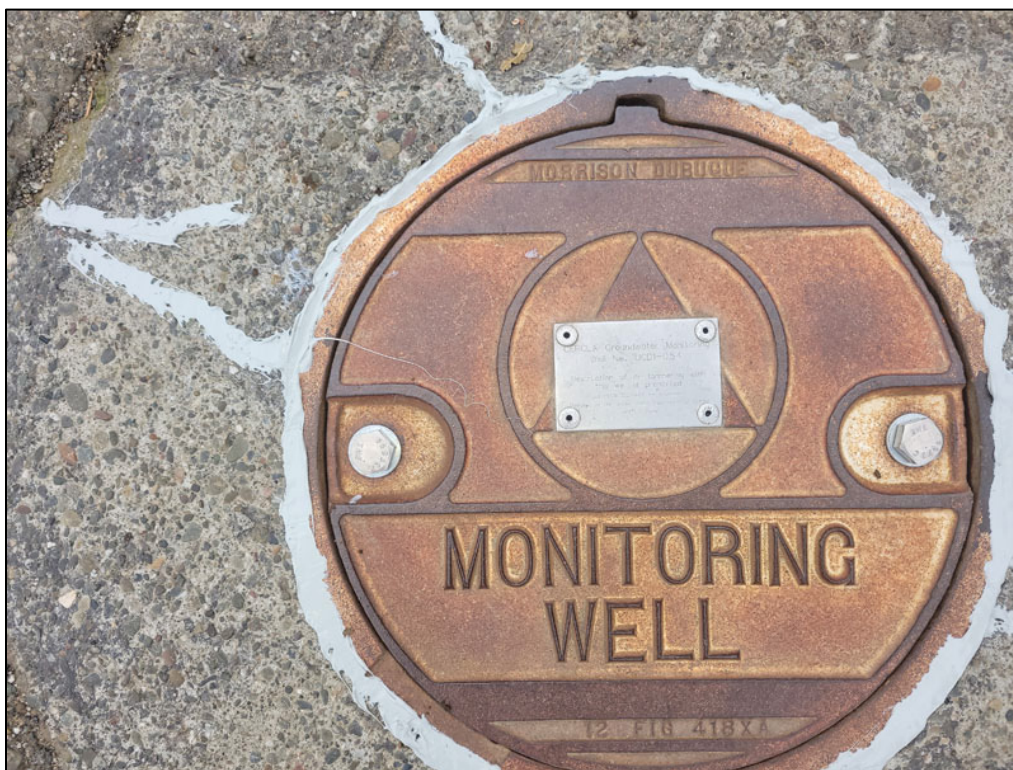
Photo F-8. Well UCD1-054: Seal Surfaces Cleaned, Seals Replaced, and Washers and Seals Installed on Bolts to Prevent Storm Water Entry (UCD1-054 #2)

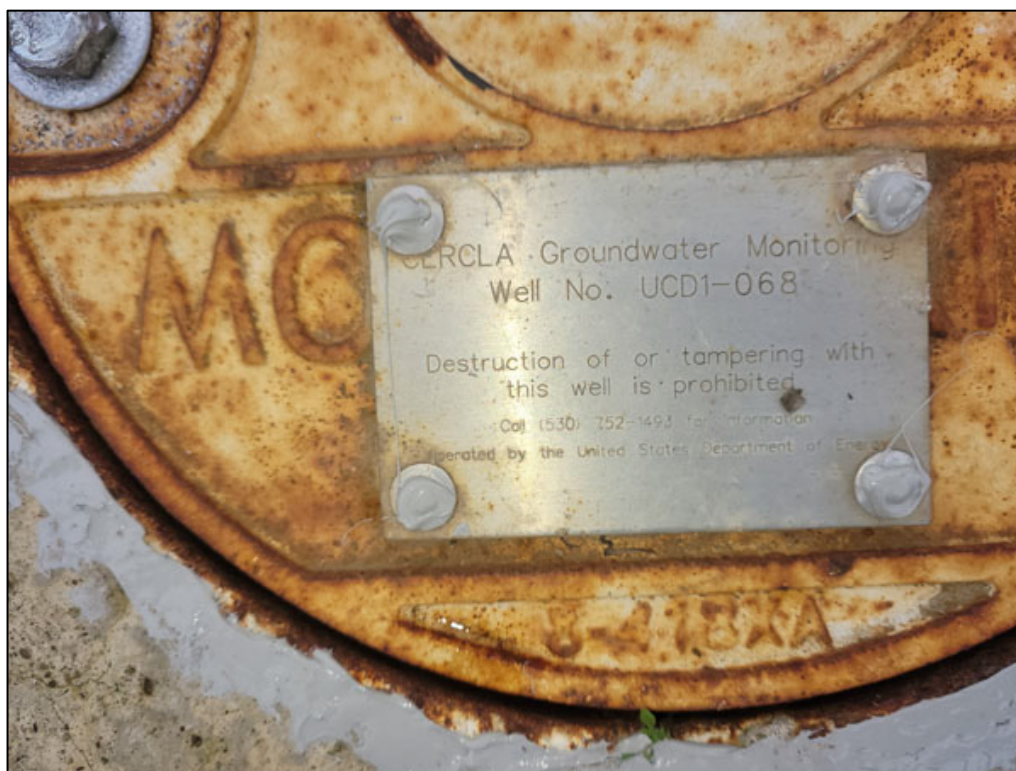
Photo F-9. Well UCD1-068: Seal Surfaces Cleaned, Seals Replaced, and Washers and Seals Installed on Bolts to Prevent Storm Water Entry (UCD1-068 #2)

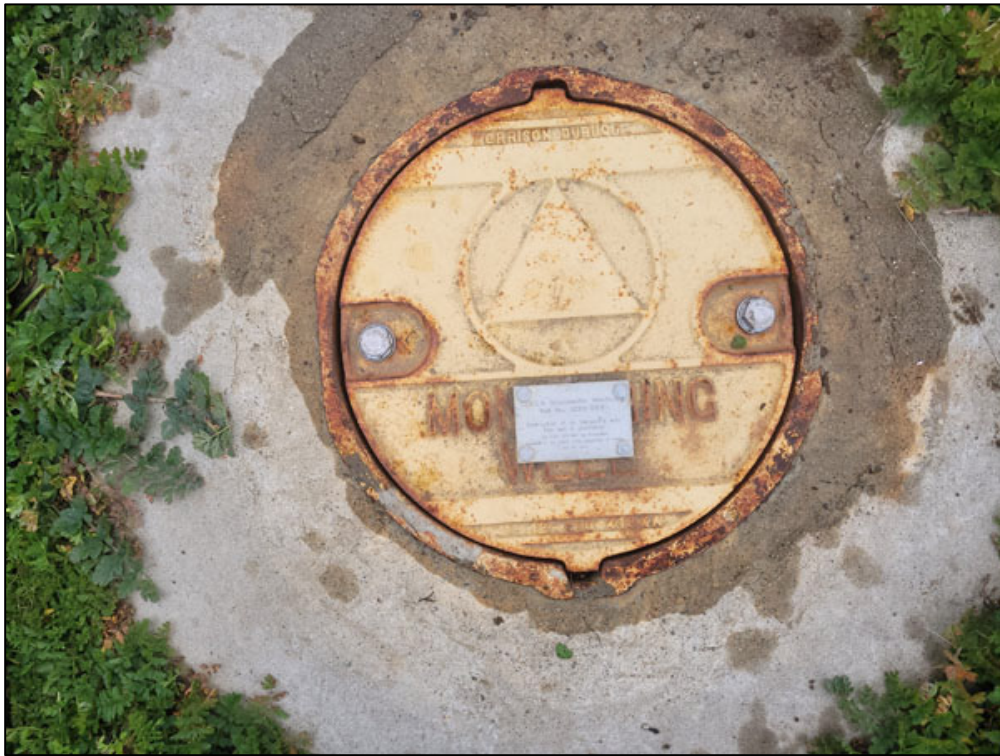
Photo F-10. Well UCD1-069: Seal Surfaces Cleaned, Seals Replaced, and Washers and Seals Installed on Bolts to Prevent Storm Water Entry (UCD1-069 #2)

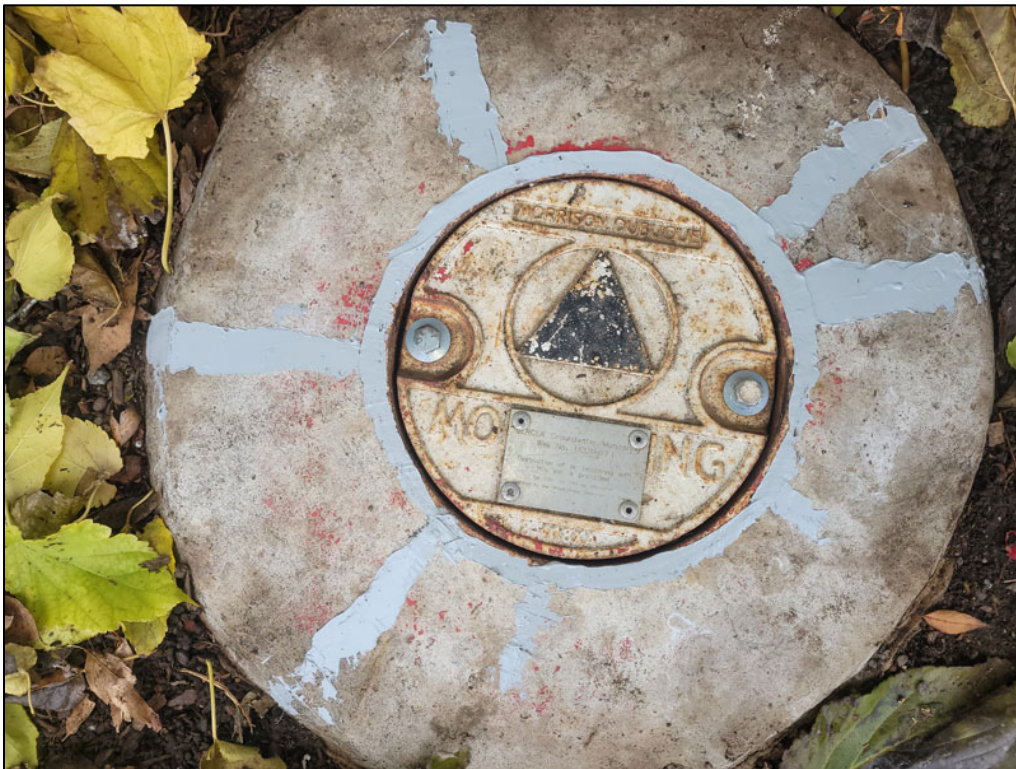
Photo F-11. Well UCD1-071: Seal Surfaces Cleaned, Seals Replaced, and Washers and Seals Installed on Bolts to Prevent Storm Water Entry (UCD1-071 #2)

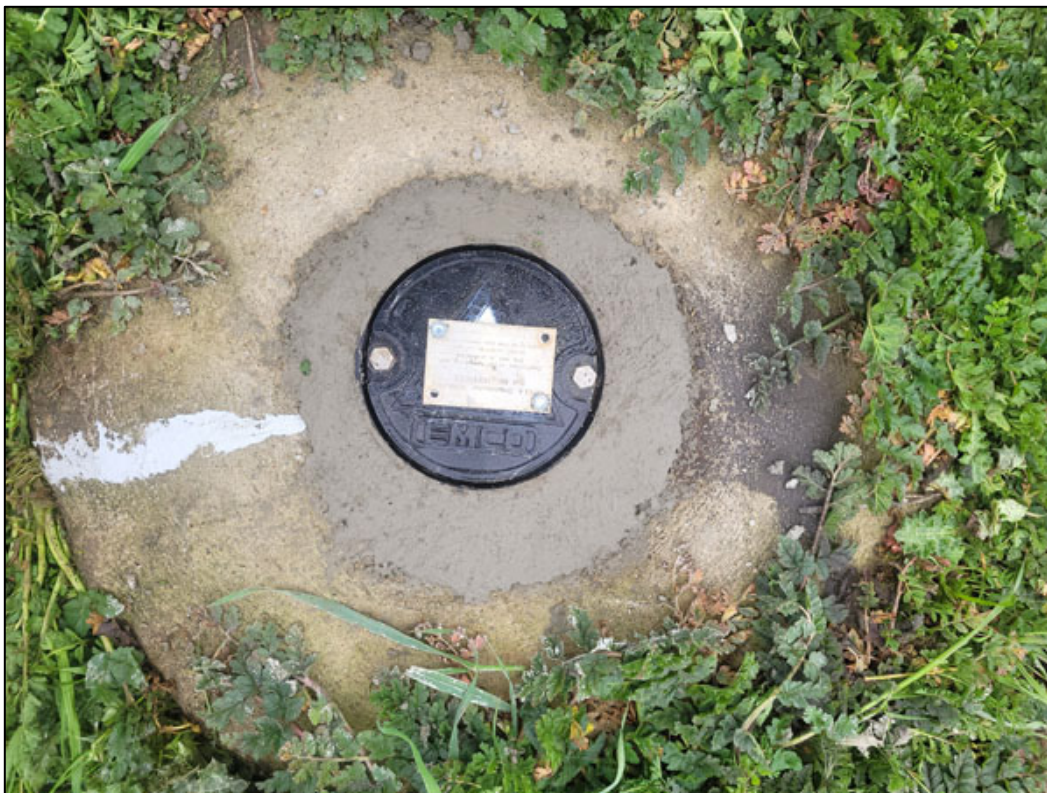
Photo F-12. Well UCD1-072: Seal Surfaces Cleaned, Seals Replaced, and Washers and Seals Installed on Bolts to Prevent Storm Water Entry (UCD1-072 #2)
