18.0 Spook, Wyoming, Disposal Site

18.1 Compliance Summary

The Spook, Wyoming, Uranium Mill Tailings Radiation Control Act (UMTRCA) Title I Disposal Site, inspected on June 10, 2008, was in excellent condition. No evidence of settling or erosion was observed over the encapsulated waste materials. Minor erosion on site has stabilized. The access road to the site had been improved (widened and surfaced with gravel) due to significant oil well drilling activity near the site. The spalling concrete base of a site marker was repaired. No other maintenance needs or cause for a follow-up or contingency inspection was identified.

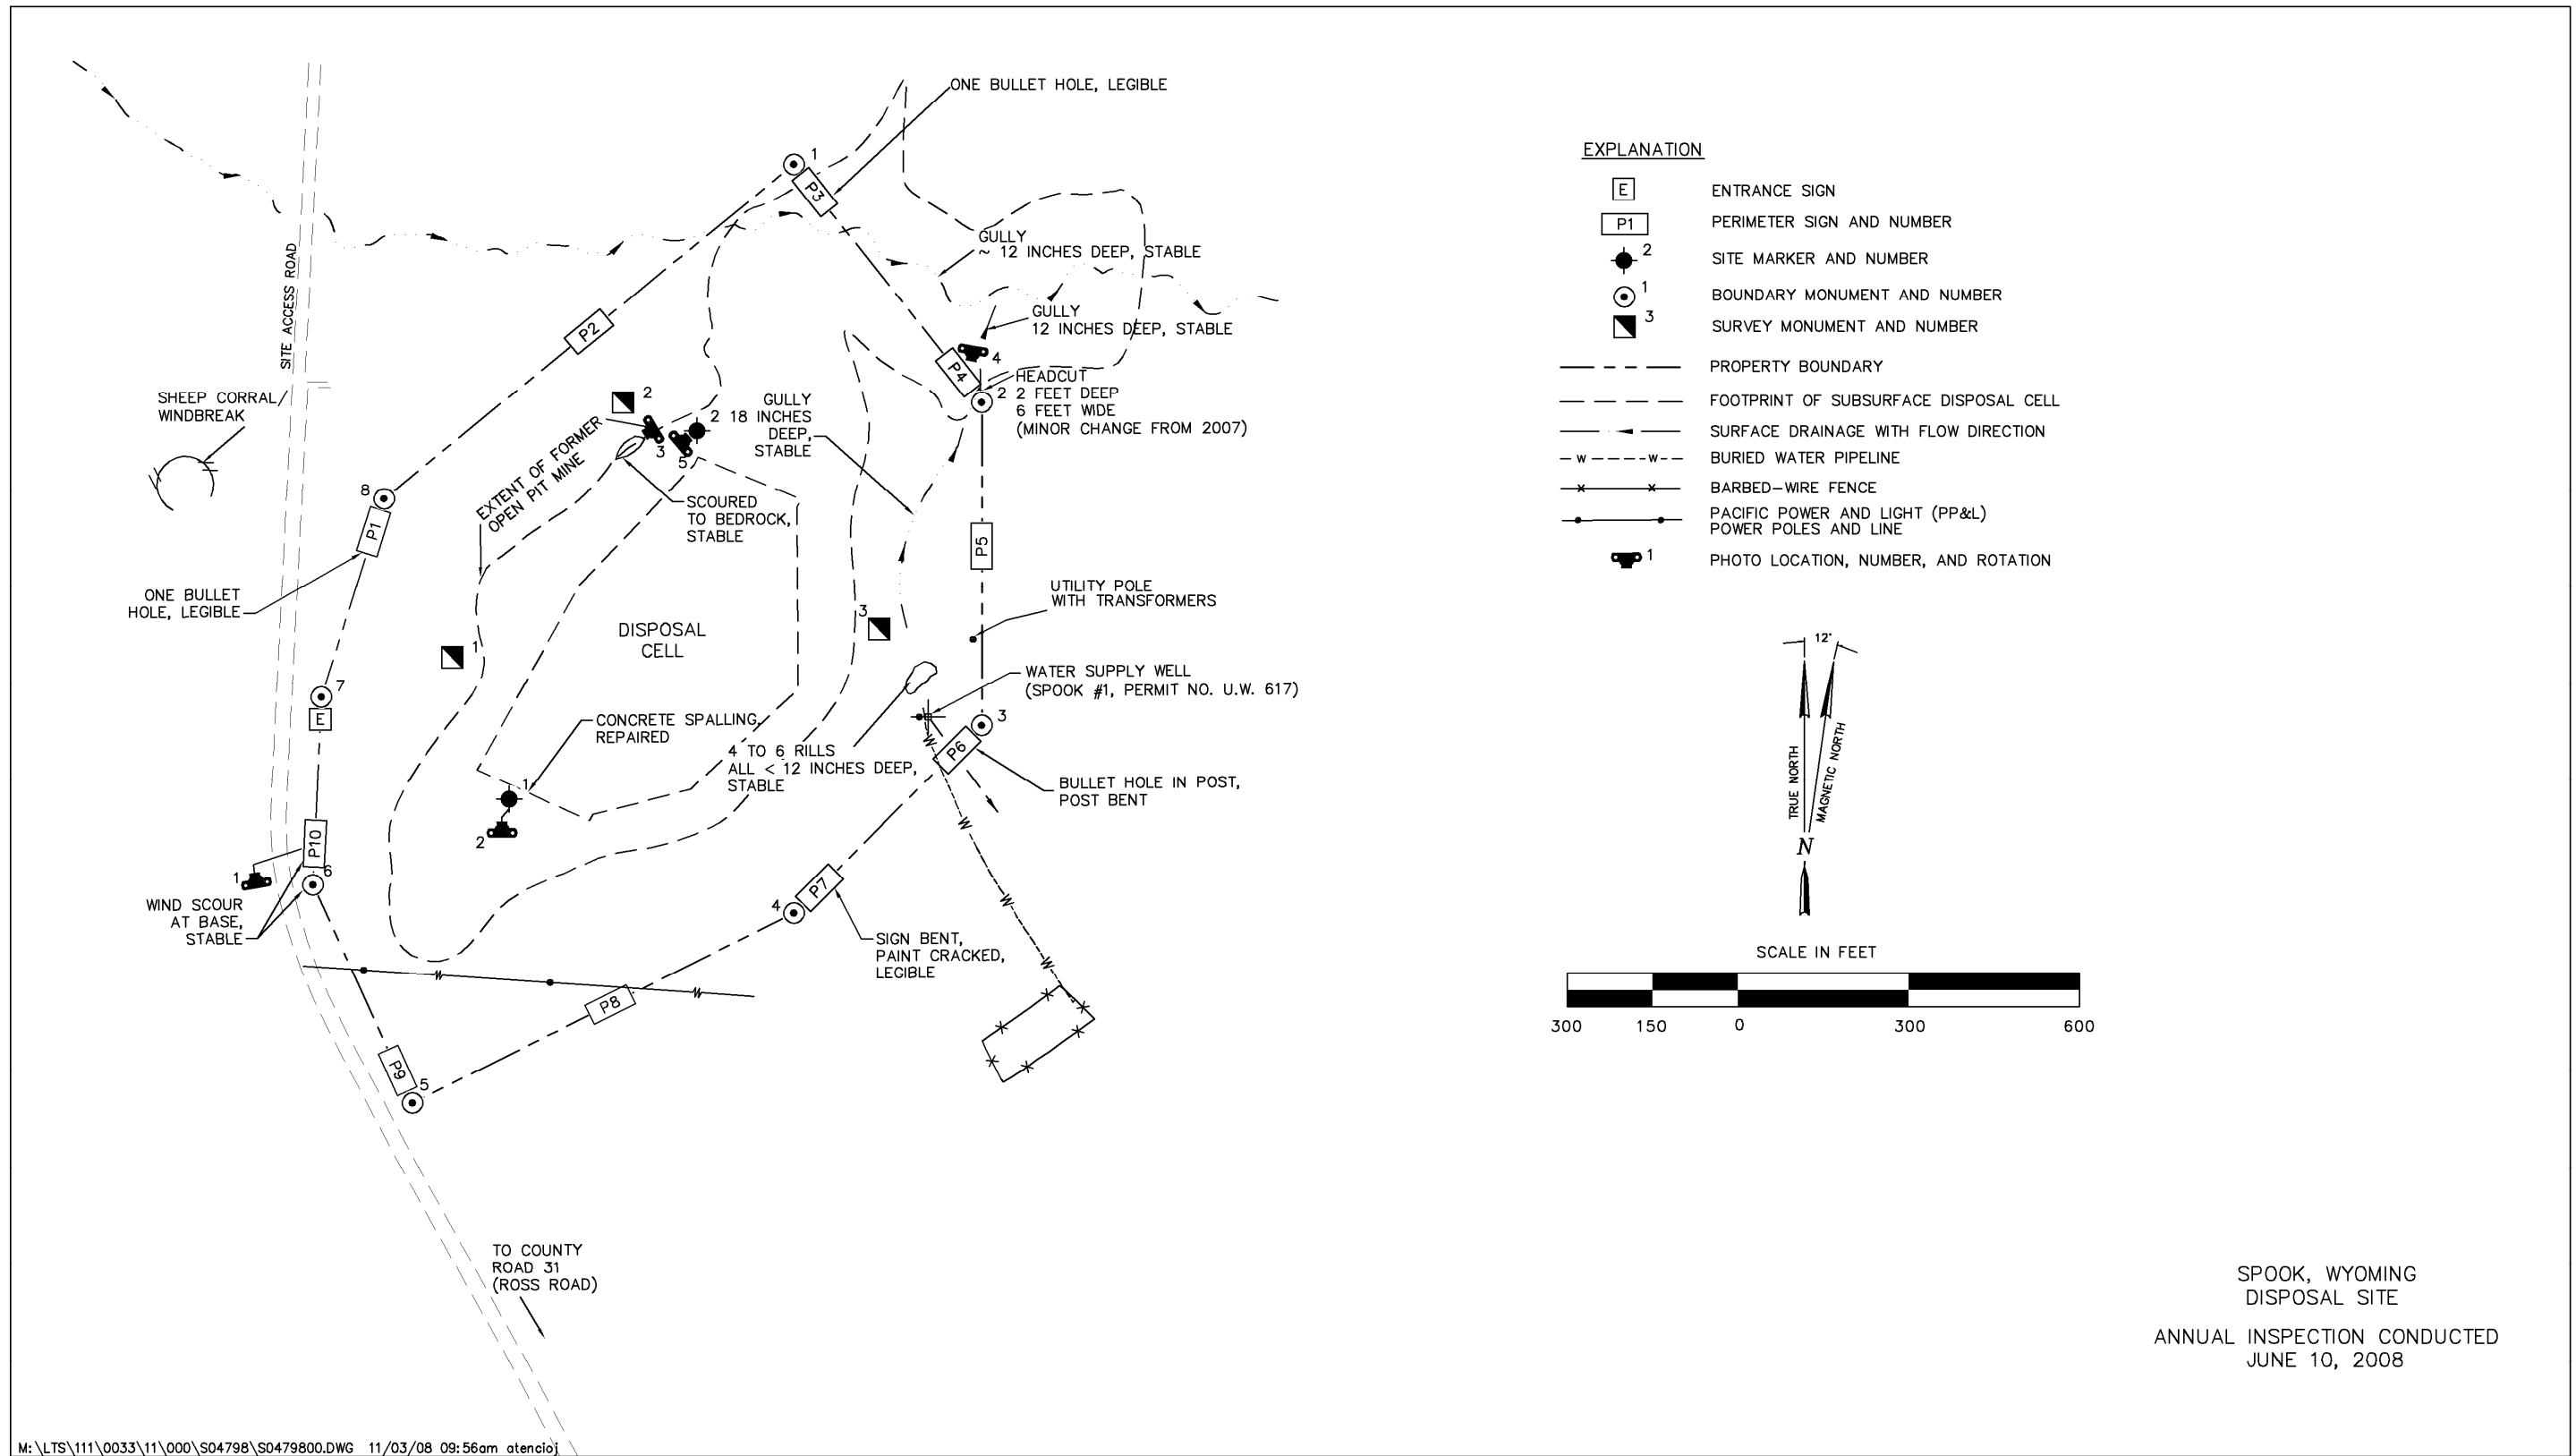
Figure 18-1. 2008 Annual Compliance Drawing for the Spook Disposal Site

The site, located in north central Converse County, Wyoming, was inspected on June 10, 2008. Results of the inspection are described below. Features and the photograph locations (PLs) mentioned in this report are shown on Figure 18–1. The number in the left margin of this report refers to items summarized in the “Executive Summary” table.

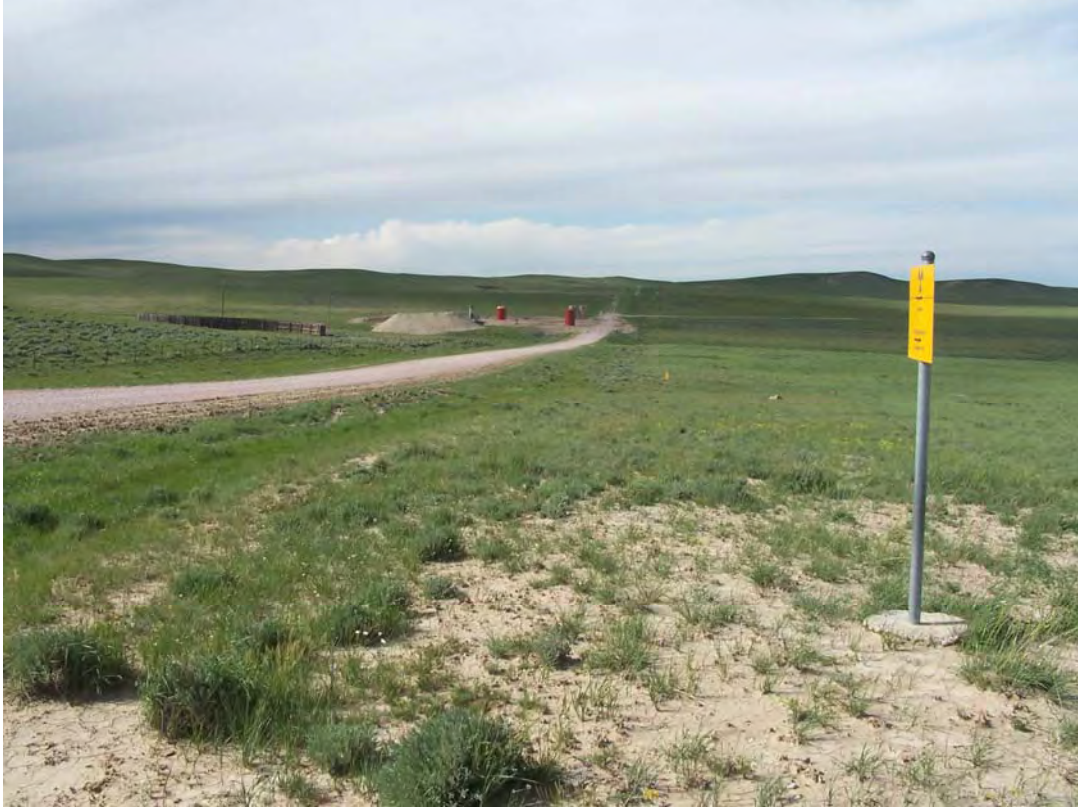
Access Road and Signs—Access to the site, located northwest of Douglas, Wyoming, is via Highway 93 to County Road 31 onto the Hornbuckle Ranch road. Site access is maintained through perpetual easements across the Hornbuckle Ranch. The road to the site is graded and hard packed. Prior to the 2008 inspection, the last portion of access road north of the Dry Fork of the Cheyenne River was a seldom-used dirt track. However, this portion has been widened and surfaced with gravel to support significant oil well drilling activity near the site (PL-1). The road continues and enters the Hardy Ranch about 0.5 mile north of the site, and is the access route to the Bear Creek, Wyoming, UMTRCA Title II site, which is located approximately a mile north of the Spook Disposal Site.

SPK 6/2008. PL-1. Improved access road and a new oil well pad northwest of the site.

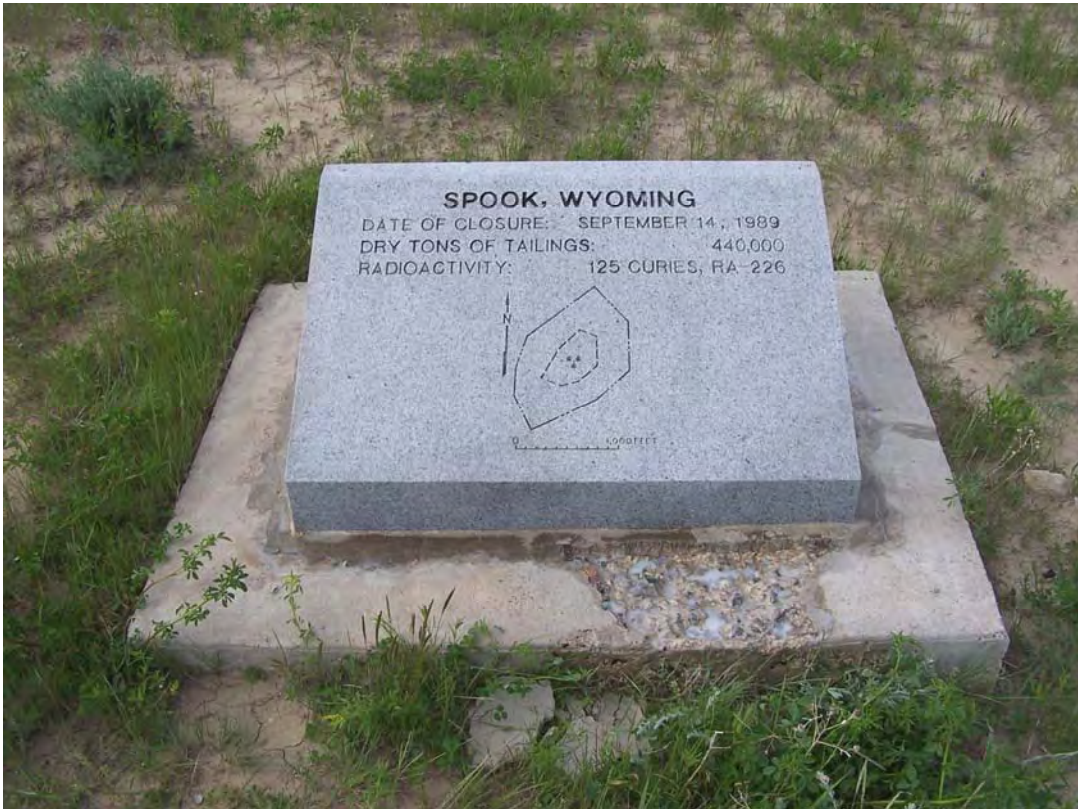
18A **Site Markers and Monuments**—Site marker SMK-2 and the eight boundary monuments and three survey monuments were in excellent condition. The concrete base of site marker SMK-1 continues to deteriorate. The spalling concrete base was chipped, cleaned, and sprayed with a concrete sealant (PL-2). Wind has scoured soil from beneath the surface concrete collar around boundary monument BM-6; however, the monument is stable.

SPK 6/2008. PL-2. Site marker SMK-1 with freshly applied concrete sealant.

The concrete base of a site marker was repaired in 2008. No other maintenance was necessary.

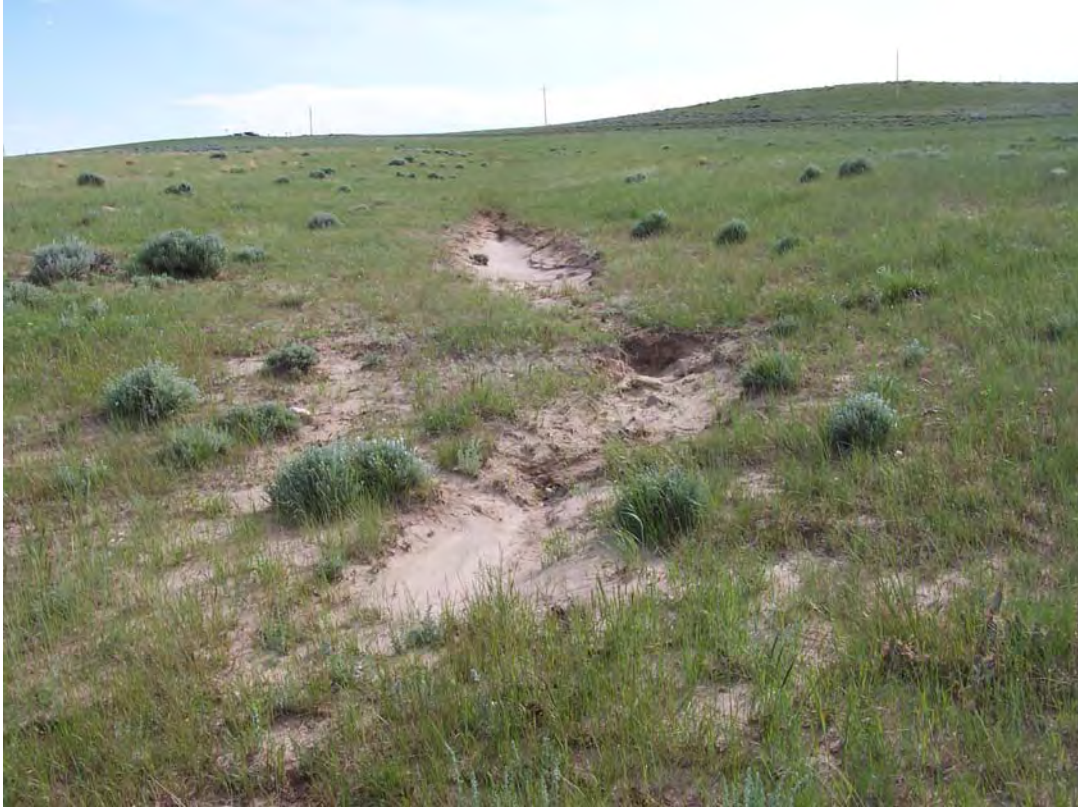
Most erosion features observed during previous inspections within the property boundary have stabilized, as indicated by vegetation growing in the channels; only minor change was observed (PL-3).

SPK 6/2008. PL-3. Stable erosion area near the northwest edge of the disposal cell.

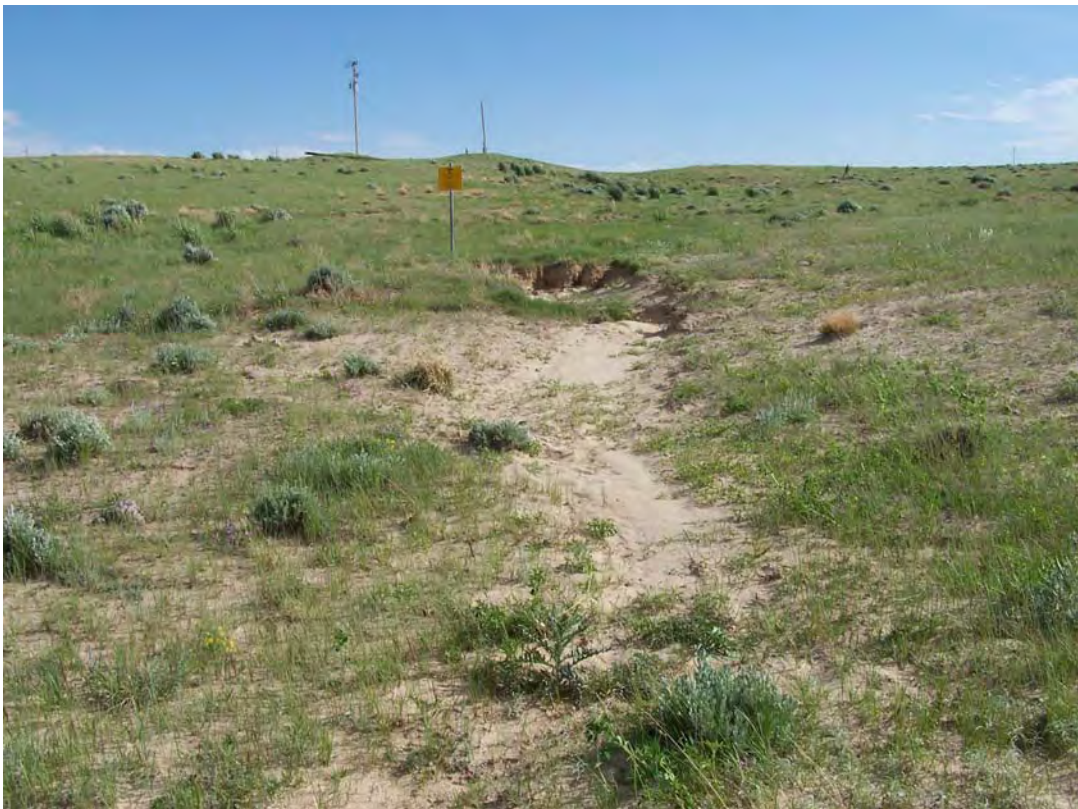
Most erosion features observed during previous inspections along and adjacent to the property boundary have stabilized. Only one gully, near perimeter sign P4, displays minimal activity, although new vegetation continues to be establishing within the gully (PL-4). Monitoring of this erosion feature will continue until stabilization occurs and to ensure that perimeter sign P4 is not impacted.

SPK 6/2008. PL-4. Gully near perimeter sign P4.

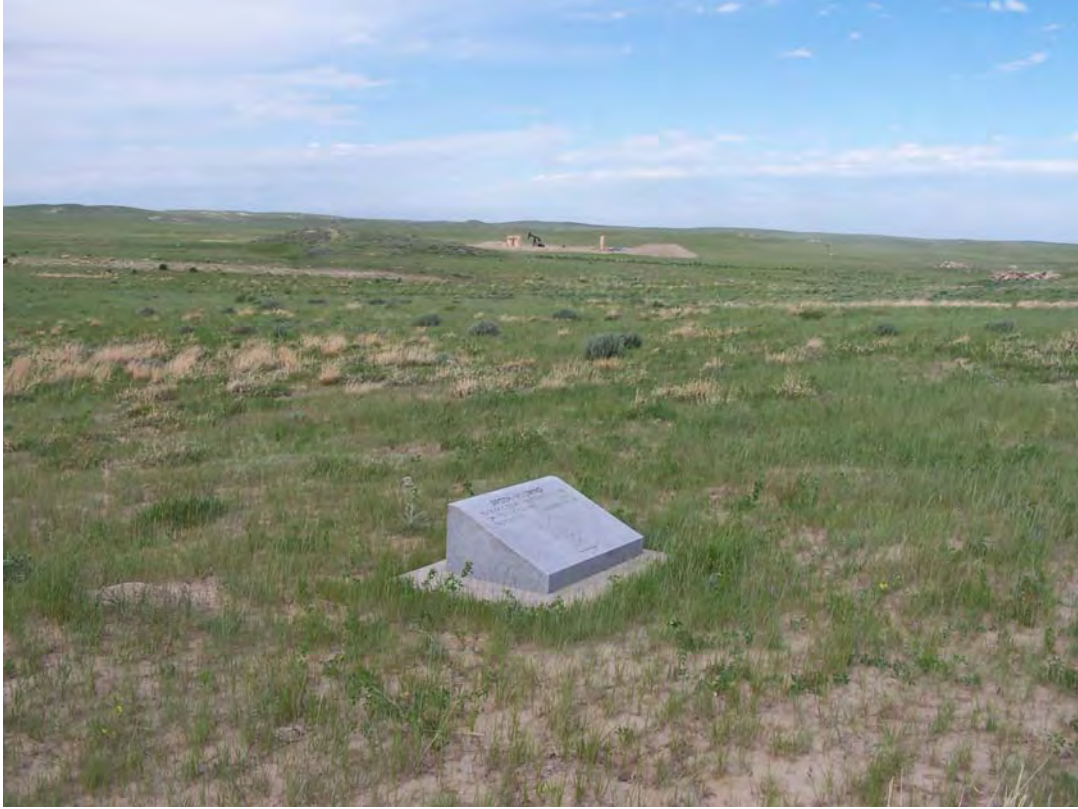
SPK 6/2008. PL-5. Site marker SMK-2 and a new oil well pad northeast of the site.
