## 18.0 Spook, Wyoming, Disposal Site

### 18.1 Compliance Summary

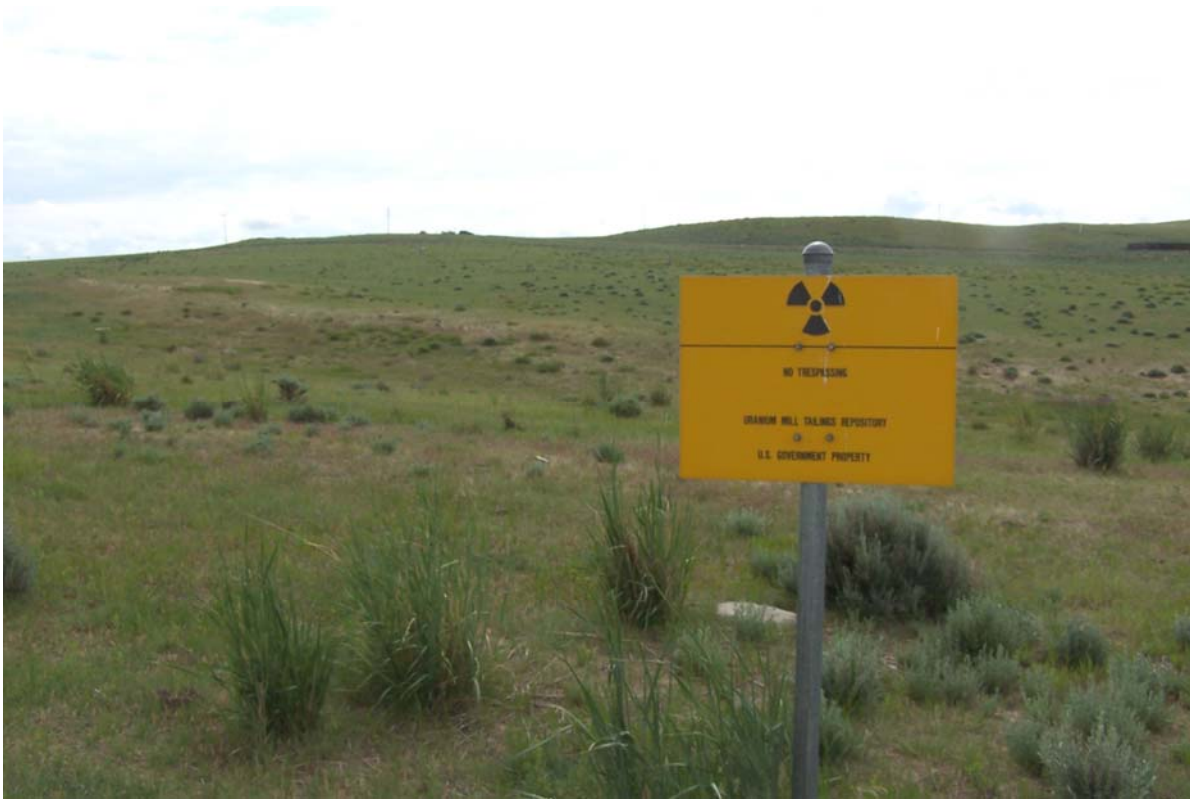
The site is open range and unfenced. All 10 perimeter signs and one entrance sign were in place and legible (PL-1). Several perimeter signs have bullet holes and perimeter sign P7 is slightly bent and the paint is cracked; however, the signs remain legible and there is no need for repairs at this time.

*SPK 6/2007. PL-1. View across the site from perimeter sign P5.*

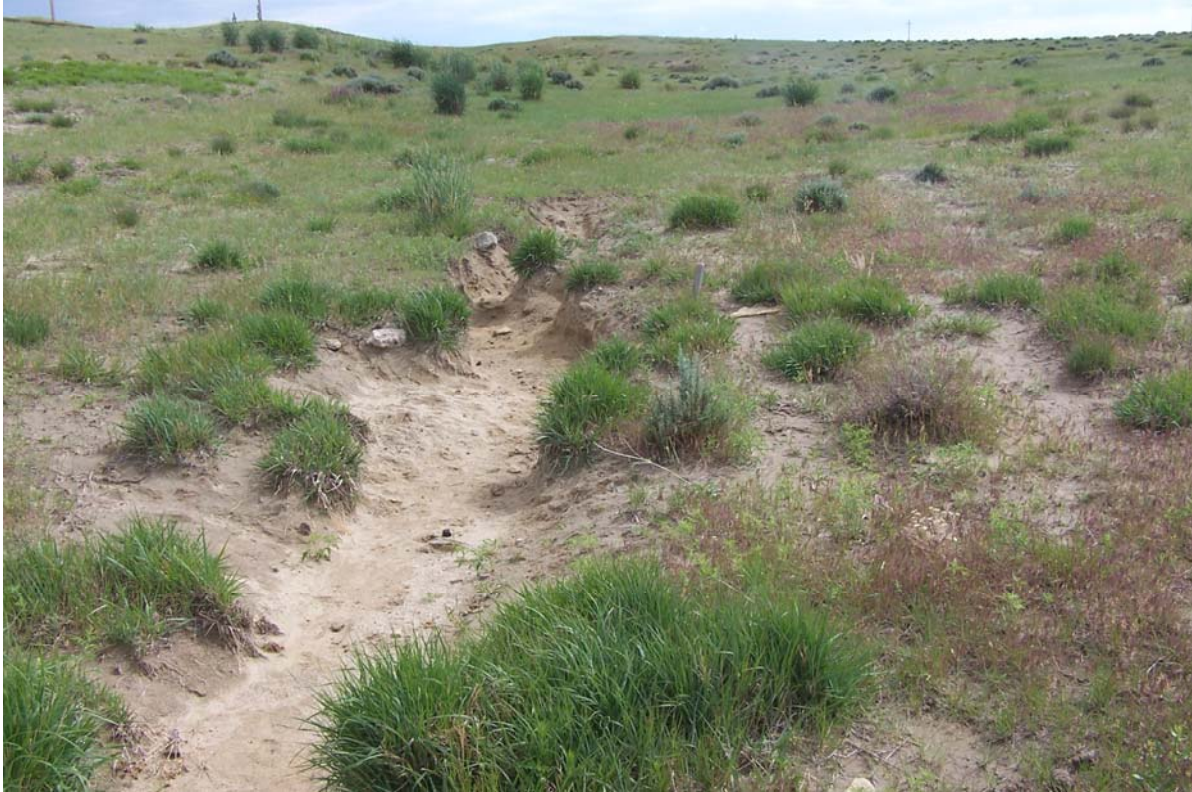
Most erosion features observed during previous inspections within the property boundary have stabilized, as indicated by vegetation growing in the channels; only minor change was observed (PL-3).

*SPK 6/2007. PL-3. Gully southwest of perimeter sign P4; minor change from 2006.*

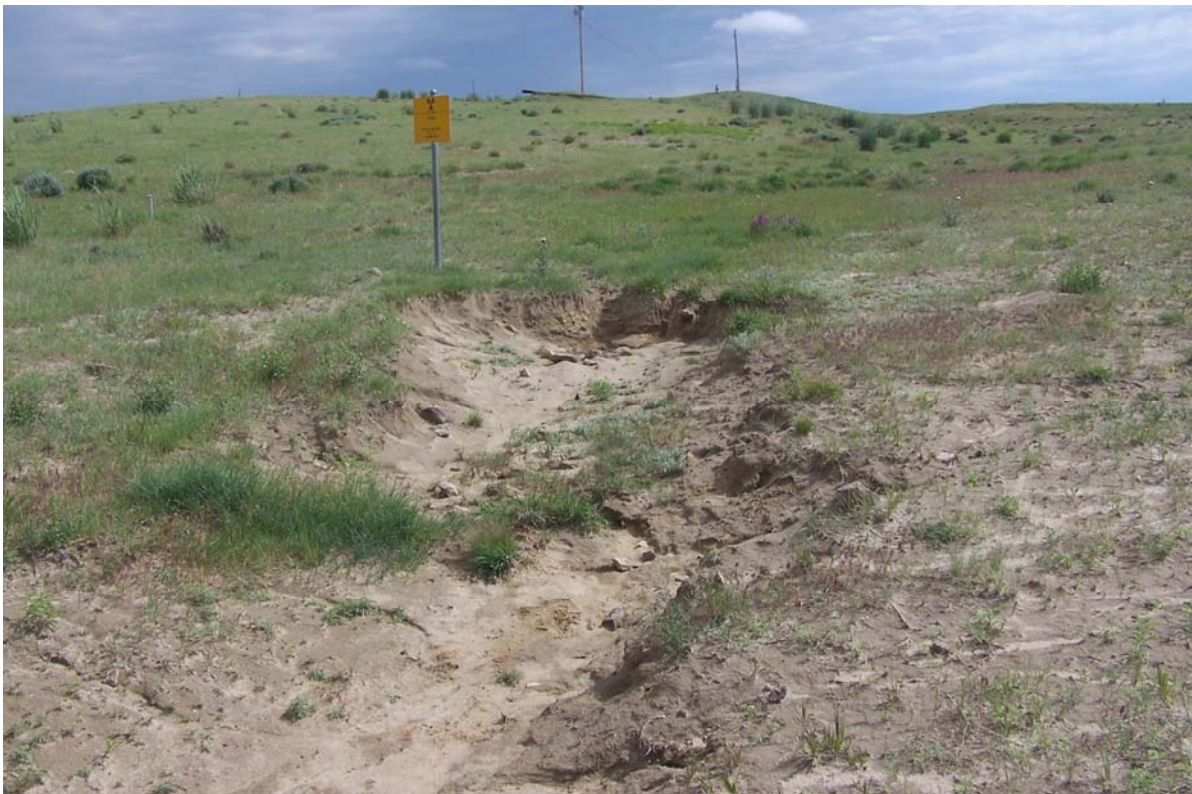
Most erosion features observed during previous inspections along and adjacent to the property boundary have stabilized. Only one gully, near perimeter sign P4, displays minimal activity, although new vegetation continues to be establishing within the gully (PL-4). Monitoring of this erosion feature will continue until stabilization occurs and to ensure that perimeter sign P4 is not impacted.

*SPK 6/2007. PL-4. Gully adjacent to perimeter sign P4; minor change from 2006.*
