# 2008 Annual Inspection and Status Report for the Hallam, Nebraska, Decommissioned Reactor Site

## Summary

The former Hallam Nuclear Power Facility (HNPF) was inspected on April 30, 2008.

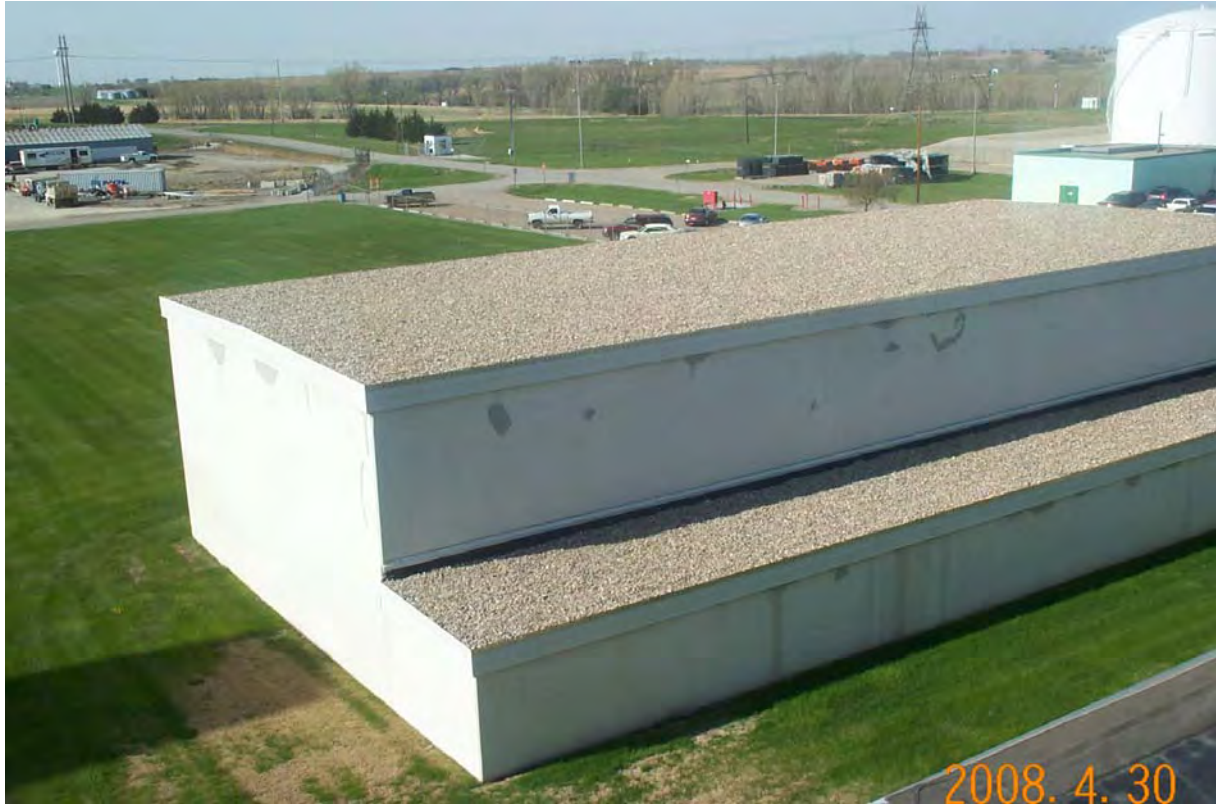
The roof of the IHX is in excellent condition (PL-1 and PL-2). The roof was replaced in 2007 and cornices noted as being in need of repair during last year's inspection were all repaired. The sides of the structure are scheduled to be re-painted in 2008.

HAL 4/2008. PL-1. Roof of IHX Building.

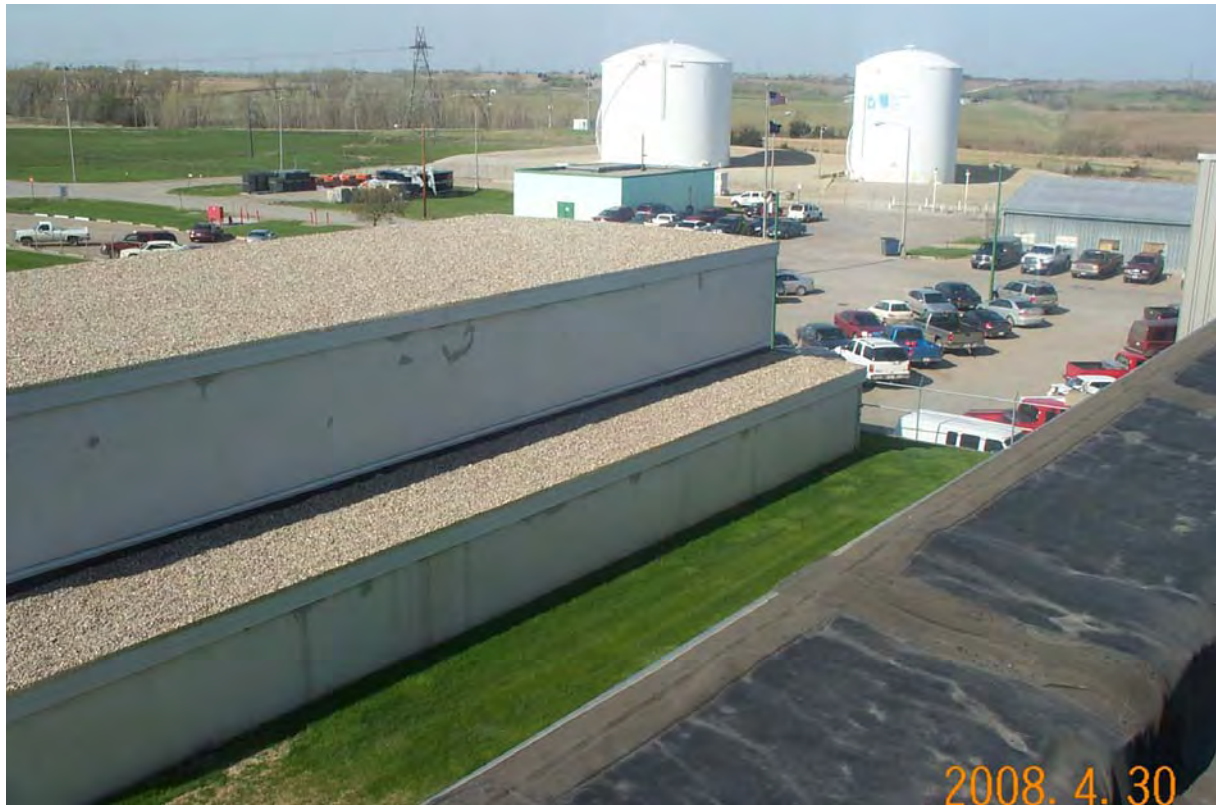
HAL 4/2008. PL-2. Roof of IHX Building.

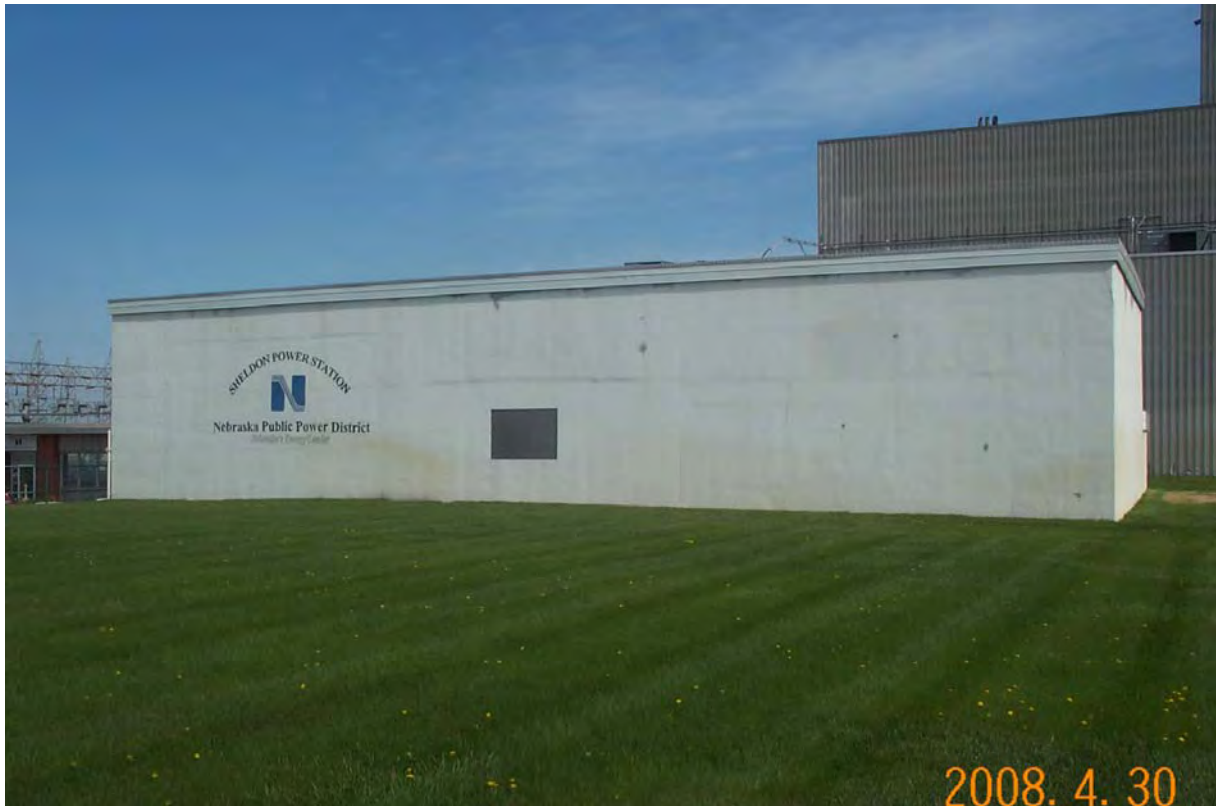
The grass is well established, and is in good condition on the grass-covered mound, with the exception of the east edge (PL-3). The east edge of the grass-covered mound, just beyond the toe of the slope, is bare of grass due to waterline work that was conducted in 2007 (PL-4). This work also left sprinkler heads exposed (PL-5). Re-seeding of the area is planned for this year.

HAL 4/2008. PL-3. South side of IHX Building.

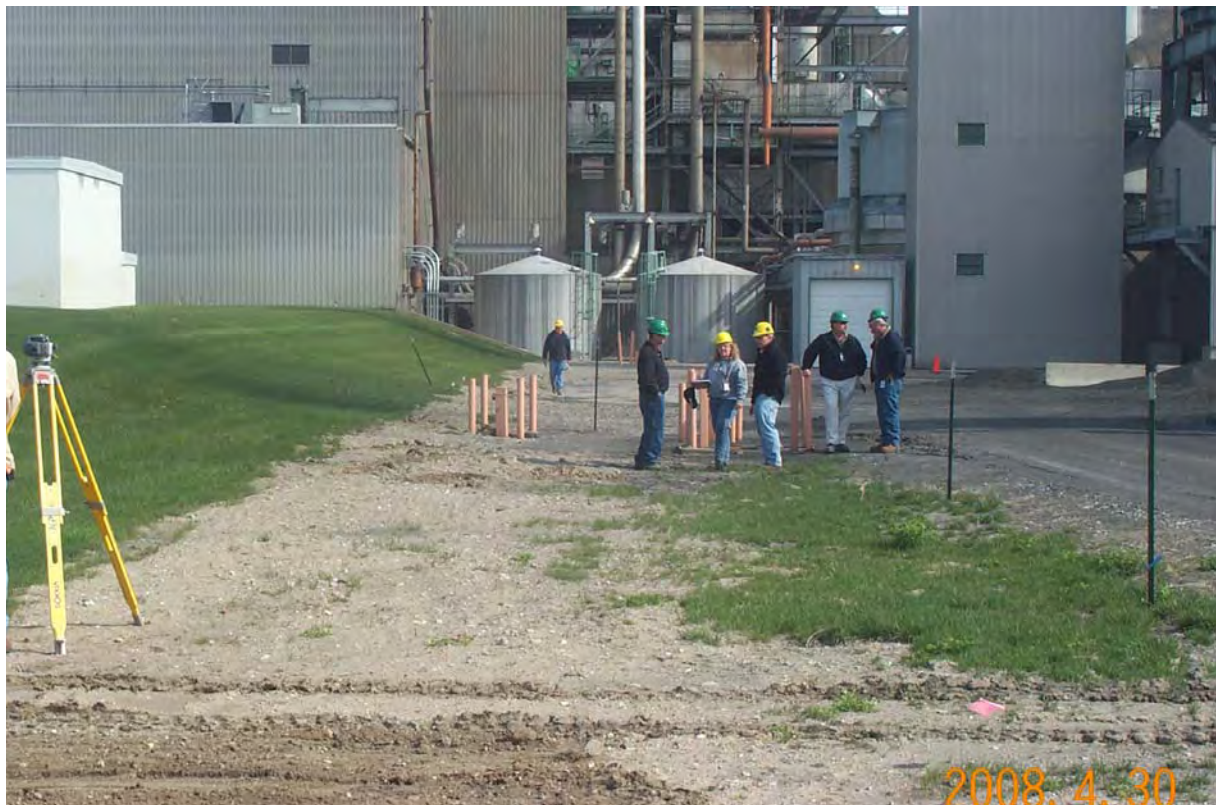
3. The east edge of the grass-covered mound, just beyond the toe of the slope, is bare of grass due to waterline work that was conducted in 2007 (page 2).

HAL 4/2008. PL-4. Looking north along east side of grass-covered mound.

**Recommendation:** Re-seeding of the area is planned for 2008.

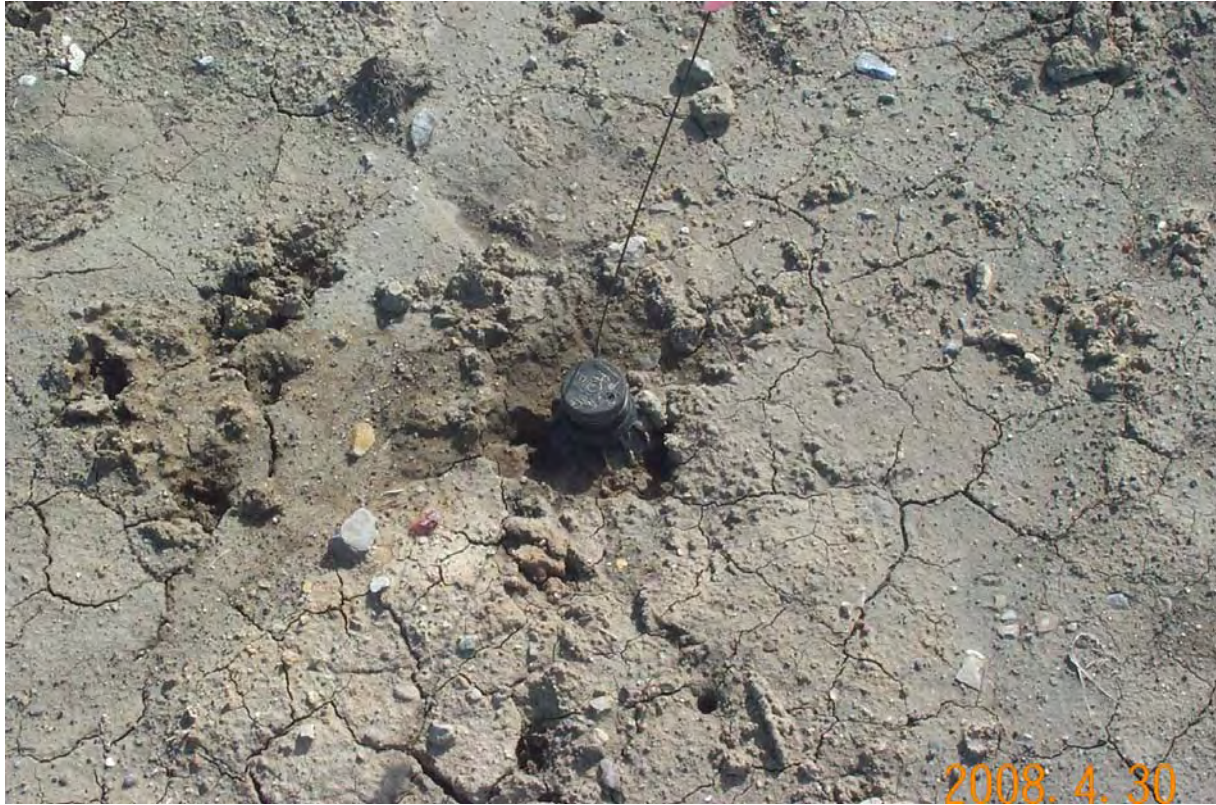
HAL 4/2008. PL-5. Exposed sprinkler head.

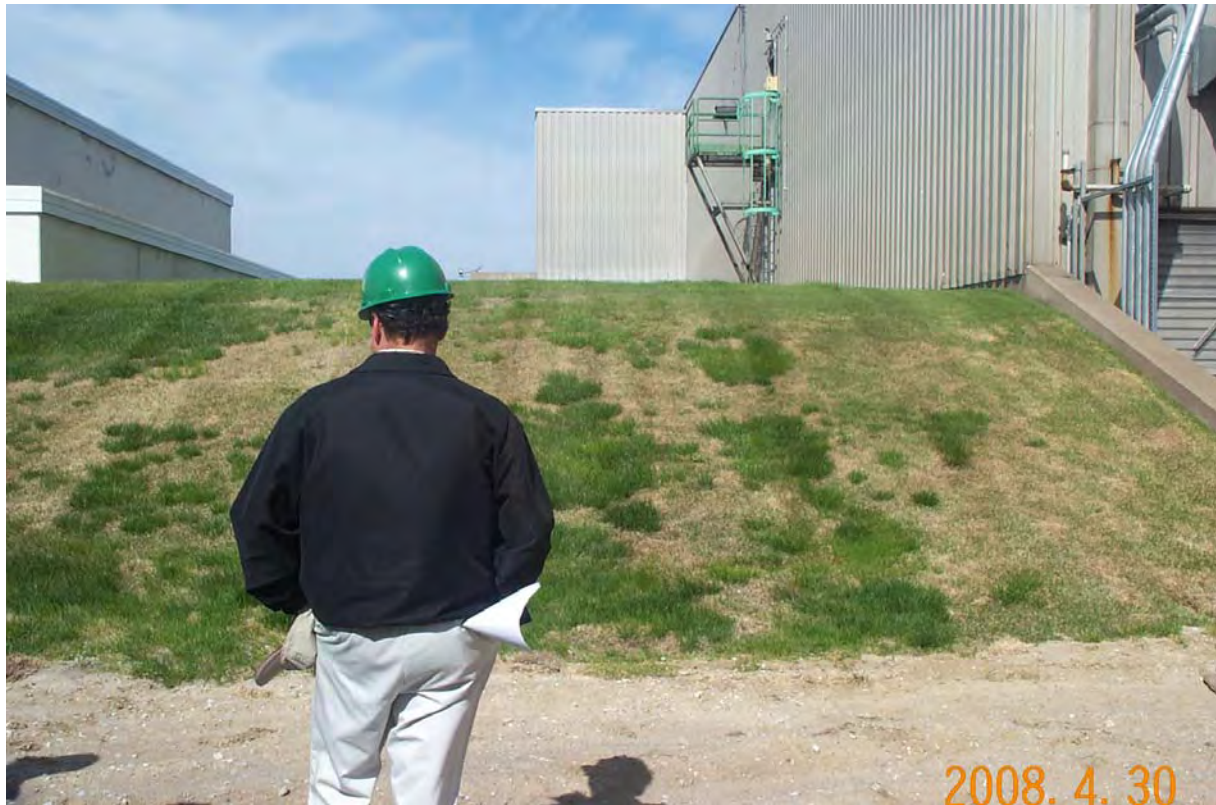
No evidence of new erosion was observed on the grass covered mound, but grass has not completely filled in an area just northeast of the IHX structure, where some work had disturbed the grass cover in prior years (PL-6).

HAL 4/2008. PL-6. Bare grass areas in northeast corner of grass covered mound.

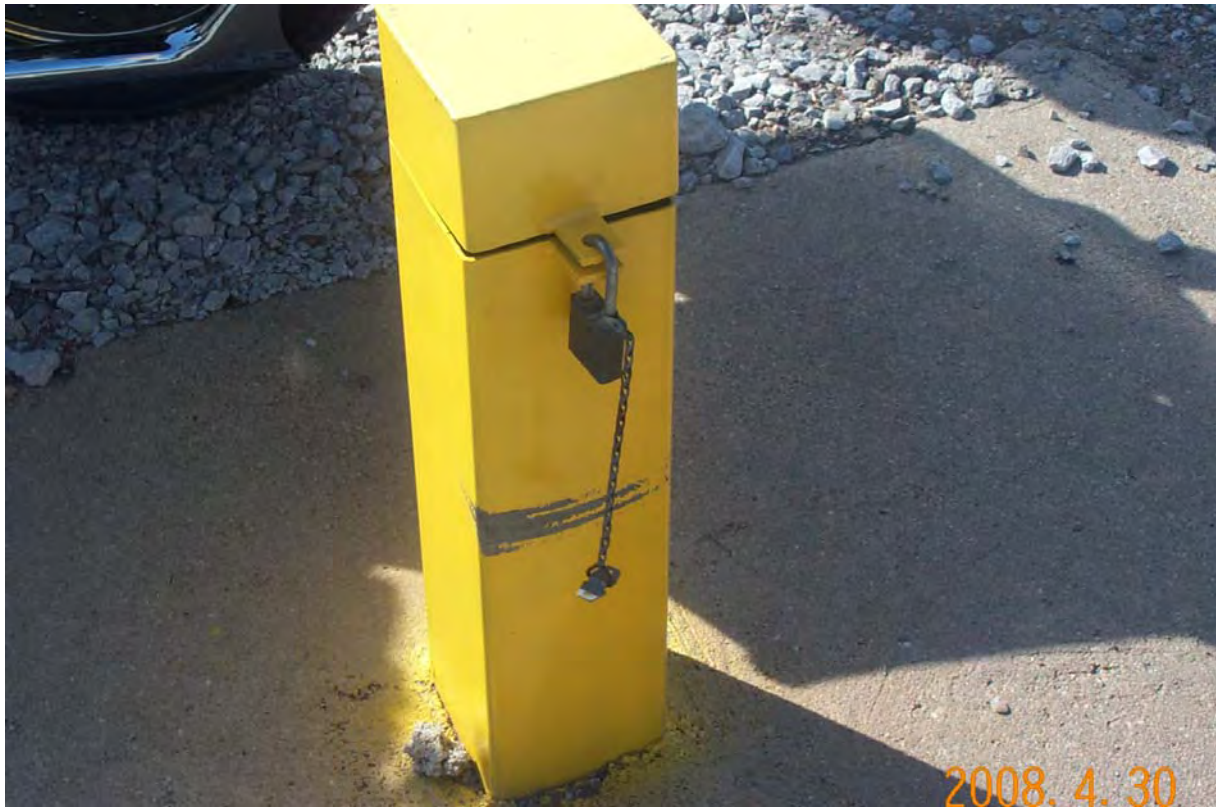
6. An un-used chain is attached to each well lock. When blown in the wind, this chain rubs against the paint on the protective casing (page 3).

HAL 4/2008. PL-7. Monitor Well OBS-4, free hanging chain on lock.

**Recommendation:** This un-used chain will be removed from each lock during the June 2008 sampling event.

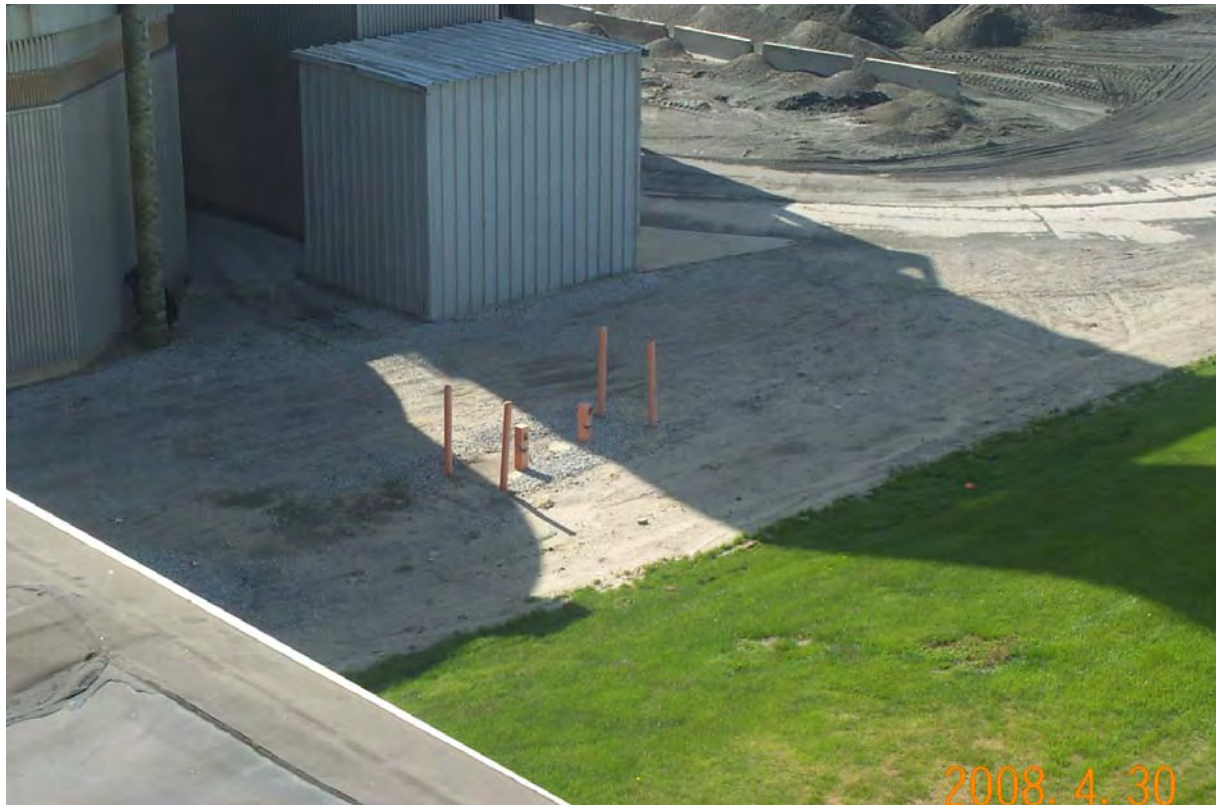
Wells OBS1A and OBS1B are located in a high traffic area (PL-8). These wells are installed in a large concrete pad and surrounded by four bollards (PL-9). A statement of work is being prepared to change these two wells to flush mount wells. A heavy-duty vault type design is planned. In Nebraska, a licensed well installer must perform this work.

7. Monitor wells OBS1A and OBS1B are located in high traffic areas. These wells need to be redesigned into flush mounts (page 3).

HAL 4/2008. PL-8. Monitor Wells OBS1A and OBS1B.

**Recommendation:** A SOW is being prepared to re-configure these wells in 2008.

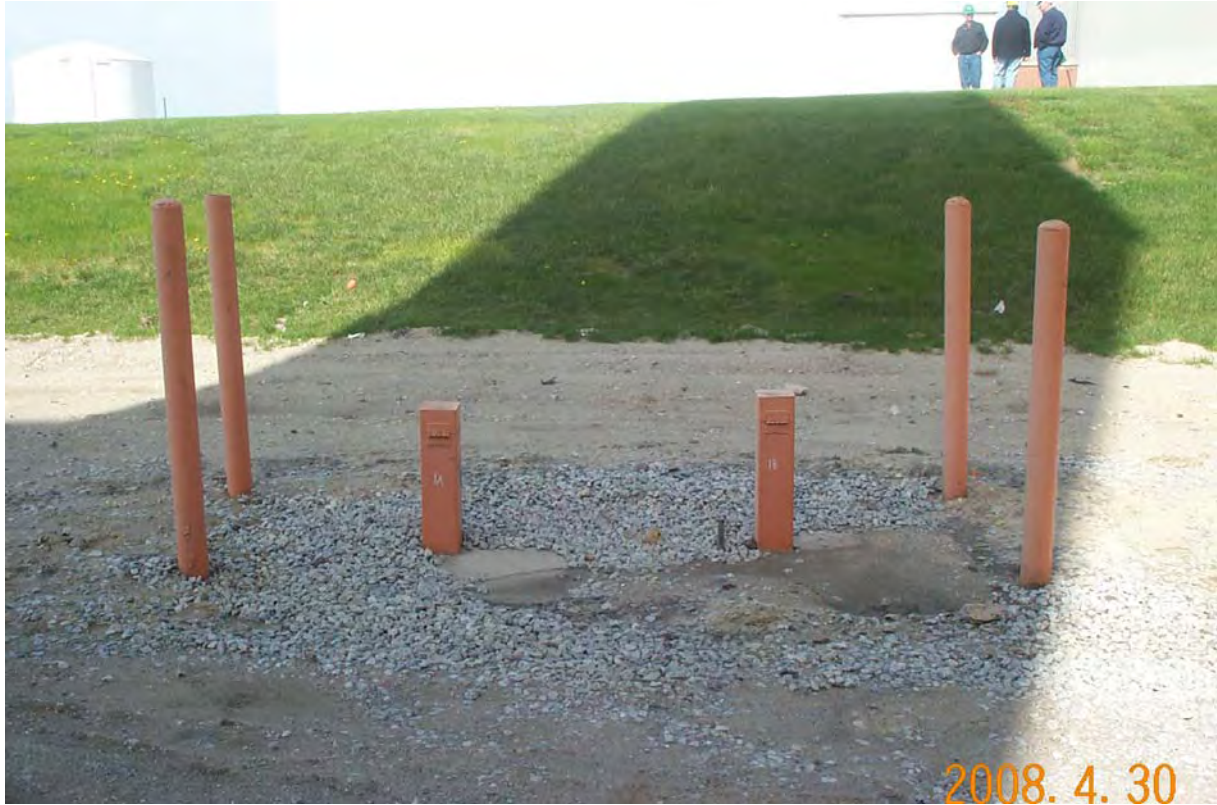
HAL 4/2008. PL-9. Monitor Wells OBS1A and OBS1B.

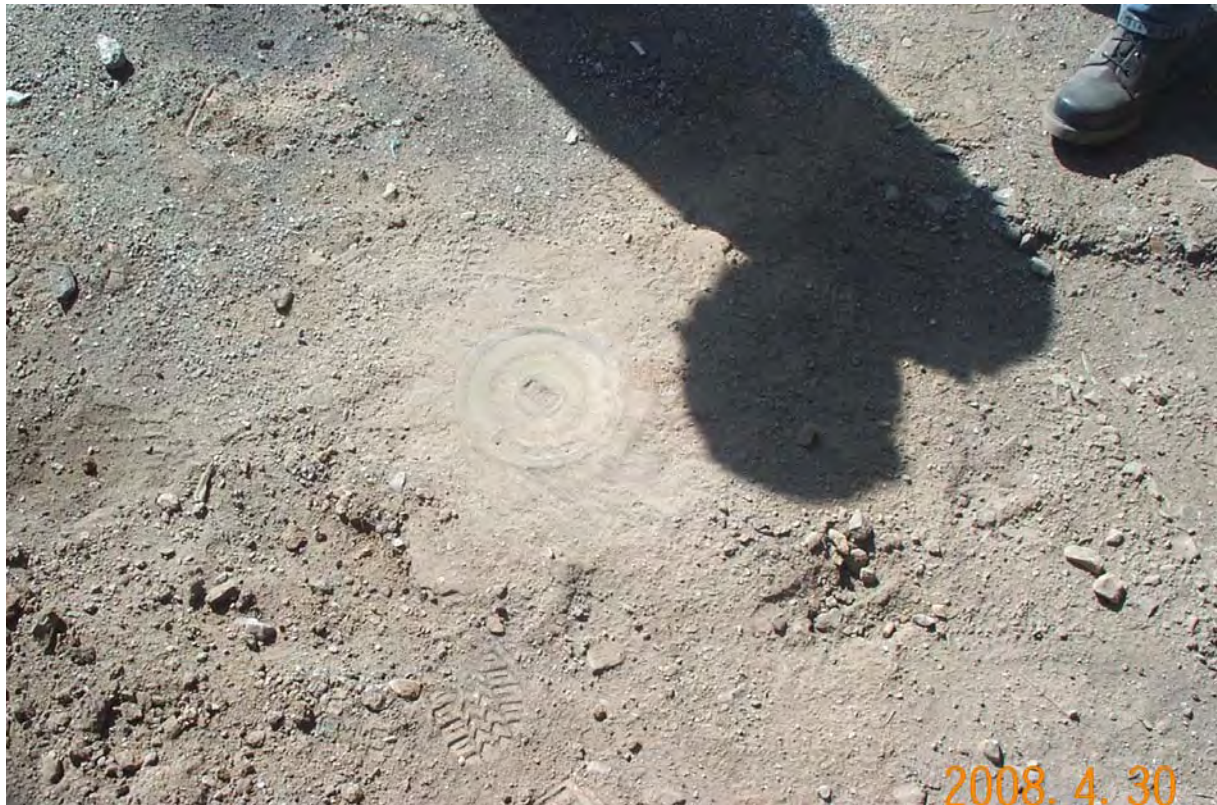
Wells OBS6A and OBS6B are flush mounted wells. The wells are usually covered with gravel and difficult to locate. The covers on these wells were not removed from 2002 through 2004 because they are cracked and wedged tight with coal dust. Since 2005, water-sampling personnel have been successful in removing the covers without damaging them. Previous attempts to find replacement covers were unsuccessful. Only one of the wells could be located during the inspection and because the wells are not labeled on the outside it was not known if the well that was found was OBS6A or OBS6B (PL-10). A statement of work is currently being prepared to re-configure these flush mounts to a more substantial design (e.g., vault type design) so they can be located and opened more easily. In Nebraska, a licensed well installer must perform this work. It is recommended that a magnetometer should accompany well samplers during their sampling visit in June 2008 to locate this well.

9. Monitor wells OBS6A and OBS6C are flush mount wells that are easily buried with coal dust and are hard to open because the covers are usually wedged tight with coal dust (page 3).

HAL 4/2008. PL-10. Monitor Well at OBS6 location.

**Recommendation:** A SOW is being prepared to re-configure these wells with a stronger vault design in 2008. Well samplers should carry a magnetometer with them during the June 2008 sampling event to help locate these wells.

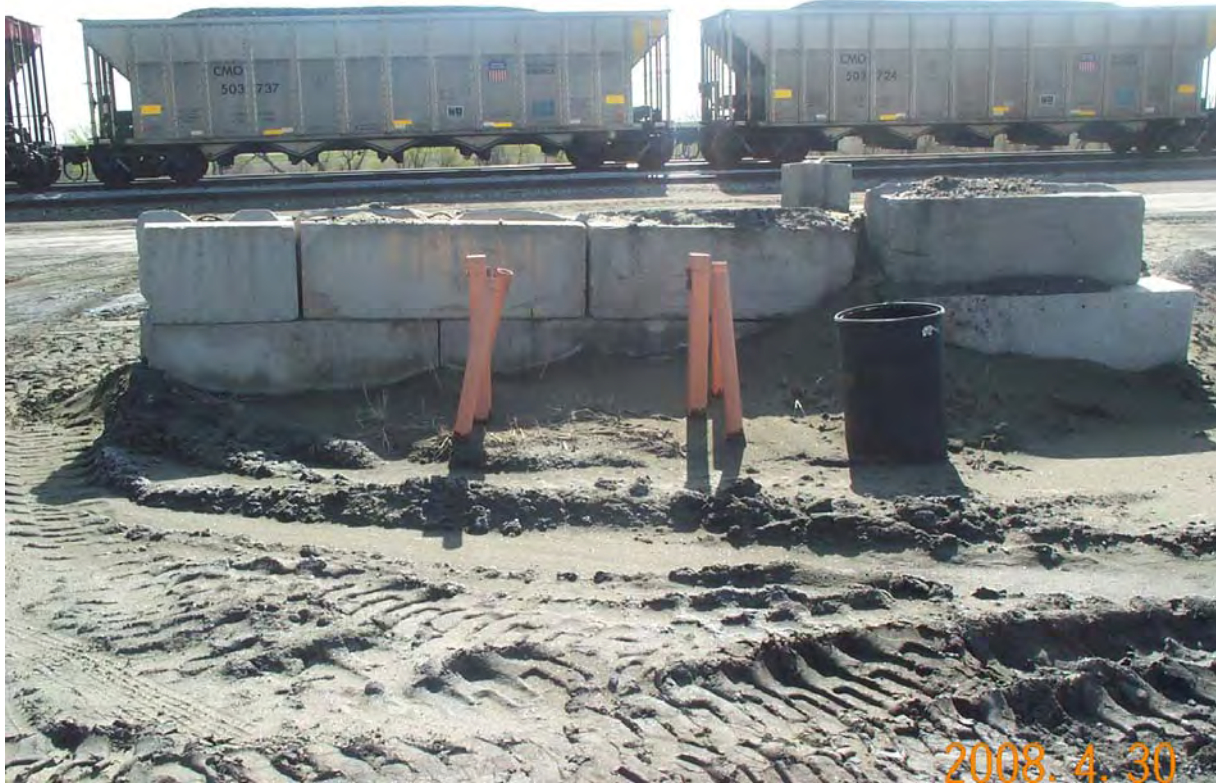
Wells OBS7B and OBS7C are located in a high traffic area and are protected by bollards (PL-11). The well pad at this location is buried and the bollards protecting the pad are bent due to being hit by heavy equipment operating in the area. There is little that can be done at this location to improve the protection of the wells. Therefore, before repairs are made to this well cluster, DOE will review data collected from this location and make a determination as to whether the data supports keeping or abandoning the monitoring location. If the decision is made to keep the monitoring location, the bollards will need to be re-enforced, perhaps with some jersey barriers, to provide additional protection against the operation of heavy equipment in the area.

10. Monitor Wells OBS7B and OBS7C are located in a high traffic area and are protected by bollards. There is little that can be done at this location to better protect these wells (page 3)

HAL 4/2008. PL-11. Monitor Wells OBS7B and OBS7C.

**Recommendation:** DOE will review the data collected from this location and make a determination as to whether the data supports keeping the monitoring location. Bollards should be placed around the location for added protection.

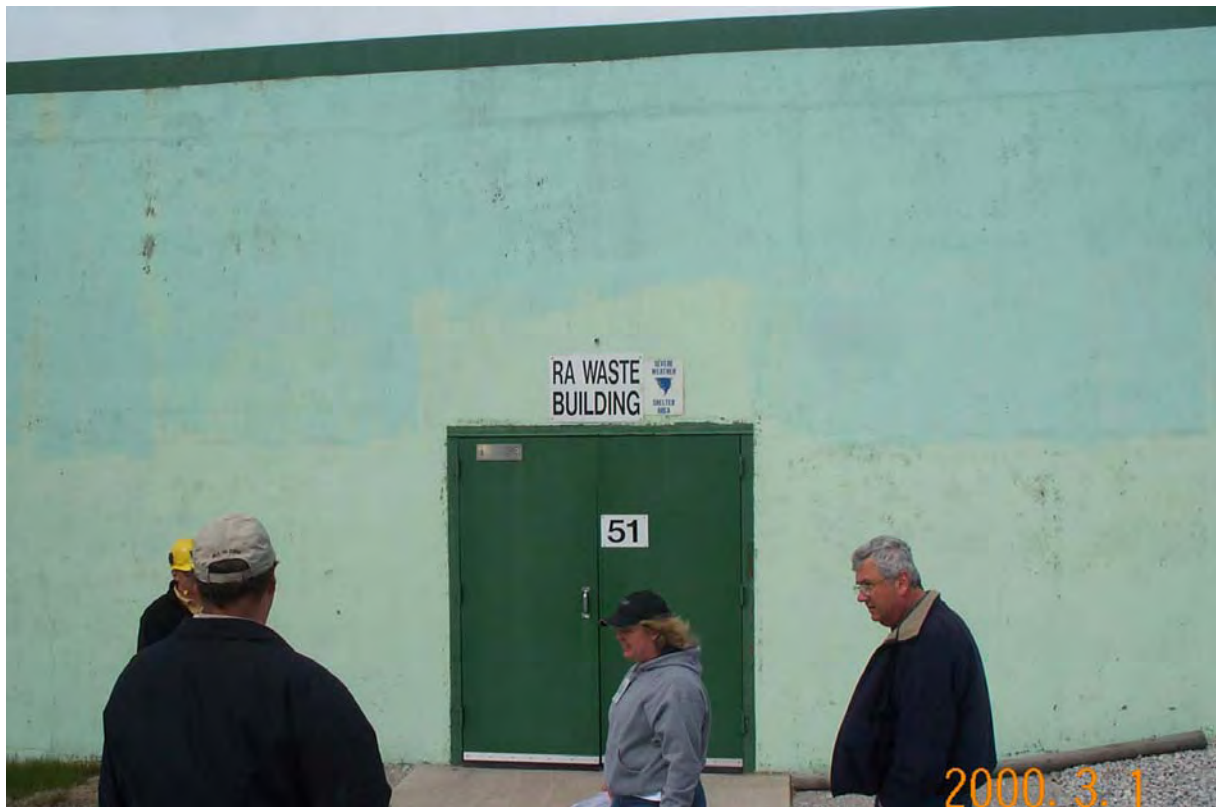
In 2007 inspectors walked through the former Radioactive Waste Building across the entrance drive from the burial mound. The basement was sealed to prevent access. This building was reported to have been surveyed for contamination and released. Stoller recommended to NPPD that the sign reading "RA Waste Building" be removed from the building. NPPD does not want to change the name of the building, as it is what the building has always been called; therefore the sign remains (PL-11).

HAL 4/2008. PL-12. Entrance to RA Building.
