2009 Annual Inspection and Status Report for the Hallam, Nebraska, Decommissioned Reactor Site

This report presents the findings of the annual U.S. Department of Energy (DOE) inspection of the decommissioned Hallam, Nebraska, Reactor Site on April 29, 2009.

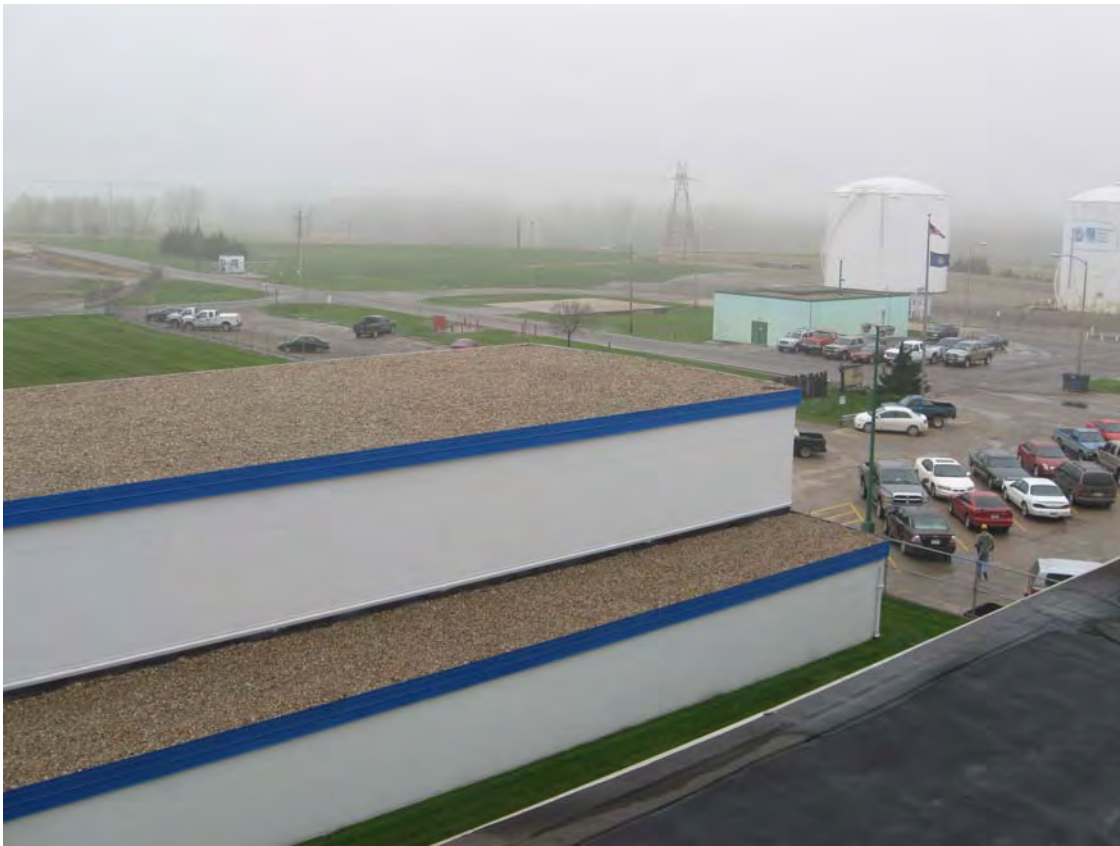
The IHX building is a massive 40-foot-wide by 80-foot-long concrete sarcophagus located at the north end of the former HNPF. On the south side, the building is two stories high (about 25- to 30-feet). On the north side, the building is one-story high. Photograph PL-1 shows the two different roof levels of the building. The roof on the second story is slightly crowned. The roof on the first story is sloped to drain.

HAL 4/2009. PL-1. Two different roof levels of IHX building.

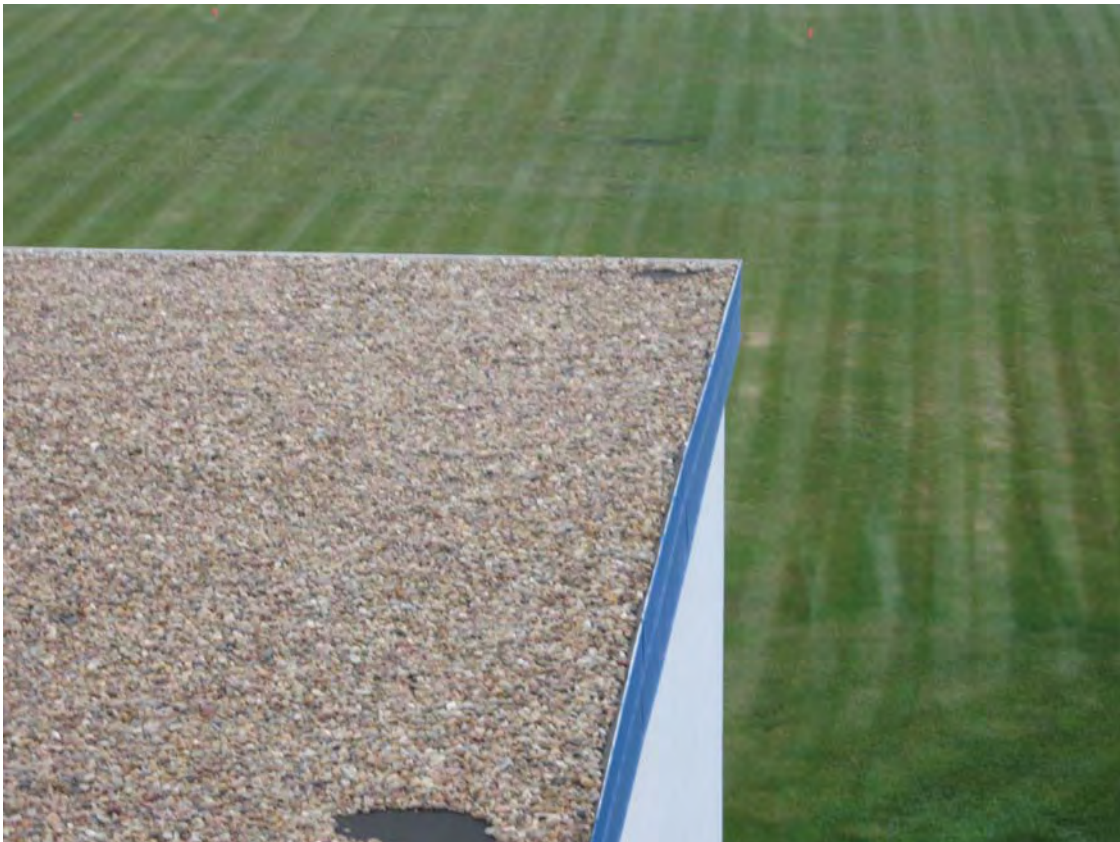
Inspectors view the roof of the IHX building from the roof of the Sheldon Power Plant, which is located north of the IHX building. The roof of the IHX building was replaced in 2007. The entire roof is covered by a layer of rock material. Roof rock has been removed from two areas on the upper roof since the 2008 inspection resulting in two bare spots. One bare spot is located in the northwest corner of the upper roof and one bare spot is located in the southwest corner of the upper roof (PL-2, PL-3, and PL-4). ***It is recommended that existing roof rock be redistributed back over the bare spots and/or supplemented with some additional roof rock.***

1. Two spots on the upper roof of the IHX building are bare of rock material (page 2).

HAL 4/2009. PL-2. Two bare spots on the upper roof of the IHX building.

Recommendation: Existing roof rock will be redistributed back over the bare spots and/or supplemented with some additional roof rock. If possible this work will be conducted in conjunction with the grading work planned for the base of the IHX building in FY2009.

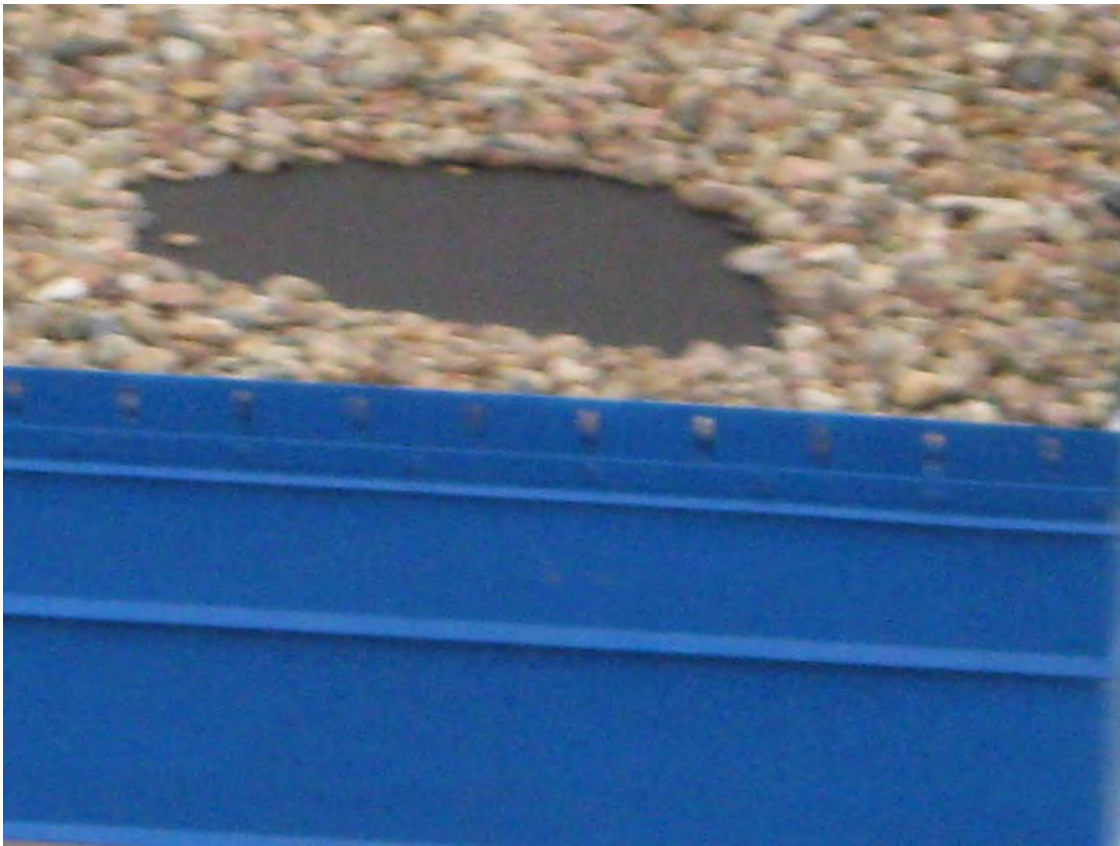
HAL 4/2009. PL-3. Bare spot in northwest corner of upper roof of the IHX building.

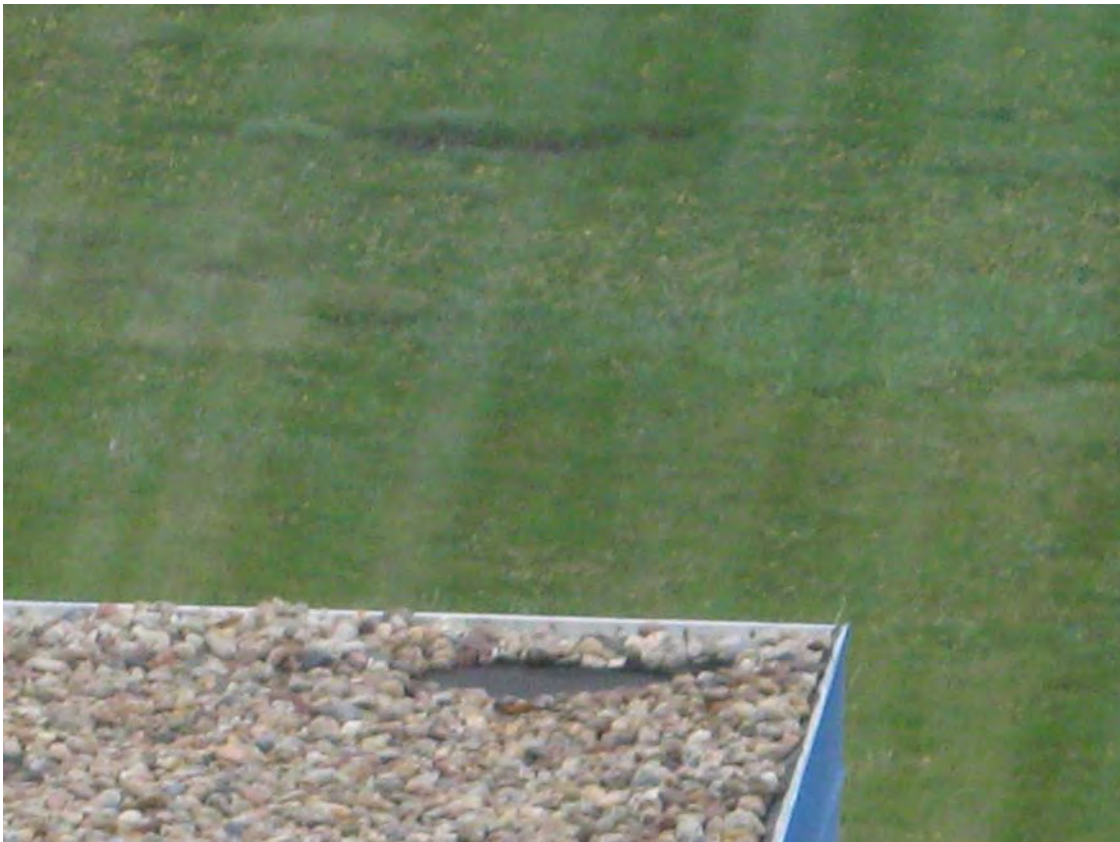
HAL 4/2009. PL-4. Bare spot in southwest corner of upper roof of IHX building.

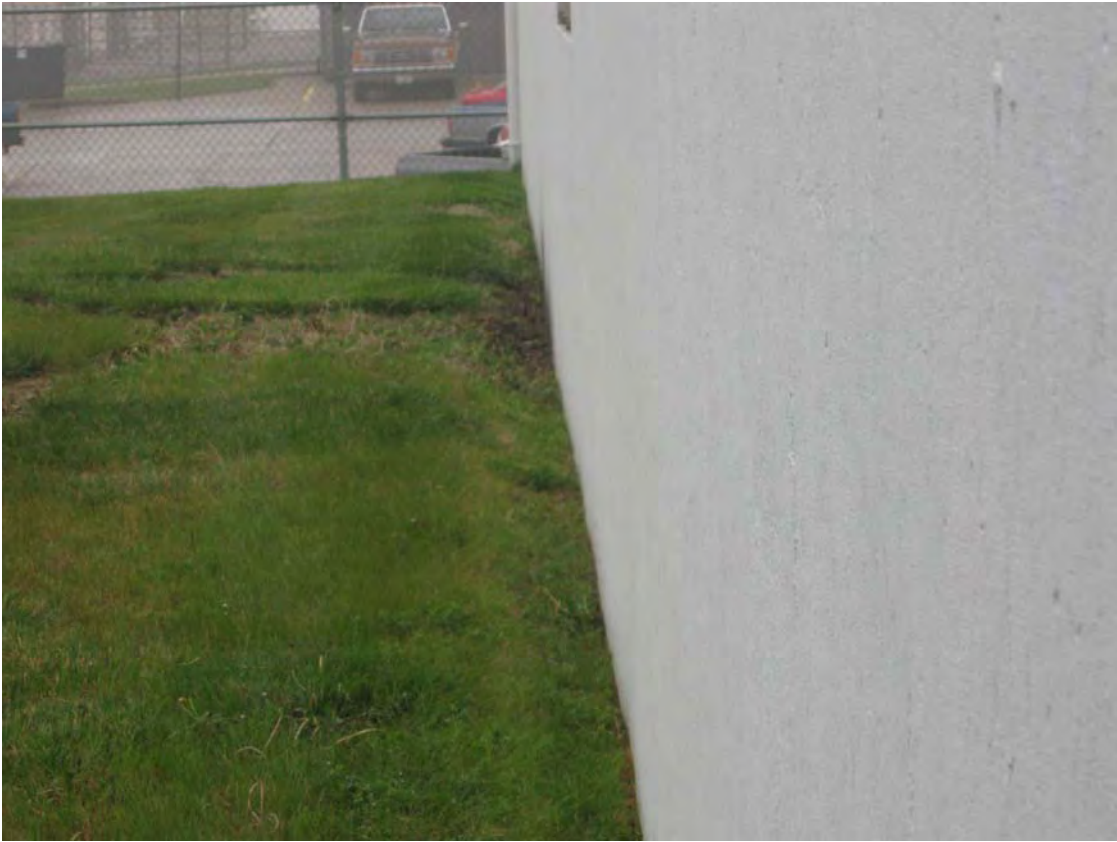
It was noted during the 2008 inspection that grading around the base of the IHX building needs to be performed. The soil around the immediate base of the building (extending out about a foot from the building) is sloped toward the building. At a distance of about a foot from the building, the soil slopes away from the IHX and serves to drain water away from the building. Photo PL-5 illustrates how the soil along the immediate base of the south wall of the IHX building is sloped toward the base of the building. The small slope toward the building probably developed over the years from water dripping off the roof. The concern is that water will pond against the base of the building rather than move away from the building. Inspectors noted this year that the situation has not worsened since it was first noted in 2008. ***It is recommended that a small***

2. Soil surrounding the base of the IHX structure is sloped toward the building (page 2).

HAL 4/2009. PL-5. Soil at the base of the south wall of the IHX is sloped toward the building.

amount of soil be added around the perimeter of the IHX building to eliminate the existing depression, and that a one-foot- wide layer of small gravel be placed around the perimeter of the IHX building on top of the soil to absorb the impact of any water dripping off the edge of the roof in the future. The gravel will also aid in helping water drain away from the base of the IHX building.

Recommendation: A small amount of soil will be added around the perimeter of the IHX building to eliminate the existing depression, and a one-foot-wide layer of small gravel will be placed around the perimeter of the IHX building on top of the soil to absorb the impact of any water dripping off the edge of the roof. The gravel will also aid in helping water drain away from the base of the IHX building.

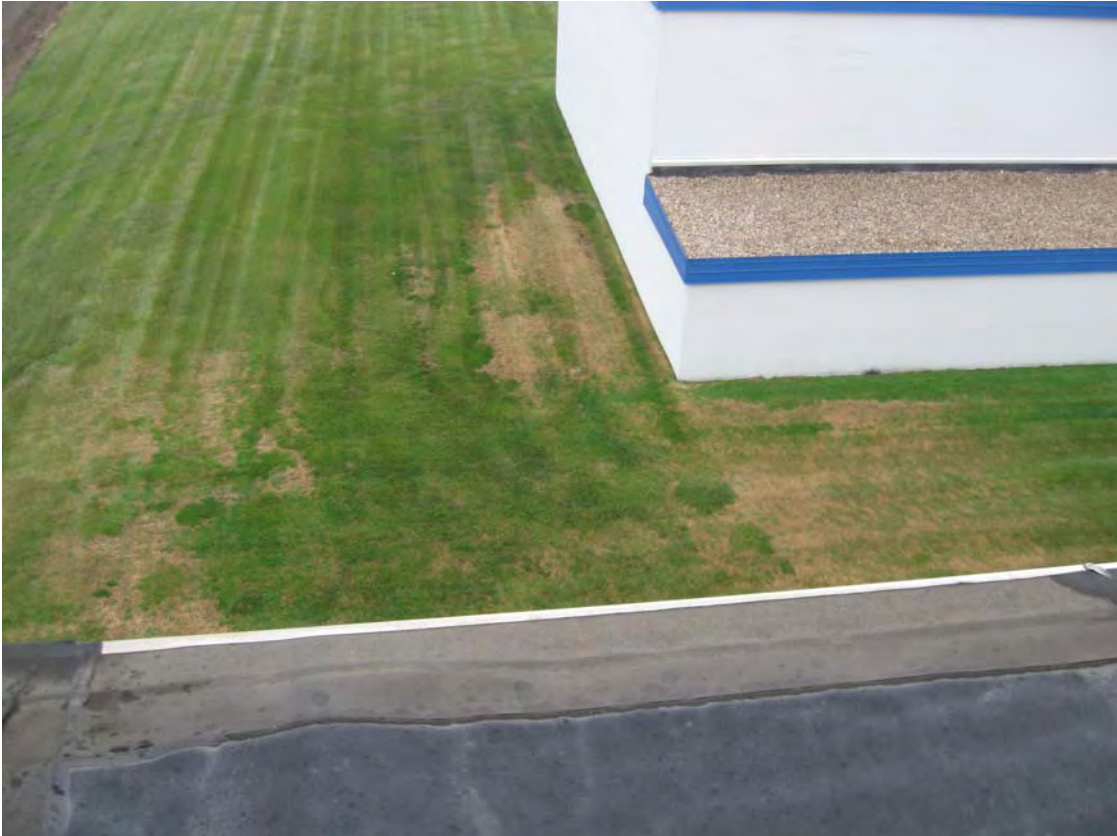
The grass on the mound is well established and in good condition with the exception of an area of struggling grass growth on the northeast corner (PL-6). The area of struggling grass growth was noted last year during the 2008 inspection. It looks as if the area just needs a little more watering and attention. Conditions on the northeast corner appear to be about the same as they were in 2008 and do not appear to compromise the integrity of the mound. ***It is recommended that inspectors continue to monitor grass conditions on the northeast corner of the mound but unless conditions get worse and the integrity of the mound is questioned no action is required.*** No evidence of erosion was observed on the grass covered mound.

3. An area of struggling grass growth is present in the northeast corner of the grass covered mound (page 3).

HAL 4/2009. PL-6. Area of struggling grass growth on northeast corner of grass covered mound.

Recommendation: Inspectors will continue to monitor grass conditions on the northeast corner of the mound, but unless conditions get worse and the integrity of the mound is questioned, no action is required.

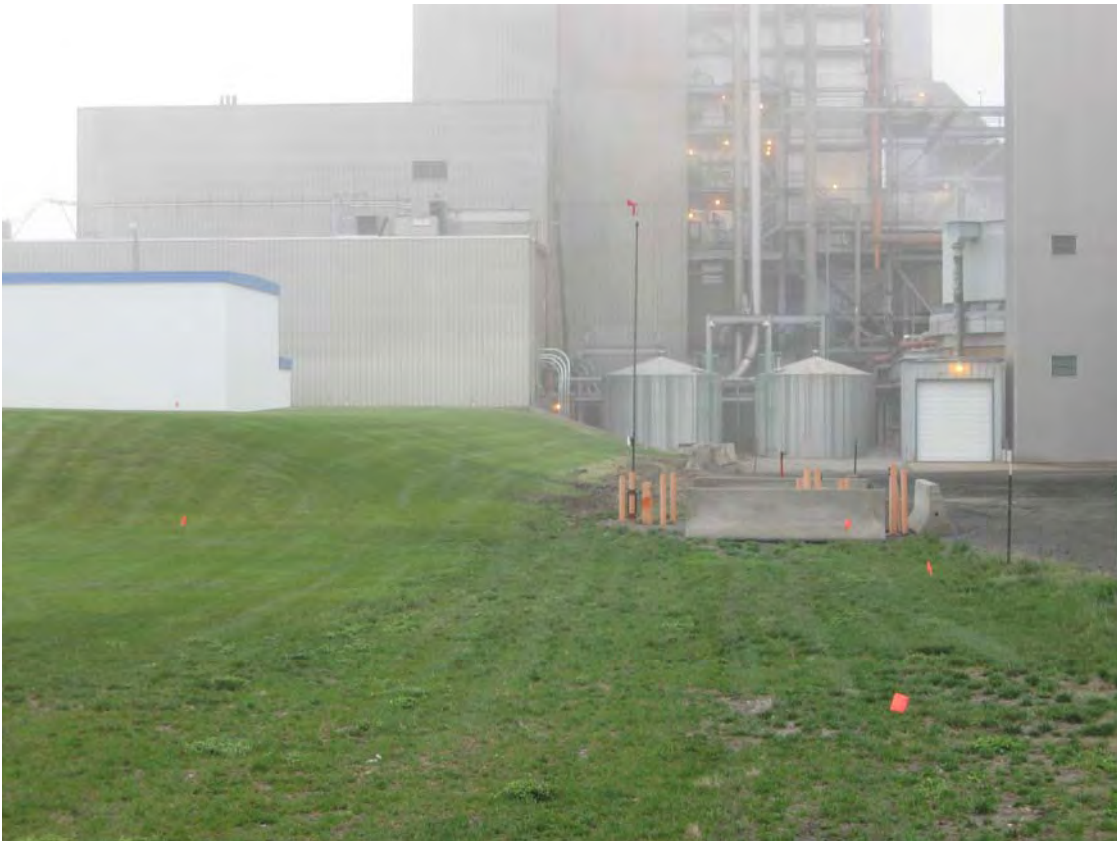
During the 2008 inspection it was observed that the east edge of the grass-covered mound, just beyond the toe of the slope, was bare of grass due to waterline work that was conducted in 2007, and the area needed to be re-seeded. Inspectors this year observed that the area has been successfully reseeded (PL-7).

HAL 4/2009. PL-7. Looking north along the edge of grass covered mound.

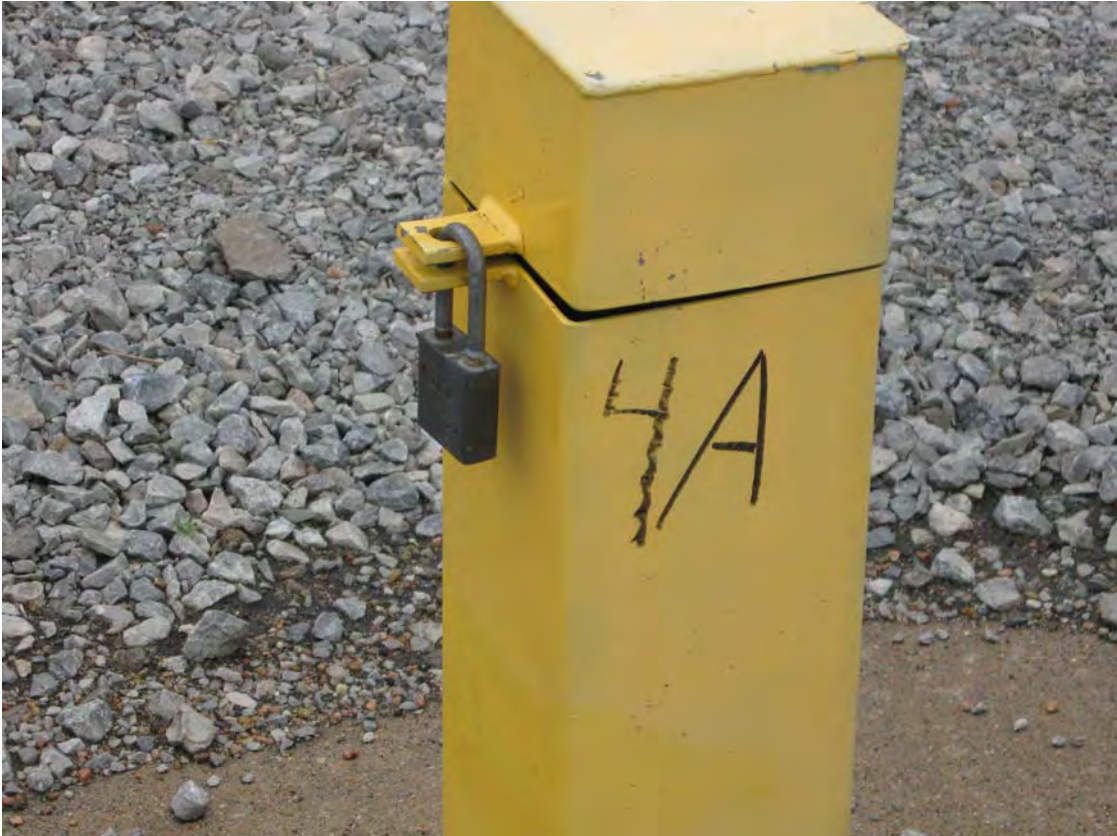
During 2008, several of the wells were freshly painted and well identification numbers were applied to the outside of all of the protective casings (PL-8). ***It is recommended that during the next scheduled sampling event (2010) the protective casings be re-painted (if deemed necessary) and the well identifications be touched up (if required) to make sure they remain visible.***

HAL 4/2009. PL-8. Monitor well 4-A clearly labeled on outside of protective casing.

Recommendation: During the next scheduled sampling event (2010) the protective casing will be re-painted (if deemed necessary) and the well identifications will be touched up to make sure they remain visible.

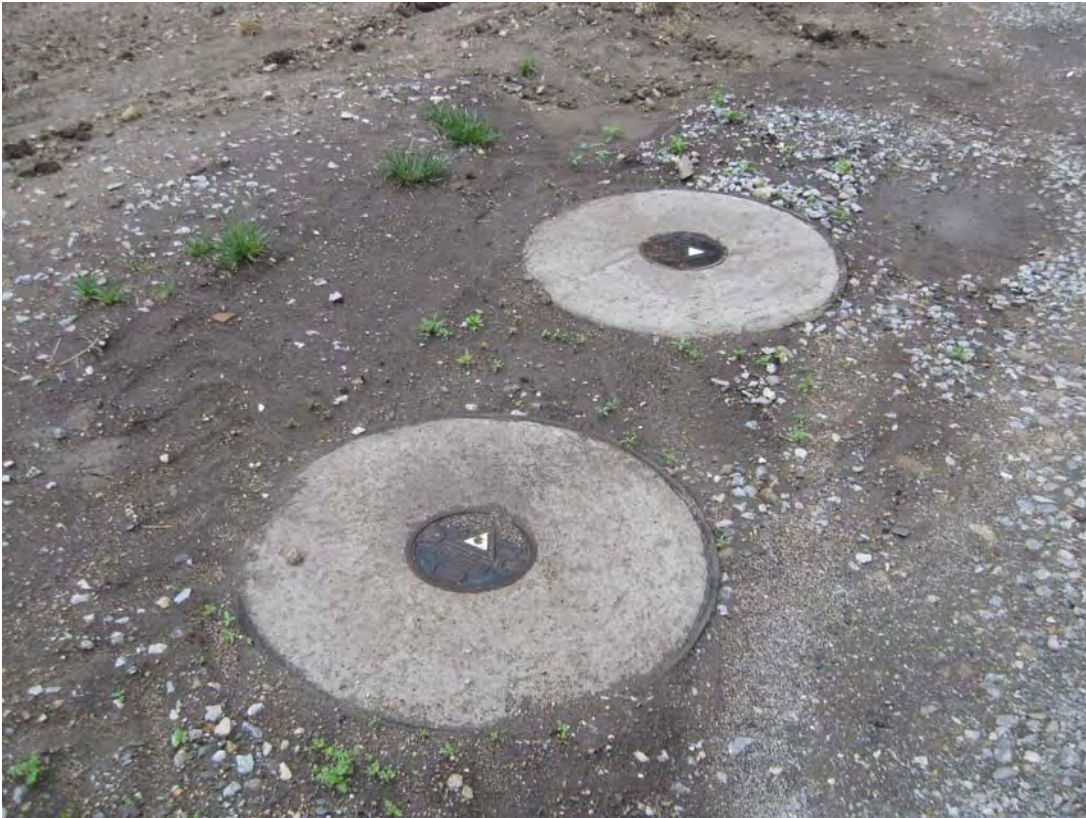
During 2008, well cluster 1 (OBS1A and 1B) was converted to a flush mount installation (PL-9). No visible well identification numbers are present on wells OBS1A and OBS1B. ***It is recommended the well caps of these two flush mount wells be labeled with their well number the next time they are sampled. There is a small white triangle present on the cap of each flush mount where a 1A or 1B could be applied (PL-10). It is also recommended that the concrete well pads be painted a bright color (e.g. fluorescent orange or green) to aid in locating them should coal dust collect in the area and cover them.***

5. No visible well identification numbers are present on wells OBS1A and OBS1B (page 3).

HAL 4/2009. PL-9. Newly installed flush mount wells 1A and 1B.

Recommendation: The well caps of these two flush mount wells will be labeled with their well number the next time that they are sampled. There is a small white triangle present on the cap of each flush mount where a 1A or 1B could be applied (PL-10). It is also recommended that the concrete pads be painted a bright color (e.g., fluorescent orange or green) to aid in locating them should coal dust collect in the area and cover them.

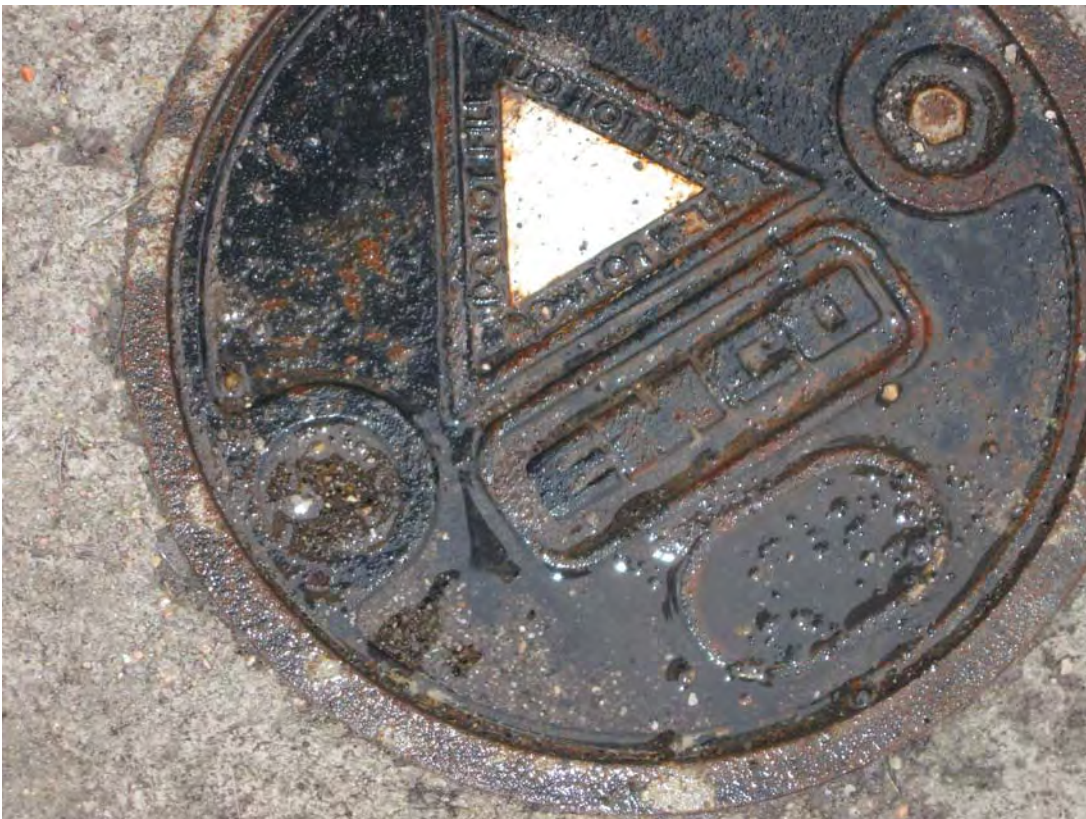
HAL 4/2009. PL-10. Well identification can be added to the white triangle on the well cap of the newly installed flush mount wells.

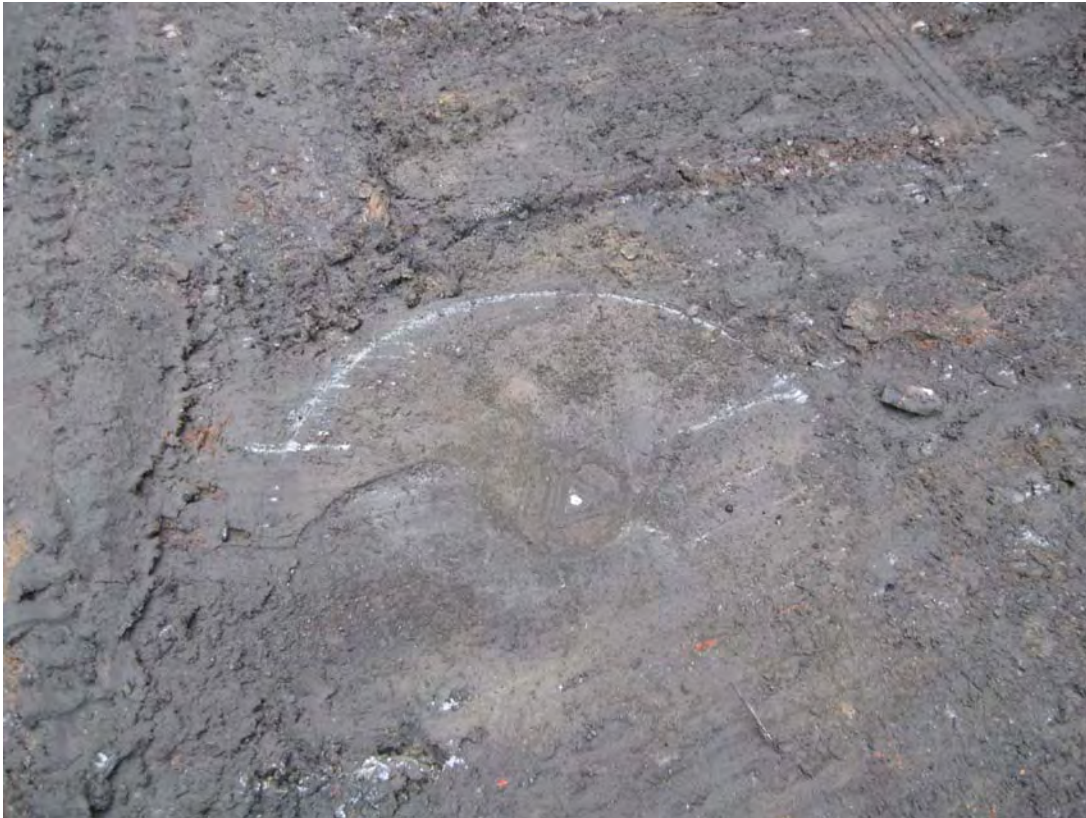
During 2008, the surface vaults of flush mount wells 6A and 6B were modified to a more durable design, identical to design used at wells 1A and 1B. Coal dust is prevalent at the location of wells 6A and 6B, and these two wells often become buried by coal dust making it hard to locate them (PL-11). Well OBS6B is located approximately 6 feet south of an existing orange pole (PL-12). A small insert map was added to this year's inspection report map showing the location of wells 6A and 6B in reference to this pole and to each other. ***It is recommended that the well caps of wells 6A and 6B be labeled with their well number when the wells are sampled next. It is also recommended that the concrete well pads be painted a bright color (e.g. fluorescent orange or green) to aid in locating them should coal dust collect in the area and cover them.***

6. No visible well identification numbers are present on wells OBS6A and OBS6B (page 4).

HAL 4/2009. PL-11. Newly installed flush mount at cluster 6.

Recommendation: The well caps of these two flush mount wells will be labeled with their well number the next time that they are sampled. There is a small white triangle present on the cap of each flush mount where a 6A or 6B could be applied. It is also recommended that the concrete pads be painted a bright color (e.g., fluorescent orange or green) to aid in locating them should coal dust collect in the area and cover them.

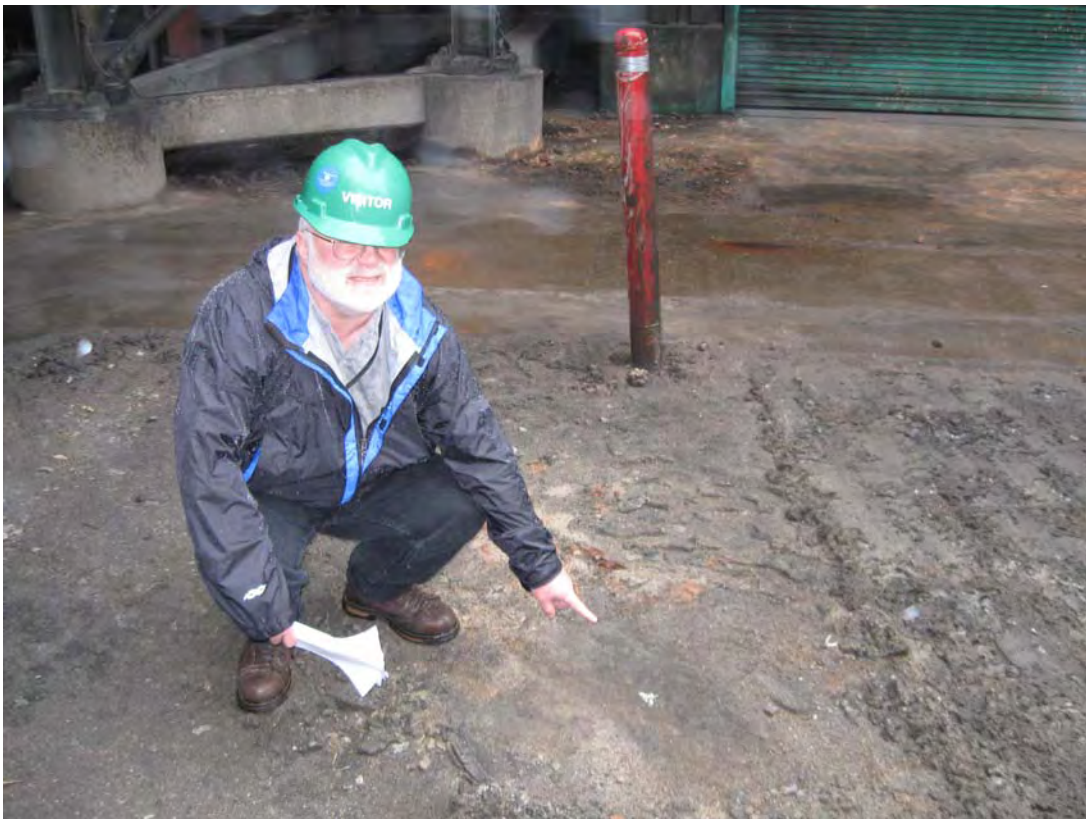
HAL 4/2009. PL-12. Can use existing pipe to help locate flush mount well at cluster 6. An insert map is provided on the inspection report map for 2009.

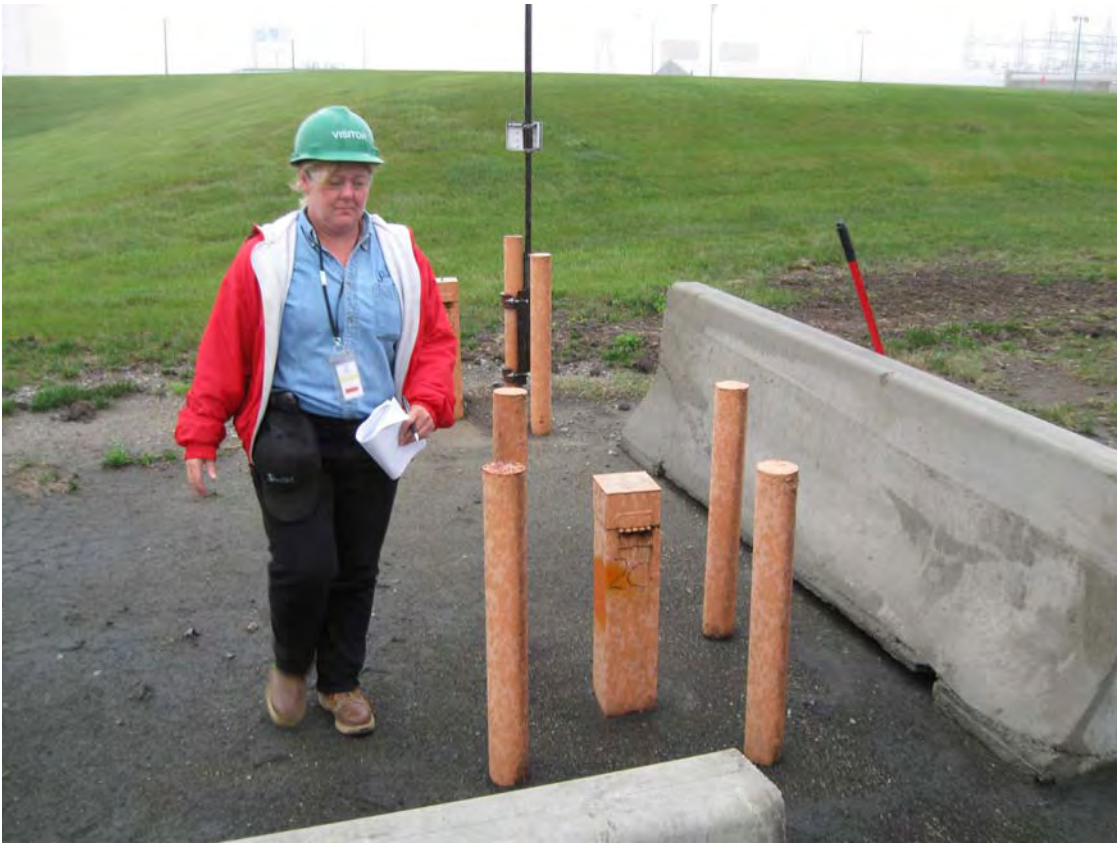
In 2008 bollards were removed from around wells OBS2A, OBS2B, OBS2B2, and OBS2C2 and were replaced with concrete barriers. These wells are located in a high traffic area. Plant personnel indicate that the new barriers are working fine to offer protection to the wells (PL-13).

HAL 4/2009. PL-13. New concrete barriers around well cluster 2.

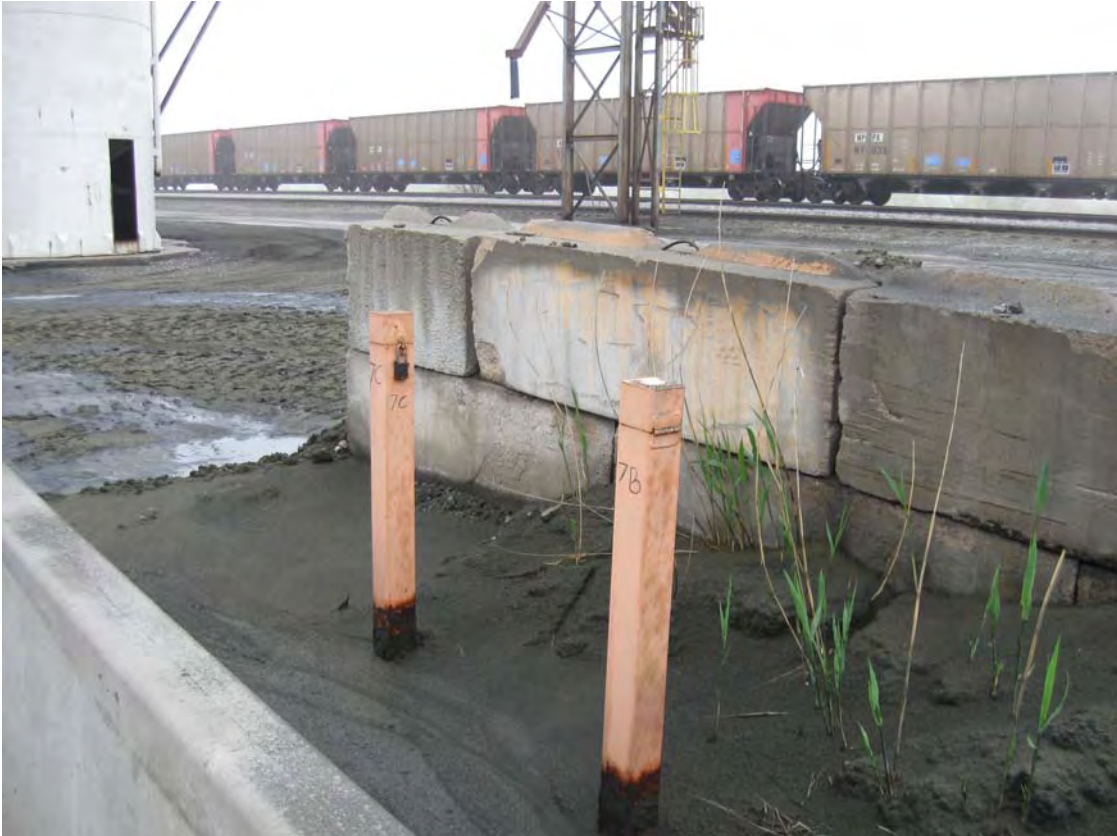
In 2008 bollards were removed from around wells OBS7B and OBS7C and replaced with concrete barriers. These wells are located in a very high traffic area (PL-14). Plant operations are impacted due to concern that heavy equipment operating in the area might accidentally damage the wells. Options considered for the wells ranged from improving protection of the wells to plugging and abandoning the wells altogether. The decision was made to focus on improving protection of the wells first before plugging and abandonment is considered. During the inspection, plant personnel indicated that the new concrete barriers greatly improve the situation.

HAL 4/2009. PL-14. New concrete barriers around well cluster 7.
