2010 Annual Inspection and Status Report for the Hallam, Nebraska, Decommissioned Reactor Site

This report presents the findings of the annual U.S. Department of Energy (DOE) inspection of the decommissioned Hallam, Nebraska, Reactor Site on April 28, 2010.

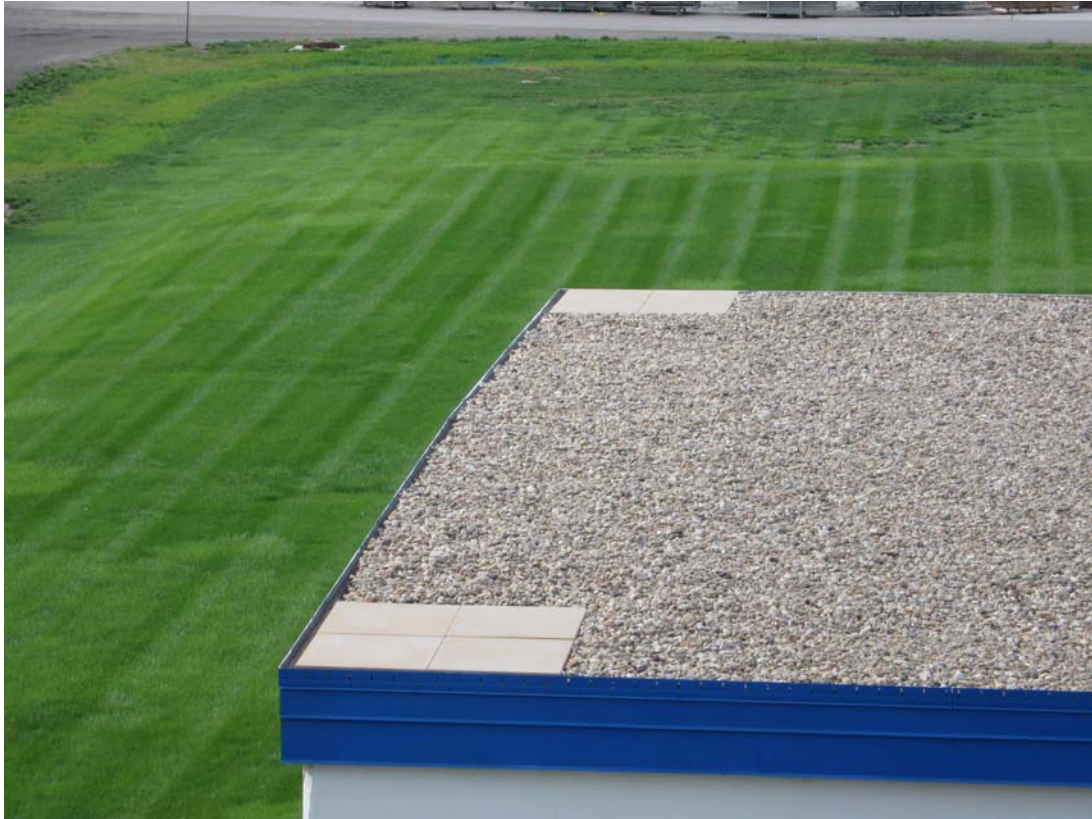
Inspectors view the roof of the IHX building from the roof of the Sheldon Power Plant, north of the IHX building. The roof of the IHX building was replaced in 2007. The entire roof is capped with a layer of rock material that protects the underlying roofing fabric. It was noted in 2008 that the roof rock was not present in the northwest and southwest corners of the upper roof. It is surmised that strong winds moved the rock from the corners of the roof exposing the underlying roofing fabric. Paver stones were placed in all corners of the roof in 2009 to correct the problem (PL–1). Inspectors found the roof to be in good shape. No bare spots were present.

HAL 4/2010. PL-1. East corners of the upper roof of the IHX building.

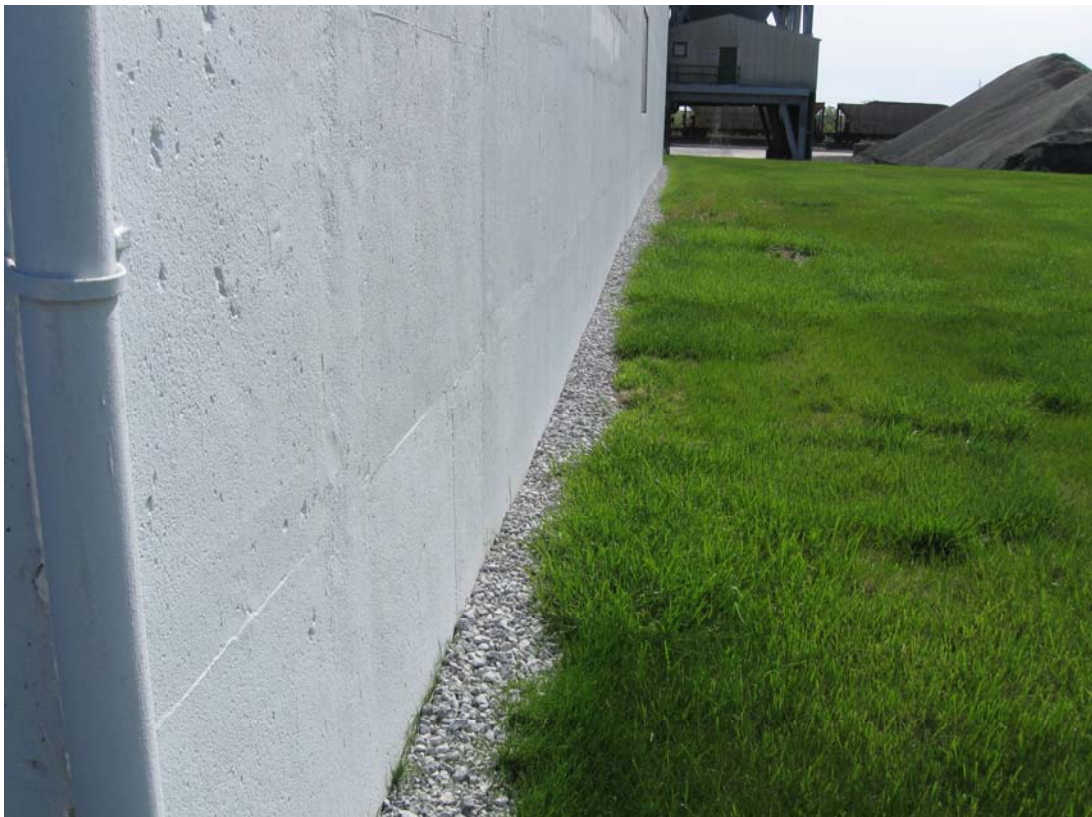
In 2009 soil and gravel were placed around the base of the IHX building (PL–2). The soil and gravel were placed in a small narrow depression in the ground surface that trapped water against the base of the building. By filling the depression, water now readily drains away from the base of the building.

HAL 4/2010. PL-2. Gravel along the base of the south side of the IHX building.

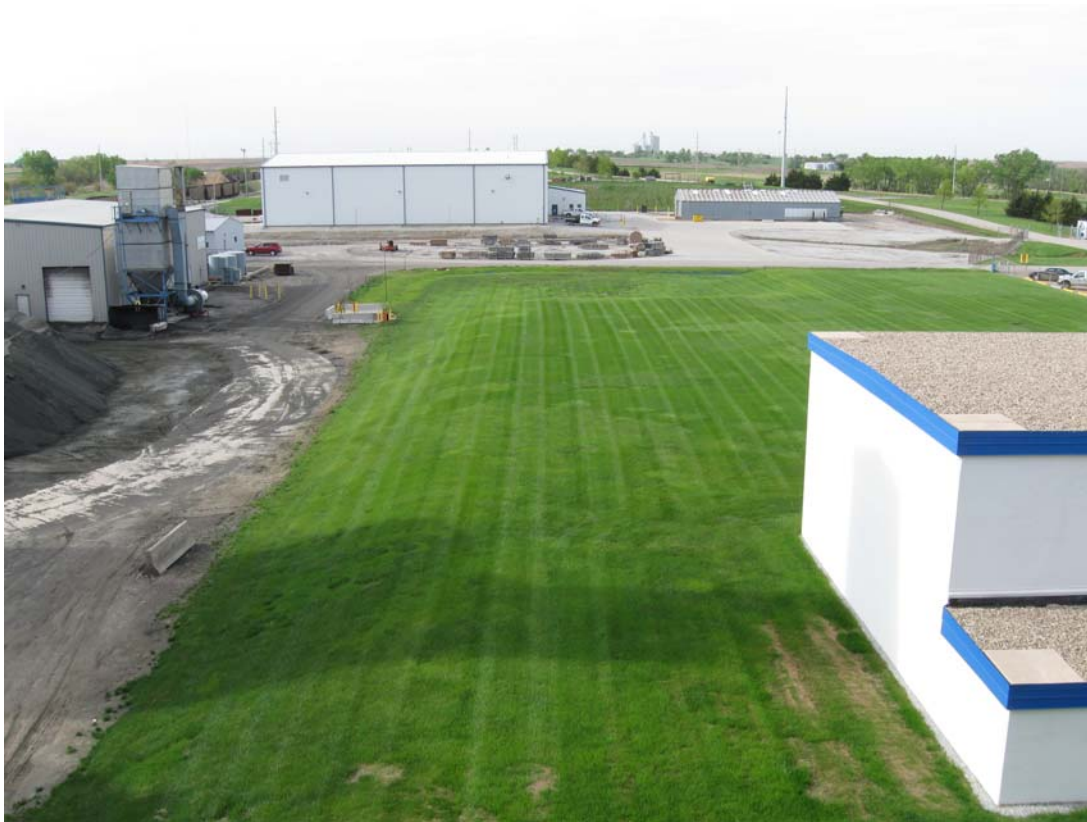
The grass on the mound was well established, and was in good condition (PL-3 and PL-4), with the exception of an ongoing struggle with grass growth on the northeast corner of the mound (PL-5). No evidence of erosion was observed on any portion of the grass-covered mound. Grass growth on the northeast corner continues to be a struggle, but conditions appear to be about the same as they were in 2009. The struggling grass growth on the northeast corner does not compromise the integrity of the mound. It is recommended that inspectors continue to monitor grass conditions on the northeast corner of the mound but unless conditions get worse and the integrity of the mound is questioned no action is required.

HAL 4/2010. PL-3. Grass-covered mound east of the IHX building.

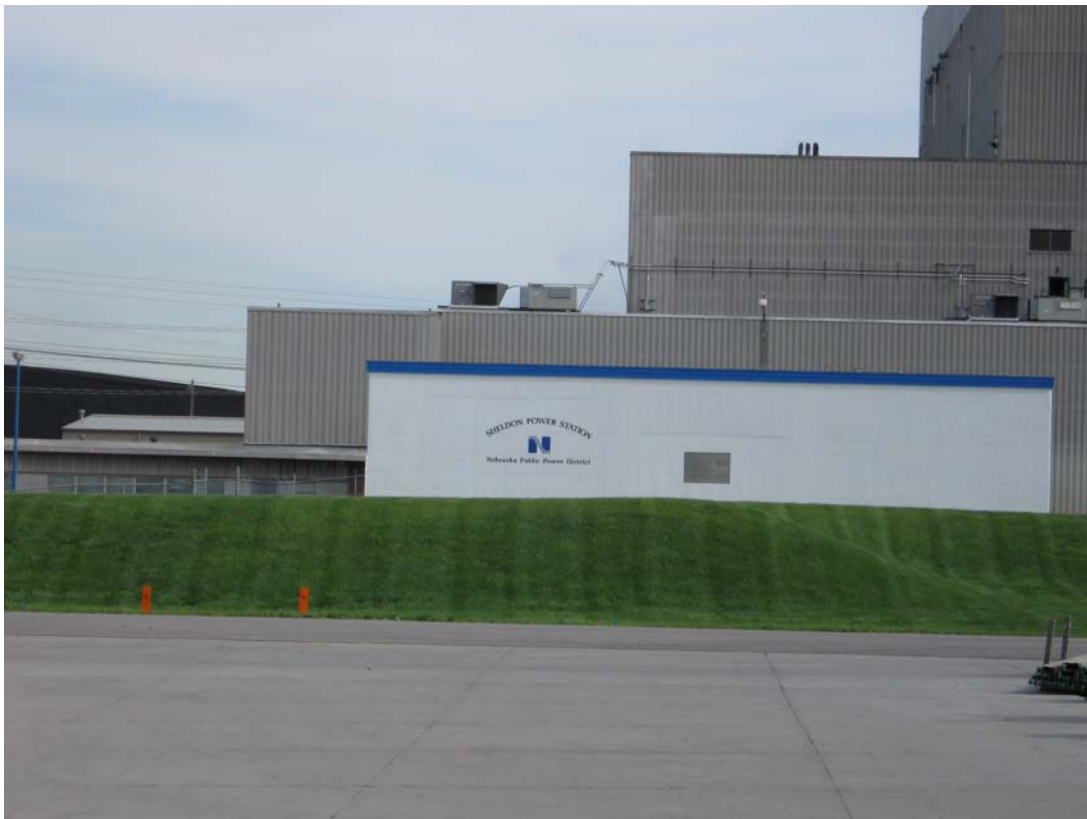
HAL 4/2010. PL-4. South side of the IHX building. Grassy mound in front, power plant in the background.

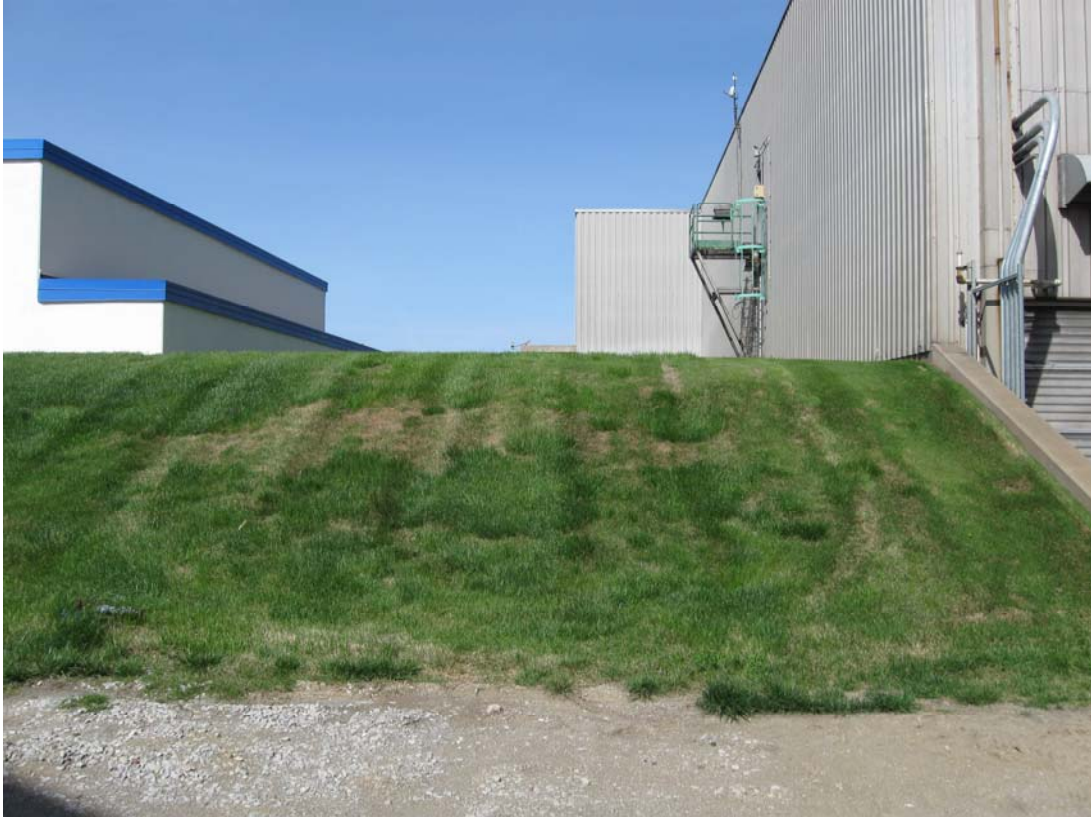
HAL 4/2010. PL-5. Grass-covered mound east of the IHX building.

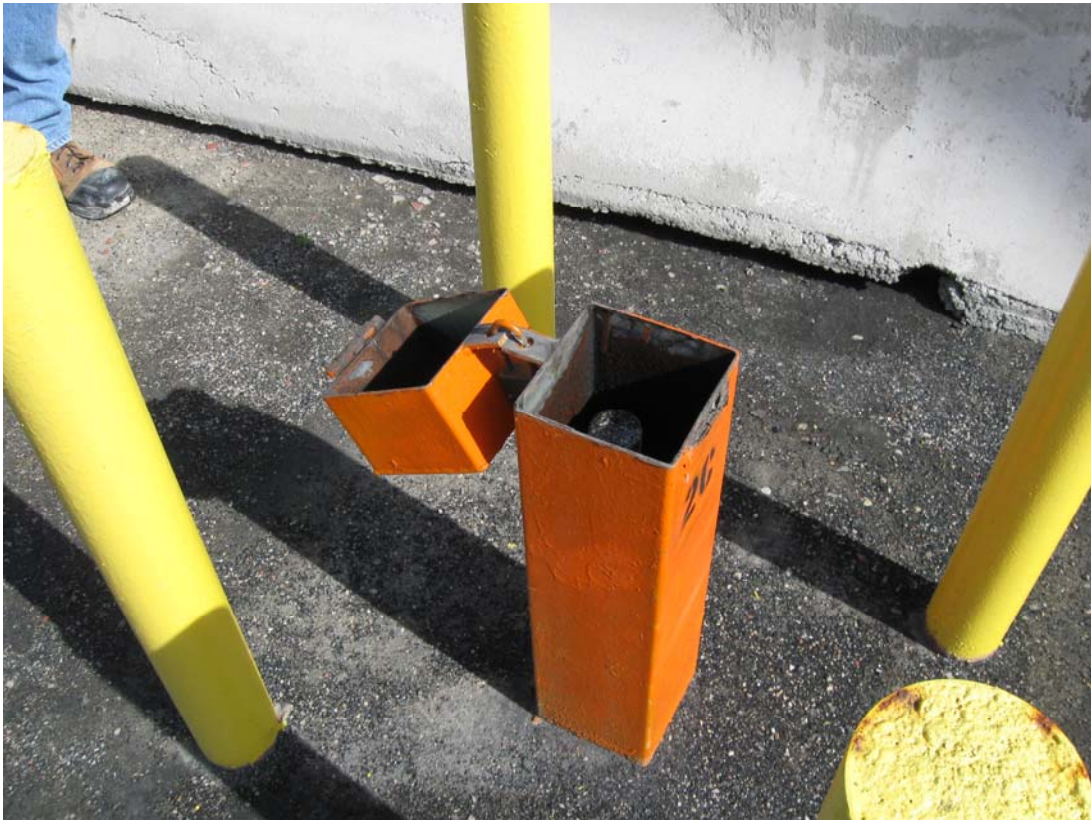
DOE monitors groundwater in response to a request from the Nebraska Department of Health. There are 19 monitoring wells. During the inspection all 19 monitoring wells were properly secured with locks but the hinges on the well caps of the protective casings on monitoring wells OBS-2B and OBS-2C were broken. So, although monitoring wells OBS-2B and OBS-2C were locked, the wells were actually unsecured (PL-6). It is recommended that the hinges on the well caps of the protective casings of monitoring wells OBS-2B and OBS-2C be repaired.

1. The hinges on the well caps of the protective casings on monitoring wells OBS-2B and OBS-2C were broken, leaving the wells unsecured (page 3).

HAL 4/2010. PL-6. Broken hinge on the protective casing cap of monitoring well OBS-2C.

Recommendation: It is recommended that the hinges on the well caps of the protective casings of monitoring wells OBS-2B and OBS-2C be repaired.

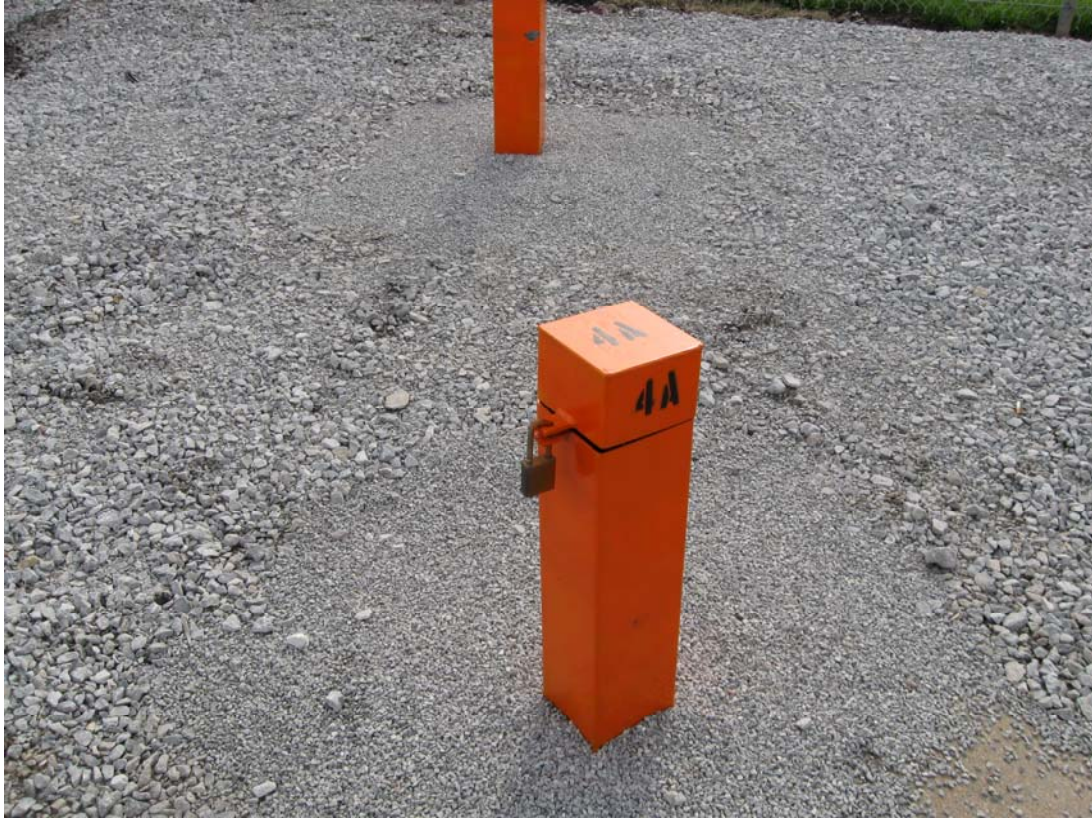
During 2008, several of the wells were freshly painted and well identification numbers were applied to the outside of all of the protective casings (PL-7). It is recommended that during the next sampling event the protective casings be re-painted (if deemed necessary) and the well identifications be touched up (if required) to make sure that they remain visible.

2. During 2008, several wells were freshly painted and well identification numbers were applied to the outside of all of the protective casings (page 3)

HAL 4/2010. PL-7. Monitoring well OBS-4A.

Recommendation: It is recommended that during the next sampling event the protective casings be re-painted (if deemed necessary) and well identifications be touched up (if required) to make sure that they remain visible.

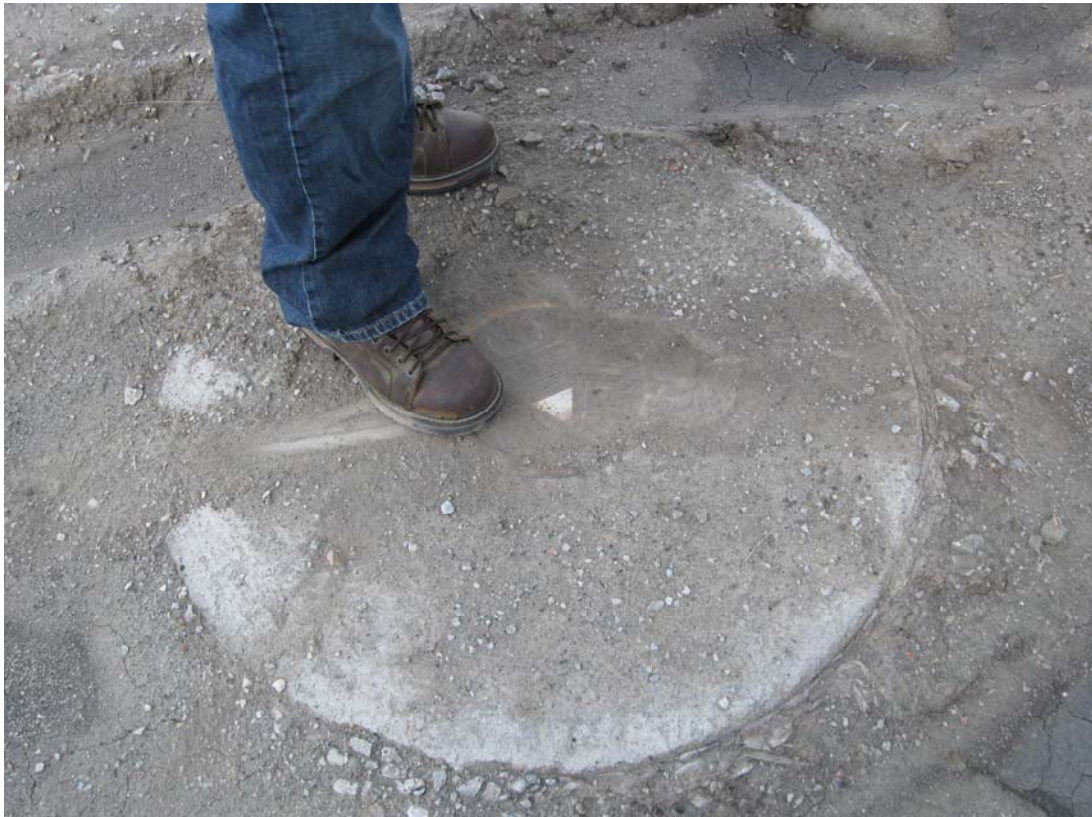
In 2008, well cluster 1 (OBS-1A and 1B) was converted to a flush mount installation (PL-8). No visible well identification numbers are present on wells OBS-1A and OBS-1B. It is recommended the well caps of these two flush mount wells be labeled with their well number when they are sampled next. There is a small white triangle present on the cap of each flush mount where a 1A or 1B could be applied. It is also recommended that the concrete well pads be painted a bright color (e.g. fluorescent orange or green) to aid in locating them should coal dust cover them.

3. In 2008, monitoring wells OBS-1A and OBS-1B were converted to flush mount designs. No visible well identification numbers are present on these wells (page 3).

HAL 4/2010. PL-8. Flush mount monitoring well OBS-1B.

Recommendation: It is recommended that both wells be labeled during the next sampling event. There is a small white triangle on the top of each well cap that could be easily labeled. It is also recommended that the concrete pads themselves be painted a

bright color (e.g. fluorescent orange or green) to aid in locating them should coal dust cover them.

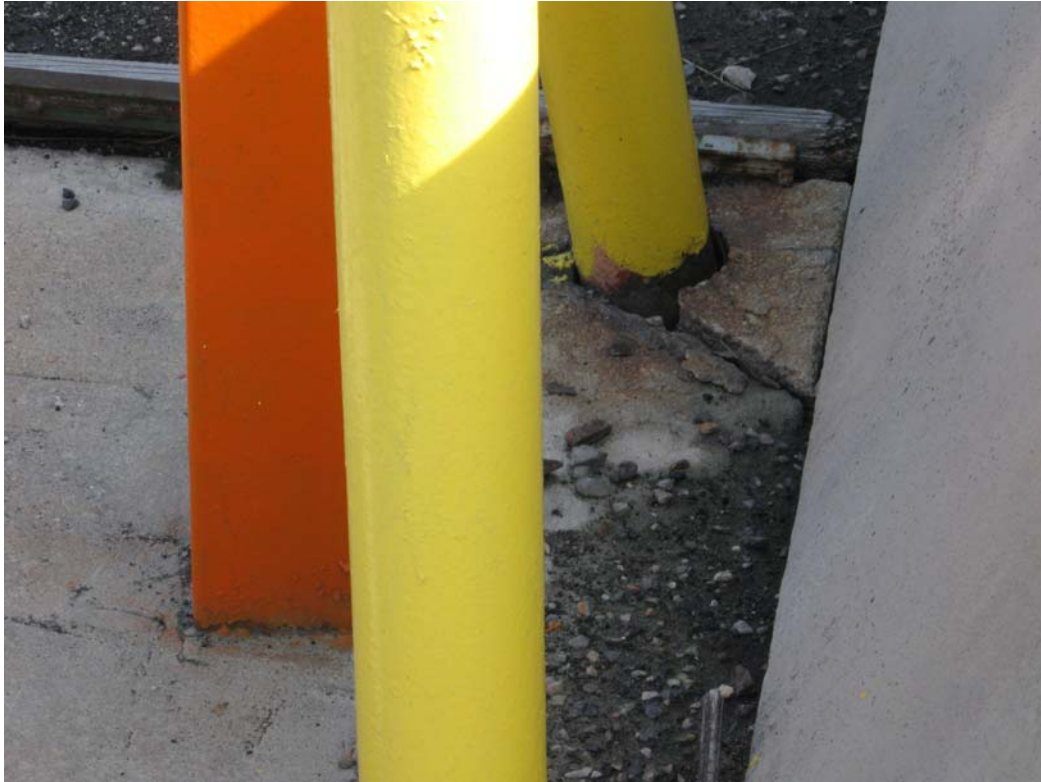
In 2008 concrete barriers were placed around the well pads for monitoring wells OBS-2A, OBS-2B, OBS-2B2, and OBS-2C2. These wells are located in a high traffic area. Inspectors found that the concrete barrier east of monitoring wells OBS-2B2 and OBS-2C2 was pushed into the well pad and that the corner of the well pad was cracked (PL-9 and PL-10). It is recommended that the concrete barrier be moved east approximately 2 feet and the corner of the well pad be repaired.

5. The concrete barrier located east of monitoring wells OBS-2B2 and OBS-2C2 was pushed into the well pad and that the corner of the well pad is cracked (page 4).

HAL 4/2010. PL-9. Concrete barrier east of monitoring wells OBS-2B2 and OBS-2C2. Concrete barrier has been pushed into the well pad. The wells are not damaged.

Recommendation: It is recommended that the concrete barrier be moved east approximately 2-feet and that the corner of the well pad be repaired.

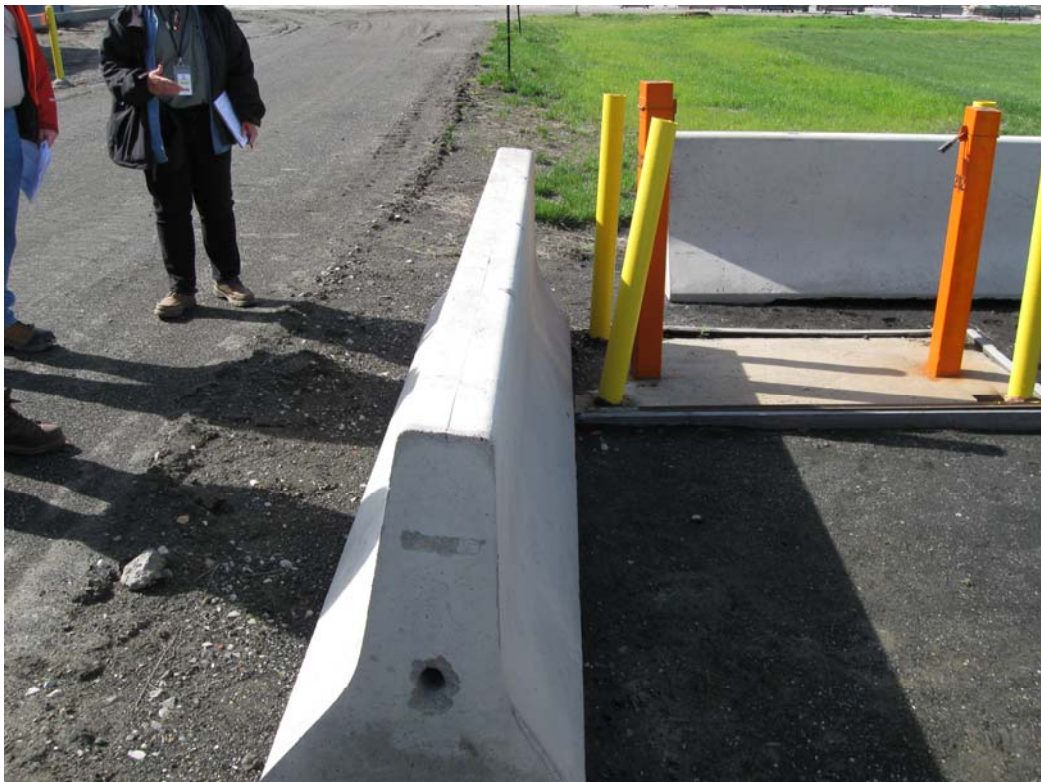
HAL 4/2010. PL-10. Concrete barrier east of monitoring wells OBS-2B2 and OBS-2C2 has been pushed into the well pad. The northeast corner of the well pad is cracked.

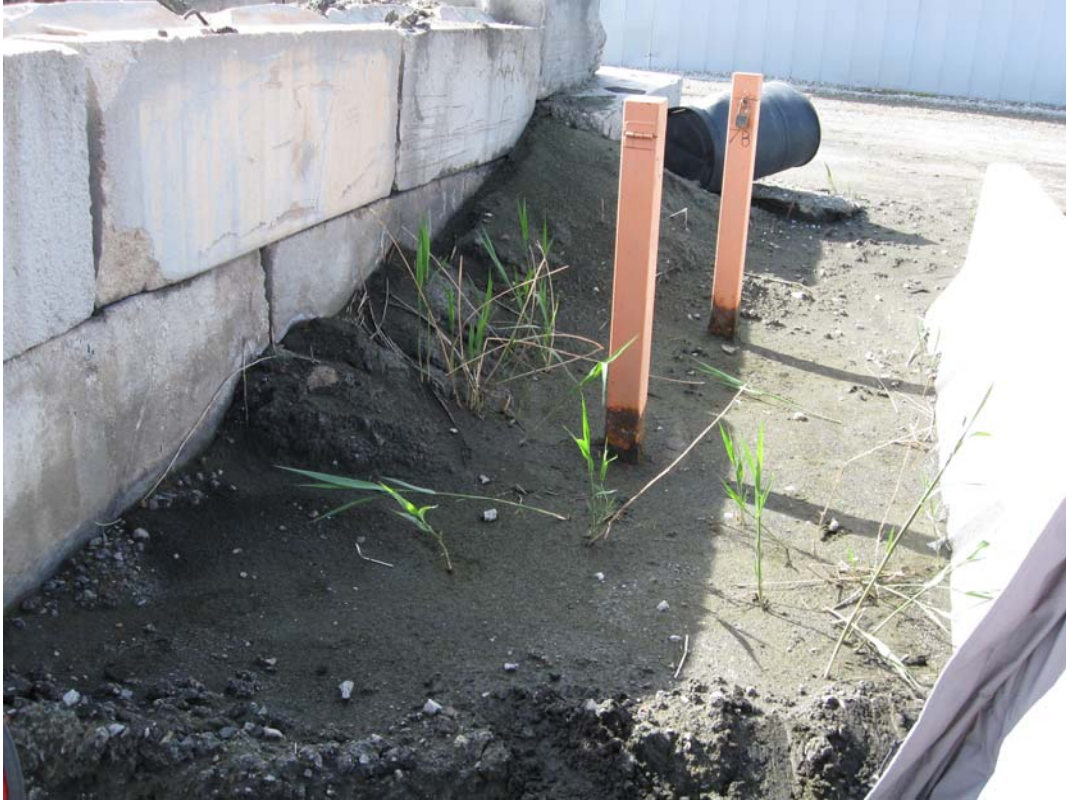
The well pad at monitoring wells OBS-7C and 7B was found to be covered in coal dust (PL-11). It is recommended that when the wells are sampled next that the sampling crew shovel the coal dust off the pad.

6. The well pad at monitoring wells OBS-7B and OBS-7C was covered by coal dust (page 4).

HAL 4/2010. PL-11. Monitoring wells OBS-7B and OBS-7C. Protected on east and west by concrete barriers. Well pad covered by coal dust.

Recommendation: It is recommended that the coal dust be removed from the well pad the next time that the wells are sampled.

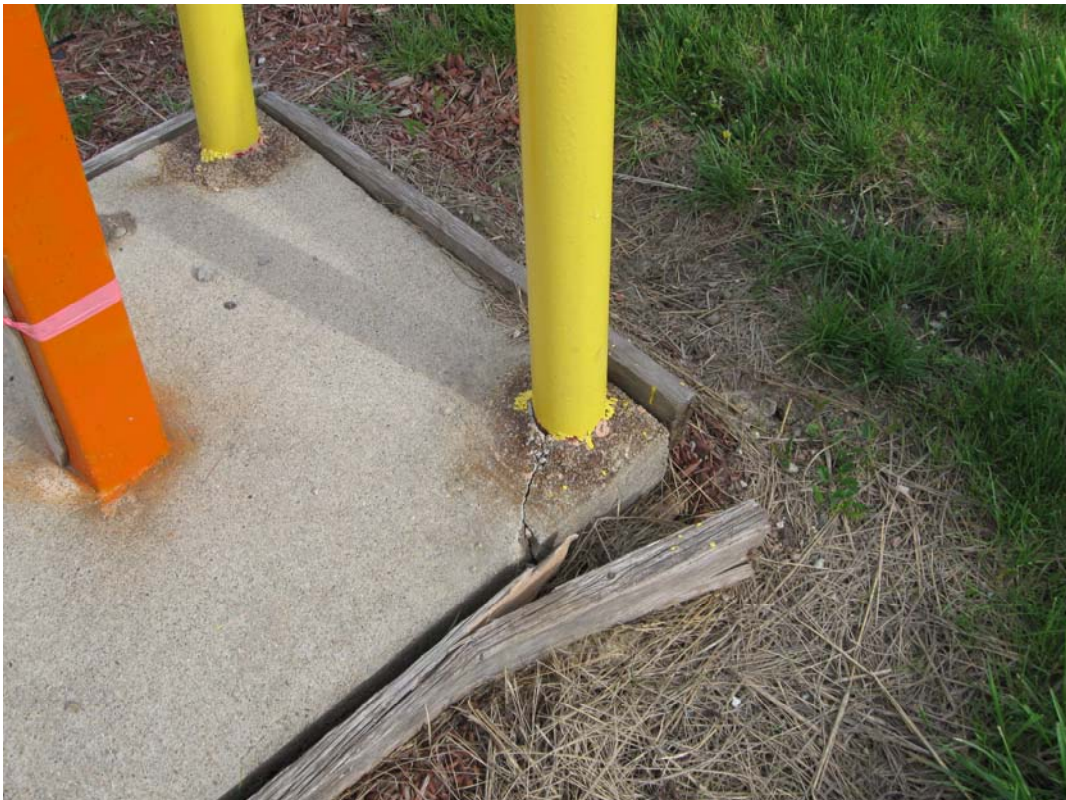
The southwest and northeast corners of the concrete pad at monitoring wells OBS-8A, B, and C are cracked (PL-12 and PL-13). It is recommended that the corners of the well pad at monitoring wells OBS 8-A, B, and C be repaired.

7. The southwest and northeast corners of the concrete pad at monitoring wells OBS-8A, OBS-8B, and OBS-8C are cracked (page 4).

HAL 4/2010. PL-12. Southwest corner of the concrete pad at wells OBS-8B and OBS-8C is cracked.

Recommendation: It is recommended that the corners of the well pad at monitoring wells OBS-8A, B, and C be repaired.

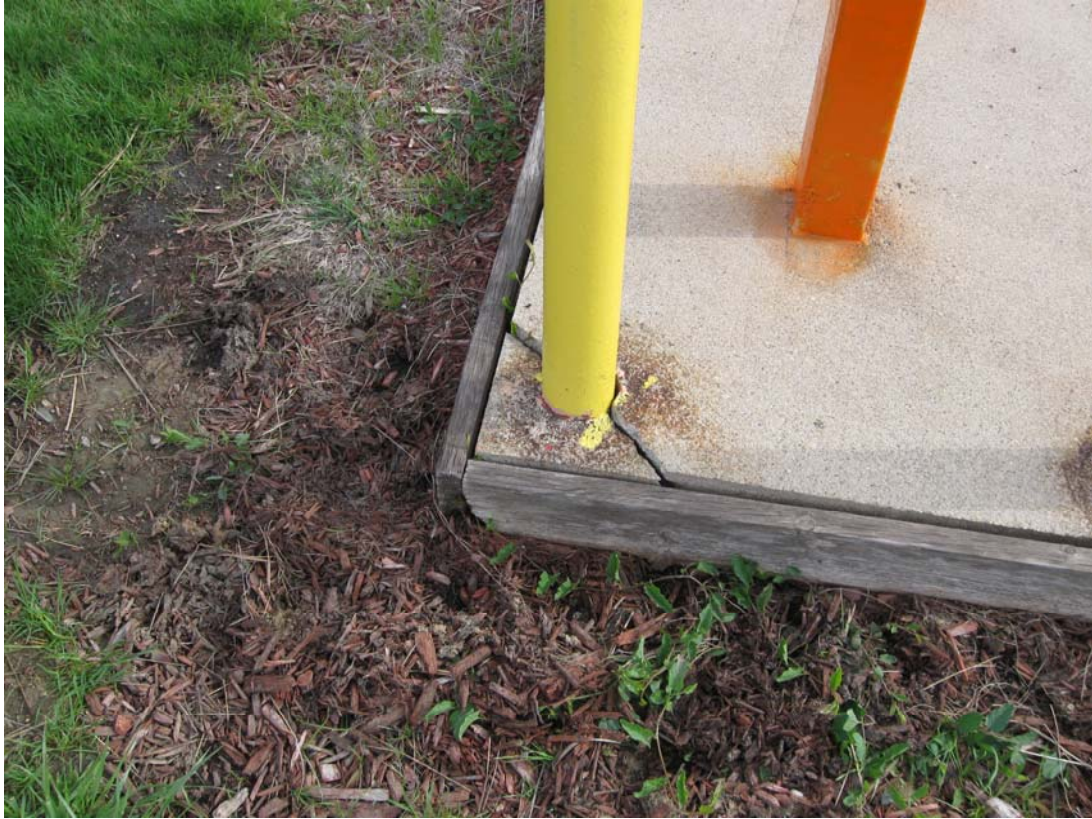
HAL 4/2010. PL-13. Northeast corner of the concrete pad at Wells OBS-8B and OBS-8C is cracked.
