2011 Annual Inspection and Status Report for the Hallam, Nebraska, Decommissioned Reactor Site

This report presents the findings of the annual U.S. Department of Energy (DOE) inspection of the decommissioned Hallam, Nebraska, Reactor Site on April 27, 2011.

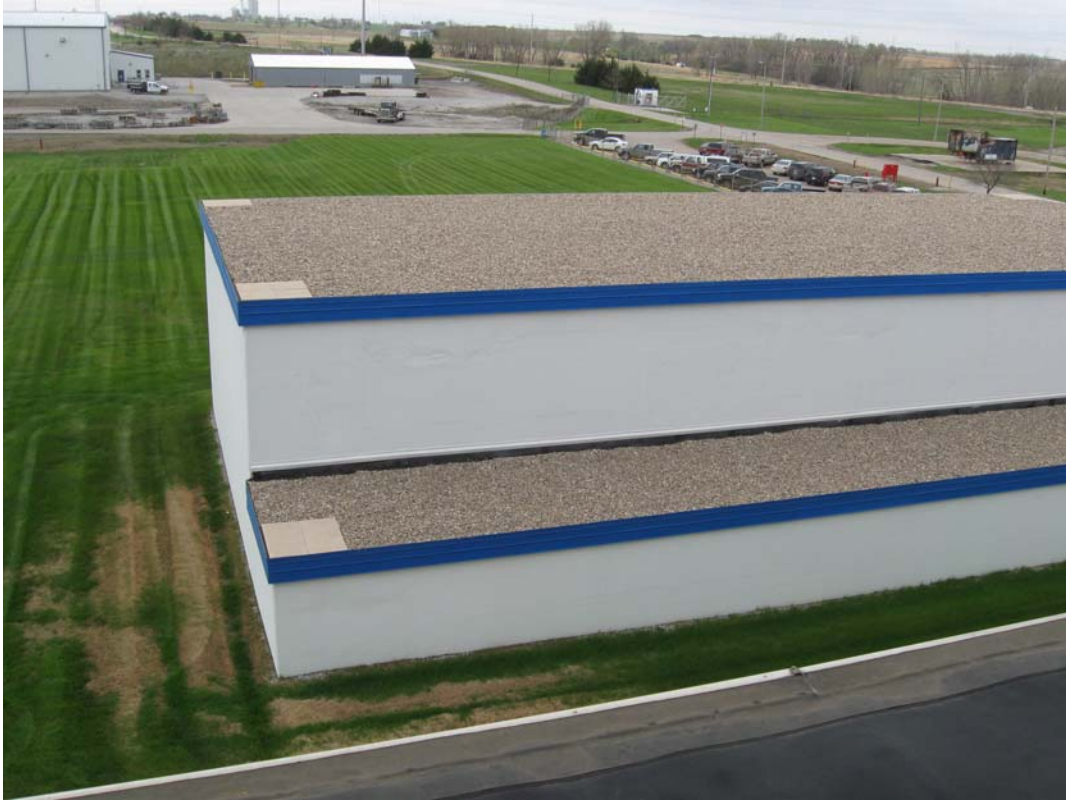
The roof of the IHX building was replaced in 2007. The entire roof is capped with a layer of rock material that protects the underlying roofing fabric. It was noted in 2008 that the roof rock was not present in the northwest and southwest corners of the upper roof. It is surmised that strong winds moved the roof rock from the corners of the roof exposing the underlying roofing fabric. Paver stones were placed in all corners of the roof in 2009 to correct the problem. Inspectors found the roof to be in good shape. No bare spots were present (PL-1 and PL-2).

HAL 4/2011. PL-1. Roof of IHX building.

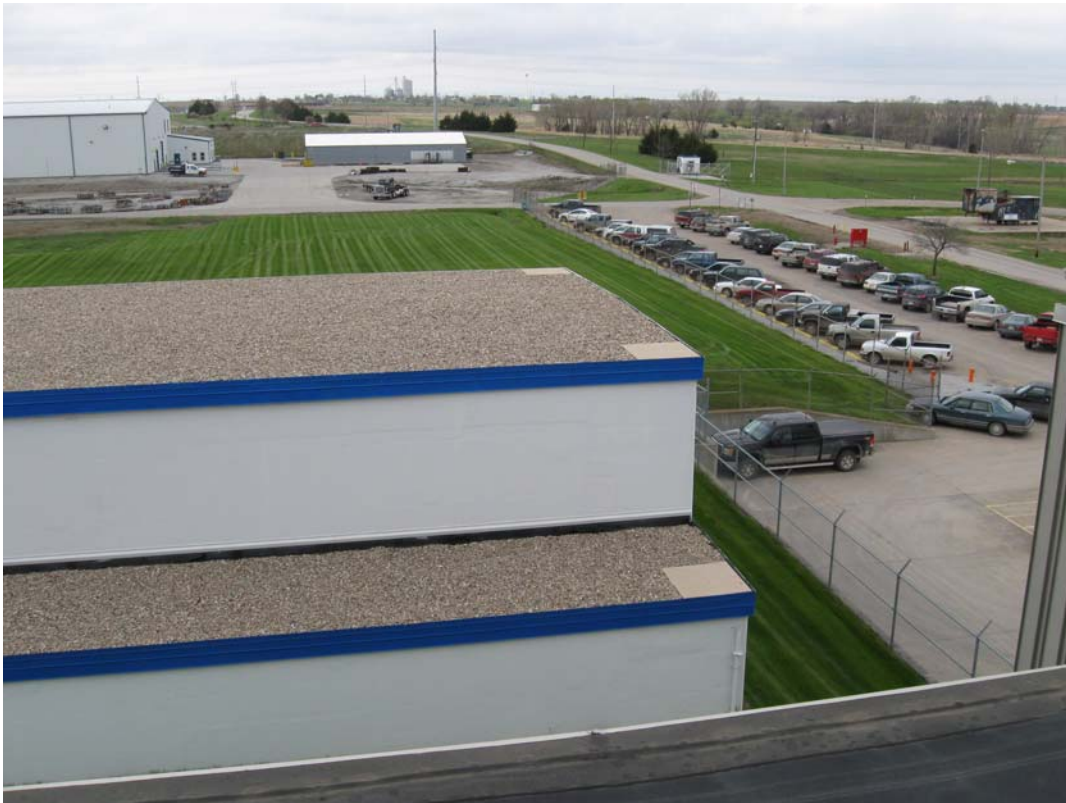
HAL 4/2011. PL-2. Roof of IHX building.

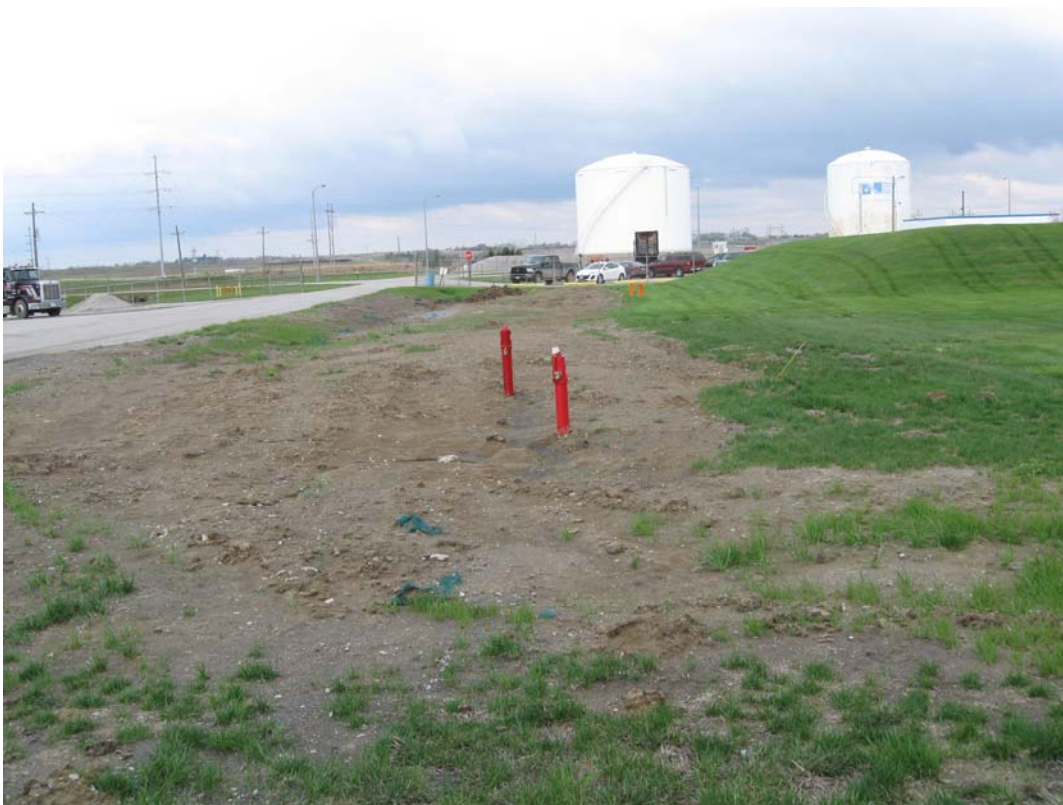
Grass on the mound was well established and in good condition with the exception of two areas: (1) the south end of the mound and (2) the northeast corner of the mound. NPPD replaced an 8-inch underground fire main that runs under the south edge of the mound in 2010. The area needs to be reseeded this year (PL-3). NPPD is already planning to re-seed, so no further action is required. Grass growth on the northeast corner of the mound continues to struggle, with little change from last year (PL-4). The struggling grass growth on the northeast corner of the mound does not compromise the integrity of the mound. Inspectors will continue to monitor grass conditions on the northeast corner of the mound but unless conditions get worse and the integrity of the mound is questioned no action is required.

HAL 4/2011. PL-3. South end of grass covered mound. New grass seeding needed.

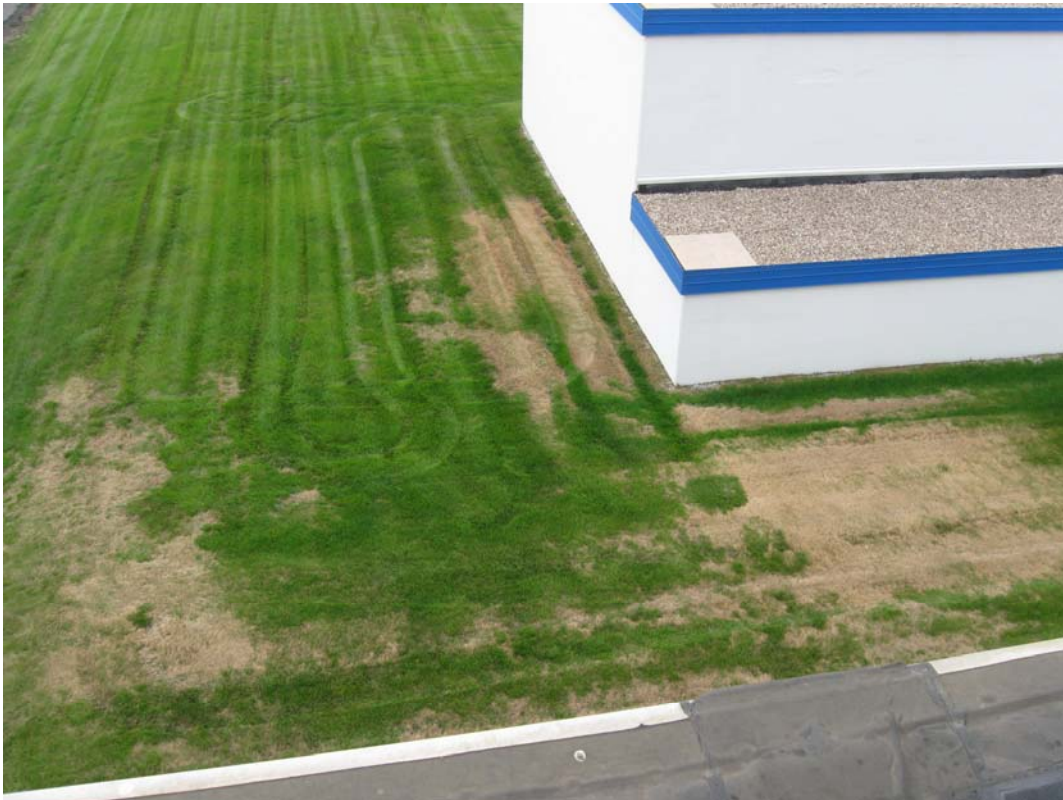
HAL 4/2011. PL-4. Stressed grass on northeast corner of grass covered mound.

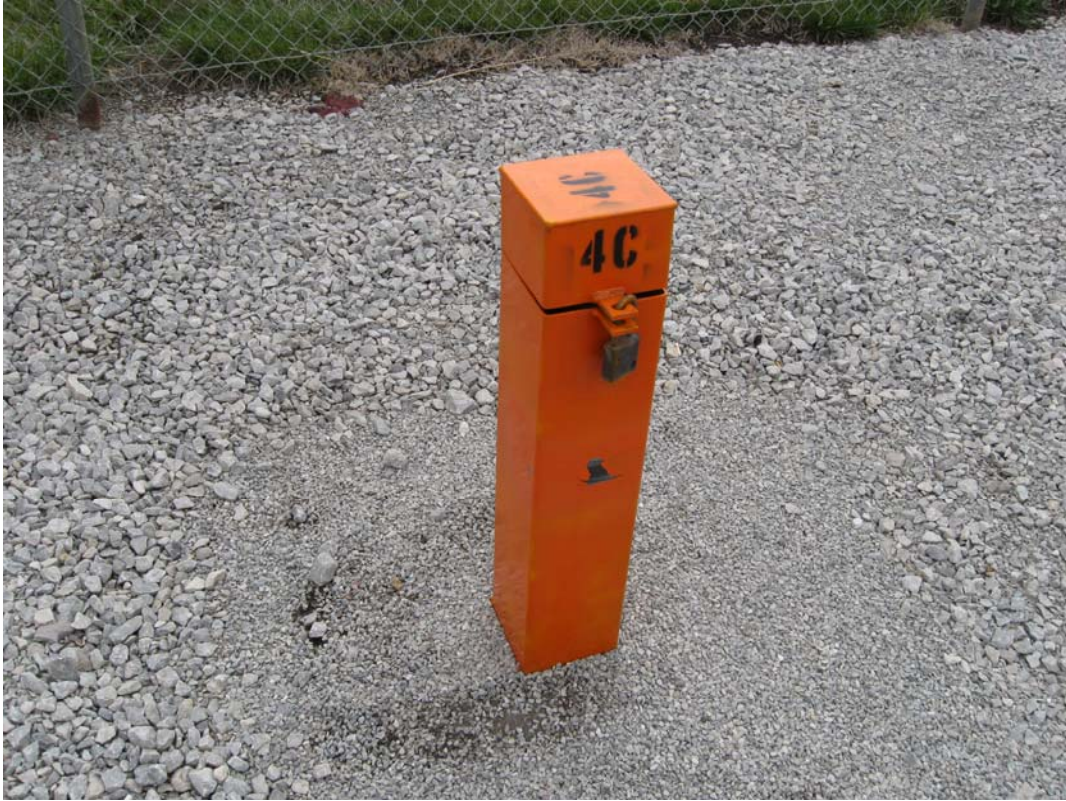
There are 19 monitoring wells. During the inspection all 19 monitoring wells were properly secured with locks (PL-5). Maintenance was conducted on the monitoring wells in the summer of 2010. Concrete pads and bollards were repaired, protective casings were painted and labeled, and hinges on some of the protective casing lids were replaced (PL-6). The wells were in good condition during this year's inspection. A few minor maintenance items were identified though, that will be addressed the next time that the wells are sampled in 2012.

HAL 4/2011. PL-5. Monitoring Well OBS-4C.

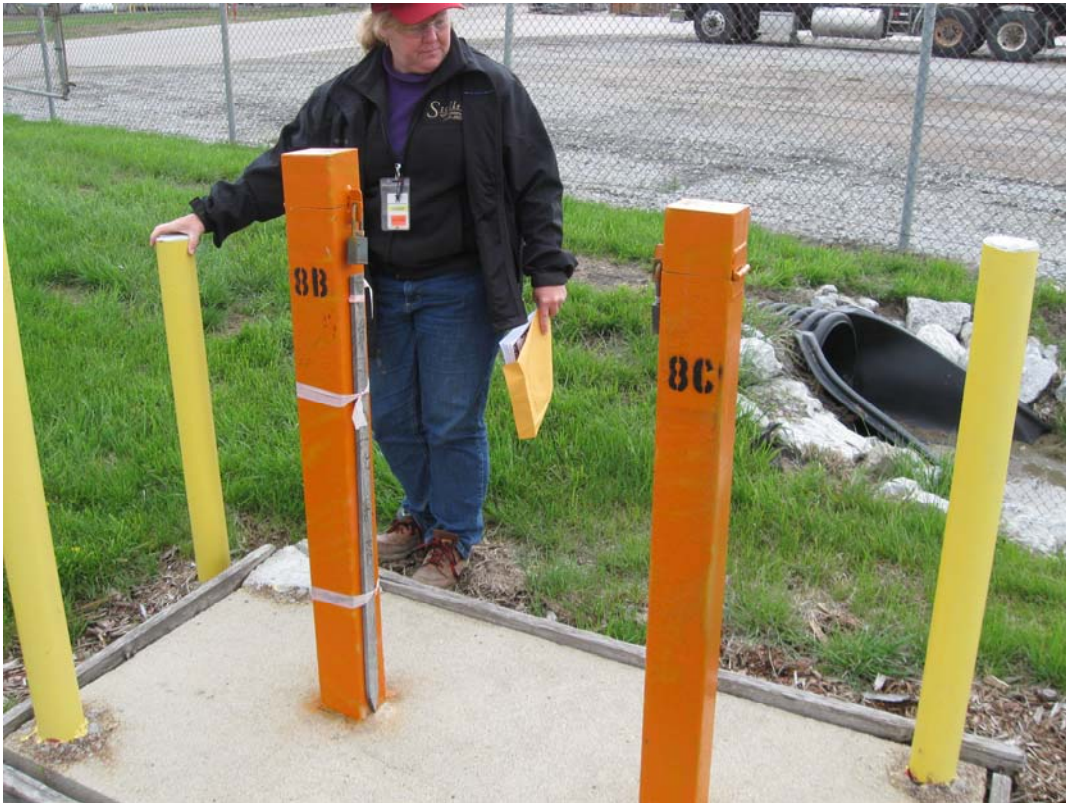
HAL 4/2011. PL-6. Monitoring Wells OBS-8B and OBS-8C.

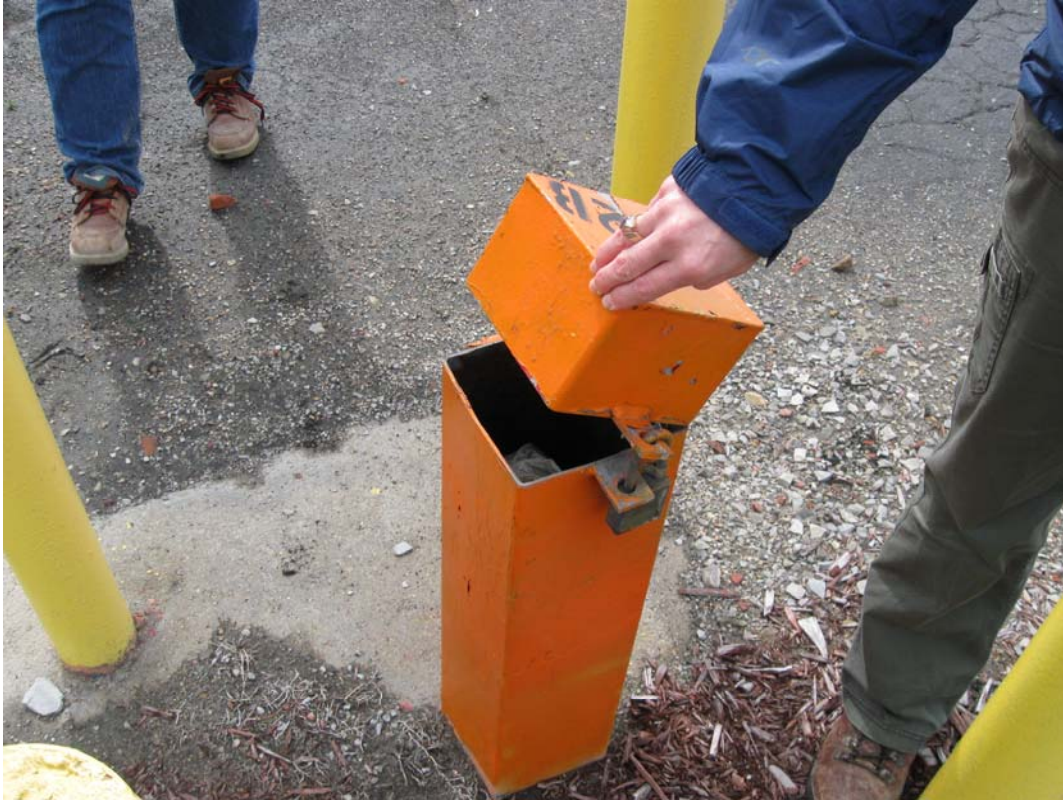
- The replacement hinges on monitoring wells OBS-2A and OBS-2B allow the protective casing lids to be partially opened when locked (PL-7). During the next sampling event, the protective casing lids will be fixed so they cannot be partially opened when locked.
- The protective casing lid on monitoring well OBS-3B is functional but needs to be replaced (PL-8). During the next sampling event, the protective casing lid will be replaced.
- Flush mount monitoring wells OBS-6A and OBS-6B are not properly labeled. During the next sampling event, these two wells will be properly labeled, and the concrete well pads will be painted (e.g. fluorescent orange or green) to aid in locating them on the ground.

HAL 4/2011. PL-7. Monitoring Well OBS-2B. Hinge placement allows well cap to partially open when locked.

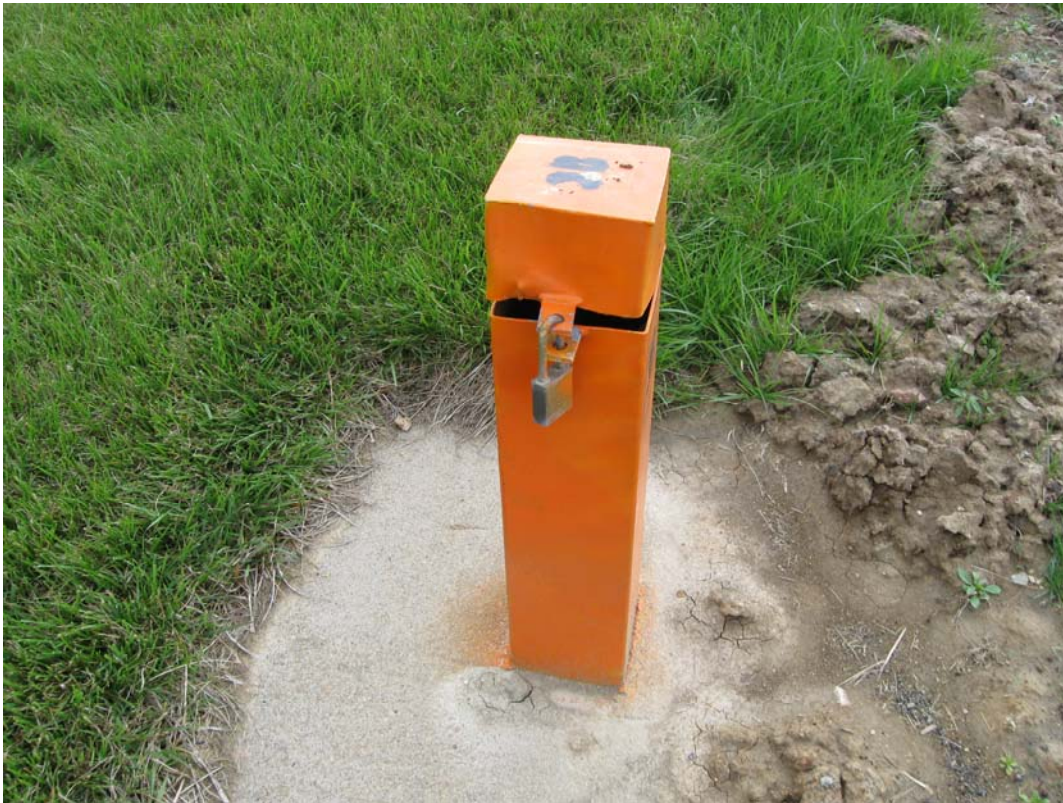
HAL 4/2011. PL-8. Monitoring Well OBS-3B.
