# 2012 Annual Inspection and Status Report for the Hallam, Nebraska, Decommissioned Reactor Site

This report presents the findings of the annual U.S. Department of Energy (DOE) inspection of the decommissioned Hallam, Nebraska, Reactor Site on April 24, 2012.

ANNUAL INSPECTION CONDUCTED  
APRIL 24, 2012

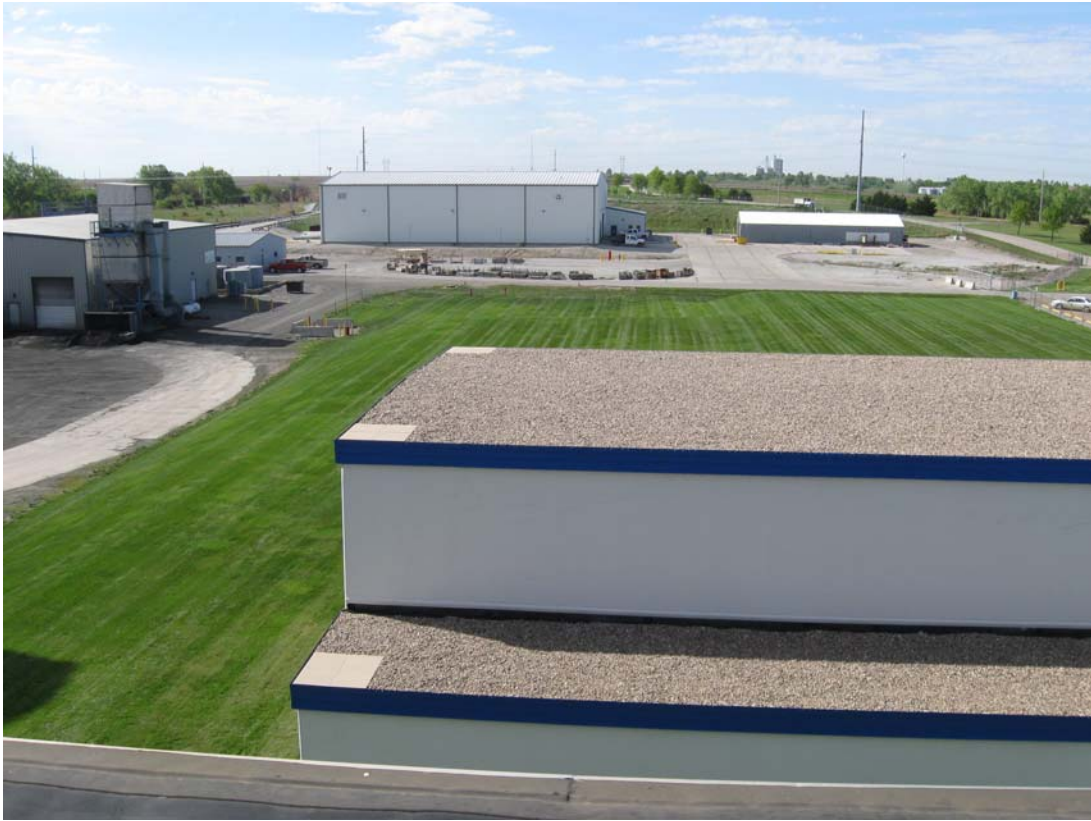
The roof of the IHX building was replaced in 2007. The entire roof is capped with a layer of rock material that protects the underlying roofing fabric. It was noted in 2008 that the roof rock was not present in the northwest and southwest corners of the upper roof. It is surmised that strong winds moved the roof rock from the corners of the roof exposing the underlying roofing fabric. Paver stones were placed in all corners of the roof in 2009 to correct the problem. The roof was in good condition. No bare spots were present (PL-1 and PL-2).

HAL 4/2012. PL-1. Northeast corner of IHX roof.

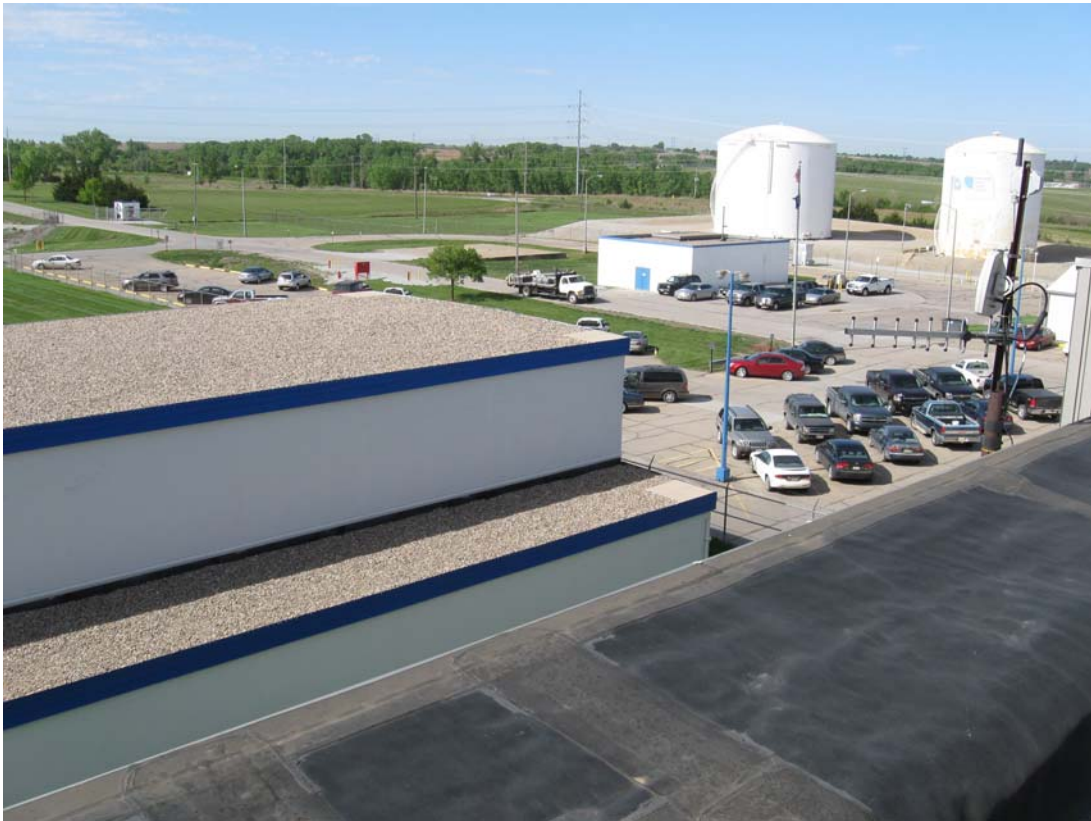
HAL 4/2012. PL-2. West end of IHX roof.

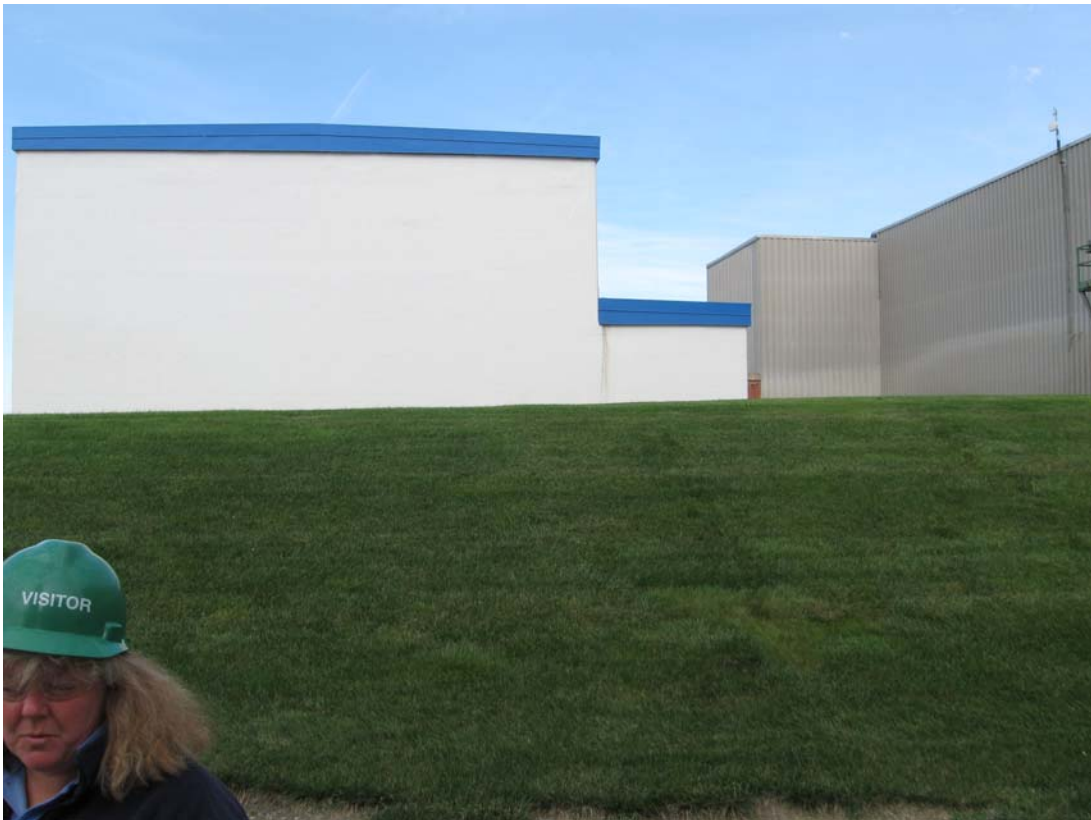
A minor surface water stain was observed on the east wall of the IHX building where the lower roof meets the wall of the two story portion of the building (PL-3 and PL-4). The water staining

appears to be the result of a heavy rain from the preceding months. No corrective action is recommended at this time. The area will be inspected and re-assessed during the inspection next year.

HAL 4/2012. PL-3. East side of IHX building.

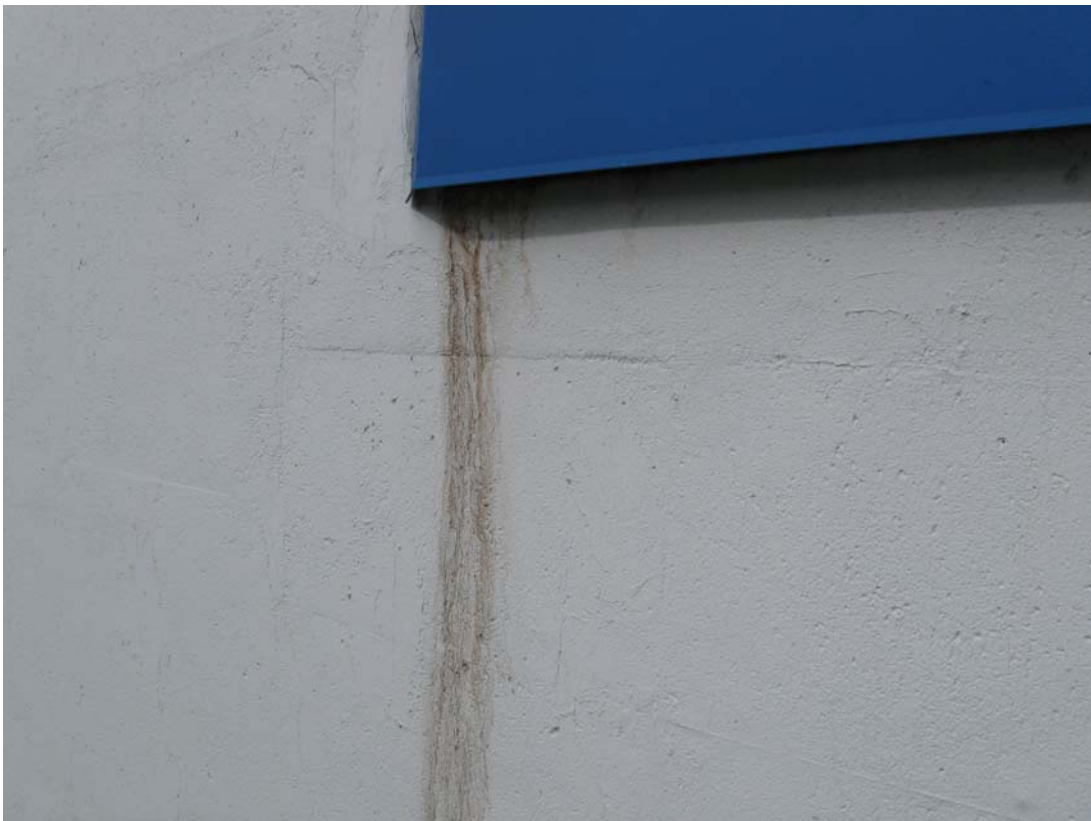
HAL 4/2012. PL-4. Water staining on east side of IHX building.

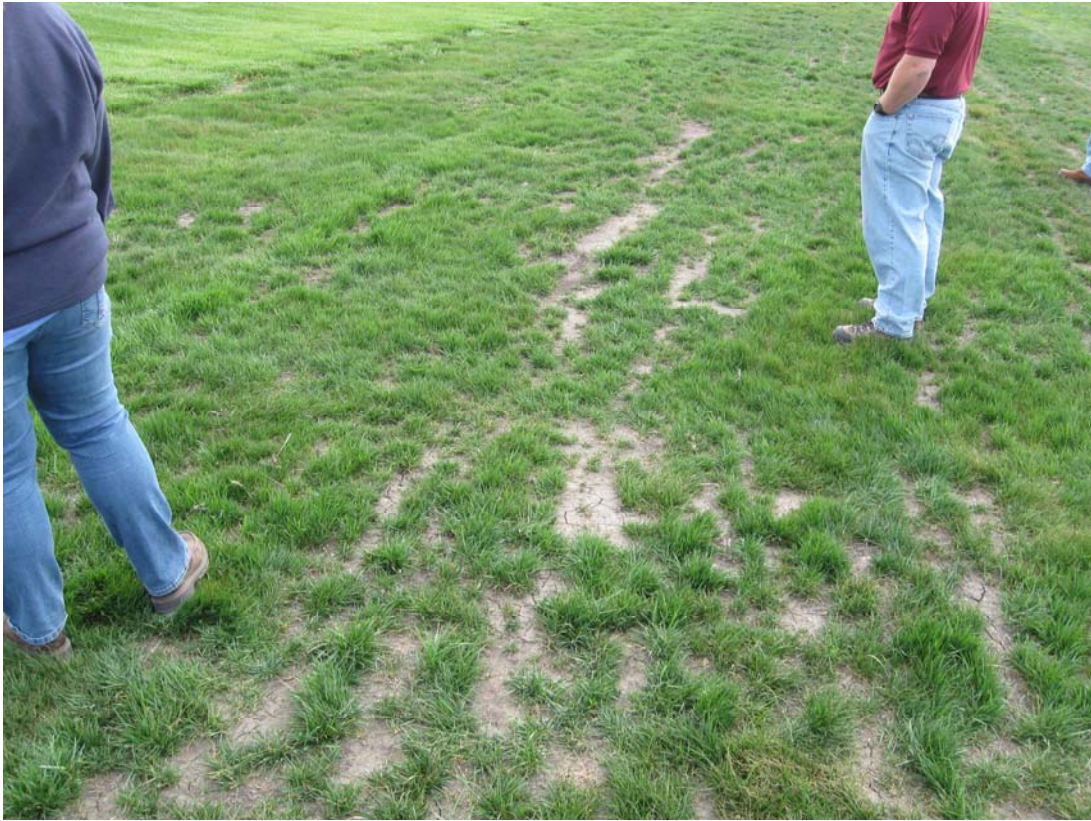
Grass on the mound was well established and in good condition with the exception of the south end of the mound. NPPD replaced an 8-inch underground fire main that runs under the south edge of the mound in 2010. The area was reseeded in 2011 but grass has not fully re-established there (PL-5).

HAL 4/2012. PL-5. Grass, south end of grass covered mound.

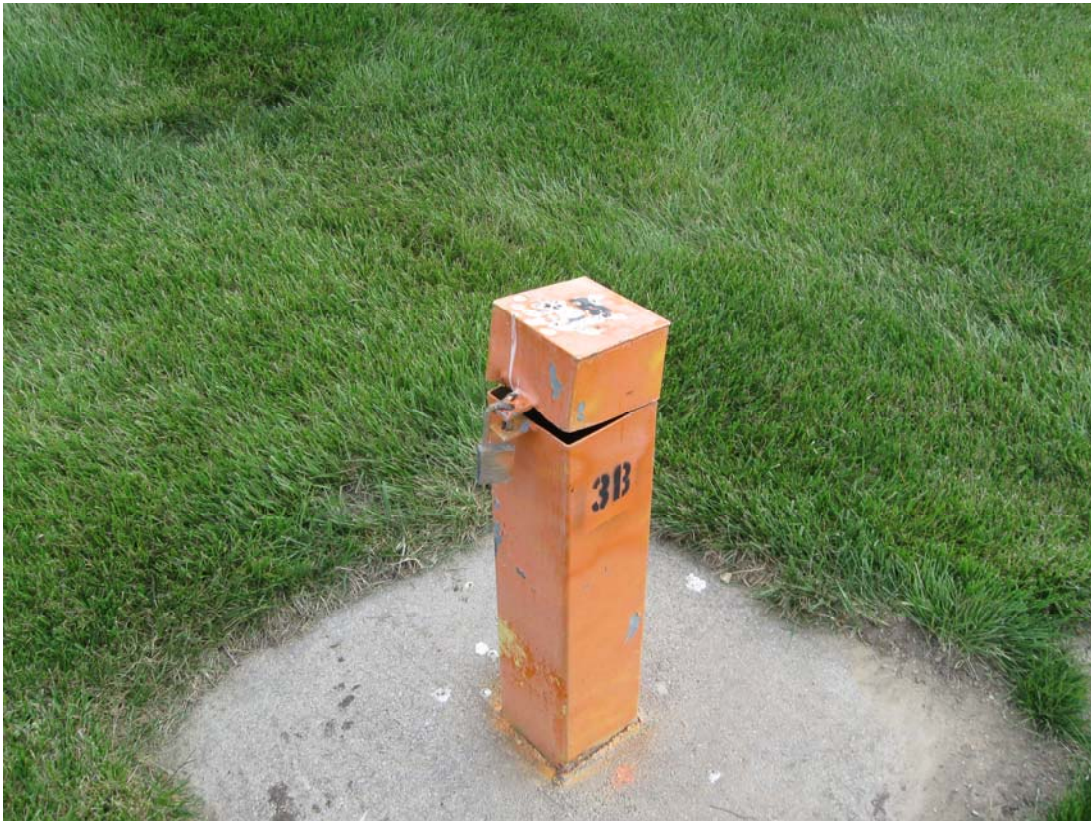
HAL 4/2012. PL-6. Monitoring Well OBS-3B.

- The replacement hinges on monitoring wells OBS-4B, OBS-2A, and OBS-2B allow the protective casing lids to be partially opened when locked. During the next sampling event, the protective casing lids will be repaired so they cannot be partially opened when locked.
- The protective casing lid on monitoring well OBS-3B is functional but needs to be replaced (PL-6). During the next sampling event, the protective casing lid will be replaced.
- Flush mount monitoring wells OBS-6A and OBS-6B are not properly labeled (PL-7). During the next sampling event, these two wells will be properly labeled, and the concrete well pads will be painted (e.g. fluorescent orange or green) to aid in locating them.

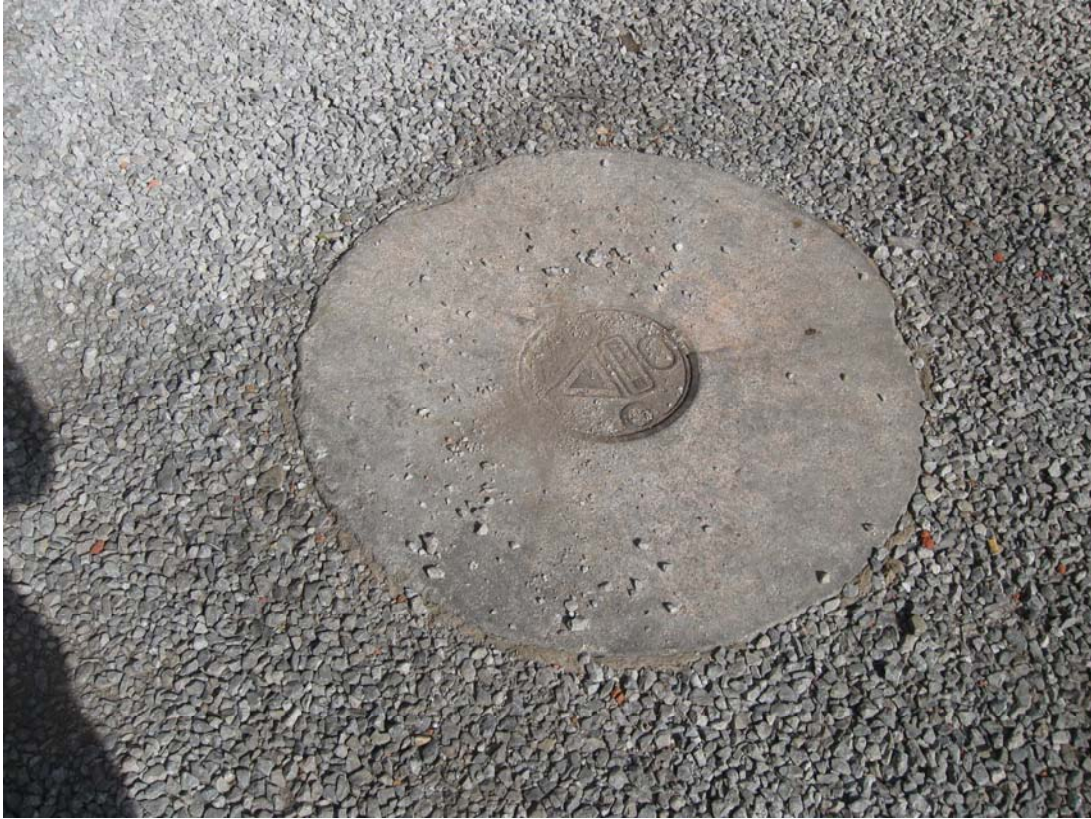
HAL 4/2012. PL-7. Flush Mount OBS-6B.
