2023 Annual Inspection Report for the Parkersburg, West Virginia, Disposal Site

March 2024

U.S. DEPARTMENT OF
ENERGY

Legacy
Management

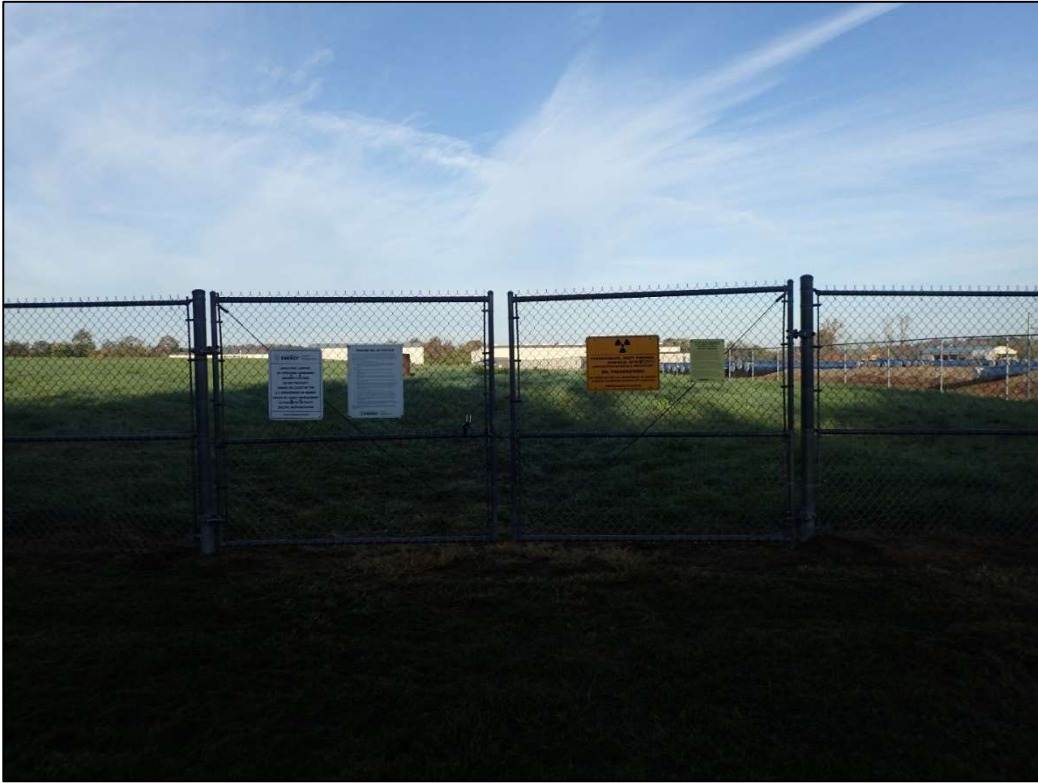
All entrance gates were properly secured, and signage posted on the gates was current (PL-1).

PL-1. Main Vehicle Gate

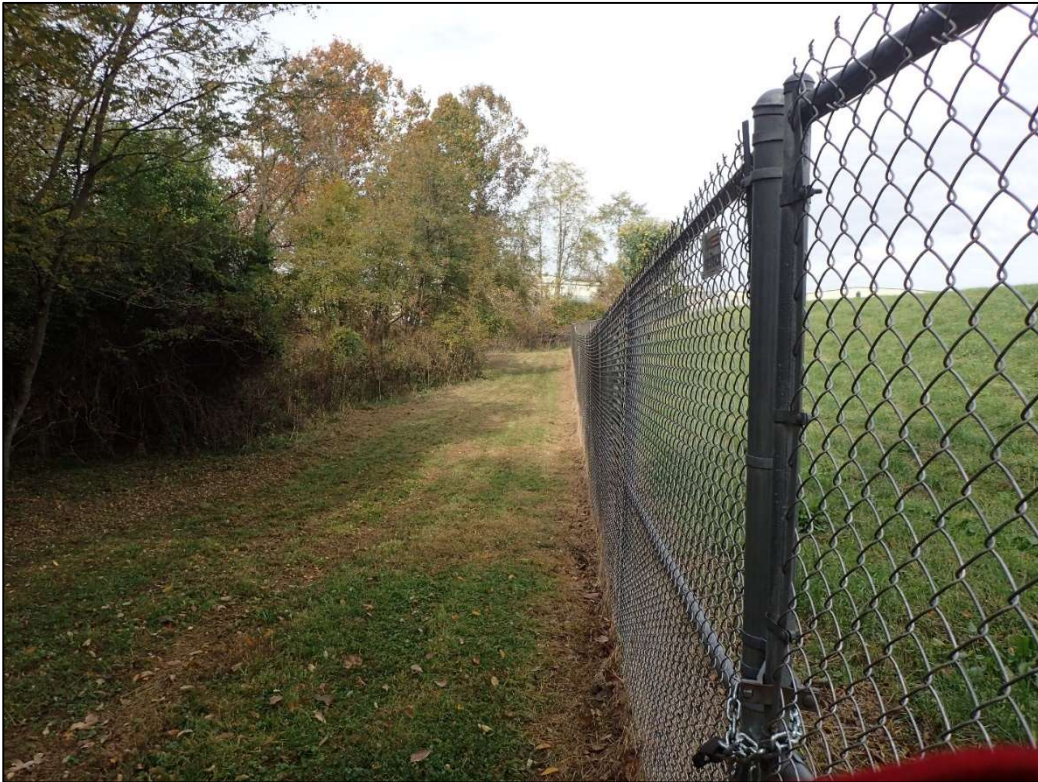
The perimeter fence was replaced in 2007. The site maintenance subcontractor maintains a vegetation-free zone along the base of the fence line and ensures that vegetation does not grow on the fence fabric. The vegetation-free zone along the fence line was being maintained (PL-2), and the fence fabric was free of vegetation.

PL-2. North Fence Line

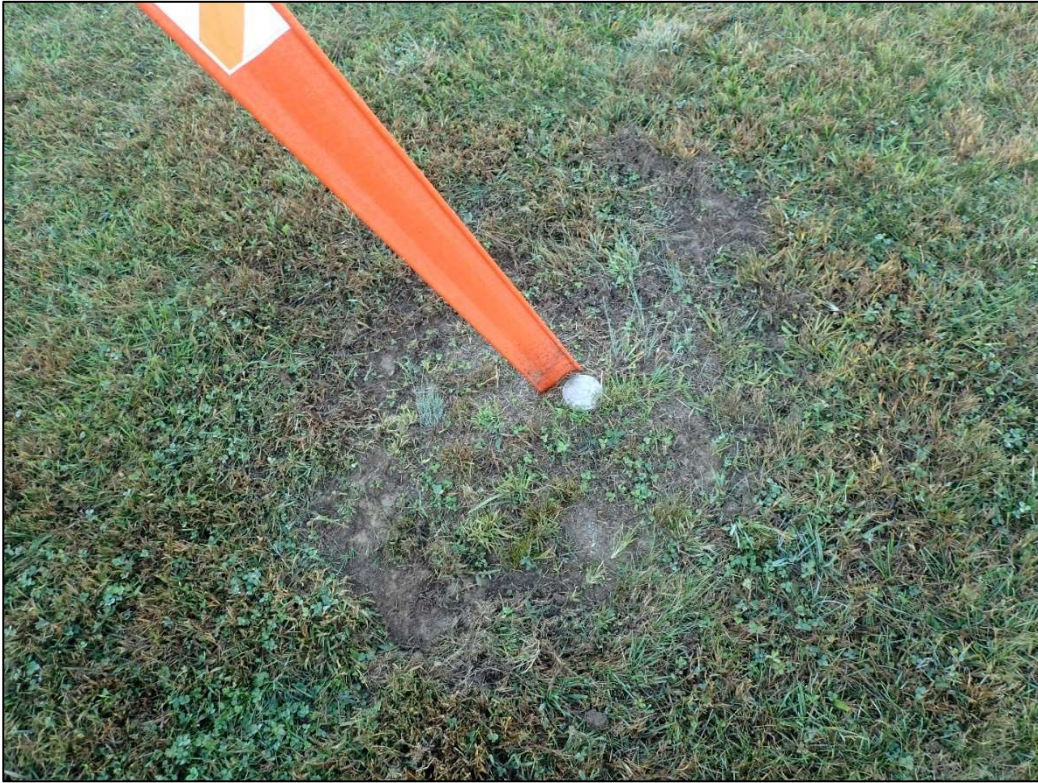
The Parkersburg site has six boundary monuments and one concrete survey monument. All six boundary monuments were located during the inspection (PL-3). It was noted in 2019 that the top of the concrete survey monument is missing, but its replacement is not necessary.

PL-3. Boundary Monument BM-1

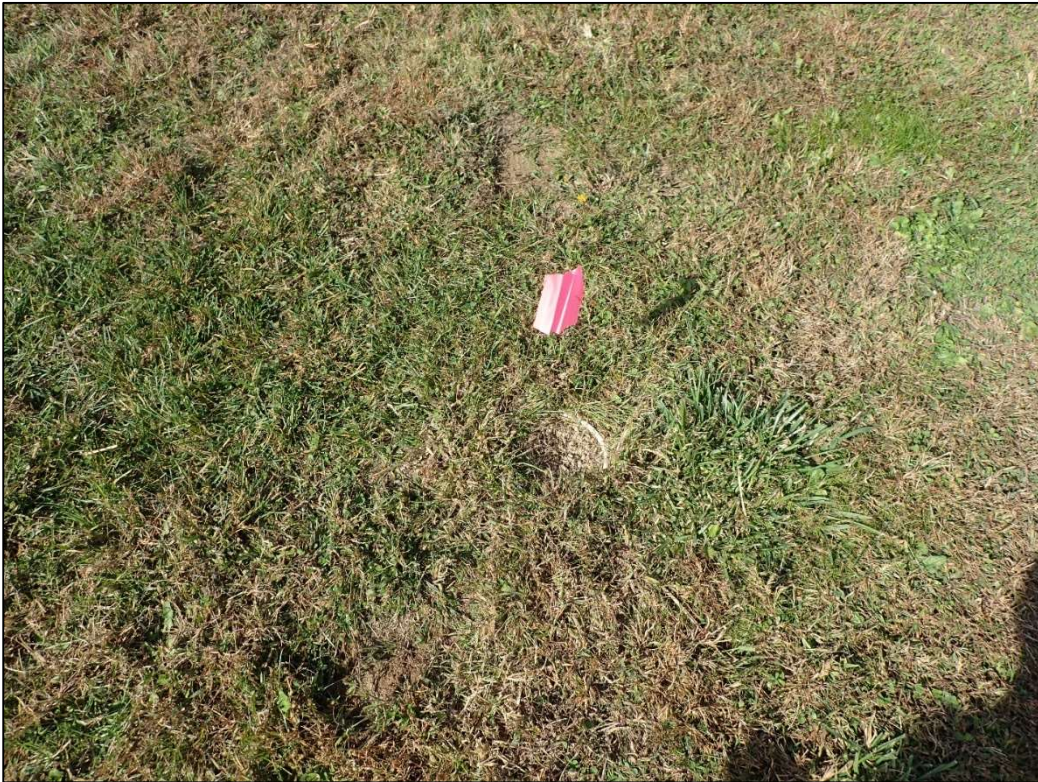
Boundary monument BM-3 is about 6 inches beneath ground surface. A 6-inch section of PVC pipe was installed around the monument and filled with pea gravel to make it flush with the ground surface (PL-4).

PL-4. Location of Boundary Monument BM-3

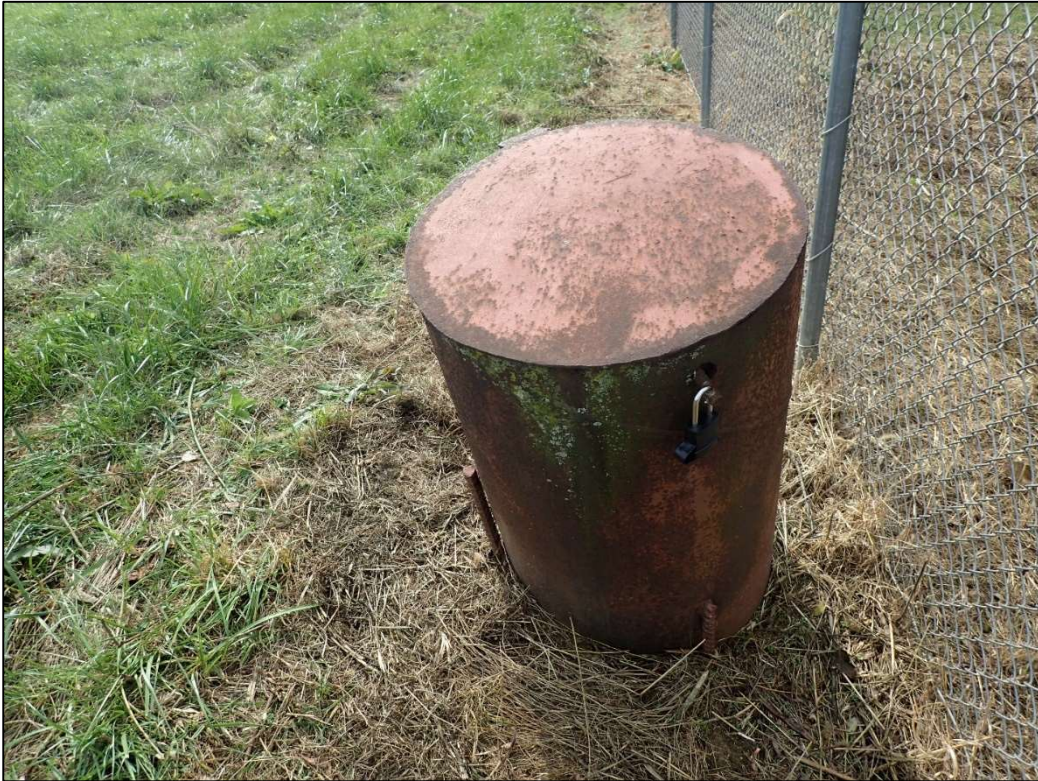
There are six groundwater monitoring wells at the Parkersburg site. All six wells are inside the security fence. The wells are numbered in the chronological order in which they were drilled and installed. All six wells were properly locked. The site maintenance subcontractor clears vegetation around the monitoring wells. Vegetation was being properly controlled around the monitoring wells (PL-5).

PL-5. Monitoring Well 2

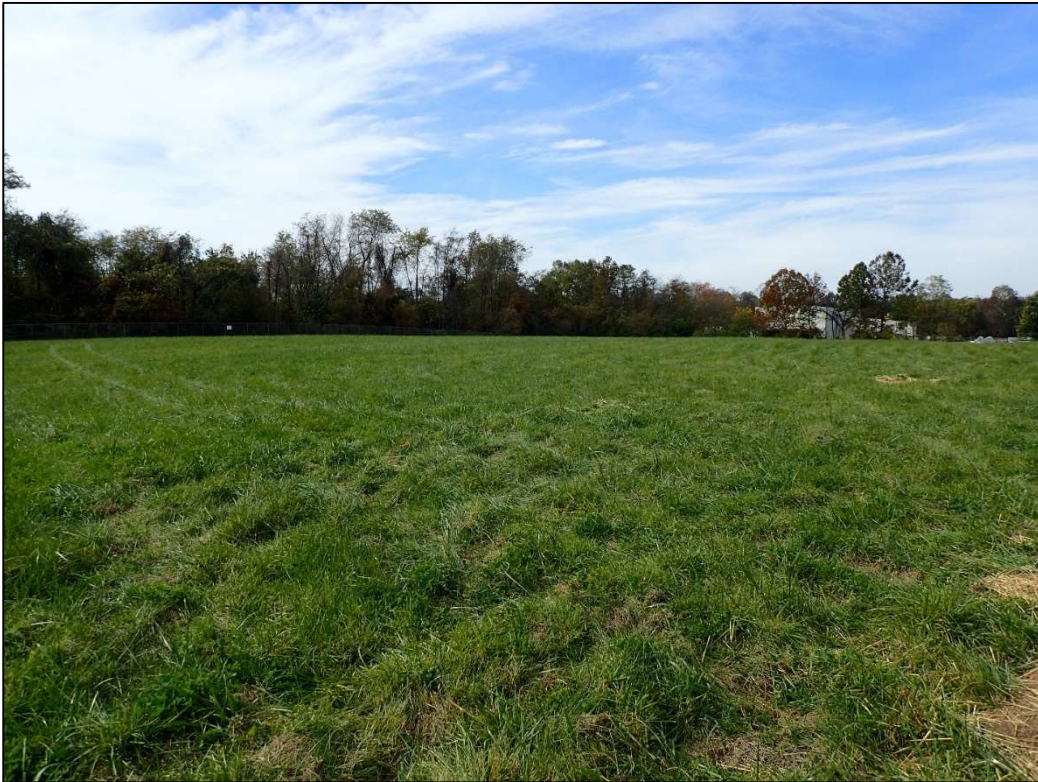
At the time of the inspection, vegetation on top of the disposal cell had been recently mowed. No evidence of erosion or slope instability on the disposal cell was noted during the inspection (PL-6).

PL-6. Top of Disposal Cell

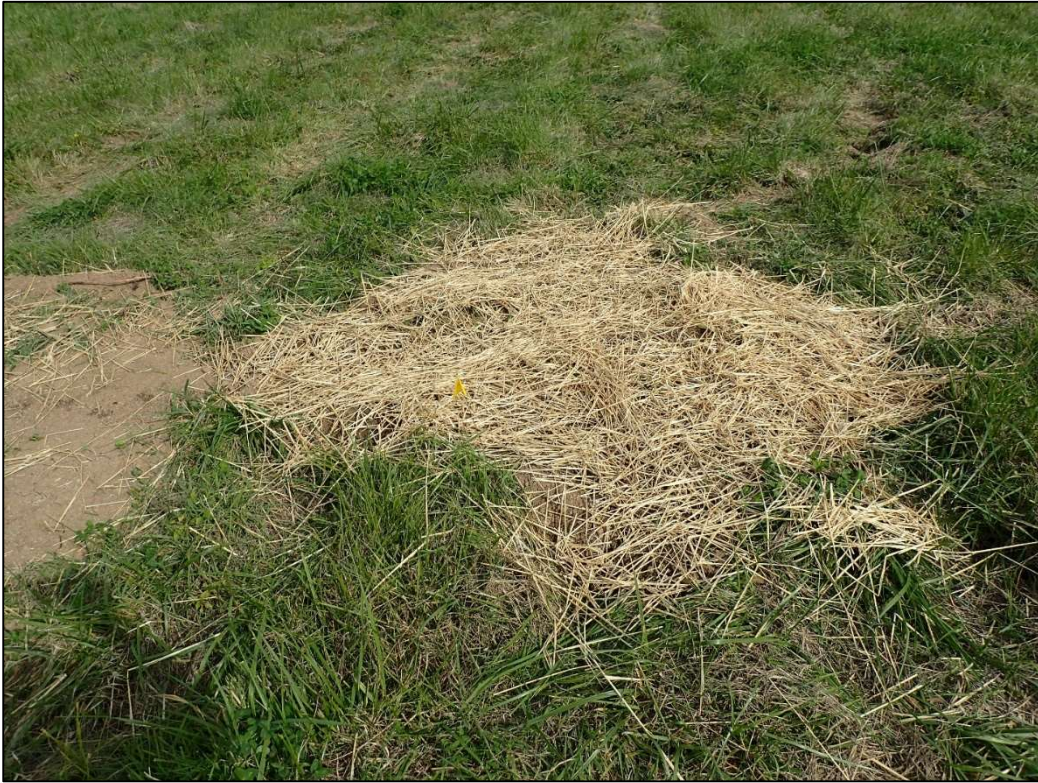
Animal burrowing activity at the site continues to be a challenge. In descending order, the cell cap consists of a 30-inch layer of topsoil, a 12-inch layer of impermeable clay, then a 6-inch layer of compacted clay. There is concern that if the burrowing is not controlled, the protective nature of the cell cap might be compromised. In 2021, 2 weeks of trap-and-release were conducted to remove two groundhogs from the site. Existing burrows were collapsed, filled with clean soil, and reseeded. Additional burrows were collapsed, filled with clean soil, and reseeded in 2022 and again in 2023 (PL-7). In 2022, a coyote den was found and collapsed. During the site inspection, new additional animal burrows were discovered. Their locations are identified on the site map (Figure A-1). These new burrows will be collapsed, filled with clean soil, and reseeded as deemed appropriate. Inspectors also noted that some of the recently collapsed burrows showed signs of new animal activity, indicating that another round of trapping is needed (PL-8).

PL-7. Collapsed Animal Burrow

LM needs to be vigilant about addressing animal burrows on the disposal cell. As burrows are located, they need to be collapsed, filled with clean soil, and reseeded. Additional rounds of trapping will be needed as long as animal burrow activity is observed at the site.

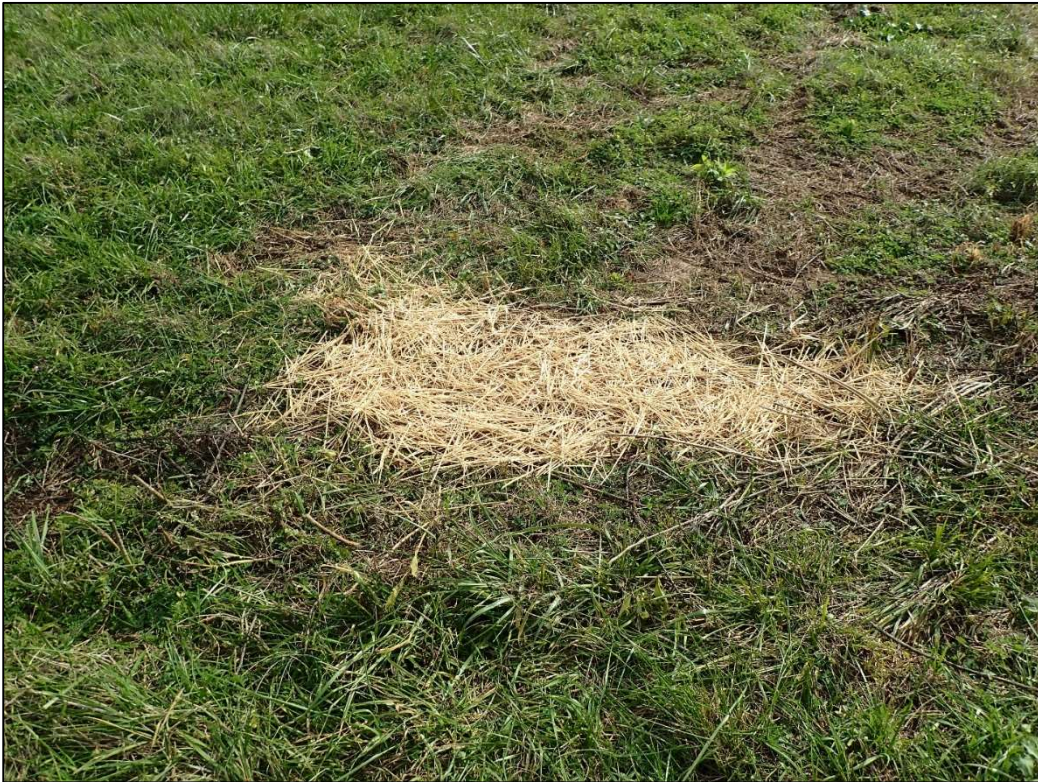
PL-8. Collapsed Animal Burrow

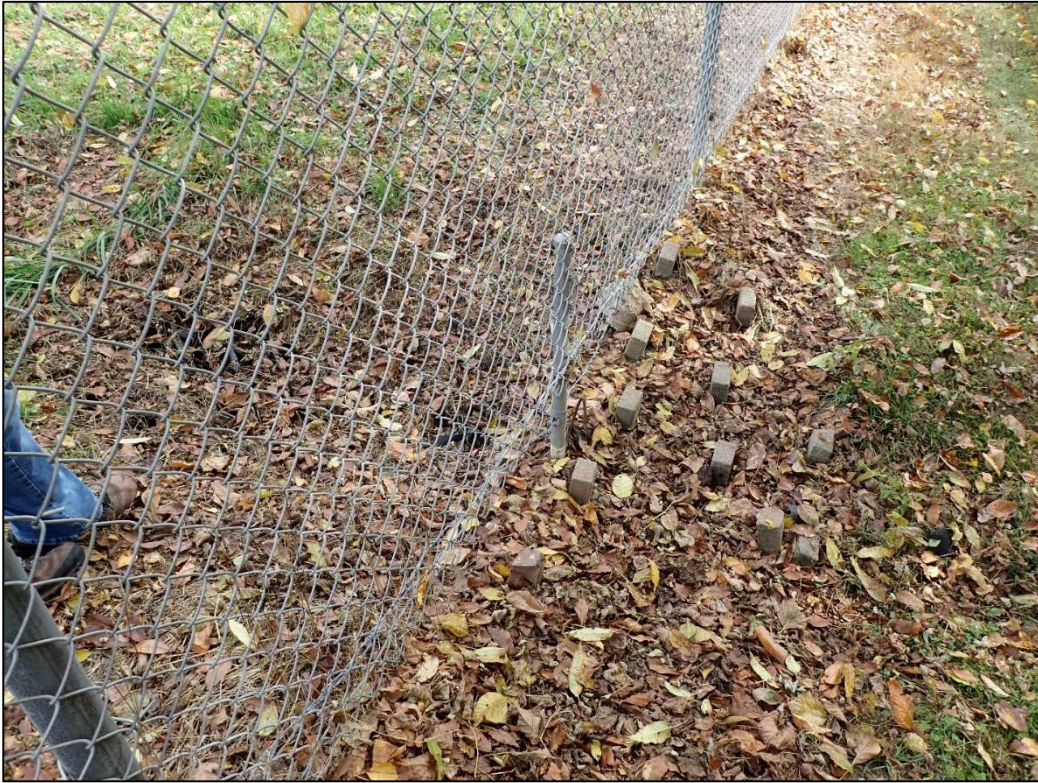
The drainage channel in the southwest corner of the site, lined with high-density polyethylene honeycomb baffles and brick energy-dissipation baffles in August 1996, is functioning as designed. Erosion in the channel appears to be unchanged from 2021 (PL-9).

PL-9. Erosion Control Area

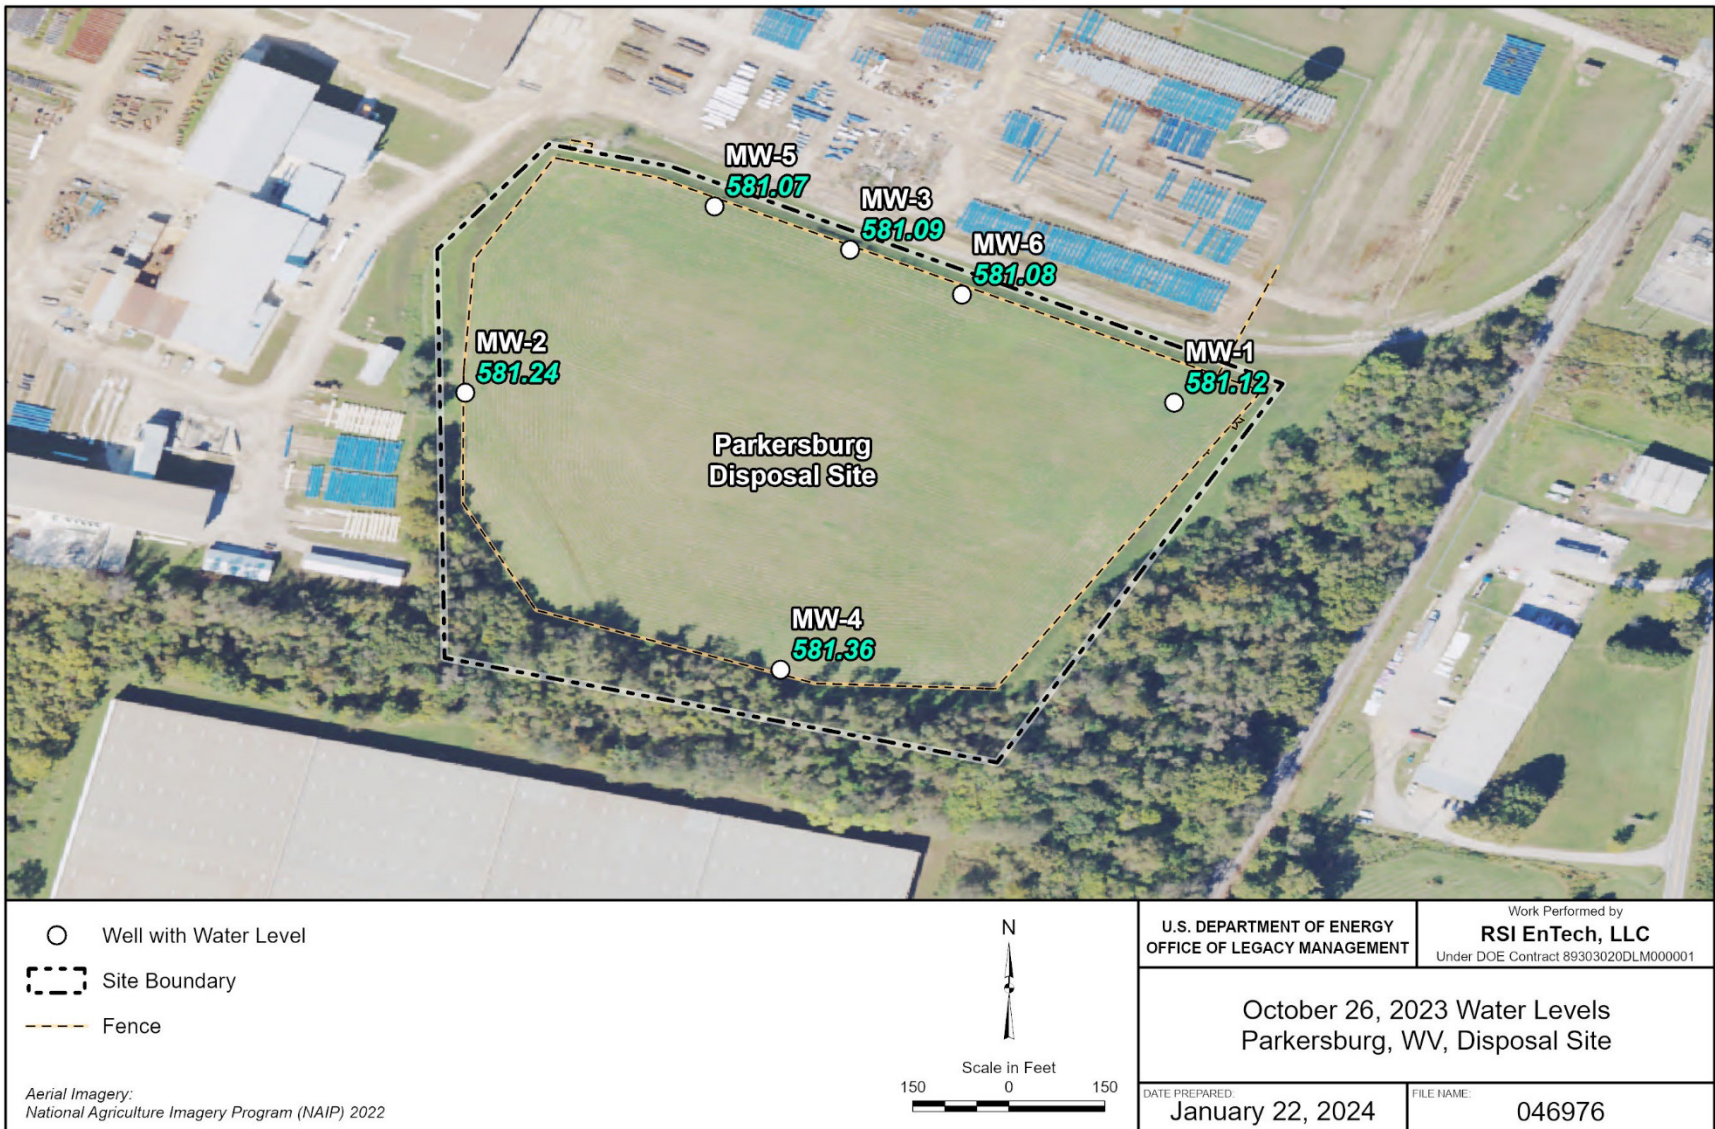
Figure A-2. 2023 Water Levels, Parkersburg, West Virginia, Disposal Site

Groundwater levels were measured at all six monitoring wells in 2023. As shown in Figure A-2, water-level elevations at the site ranged from 581.36 feet to 581.07 feet above mean sea level (amsl), a difference of 0.29 feet. Similar to previous years, the distribution of water-level elevations suggests groundwater flow away from the site is northerly (DOE 2014). Given the small measurement range, water elevation contours were not added to the figure.

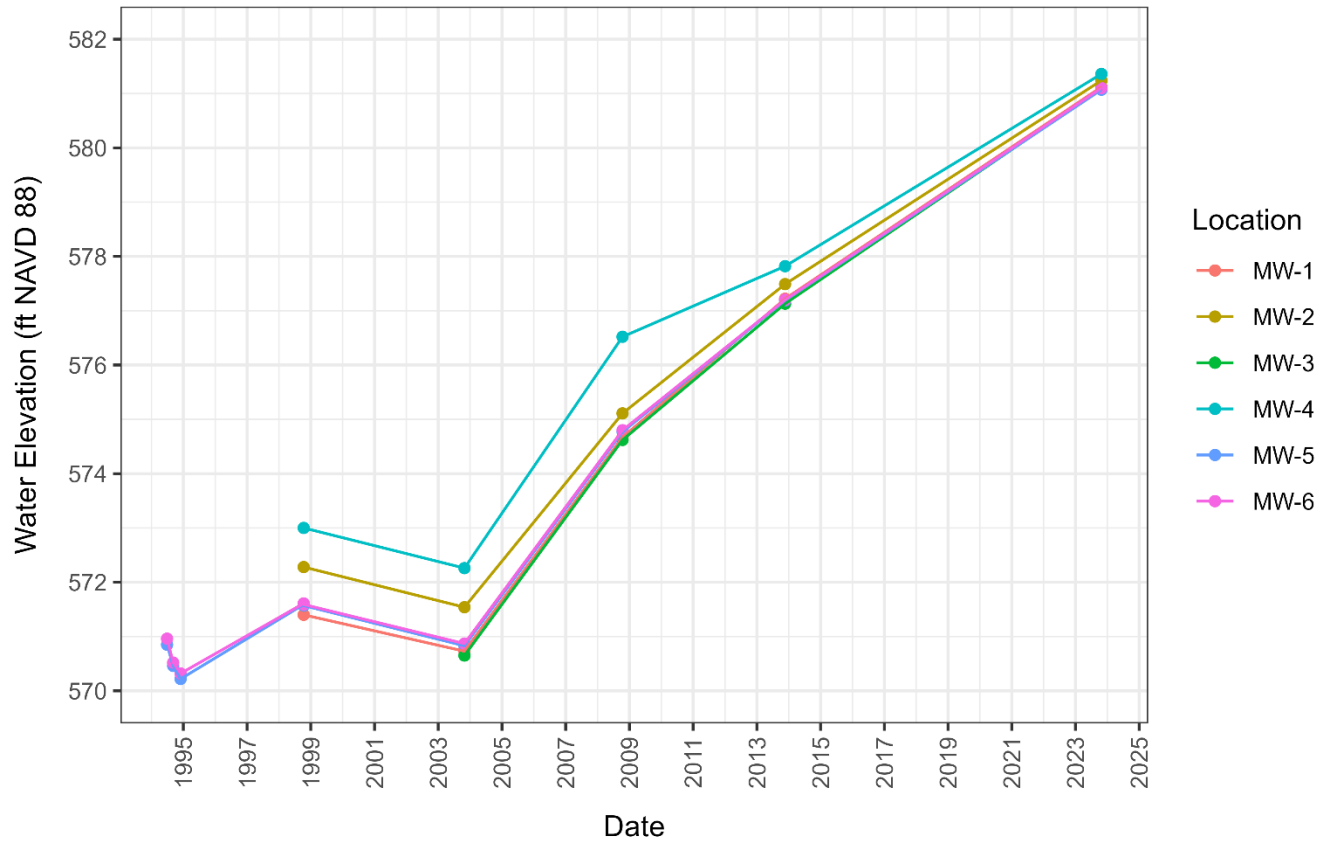
Figure A-3. Water Level

Figure A-3 is a graph that shows water level measurements from 1994 to 2023. As shown in Figure A-3, the water levels have collectively risen from between 570 to 571 feet amsl in 1994 to slightly above approximately 581 feet amsl in 2023; a rise of approximately 11 feet in 29 years. As discussed below, LM plans to install water level transducers in all six monitoring wells to obtain more frequent water level measurements.
