2013 Annual Inspection and Status Report for the Hallam, Nebraska, Decommissioned Reactor Site

ANNUAL INSPECTION CONDUCTED
MAY 1, 2013

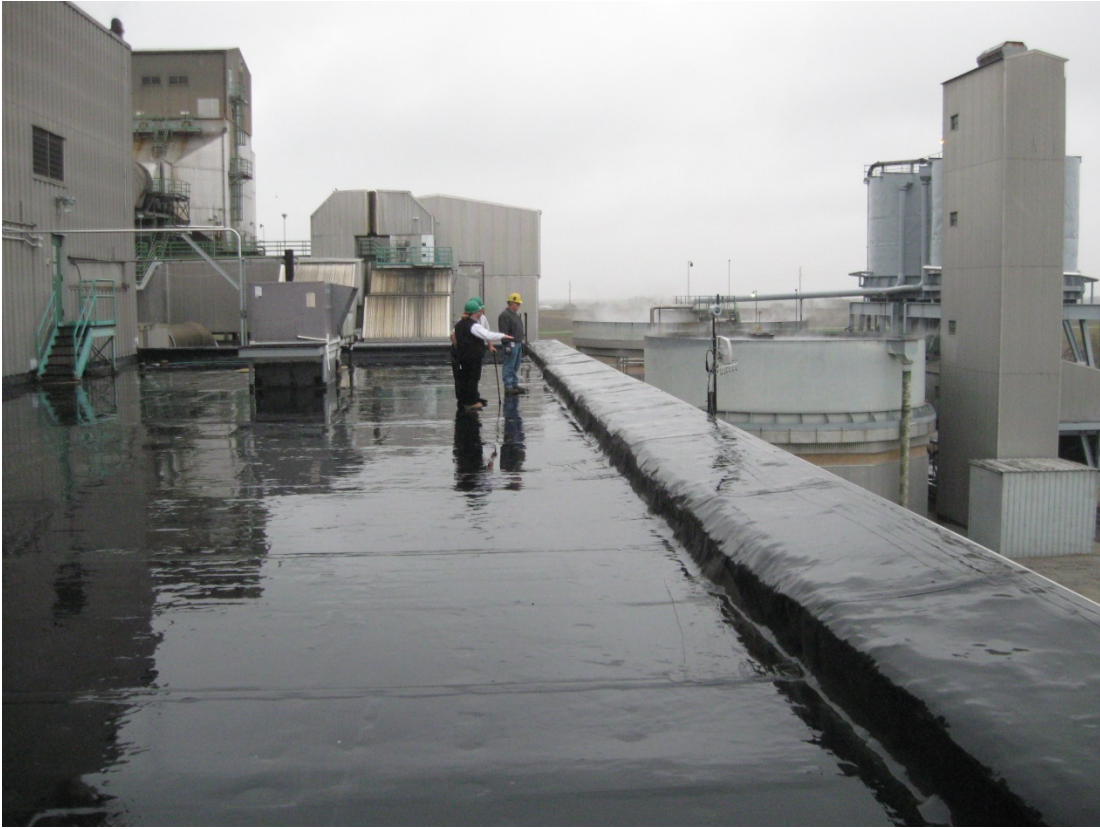
The IHX building is a massive 40 feet wide by 80 feet long concrete sarcophagus located at the north end of the former HNPF. The south side of the building is two stories high (about 25- to 30-feet) with a slightly crowned roof, and the north side of the building is one-story high with a roof that is sloped to drain. Inspectors view the roof of the IHX building from the roof of the Sheldon Power Plant, north of the IHX building (PL-1).

HAL 4/2013. PL-1. Roof of Power Plant building.

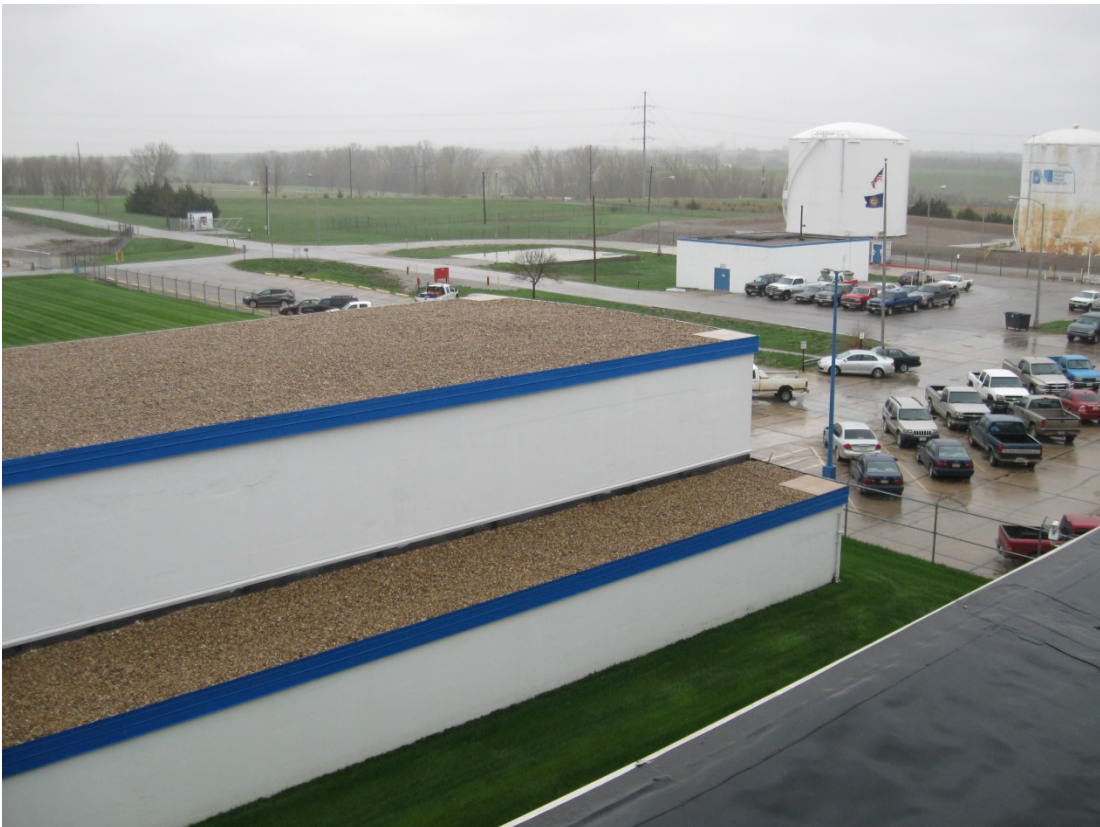
The roof of the IHX building was replaced in 2007. The entire roof is capped with a layer of rock material that protects the underlying roofing fabric. It was noted in 2008 that the roof rock was not present in the northwest and southwest corner of the upper roof. It is surmised that strong winds moved the roof rock from the corners of the roof exposing the underlying roofing fabric. Paver stones were placed in all corners of the roof in 2009 to correct the problem. The roof was in good condition. No bare spots were observed (PL-2 and PL-3).

HAL 4/2013. PL-2. Roof of IHX building.

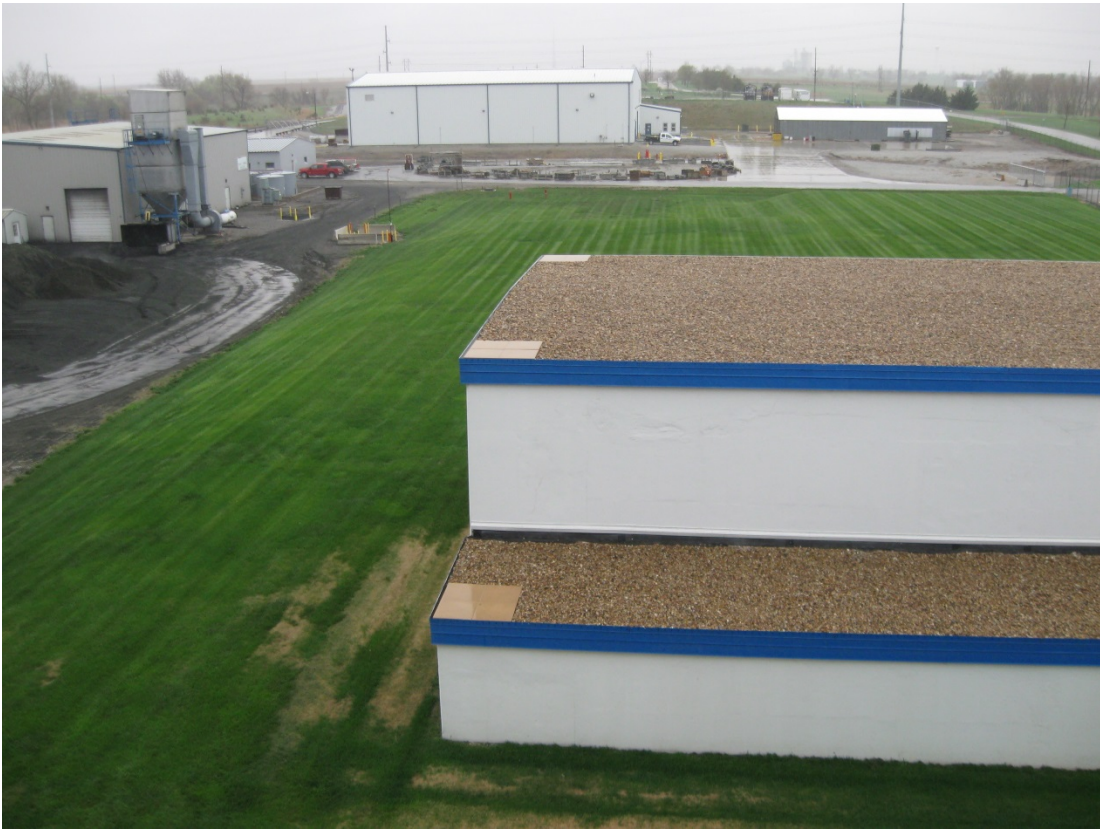
HAL 4/2013. PL-3. Roof, east half of IHX building.

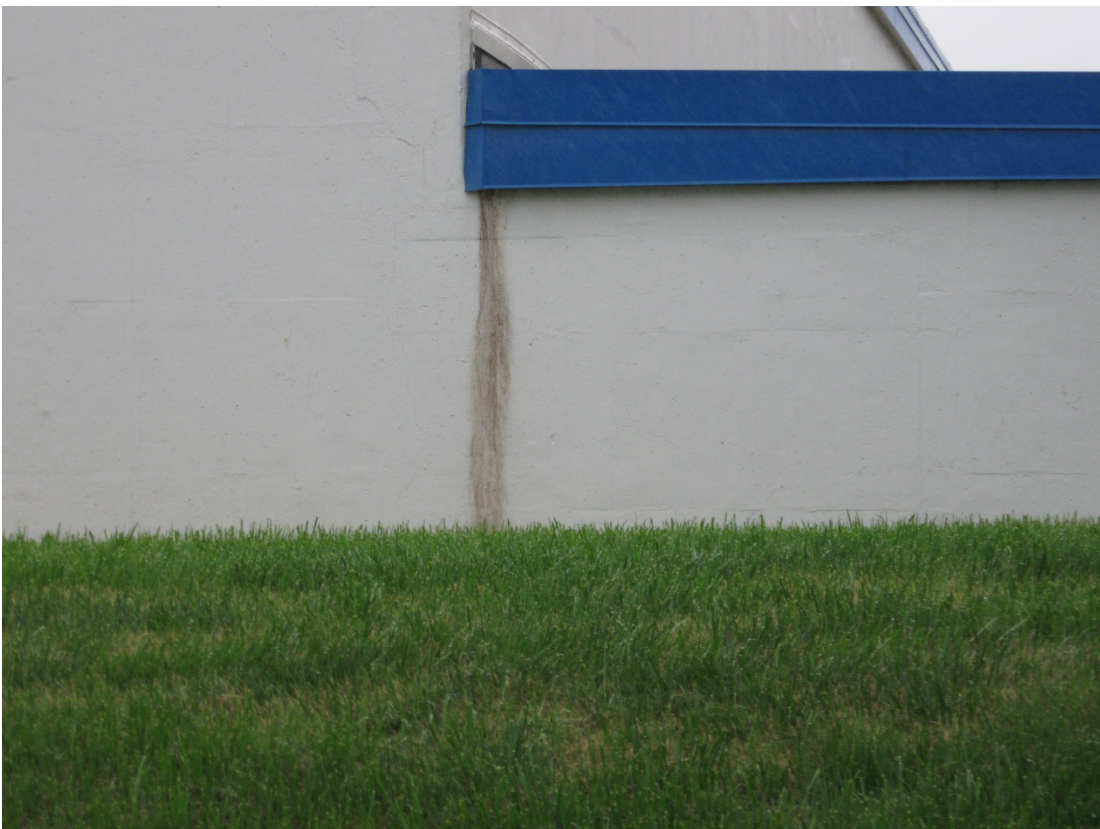
A water stain (noted in previous inspections) remains on the outer east wall of the IHX building where the lower roof meets the wall of the two story structure (PL-4). The size and intensity of the stain does not appear to be progressing. The cause for the staining is not known. It could be the result of a one-time heavy rain event that overwhelmed the roof drainage system, or perhaps the onset of a chronic roof drainage problem. No corrective action is recommended at this time to address the stain. The area will be inspected next year to determine if the staining is progressing.

HAL 4/2013. PL-4. Stain on east side of IHX building.
