2014 Annual Inspection and Status Report for the Hallam, Nebraska, Decommissioned Reactor Site

This report presents the findings of the annual U.S. Department of Energy (DOE) inspection of the decommissioned Hallam, Nebraska, Reactor Site on April 8, 2014.

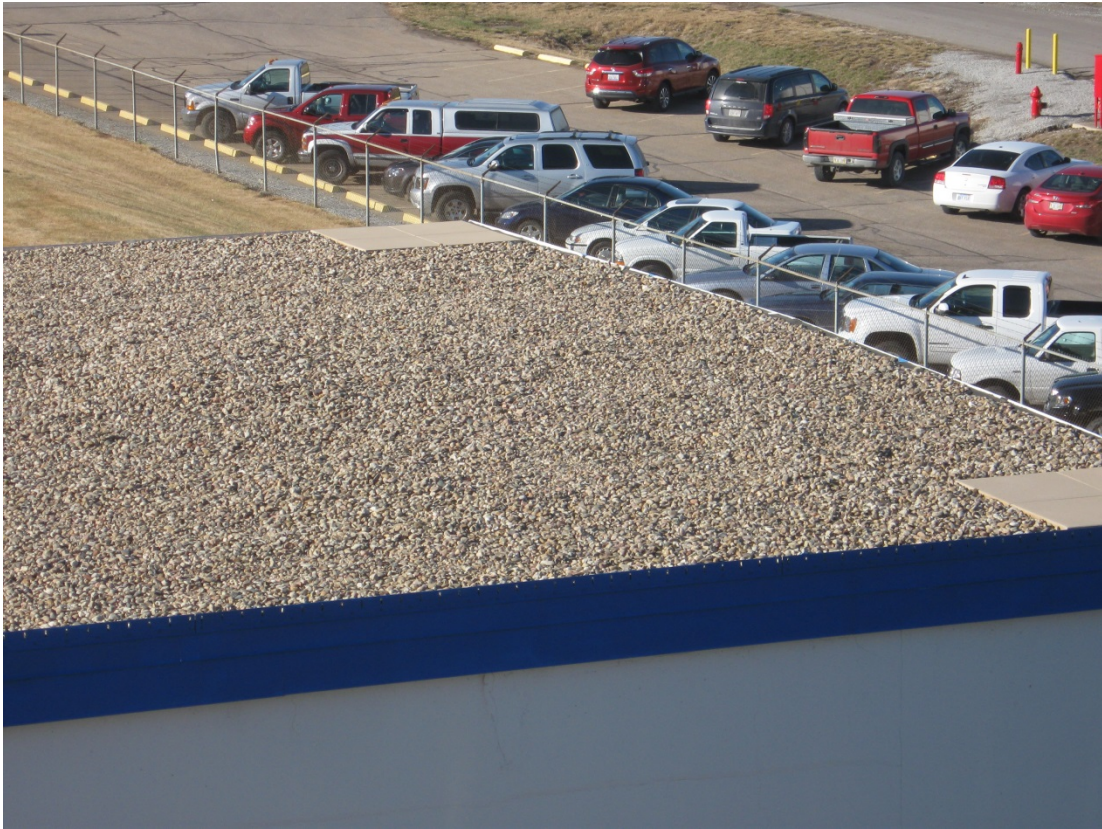
The IHX building is a massive 40-foot wide by 80-foot long concrete sarcophagus located at the north end of the former HNPF. The south side of the building is two stories high (about 25- to 30-feet) with a slightly crowned roof, and the north side of the building is one-story high with a roof that is sloped to drain. Inspectors view the roof of the IHX building from the roof of the Sheldon Power Plant, north of the IHX building (PL-1).

HAL 4/2014. PL-1. West Edge of Upper IHX building roof.

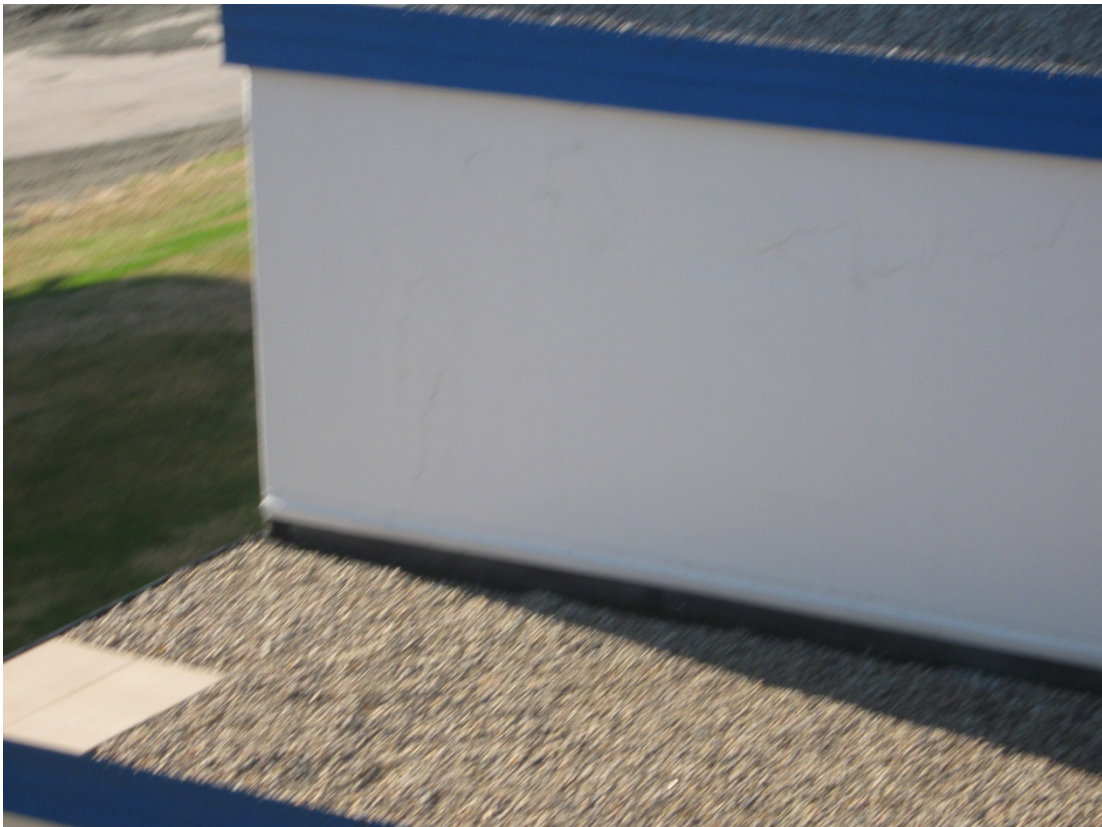
The roof of the IHX building was replaced in 2007. The entire roof is capped with a layer of rock material that protects the underlying roofing fabric. It was noted in 2008 that the roof rock was not present in the northwest and southwest corners of the upper roof. It is surmised that strong winds moved the roof rock from the corners, exposing the underlying roofing fabric. Paver stones were placed in all corners of the roof in 2009 to correct the problem. The roof was in good condition. No bare spots were observed (PL-2 and PL-3).

HAL 4/2014. PL-2. Northeast corner of lower IHX Building.

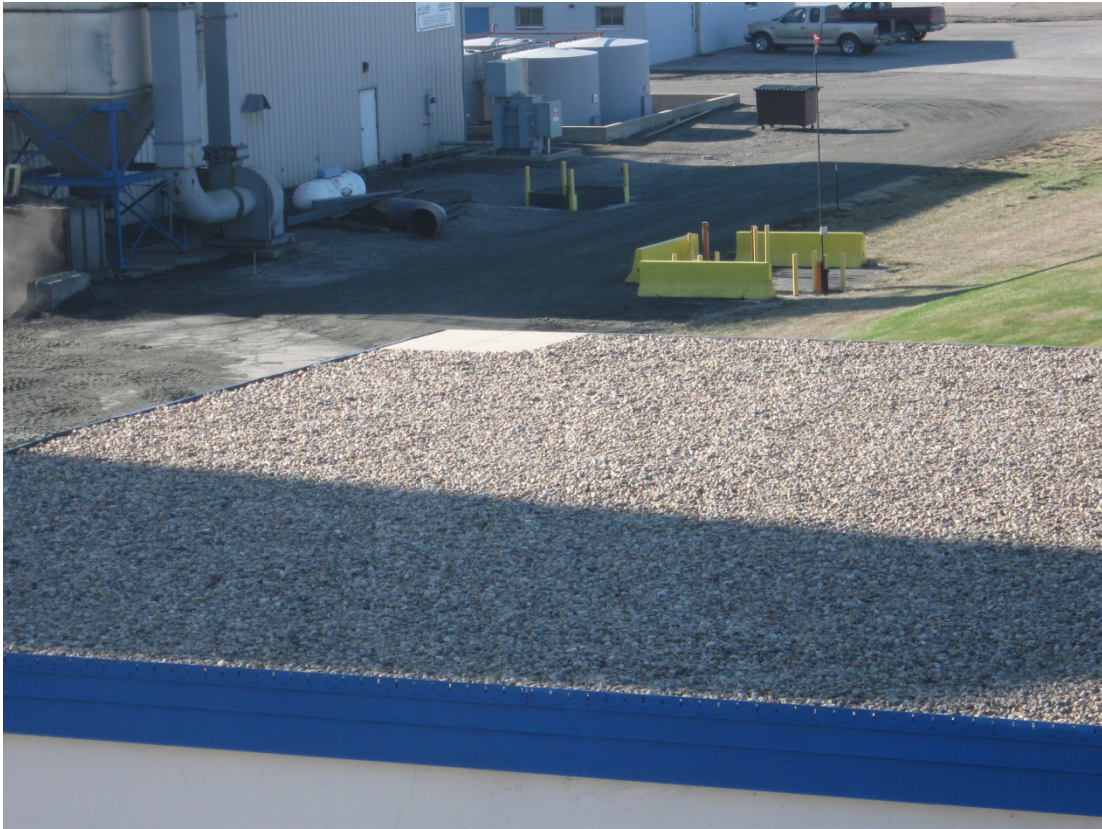
HAL 4/2014. PL-3. Southeast corner of upper IHX Building.

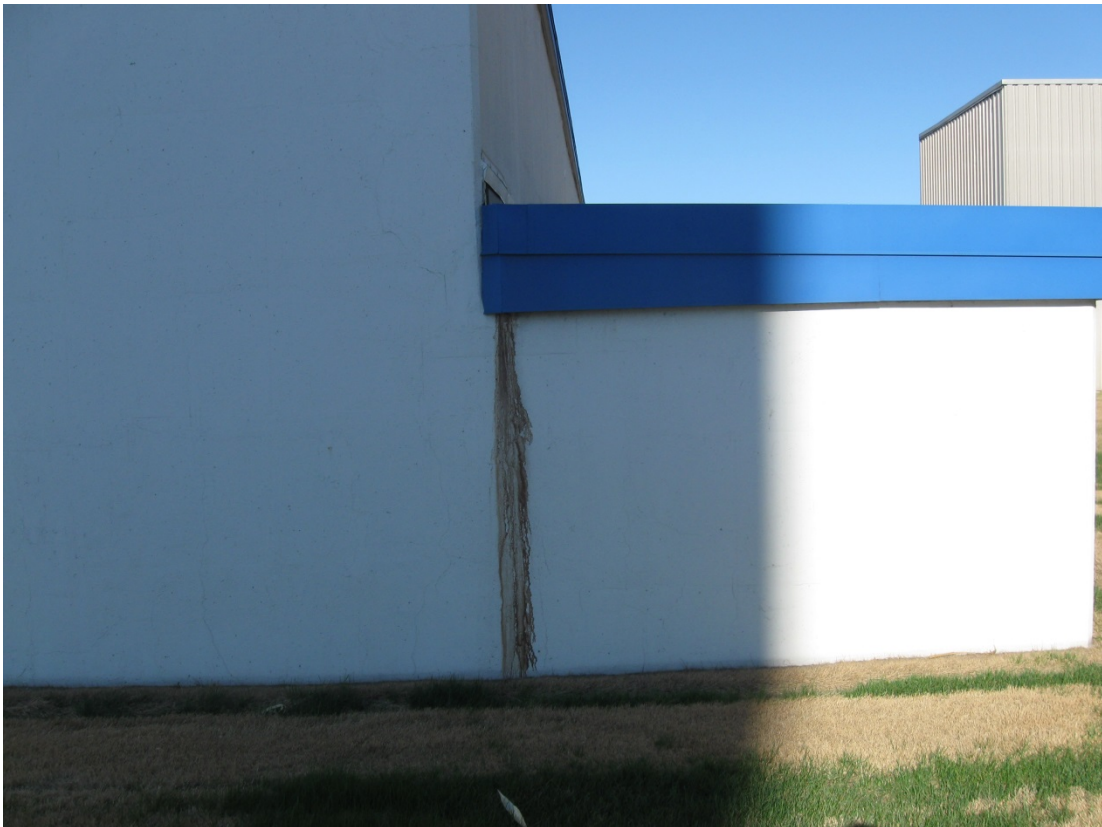
A water stain (noted in previous inspections) remains on the outer east wall of the IHX building where the lower roof meets the wall of the two story structure (PL-4). The size and intensity of the stain appears to be increasing. The cause for the staining is not known. It could be the onset of a chronic roof drainage problem. No corrective action is recommended at this time to address the stain. The area will be inspected next year to determine if the staining is progressing.

HAL 4/2014. PL-4. Water stain on east wall of IHX building.

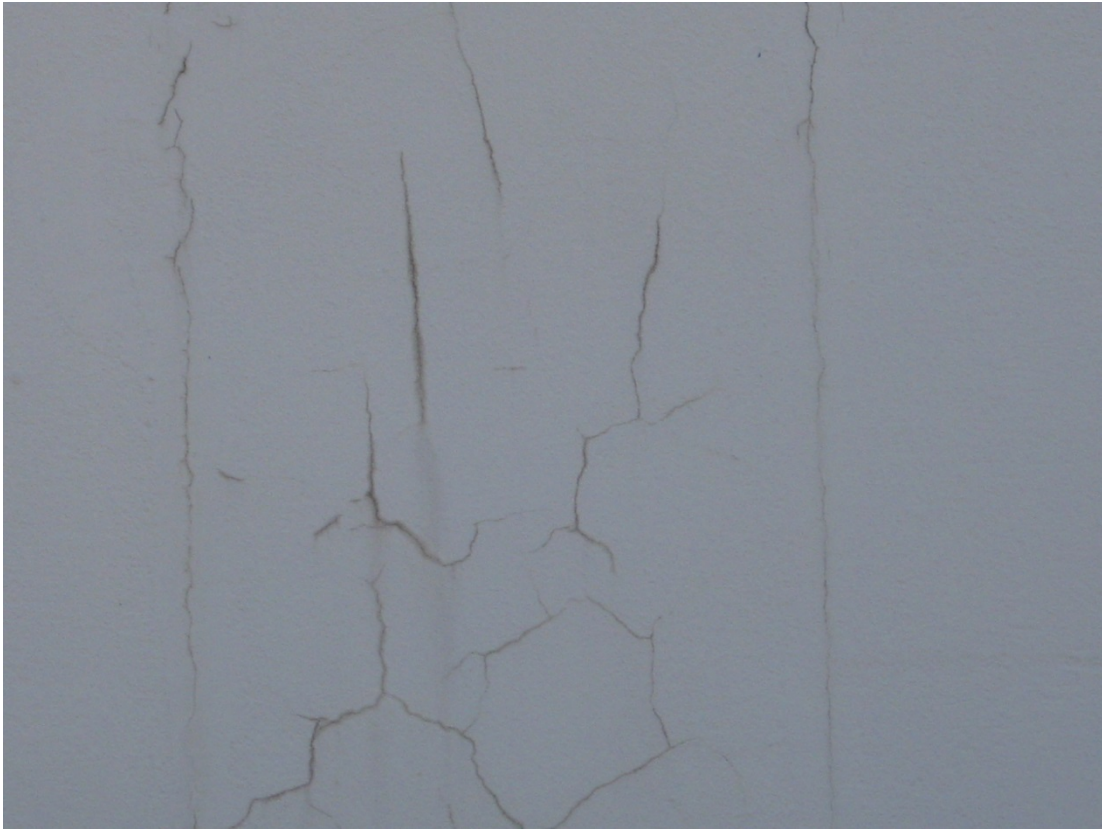
Several shallow surface cracks were observed this year on the north wall of the IHX building (PL-5 and PL-6). They appear to be cracks in the paint, possibly the result of the extreme cold conditions that were experienced at the site during the previous winter. No corrective action is recommended at this time to address the cracks. They will be inspected next year to determine if they are increasing.

HAL 4/2014. PL-5. Surface cracks on north wall of IHX Building.

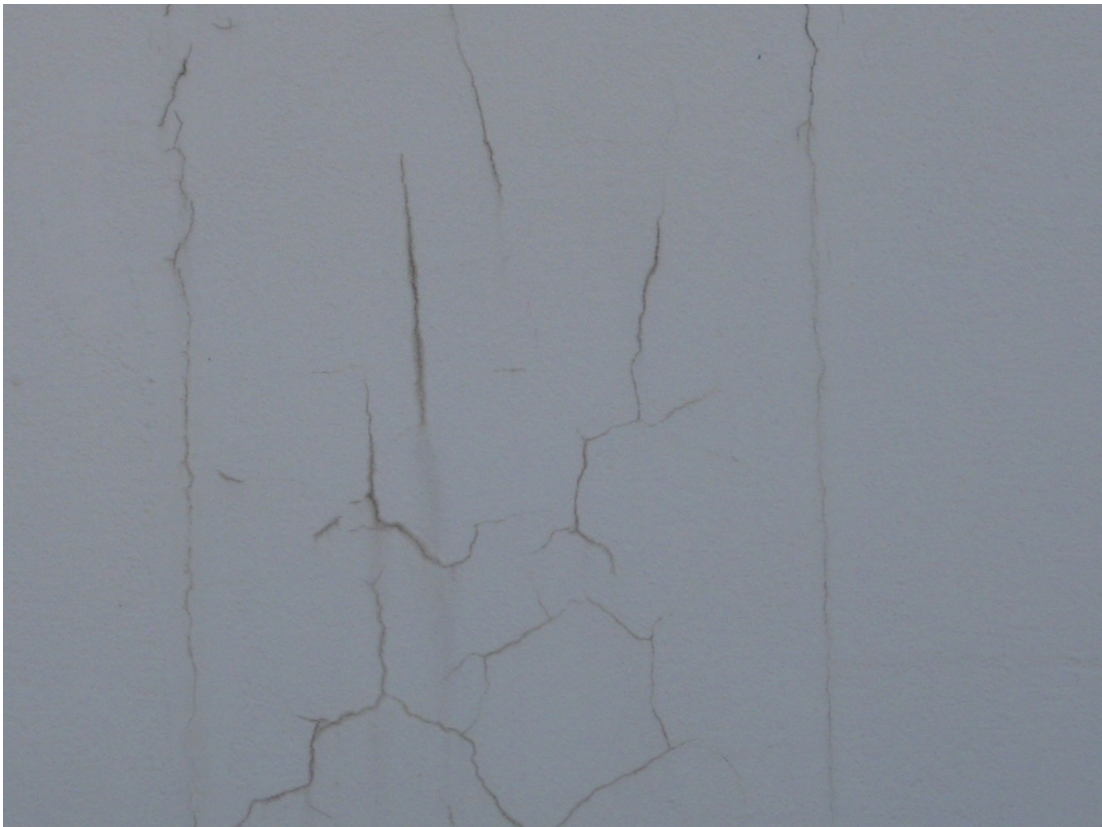
HAL 4/2014. PL-6. Surface cracks on north wall of IHX Building.

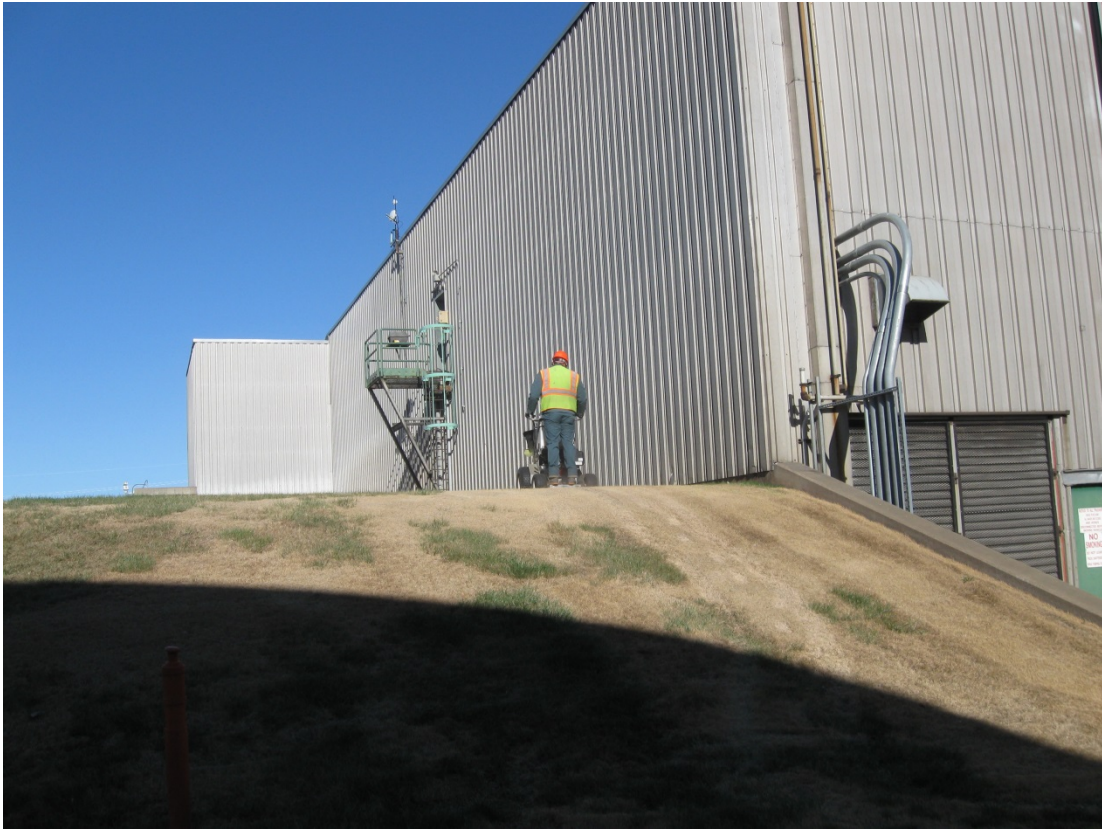
The old reactor foundation is buried beneath a waterproof membrane that is overlain by soil and grass. Today the buried structure appears as a low, flat-topped, grass-covered mound, 1.4 acres in extent, immediately south of the IHX building. Inspectors check that areas of erosion are not developing on the mound, and that the sprinkler system is operating adequately to maintain the grass on the mound. Grass on the mound was well established, in good condition, and is being maintained (PL-7).

HAL 4/2014. PL-7. Spreading fertilizer on grass covered mound.
