2015 Annual Inspection and Status Report for the Hallam, Nebraska, Decommissioned Reactor Site

This report presents the findings of the annual U.S. Department of Energy (DOE) inspection of the decommissioned Hallam, Nebraska, Reactor Site on April 9, 2015.

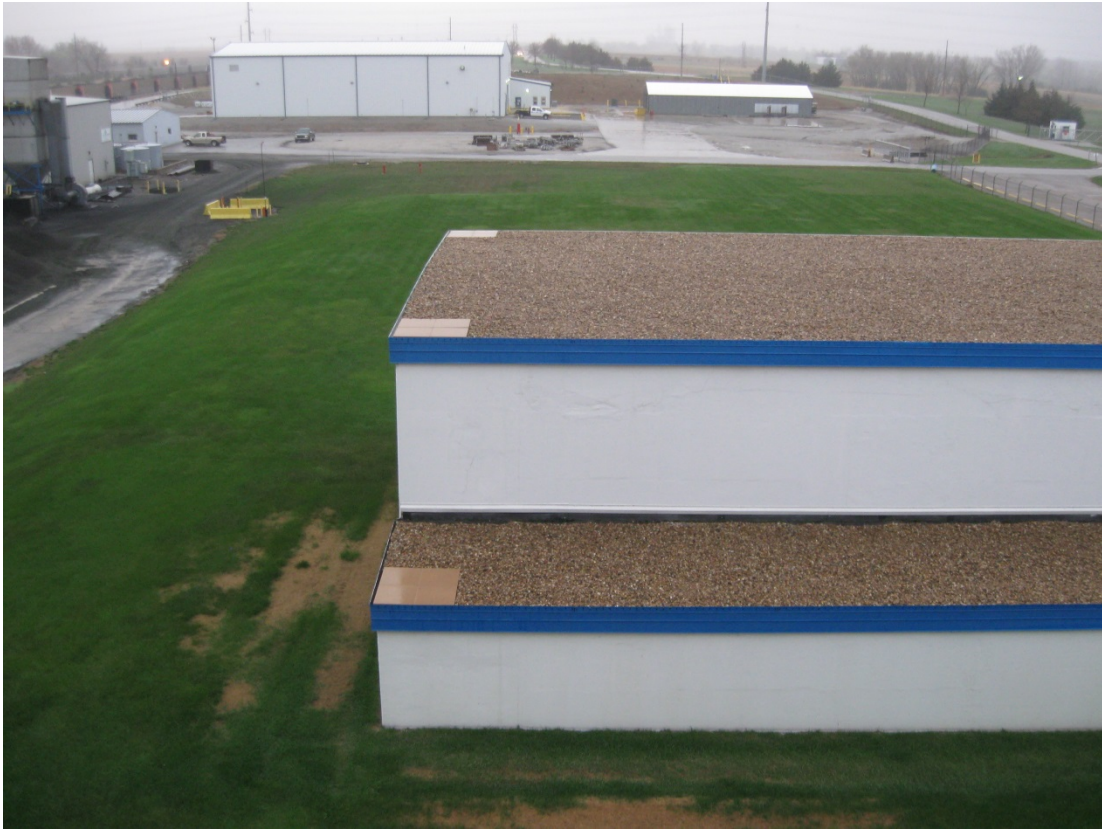
The roof of the IHX building was replaced in 2007. The entire roof is capped with a layer of rock material that protects the underlying roofing fabric. It was noted in 2008 that the roof rock was not present in the northwest and southwest corners of the upper roof. It is surmised that strong winds moved the roof rock from the corners, exposing the underlying roofing fabric. Paver stones were placed in all corners of the roof in 2009 to correct the problem. The roof was in good condition. No bare spots were observed (PL-1, PL-2, and PL-3).

HAL 4/2015. PL-1. East end of IHX Building roof.

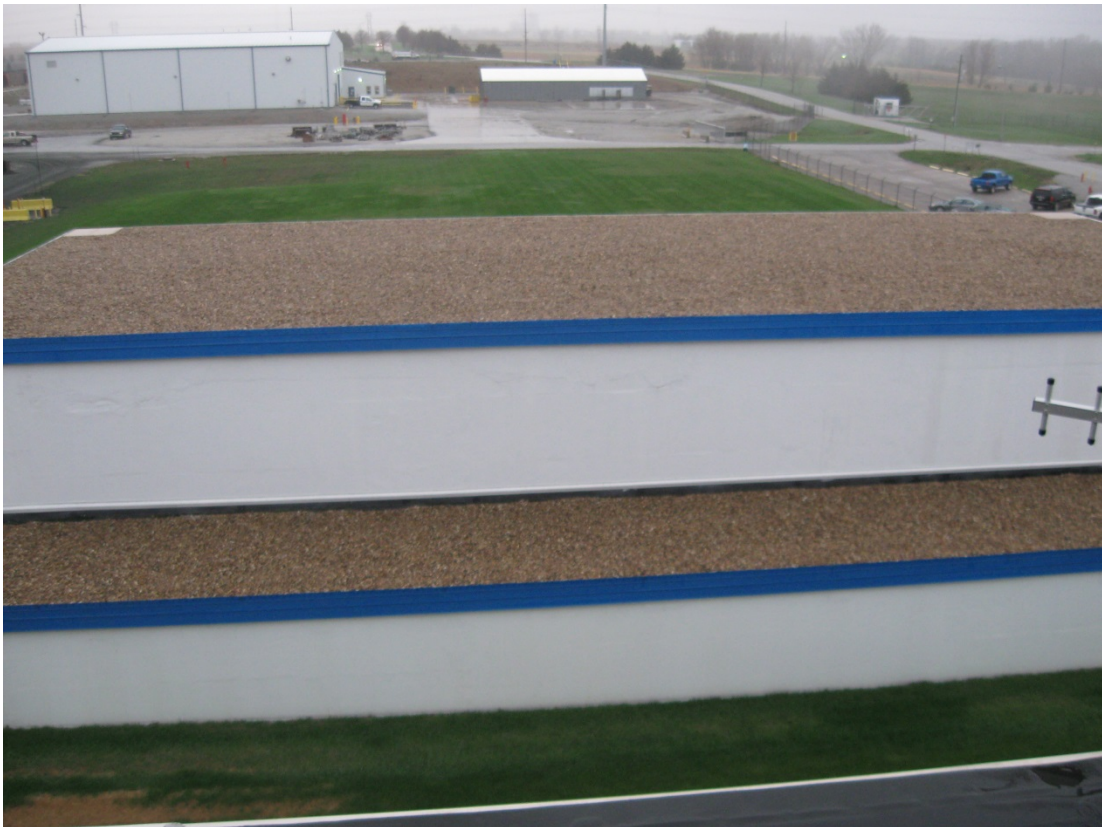
HAL 4/2015. PL-2. IHX building roof.

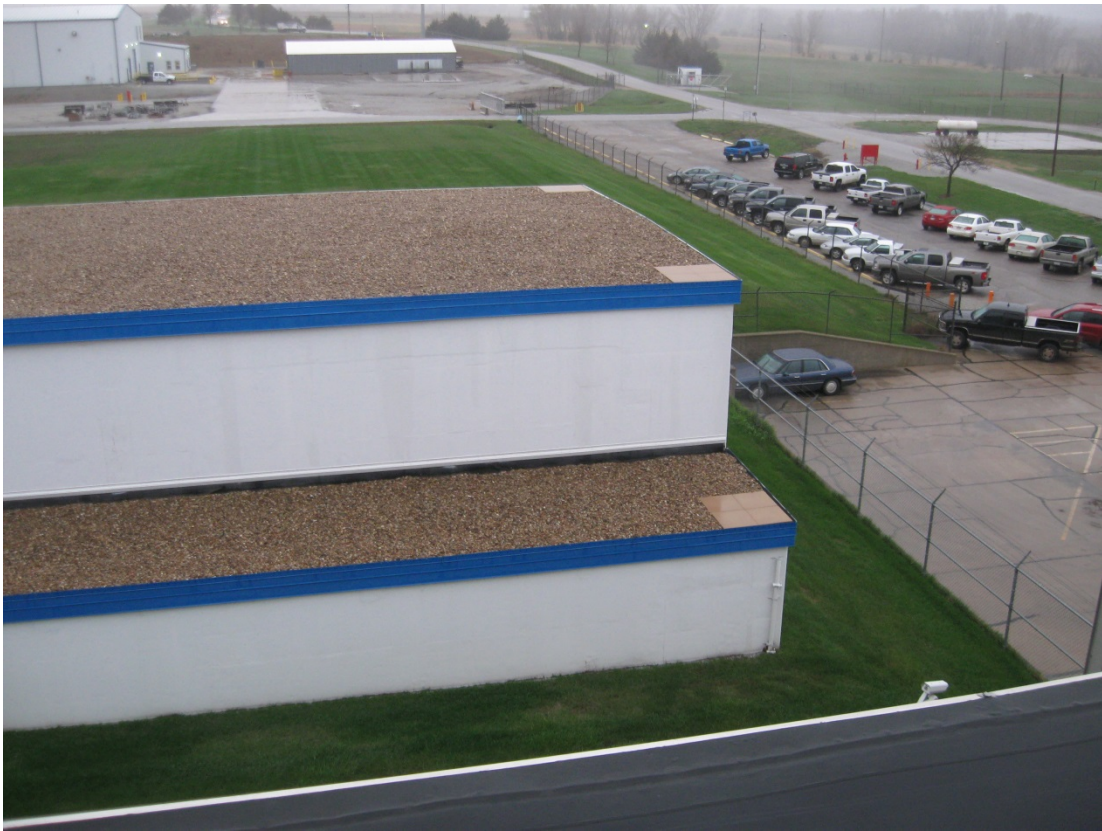
HAL 4/2015. PL-3. West end of IHX building roof.

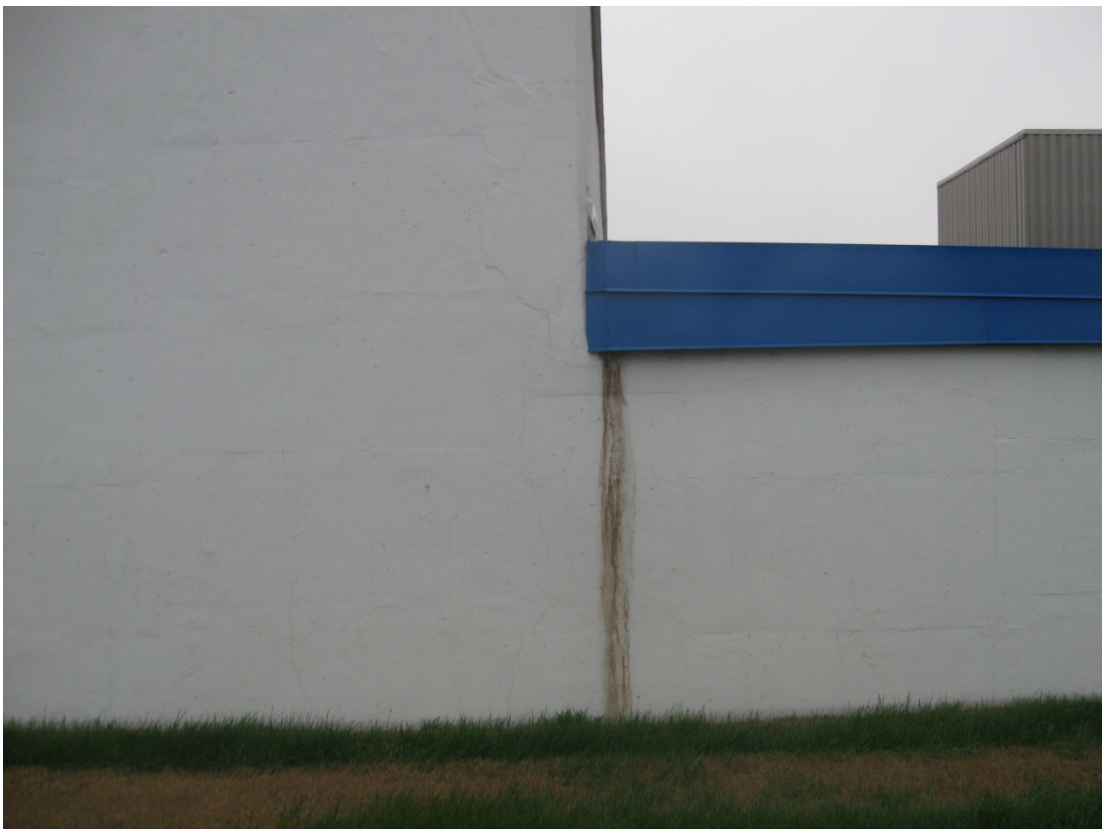
A water stain (noted in previous inspections) remains on the outer east wall of the IHX building where the lower roof meets the wall of the two story structure (PL-4). The size and intensity of the stain appears to be stable. The cause for the staining is not known. It could be the onset of a chronic roof drainage problem. No corrective action is recommended at this time to address the stain. The area will be inspected next year to determine if the staining is progressing.

HAL 4/2015. PL-4. Water stains on east wall of IHX building.

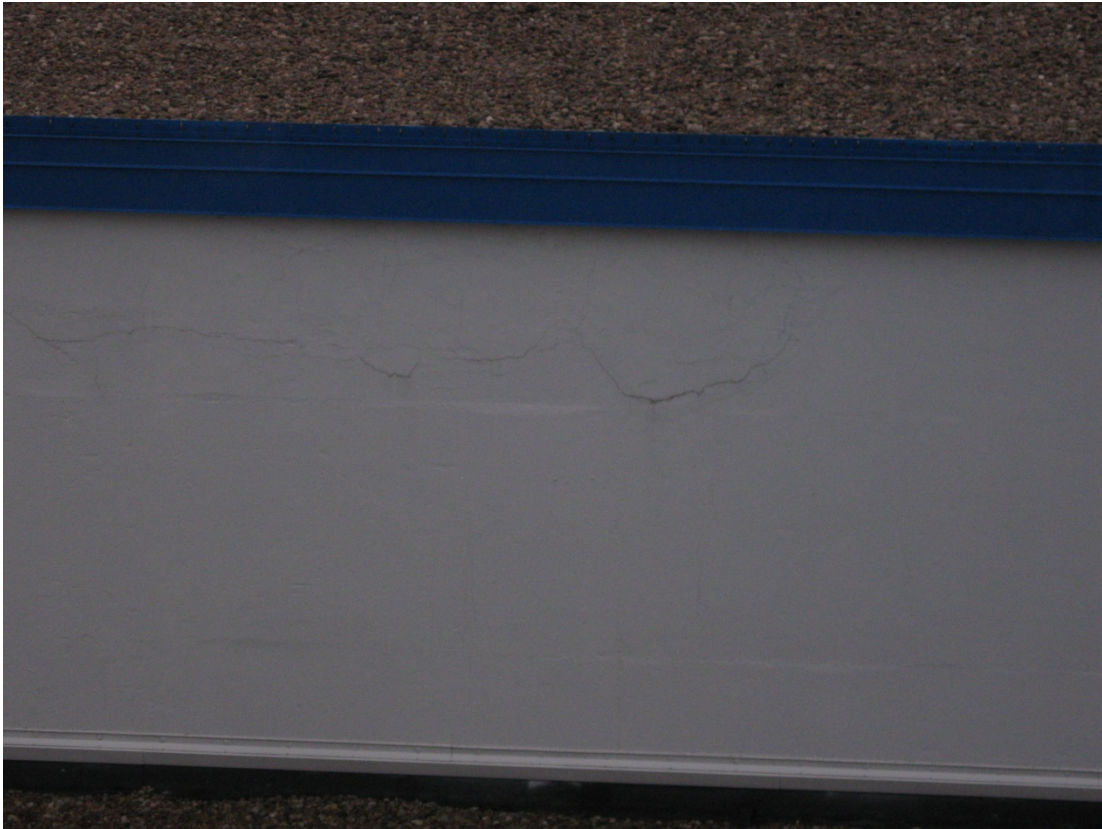
Several shallow surface cracks were observed this year on the north wall of the IHX building (PL-5). They appear to be cracks in the paint, possibly the result of the extreme cold conditions that were experienced at the site during the previous winter. No corrective action is recommended at this time to address the cracks. They will be inspected next year to determine if they are increasing.

HAL 4/2015. PL-5. Surface cracks on north wall of IHX Building.

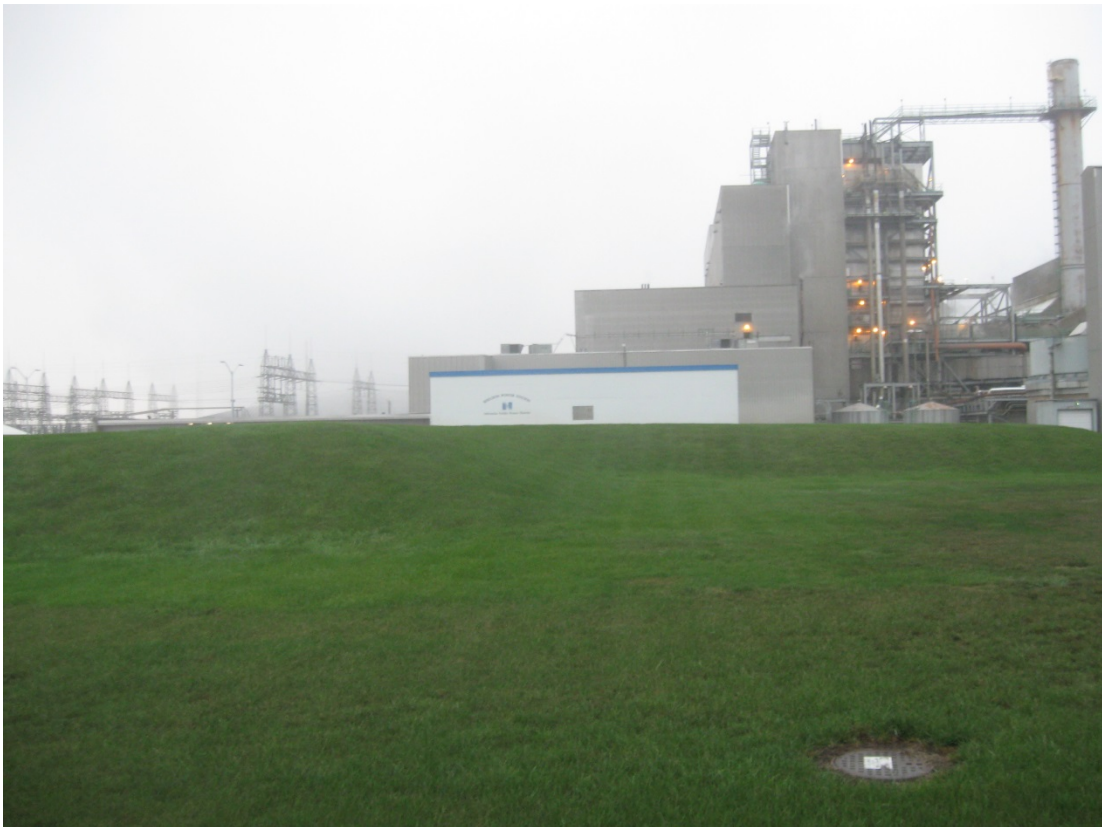
The old reactor foundation is buried beneath a waterproof membrane that is overlain by soil and grass. Today the buried structure appears as a low, flat-topped, grass-covered mound, 1.4 acres in extent, immediately south of the IHX building. Inspectors check that areas of erosion are not developing on the mound, and that the sprinkler system is operating adequately to maintain the grass on the mound. Grass on the mound was well established, in good condition, and is being maintained (PL-6).

HAL 4/2015. PL-6. View of south side of IX building.
