2016 Annual Inspection and Status Report for the Hallam, Nebraska, Decommissioned Reactor Site

June 2016

U.S. DEPARTMENT OF
ENERGY

Legacy
Management

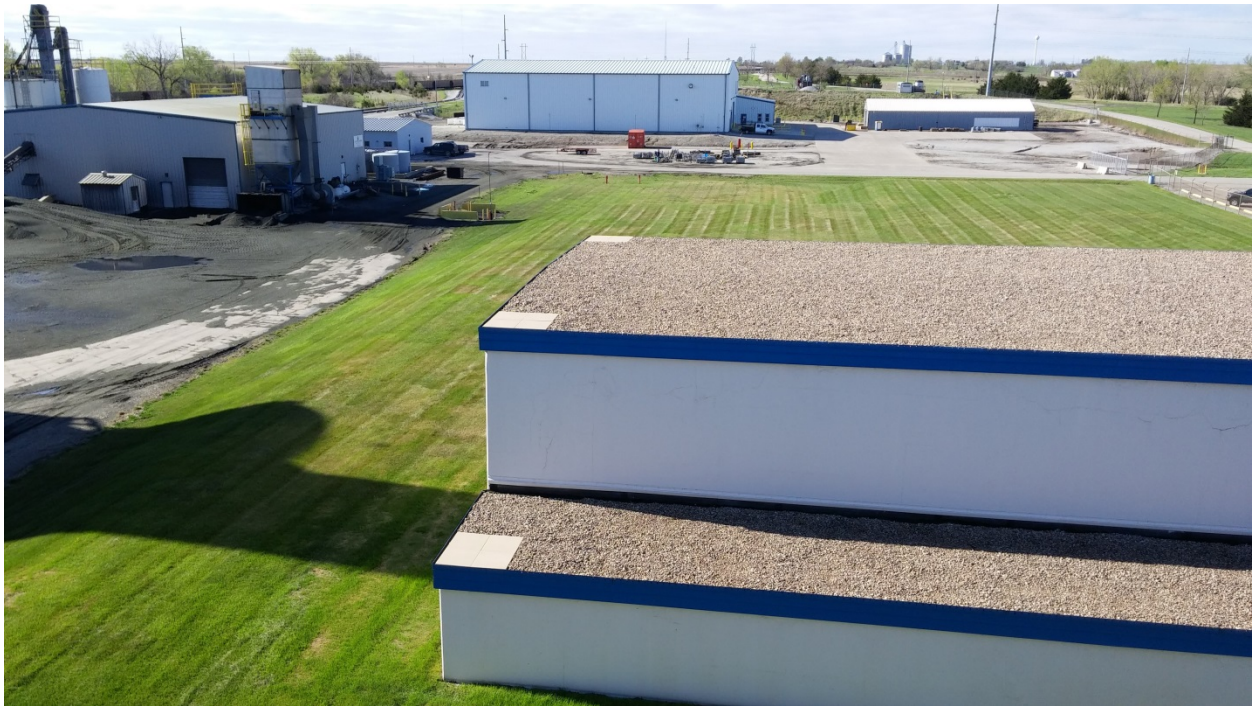
The roof of the IHX building was replaced in 2007. The entire roof is capped with a layer of rock material that protects the underlying roofing fabric. It was noted in 2008 that the roof rock was missing in the northwest and southwest corners of the upper roof. It is surmised that strong winds moved the roof rock from the corners, exposing the underlying roofing fabric. Paver stones were placed in all corners of the roof in 2009 to correct the problem. The roof was in good condition during the 2016 inspection. No bare spots were observed (PL-1 and PL-2).

HAL 4/2016. PL-1. Northeast corner of roof of IHX building.

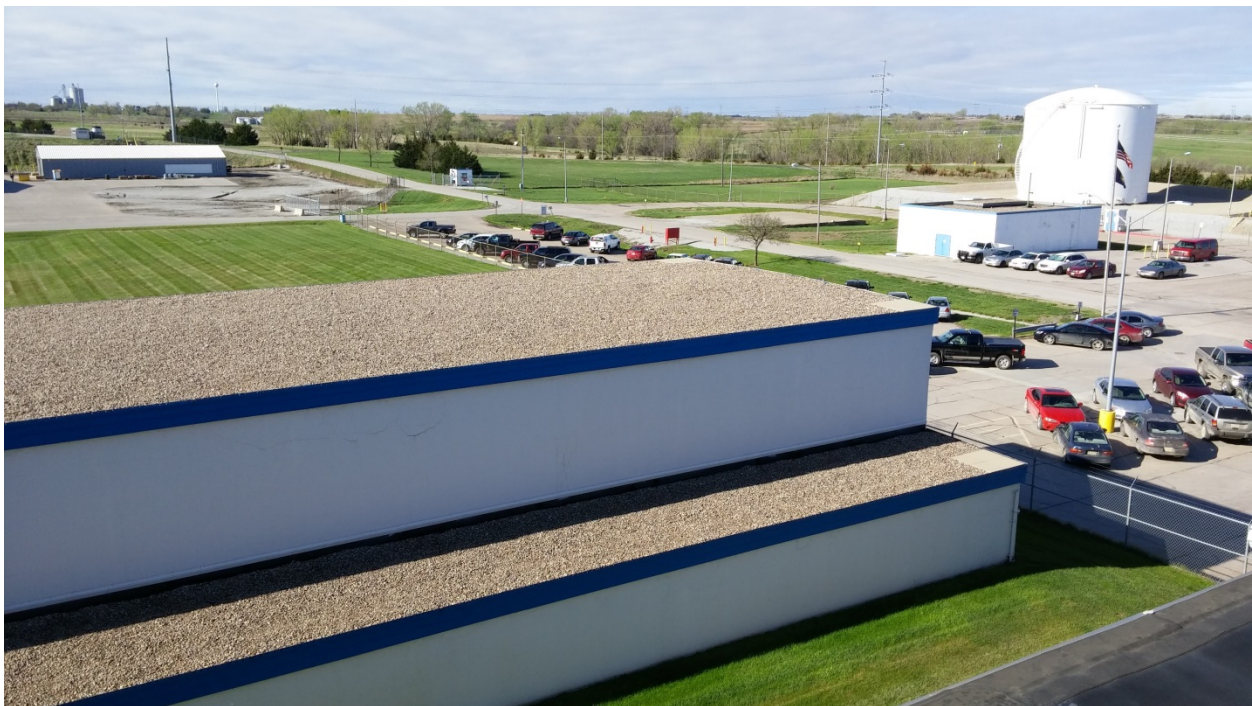
HAL 4/2016. PL-2. Northwest corner of roof of IHX building.

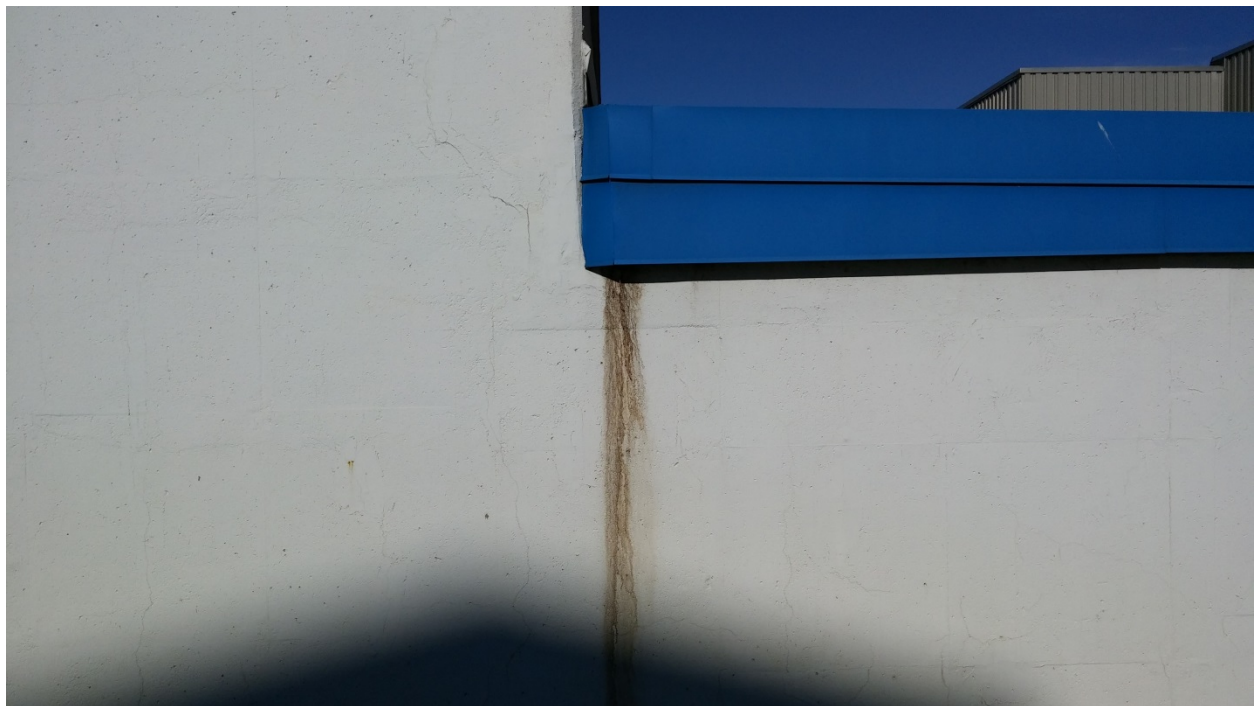
A water stain (noted in previous inspections) remains on the outer east wall of the IHX building where the lower roof meets the wall of the two story structure (PL-3). The size and intensity of the stain appears to be stable. The cause for the staining is not known. It could be the onset of a chronic roof drainage problem. No corrective action is recommended at this time to address the stain. The area will be inspected next year to determine if the staining is progressing.

HAL 4/2016. PL-3. Water staining on east wall of IHX building.

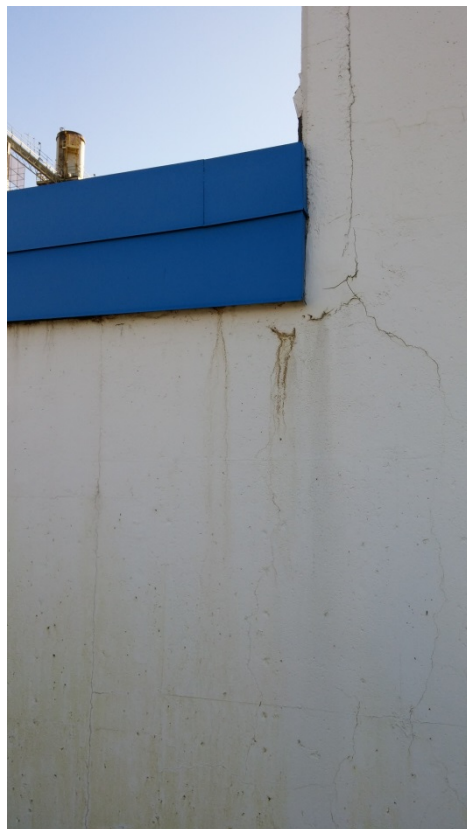
Several shallow surface cracks were observed this year on the north wall of the IHX building and on the west wall (PL-4). They appear to be cracks in the paint. No corrective action is recommended at this time to address the cracks. They will be inspected next year to determine if they are increasing.

HAL 4/2016. PL-4. Surface cracks on west wall of IHX building.

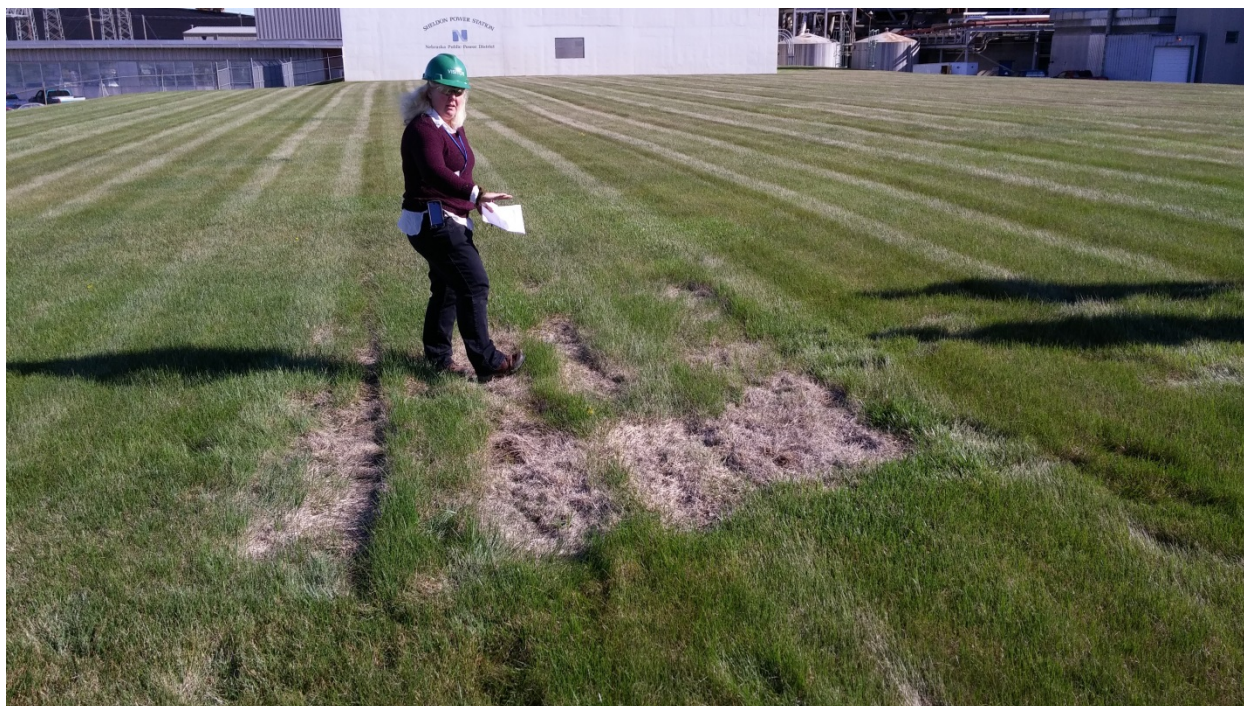
The old reactor foundation is buried beneath a waterproof membrane that is overlain by soil and grass. Today the buried structure appears as a low, flat-topped, grass-covered mound, 1.4 acres in area, immediately south of the IHX building. Inspectors check that areas of erosion are not developing on the mound and that the sprinkler system is operating adequately to maintain the grass on the mound. Grass on the mound was well established, in good condition, and is being maintained with the exception of one small area (PL-5). The grass in this area was dry and matted down. The cause for the dry grass area is not known. This area will be watched to determine if it goes away or if a cause can be determined.

HAL 4/2016. PL-5. Brown grass area on grass-covered mound.

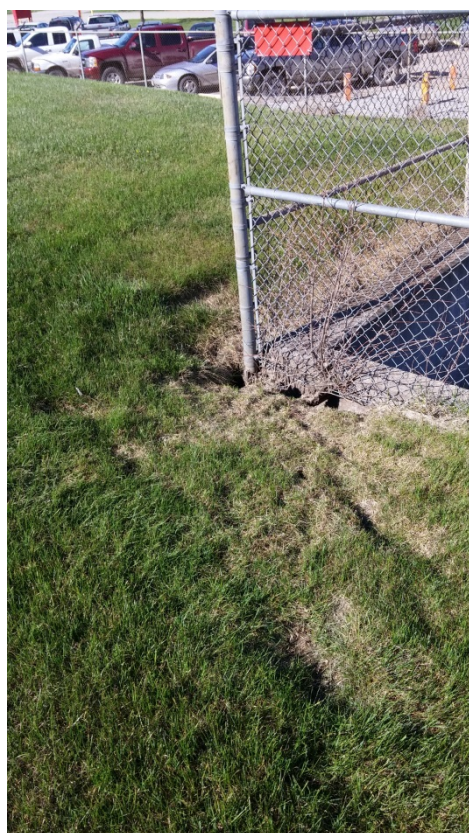
A small area of ground erosion was observed along the fenced perimeter of the grass-covered mound, located west of the IHX building, where a retaining wall is located to separate the grass-covered mound on the east from the parking lot to the west (PL-6 and PL-7). Inspectors requested that Sheldon Power Plant personnel fill in these two areas with soil to hinder further erosion.

HAL 4/2016. PL-6. Erosion at base of fence.

Inspectors requested that NPPD personnel fill in some small areas of erosion along the fence line, just west of the IHX building to hinder further erosion, and move a concrete Jersey barrier a few feet to the east of well pad OBS-2.

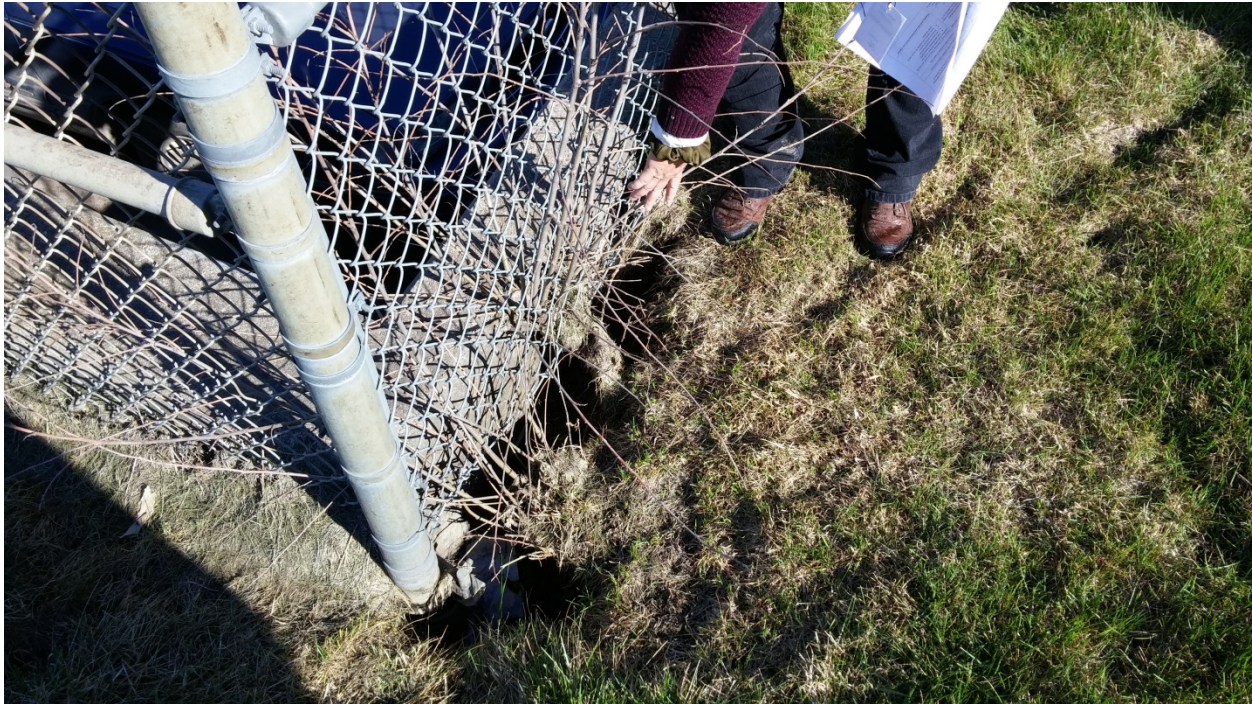
HAL 4/2016. PL-7. Erosion at base of fence.

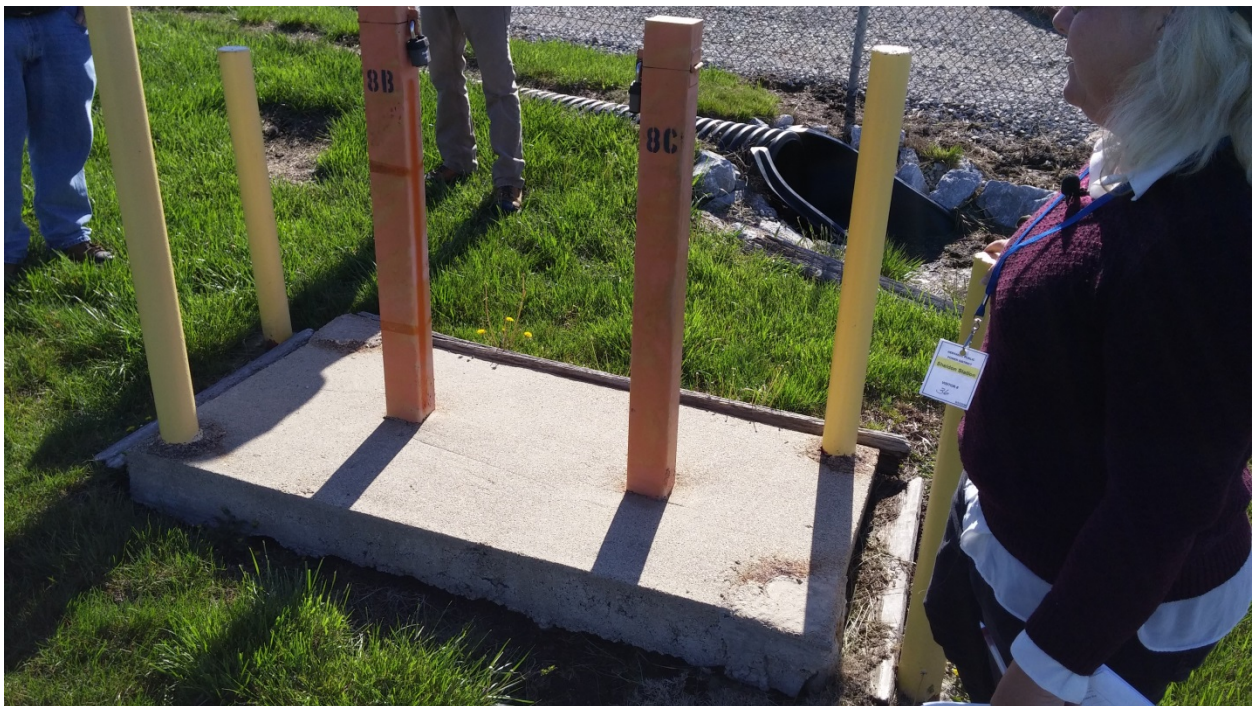
The OBS-8 well pad was loose, and some of the protective bollards were also loose. When the wells are sampled in June, the sampling crew will be asked to assess the pad situation and stabilize both the pad and the bollards if possible. The crew will also be instructed to remove the wood surrounding the well pad, as it no longer serves a purpose (PL-8).

HAL 4/2016. PL-8. Slight erosion around base of OBS-8 well pad.

- Install a new lock at monitoring well OBS-3B.
- Secure the loose well pad and bollards at the OBS-8 monitoring wells.
- Label the well caps of flush-mount wells OBS-1A and OBS-1B.

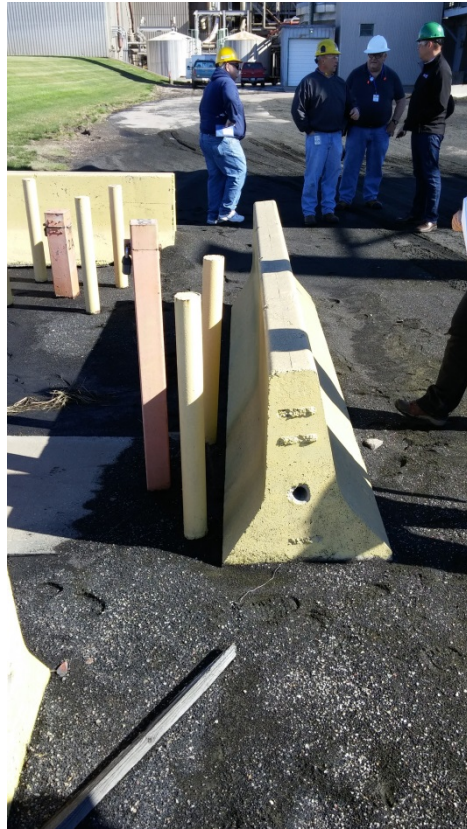
The concrete Jersey barrier located on the east side of the OBS-2 well pad serves to protect the well pad from local traffic. The barrier has been nudged west, closer to the well pad, over the past year (PL-9). A request was made to have Sheldon Power Station personnel nudge the barrier back a few feet to the east.

HAL 4/2016. PL-9. Jersey barrier on east side of OBS-2 well pad.

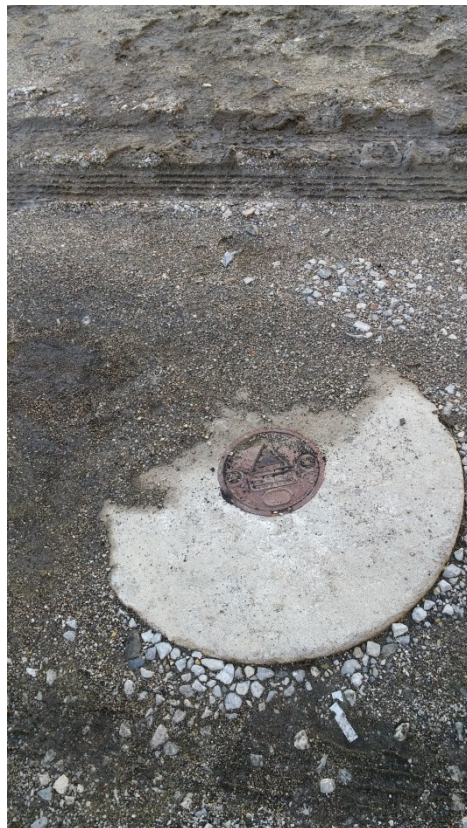
Monitoring wells OBS-1A and OBS-1B are flush-mount wells. The well IDs that had been on the well caps have worn away and need to be replaced. The sampling crew in June will be instructed to replace the well ID labels (PL-10 and PL-11).

HAL 4/2016. PL-10. OBS-1A (flush-mount well).

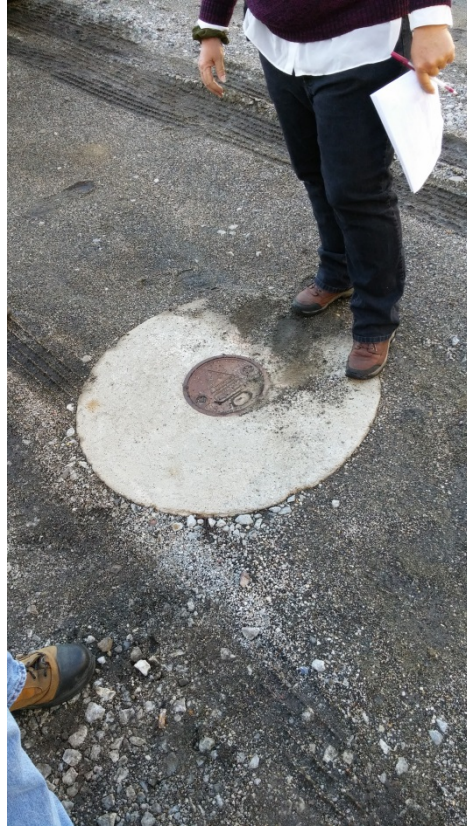
HAL 4/2016. PL-11. OBS-1B (flush-mount well).
