2017 Annual Inspection and Status Report for the Hallam, Nebraska, Decommissioned Reactor Site

June 2017

U.S. DEPARTMENT OF
ENERGY

Legacy
Management

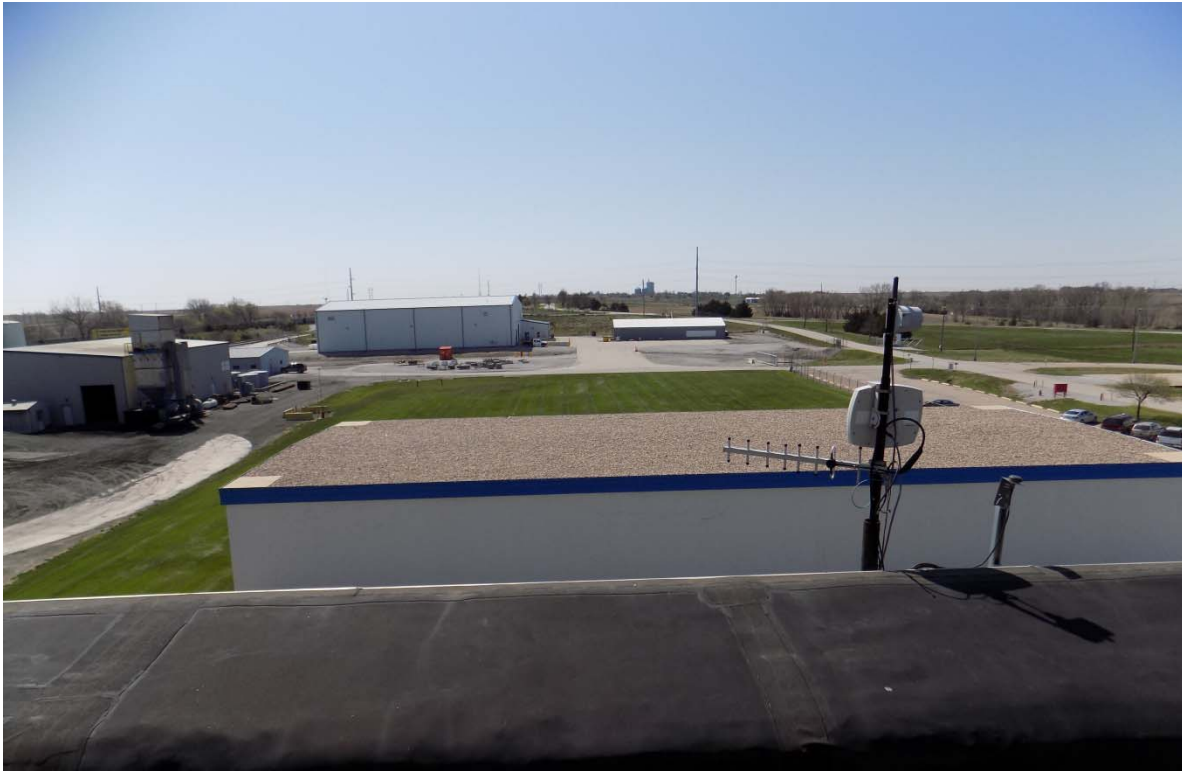
The roof of the IHX Building was replaced in 2007. The entire roof is capped with a layer of rock material that protects the underlying roofing fabric. Inspectors noted in 2008 that roof rock was missing in the northwest and southwest corners of the crowned roof, exposing the underlying fabric. Strong winds are believed to be the cause of the missing stones. Paver stones were placed in all corners of the roof in 2009 to correct the problem. The roof was in good condition during the 2017 inspection. No bare spots were observed (PL-1 through PL-3).

PL-1. IHX Roof

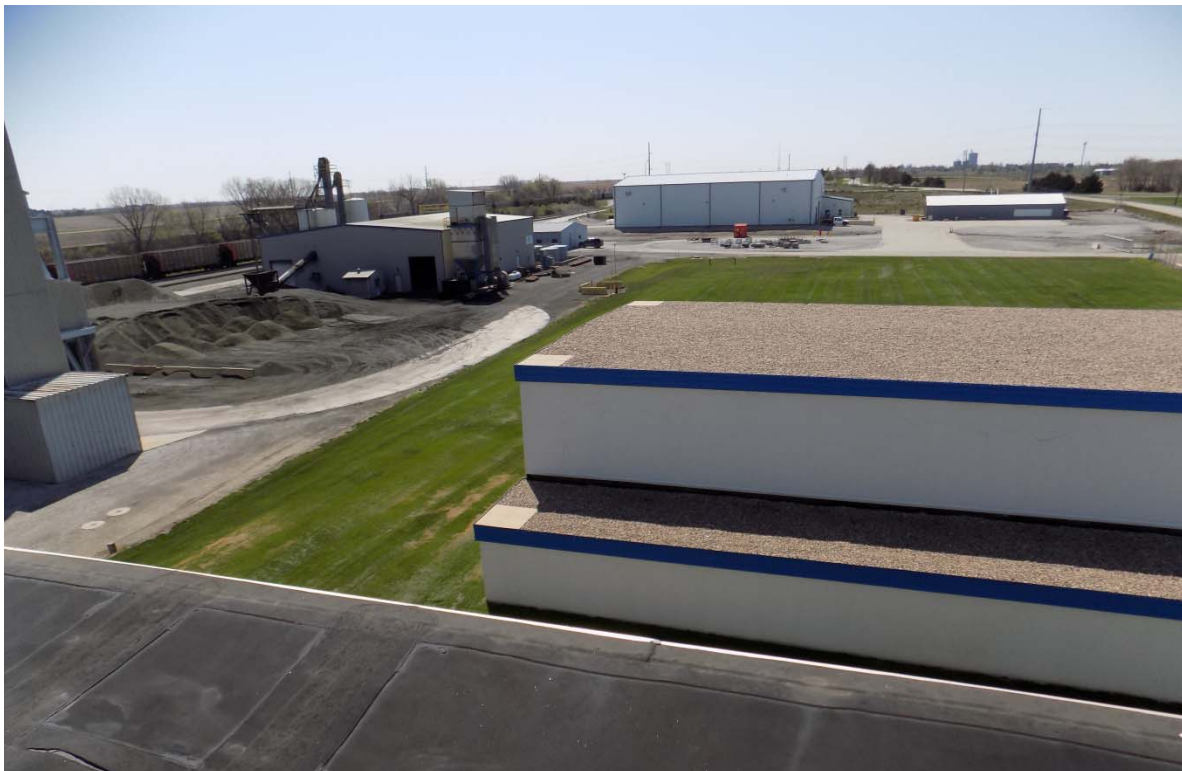
PL-2. East End of IHX Roof

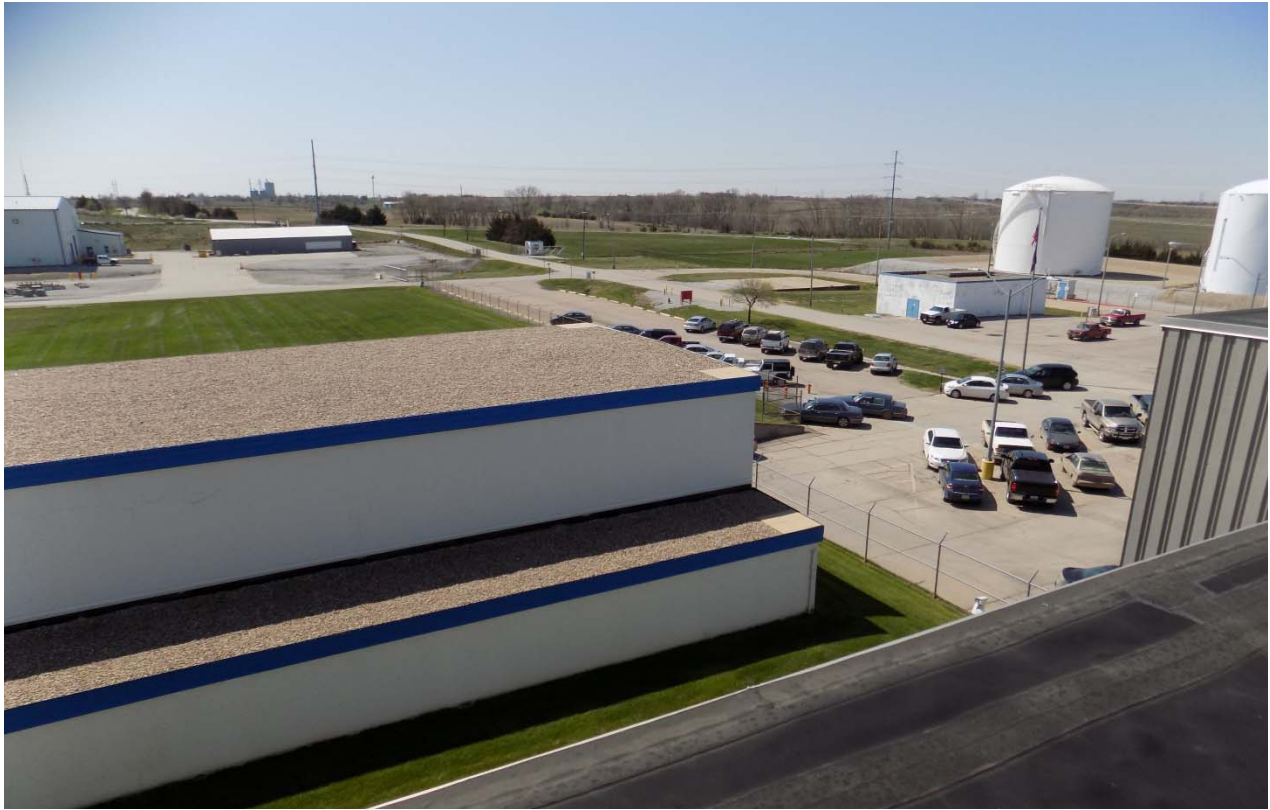
PL-3. West End of IHX Roof

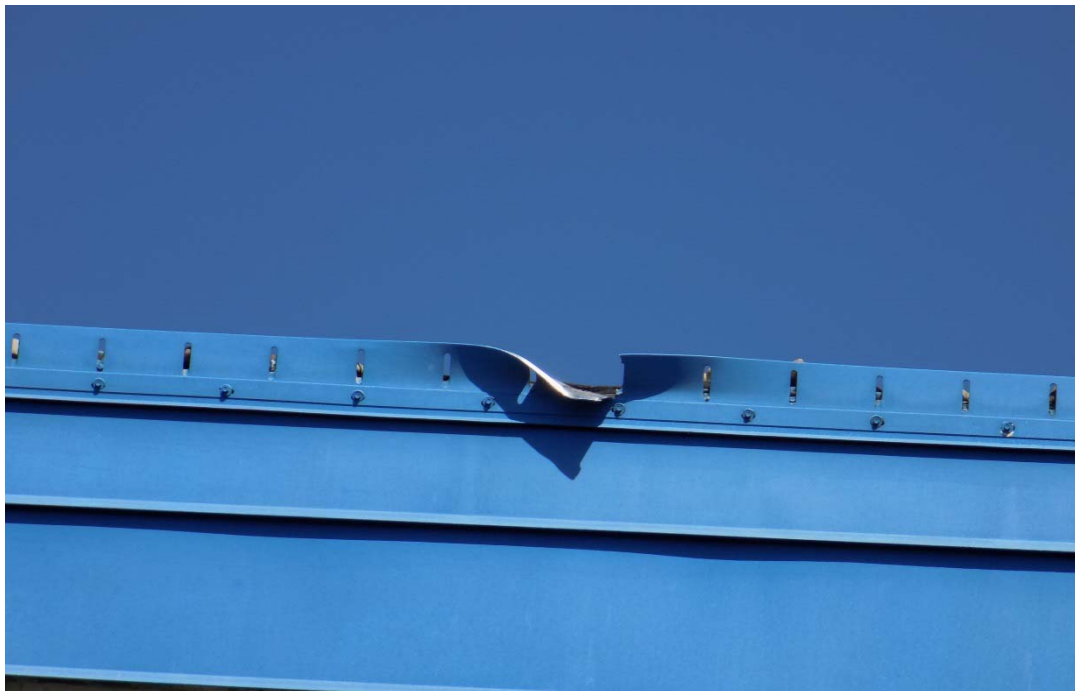
Damage of unknown origin was discovered in one spot on the metal roof edge on the building's south side (PL-4). The roof gutter system appears to remain serviceable but needs to be checked in a heavy rain. If significant water drains from the roof and down the south wall through the damaged metal edge during a heavy rain, the metal edge will need to be repaired so the base of the building is not undermined.

PL-4. Damaged Roof Edge

- Observe whether significant water is exiting the roof from the damaged metal edge of the IHX Building during heavy rains. If it is, DOE will need to initiate repairs.
- Rake dead grass from the edge of the retaining wall west of the IHX Building to mitigate further erosion in the area.
- Re-locate the concrete Jersey barrier on the east side of the OBS-2 well pad by moving it a few feet to the east to provide 3 feet of clearance.

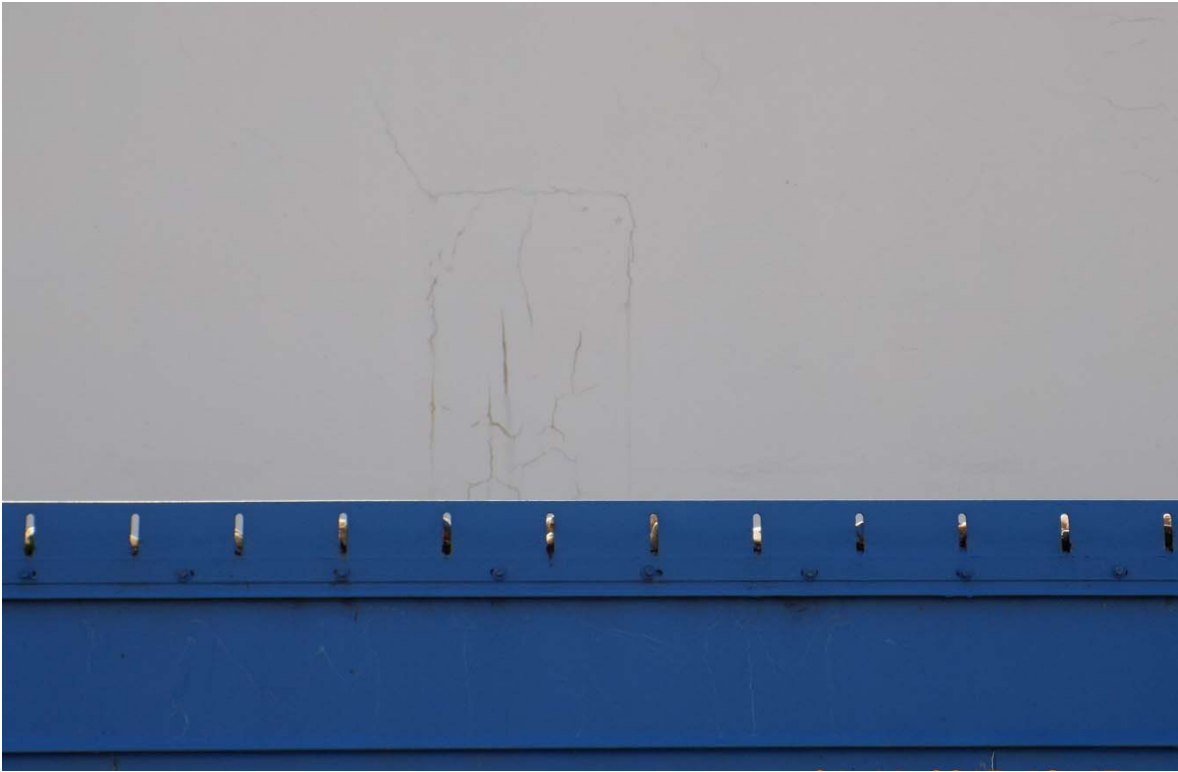
Several surface cracks were observed this year on the north wall of the IHX building that do not appear to compromise the structure (PL-5 and PL-6). No corrective action is recommended at this time to address the cracks. They will be inspected each year to determine if they are growing.

PL-5. Surface Cracks on North Wall of IHX Building

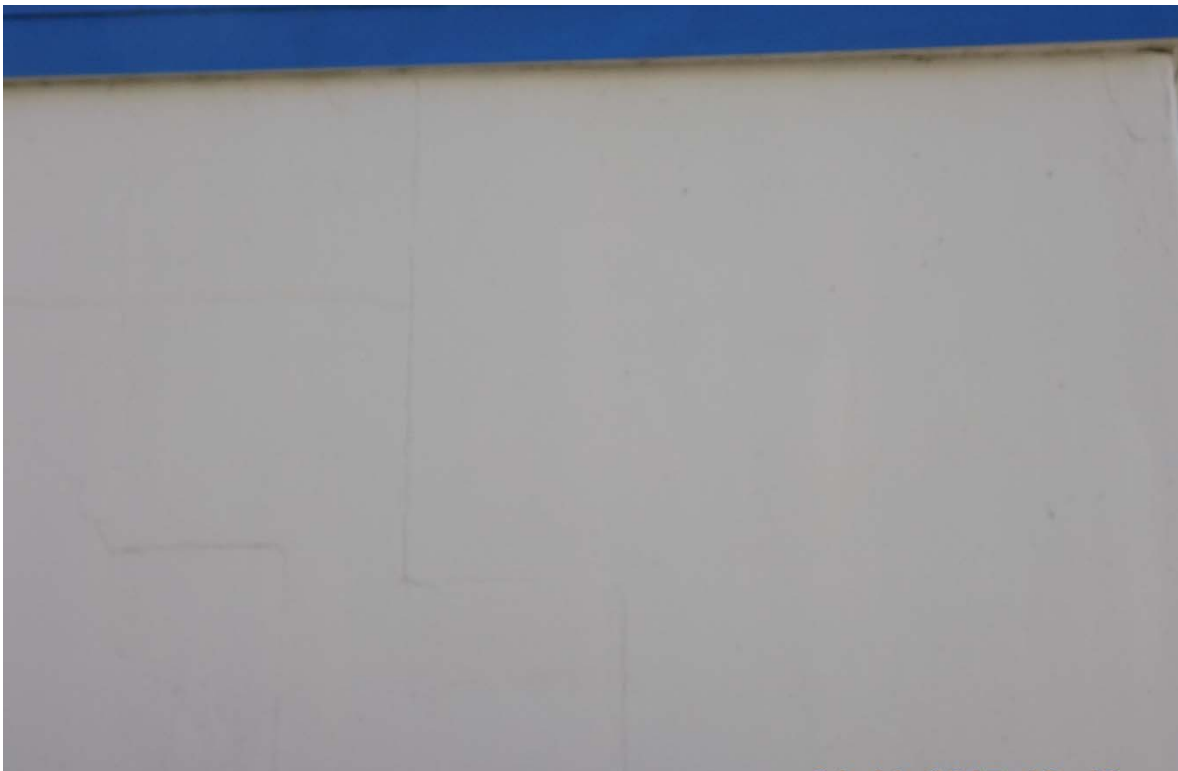
PL-6. Surface Cracks on North Wall of IHX Building

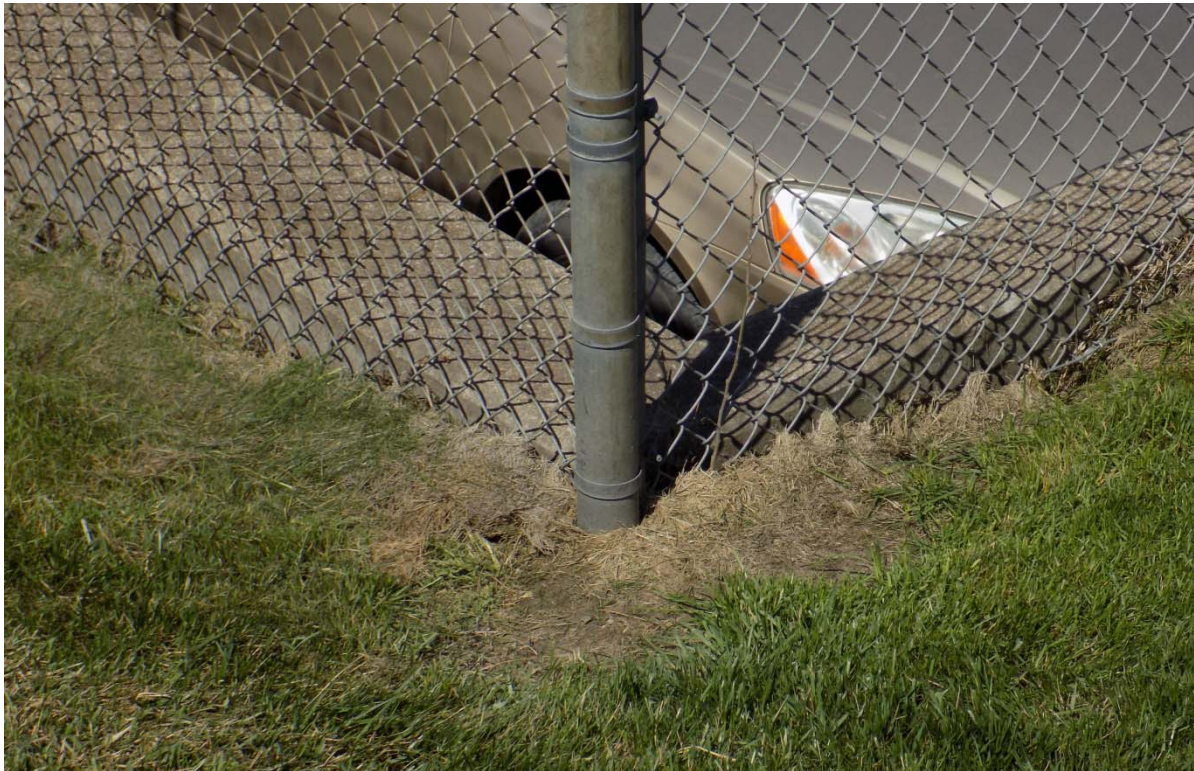
A small area of ground erosion was observed in 2016 along the fenced perimeter of the grass-covered mound west of the IHX Building, where a retaining wall separates the mound from a parking lot to the west. This small area was filled in with dirt and is much improved (PL-8 and PL-9). Inspectors requested that Sheldon Station personnel rake dead grass out of the area to mitigate further erosion.

PL-8. Repaired Erosion Around Retaining Wall

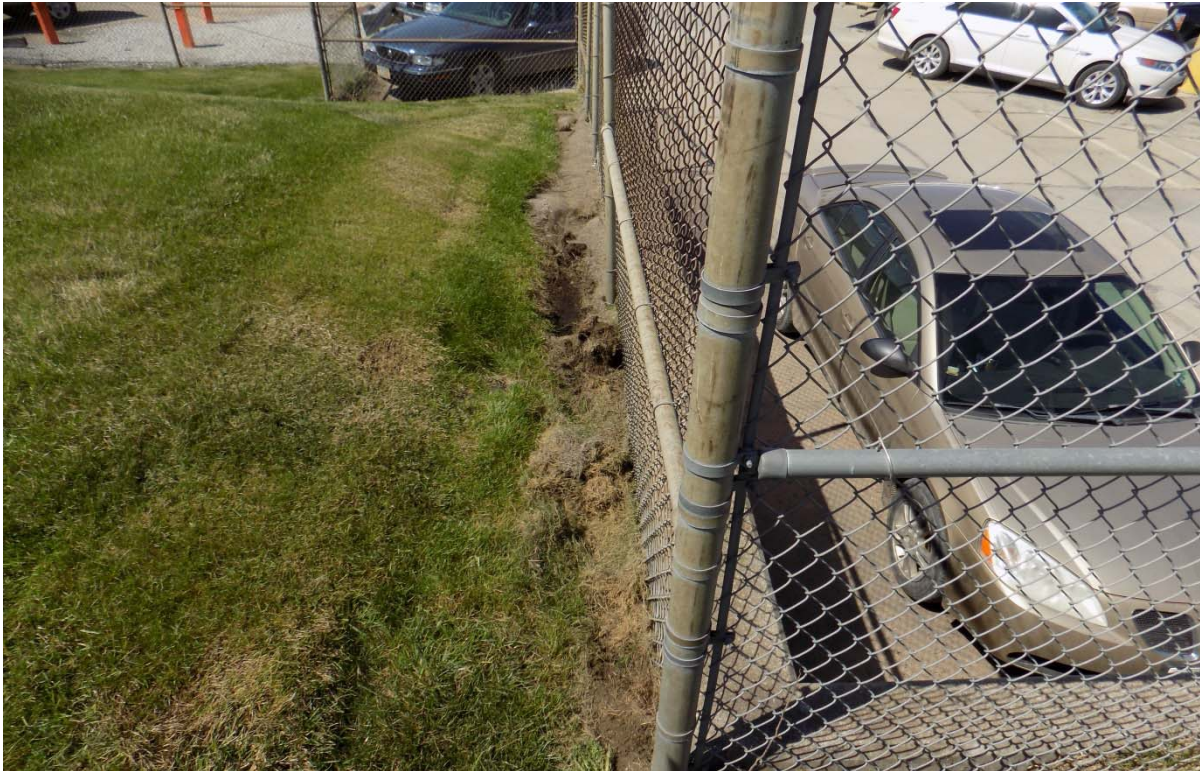
PL-9. Repaired Erosion Around Retaining Wall

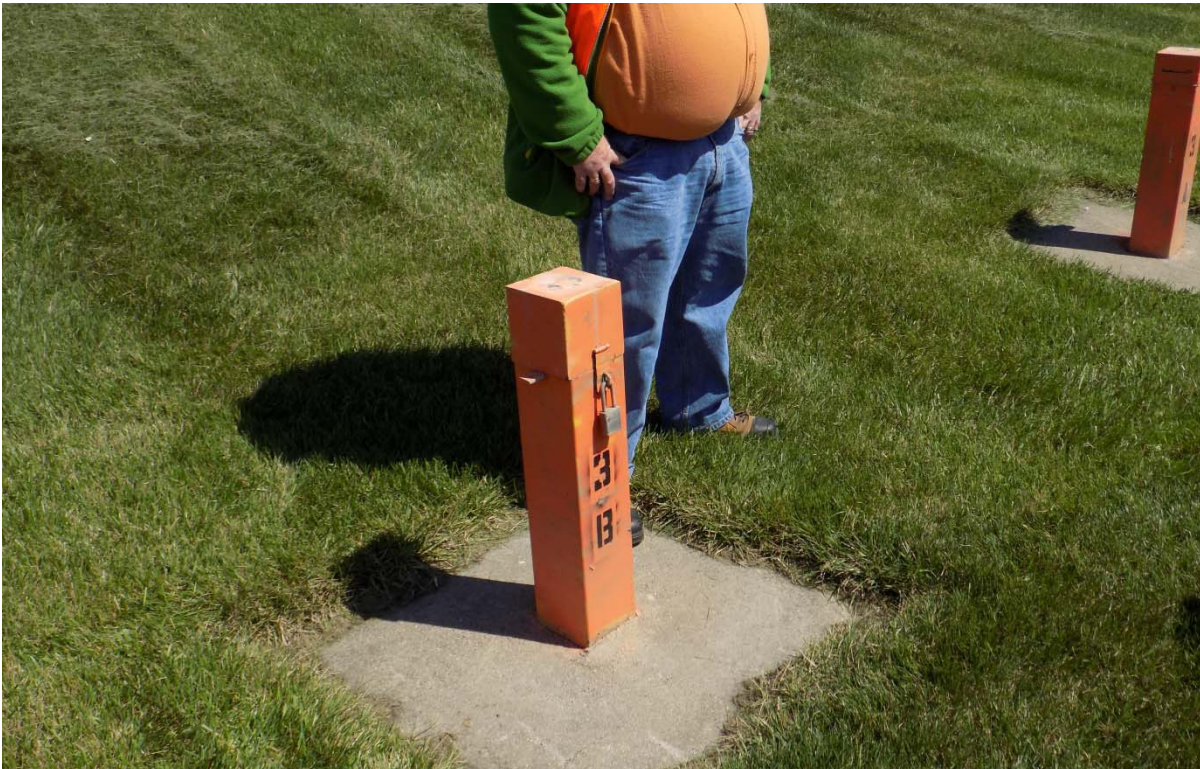
PL-10. Well OBS-3B

Four of the 19 monitoring wells are a flush-mount design and are locked using a special tool. The other 15 wells require a padlock. All 15 padlocked wells received a new lock in 2013, except for well OBS-3B. The hasp on well OBS-3B was too small for the shank of the new lock. A new smaller shank lock was installed in 2016 (PL-10). The wells are scheduled to be sampled again in 2021.

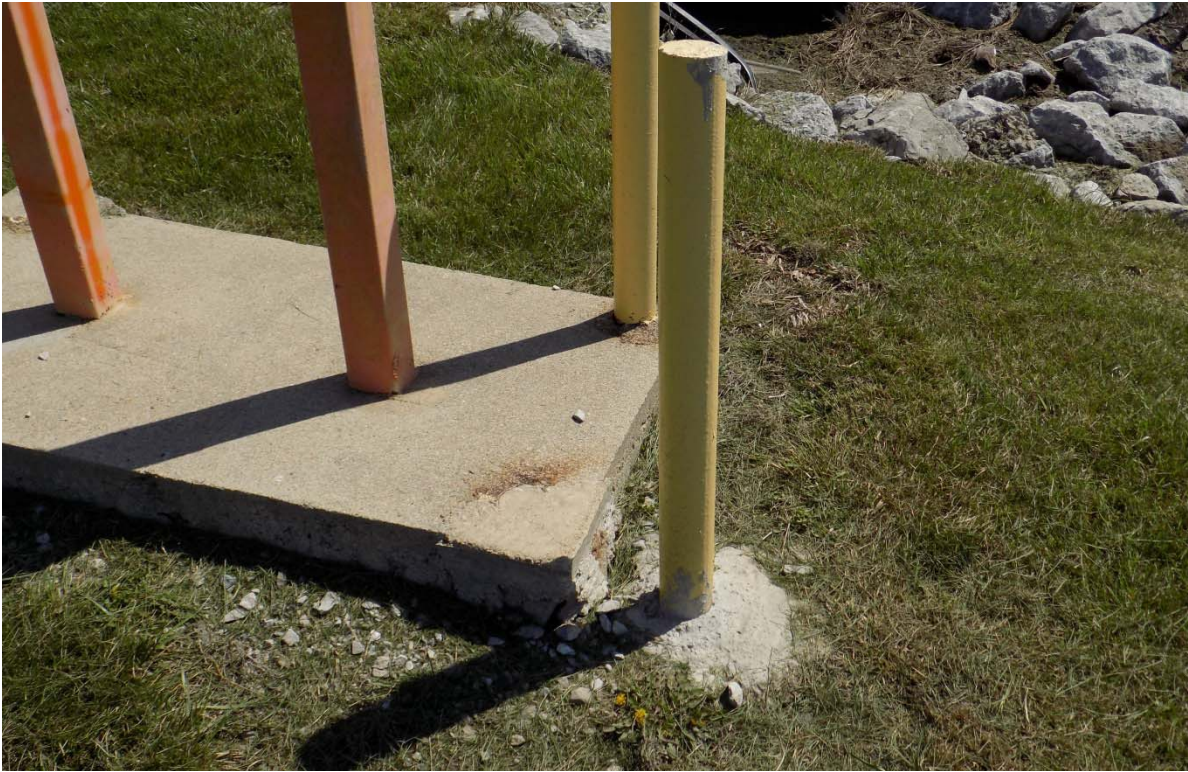
In 2016, the OBS-8 well pad was found to be loose, as were some of the protective bollards. When the wells were sampled in June, the sampling crew made repairs. The well pad and protective bollards are once again in good condition (PL-11 and PL-12).

PL-11. Southwest Corner of OBS-8 Well Pad

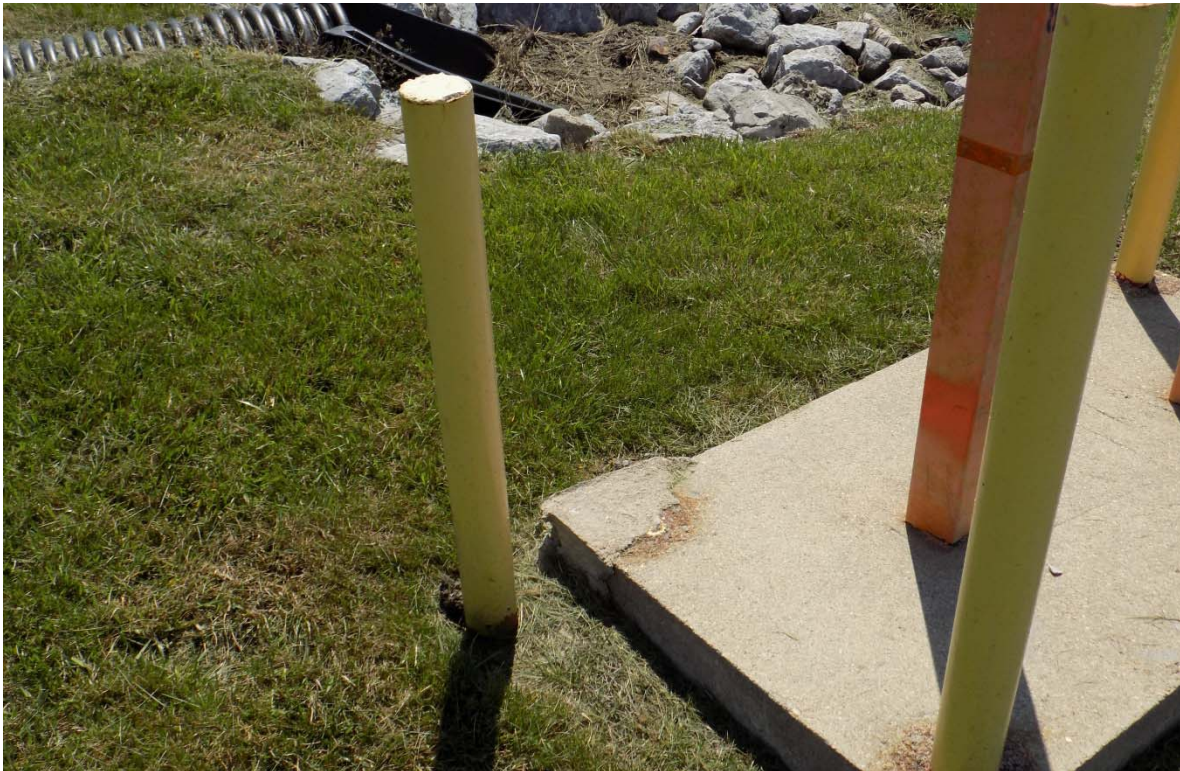
PL-12. Northeast Corner of OBS-8 Well Pad

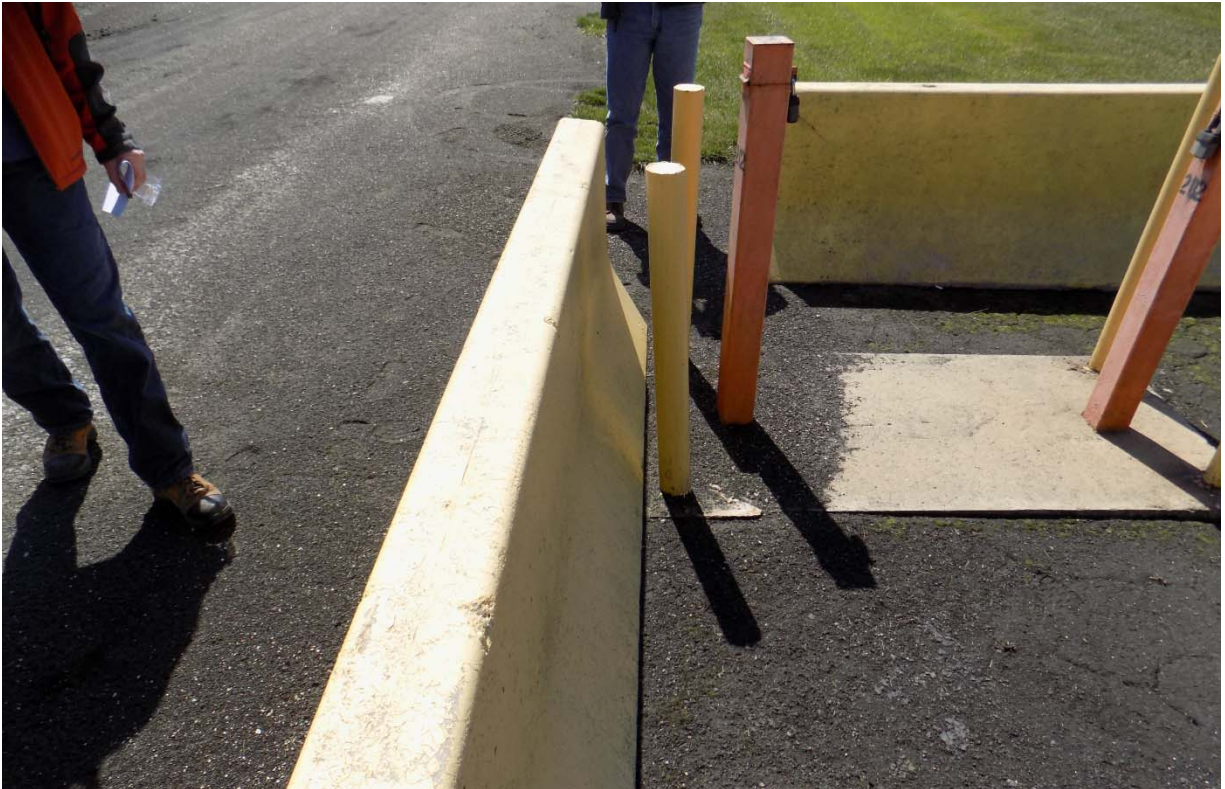
The concrete Jersey barrier on the east side of the OBS-2 well pad protects the well pad from power plant operations. Movement of this barrier continues to be a concern, as the barrier has been nudged west, closer to the well pad, over the past year (PL-13). A request was made to have Sheldon Station personnel nudge the barrier back a few feet to the east to provide a 3-foot spacing.

PL-13. Jersey Barrier Too Close to OBS-2 Well Pad
