# **1.0** Site Overview and Inspection Summary

The Burris Park, California, Site (formerly the Burris Park Field Station), is in the central part of a 57-acre park owned and maintained by Kings County Parks and Grounds Department. The site consists of a  $50 \times 50$  foot (ft) fenced area surrounding the  $42 \times 42$  ft decommissioned test pad, which is reinforced by concrete protective cover. This area once consisted of  $6 \times 6$  ft soil-filled concrete plots used to test the effectiveness of removing strontium-90 ( $^{90}$ Sr) from the soil. University of California—Berkeley scientists applied 72 millicuries (mCi) of  $^{90}$ Sr evenly to the soil in the late 1950s to conduct these tests under a contract with the U.S. Atomic Energy Commission. The site was decommissioned by filling and capping the plots with metal-mesh reinforced concrete in 1963. Although no further remediation is required, the U.S. Department of Energy (DOE) Office of Legacy Management (LM) accepted maintenance-only responsibility for the site and its remaining radioactive contents in November 2014.

The November 2023 (FY 2024) site inspection found the site in good condition with no follow-up acti

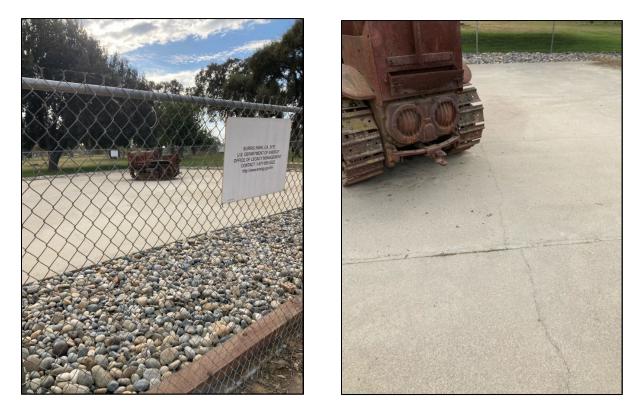
One antique farm tractor remains on the concrete pad due to its immobility and age (Photo 1). The Kings County Parks and Grounds Department superintendent and LM site manager discussed and agreed to keep the antique farm tractor on the concrete pad to avoid damage to the concrete protective pad. If and when the tractor needs to be removed in the future, both parties will discuss and schedule accordingly.

Photo 1. Historical Farm Tractor

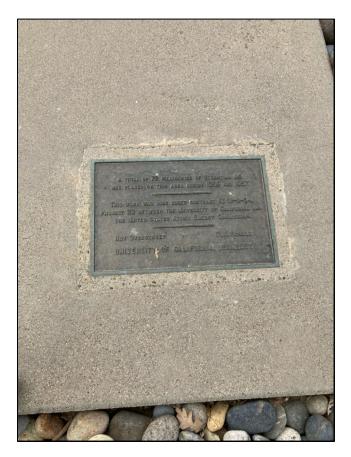
The historical bronze plaque on the southeast corner of the pad is legible and free of debris and remains in good condition. No maintenance or deferred maintenance are needed for this IC. Photo 3 shows the current condition of the plaque.

Photo 3. Historical Bronze Plaque

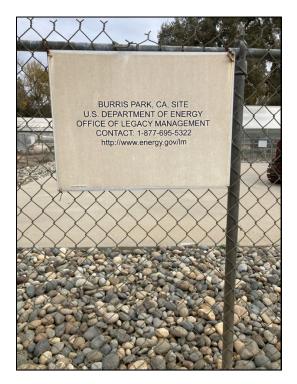
Signs on each side of the fenced area were present and found to be in good condition with no maintenance needs or cause for a follow-up inspection identified (Photo 4). However, it is recommended that signage be replaced with a modern version. Signs will be sent to Kings County to install.

Photo 4. Signage Posted on All Sides of Fencing
