2010 Inspection and Annual Site Status Report for the Site A/Plot M, Cook County, Illinois Decontamination and Decommissioning Program Site

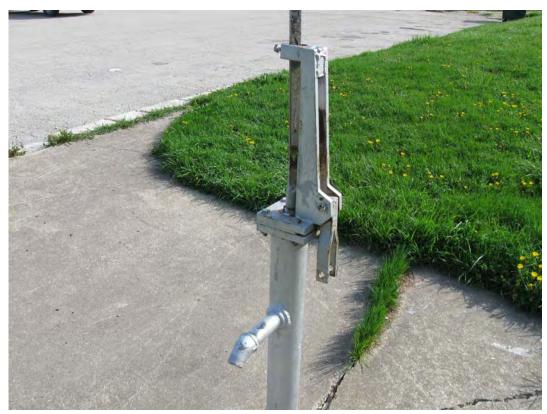
Inspectors met at the Red Gate Woods parking area and reviewed the Plan of the Day and the Job Safety Analysis. Inspectors noted that the pump handles remained off the picnic wells and that a portable restroom was in place (PL-1). The handles were removed from the pump to prevent exposure to tritium detected in the dolomite aquifer as well as fecal coliform detected in the groundwater. The fecal coliform originated from a nearby permanent restroom facility, which was removed and replaced with a portable restroom.

SAM 4/2010. PL-1. Public drinking water well at Red Gate Woods is inoperable because the handle has been removed.

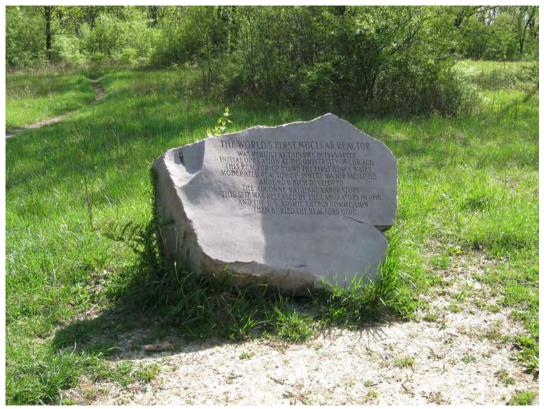
Inspectors drove to Site A, walked to the center of the area, examined the site marker (PL-2) and the monitoring wells. The site marker was in good shape.

SAM 4/2010. PL-2. Site Marker at Site A.

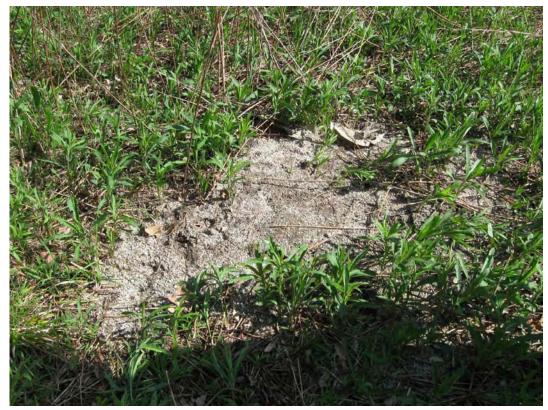
The holes identified last year during the 2009 inspection at Site A have been properly filled in with topsoil eliminating them as tripping hazards (PL-3).

SAM 4/2010. PL-3. Filled in hole at Site A.

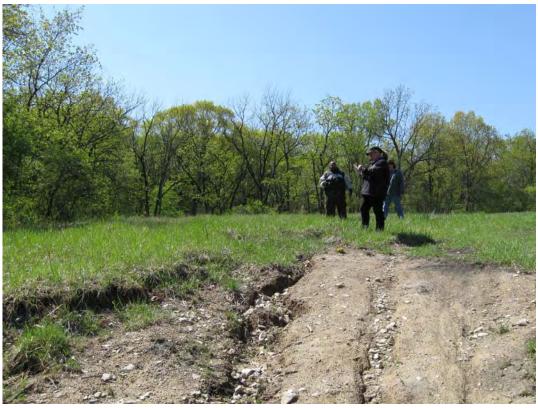
Erosion on top of the grass covered mound at Plot M (identified in previous inspections) has not been repaired. Two areas are present, one north of the site marker and one west of the site marker. Efforts by ANL to secure a subcontractor to repair the erosion are underway. The area north of the site marker has grown in size to be approximately 31 feet by 12 feet by 2-feet deep (PL-4, PL-5, and PL-6). The erosion in this area is impacting monitoring well BH-9 (PL-7) and also the area around one of the Plot M corner markers (PL-8). The erosion west of the site marker has grown to be approximately 13 feet by 3 feet by 1-foot deep (PL-9). The erosion in this area is also getting close to one of the Plot M corner markers (PL-10). It is recommended that both areas be restored to pre-erosion conditions using top soil to fill in the areas and perhaps honeycomb baffles to decrease the cutting power of future water flows in the areas.

5. Erosion on top of the mounded earth cover at Plot M is progressing (page 4).

SAM 4/2010. PL-4. Erosion at Plot M, north of site marker.

Recommendation: It is recommended that the erosion be addressed as soon as possible.

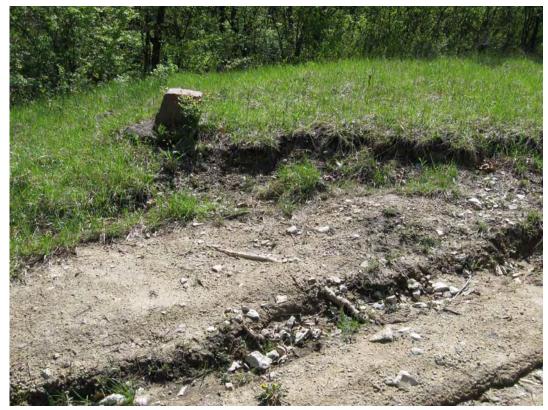
SAM 4/2010. PL-5. Erosion at Plot M, north of site marker.

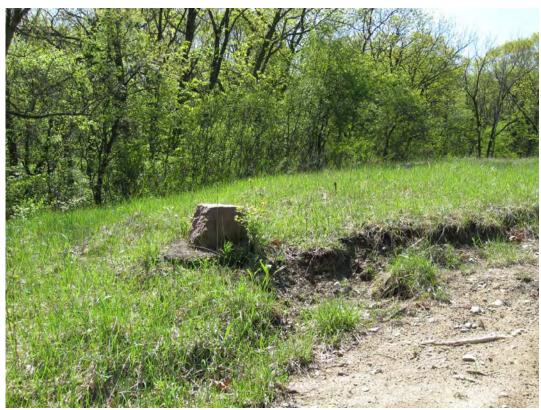
Inspectors drove from Site A to an area leading back to Plot M, and then walked back to Plot M. The Plot-M site marker was unchanged from last year's inspection. It was in good shape, with the exception of some minor vandalism. Some words on the marker are chiseled off. All of the Plot M corner markers were located and were in good shape, but as discussed below, erosion is beginning to undercut some of the markers and unless the erosion is corrected soon the markers will be further impacted.

SAM 4/2010. PL-6. Erosion at Plot M undercutting the corner marker north of site marker.

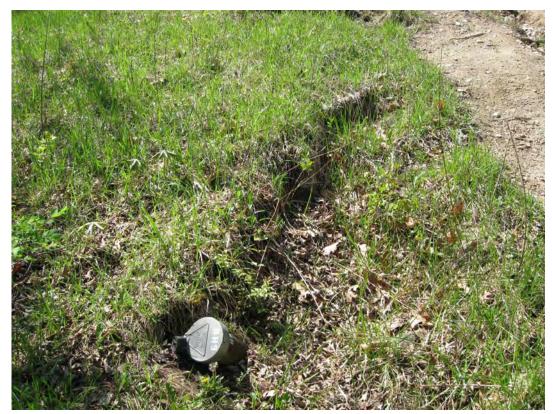
SAM 4/2010. PL-7. Monitoring well BH-9 impacted by erosion north of the Plot M site marker.

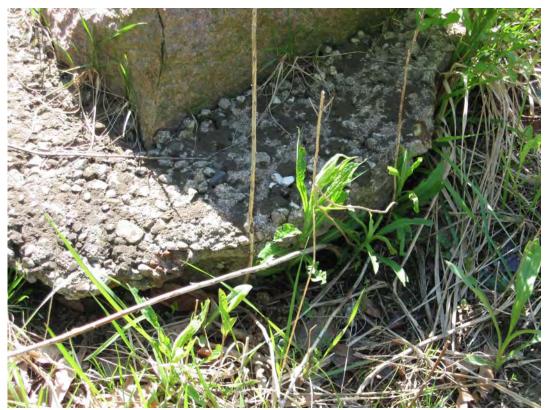
SAM 4/2010. PL-8. Erosion on Plot M north of the site marker is undercutting a corner marker.

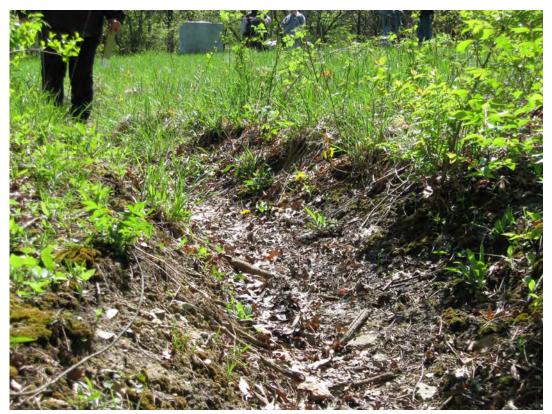
SAM 4/2010. PL-9. Erosion at Plot M west of the site marker.

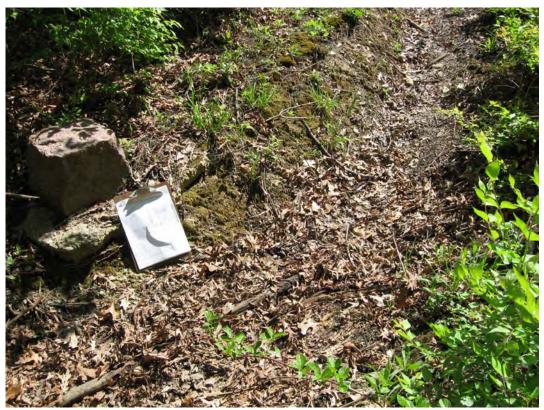
SAM 4/2010. PL-10. Erosion at Plot M west of the site marker.

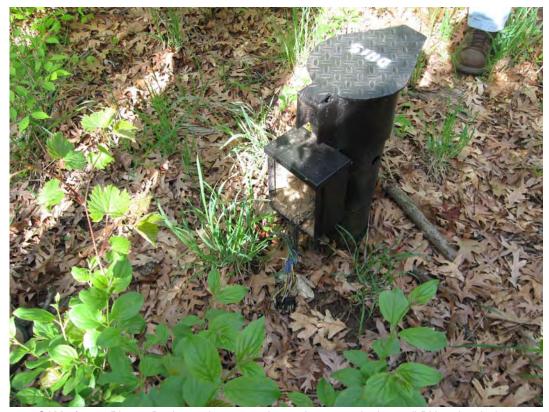
3. A panel on the well head of monitoring well DH–15 is missing and wires are exposed to the public (page 4).

SAM 4/2010. PL-11. Back panel on protective casing at monitoring well DH-15 is missing. Wires are exposed to the public.

Recommendation: It is recommended that the cover be replaced or the wires removed.

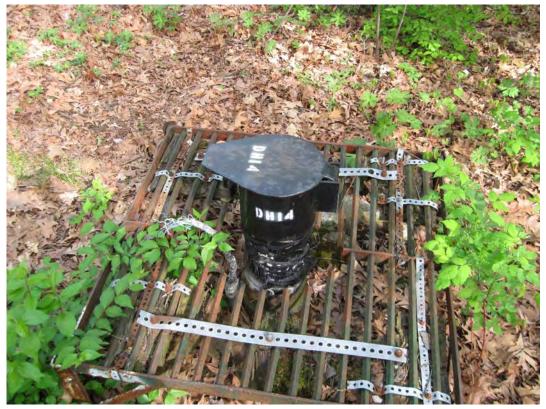
All nine monitoring wells at Plot M and ten monitoring wells north of Plot M were inspected and found to be secured with locks and identified with a well number on the outer casing. No monitoring wells were opened during the inspection. ANL personnel visit the wells quarterly for sampling, ensure well security, and perform required maintenance at that time. A couple of minor maintenance issues were identified in two of the ten wells north of Plot M. A panel on the well head of monitoring well DH–15 is missing, and wires are exposed to the public (PL–11). It is recommended that the cover be replaced or the wires removed. Metal grating is present around monitoring well DH–14 that could present a tripping hazard to the public and some wires also are exposed at the wellhead (PL–12). It is recommended that the metal grating and wires be removed.

4. Metal grating is present around monitoring well DH–14 that could present a tripping hazard to the public, and some wires are exposed at the wellhead (page 4).

SAM 4/2010. PL-12. Grate around monitoring well DH-14.

Recommendation: It is recommended that metal grating and exposed wires be removed.
