2017 Annual Inspection Report for the Parkersburg, West Virginia, Disposal Site

December 2017

U.S. DEPARTMENT OF
ENERGY

Legacy
Management

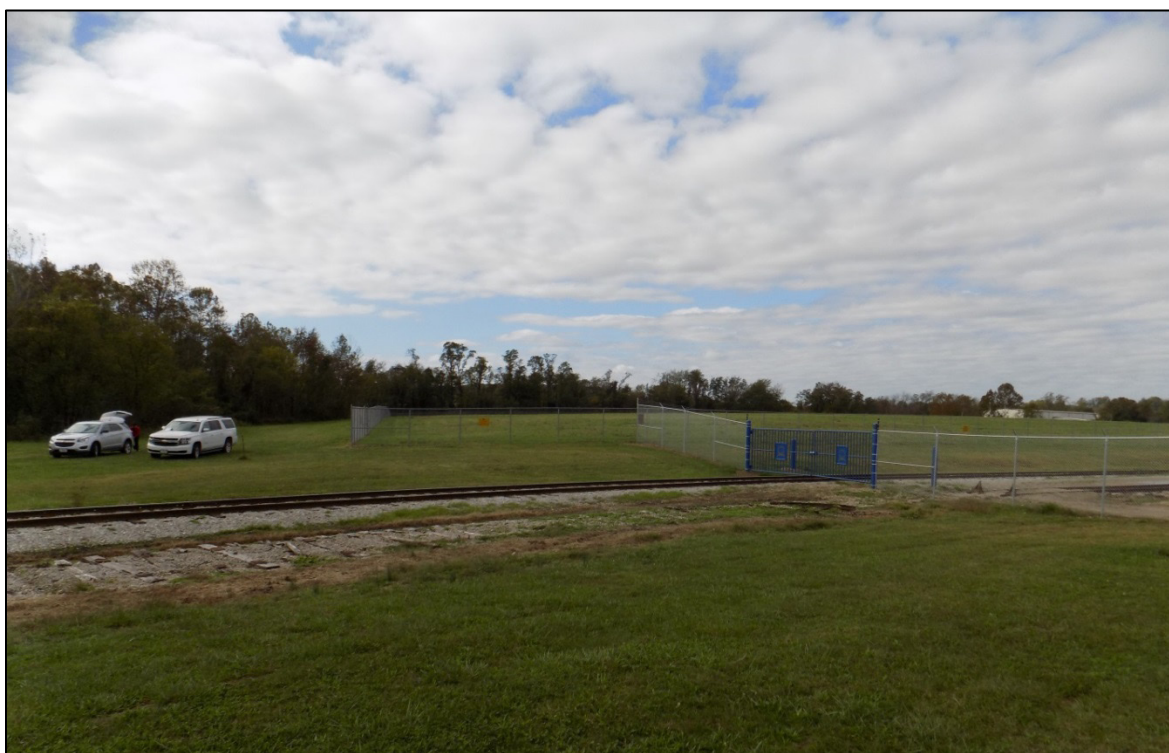
A rail spur that crosses the site right-of-way was replaced by Northwest Pipe in 2016. Vehicle access across the new spur is good. Northwest Pipe installed a new gate on the spur that connects to the site perimeter fence (PL-1).

PL-1. Looking Southwest Toward Site, Showing New Gate Installed on Rail Spur Leading to Northwest Pipe Property, with DOE Site in Background

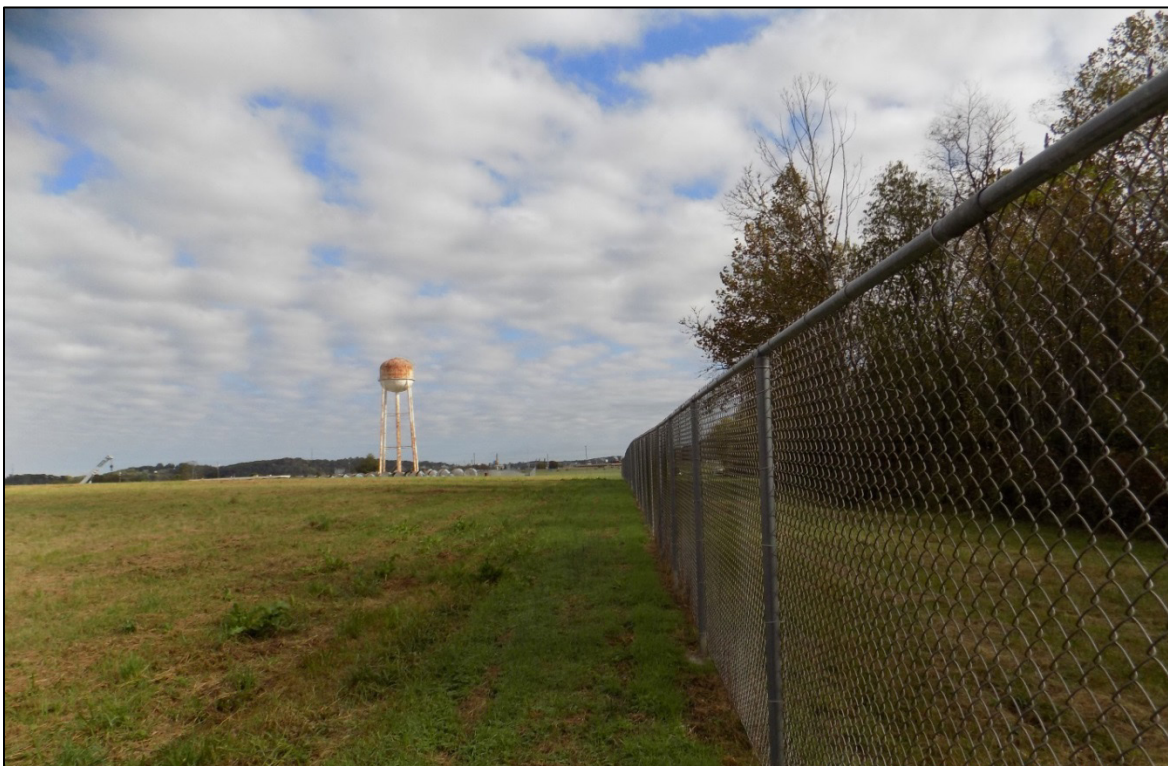
The perimeter fence was replaced in 2007. The site maintenance subcontractor maintains a vegetation-free zone along the base of the fence line (PL-2).

PL-2. Looking Northeast Down Fence Line

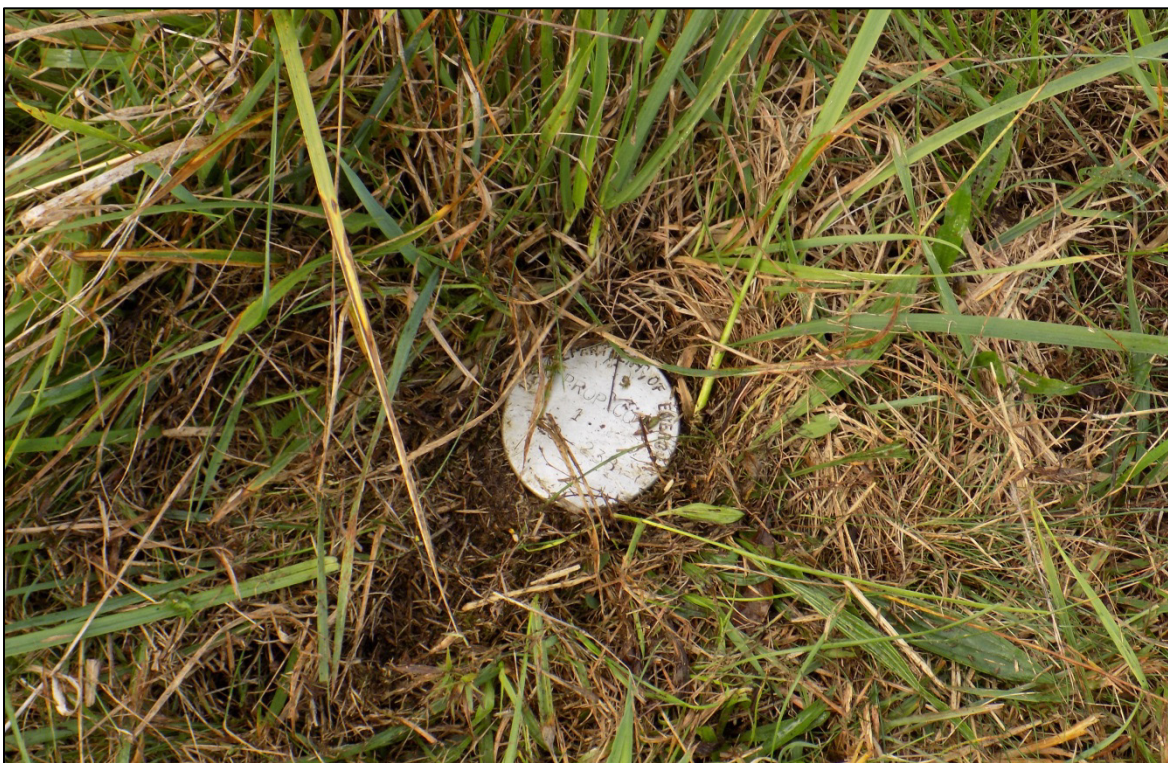
The Parkersburg site has six boundary monuments and one concrete survey monument. Boundary monuments BM-1, BM-2, BM-5, and BM-6 were located during the site inspection (PL-3). Despite the use of GPS instrumentation and a metal detector, boundary monuments BM-3 and BM-4 could not be located and need to be replaced. The concrete survey monument was not visited this year; it was visited in 2016.

PL-3. Looking Down at Boundary Monument BM-1

Boundary monuments BM-3 and BM-4 need to be replaced.

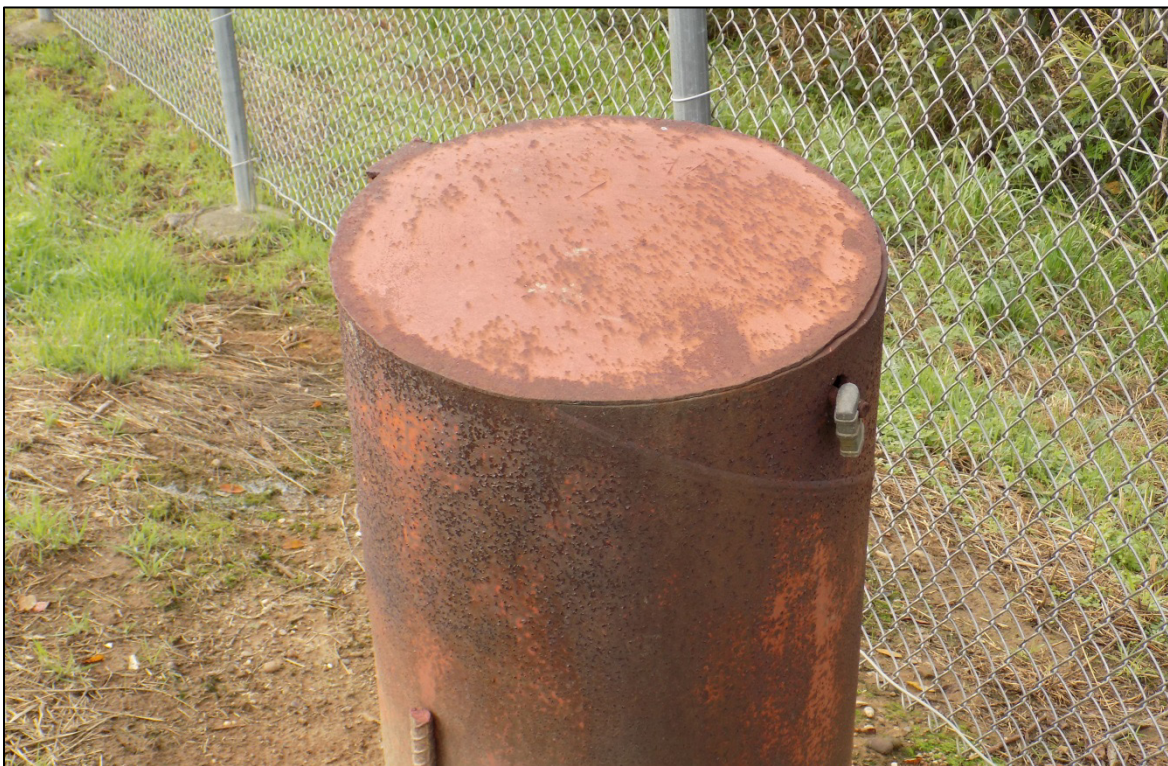
There are six groundwater monitoring wells at the Parkersburg site (PL-4). All six wells are inside the security fence. The wells are numbered in the chronological order in which they were drilled and installed. All six wells were properly locked. The site maintenance subcontractor is keeping vegetation cleared from around the monitoring wells.

PL-4. Looking West at Protective Casing of Monitoring Well MW-2

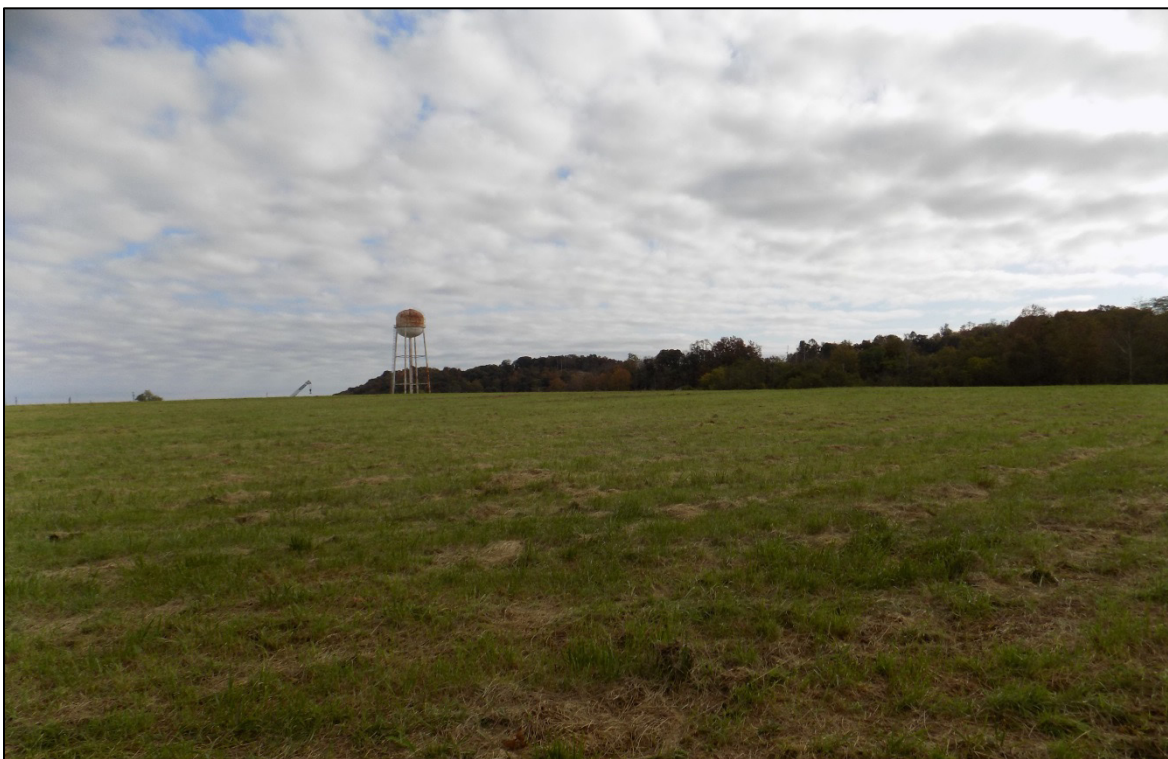
No evidence of erosion or slope instability on the disposal cell was noted during the inspection (PL-5). Dominant vegetation consists of fescue, crown vetch, and goldenrod.

PL-5. Looking Northeast Across the Top of the Disposal Cell

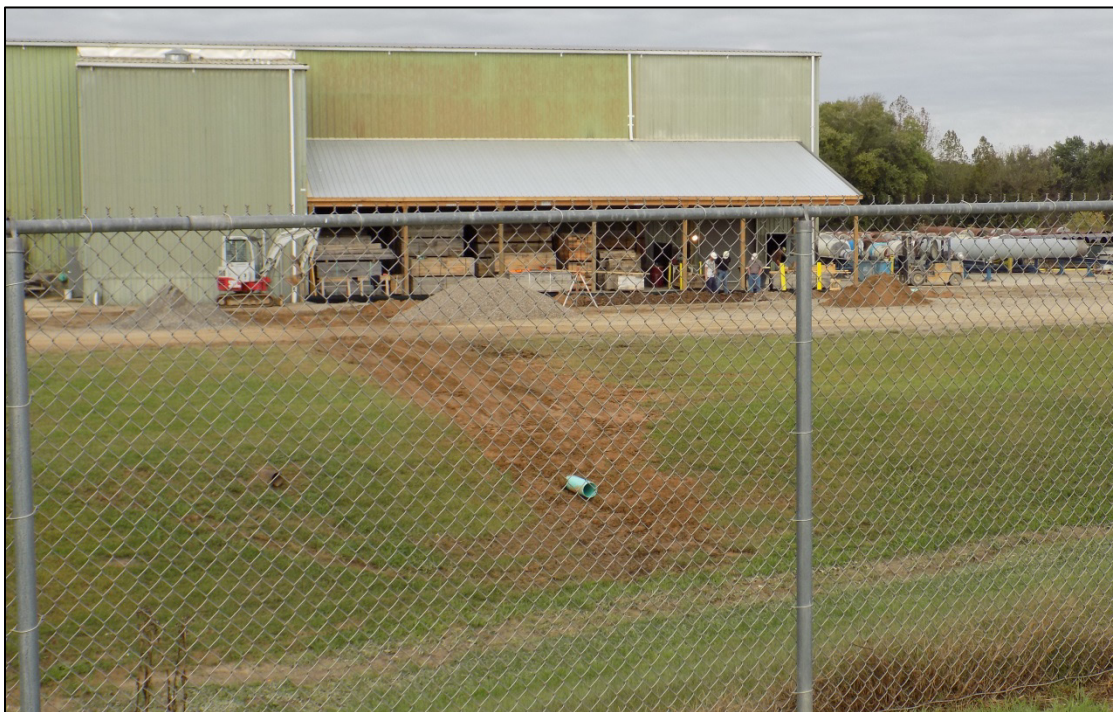
The Parkersburg site is in a developed industrial area. Inspectors observed what appears to be a lot of activity at Northwest Pipe. The area west of the perimeter fence, near boundary monument BM-4, was cleared of vegetation and is being maintained by Northwest Pipe (PL-6).

PL-6. Looking Northeast at New Drainage Pipe Installed from Northwest Pipe Property, with Site Fence in Background

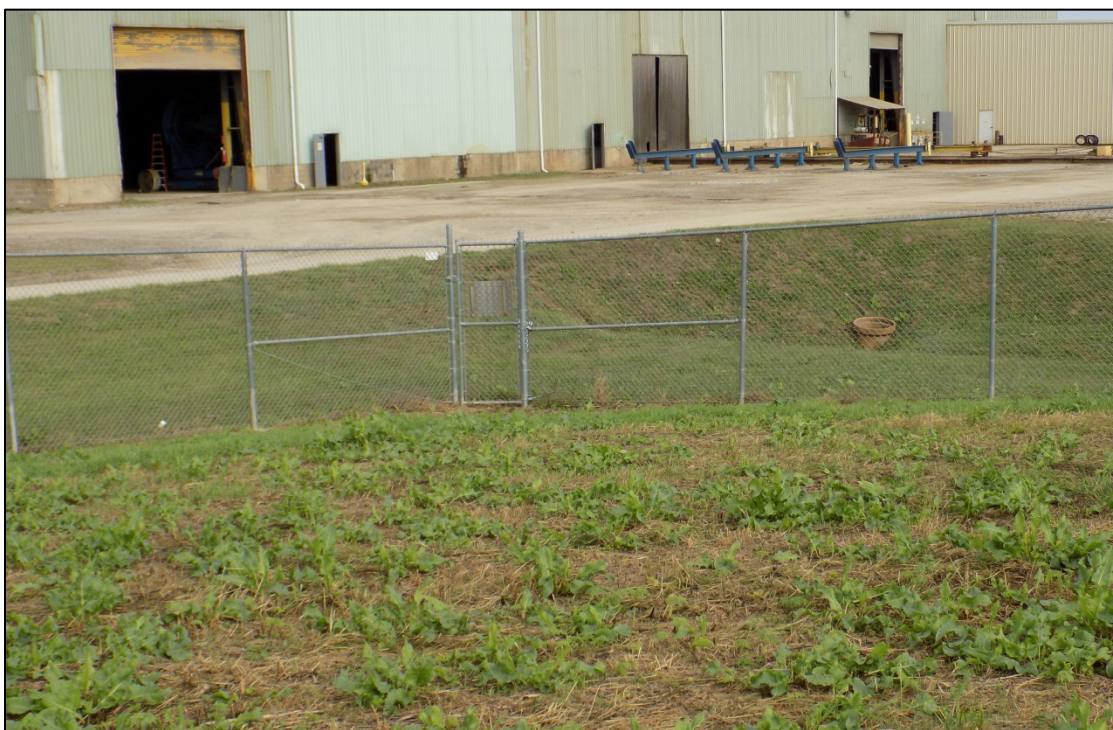
Vegetation management efforts have been partially successful and can be improved. Poison hemlock and Canada thistle are on the decline. However, excessive thatch buildup has left several large bare areas that are susceptible to invasive species (PL-7). Possibilities to improve the vegetation management efforts, including conservation reuse initiatives, will be investigated.

PL-7. Looking Northwest at Personnel Gate in Northwest Corner of the Site, with Northwest Pipe Facility in the Background

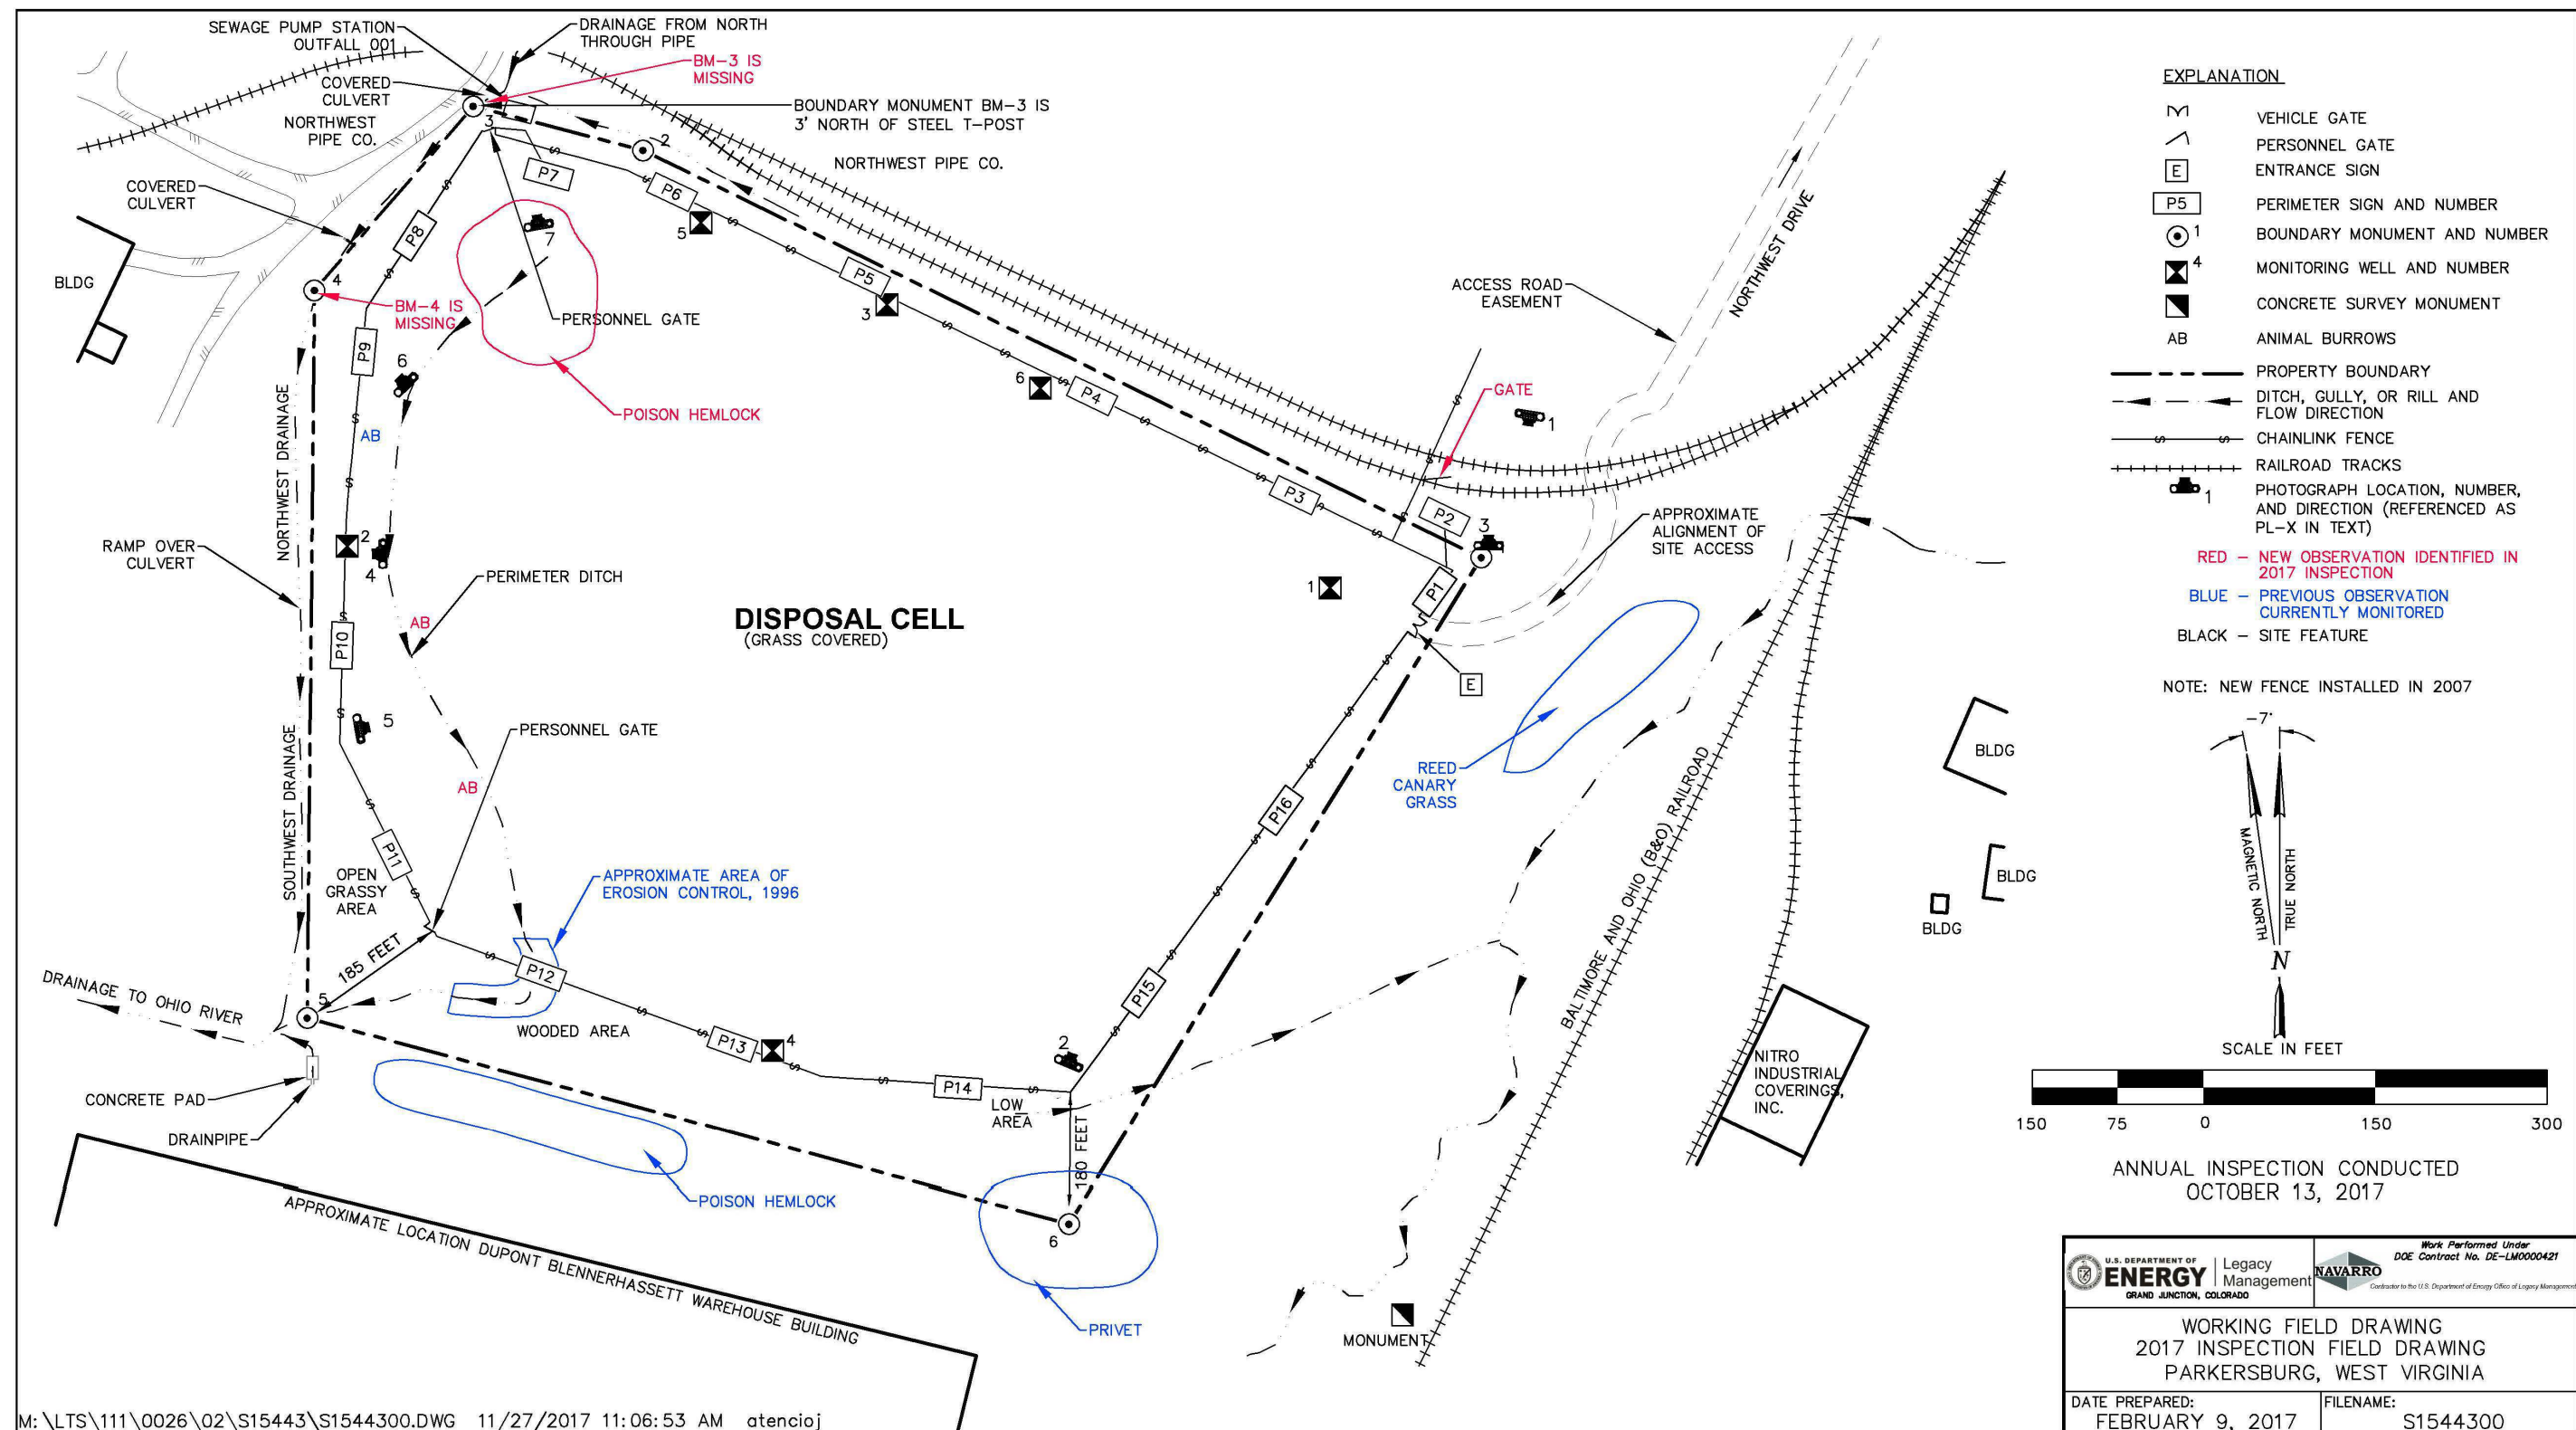
Figure A-1. 2017 Annual Inspection Drawing for the Parkersburg, West Virginia, Disposal Site

Animal burrows were present along the west perimeter fence; a couple of the burrows were quite large. Burrow locations are noted on the site inspection map to alert future inspectors to potential tripping hazards.

Several invasive species were observed in the eastern wooded portion of the site. Reed canary grass and wintercreeper have become established at locations identified in Figure A-1. Neither species is designated by the State of West Virginia as a noxious weed, but both are considered invasive due to their aggressive growth and because they are nonnative to the local ecosystem.
