2019 Annual Inspection Report for the Parkersburg, West Virginia, Disposal Site

January 2020

U.S. DEPARTMENT OF
ENERGY

Legacy
Management

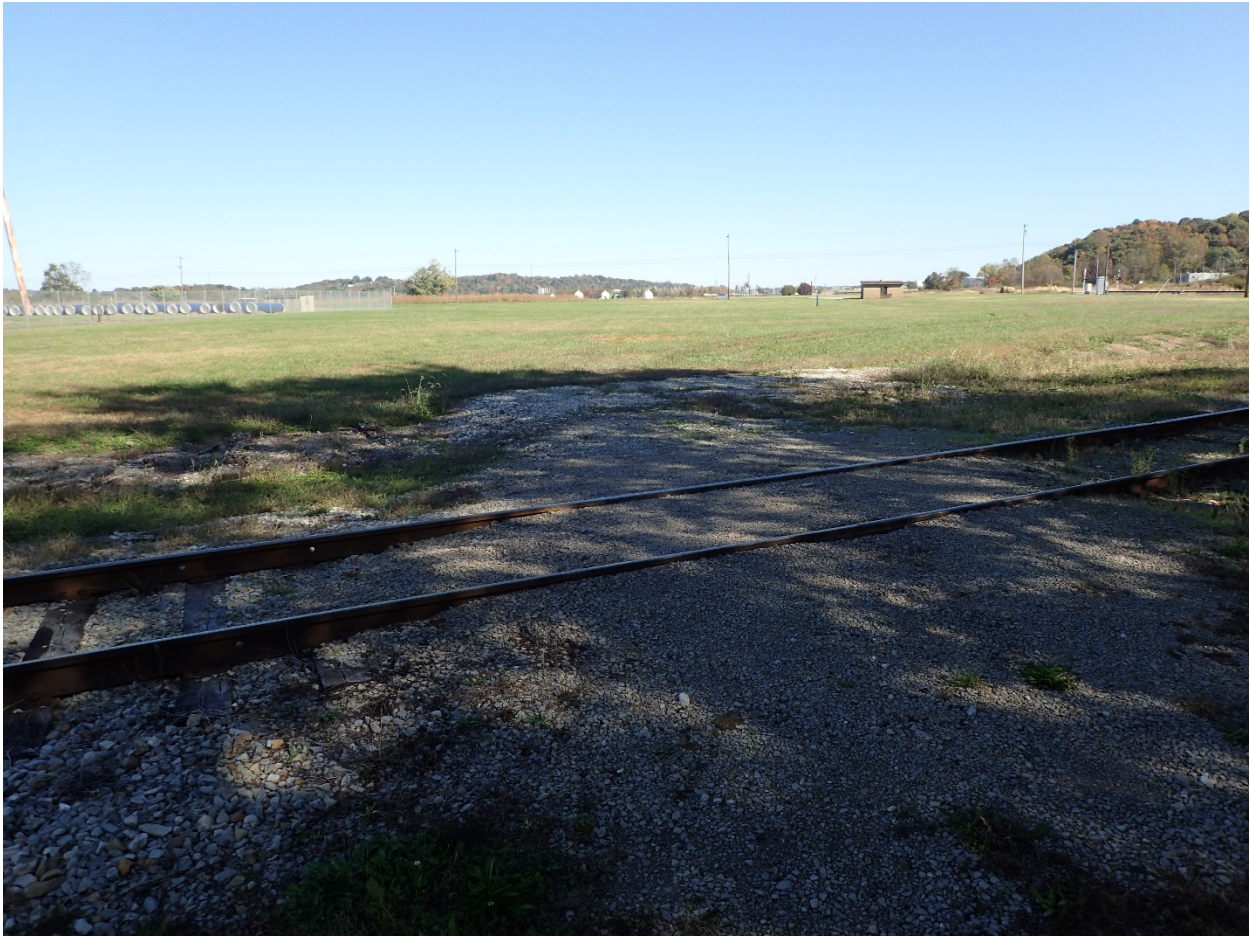
A rail spur belonging to Northwest Pipe, that crosses the site right-of-way, was replaced in 2016. Northwest Pipe maintains a gravel crossing where the rail spur crosses the site right-of-way to provide vehicle access to the site. The gravel crossing appeared to be well-maintained (PL-1). Vehicle access across the new spur was good.

PL-1. Gravel access across railroad tracks

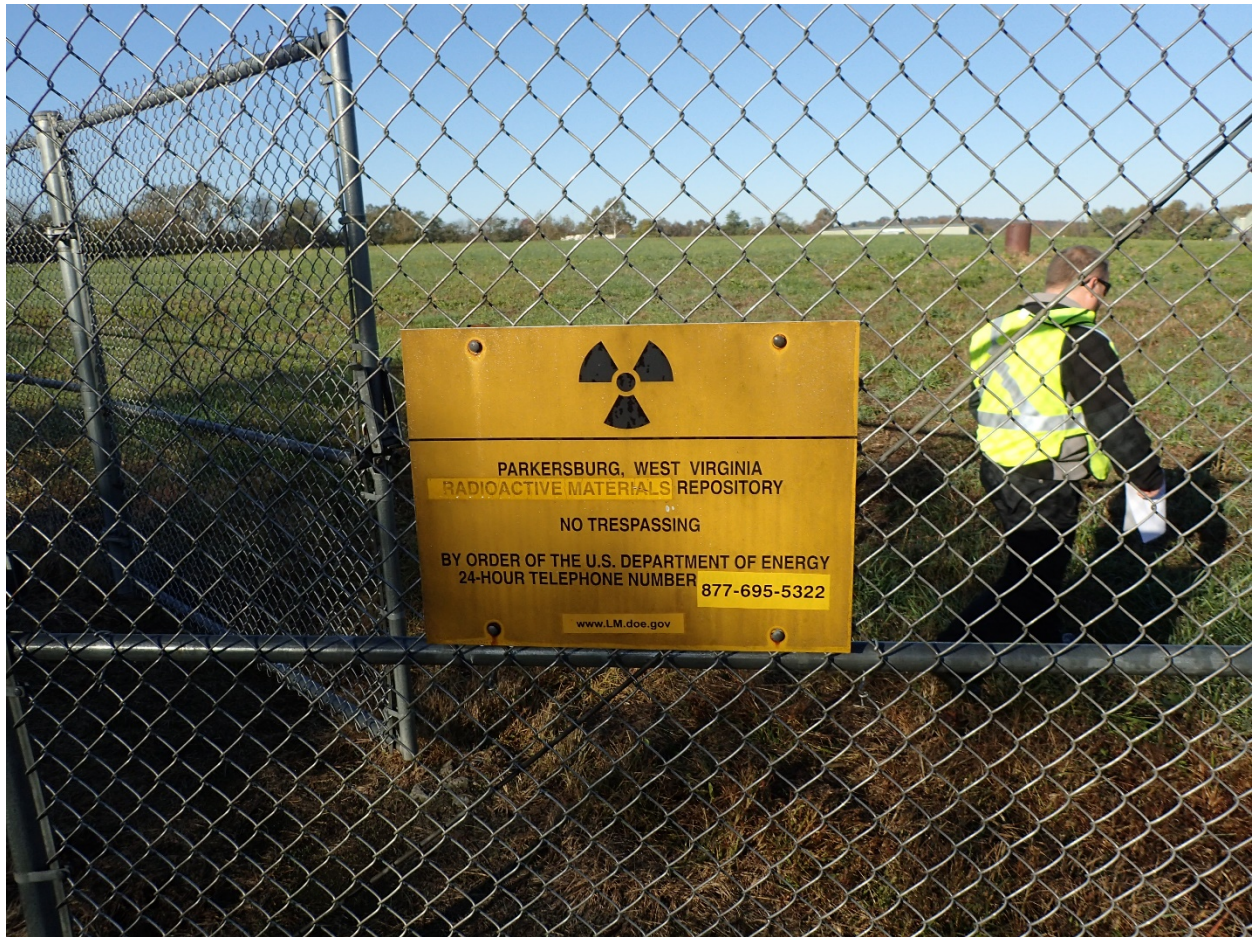
All entrance gates were properly secured. The entrance sign is current and legible (PL-2).

PL-2. Site entrance sign

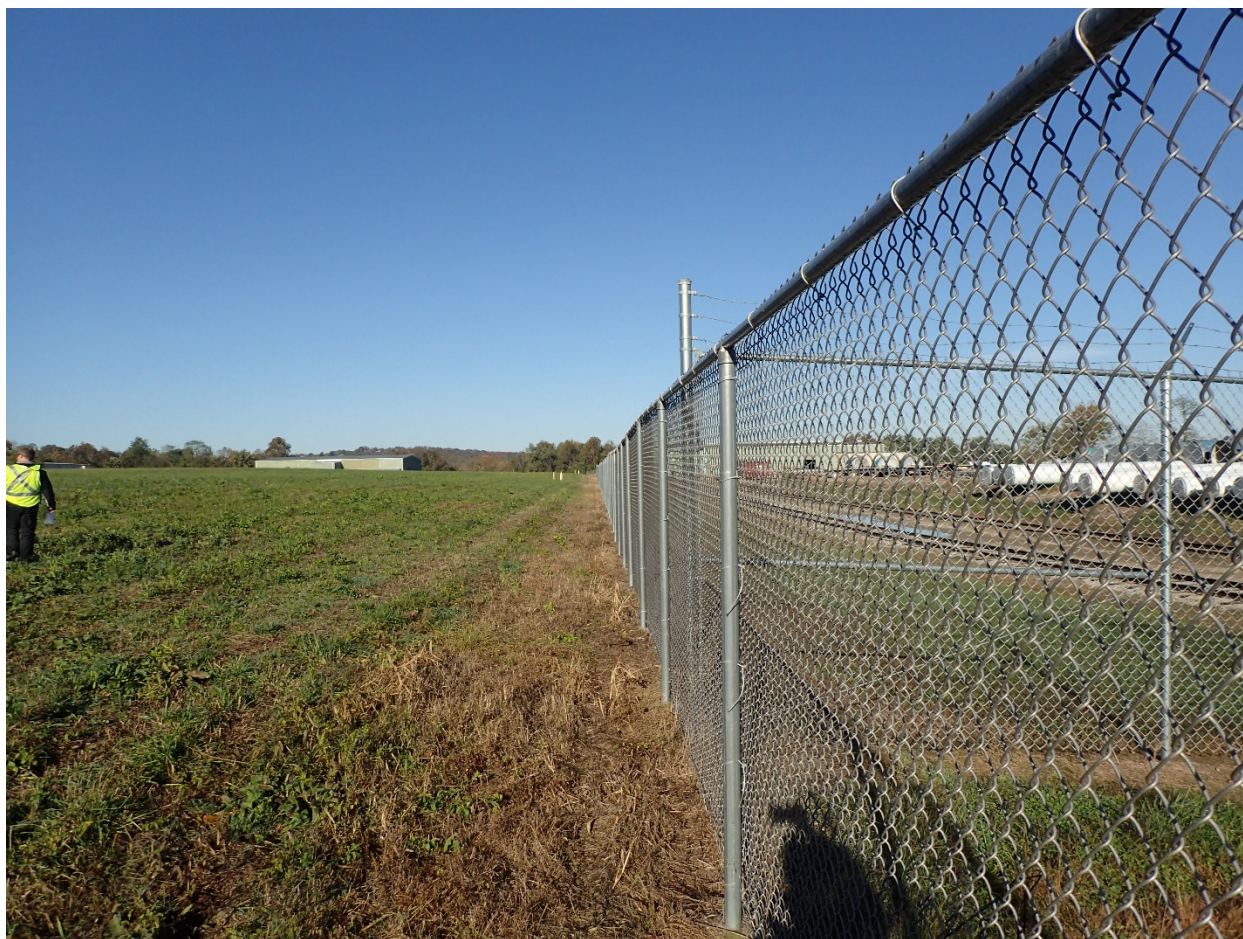
The perimeter fence was replaced in 2007. The site maintenance subcontractor is tasked with maintaining a vegetation-free zone along the base of the fence line and to keep vegetation from growing on the fence fabric. The vegetation-free zone along the fence line was being maintained, and the fabric was free of vegetation (PL-3).

PL-3. Northeast fence

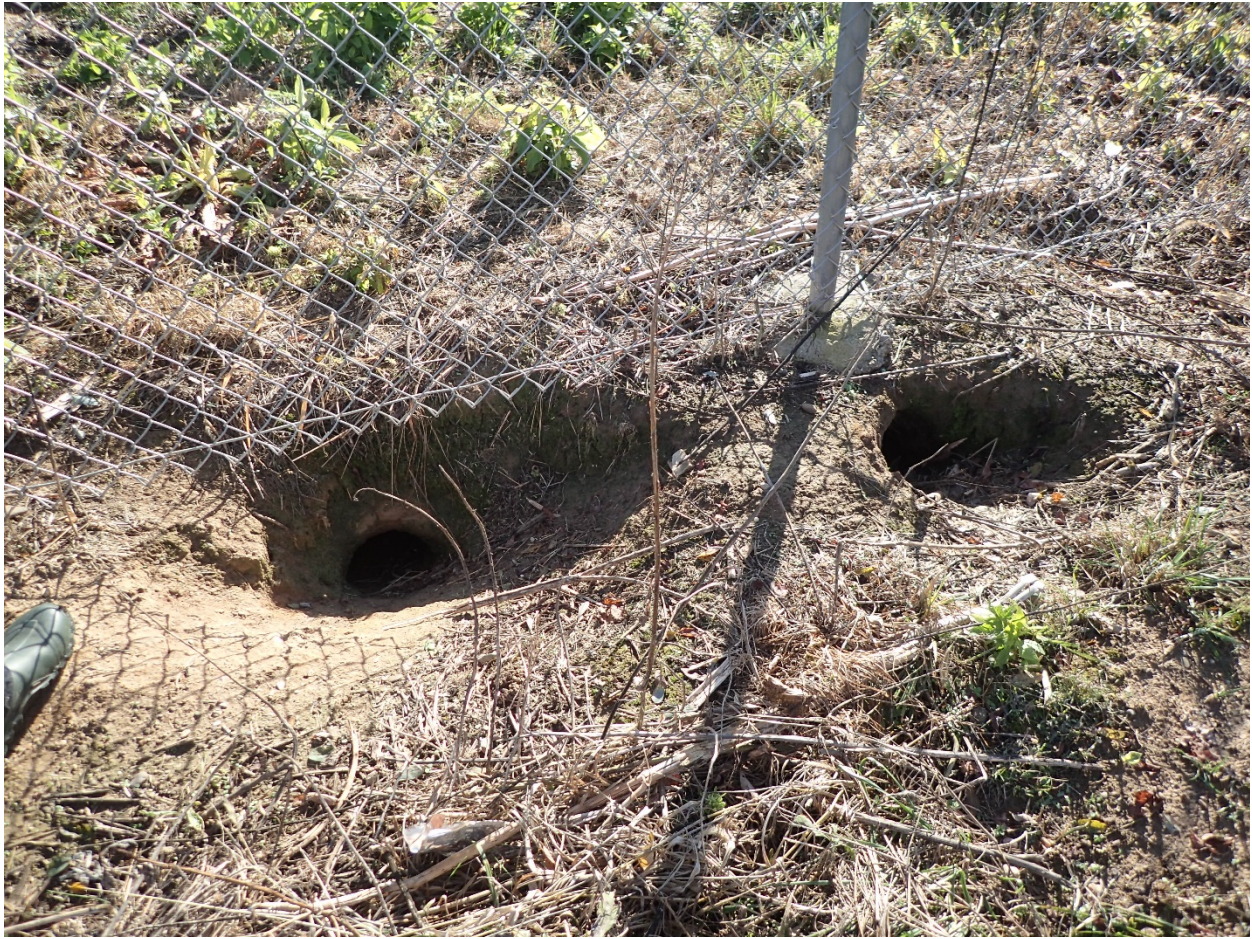
Animal burrows along the west perimeter fence (between perimeter signs P9 and P10) are noted on the site inspection map to alert future inspectors to potential tripping hazards. The animal burrows are getting rather large and will need to be addressed to eliminate a potential safety hazard to the vegetation management crew (PL-4). The site has 1 entrance sign and 16 perimeter signs. All signs were in place and legible.

PL-4. Animal burrows

Animal burrows along the west perimeter fence (between perimeter signs P9 and P10) need to be addressed to eliminate a potential safety hazard to the vegetation management crew.

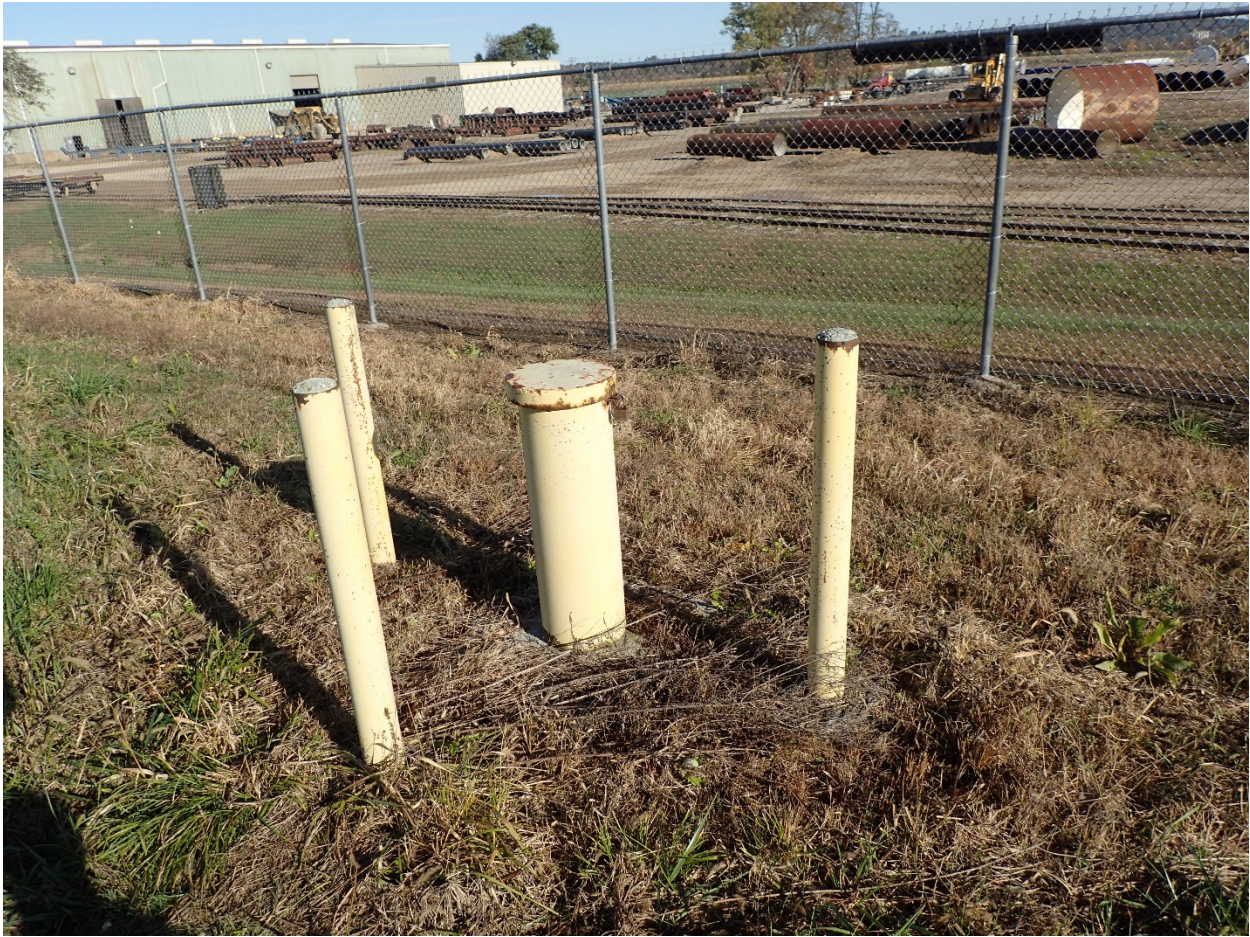
There are six groundwater monitoring wells at the Parkersburg site. All six wells are inside the security fence. The wells are numbered in the chronological order in which they were drilled and installed. All six wells were properly locked. The site maintenance subcontractor is tasked with keeping vegetation cleared from around the monitoring wells. Vegetation was being properly controlled around the monitoring wells (PL-5).

PL-5. Monitoring well 5

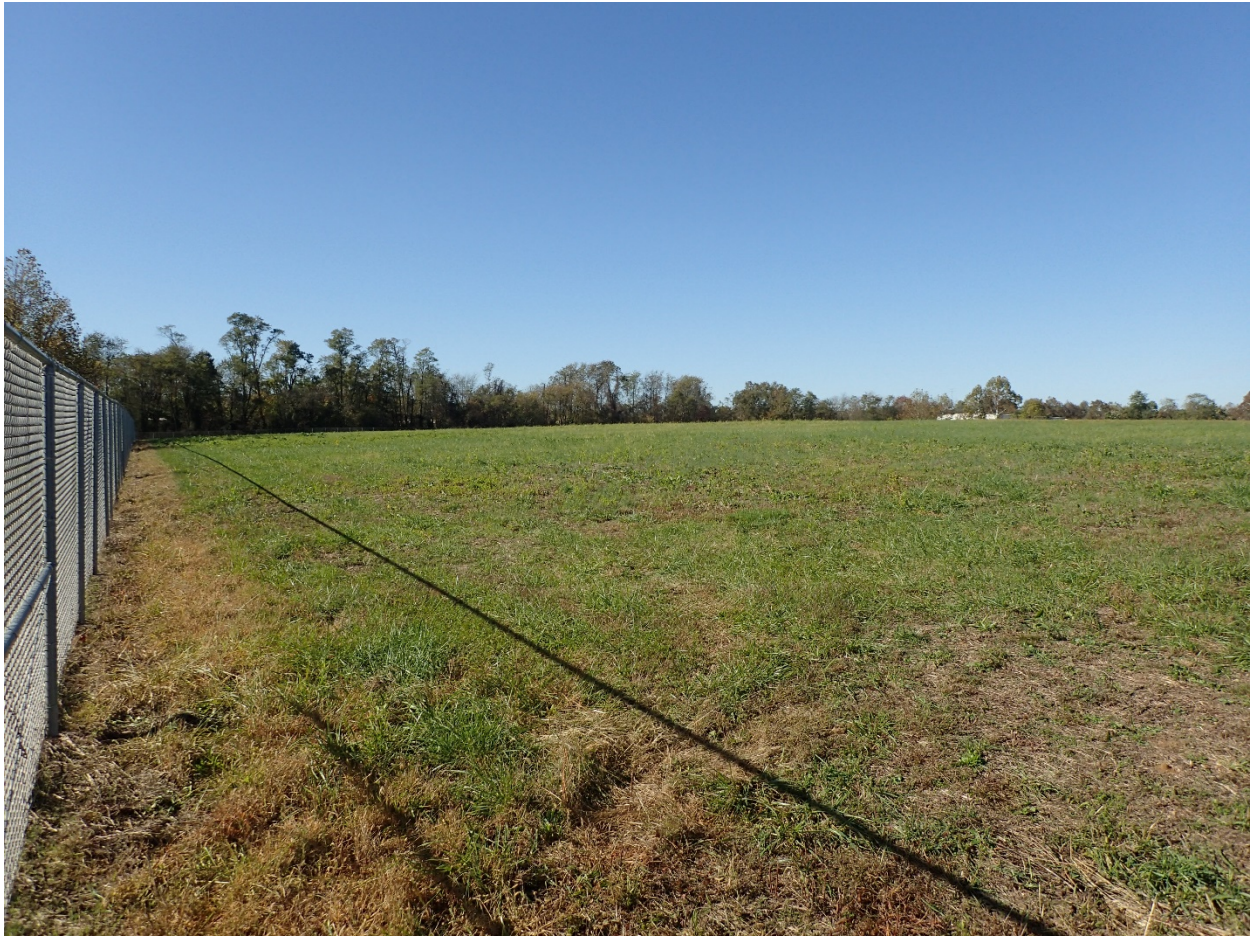
At the time of the inspection, vegetation on top of the disposal cell had been recently mowed. No evidence of erosion or slope instability on the disposal cell was noted during the inspection (PL-6 and PL-7).

PL-6. South side of disposal cell

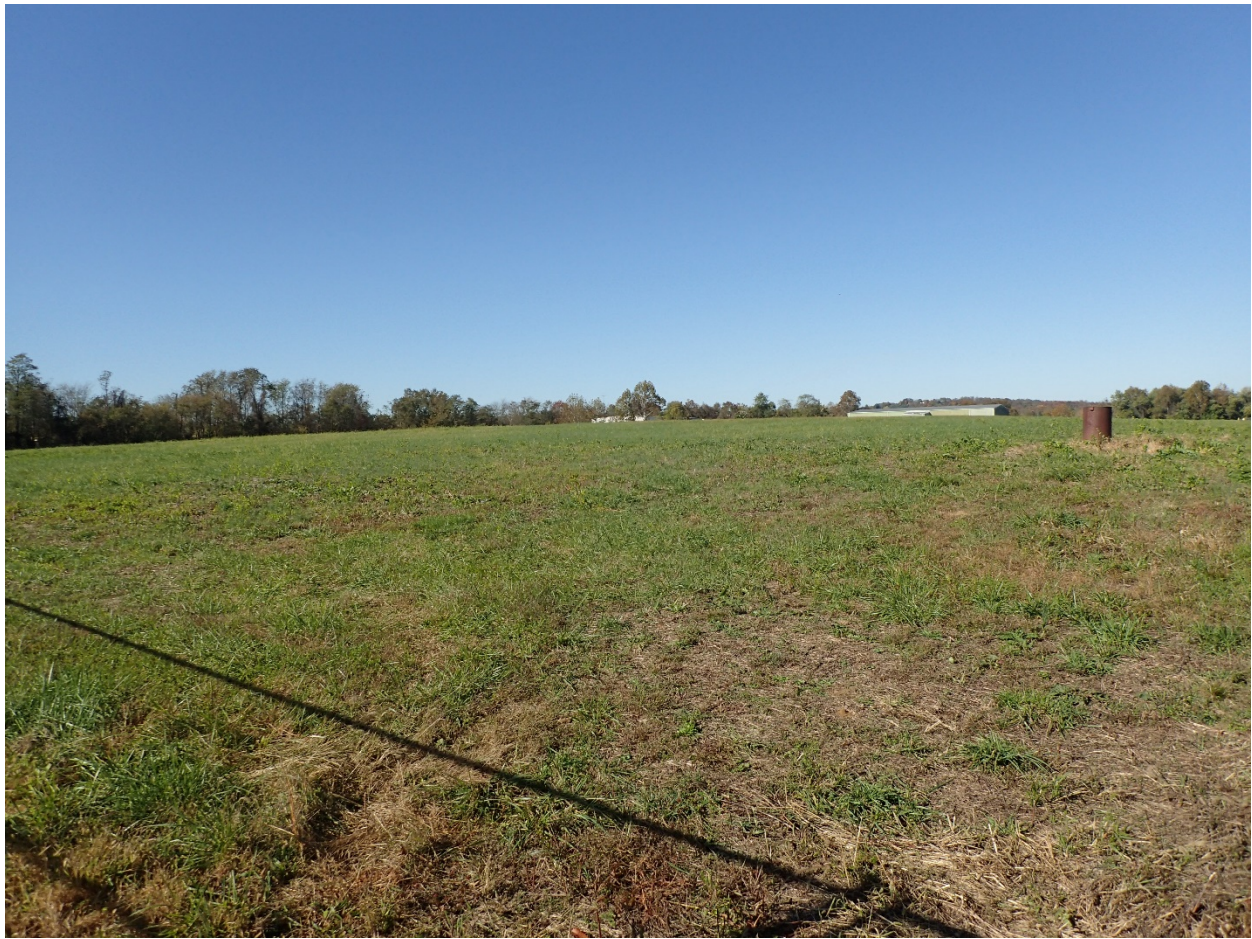
PL-7. Top of disposal cell
