2024 Annual Site Inspection Report for the Piqua, Ohio, Decommissioned Reactor Site

June 2024

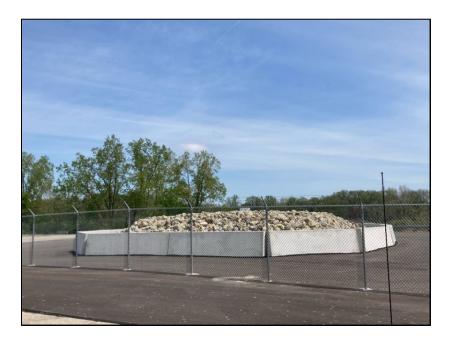
The onsite low-level waste entombment was found to be in excellent condition. No slumping was observed in the riprap cover nor was there any presence of vegetative growth (refer to Figure 1).

Figure 1. Onsite Low-Level Radioactive Waste Entombment

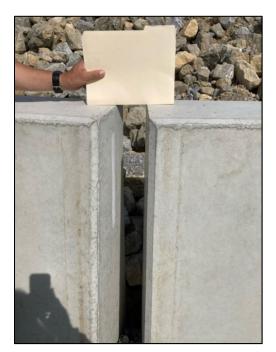
The protective jersey barriers are in place as designed surrounding the entombment. It was observed that there are several instances where the jersey barriers do not contact each other, leaving gaps of up to 6 inches. Although this condition was observed, there is no adverse impact to their functionality of protectiveness (refer to Figure 2). The site marker was in place in the center of the entombment and found to be in excellent condition (Figure 3). Lastly, there was no evidence of trespassing or vandalism.

Figure 2. Examples of Spacing Between Protective Jersey Barriers

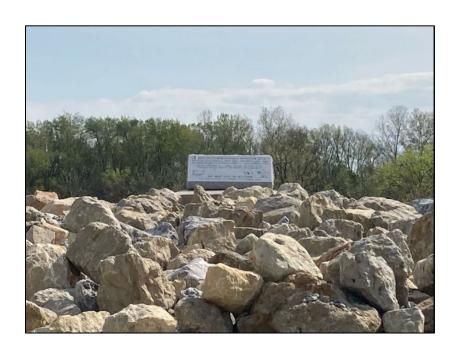
Figure 3. Piqua Site Marker Placed atop the Center of the Entombment

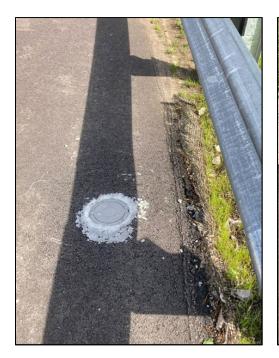
The area surrounding the entombment was visually observed. The four corner markers of the DOE-owned property were visually verified (refer to Figure 4). In addition, the newly (2023) paved parking lot and 1-year-young vegetation on the eastern hillside were visually inspected. The parking lot was found to be in excellent condition. No subsidence was observed (refer to Figure 5).

Figure 4. Two of the Four Property Corner Markers

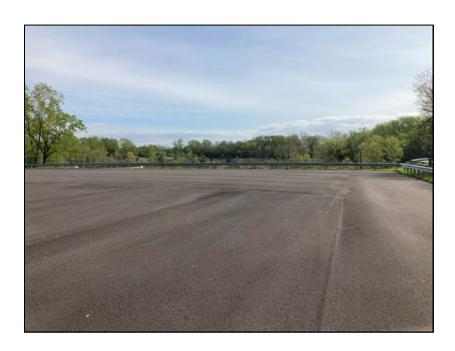
Figure 5. Newly Paved Area Where Administration Building Stood in 2023

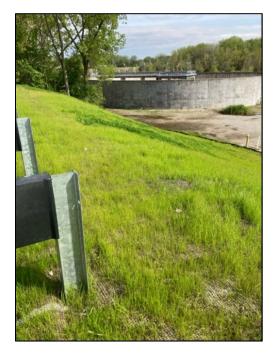
As for the eastern hillside, the vegetation was in good health with a few bare spots noticed and a minor surface erosion near the base of the hillside near the wastewater treatment plant retaining wall. No slumping or sliding was observed. The area of slight erosion does not appear to be impactful to the stability of the hillside. This area will be reassessed during the 2025 site inspection to reaffirm no impact. Refer to Figure 6 and Figure 7.

Figure 6. Vegetation on Eastern Hillside

Figure 7. Small Erosion Near Base of Hillside

No maintenance action resulted from the site inspection. It is noted that the eastern hillside minor erosion area will be reassessed during the 2025 annual site inspection.

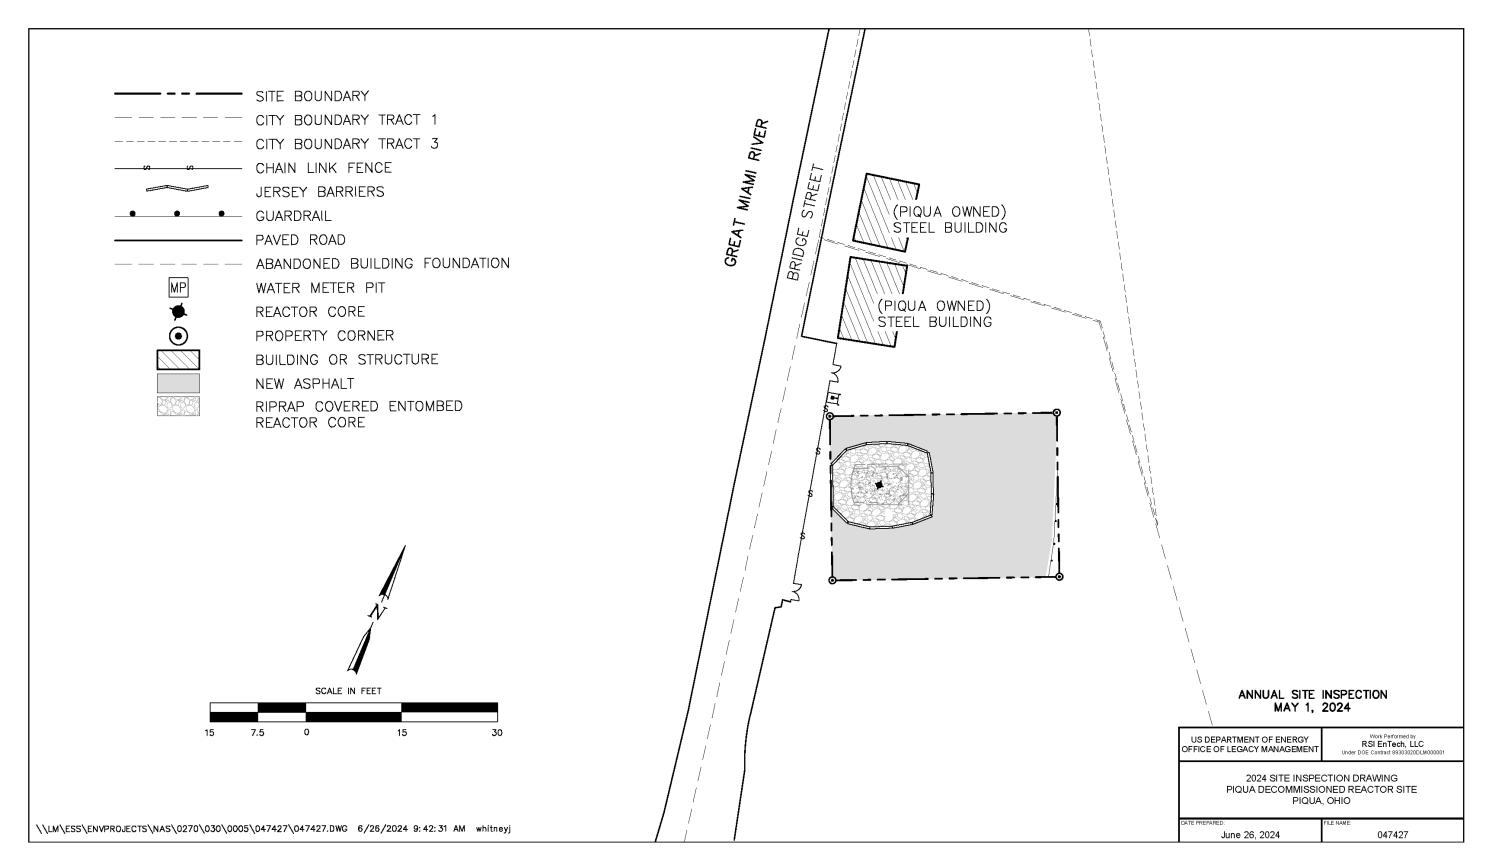
Figure A-1. 2024 Annual Site Inspection Map for the, Piqua, Ohio, Decommissioned Reactor Site
