**2024 Annual Land-Use Covenant
Inspection Report
for DOE Areas at the Laboratory
for Energy-Related Health
Research/Old Campus Landfill
Superfund Site
University of California, Davis**

January 2025

U.S. DEPARTMENT OF
ENERGY

Legacy
Management

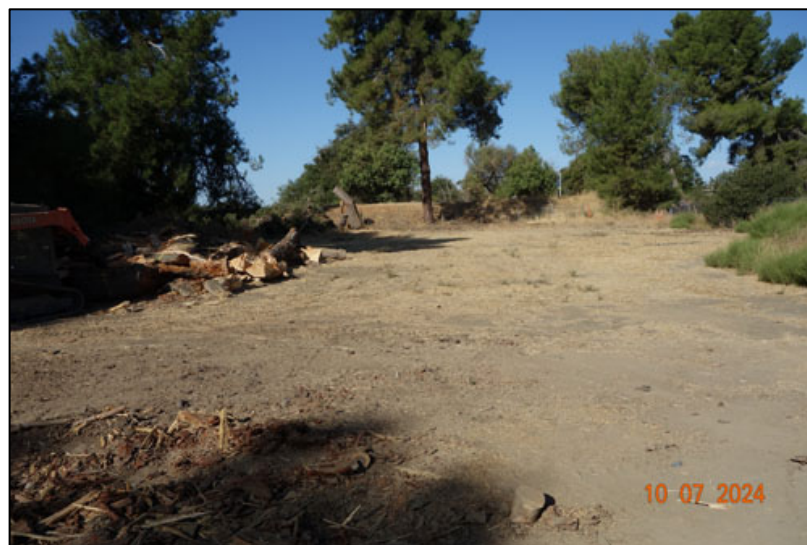
View West of SWT Area: Shoulder of Old Davis Road in Background; UC Davis Tree Debris in Center Left of Photo (Photo No. 8809)

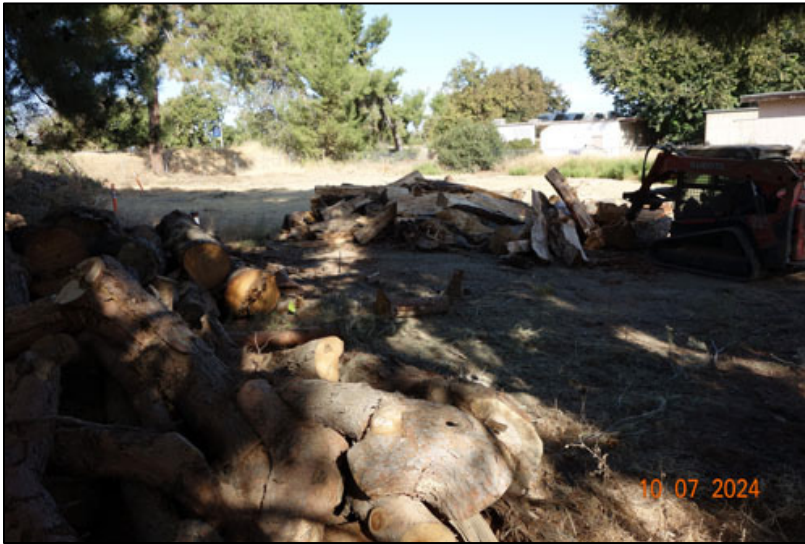
View Northwest of SWT Area: UC Davis Tree Debris in Center of Photo (Photo No. 8810)

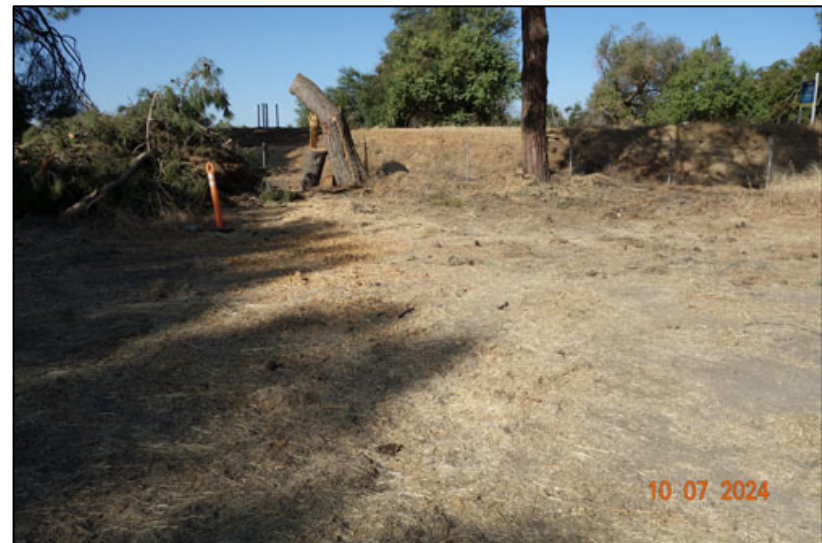
On October 8, 2024, one tree located in the WRS Area (tree 16206), and one tree located in the SWTs Area (tree 16220) were observed to be removed, and lower limbs from SWTs Area tree 16219 were also observed to be removed. As presented in Section 1.3.1, trees 16206 and 16220 had fallen in August 2024 and UC Davis Facilities Management staff had moved them along with the lower limbs of tree 16219 to a new stockpile in the southwest corner of the SWT Area. In addition, stanchions and rope installed in previous years that surrounded fallen limbs from SWT Area trees 16219 and 16220 were observed surrounding the new stockpile in the southwest corner of the SWT Area. UC Davis Facilities Management staff had also moved the previously fallen limbs from trees 16219 and 16220 to the new SWT Area stockpile.

View West from Center of SWT Area: Fallen Tree 16220 and Stanchions and Rope Surrounding New Tree Debris Stockpile in Upper Left of Photo (Photo No. 8813)

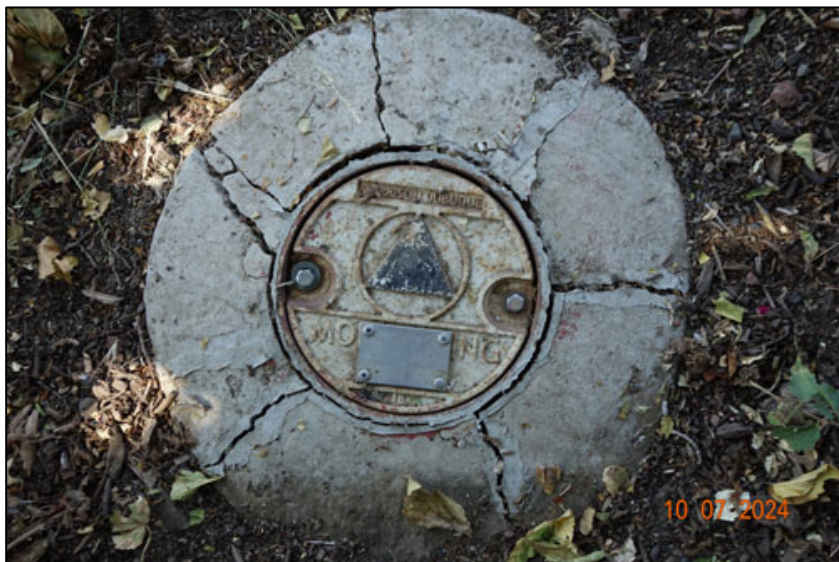
- Well UCD1-071—One vault lid bolt has stripped threads and needs to be replaced.
- Well UCD1-071—The concrete apron surrounding this wellhead is severely cracked and needs to be replaced.
- Well UCD1-072—One bolt hole used to secure the vault lid is corroded and needs to be cleaned or rethreaded.

UCD1-071 Wellhead with Cracks in Concrete Apron (Photo No. 8848)

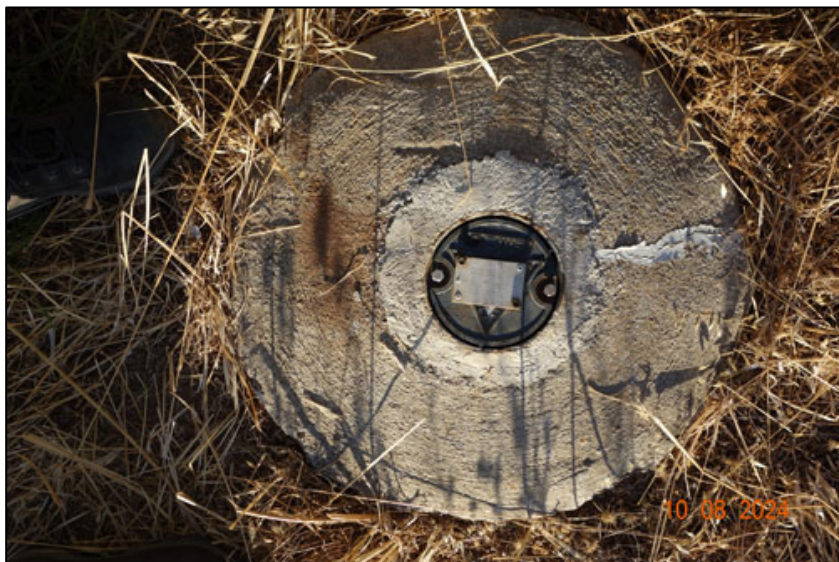
UCD1-072 Wellhead (Photo No. 8898)

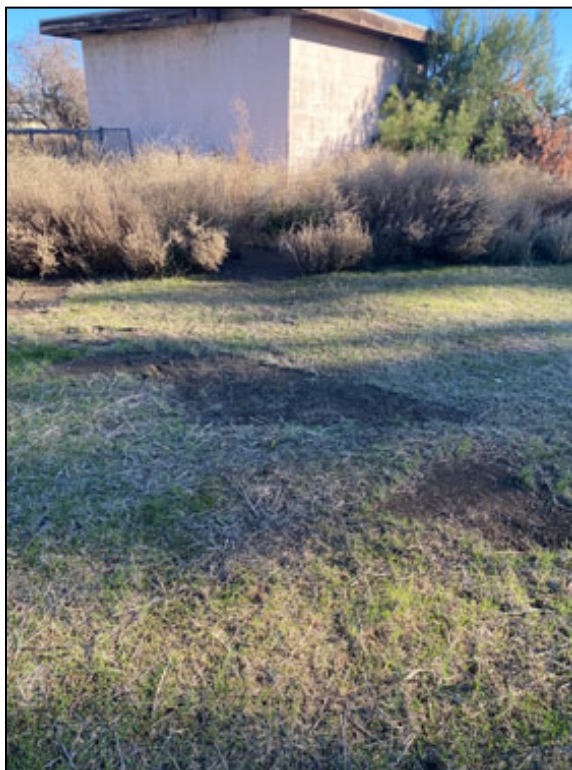
On March 13, 2024, DOE notified UC Davis of less than one-cubic yard of roofing material and a box containing equipment found during the 2023 walkthrough inspections in the SWT Area. These items are understood to originate from recent improvement to UC Davis property. UC Davis has agreed to remove these items and their removal has been confirmed as documented in Appendix F, Table F-1.

Photo F-12. View Northeast from Northeast Corner of SWT Area: Locations of Removed and Disposed Former Washdown Pad Roofing Material in Center of Photo (005)
