5.0 Falls City, Texas, Disposal Site

5.1 Compliance Summary

5.4 Inspection Results

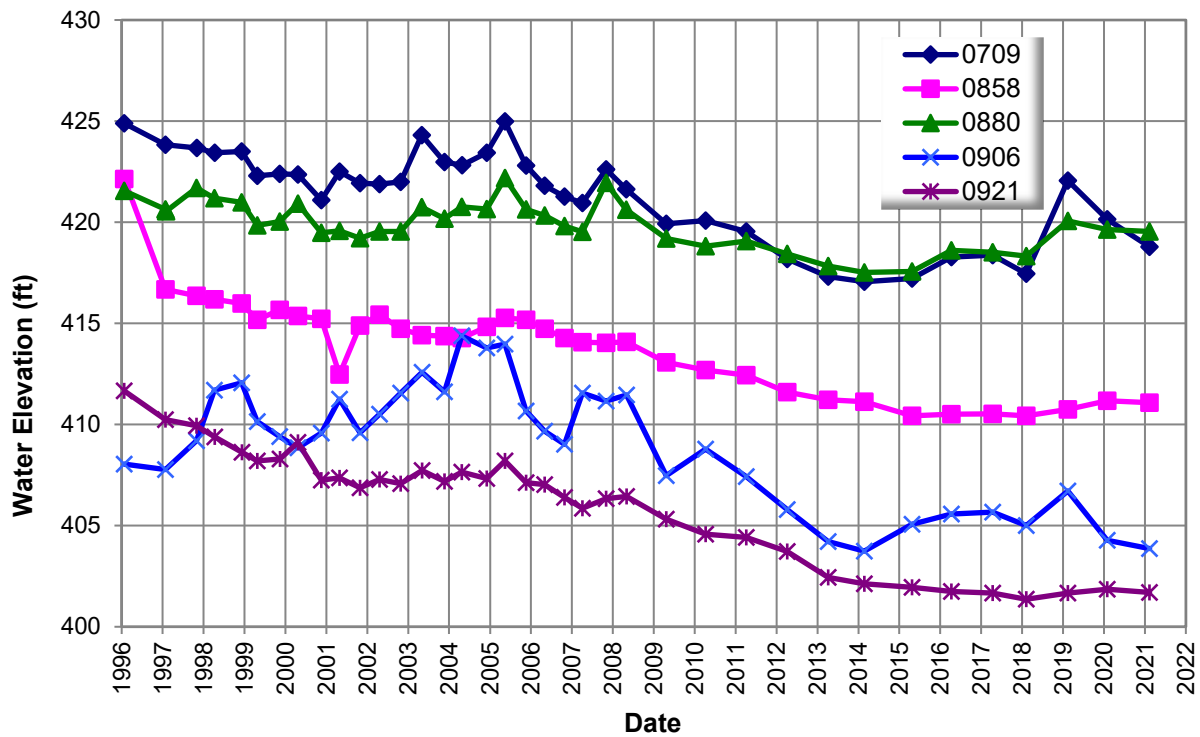
Figure 5-3. Water-Level Measurements at Disposal Cell Performance Monitoring Wells at the Falls City, Texas, Disposal Site

Water levels in all disposal cell performance wells had decreasing trends from 1996 to 2014 based on Mann-Kendall trend analyses (Figure 5-3). Water levels in these wells appear to have stabilized by 2014, but wells 0709, 0880, and 0906 have had increases in water level since 2014, which are more subtle in wells 0858 and 0921 (Figure 5-3). Groundwater compliance wells 0862, 0886, and 0963 had significant increasing water level trends since 1996, and wells 0891 and 0924 had no statistically significant trend (Figure 5-4). Wells with increasing water level trends each had a water elevation increase of about 5 ft since 1996.

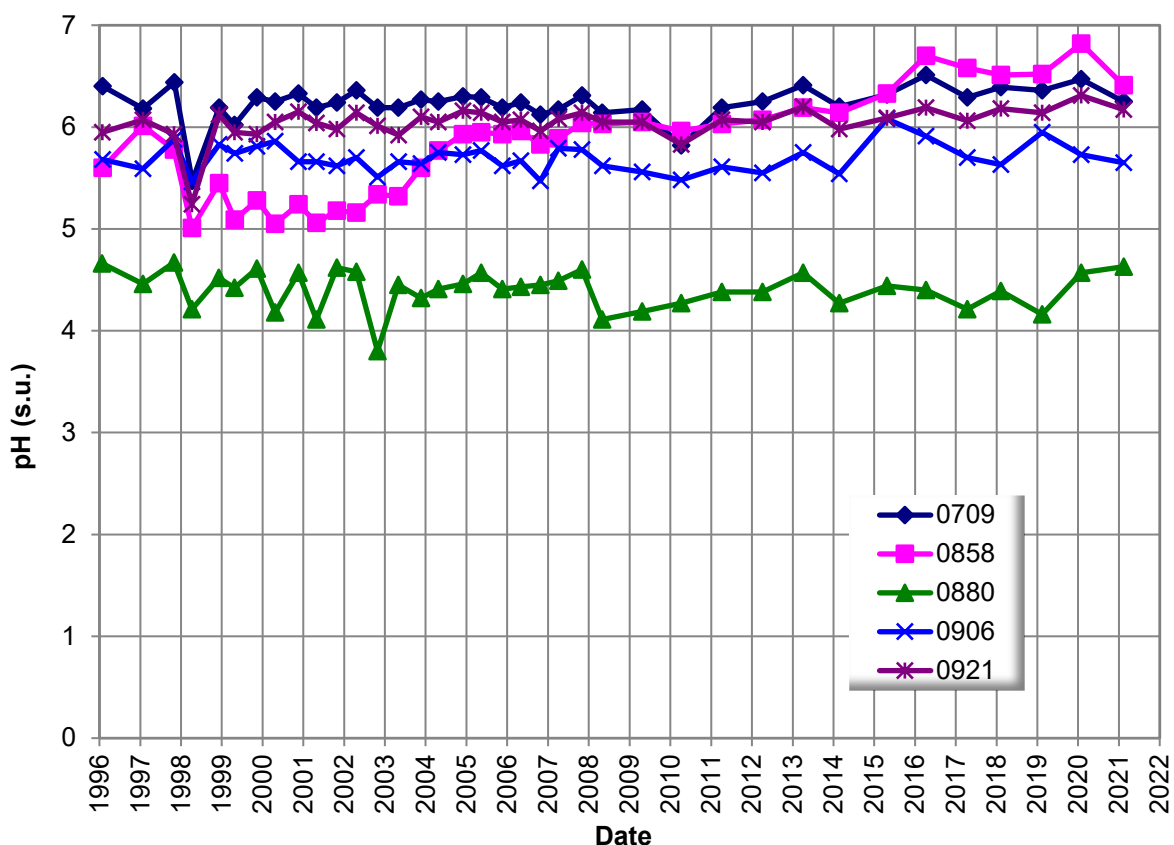
Figure 5-5. pH at Disposal Cell Performance Monitoring Wells at the Falls City, Texas, Disposal Site

pH: Wells 0858 and 0921 had significant increasing pH trends since 1996, based on Mann-Kendall trend analyses, and all other disposal cell performance wells had no significant trend. At the disposal cell performance monitoring wells, pH levels have historically been greater than the pH in tailings pore fluids (pH level of 2.93). The 2021 pH levels were within the range of historical values for all disposal cell performance monitoring wells (Figure 5-5).

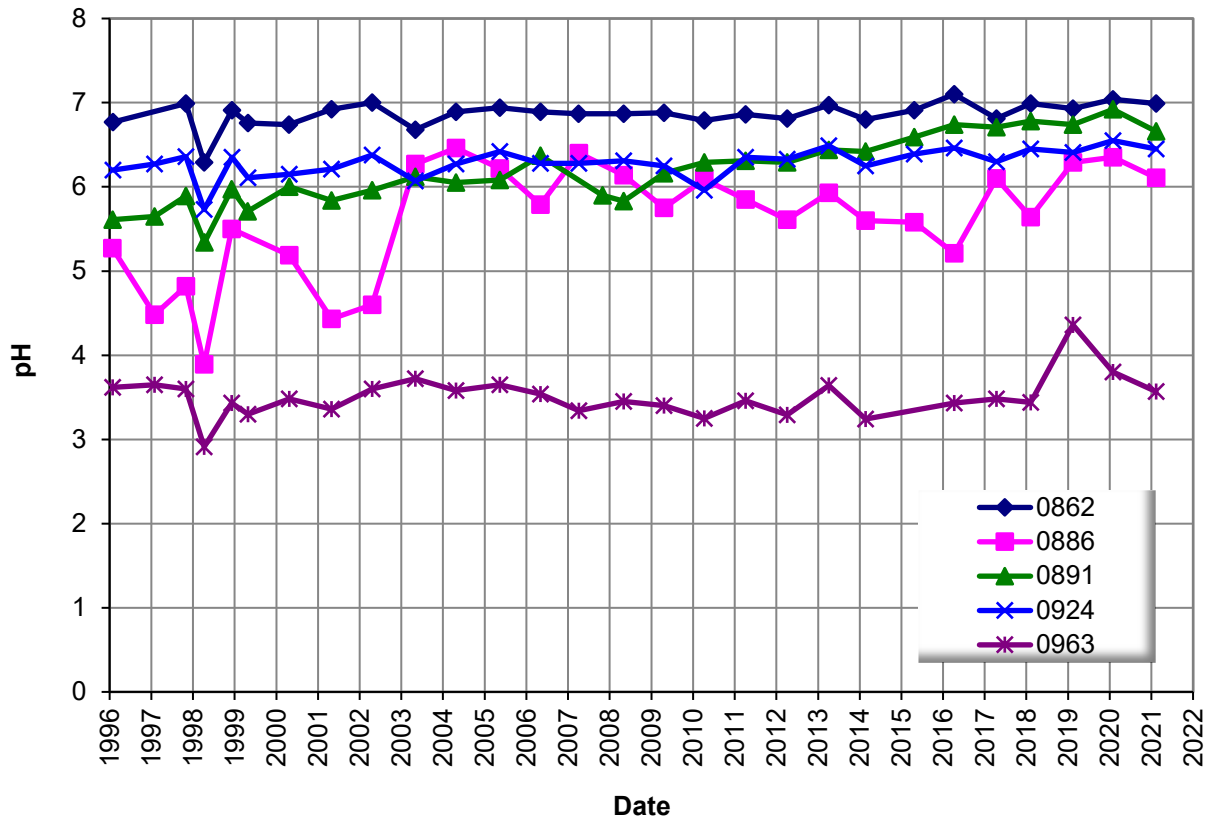
Figure 5-6. pH at Groundwater Compliance Monitoring Wells at the Falls City, Texas, Disposal Site

For compliance monitoring wells, statistically significant increasing trends in pH have been seen in wells 0886, 0891, and 0924 since 1996, with no significant trends in wells 0862 and 0963 (Figure 5-6). The 2021 pH levels were within the range of historical values for all groundwater compliance monitoring wells. The pH in monitoring well 0963 historically has been lower than at the other groundwater compliance wells, with a pH of 3.6 in 2021 compared to between 6.0–7.0 in the other wells. Overall, groundwater in well 0963 had a similar pH to that of the tailings pore fluids, even compared to the wells adjacent to the disposal cell.

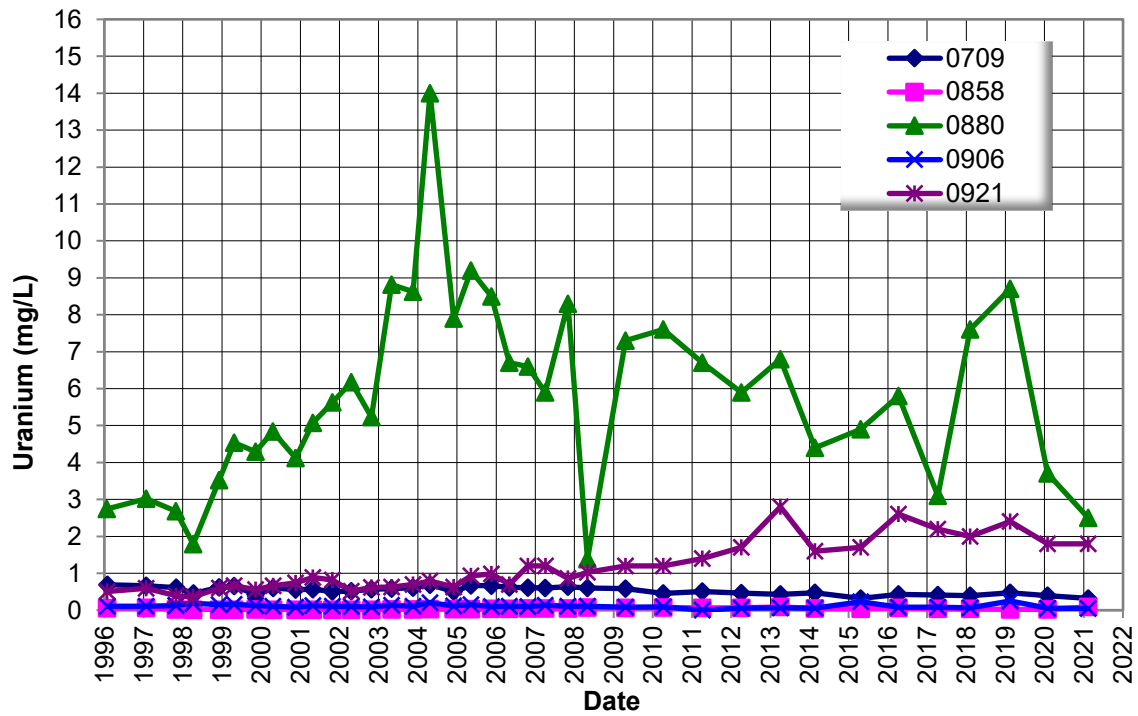
Figure 5-7. Uranium Concentrations at Disposal Cell Performance Monitoring Wells at the Falls City, Texas, Disposal Site

Uranium: The 2021 uranium concentrations for disposal cell performance monitoring wells were within the range of historical values for all groundwater compliance monitoring wells (Figure 5-7). In 2021, the uranium concentrations for monitoring wells 0709, 0906, and 0858 remained generally constant when compared with previous results. The uranium concentration in monitoring wells 0921 and 0880 decreased. Uranium concentrations in monitoring well 0880 show considerable variation, ranging from a high of 14 milligrams per liter (mg/L) in 2004 to a low of 1.38 mg/L in 2008. The 2021 uranium concentrations for groundwater compliance monitoring wells were within the range of historical values for all groundwater compliance monitoring wells (Figure 5-8).

Uranium concentrations in disposal cell performance monitoring well 0880 have varied considerably since 1996, ranging from 14 mg/L in 2004 to 1.38 mg/L in 2008 (Figure 5-7). The uranium concentration was 2.5 mg/L in 2021. The pH at this location is less than at other disposal cell performance monitoring wells. Water levels at all the cell performance monitoring wells trended lower from 2007 until 2016, then increased in recent years (Figure 5-3). Because the uranium concentrations at some of the cell performance monitoring wells have been steady and concentrations vary at other locations, local conditions are likely influencing uranium concentrations. This is reasonable because (1) the disposal cell is on tailings that were placed in existing open pit mines; (2) subeconomic ore remains in unmined areas; (3) the uppermost aquifer beneath the cell is oxidized and near the aquifer recharge area; and (4) uranium mineralization processes, which involve redistributing and concentrating uranium in the formation materials, are ongoing. Given local conditions, it is difficult to assess whether elevated uranium concentrations in the uppermost aquifer are a result of disposal cell performance or existing background conditions.

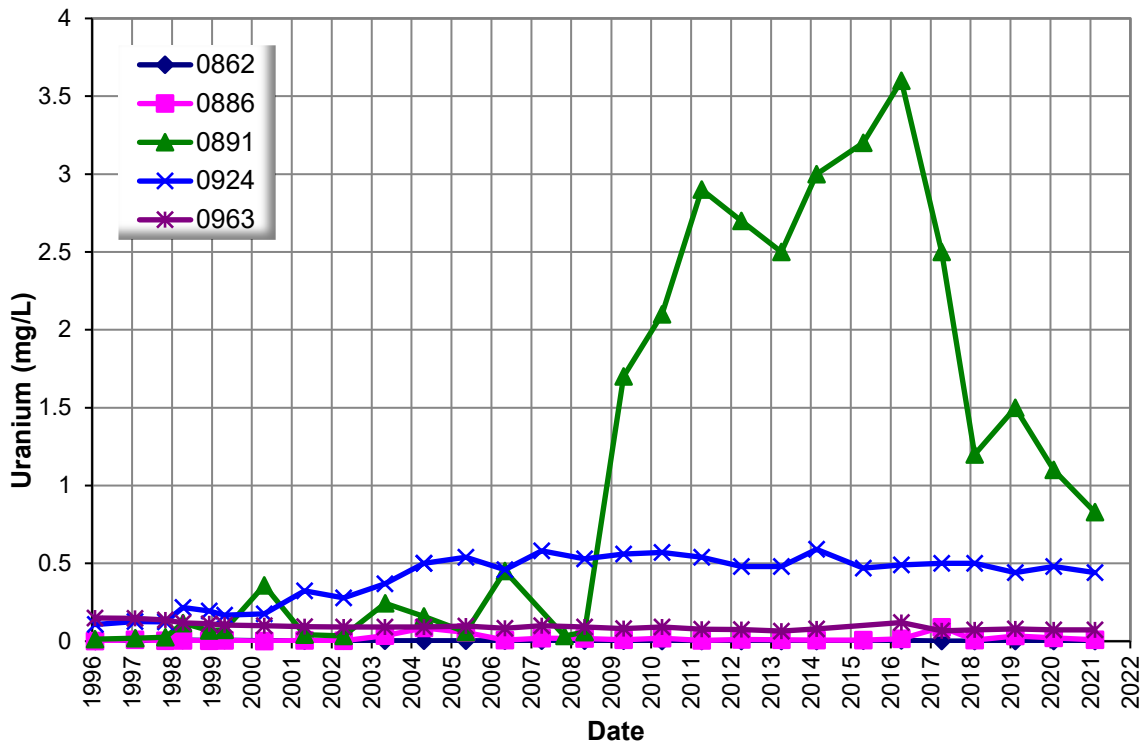
Figure 5-8. Uranium Concentrations in Groundwater Compliance Monitoring Wells at the Falls City, Texas, Disposal Site

The uranium concentration at monitoring wells 0862, 0886, and 0963 remains less than 0.2 mg/L. The uranium concentration at monitoring well 0924 has been relatively stable since 2004, fluctuating between 0.4 mg/L and 0.6 mg/L. Since 2008, the uranium concentrations measured at monitoring well 0891 have been greater than at other monitoring wells and are currently elevated when compared to the historical range for the well but not for the historical range of the aquifer (DOE 2010). The 2021 uranium result (0.83 mg/L) at monitoring well 0891 remains significantly less than the 2016 uranium result of 3.7 mg/L and less than the uranium concentration value used for groundwater in the Dilworth aquifer in the *Baseline Risk Assessment of Ground Water Contamination at the Uranium Mill Tailings Site Near Falls City, Texas* (3.04 mg/L) (DOE 1994). This suggests that groundwater with elevated uranium has flowed past this location.

The high uranium concentrations in groundwater compliance well 0891 since 2008, trending downward since 2016, likely reflects the passage of a groundwater with elevated uranium flowing from the direction of the former processing site. Historical data from upgradient monitoring wells that were abandoned in 2001 show a uranium anomaly moved past them (Figure 5-9) (DOE forthcoming). LM defined the groundwater flow directions in the Deweesville and the Dilworth aquifers and identified areas of low pH where tailings-derived fluids have consumed all the natural buffering capacity (DOE 2008; Figure 2-7; Figure 2-8). Monitoring well 0891 is completed in the Dilworth aquifer. Monitoring well 0963 (completed in the Deweesville Sandstone) is in a zone of low pH where groundwater in the Deweesville aquifer flows into the underlying Dilworth aquifer. Monitoring well 0966 is the next downgradient Dilworth aquifer well.

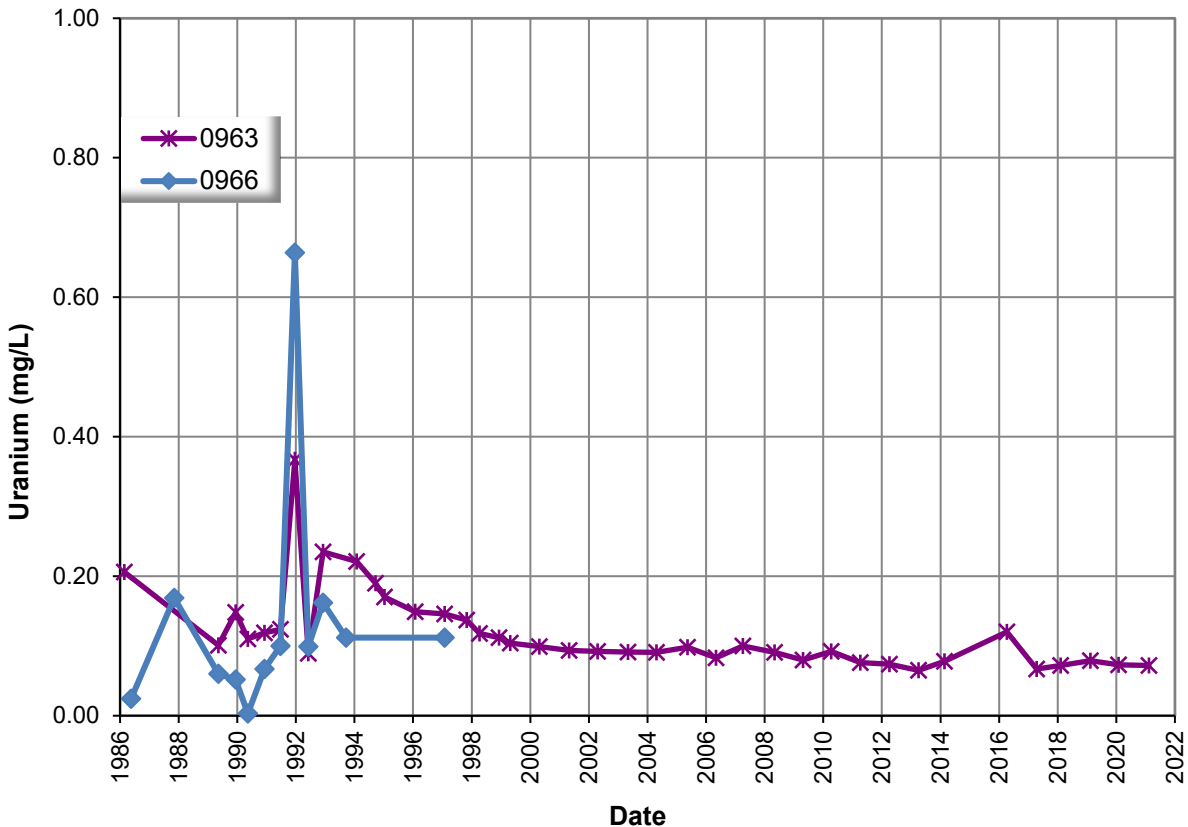
Figure 5-9. Uranium Concentrations in Monitoring Wells 0963 (in the Deweesville aquifer) and 0966 (in the Dilworth aquifer)

Figure 5-9 shows uranium concentration spikes in both wells (0963 and 0966) in 1992, with slowly declining uranium concentrations in 0963 over time (data for monitoring well 0966 are limited). This is likely due to an initial release of uranium and low pH tailings fluids during tailings deposition and subsequent acid leaching, with tailings removal by 1994 (DOE forthcoming). Monitoring well 0891 is the next Dilworth well directly downgradient of the low pH zone. Additionally, the elevated uranium at monitoring well 0891 is accompanied by elevated alkalinity and chloride, which also supports the conclusion that the elevated uranium is the result of passage of groundwater containing processing-related constituents.

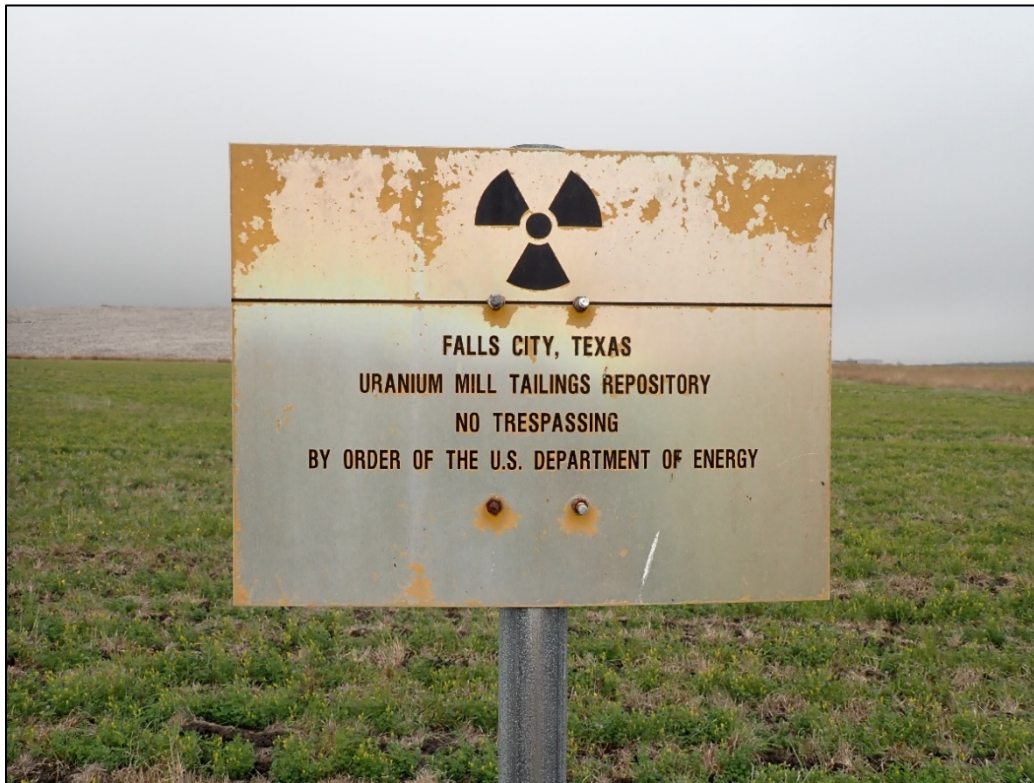
PL-1. Perimeter Sign P18

There are 64 perimeter signs attached to steel posts set in concrete positioned along the property boundary and set back 5 feet (ft). Perimeter sign P56 was reported missing before the inspection and was replaced following the inspection. Perimeter sign P33 has bullet damage but remains legible. Additional perimeter signs are fading but remain legible (PL-1). No additional maintenance needs were identified.

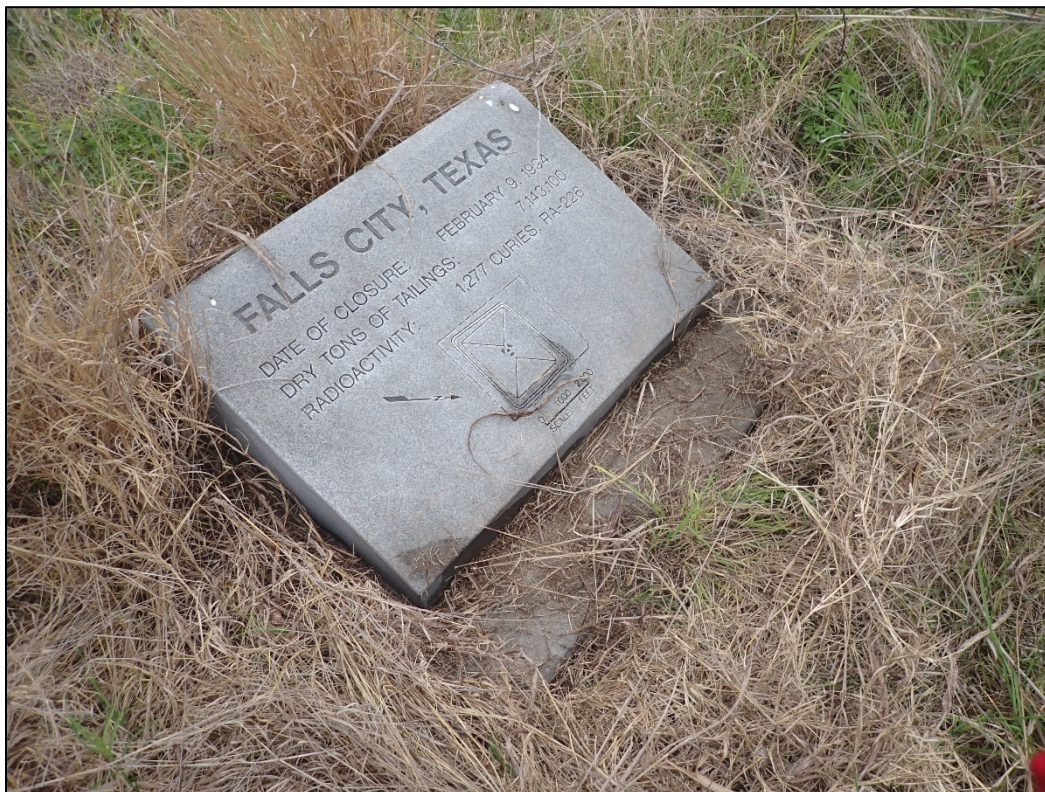
PL-2. Site Marker SMK-1

The site has two site markers. Site marker SMK-1 is just inside the entrance gate (PL-2). The corners of the concrete base around the marker are cracked. The cracks are unchanged since the last inspection, and repairs are not needed at this time. Site marker SMK-2 is on the top slope of the disposal cell. No maintenance needs were identified.

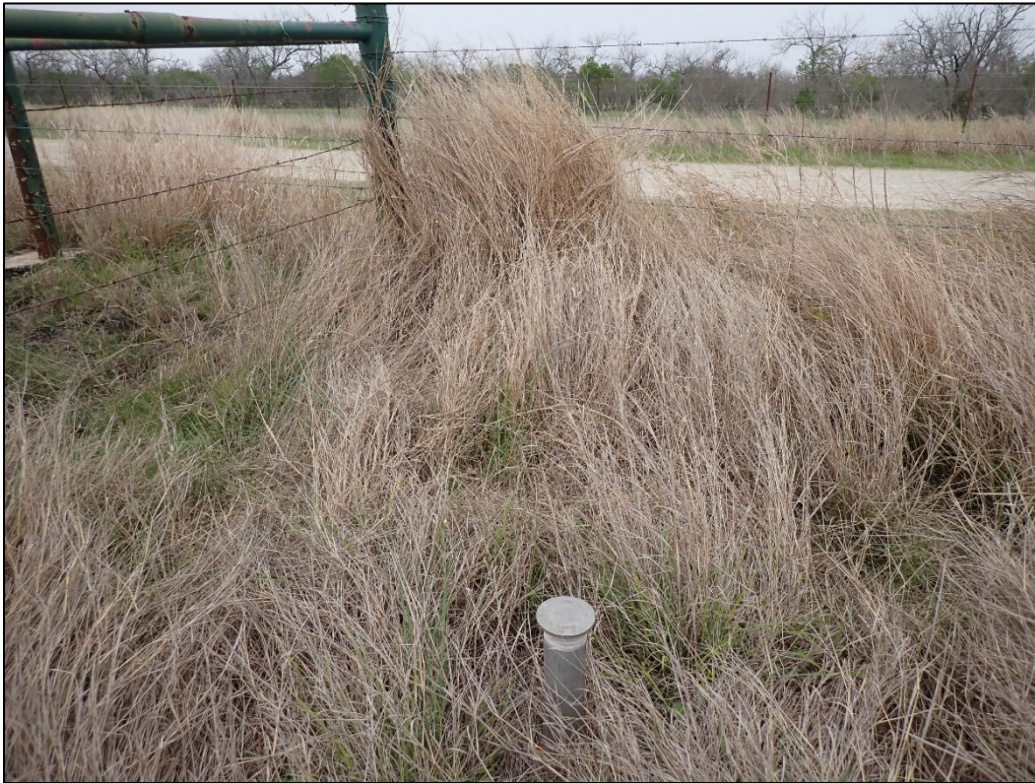
PL-3. Boundary Monument BM-1

Three survey monuments and two boundary monuments delineate the corners of the property (PL-3). All monuments were located. No maintenance needs were identified.

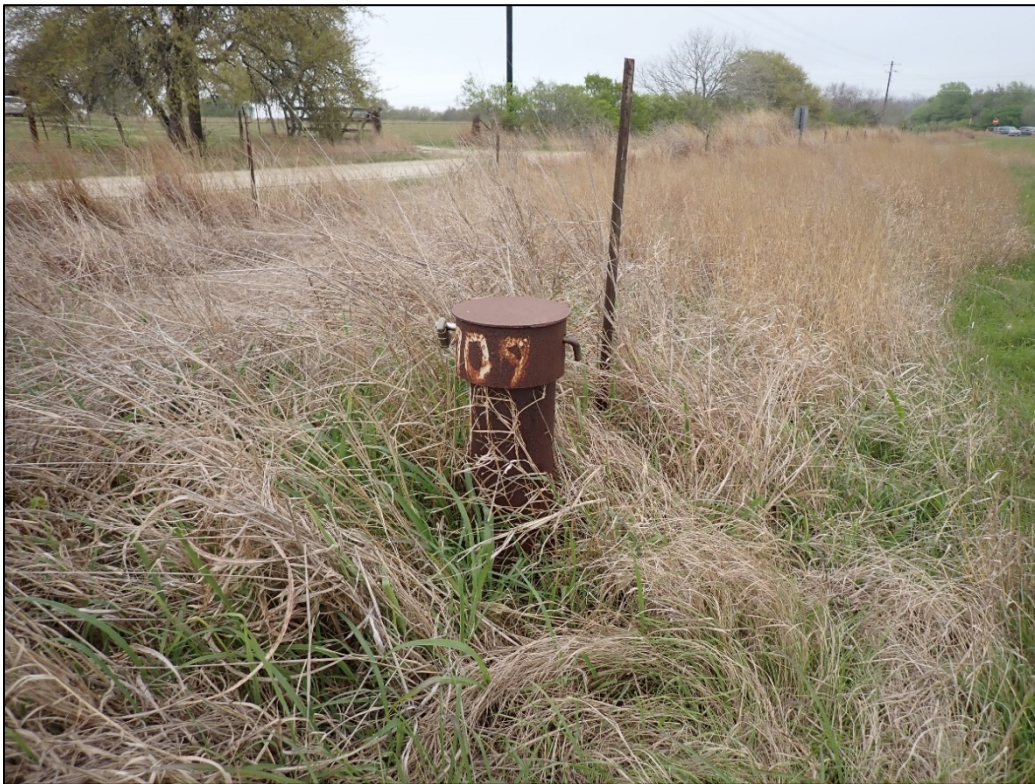
PL-4. Monitoring Well 0709

There is one monitoring well onsite; 11 monitoring wells are offsite. All monitoring wells were inspected during the February 2021 sampling event, and wellhead protectors were undamaged and locked (PL-4). No maintenance needs were identified.

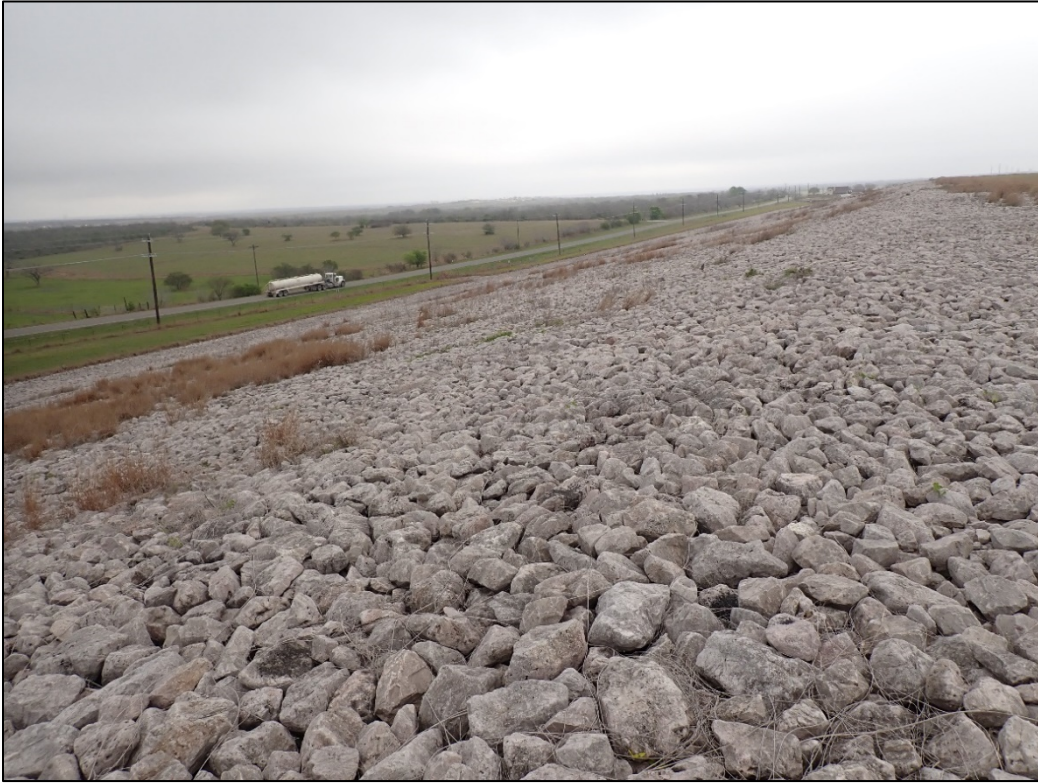
PL-5. Northeast Side Slope

Riprap armors the disposal cell side slopes and a transition zone where the top slope meets the side slopes (PL-5). LM has monitored several small depressions on the northwest side slope of the disposal cell since 2010. These depressions do not compromise the protectiveness of the riprap side slope, and no changes have been observed since 2010. Inspectors will continue to monitor these areas.

Fractured riprap has been observed on the disposal cell side slopes since it was completed. Pieces of riprap are fractured in place, indicating that the fracturing occurred after placement. Fracturing is likely a consequence of mechanical placement or thermal expansion and contraction; the riprap condition appears stable. LM periodically takes photos of riprap at the base of T-post 4 on the west corner of the disposal cell. On the basis of a qualitative evaluation of the photos in 2018, there is no indication that the riprap is degrading, but its durability will continue to be monitored. If the number of fractured rocks appears to be increasing, LM will establish a more quantitative monitoring program.

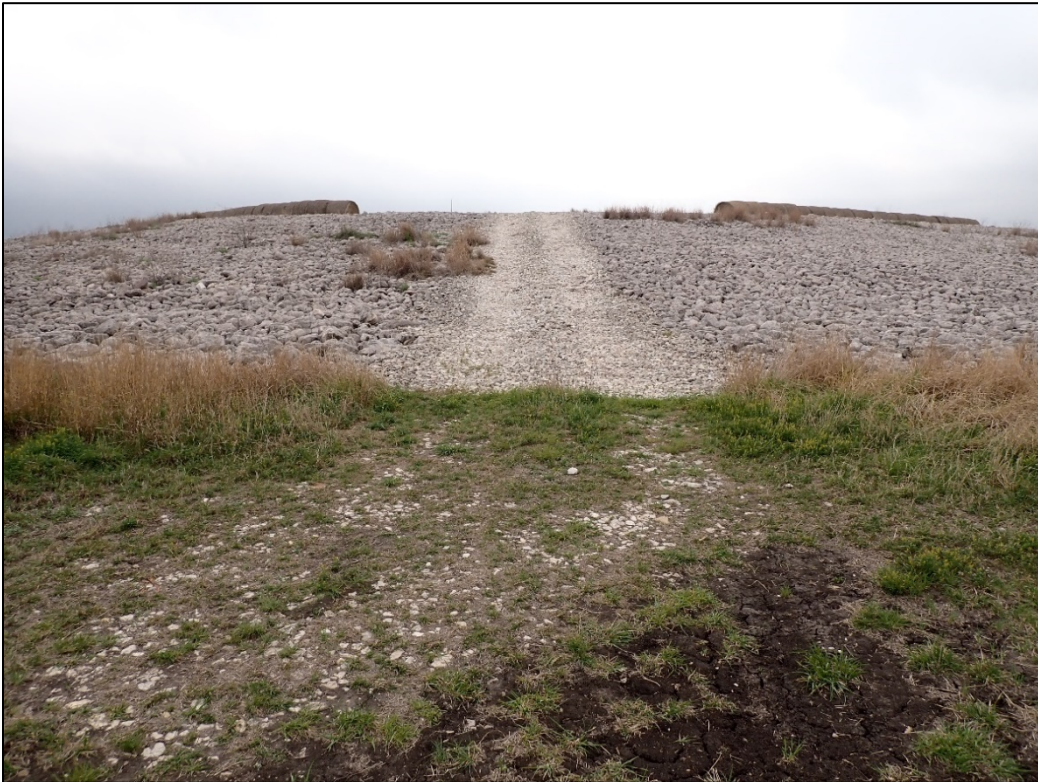
PL-6. Equipment Access Ramp

An equipment access ramp to the top of the disposal cell is at the west corner of the side slope (PL-6). The ramp was installed in 2008 using clean, angular riprap of progressively smaller rock sizes to provide a free-draining and stable driving surface that does not encourage vegetation encroachment. Some displacement of smaller rock has occurred, as would be expected from use, but the ramp continues to provide a stable driving surface.

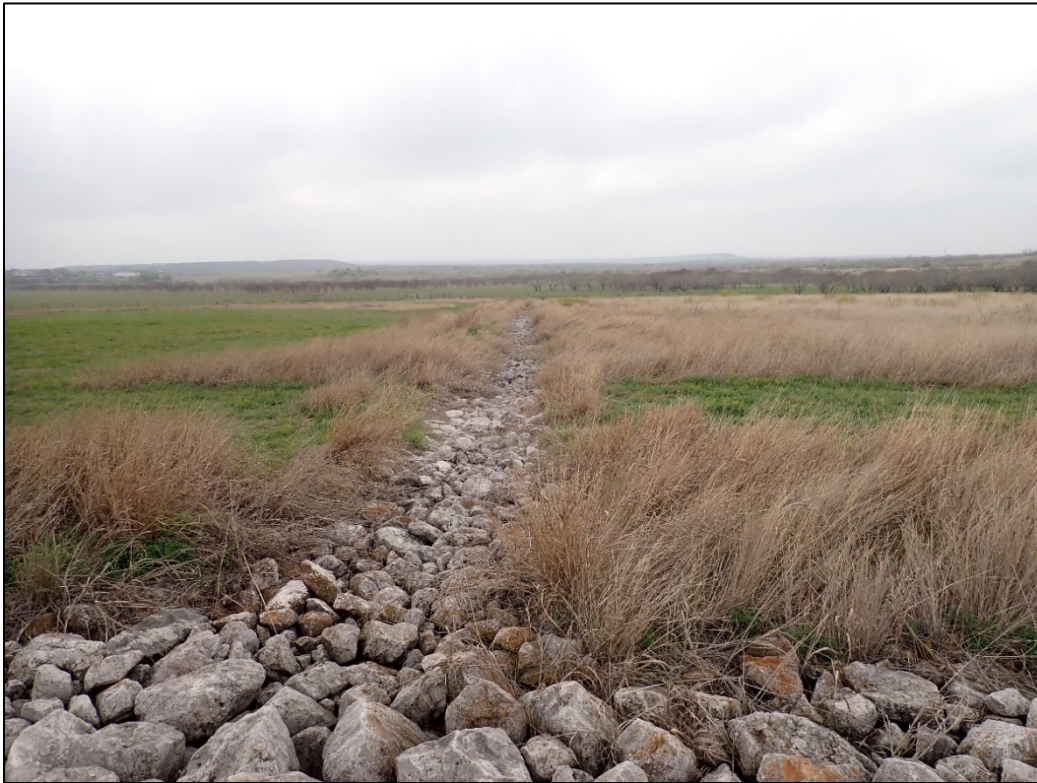
PL-7. Rock Drain on South Corner of Disposal Cell

No water was flowing in the south rock drain during the inspection (PL-7). Willows that grow along the south drain are periodically removed by the LMS maintenance subcontractor. No water was observed in the north rock drain. Vegetation is left uncut at the outlets of the rock drains to help dissipate the energy of stormwater runoff and to reduce soil erosion. No maintenance needs were identified.

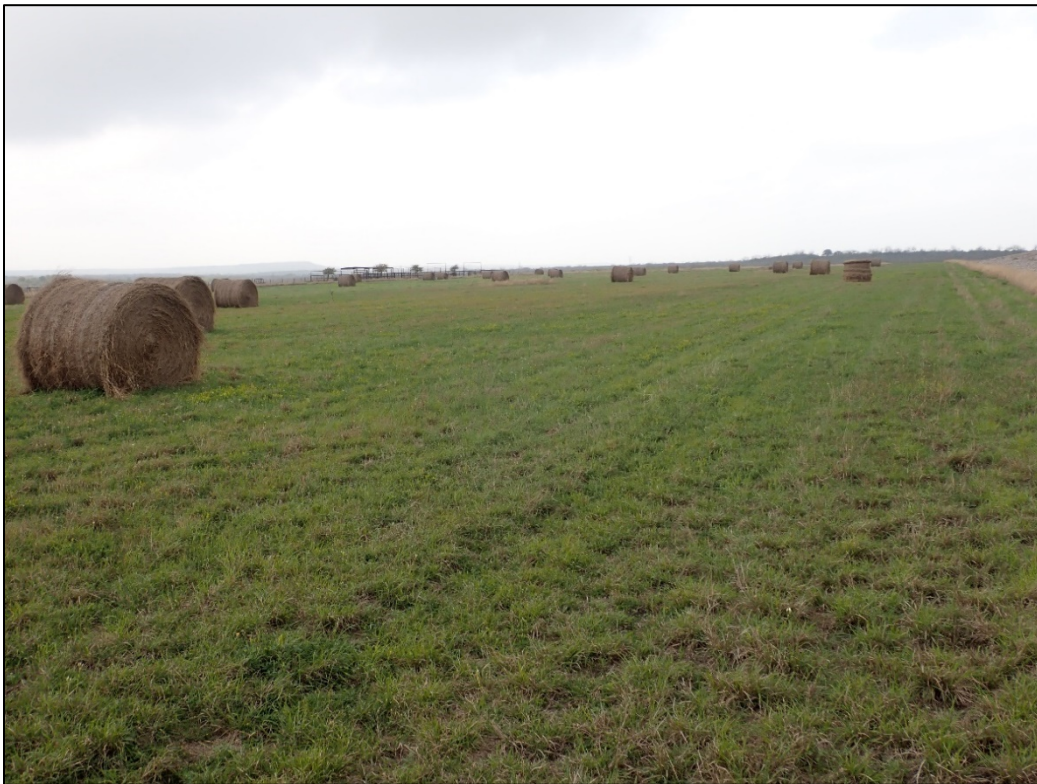
PL-8. Cut and Baled Grass Between Disposal Cell and Perimeter Fence

The area between the perimeter fence and the apron at the toe of the disposal cell side slopes is covered with well-established grass, which is primarily kleingrass with some coastal Bermudagrass. Grass is cut and baled one to three times annually, depending on precipitation (PL-8). It is usually left uncut along the fence, along rock drains, and around some surveillance features such as survey monuments that cannot be accessed with conventional farming equipment.

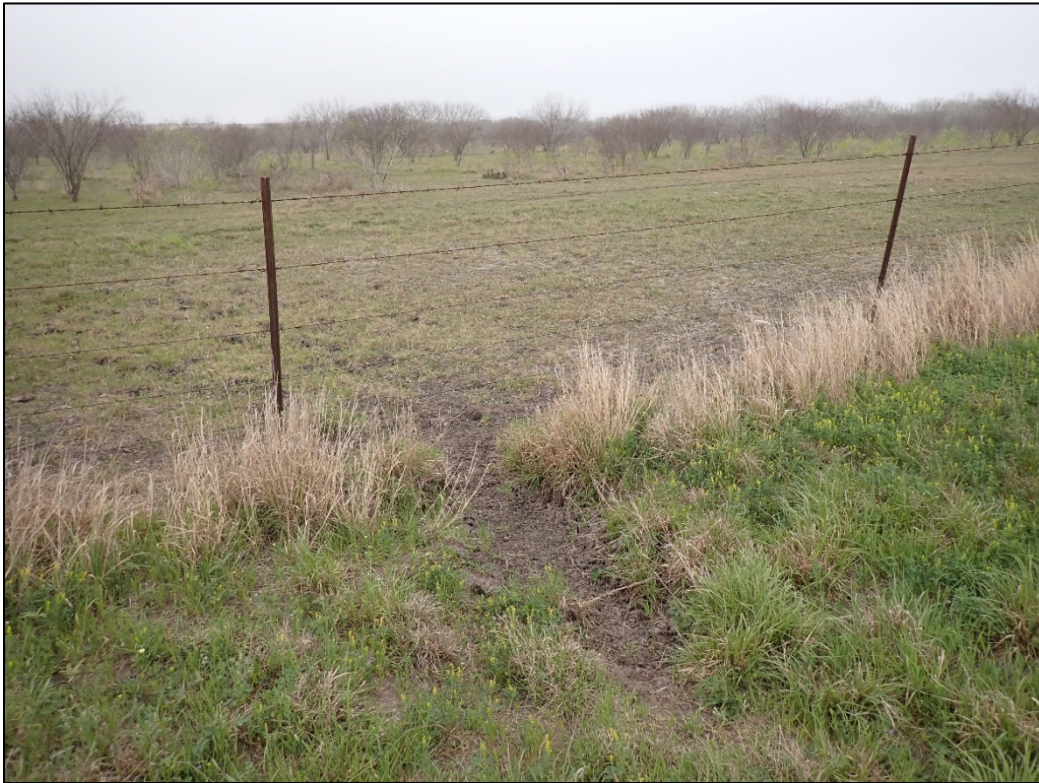
PL-9. Hog Crossing Under Southwest Fence Line

Wild hogs dig under the perimeter fence line in some areas (PL-9). Their crossings are filled in by the LMS maintenance subcontractor, as they can potentially compromise the integrity of the perimeter fence or damage haying equipment. No maintenance needs were identified.
