5.0 Falls City, Texas, Disposal Site

The Falls City, Texas, Uranium Mill Tailings Radiation Control Act (UMTRCA) Title I Disposal Site was inspected on May 10, 2022. No changes were observed in the disposal cell or associated drainage features, and personnel found no cause for a follow-up inspection.

The site, 8 miles southwest of Falls City, Texas, was inspected on May 10, 2022, by D. Marshall and J. Doebele of the Legacy Management Support (LMS) contractor. C. Boger (LM site manager) and R. Lyssy (LMS maintenance subcontractor) attended the inspection. The purposes of the inspection were to confirm the integrity of visible features at the site, identify changes in conditions that might affect conformance with the 2008 LTSP, and evaluate whether maintenance or follow-up inspection and monitoring are needed.

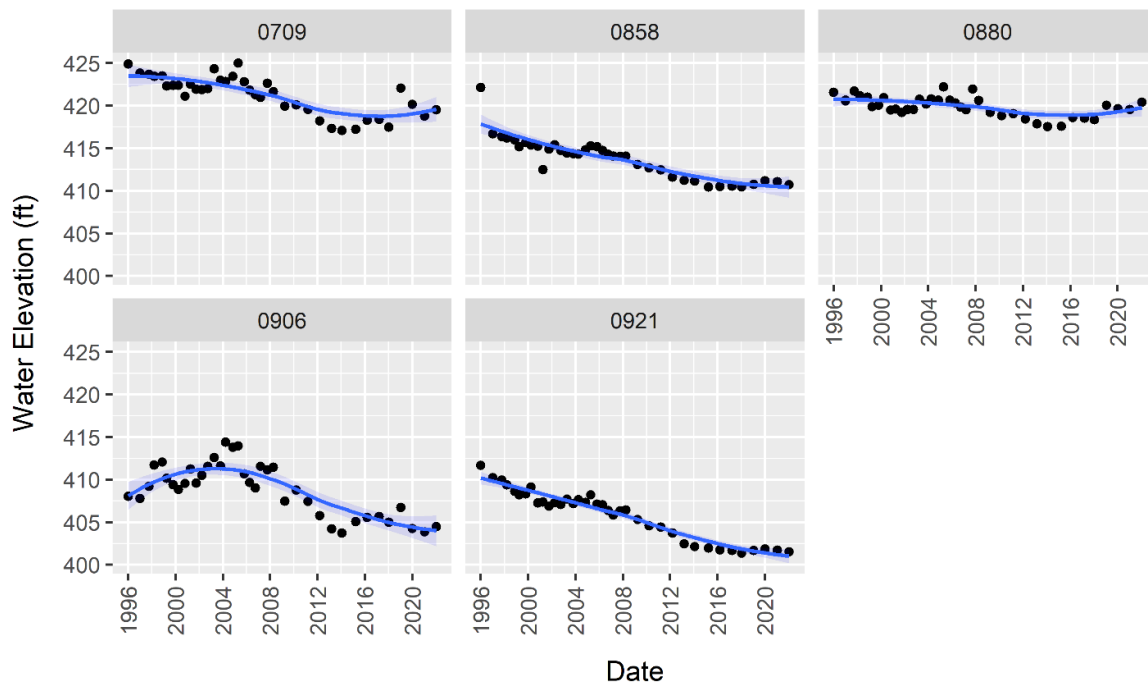
Figure 5-3. Water-Level Measurements at Disposal Cell Performance Monitoring Wells at the Falls City, Texas, Disposal Site

Water levels in all disposal cell performance wells had significant decreasing trends from 1996 to 2022 based on Mann-Kendall trend analyses (Figure 5-3). Since 1996, water levels in wells 0858 and 0921 decreased 10 to 11 ft. Smaller declines are apparent for remaining wells (0709, 0880, and 0906), with 2022 water levels 1.2–5.4 ft lower than corresponding 1996 elevations. Groundwater compliance wells 0862, 0886, and 0963 had significant increasing water level trends since 1996 (5–7 ft increases); well 0891 had no statistically significant trend (Figure 5-4). Although a significant decreasing trend was identified for well 0924, water levels have declined only about 0.4 ft since 1996.

Note: Disposal cell performance monitoring wells 0908 and 0916 have been dry since 1987.

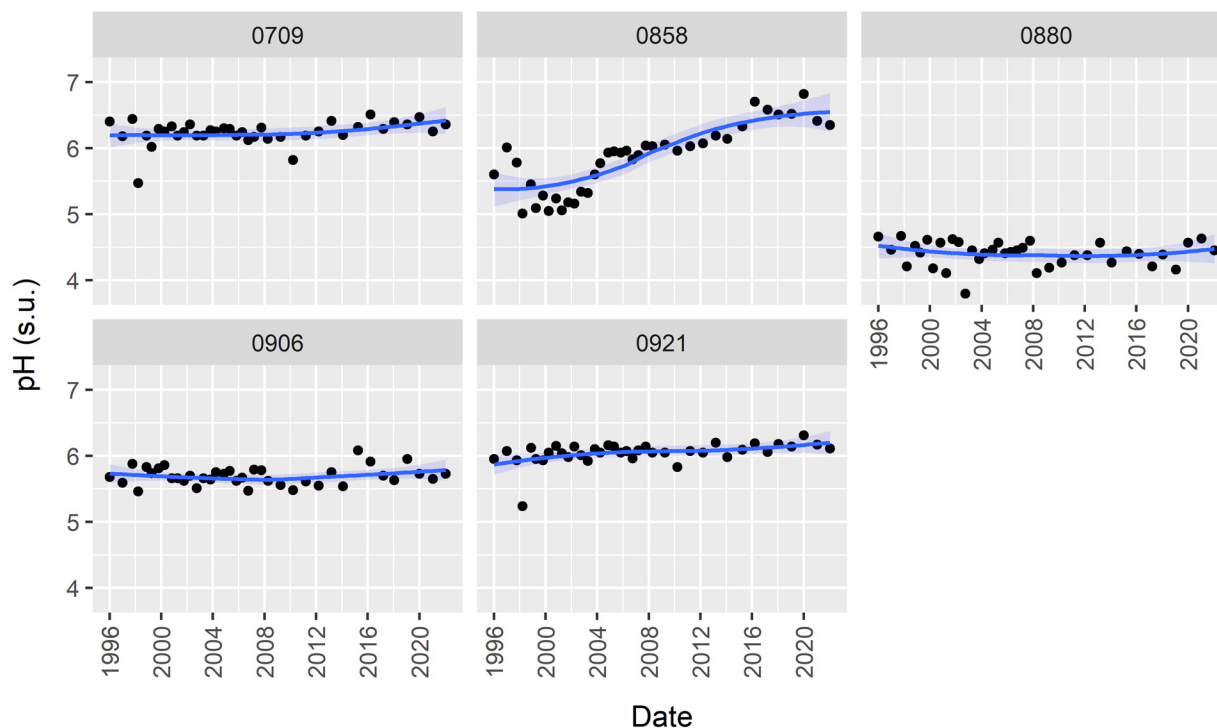
Figure 5-5. pH at Disposal Cell Performance Monitoring Wells at the Falls City, Texas, Disposal Site

pH: Mann-Kendall trend analysis indicates significant increasing trends in pH (since 1996) for wells 0858 and 0921. No significant trends were identified for the remaining disposal cell performance wells. Although pH levels in all cell performance wells have been greater than that measured in tailings pore fluids (pH of 2.93 [DOE 1997a]), pH levels in well 0880 remain relatively low, ranging from 3.4–5.2 historically and 3.8–4.7 for the 1996–2022 period shown in Figure 5-5. The pH levels measured in 2022 were within the range of historical values for all disposal cell performance monitoring wells; that is, there have been no recent significant changes in pH in these wells (Figure 5-5).

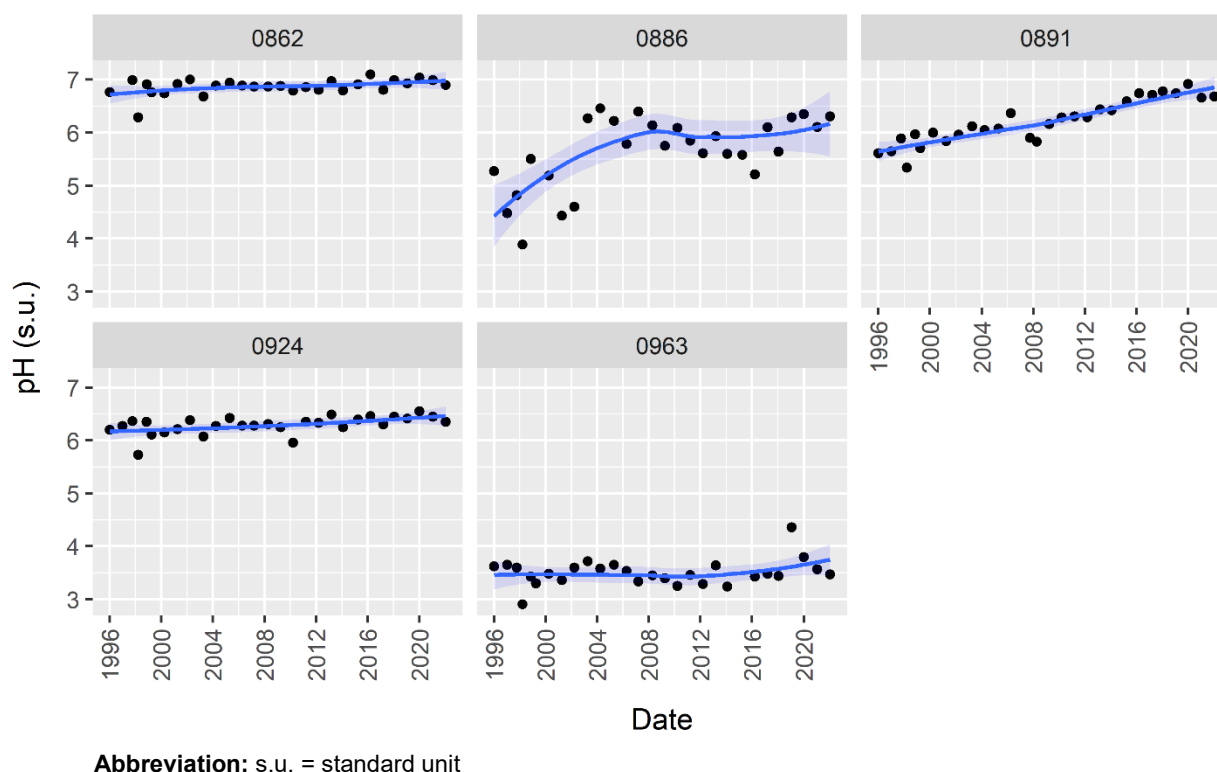
Figure 5-6. pH at Groundwater Compliance Monitoring Wells at the Falls City, Texas, Disposal Site

For compliance monitoring wells, statistically significant increasing trends in pH have been identified in wells 0886, 0891, and 0924 since 1996, with no significant trends in wells 0862 and 0963 (Figure 5-6). The pH levels measured in 2022 were within the range of historical values for all groundwater compliance monitoring wells. The pH in monitoring well 0963 historically has been lower than at the other groundwater compliance wells (and the disposal cell performance monitoring wells), with a pH of 3.5 in 2022 compared to between 6.0–7.0 in the other wells.

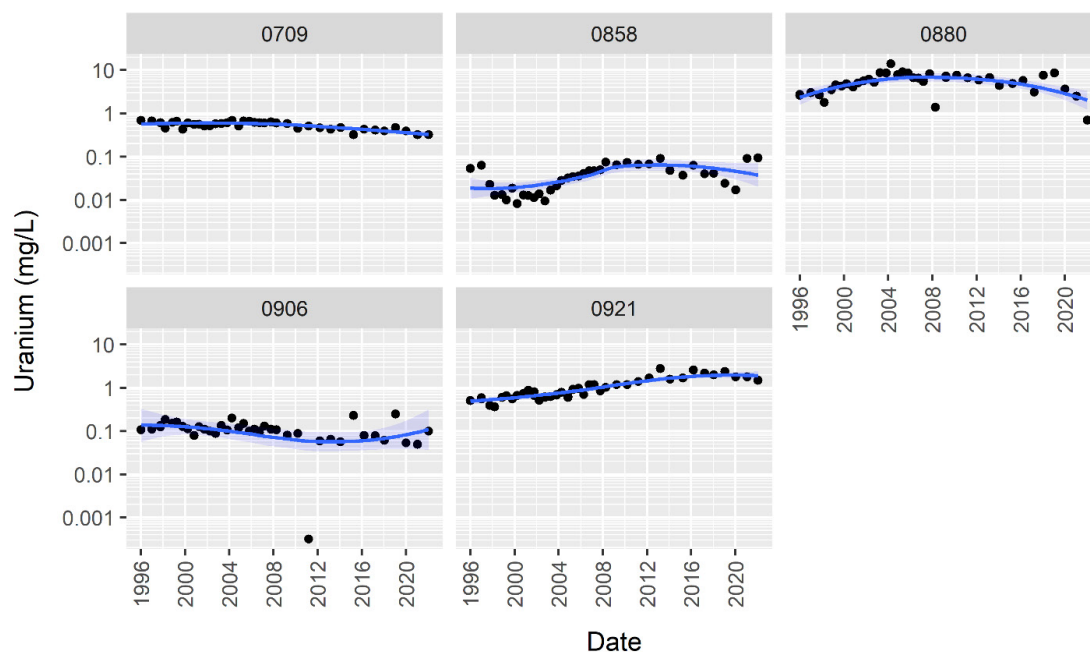
Figure 5-7. Uranium Concentrations at Disposal Cell Performance Monitoring Wells at the Falls City, Texas, Disposal Site

Uranium: The 2022 uranium concentrations for disposal cell performance monitoring wells were within the range of historical values for all groundwater compliance monitoring wells (Figure 5-7); concentrations measured in 2022 are similar to those reported in recent years. Using data since 1996, Mann-Kendall trend analysis identified significant trends in uranium concentrations in all disposal cell performance monitoring wells except well 0880. Significant increasing trends were found for wells 0858 and 0921, while significant decreasing trends were identified for wells 0709 and 0906. Uranium concentrations in monitoring well 0880 are most variable, ranging from 0.7 mg/L (most recent measurement) to 14 mg/L in 2004.

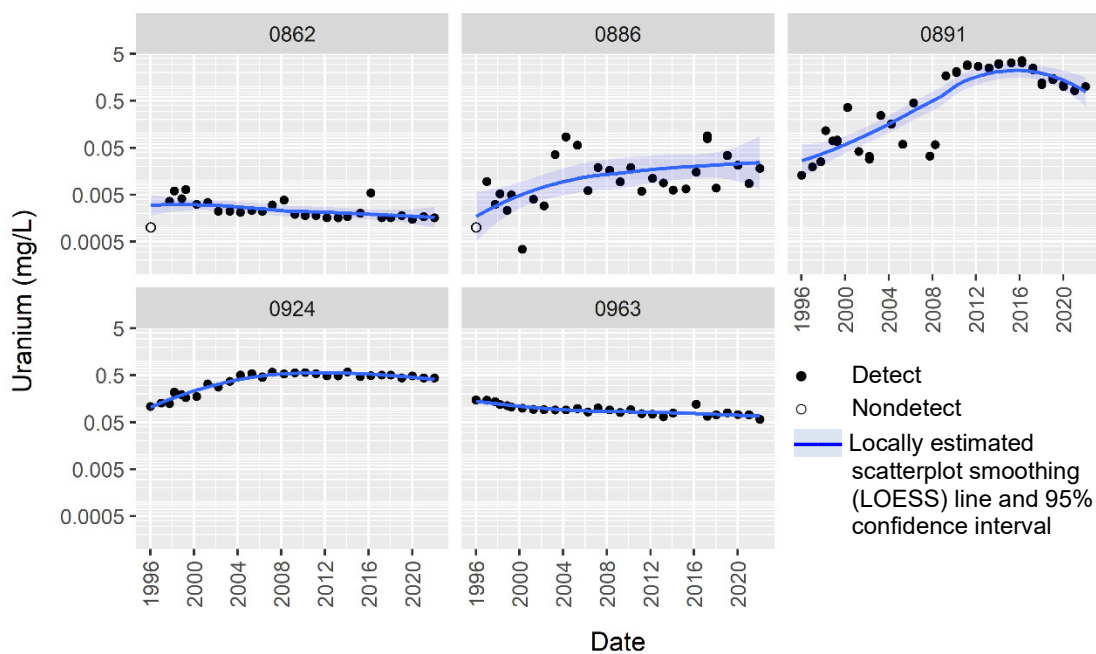
Figure 5-8. Uranium Concentrations in Groundwater Compliance Monitoring Wells at the Falls City, Texas, Disposal Site

In 2022, uranium concentrations in groundwater compliance monitoring wells were within the range of historical values (Figure 5-8). Mann-Kendall trend analysis identified significant uranium concentration trends in all wells, with increasing trends found for wells 0886, 0891, and 0924, and decreasing trends in wells 0862 (characterized by low uranium levels) and 0963. Although a significant increasing trend was identified for well 0924, uranium concentrations have been relatively stable since 2004, fluctuating between 0.4 mg/L and 0.6 mg/L. Uranium concentrations in well 0886 have stabilized in recent years (most recent result of 0.018 mg/L). Since 2008, the uranium concentrations measured at monitoring well 0891 have been greater than at other monitoring wells. The 2022 uranium result at this well (1.0 mg/L) is less than the 2016 (maximum) result of 3.6 mg/L.

For the groundwater compliance monitoring wells, wells 0886, and 0891, and 0924 have increasing uranium concentrations (Figure 5-8). According to DOE (1997a) and the 2008 LTSP, these results are not unexpected, as these three wells were at the downgradient edge of low-pH groundwater plumes with mill processing-derived fluids and elevated uranium concentrations. Currently, the pH values in these three wells are increasing (Figure 5-6; Table 5-3), thereby confirming that longer term, the low-pH areas do not necessarily define areas with uranium contamination. This correlation was true in the past (DOE 1997a) during the continued addition of low-pH fluids from uranium processing and low-pH fluids produced from the oxidation of the tailings. Currently, these processes are no longer occurring, but uranium can continue to be mobile with increasing pH values.

The higher uranium concentrations in groundwater compliance well 0891—that increased from 1996–2016 and subsequently declined—likely reflects the passage of groundwater with elevated uranium flowing from the direction of former mill tailings (specifically, tailings pile No.3.) (DOE 1997a). To maintain the protection of human health and the environment, DOE is planning on evaluating the groundwater flow and potential uranium transport downgradient of wells 0924, 0886, and 0891 to confirm that (1) groundwater quality continues to meet the groundwater class of use and (2) groundwater discharge to surface water is not an issue. Best management practice groundwater monitoring of the current monitoring well network will be continued at least through, and possibly beyond, the conclusion of this additional evaluation until concurrence for cessation is provided by NRC.

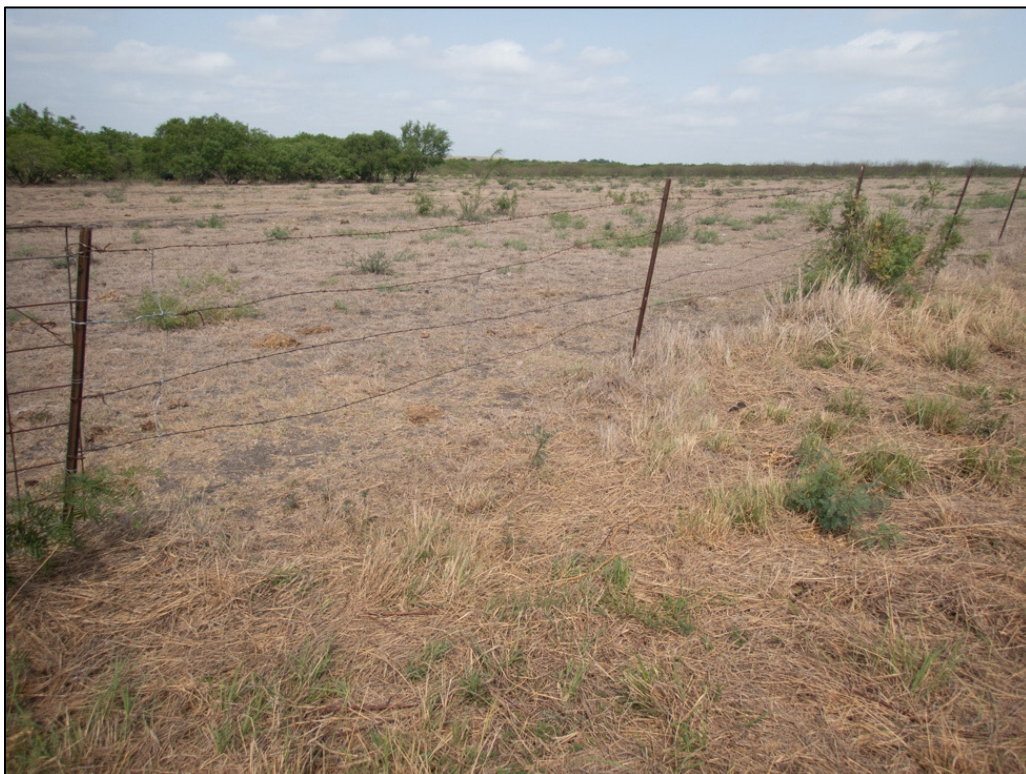
A five-strand barbed-wire perimeter fence encloses the site. As noted in previous inspections, perimeter fence strands and posts are beginning to rust except along the northwest side, where the fence was replaced in 2006. The fence on the southwest side, between perimeter sign P18 and survey monument SM-3, showed signs of rust and damage from cattle crossing the fence and accessing the site (PL-1). This section of the fence will be replaced to ensure site security.

PL-1. Rusted and Damaged Fence Line

- Replacement of perimeter sign P62
- Replacement of the perimeter fence between P18 and survey monument SM-3

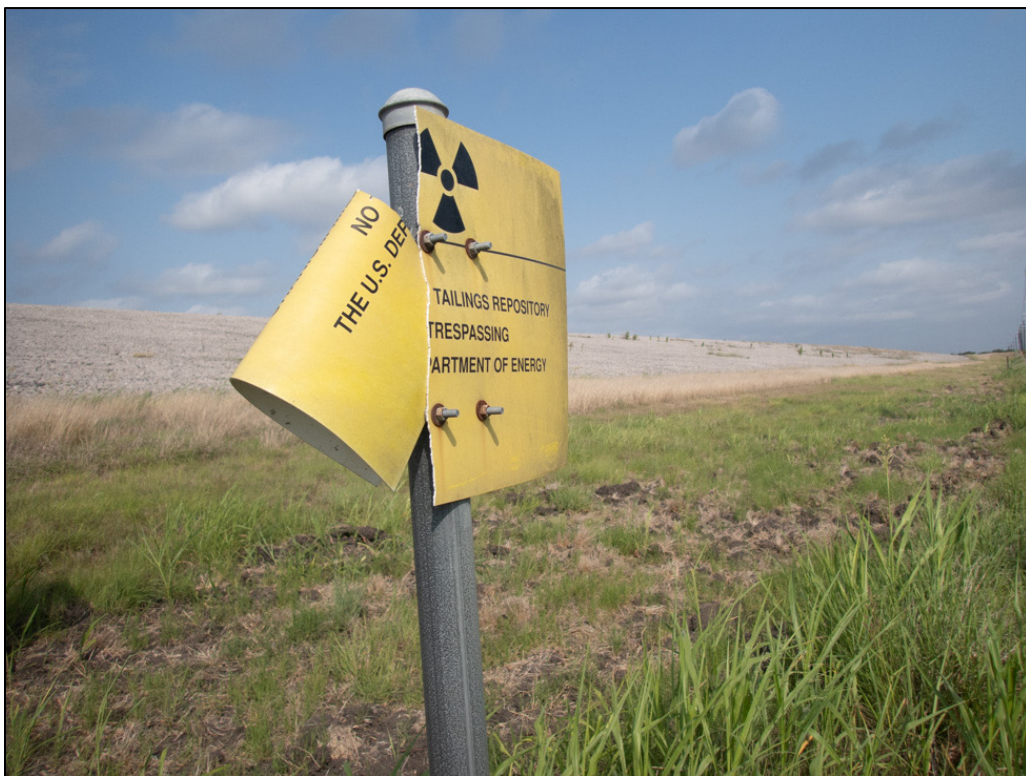
There are 64 perimeter signs attached to steel posts set in concrete and positioned along the property boundary and set back 5 feet (ft). Perimeter sign P62 was broken in half and will be replaced before the 2023 inspection (PL-2). Perimeter sign P33 has bullet damage but remains legible. Additional perimeter signs are fading but remain legible (PL-3). No other maintenance needs were identified.

PL-2. Broken Perimeter Sign P62

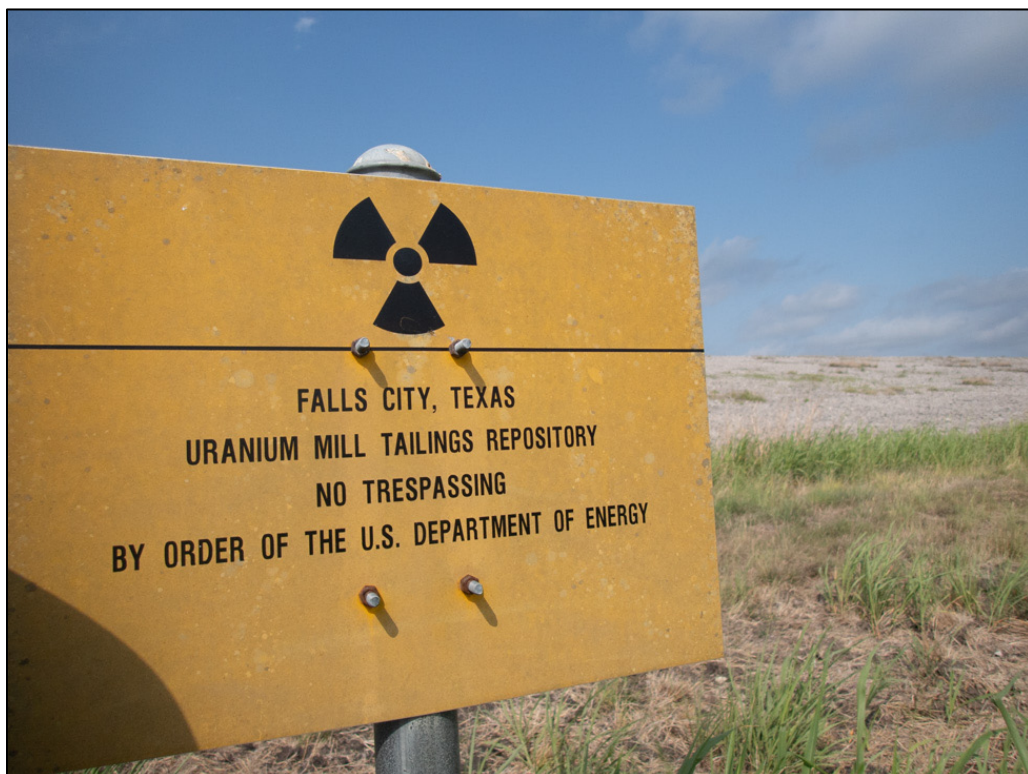
PL-3. Perimeter Sign P58

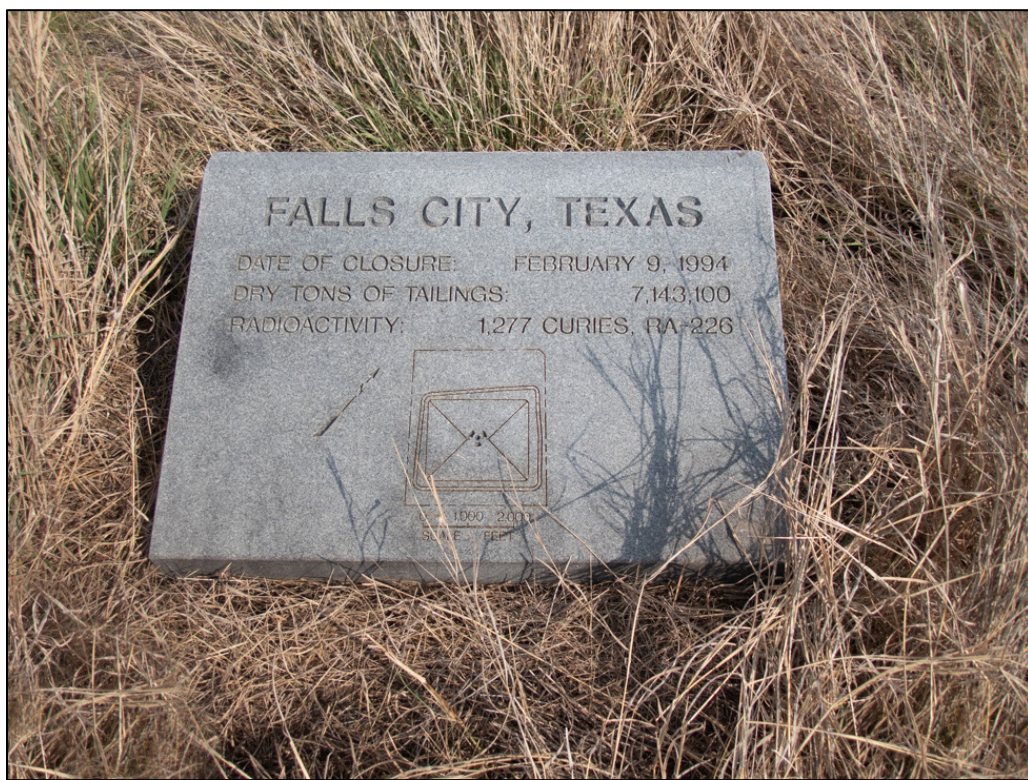
inspection, and repairs are not needed at this time. Site marker SMK-2 is on the top slope of the disposal cell (PL-4). No maintenance needs were identified.

PL-4. Site Marker SMK-2

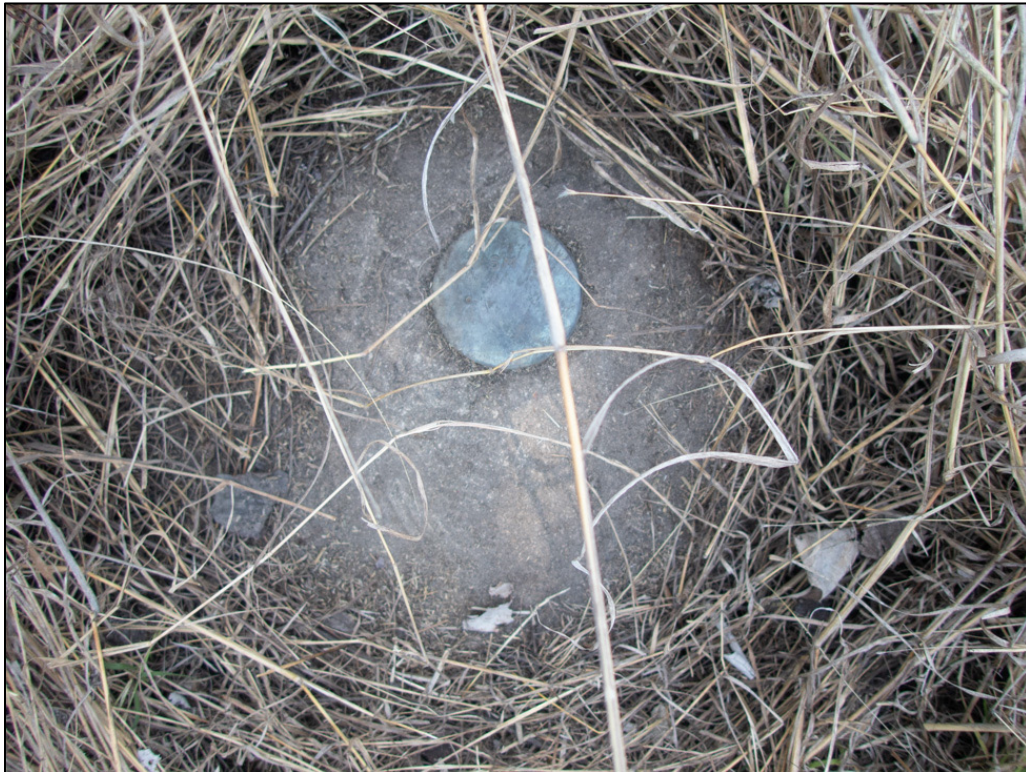
Three survey monuments and two boundary monuments delineate the corners of the property (PL-5). All monuments were located. No maintenance needs were identified.

PL-5. Survey Monument SM-2

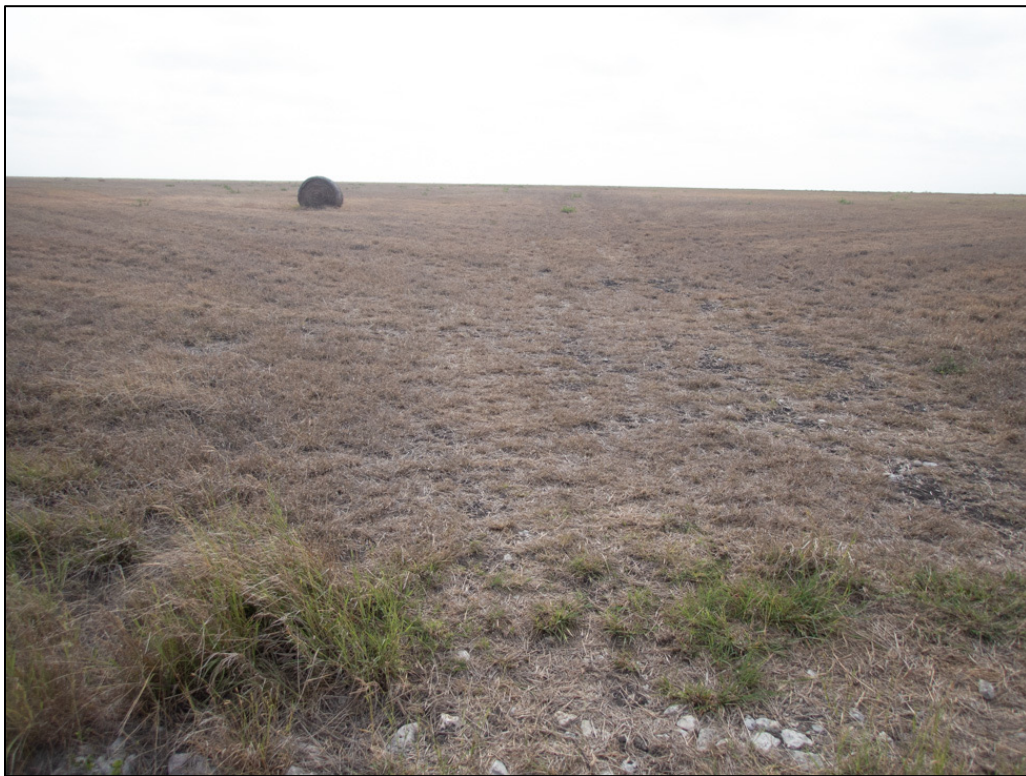
The disposal cell, completed in 1994, occupies 127 acres. Its vegetated cover consists primarily of well-established coastal Bermudagrass and kleingrass, with other species interspersed (PL-6). The site, including the disposal cell, is managed for hay production, which ensures that turf vitality is maintained. The LMS maintenance subcontractor can take as many as three cuttings of hay each year from the site. The LMS maintenance subcontractor spot-sprays woody vegetation distributed in the uncut grass. At the time of the May 2022 inspection, hay bales were present on the property.

PL-6. Disposal Cell Cover

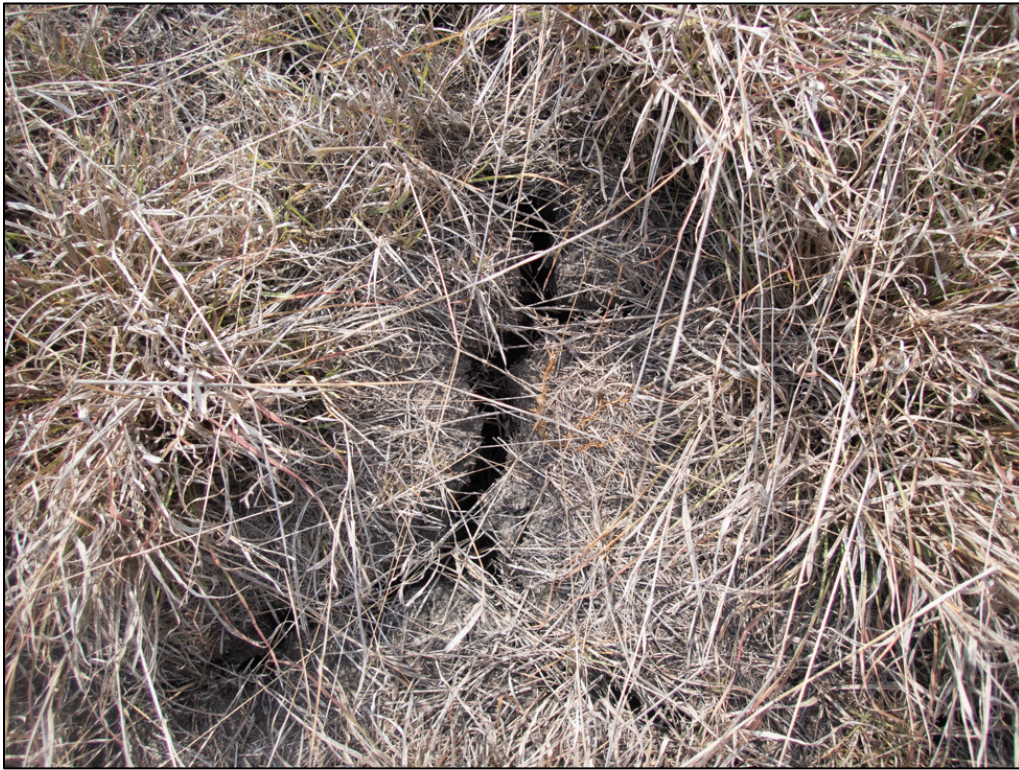
Desiccation cracks were observed in the soil on the top of the disposal cell (PL-7). There was no evidence of erosion, settling, slumping, or other modifying processes that might affect the integrity of the disposal cell. No areas of ponded water or areas of settlement were observed on top of the disposal cell during the 2022 inspection.

PL-7. Soil Desiccation Cracks on Top Slope of Disposal Cell

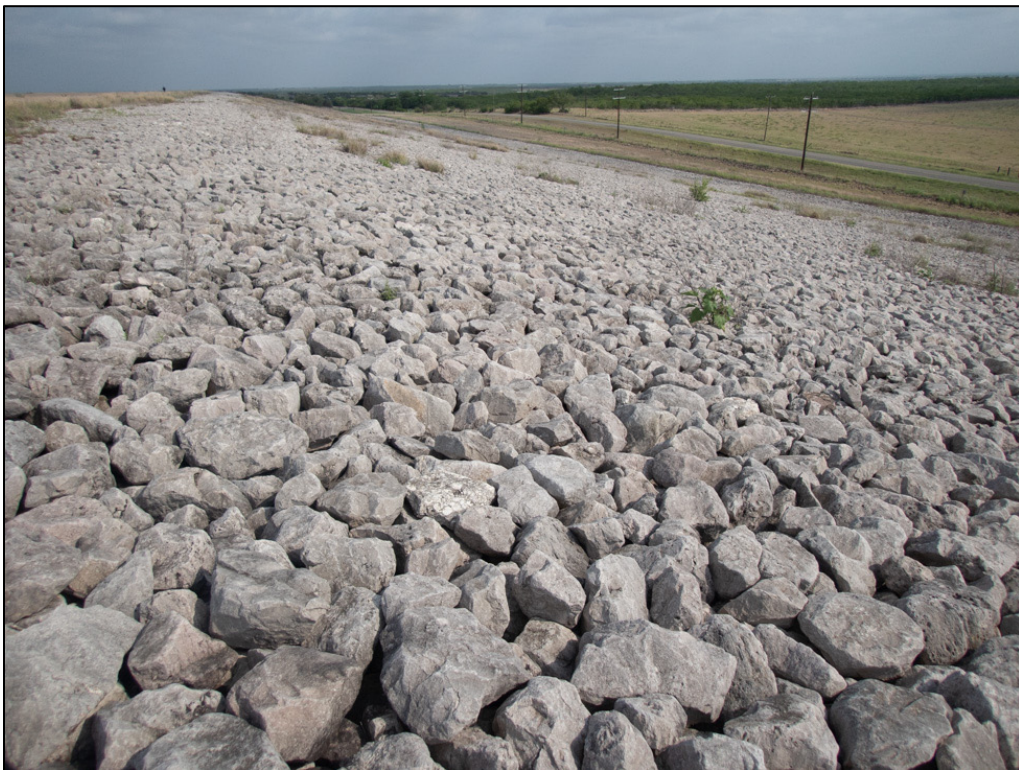
Riprap armors the disposal cell side slopes and a transition zone where the top slope meets the side slopes (PL-8). LM has monitored several small depressions on the northwest side slope of the disposal cell since 2010. These depressions do not compromise the protectiveness of the riprap side slope, and no changes have been observed since 2010. Inspectors will continue to monitor these areas.

Fractured riprap has been observed on the disposal cell side slopes since it was completed. Pieces of riprap are fractured in place, indicating that the fracturing occurred after placement. Fracturing

is likely a consequence of mechanical placement or thermal expansion and contraction; the riprap condition appears stable.

PL-8. Northeast Side Slope
