## 5.0 Falls City, Texas, Disposal Site

### 5.1 Compliance Summary

The Falls City, Texas, Uranium Mill Tailings Radiation Control Act (UMTRCA) Title I Disposal Site was inspected on May 23, 2023. No changes were observed in the disposal cell or associated drainage features, and personnel found no cause for a follow-up inspection.

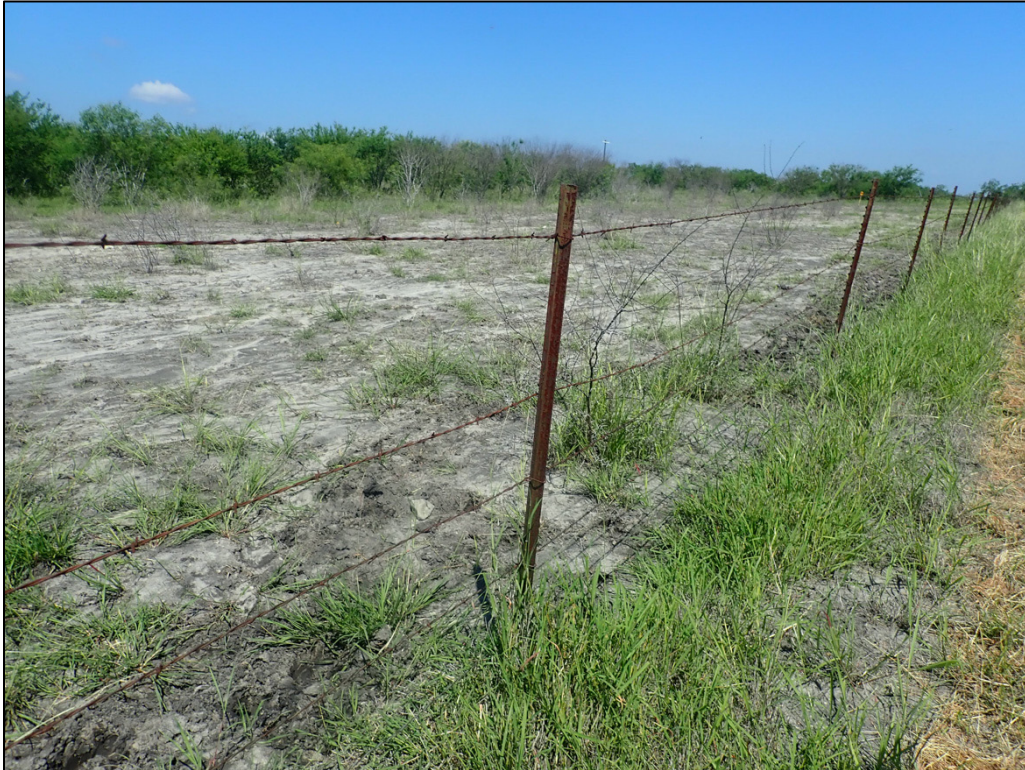
A five-strand barbed-wire perimeter fence encloses the site. As noted in previous inspections, perimeter fence strands and posts are beginning to rust except along the northwest side where the fence was replaced in 2006. The fence on the southwest side, between perimeter signs P33 and P38, showed signs of rust and damage and was repaired following the inspection. The rusting occurring between perimeter signs P29 and P32 will continue to be monitored (PL-1). The post at perimeter sign P38 is bent but functional (PL-2).

*PL-1. Rusting Fence Line*

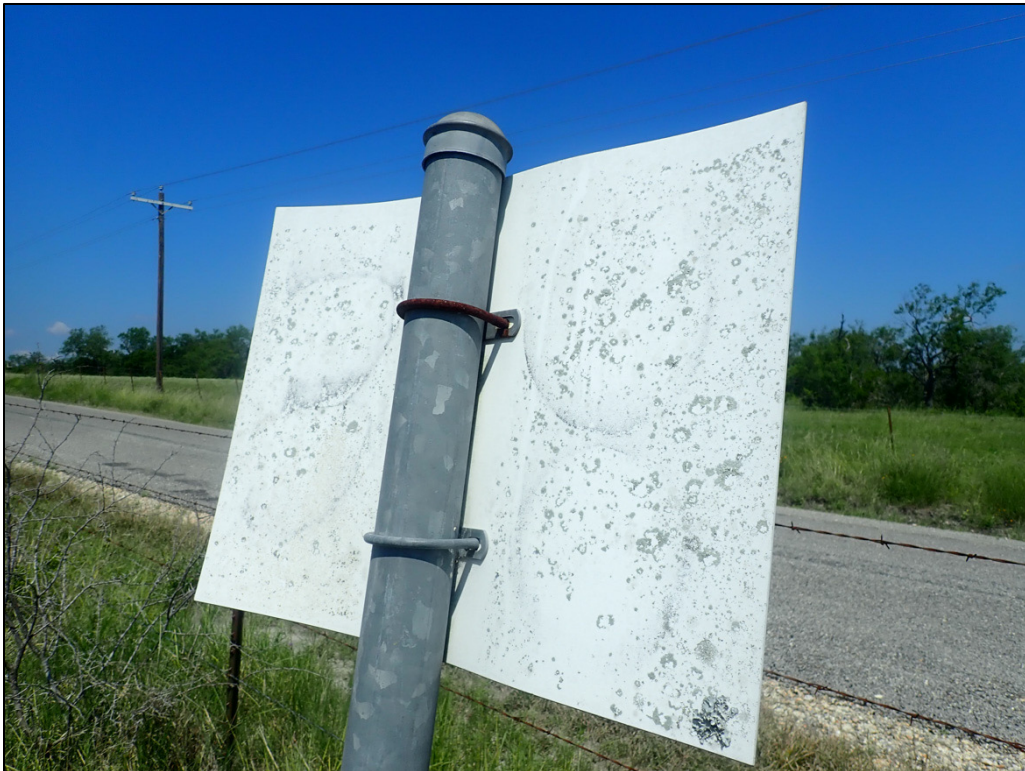
*PL-2. Perimeter Sign P38 with Bent Post*

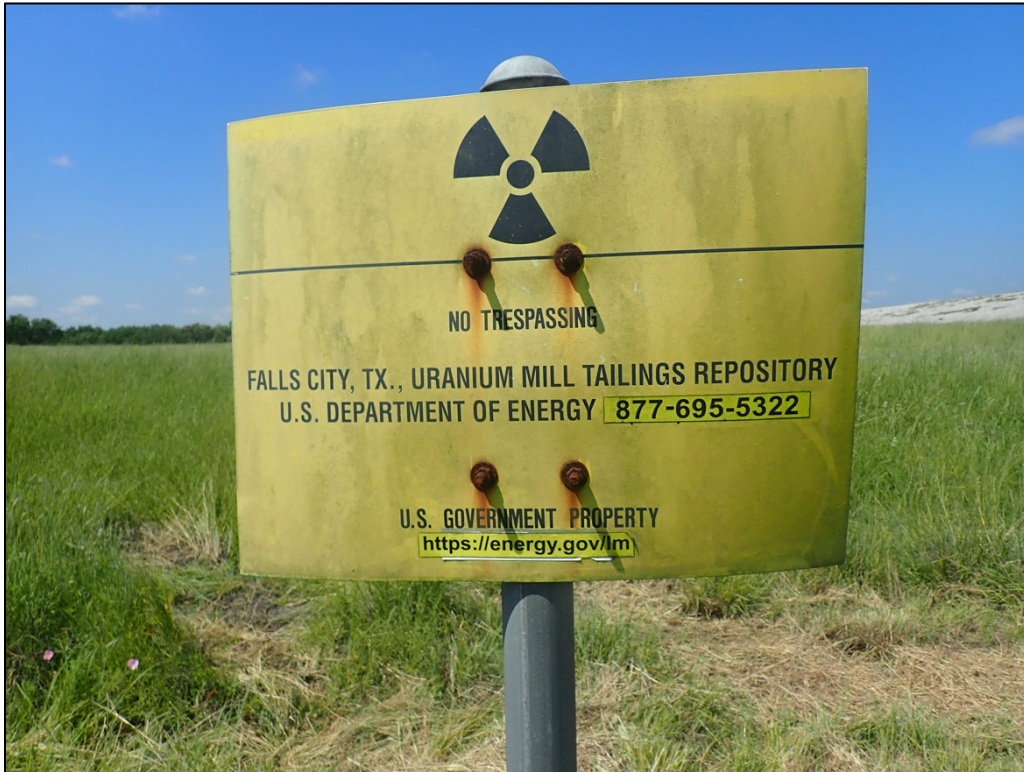
There are 64 perimeter signs attached to steel posts set in concrete and positioned along the property boundary and set back 5 feet (ft). Perimeter sign P64 (PL-3) was brittle and was replaced following the inspection, along with perimeter sign P62. Perimeter sign P45 was illegible and was replaced following the inspection. Perimeter sign P33 has bullet damage but remains legible. Additional perimeter signs are fading but remain legible. Replacement of the

*PL-3. Perimeter Sign P64*

- Replacement of perimeter signs P45, P62, and P64
- Replacement of the entrance sign on the northeast gate between perimeter signs P64 and P63
- Repair of the perimeter fence between perimeter signs P33 and P38
- Repair of the hog crossing between perimeter signs P27 and P28
- Repair of the hog rootings on the northwest and southeast outlying areas
- Removal of the tall grass and vegetation on the northeast side slope transition

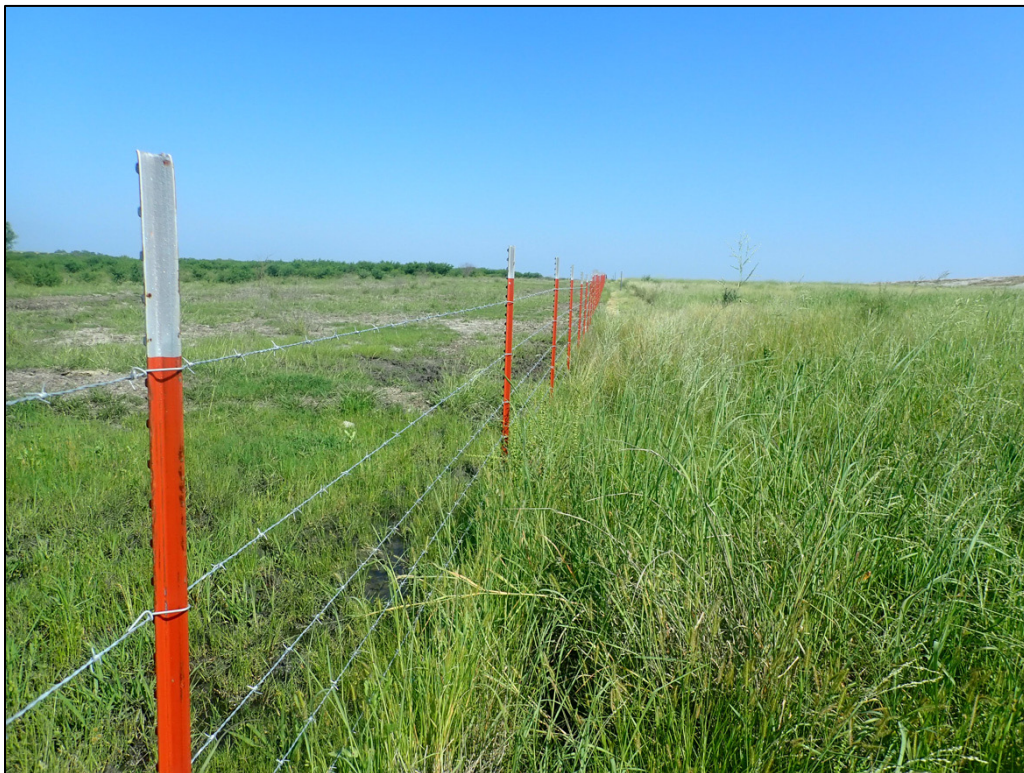
perimeter fence between perimeter sign P18 and survey monument SM-3 was completed following the 2022 inspection (PL-4). No other maintenance needs were identified.

*PL-4. Repaired Fence Line Between Survey Monument SM-3 and Perimeter Sign P18*

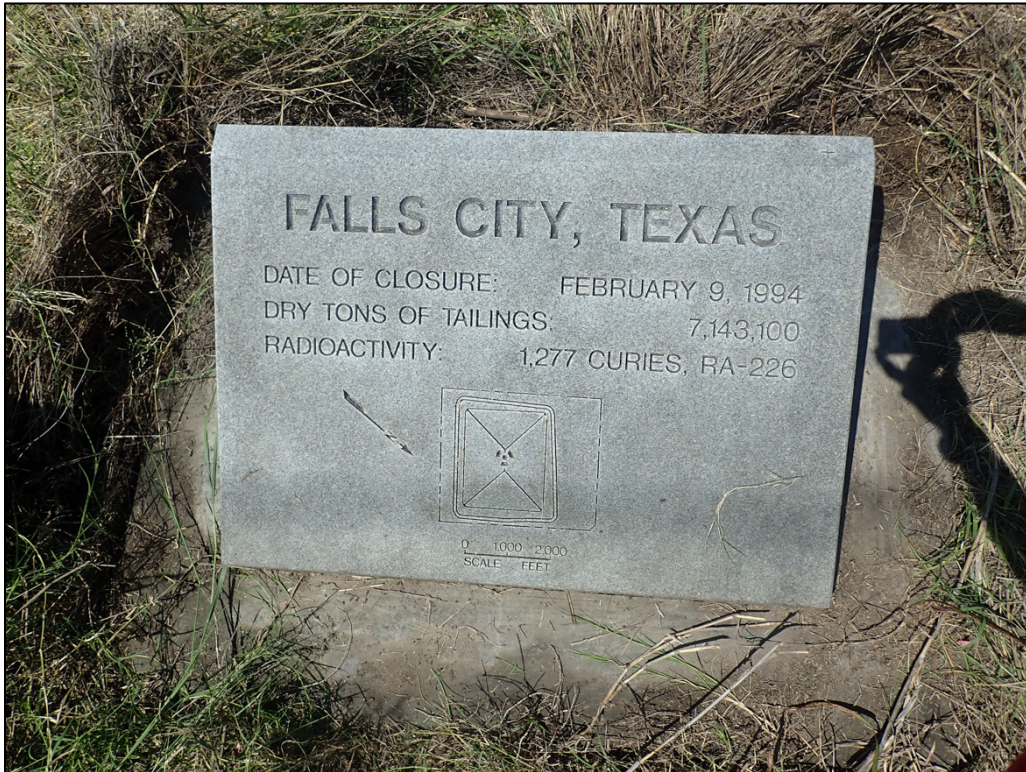
The site has two site markers. Site marker SMK-1 is just inside the entrance gate (PL-5). The corners of the concrete base around the marker are cracked. The cracks are unchanged since the last inspection, and repairs are not needed. Site marker SMK-2 is on the top slope of the disposal cell. No maintenance needs were identified.

*PL-5. Site Marker SMK-1*

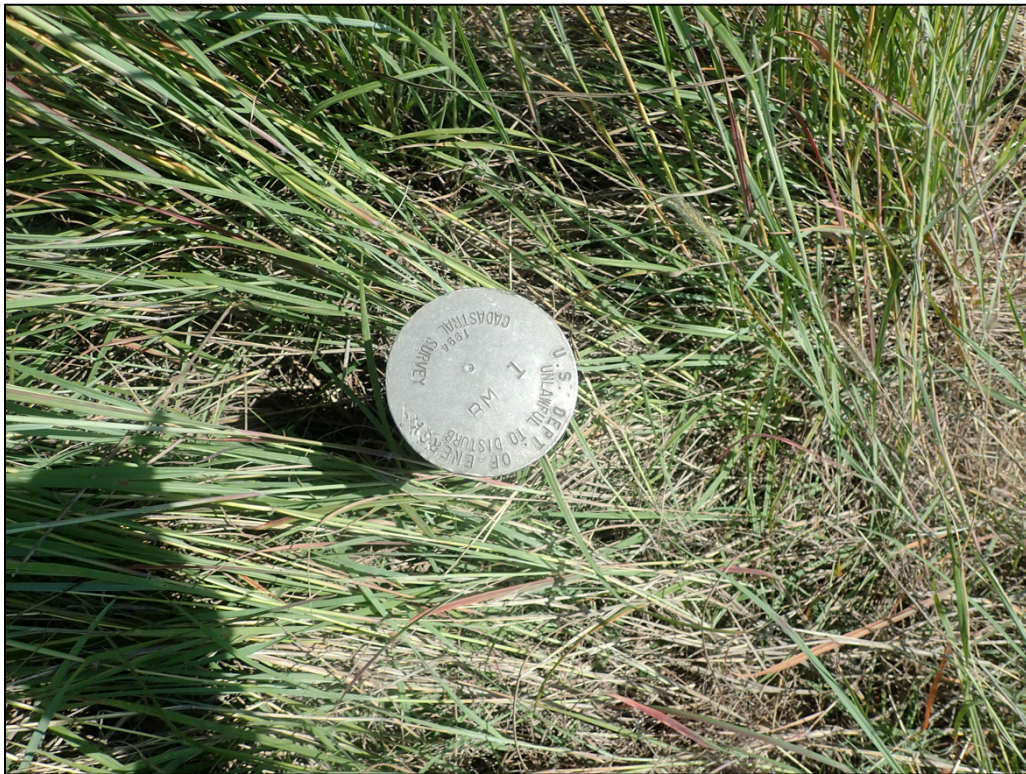
Three survey monuments and two boundary monuments delineate the corners of the property (PL-6).

*PL-6. Boundary Monument BM-1*

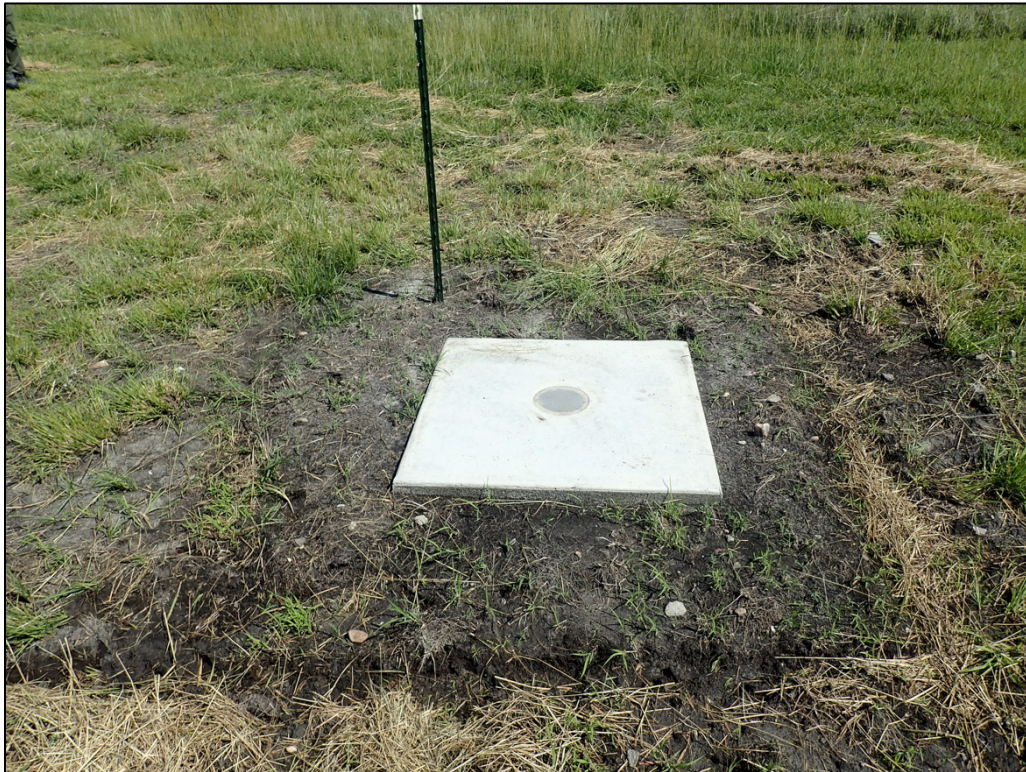
Six aerial survey quality control monuments were installed in February 2023 (PL-7). All monuments were in good condition during the inspection. No maintenance needs were identified.

*PL-7. Quality Control Monument QC-4*

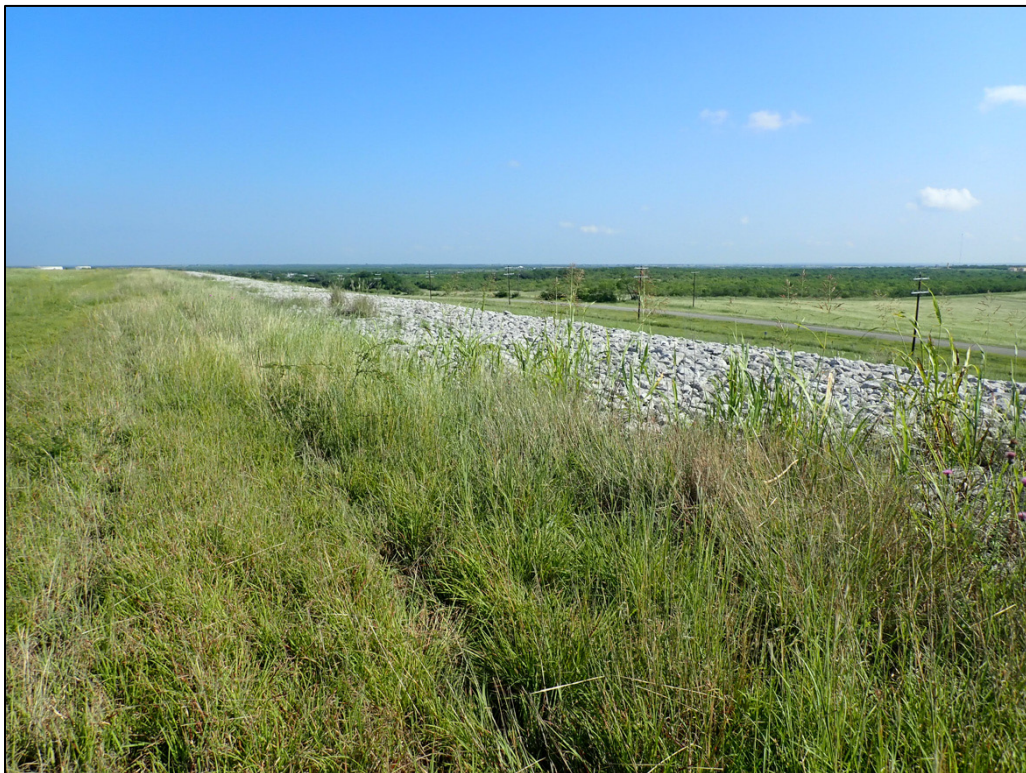
On the northwest side slope, there was tall grass overgrown at the transition point from the top of the side slope to the riprap side slope that was treated following the inspection (PL-8). LM has also monitored several small depressions on the northwest side slope of the disposal cell since 2010. These depressions do not compromise the protectiveness of the riprap side slope, and no changes have been observed since 2010. Inspectors will continue to monitor these areas.

*PL-8. Tall Grass Overgrown on Slide Slope Transition to Riprap*

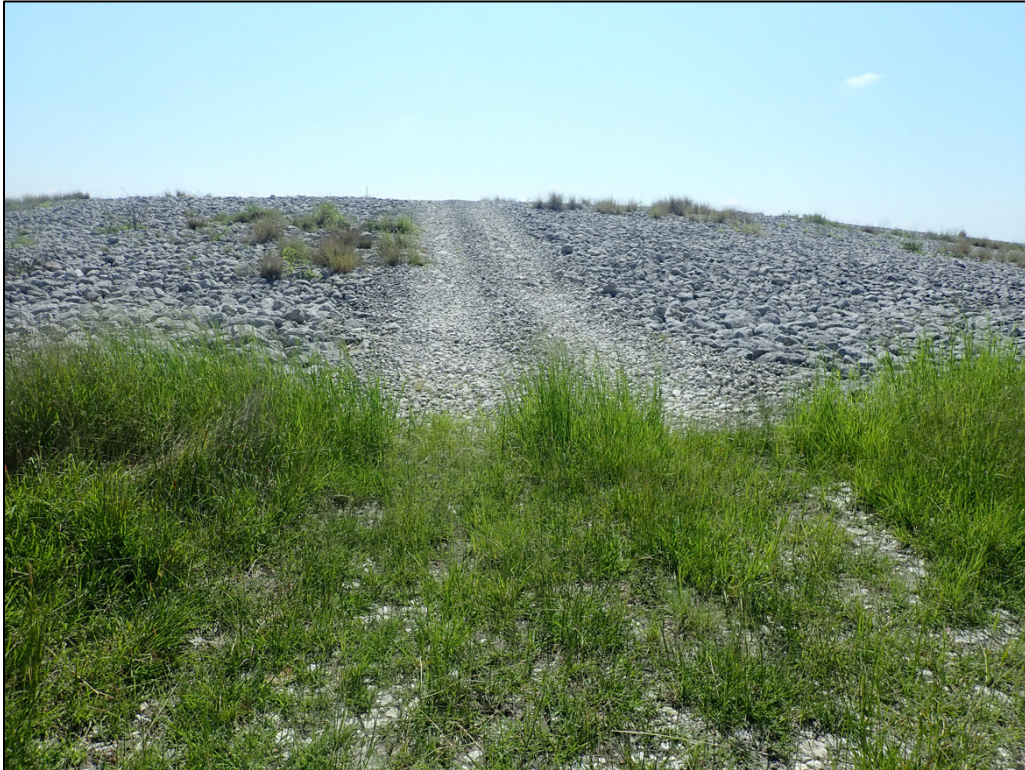
An equipment access ramp to the top of the disposal cell is at the west corner of the side slope (PL-9). The ramp was installed in 2006 using clean, angular riprap of progressively smaller rock sizes to provide a free-draining and stable driving surface that does not encourage vegetation encroachment. Some displacement of smaller rock has occurred, as would be expected from use, but the ramp continues to provide a stable driving surface.

*PL-9. Equipment Access Ramp*

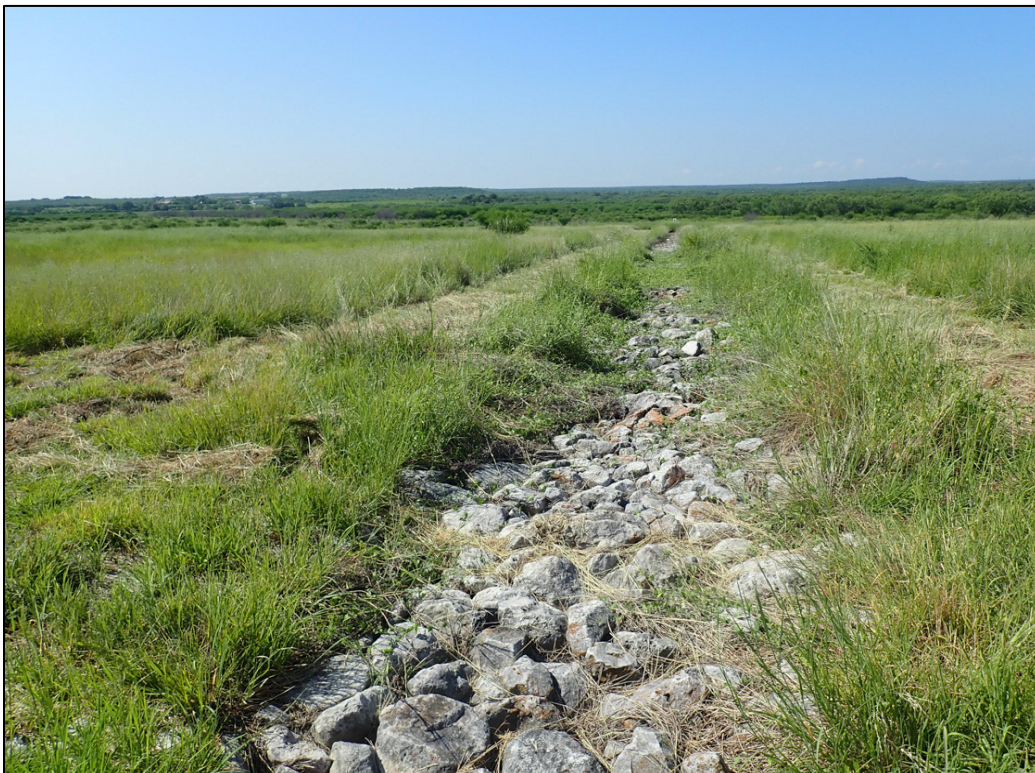
There was water slowly flowing in the south rock drain during the inspection (PL-10) with water ponding on the south corner noted on the inspection map. Willows that grow along the south drain are periodically removed by the LMS maintenance subcontractor. No water was observed in the north rock drain. Vegetation is left uncut at the outlets of the rock drains to help dissipate the energy of stormwater runoff and reduce soil erosion. No maintenance needs were identified.

*PL-10. South Rock Drain*
