2.0 Edgemont, South Dakota, Disposal Site

Figure 2-1. 2008 Annual Compliance Drawing for the Edgemont, South Dakota, Disposal Site

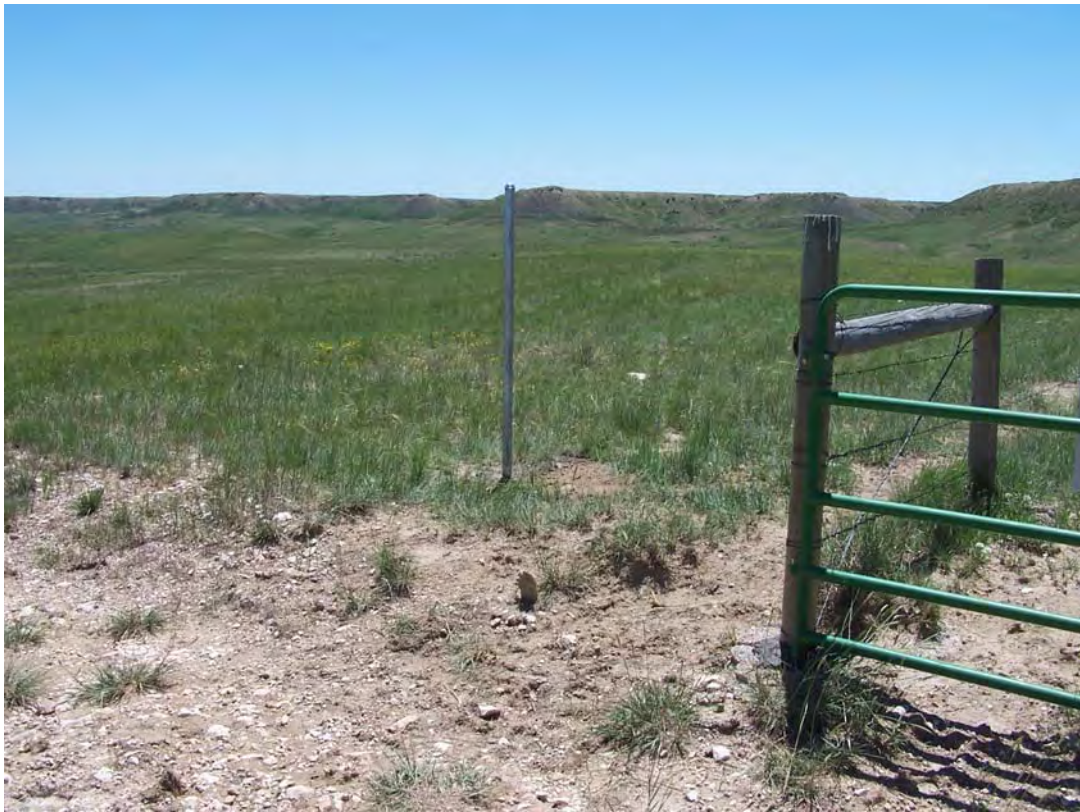
2A A new entrance signpost was set in concrete during the inspection (PL-1); cattle had knocked it down the previous year. To allow time for the concrete to cure, the entrance sign was left at its temporary location on the entrance gate; it was fastened to the signpost in September 2008.

EDG 6/2008. PL-1. New signpost installed at the entrance gate.

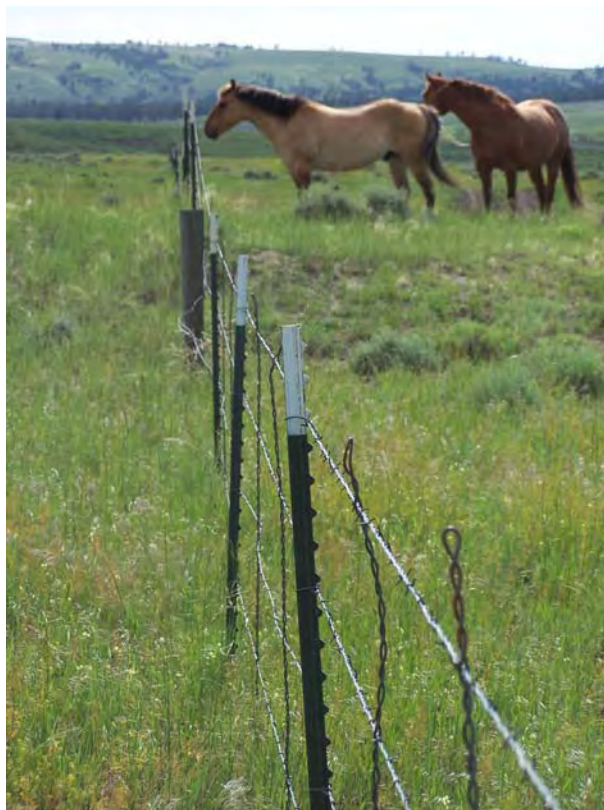
A four-strand barbed wire fence was installed in spring 1999 along the site perimeter boundary to demarcate DOE property and to control grazing on the property. The fence truncates the southeast corner to allow livestock access to a pre-existing stock pond. A grazing license granted by DOE allows a local rancher to graze the site in return for checking site security and maintaining the perimeter fence. An all-terrain vehicle was used to inspect the entire site perimeter, and the fence was in excellent condition (PL-2).

EDG 6/2008. PL-2. South fence line and grazing horses.

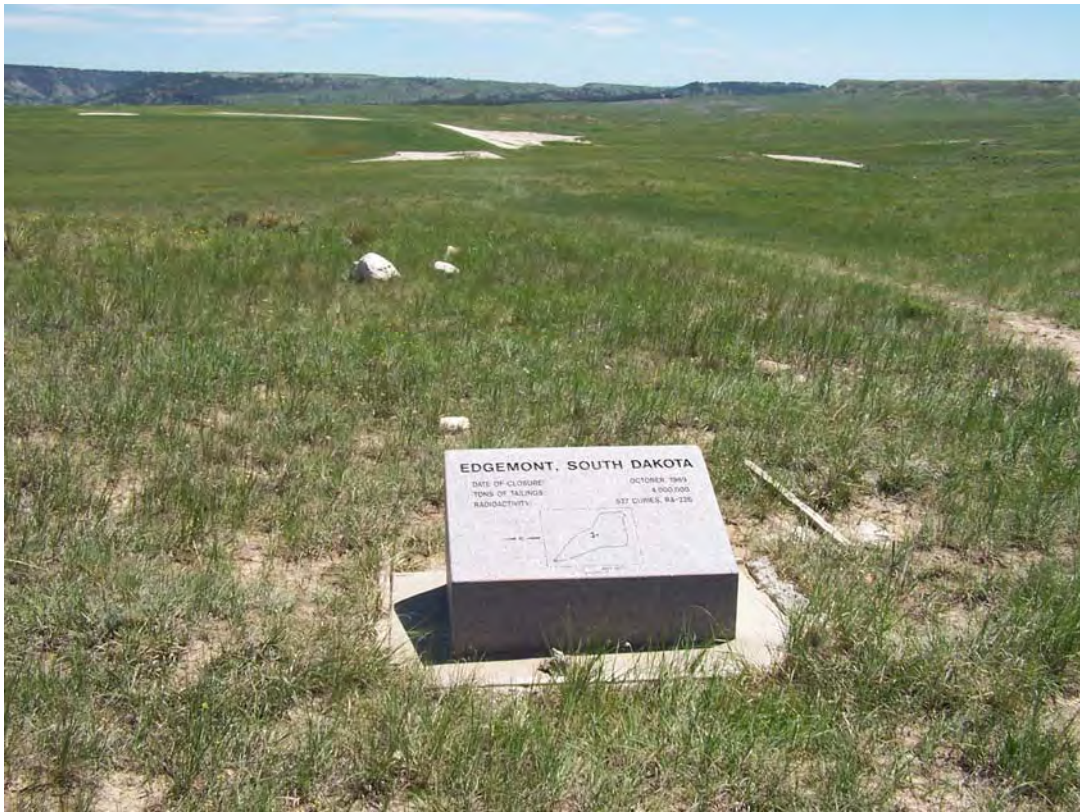
Site Marker and Monuments—One unpolished granite site marker identifying the disposal site is located just inside the entrance gate and was in excellent condition (PL-3). Four boundary monuments, located at each corner of the property, were in excellent condition.

EDG 6/2008. PL-3. Site marker.

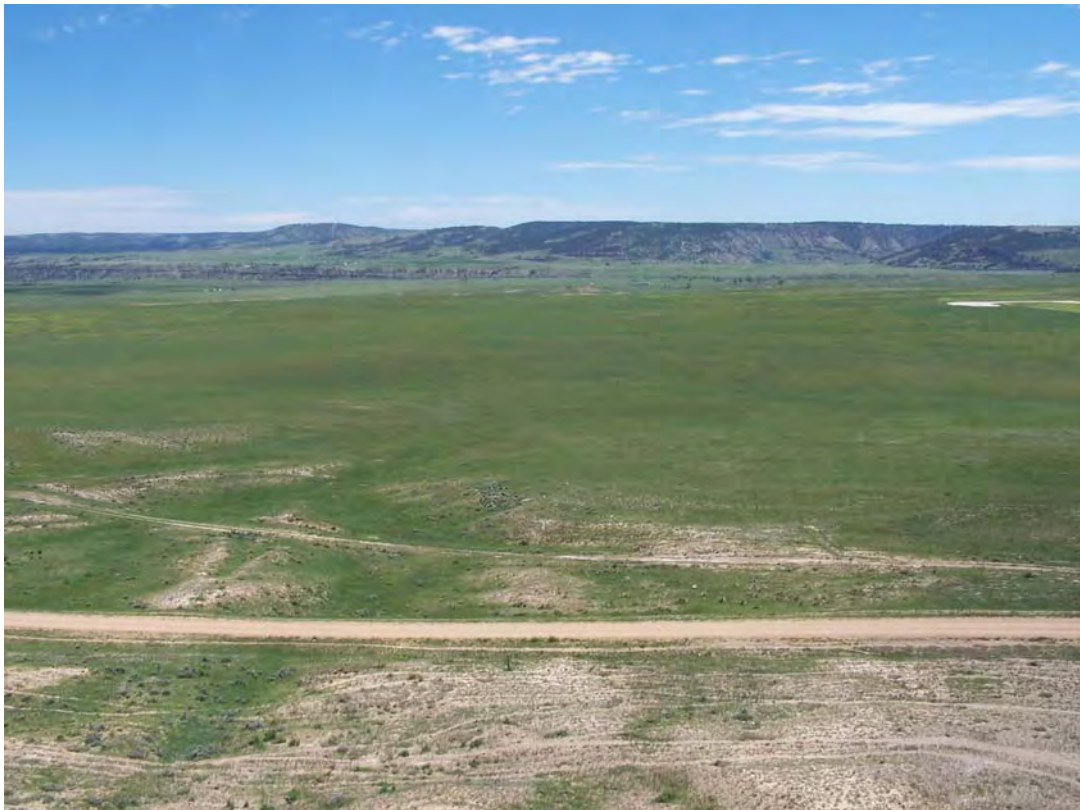
Top of the Disposal Cell—The 100-acre top of the disposal cell, completed in 1989, is grass-covered and in good condition (PL-4). Cattle and antelope were present on the cell cover the day of the inspection (PL-5). Although numerous cattle trails are present on the cell, no signs of erosion, settling, or other modifying processes that might affect the integrity of the cell were noted. The grass cover, which DOE manages through controlled grazing under license agreement, was healthy but weedy. The seeded grasses were well established, but a significant percentage of the plant cover was composed of non-noxious weedy species. Grazing periods will be modified and the range condition will continue to be monitored.

EDG 6/2008. PL-4. Central portion of the disposal cell.

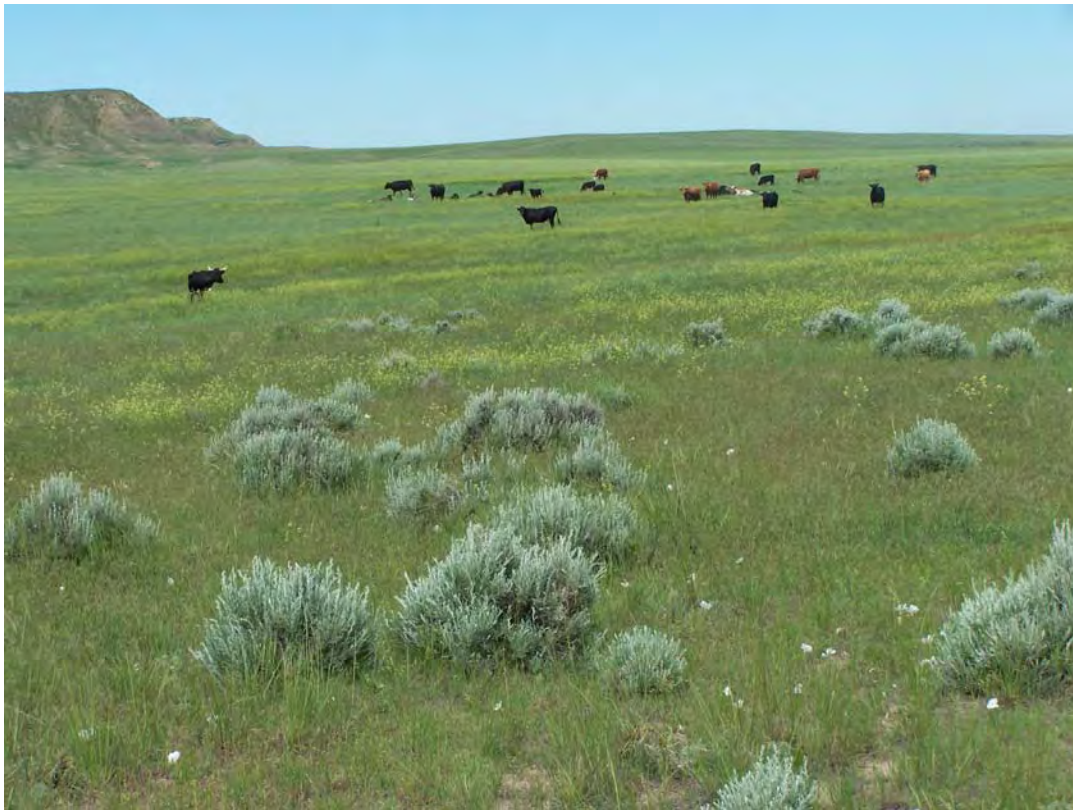
EDG 6/2008. PL-5. Cattle grazing on the disposal cell cover.

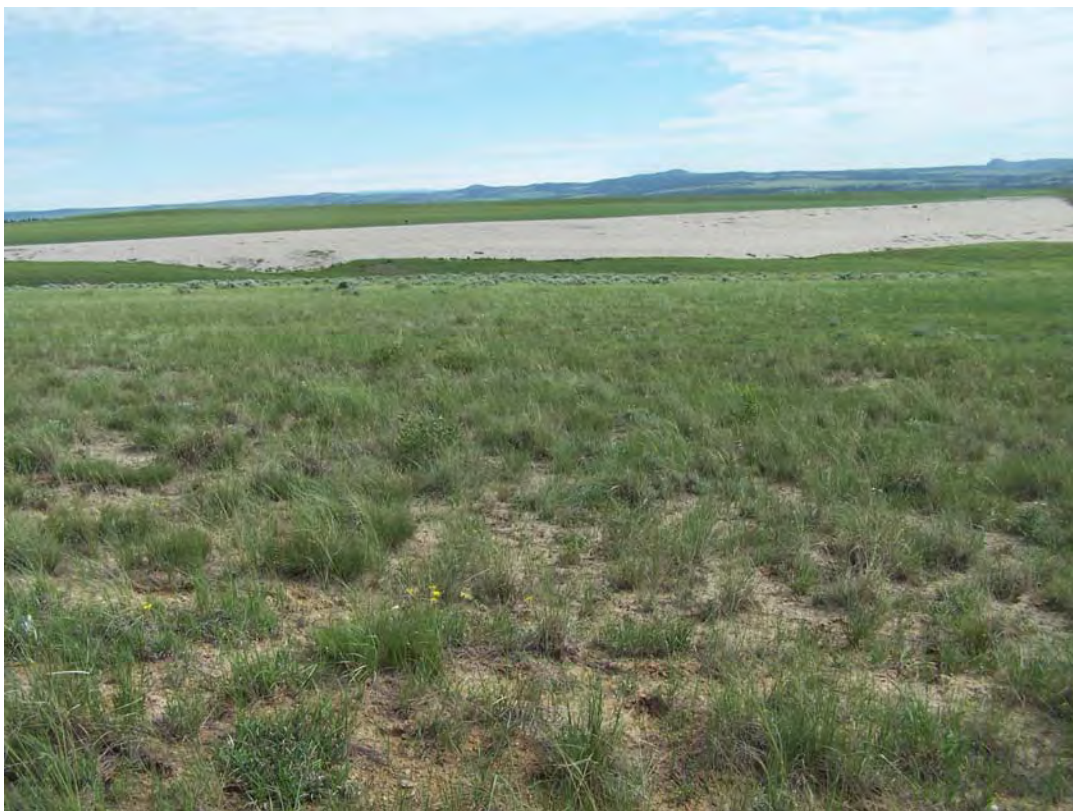
Embankment Face and Drainage and Diversion Channels—The embankment face, the steepest man-made slope on site, is covered with riprap. The slope is stable, and the riprap showed no signs of degradation (PL–6). Scattered plants, mostly grass and annual weeds, grow in the riprap. These plants do not pose a threat to the stability or function of the embankment face.

EDG 6/2008. PL-6. View of native rangeland and the tailings embankment face.

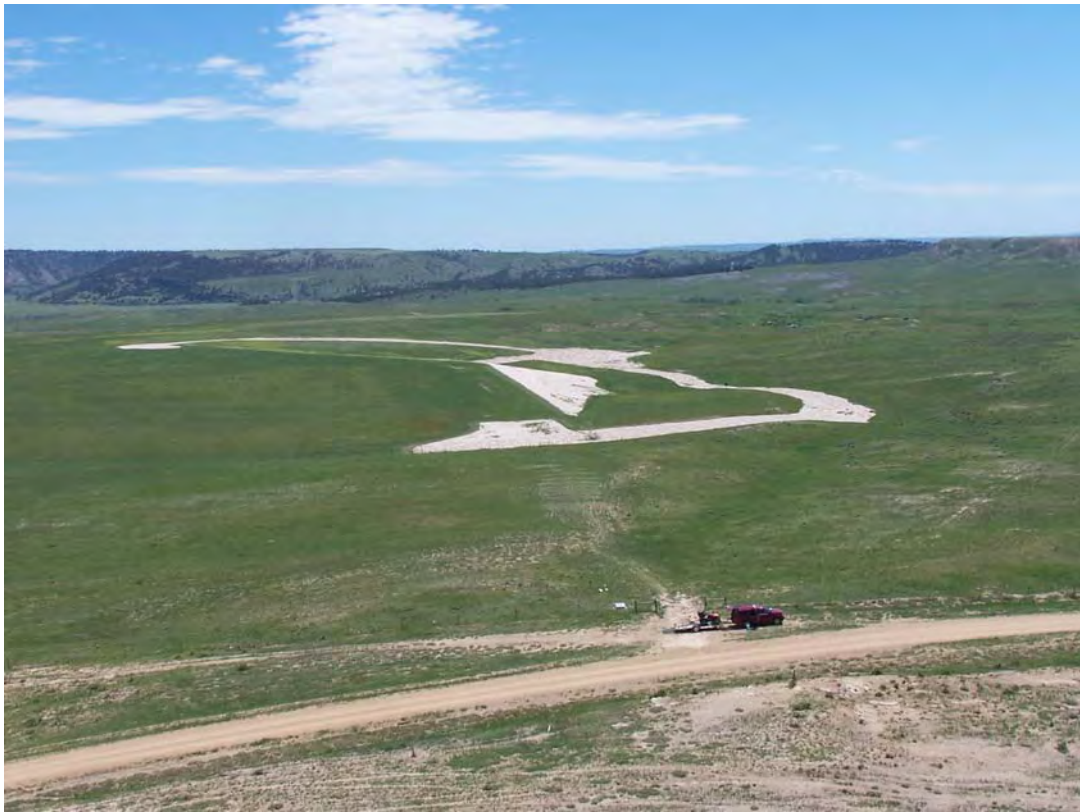
Diversion and drainage channels are grass-covered on their upgradient portions (these are gentle swales on each side of the disposal cell) and riprap-armored on their downgradient portions and on steeper slopes (PL–7, PL–8, and PL–9). Grass in the vegetated portions of the channels is dense and healthy, and there was no evidence of erosion. Minor amounts of vegetation occur in the riprap. The vegetation density does not appear to have increased significantly in the last few years and does not pose a threat to the function of the channels. The riprap-armored surface drainage channel just outside the northwest corner of the property, designed to prevent headward erosion onto the disposal site, was also stable and in good condition.

EDG 6/2008. PL-7. Southeast portion of the disposal cell showing the tailings embankment and diversion channels.

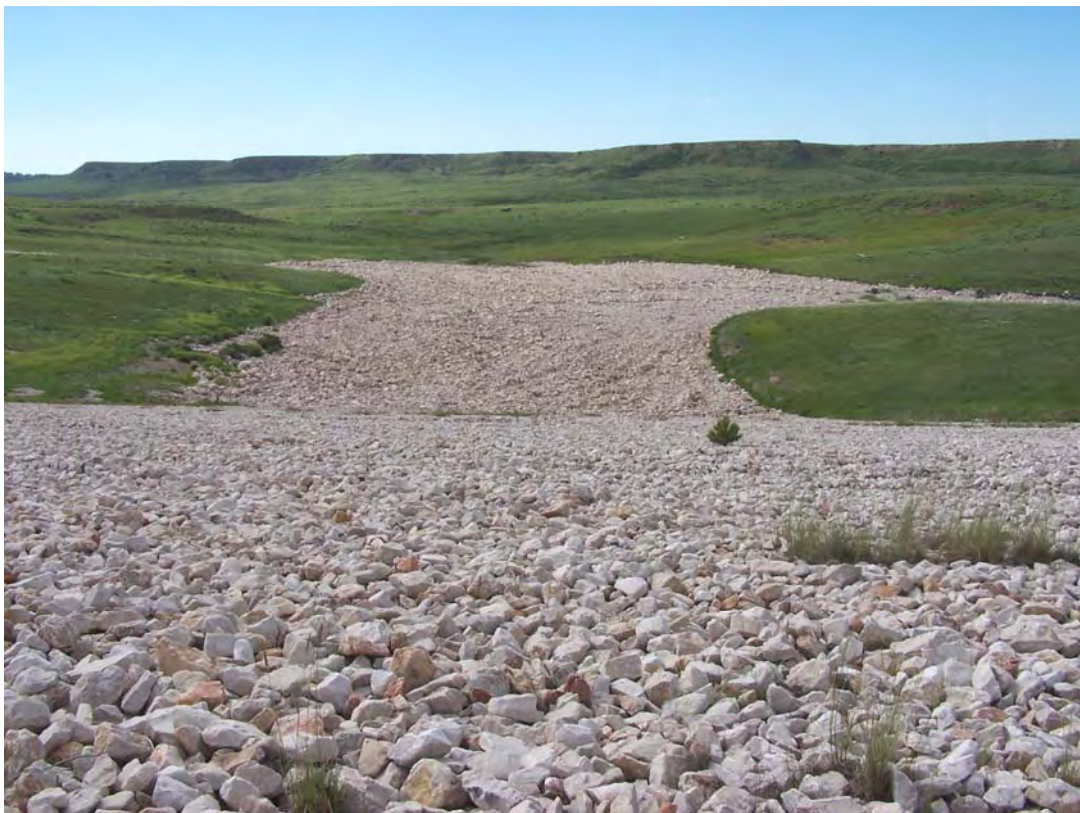
EDG 6/2008. PL-8. Main drainage channel viewed from the top of the tailings embankment.

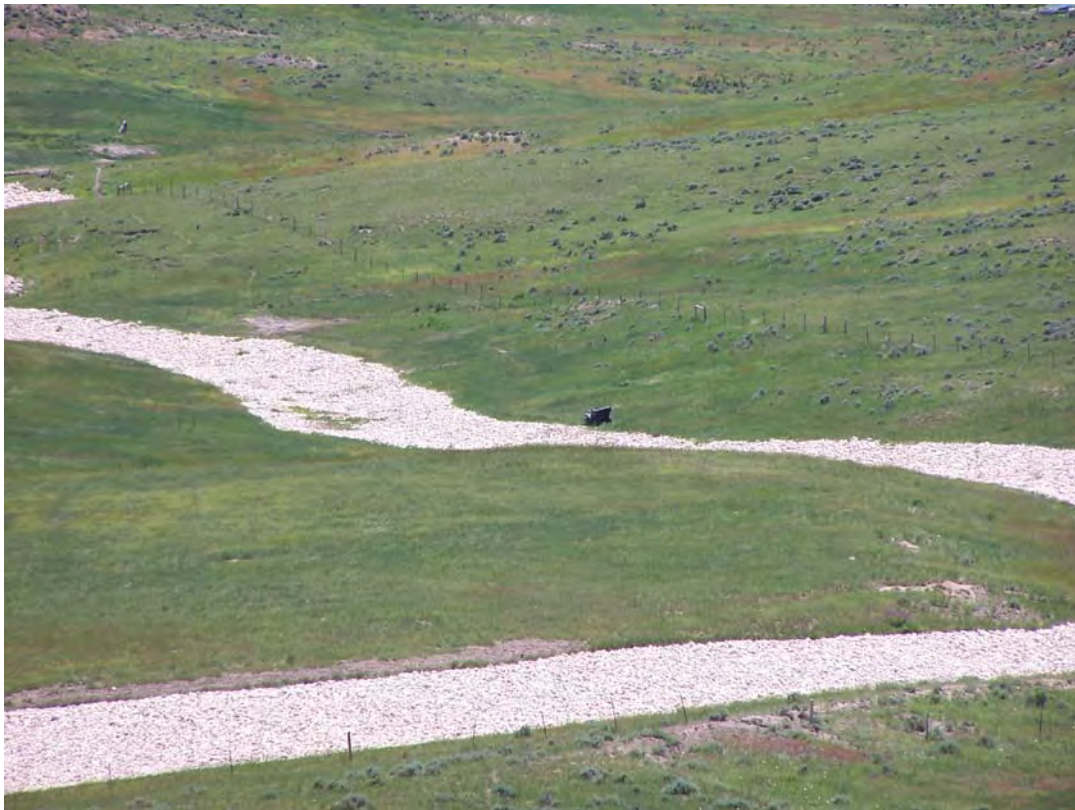
EDG 6/2008. PL-9. West diversion channel.

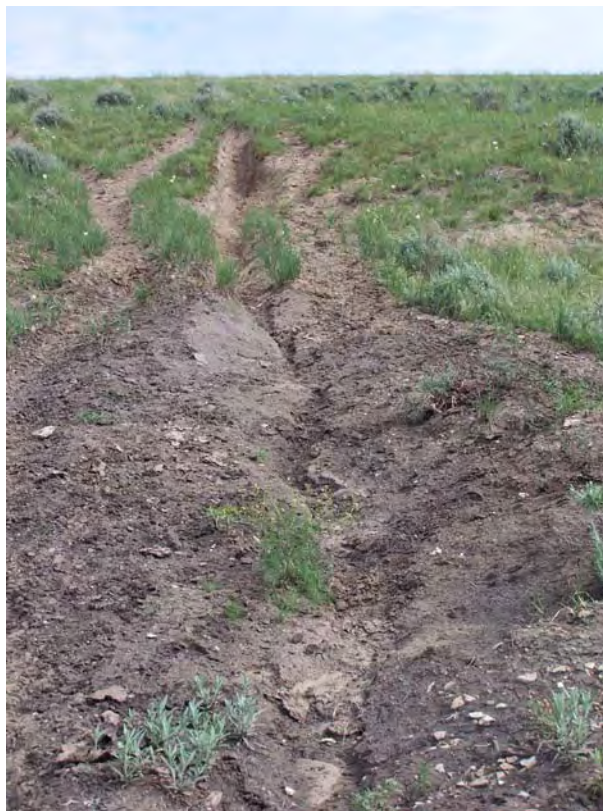
Evidence of cattle grazing is present throughout this area of the site. Cattle trails are common and in a few places have concentrated storm runoff and created rills and gullies. The worst erosion features, located in the southeast portion of the site (PL–10), do not have the potential to affect the disposal cell. Although minor natural erosion is occurring on the steep shale slopes in the east and northeast portions of the site, this undisturbed region of the site remains in good condition.

EDG 6/2008. PL-10. Soil erosion along cattle trail.
